APPENDIX H

Field Reports

PROJECT VISITED: Fort Totten Army Garrison, Bayside Queens, NY

PURPOSE OF VISIT: To perform groundwater sampling of newly installed monitoring well, as well as, perform pipe inspection of the floor drain located in building 615.

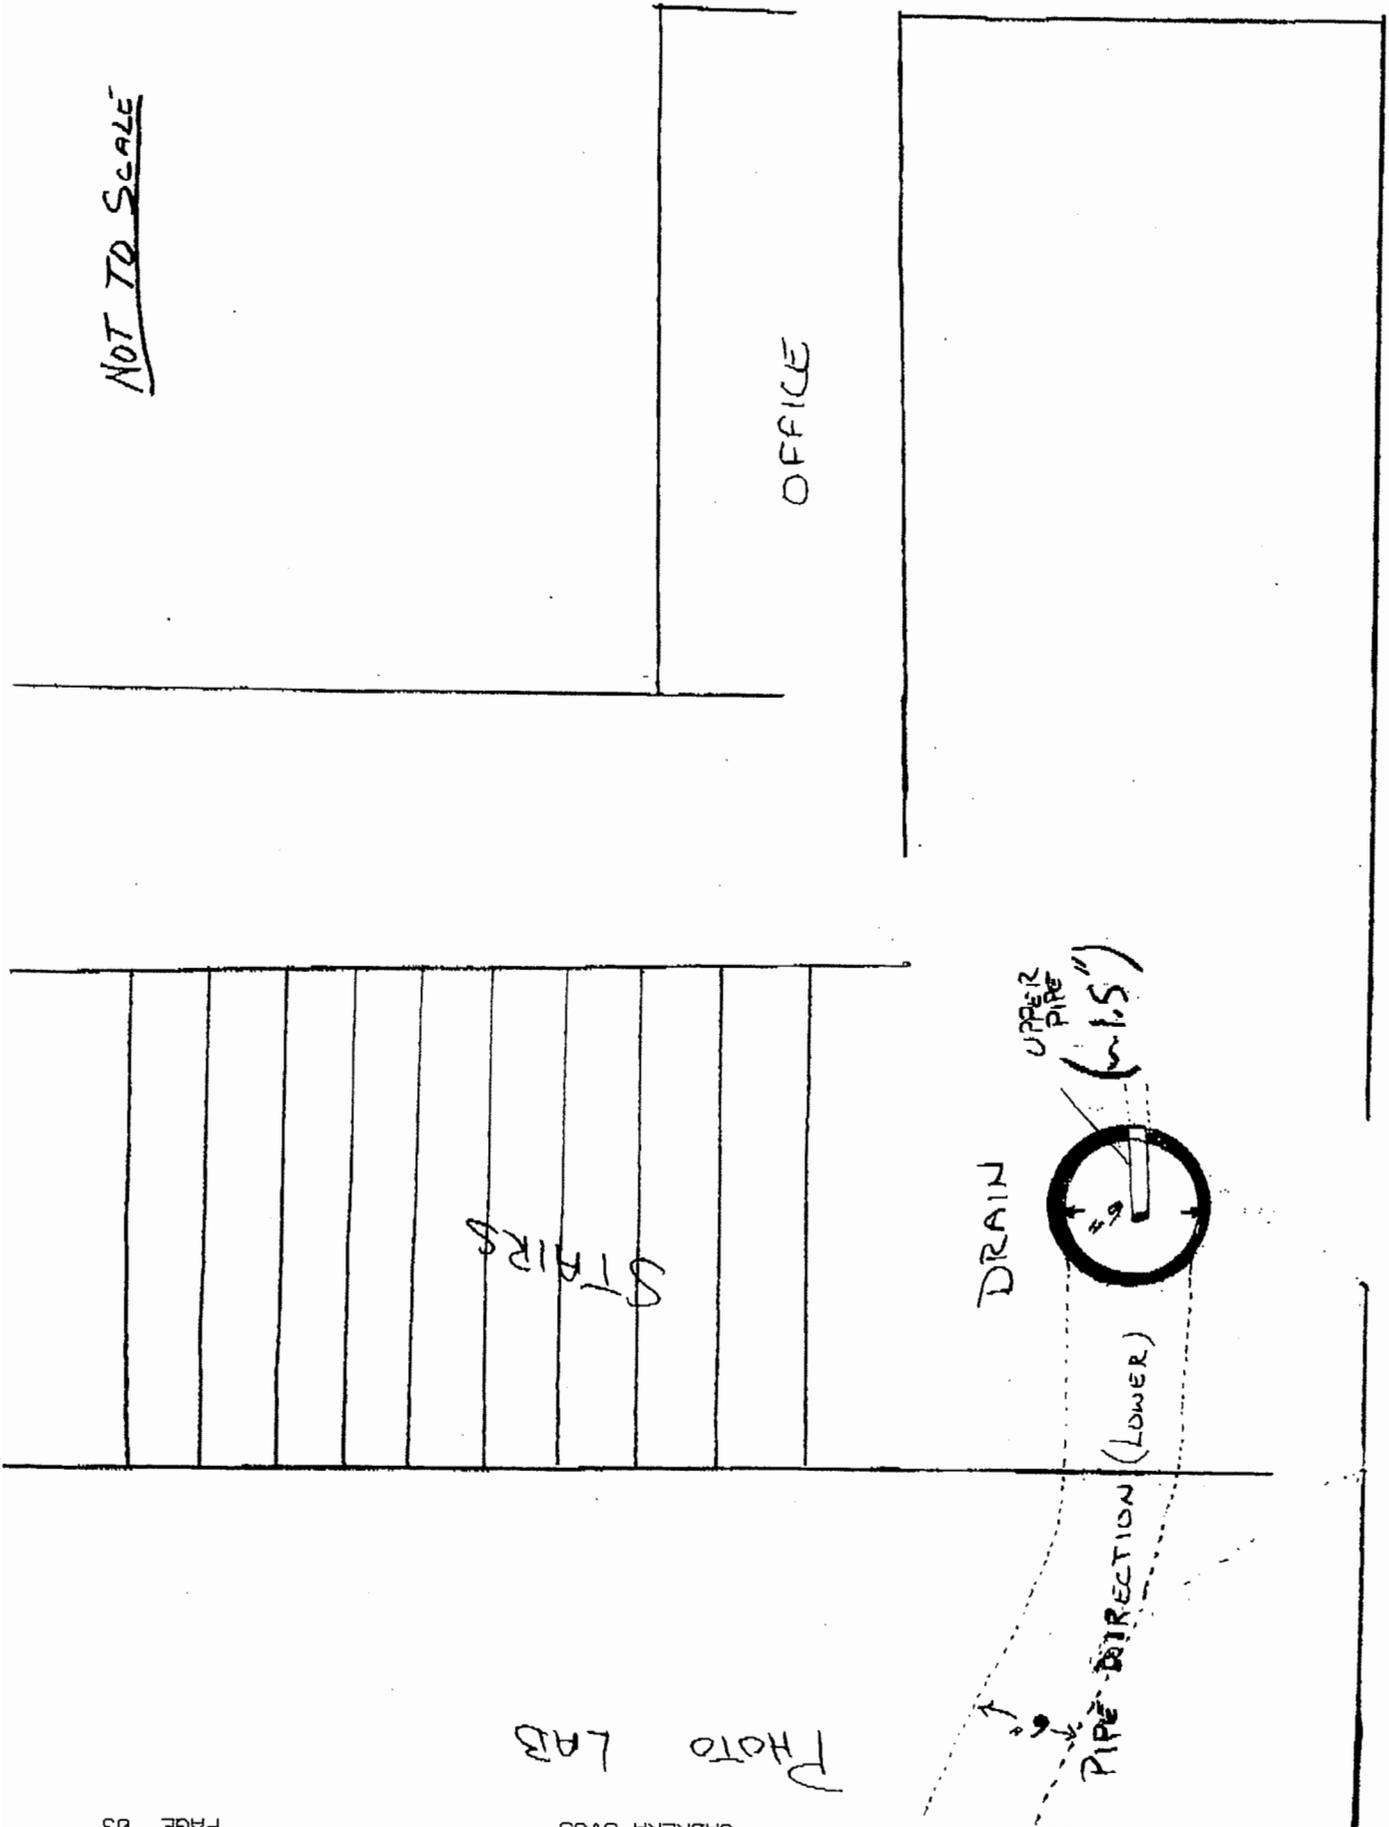
INSIDE BLDG 615 FRONT DOOR

Prior to any work being conducted on the floor drain, a visual inspection was performed on both pipes (upper and lower). The upper pipe, a 1-1.5 inch steel pipe, lead in the direction of the building 615 bays, which are now occupied by the NYPD, new vehicle preparation unit. After closer evaluation, small, shiny, drops appeared to be inside the upper pipe.

During the visual observation of the drain, it was noticed that there was an obstruction of compacted mud just inside the elbow of the drain. The manual plumbers snake was utilized in conjunction with the bore-o-scope to break up this obstruction.

The visual inspection of the pipe ended when an elbow in the pipe was reached. When the bore-o-scope was pushed past this elbow, mud packed the camera lens blinding the camera.

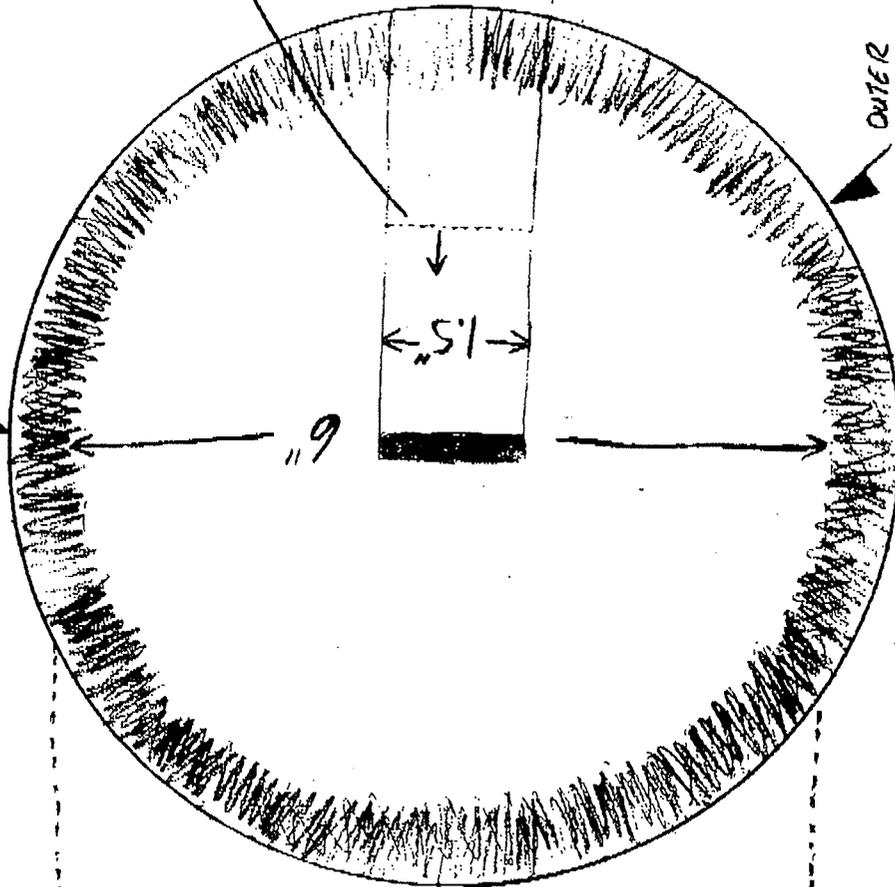
FRONT DOOR
VIEW INSIDE FLOOR DRAIN (2 PIPES)

Prior to the introduction of the bore-o-scope into the floor drain, a portion of the upper pipe had to be cut off so that the bore-o-scope could be placed in the floor drain. The portion of the pipe that was removed was placed in a double plastic bag and stored on ice to be shipped to the lab for mercury analysis.
