Excavation Field Reports 2006 and 2007

FIELD REPORT, FORT TOTTEN CONTENT SAMPLING ON 9 MAY 2006

**FIELD REPORT, BUILDING 615 FORT TOTTEN EXPLORATORY
INVESTIGATION
30-31 OCTOBER 2006**

SUBJECT: Field Report and Recommendations, Fort Totten Building 615 Remedial Excavation,
22 March 2007

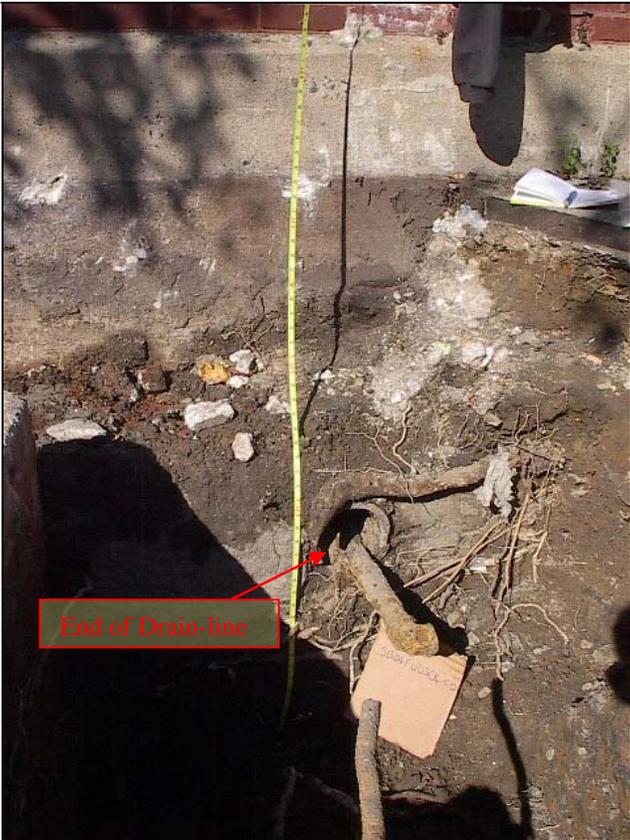
Photo 1 - Probable End of Drain-line

The apparent end of the drain-line was discovered. It appeared to be of the same material and diameter as the drain-line observed at the 15-ft T-joint. The end was flush with the footing wall. There was a 2-in metal pipe stuck inside it (Photo 1). This may have been used at one time to plug the drain-line. The top of the drain-line was 0.6-ft below the top lip of the footing wall.

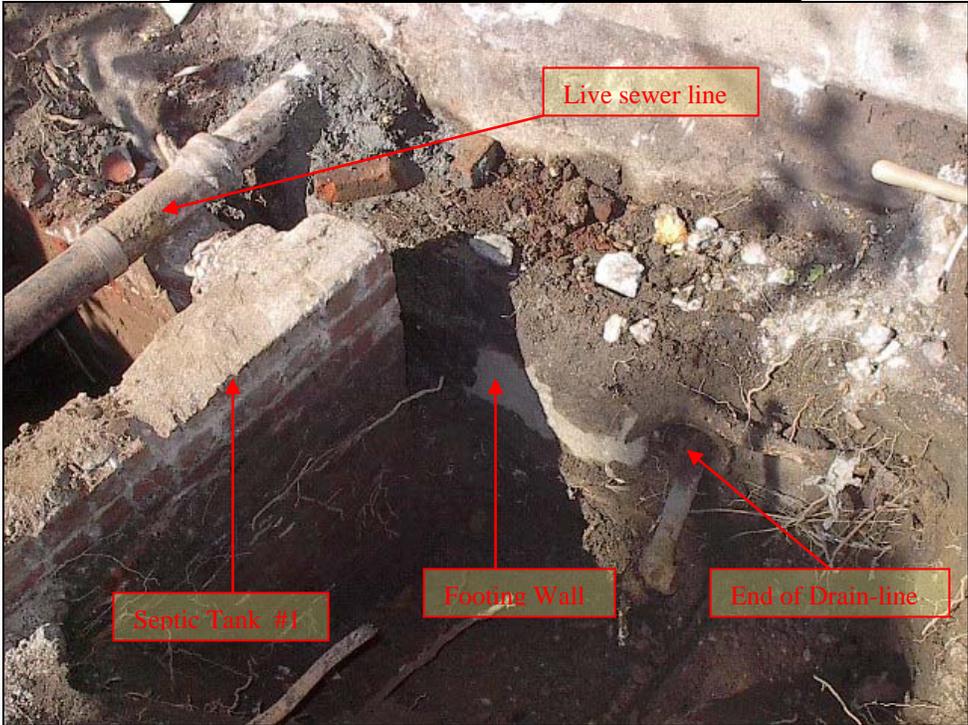
It appears the drain-line never did drain into any of the septic tanks, but instead drained into the surrounding soil at the point of discharge at the footing wall (Photo 2). The evidence for this conclusion is based on:

- The end of the drain-line was flush with the building footing wall which implies it never extended beyond this point.
- Also, the drain-line's elevation as it exits the footing is below the top of the brick of the septic tanks.
- There were no perforations along the walls of the septic tank.

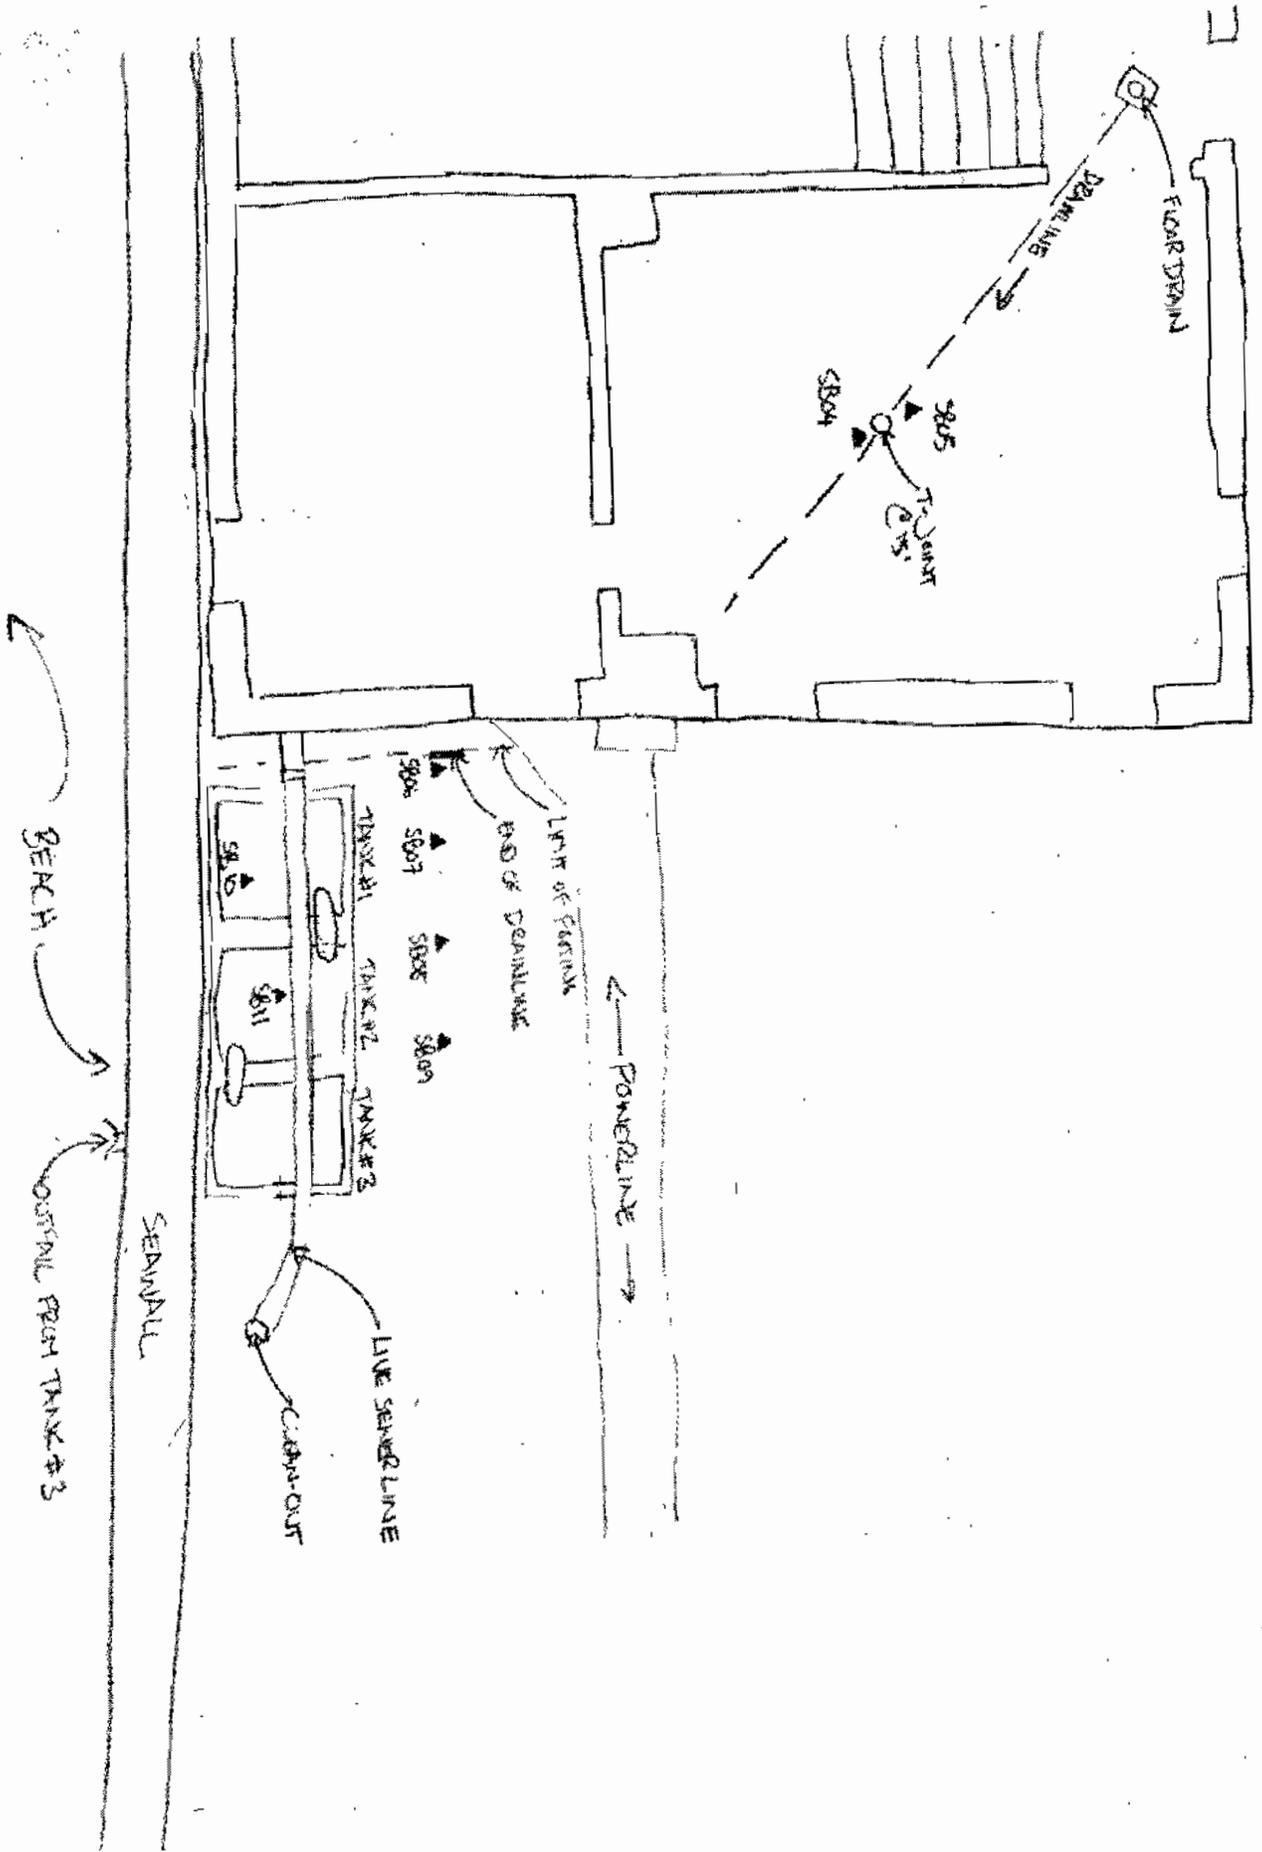
FIGURE 1 - 30-31 OCTOBER 2006

Two septic tanks were excavated by hand digging. The septic tanks were constructed of two courses of brick and were in-line and upstream from the septic tank uncovered during the 9 May 2006 investigation. Septic tank #1 were dug out to a depth of 5-ft below the top of the brick. There was evidence of the tank being filled in. There was a layer of soil with brick and concrete debris from 3 to 4 feet below the top of the tank, suggesting the lid of the tank had been punched in and subsequently filled in. This probably occurred during the activities of Pete the Plumber. Figure 1 shows the location of the three septic tanks.

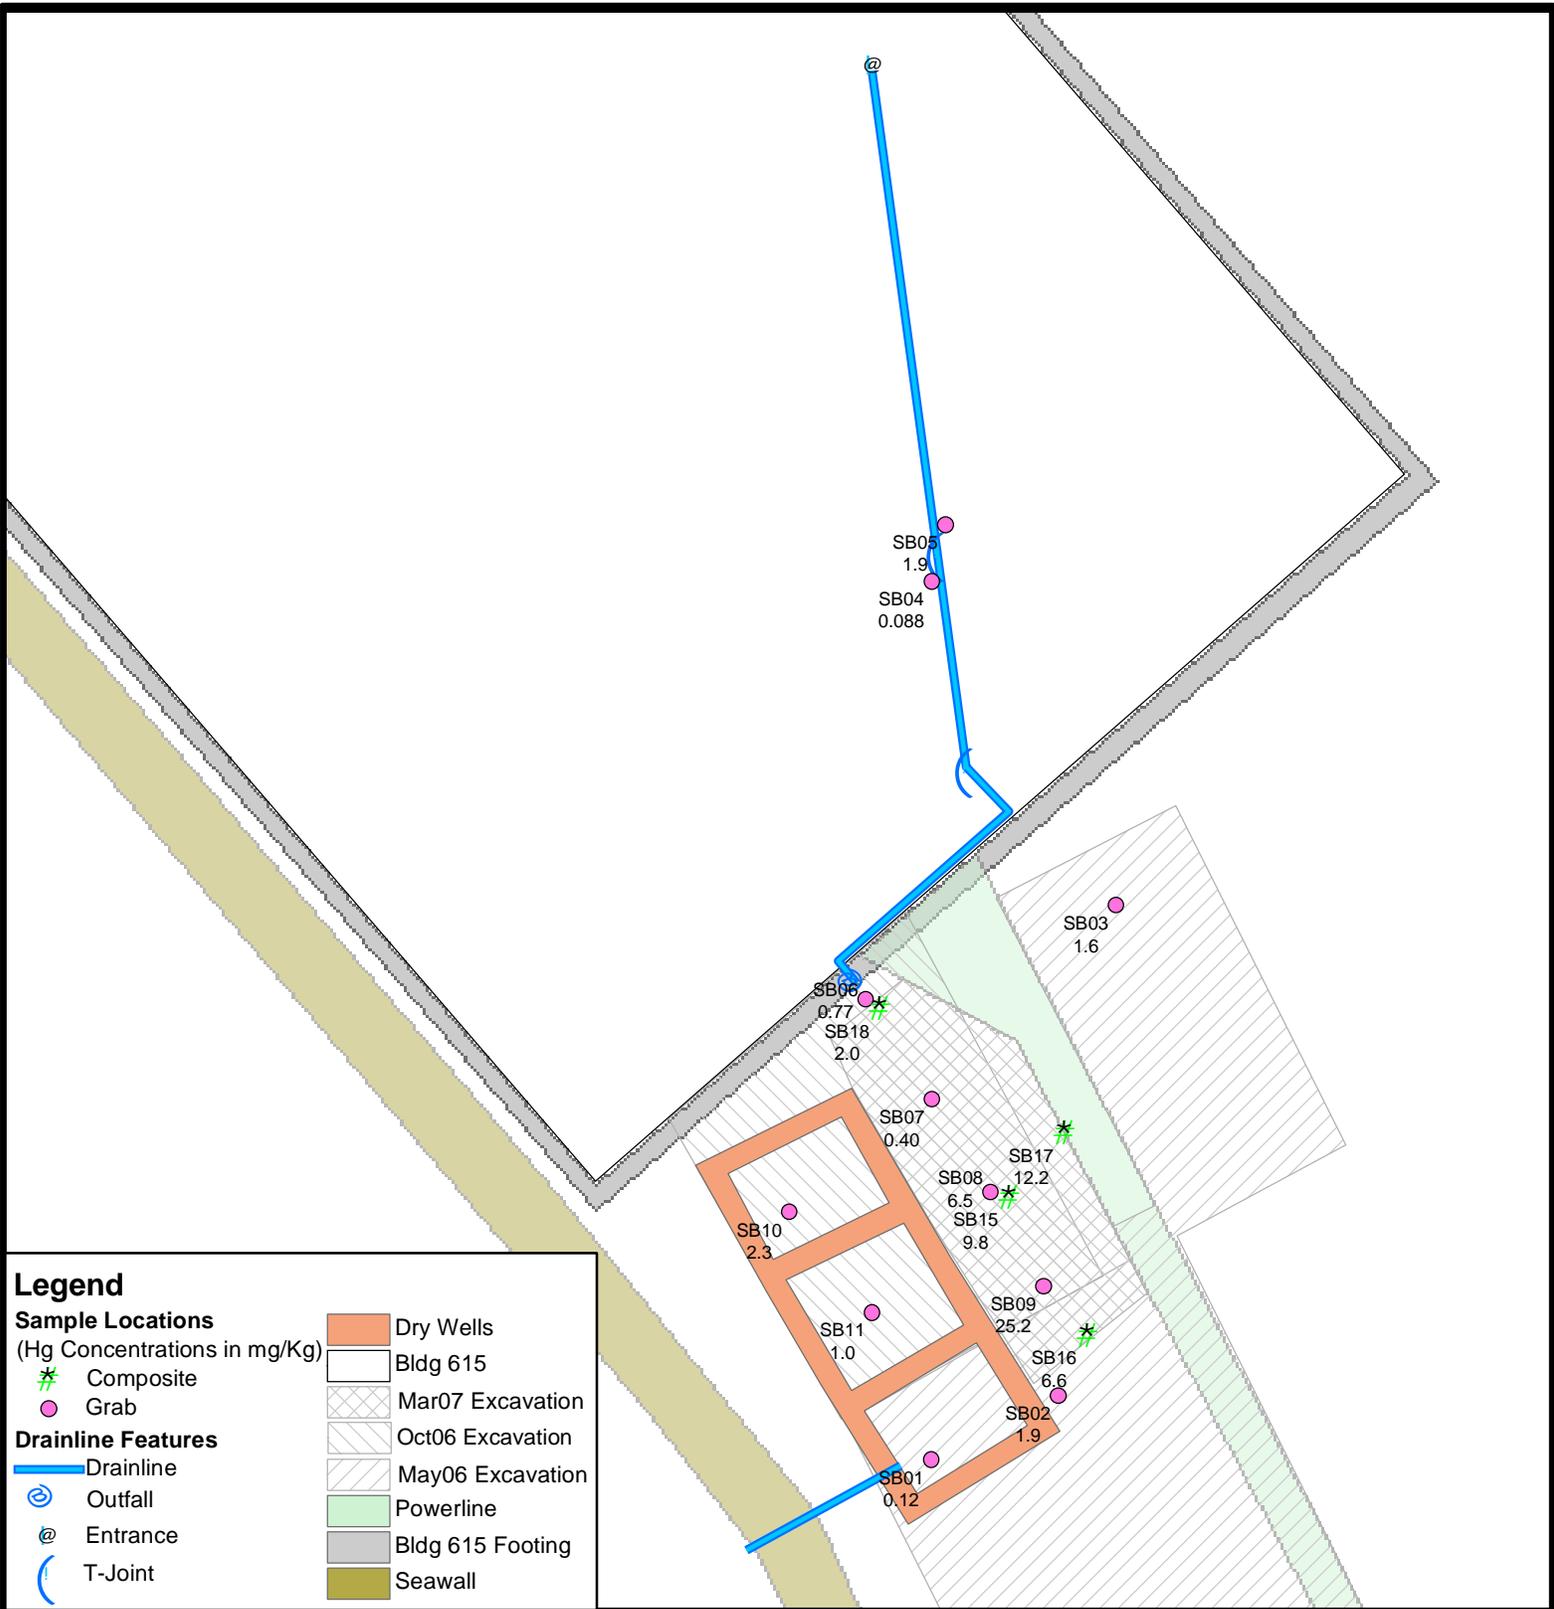
FIGURE 1
SITE DETAIL

Previous investigations identified a hot spot of mercury contamination centered around soil sample locations SB-08 (6.5 mg/kg at 4.2 ft bgs) and SB-09 (25 mg/kg at 4.4 ft bgs) (see Figure 1). Based on the distribution of mercury concentrations and the current location of the drain-line, it is hypothesized that the drain-line extended out from the building footing at the approximate location of sample SB06, and terminated at a point proximate to SB-09.

An additional approximate ten cubic yards of soil was excavated from the hot spot area. The excavation extended laterally west to the three dry wells, east to the buried power line, north to SB-07 and south to SB-02 (Figure 1). Vertically, the excavation extended down to approximately 7-ft bgs. The three cesspools and the buried power line were not disturbed during the excavation. Excavated soils were stored on-site in a lined 20 yard roll-off container pending waste characterization and the determination of the soil disposal location.

As shown in the table above, elevated mercury concentrations in soil remain to the north, east, and south of the excavation in addition to the bottom of the excavation.

Given the above factors it is recommended that the site be closed without further excavation. The 10 cubic yards of material excavated on 22 March 2007 will be disposed of as required, based on the results of the waste characterization results. The excavation will be lined with snow fence (as a marker), filled with clean fill material, and covered with asphalt. Finally the relocated AST will be place back in its original location.
