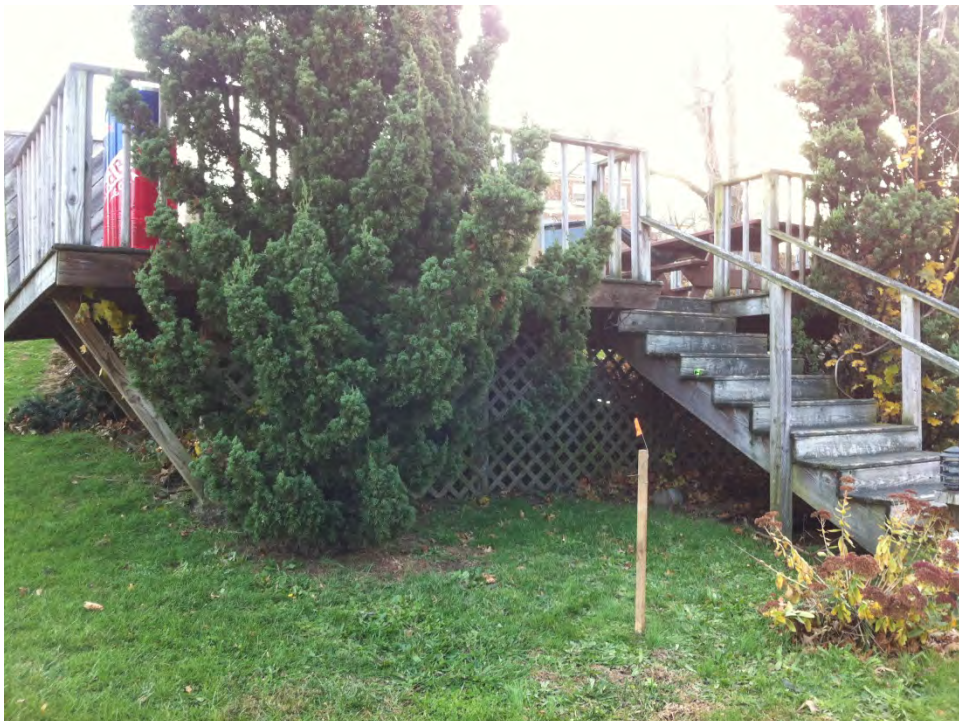
Photograph #14: 11/29/12, Area 3
Stake in foreground is position of sampling location AI3-105 adjacent to pressure-treated deck.

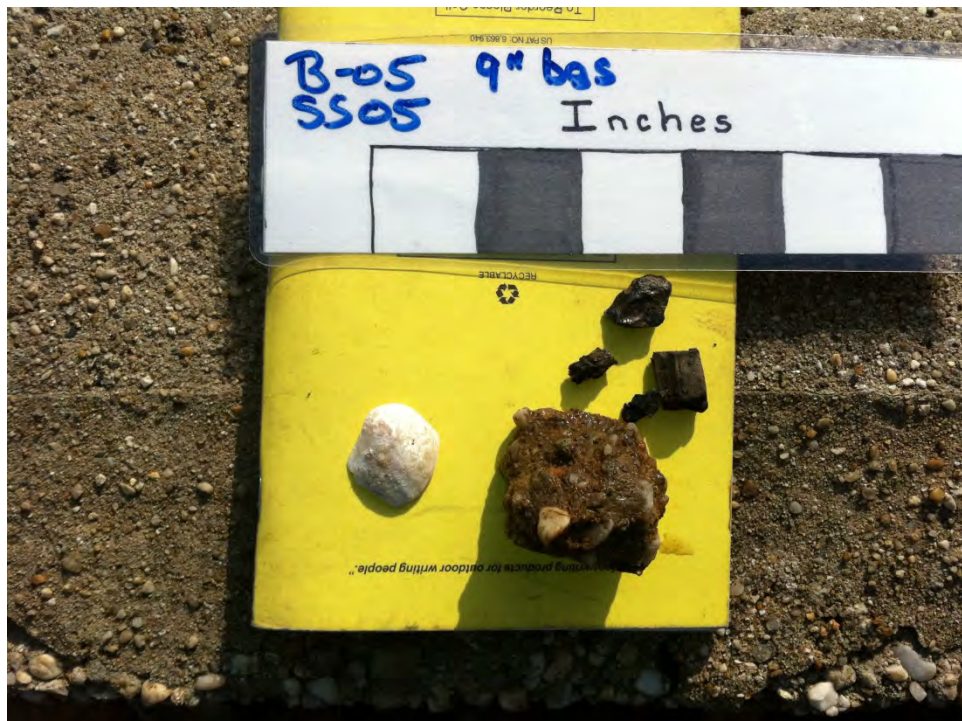
Photograph #24: 11/29/12 Area 4, Evidence of fill at hole dug at adjacent sampling locations B-05 and SS-5. Coal, concrete, and a shell.

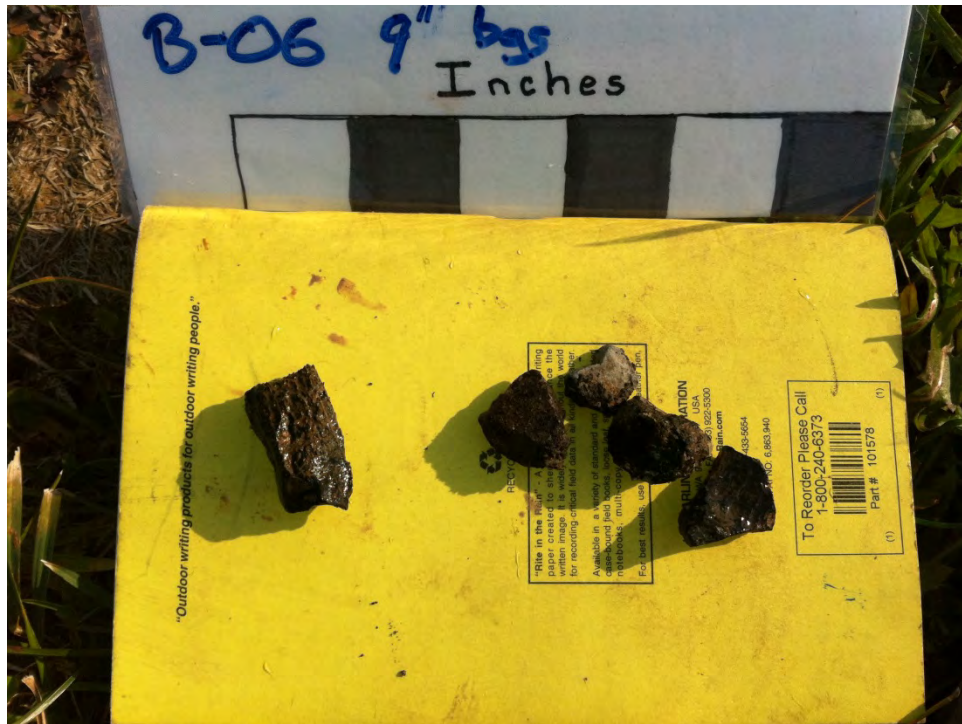
Photograph #25: 11/29/12 Area 4, Evidence of fill at hole dug at sampling location B-06. Coal and asphalt.

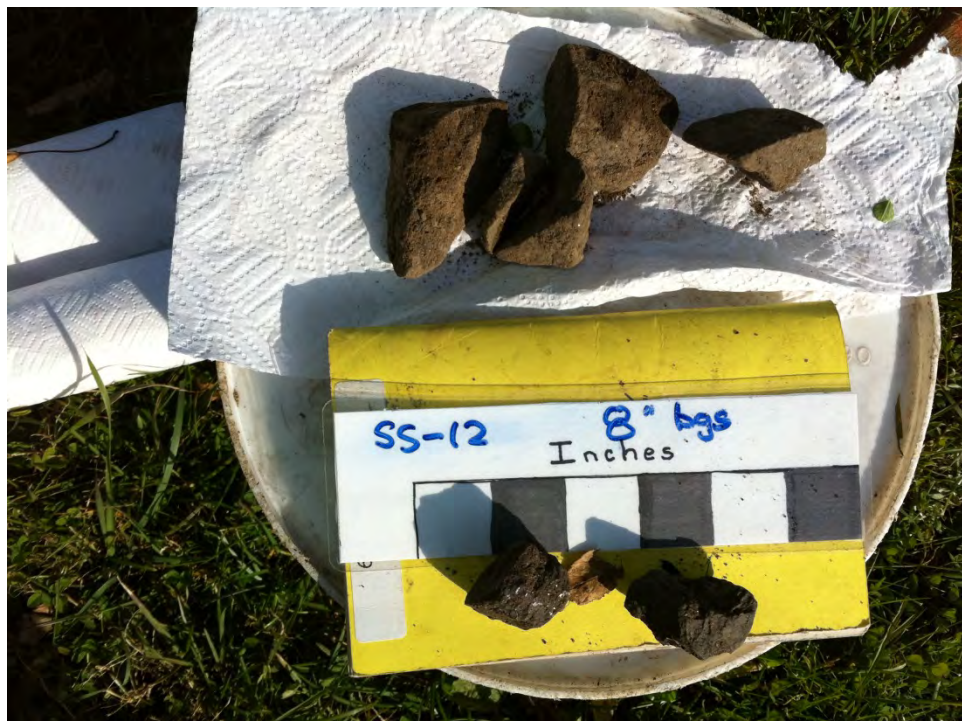
Photograph #26: 11/29/12 Area 4, Evidence of fill at hole dug at sampling location SS-12. Crushed stone up to 2-inch diameter, coal and asphalt.

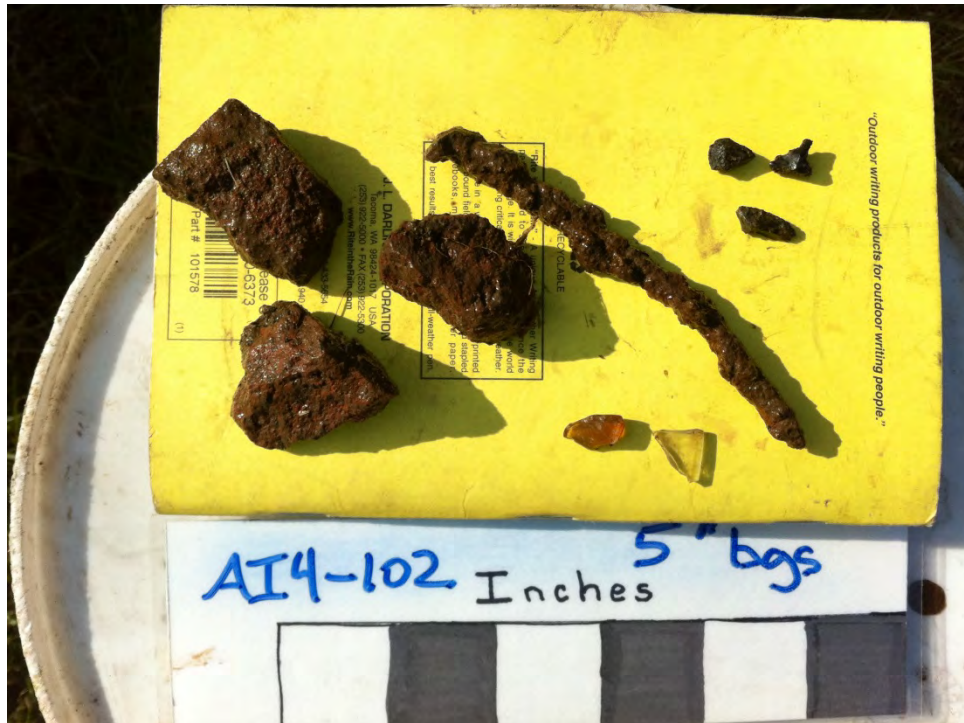
Photograph #27: 11/29/12 Area 4, Evidence of fill at hole dug at sampling location AI4-102. Coal, asphalt-coated rocks, rusty nail, and glass.

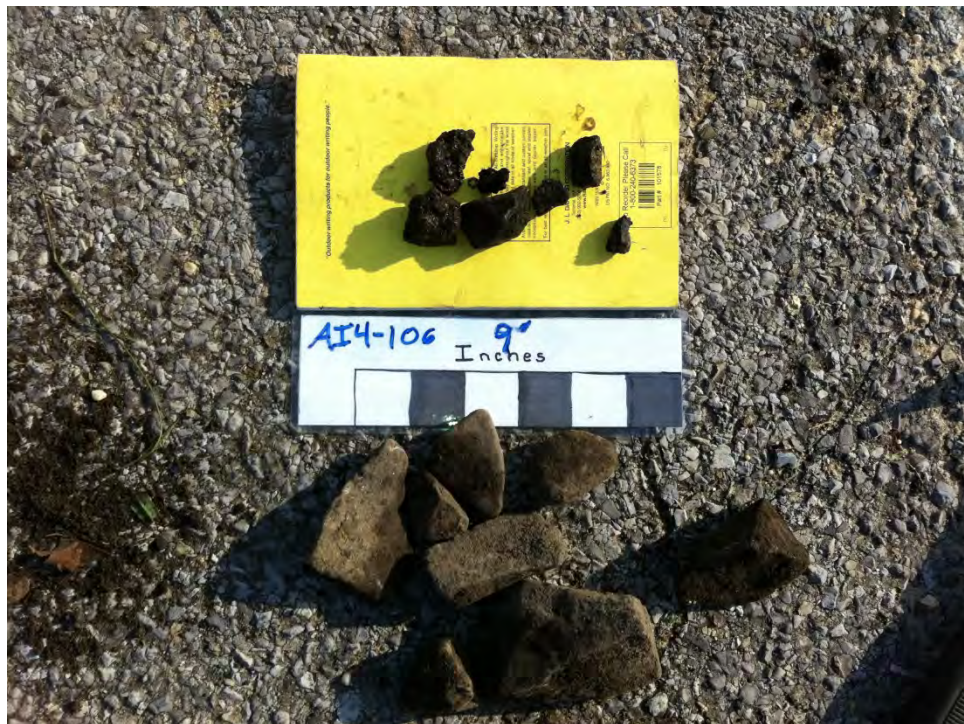
Photograph #28: 11/29/12 Area 4, Evidence of fill at hole dug at sampling location AI4-106. Crushed stone up to 2 inches in diameter, coal, and asphalt.

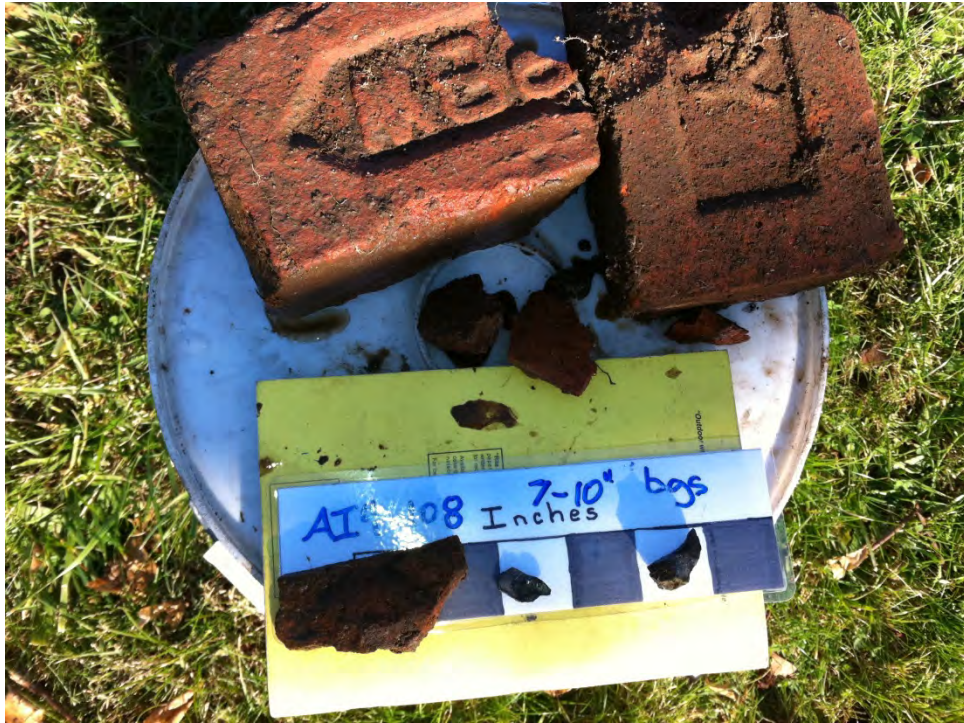
Photograph #29: 11/29/12 Area 4, Evidence of fill at hole dug at sampling location AI4-108. Bricks and coal.

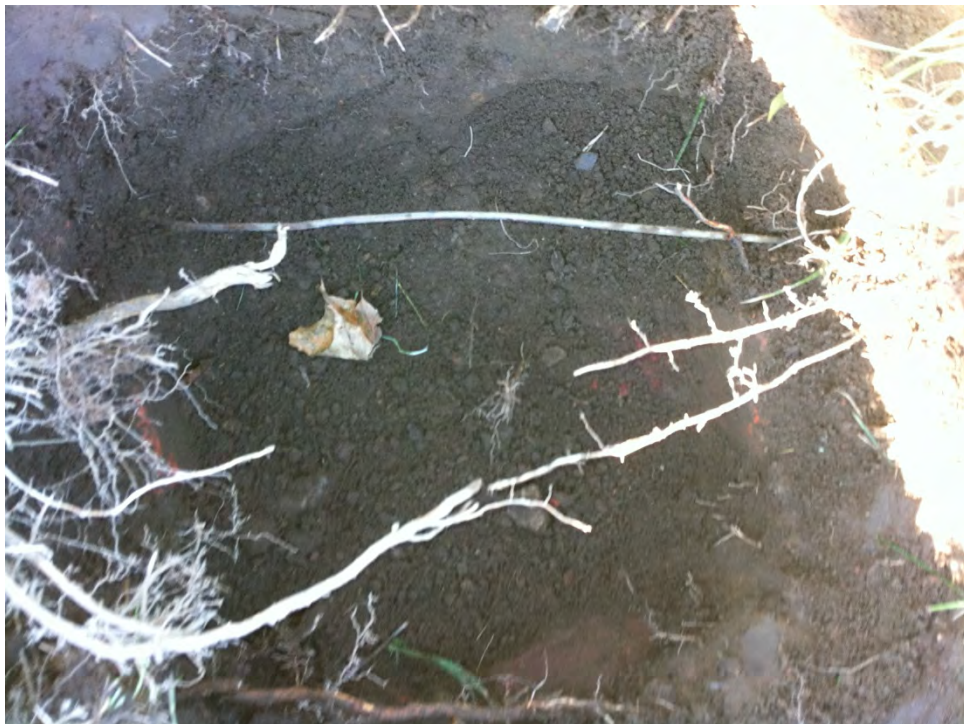
Photograph #30: 11/29/12 Area 4, Evidence of fill at hole dug at sampling location AI4-108. Wire and bricks.

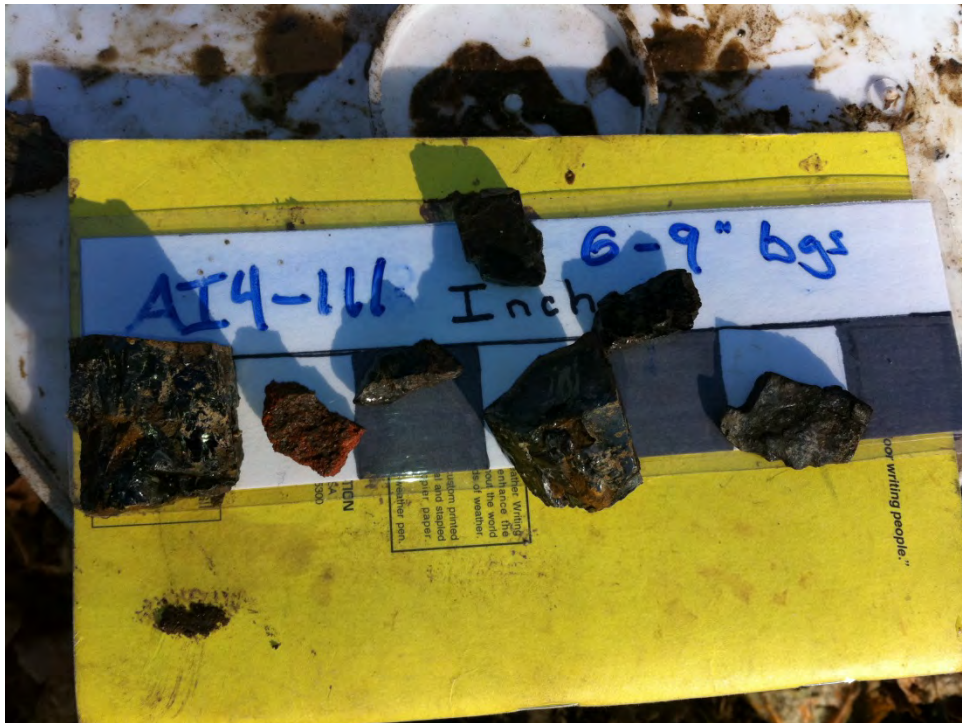
Photograph #31: 11/29/12 Area 4, Evidence of fill at hole dug at sampling location AI4-111. Coal and brick.

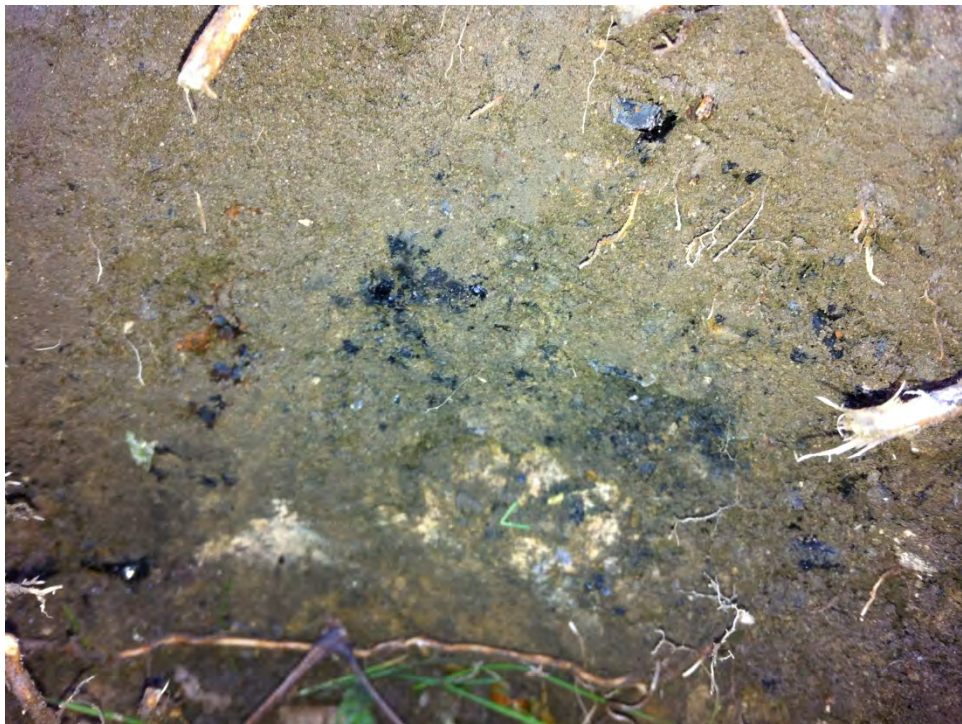
Photograph #32: 11/29/12 Area 4, Evidence of fill at hole dug at sampling location AI4-111. Coal and coal ash in hole.

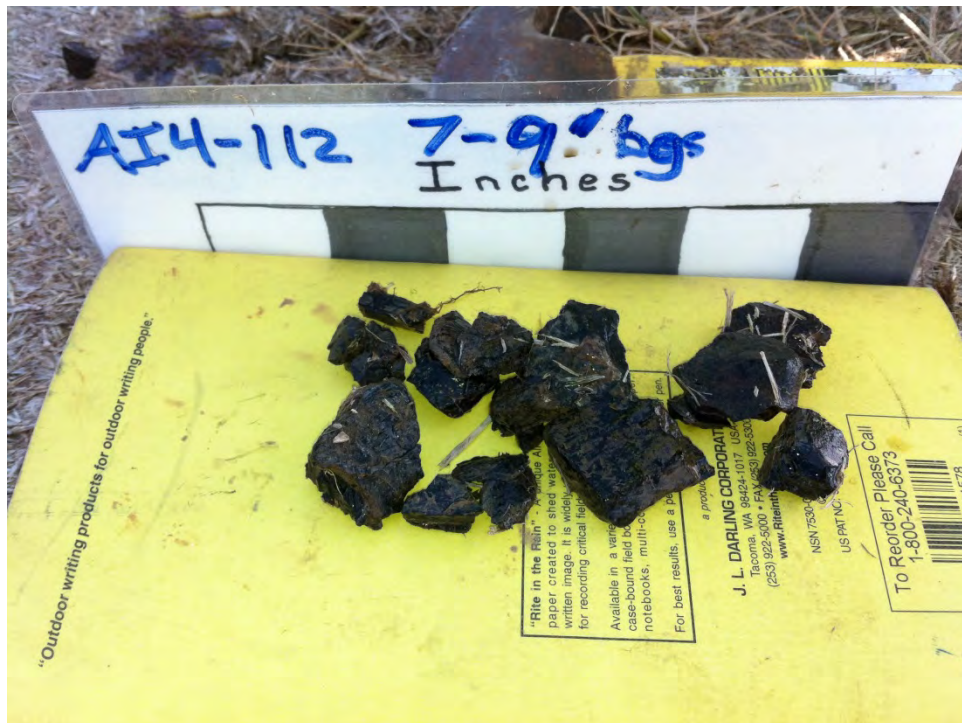
Photograph #33: 11/29/12 Area 4, Evidence of fill at hole dug at sampling location AI4-112. Coal. Glass was observed in the hole during backfilling.

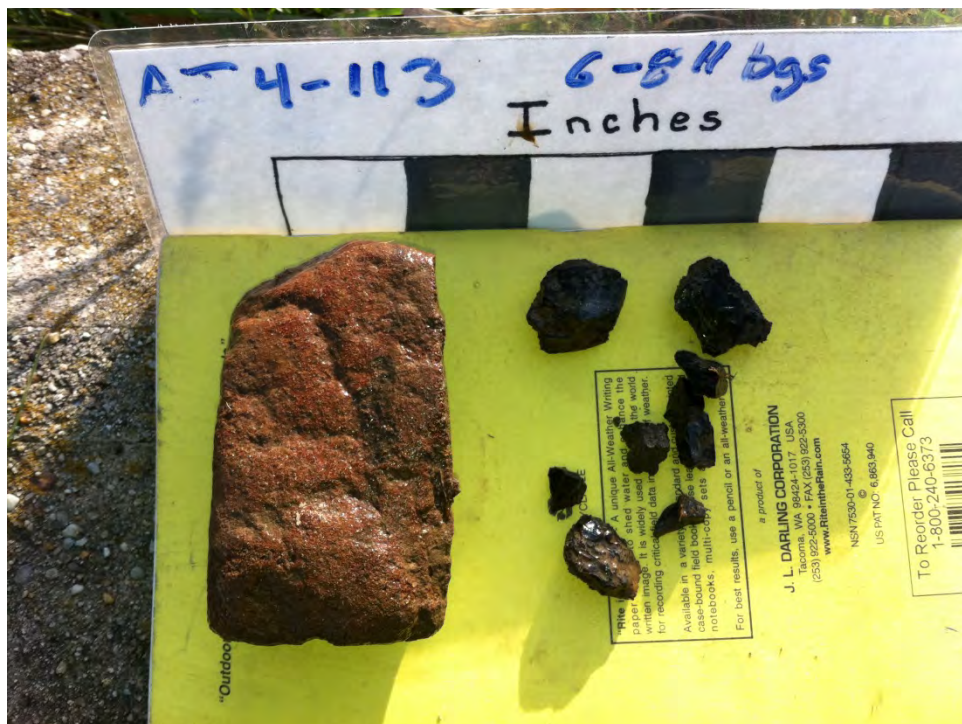
Photograph #34: 11/29/12 Area 4, Evidence of fill at hole dug at sampling location AI4-113. Coal and brick.

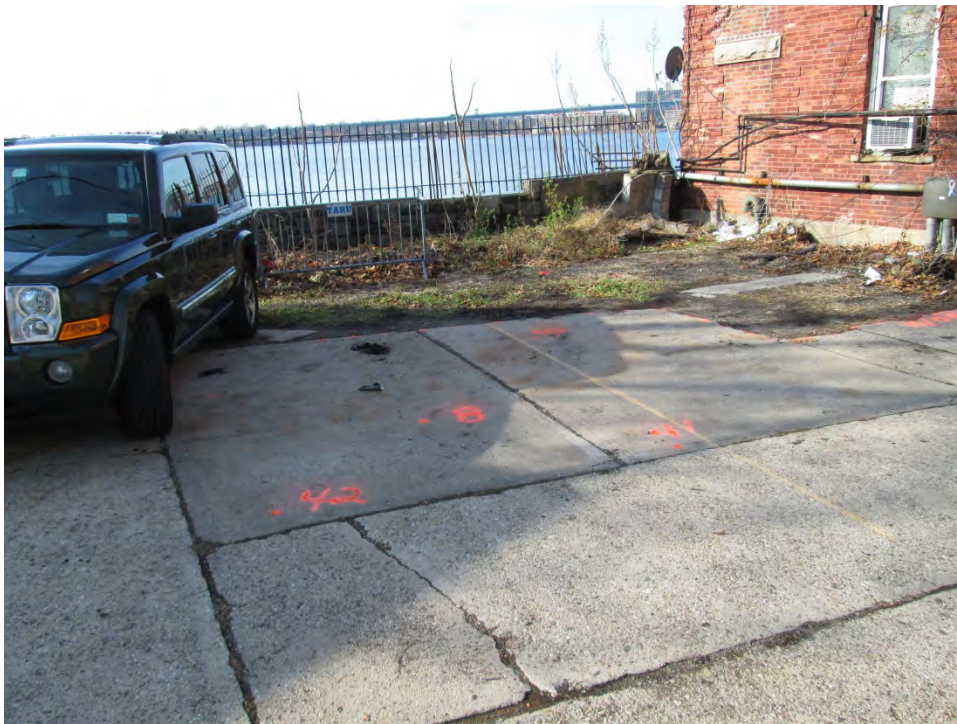
Photograph #44: 11/28/12 Area 5. View facing northwest towards south end of Bldg. 615; Approximate locations of former soil boring SB-08 and former sample locations SS-41, SS-42, S-43, and SS-44, and former excavation area.

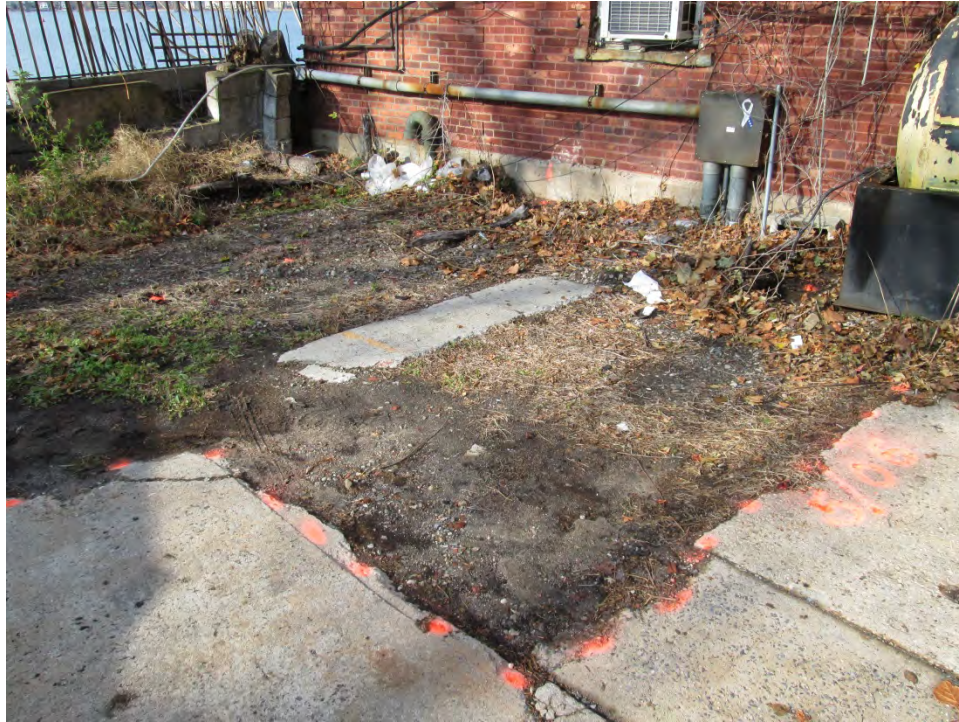
Photograph #45: 11/28/12 Area 5. View facing northwest towards south end of Bldg. 615, buried utility corridor, and former excavation area.

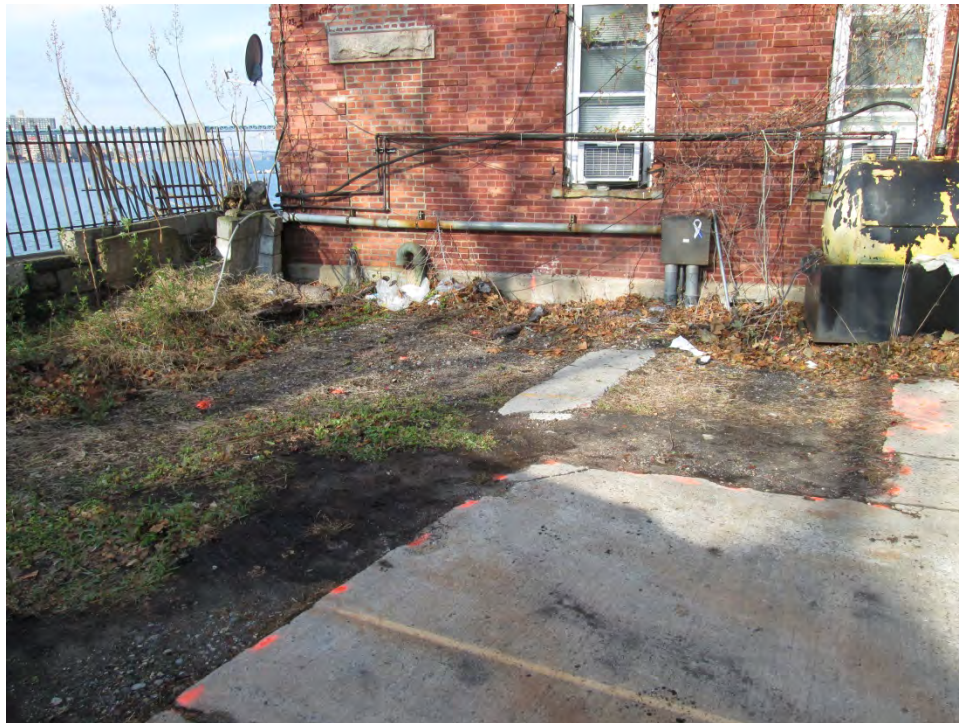
Photograph #46: 11/28/12 Area 5. View facing north-northwest towards south end of Bldg. 615, buried utility corridor, and former excavation area.

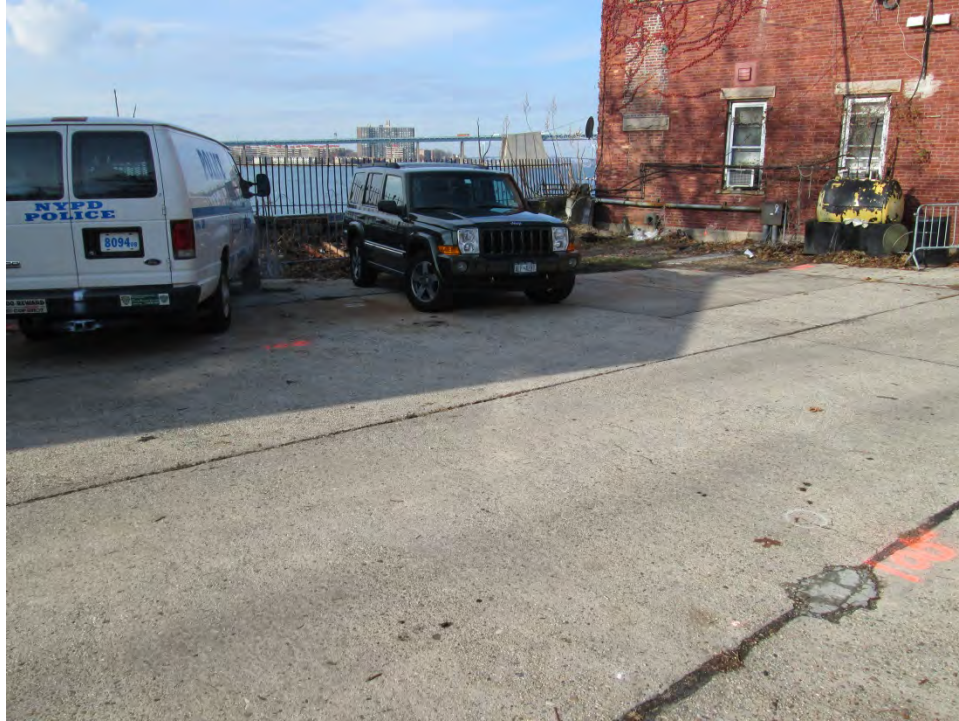
Photograph #47: 11/28/12 Area 5. View facing northwest towards south end of Bldg. 615, former soil boring AI5-105, and former excavation area.

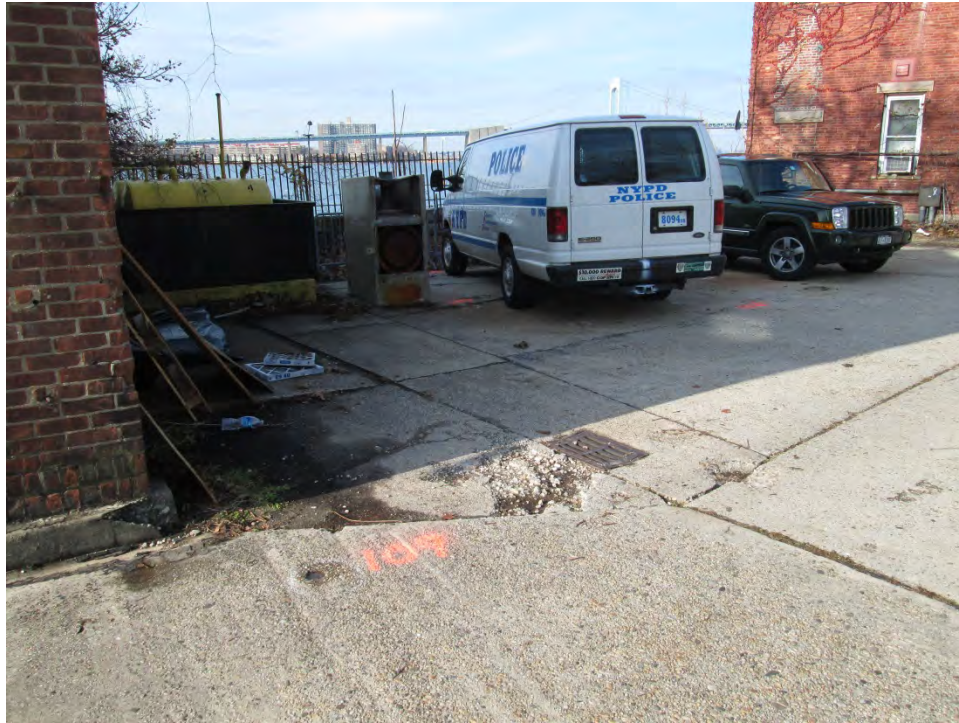
Photograph #49: 11/28/12 Area 5. View facing northwest between Bldg. 615 and Bldg. 614, former soil boring AI5-109, and former excavation area.

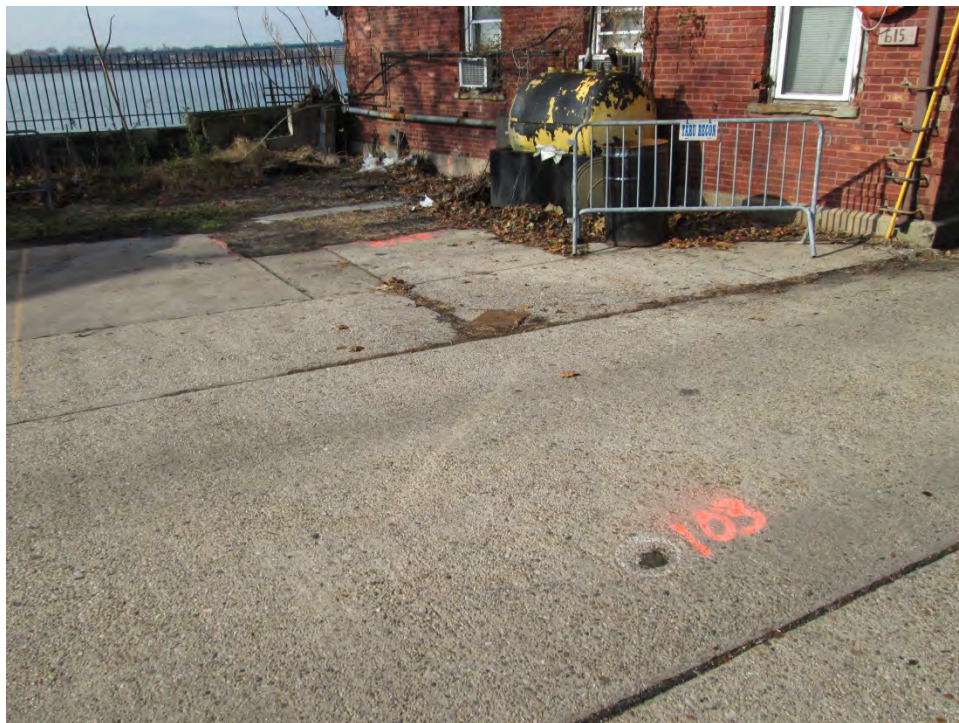
Photograph #50: 11/28/12 Area 5. View facing northwest towards south end of Bldg. 615, former soil boring AI5-103, and former excavation area.

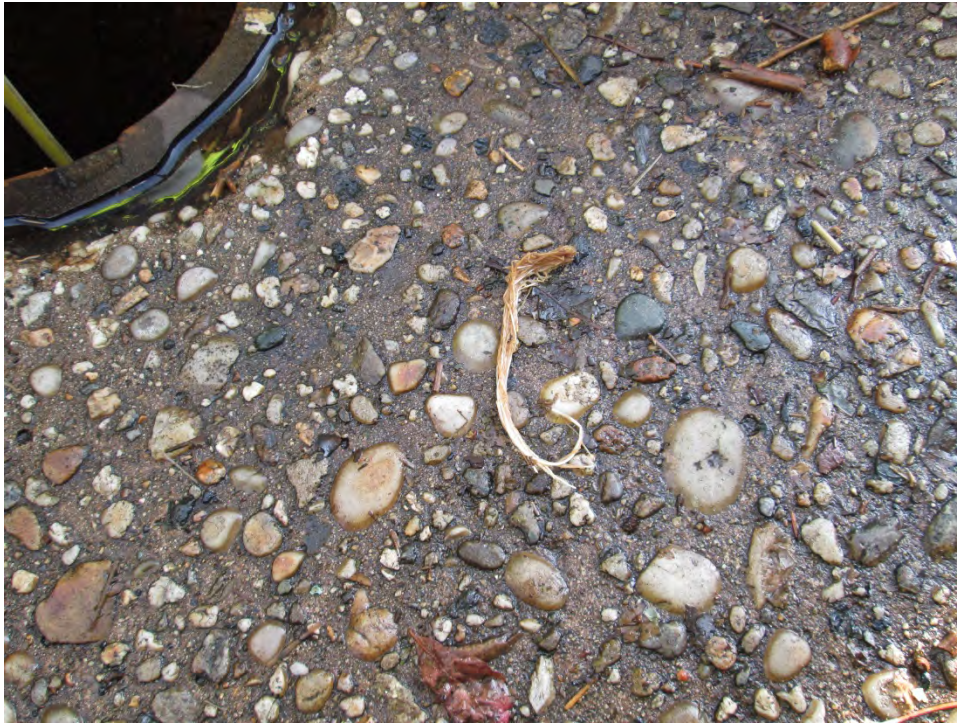
Photograph #51: 11/28/12 Area 5. Some of the roots recovered from MW-4R via the water level meter.
