**FIELD REPORT, BUILDING 615 FORT TOTTEN EXPLORATORY  
INVESTIGATION  
30-31 OCTOBER 2006**

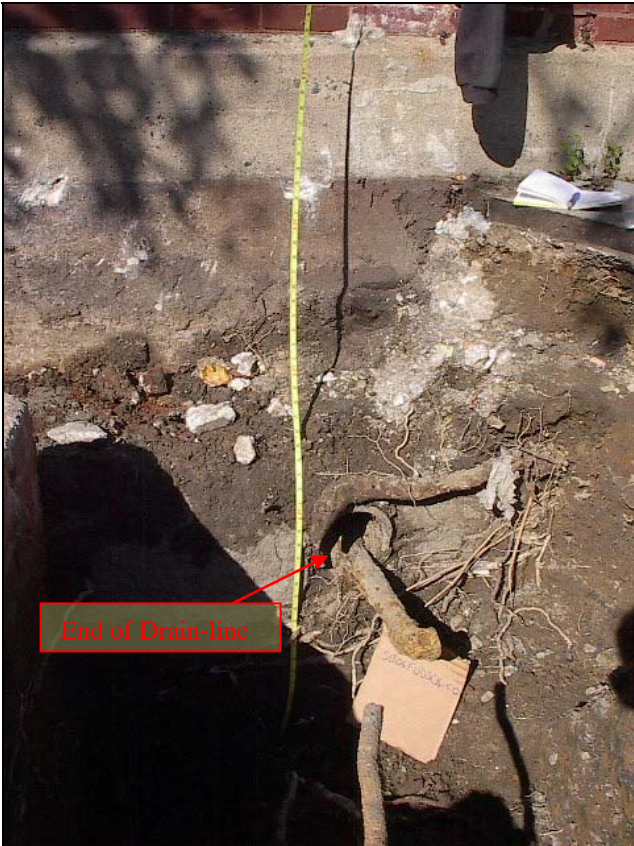
The apparent end of the drain-line was discovered. It appeared to be of the same material and diameter as the drain-line observed at the 15-ft T-joint. The end was flush with the footing wall. There was a 2-in metal pipe stuck inside it (Photo 1). This may have been used at one time to plug the drain-line. The top of the drain-line was 0.6-ft below the top lip of the footing wall.

Photo 1 - Probable End of Drain-line

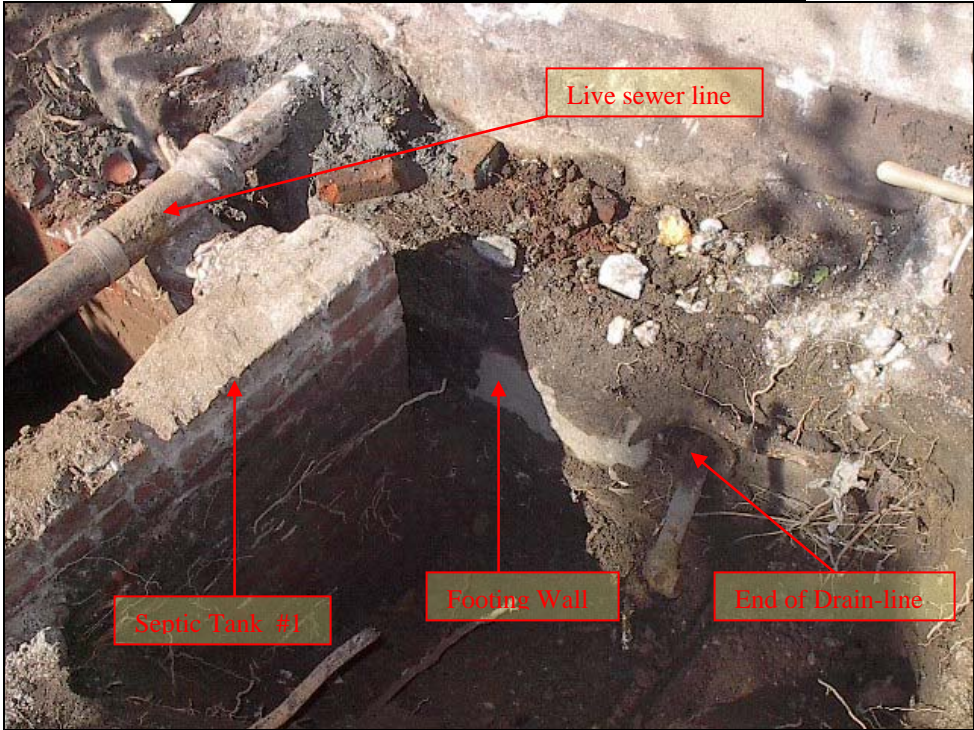
It appears the drain-line never did drain into any of the septic tanks, but instead drained into the surrounding soil at the point of discharge at the footing wall (Photo 2). The evidence for this conclusion is based on:

- The end of the drain-line was flush with the building footing wall which implies it never extended beyond this point.
- Also, the drain-line's elevation as it exits the footing is below the top of the brick of the septic tanks.
- There were no perforations along the walls of the septic tank.
