Appendix A

Photograph Log

**APPENDIX A
SITE PHOTOGRAPHS**

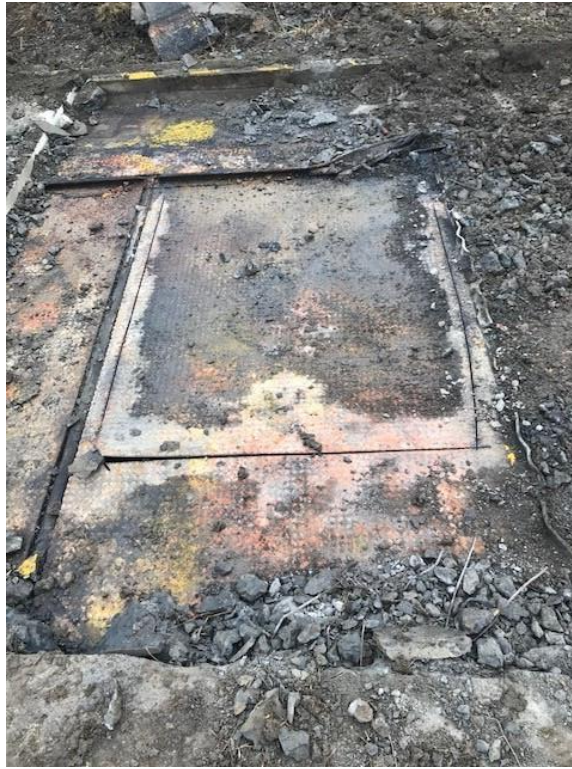
Photograph 1: Typical Silo Access Hatch (4/12/18).

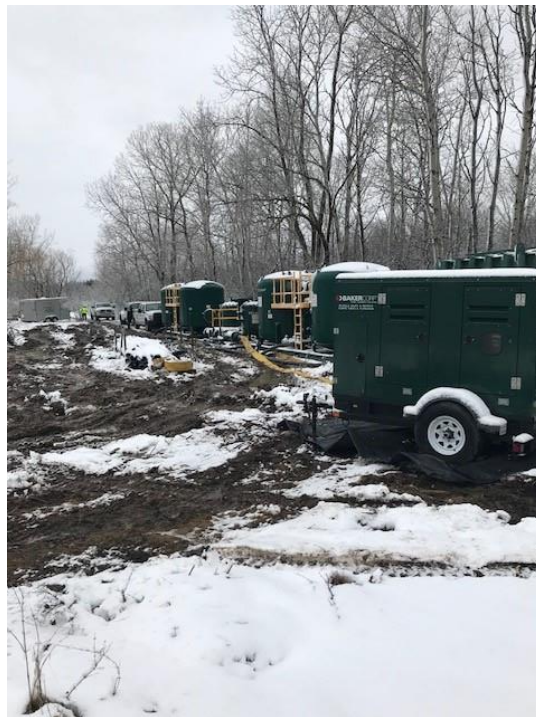
Photograph 2: Water treatment system (4/17/18).

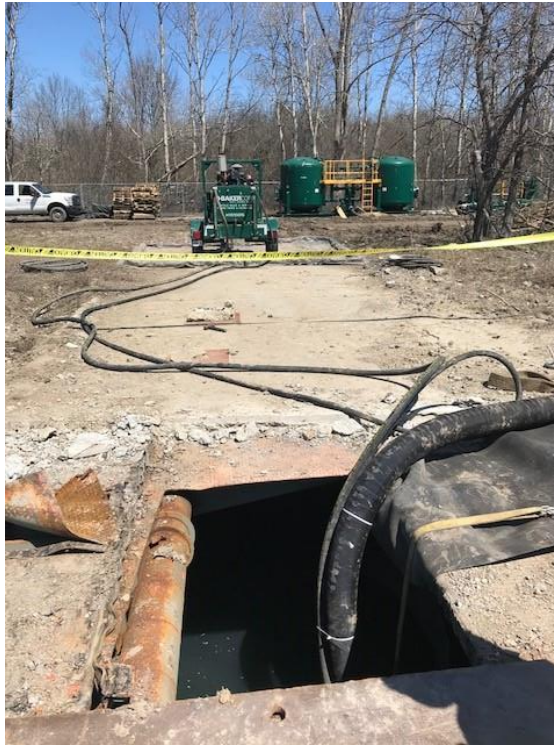
Photograph 3: Dewatering Silo 2 (4/23/18).

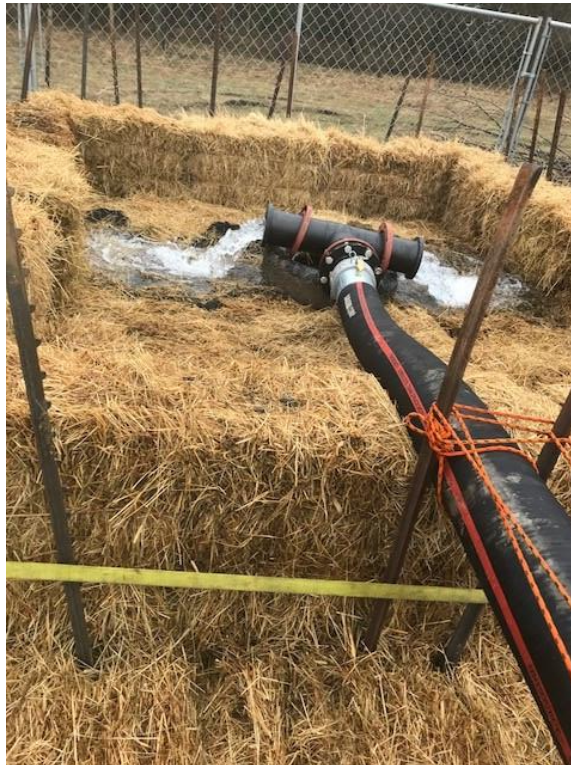
Photograph 4: Water treatment system discharge (4/25/18).

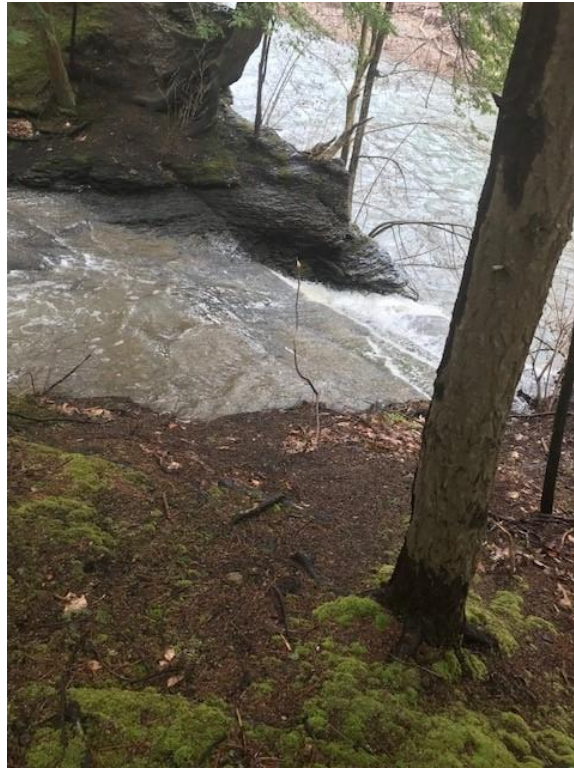
Photograph 5: Point where discharge meets Cazenovia Creek (4/25/18).

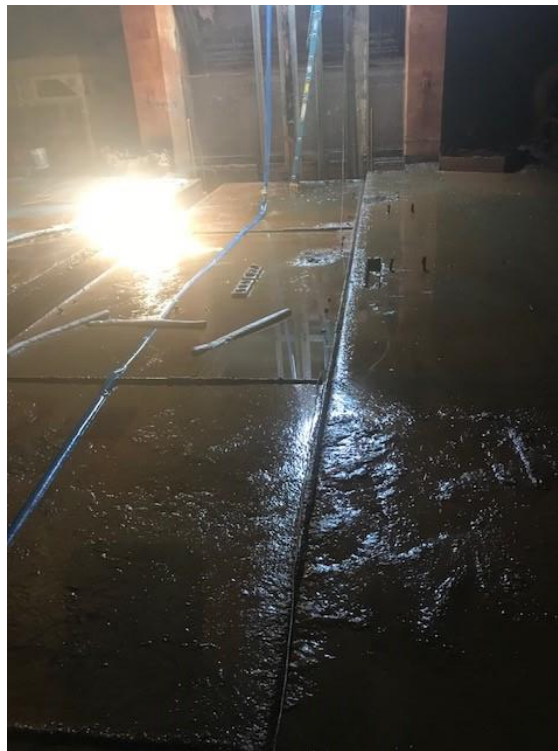
Photograph 6: Dewatering elevator shaft inside Silo 2 (5/1/18).

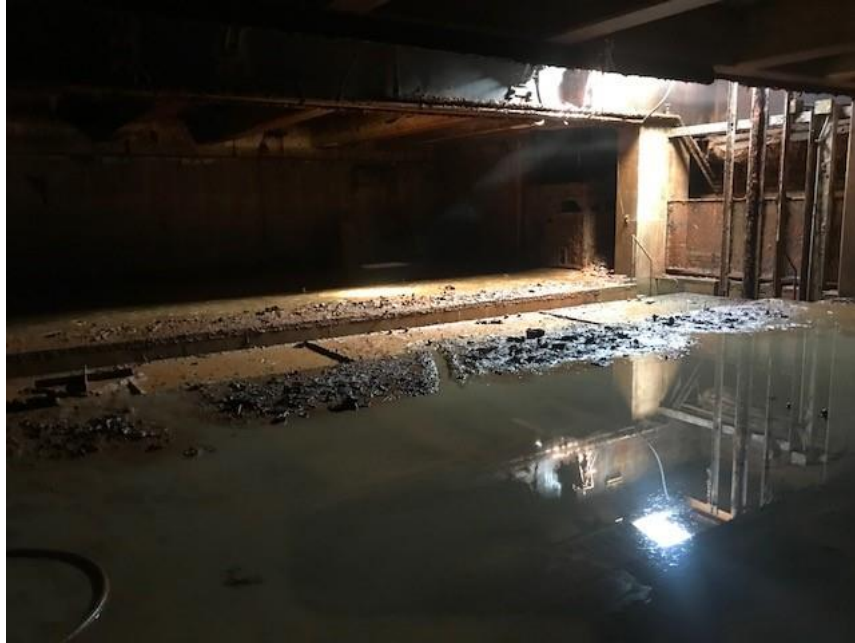
Photograph 7: Interior of Silo 5 after dewatering (5/15/18).

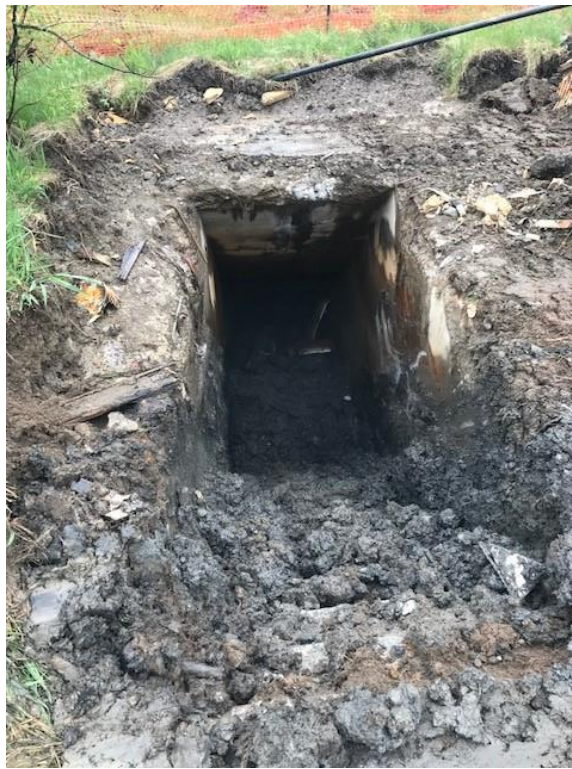
Photograph 8: Soil and debris located in Silo 1 stairwell (5/15/18).

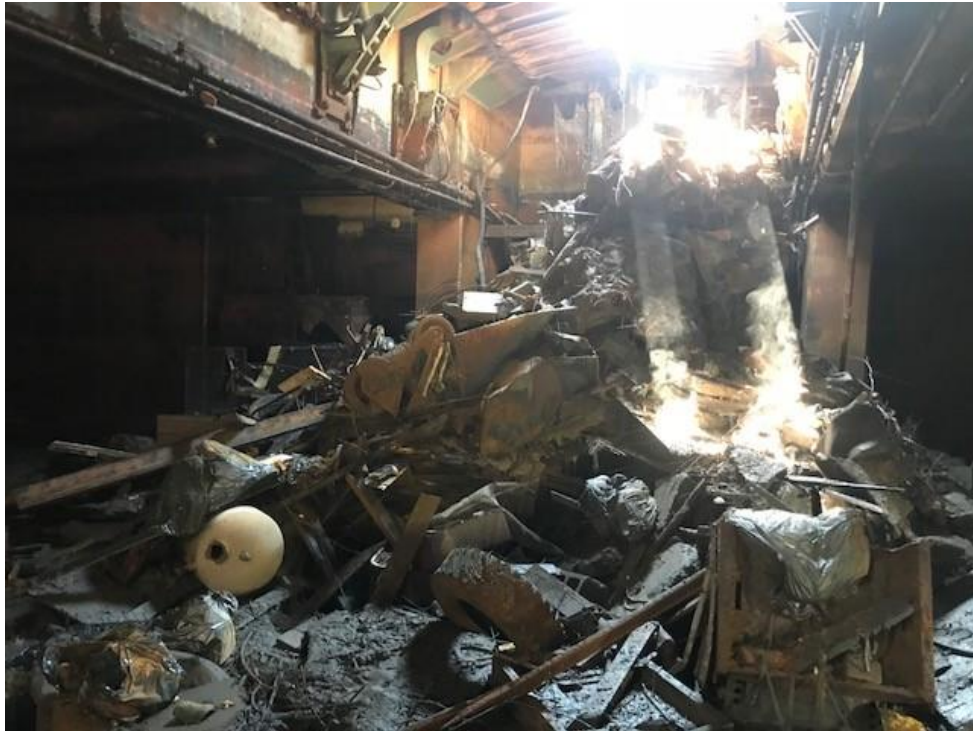
Photograph 9: Debris inside Silo 1 (5/17/18).

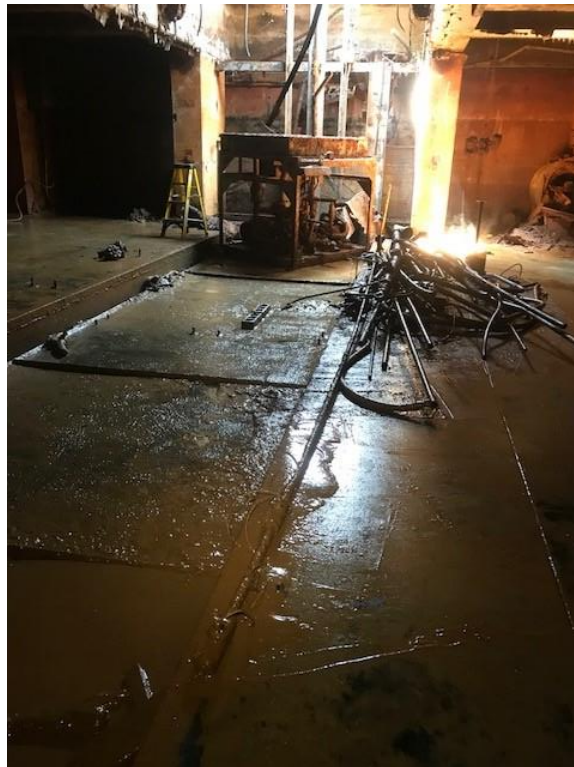
Photograph 10: Hydraulic system and associated piping removal from Silo 2 (6/7/18).

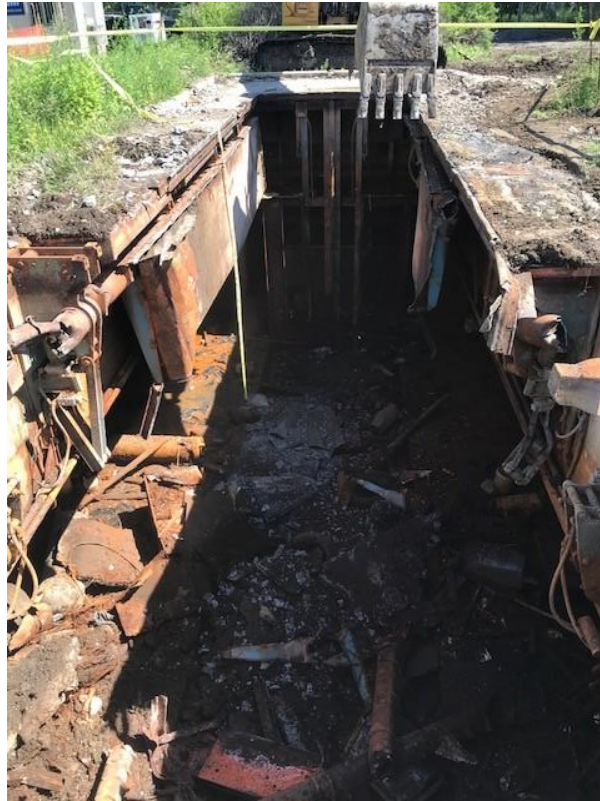
Photograph 11: Debris removal from Silo 1 (6/25/18).

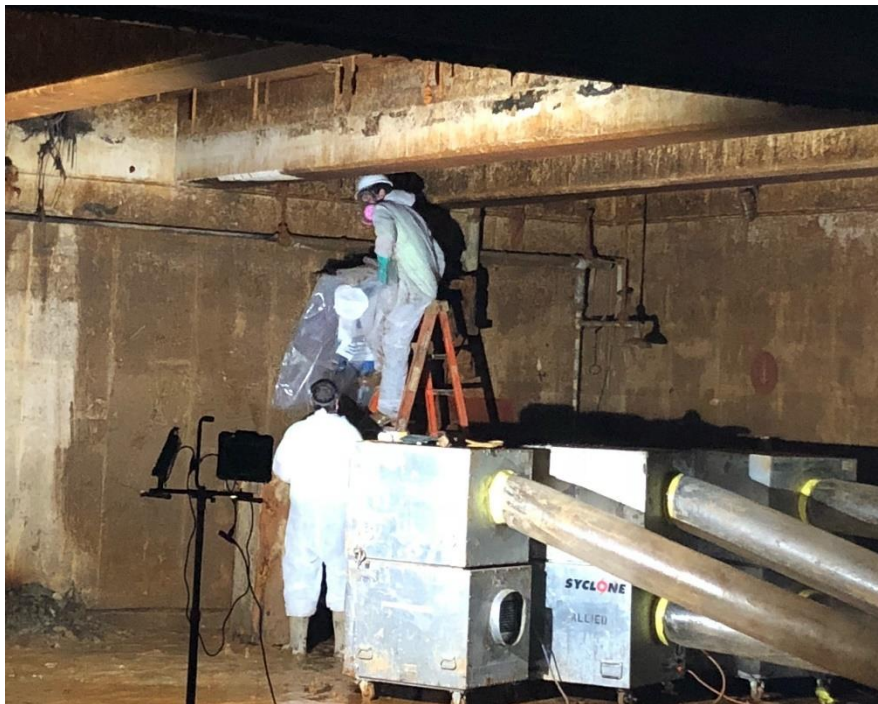
Photograph 12: Asbestos removal inside Silo 5 (7/10/18).

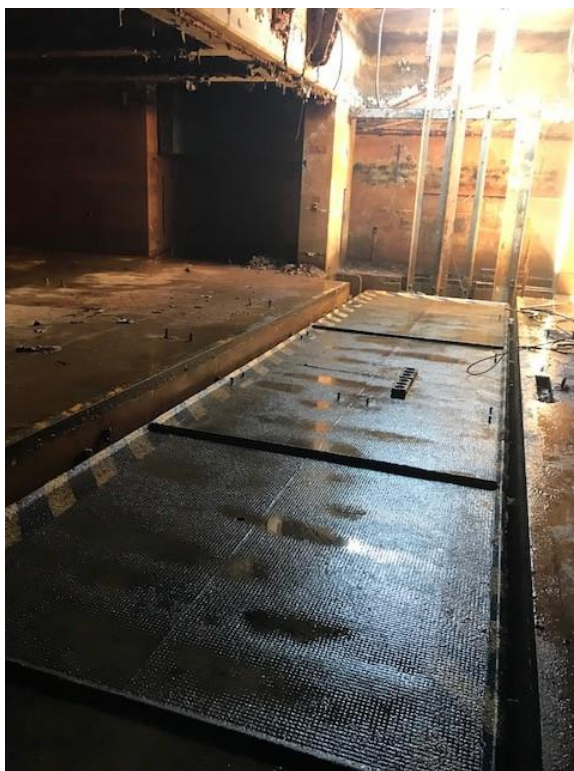
Photograph 13: Silo 2 pressure washed and ready for demo (7/12/18).

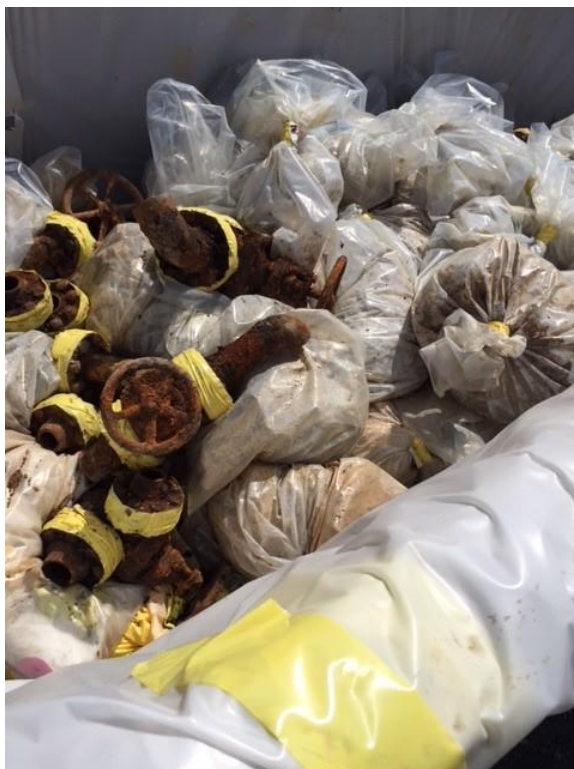
Photograph 14: Non friable asbestos inside roll off container (7/17/18).

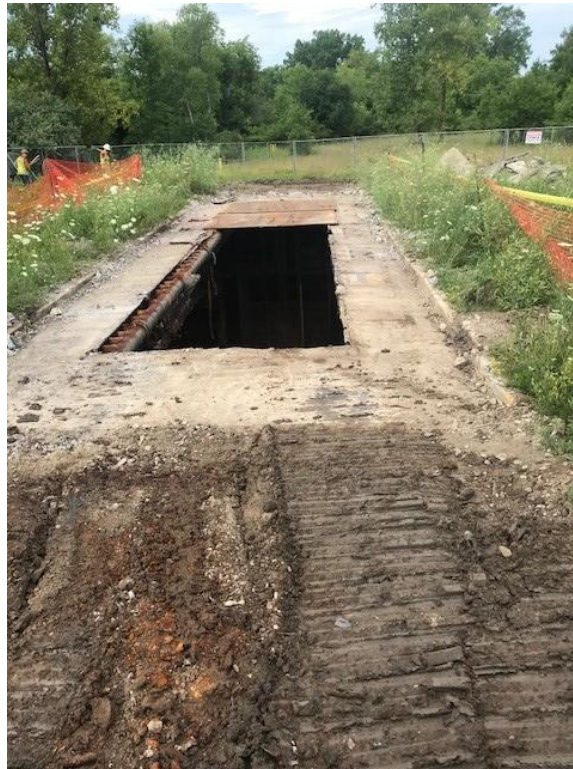
Photograph 15: Elevator doors removed at Silo 4 (7/24/18).

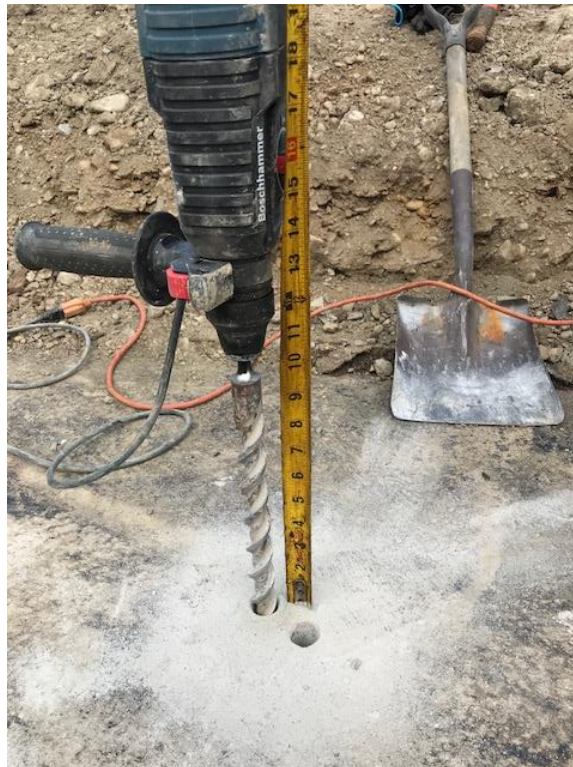
Photograph 16: Concrete core sample collected from Silo 5 roof (7/26/18).

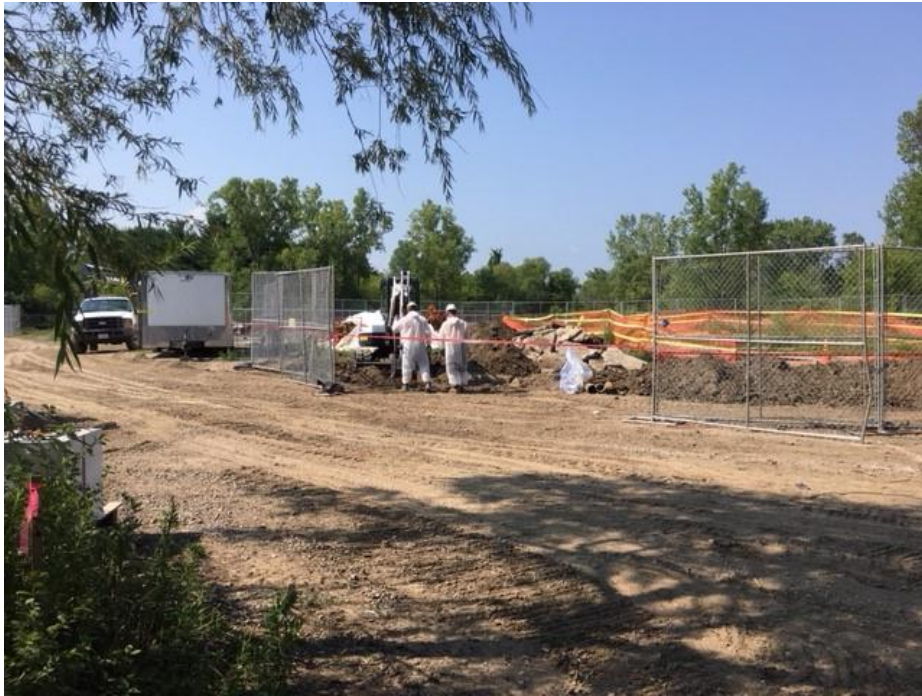
Photograph 17: Excavation to remove asbestos containing transite piping from Silo 1 (8/6/18).

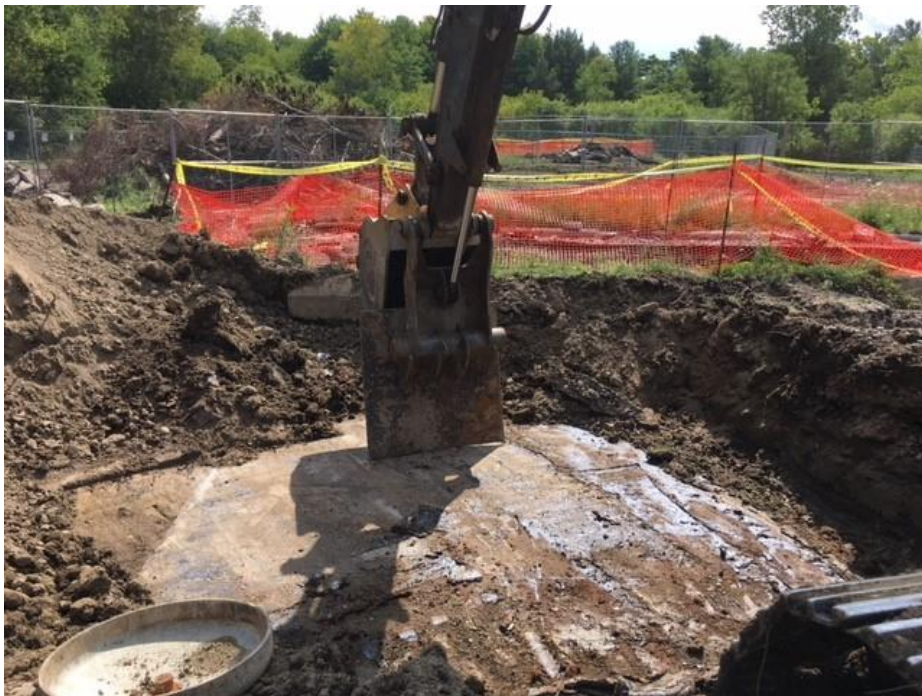
Photograph 18: Roof coating removal from Silo 2 (8/9/18).

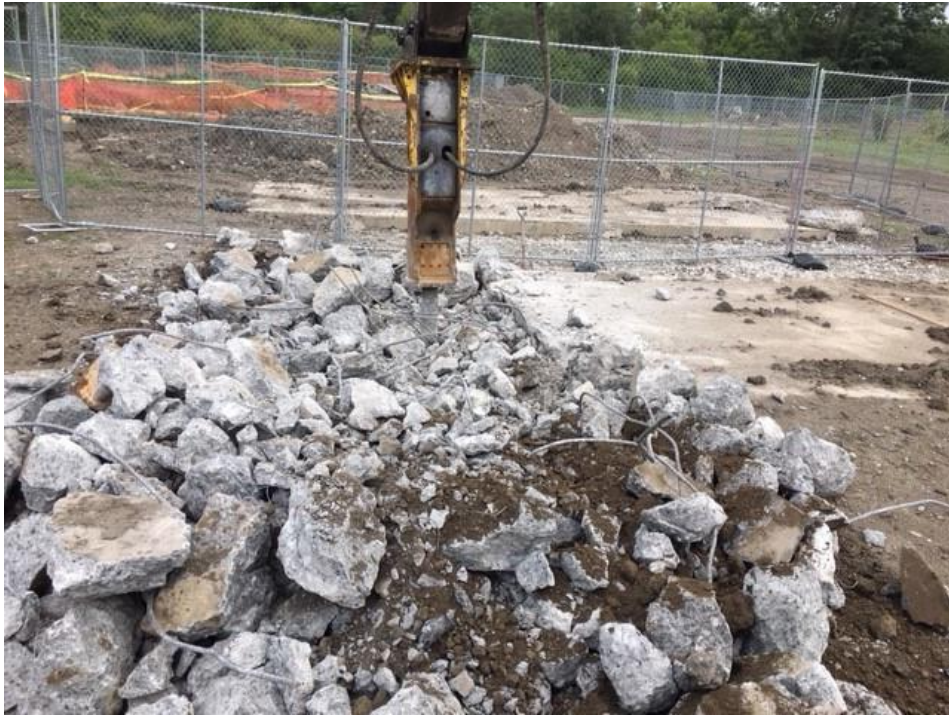
Photograph 19: Hammering concrete launch pad at Silo 2 (8/22/18).

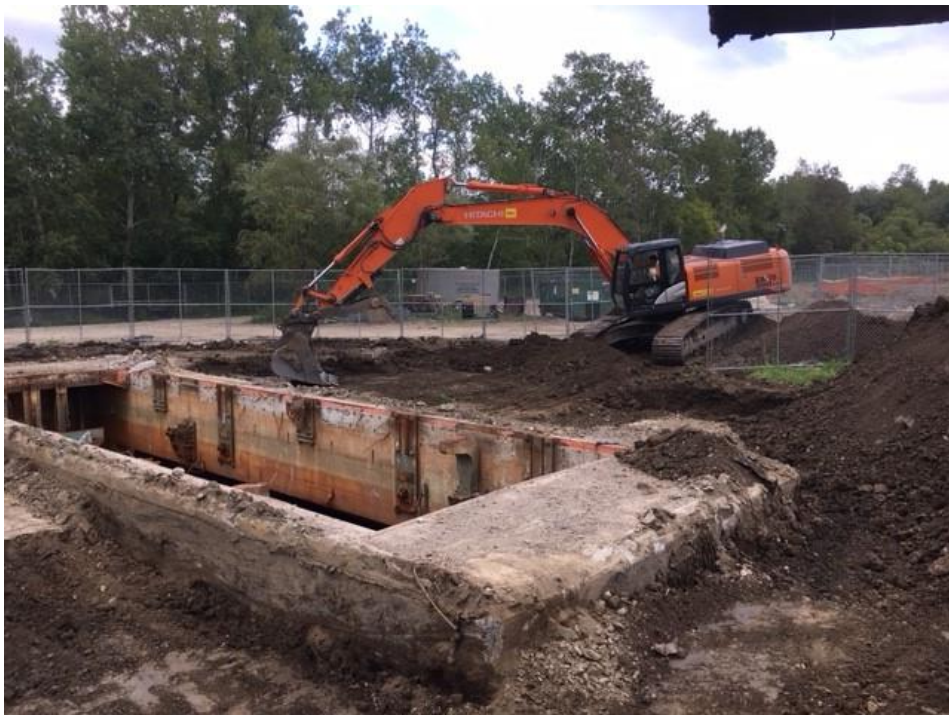
Photograph 20: Excavation at Silo 1 (8/29/18).

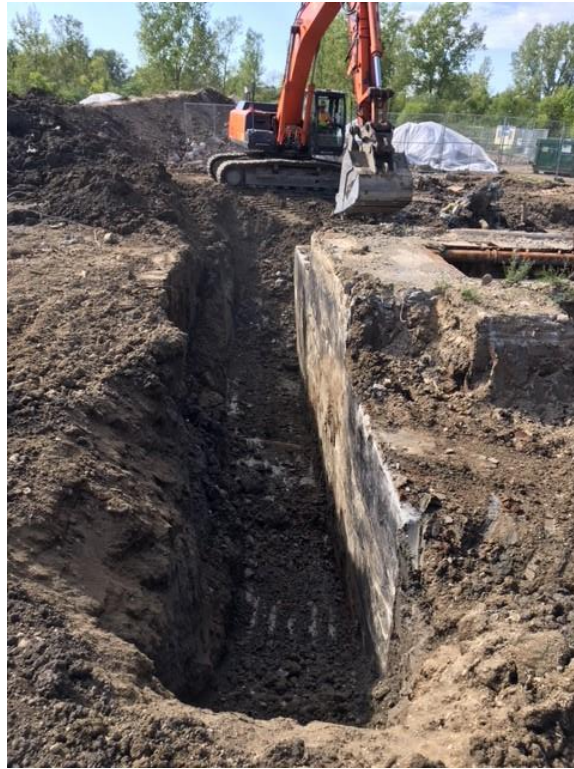
Photograph 21: Excavation of side wall at Silo 2 and covered soil pile (9/4/18).

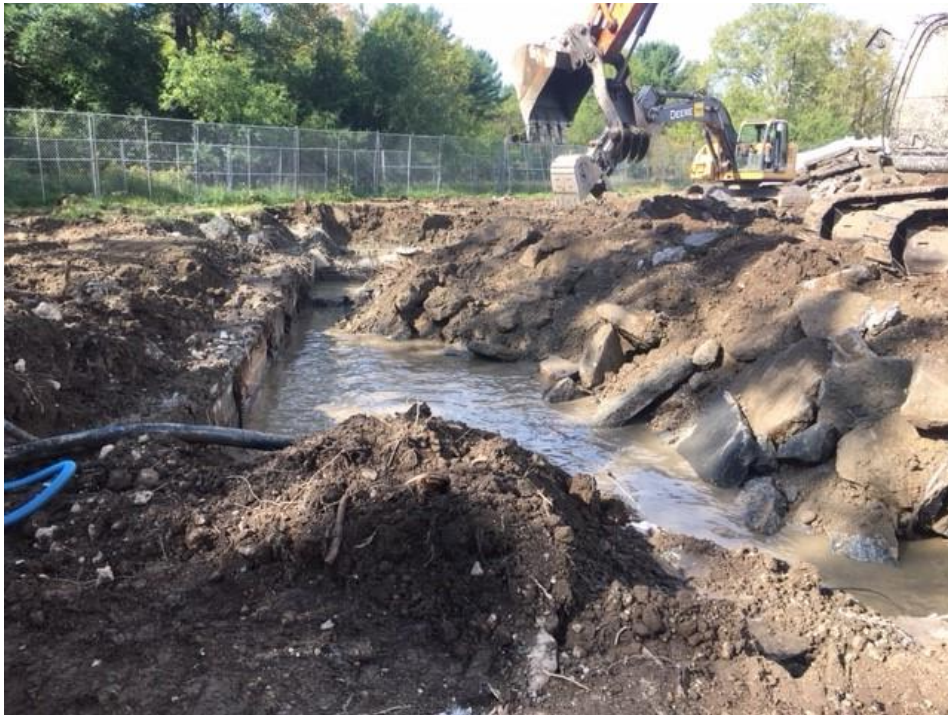
Photograph 22: Excavation and dewatering at previously demolished Silo 6 (9/20/18).

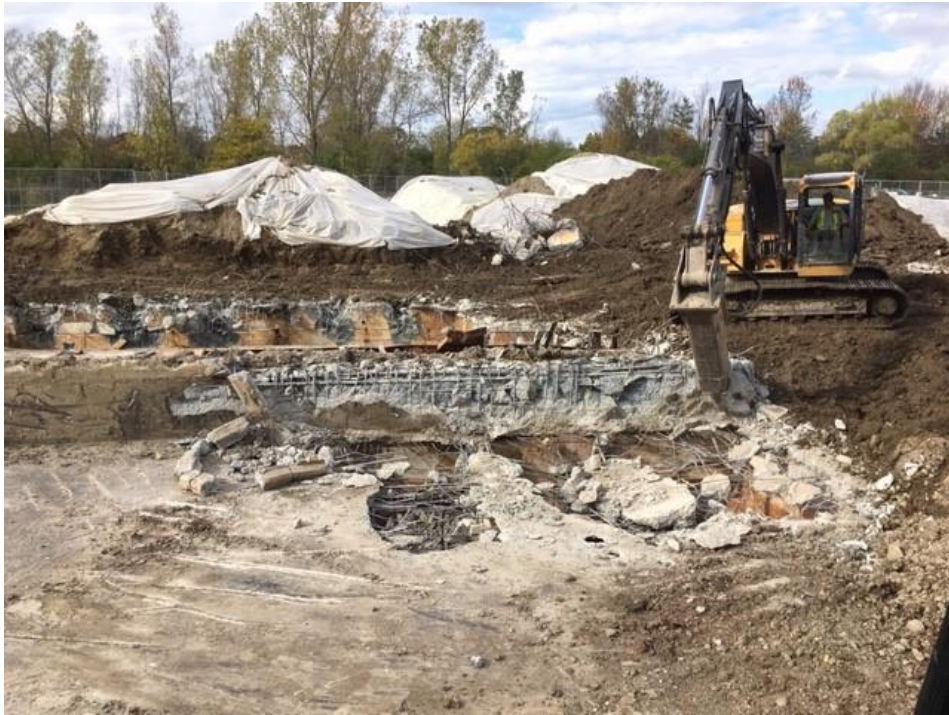
Photograph 23: Demolition of side walls at Silo 4 (10/10/18).

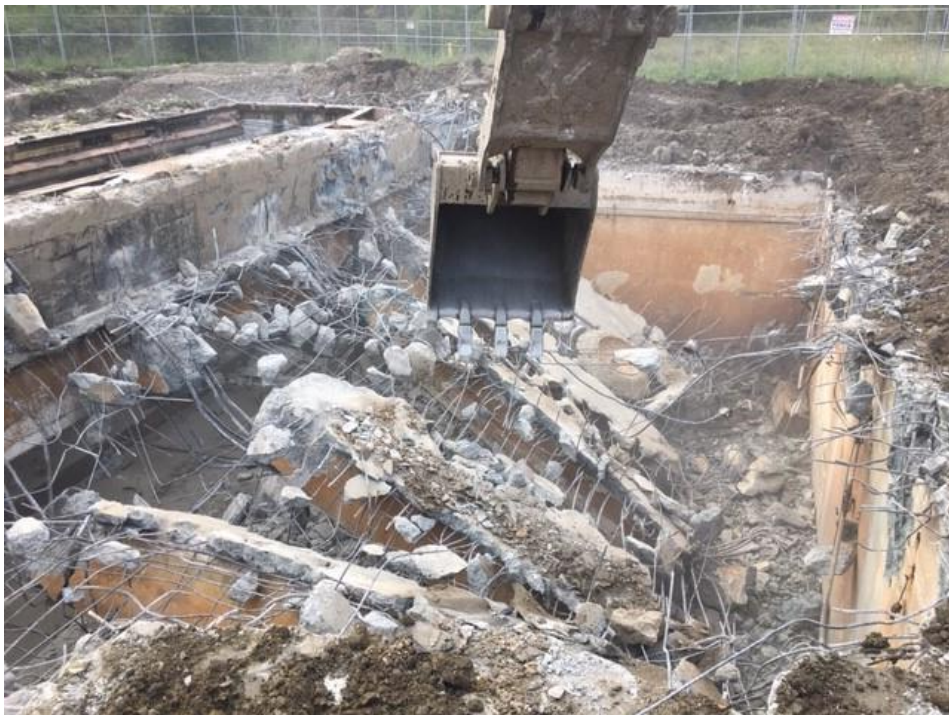
Photograph 24: Demolition of support beams and elevator door platform at Silo 4 (10/10/18).

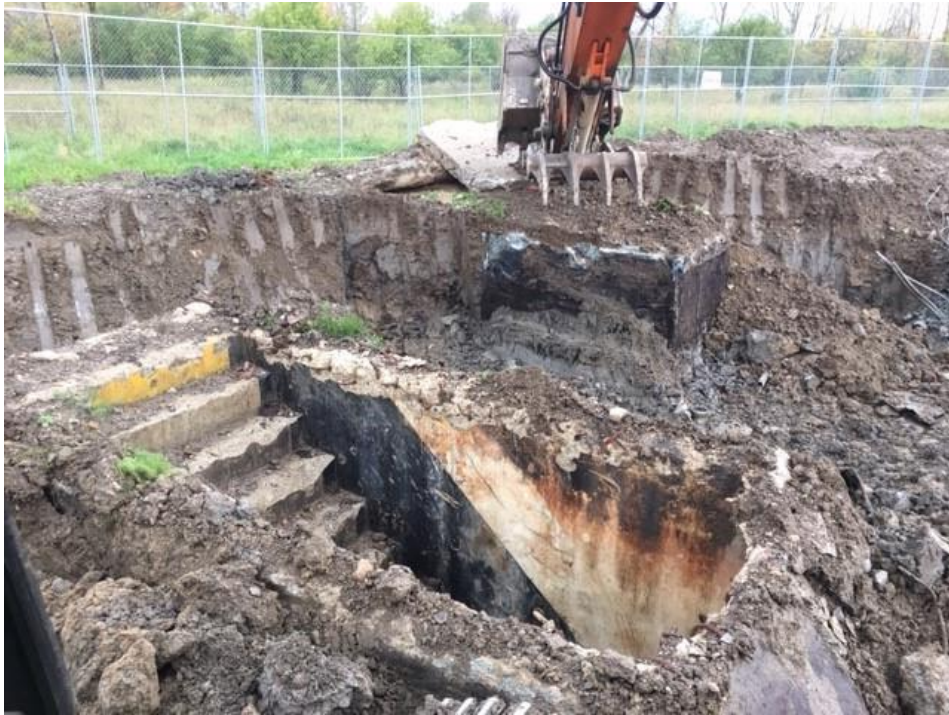
Photograph 25: Excavation around personnel room and stairwell at Silo 4 (10/11/18).

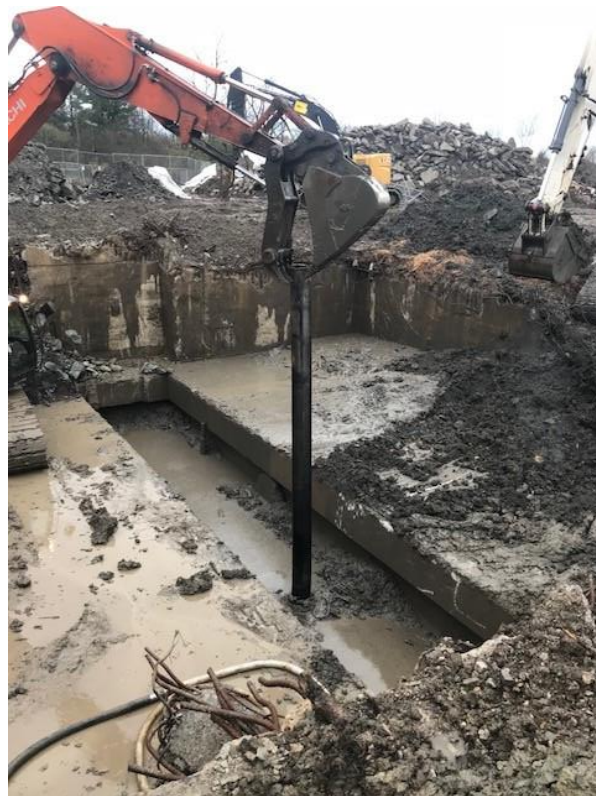
Photograph 26: Removing elevator piston at Silo 6 (11/6/18).

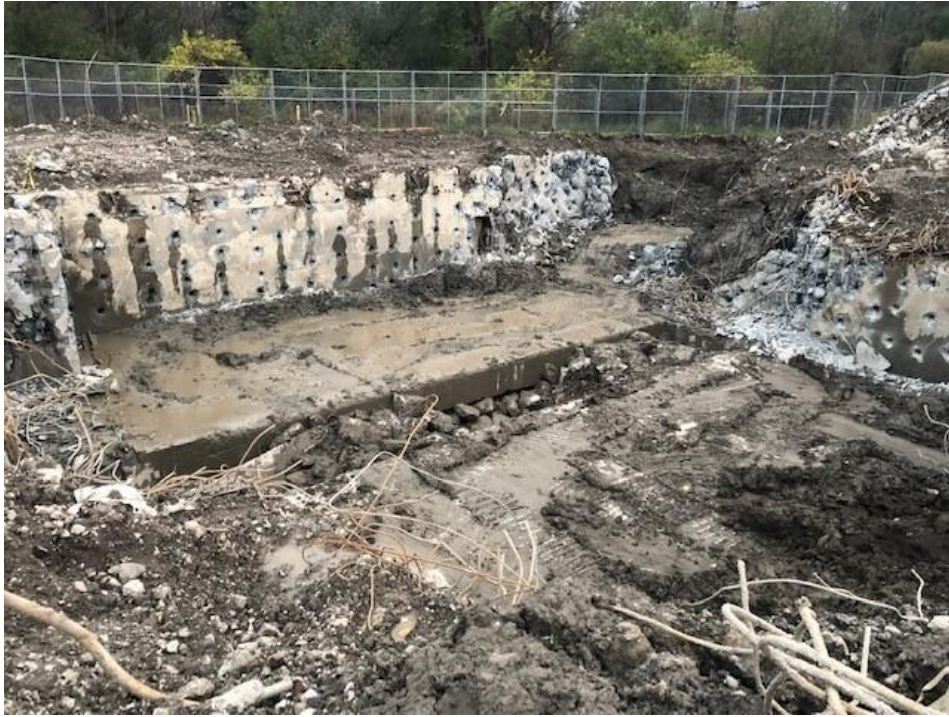
Photograph 27: Demolition at Silo 6 (11/7/18).

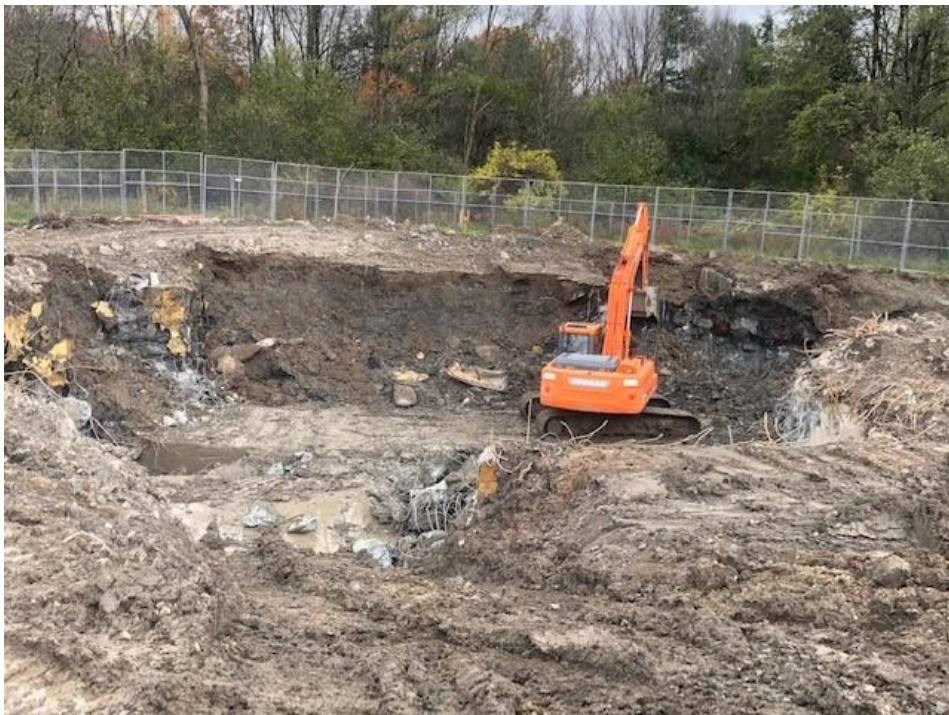
Photograph 28: Walls removed as demolition continues at Silo 6 (11/8/18).

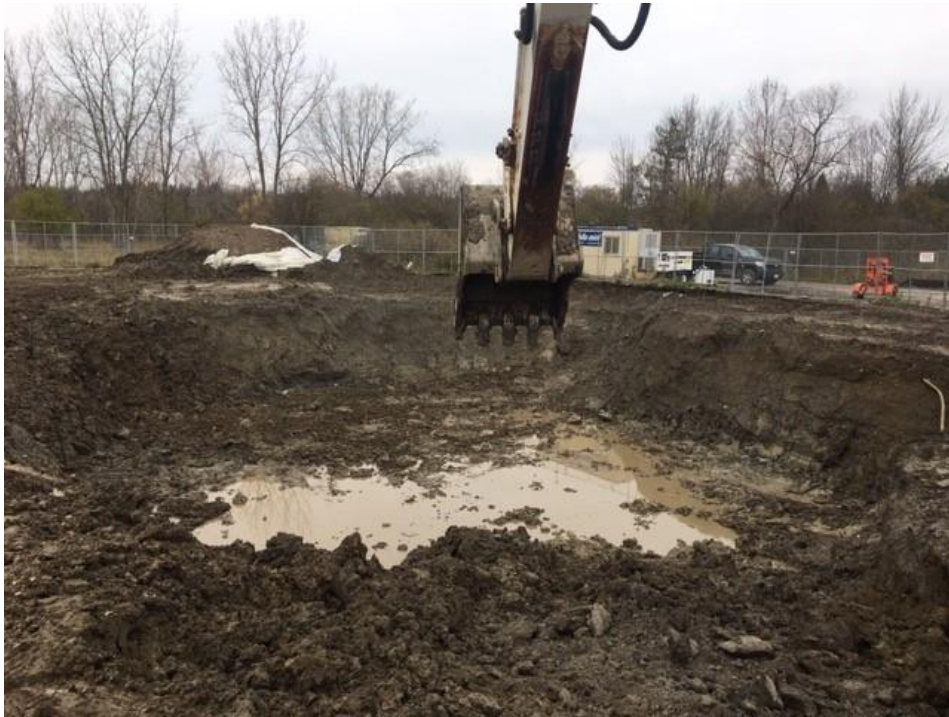
Photograph 29: Backfill with soil and crushed concrete at Silo 1 (11/12/18).

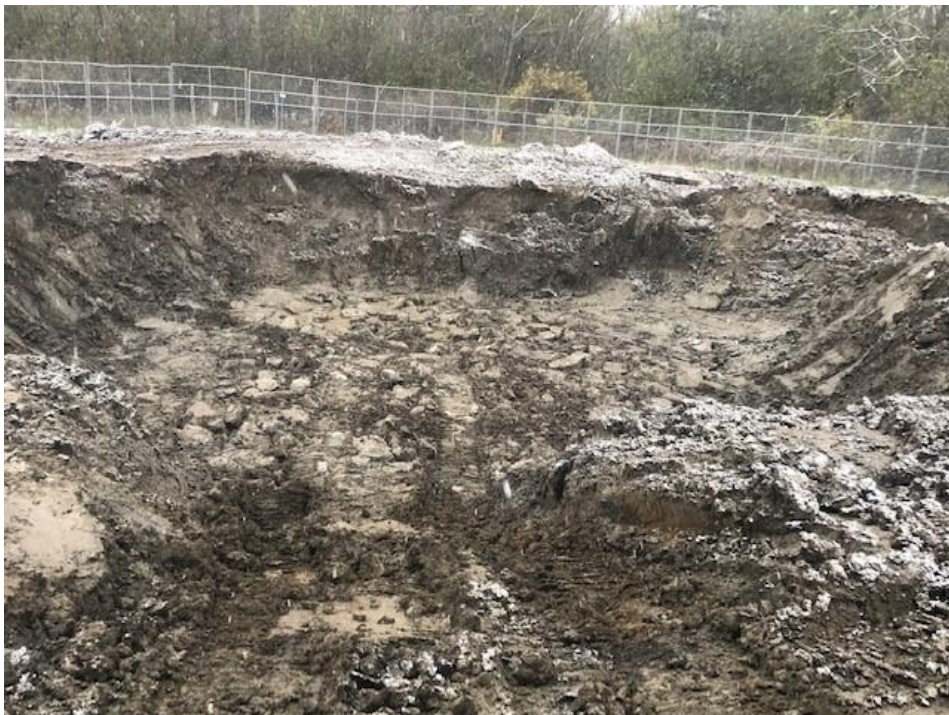
Photograph 30: Backfill with soil and crushed concrete at Silo 6 (11/13/18).

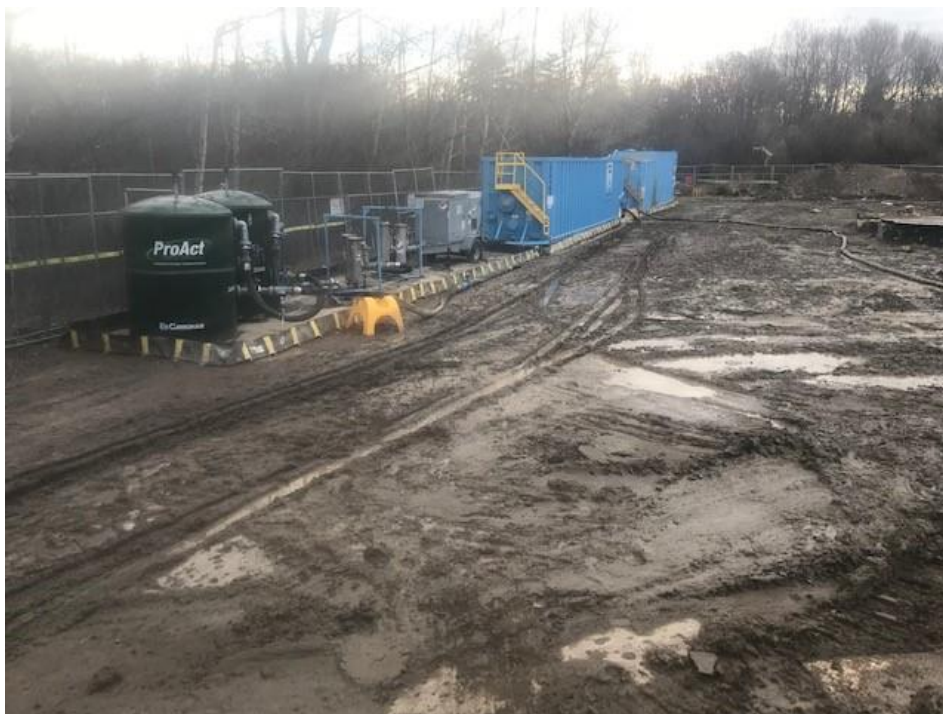
Photograph 31: Water treatment system setup (04/15/19).

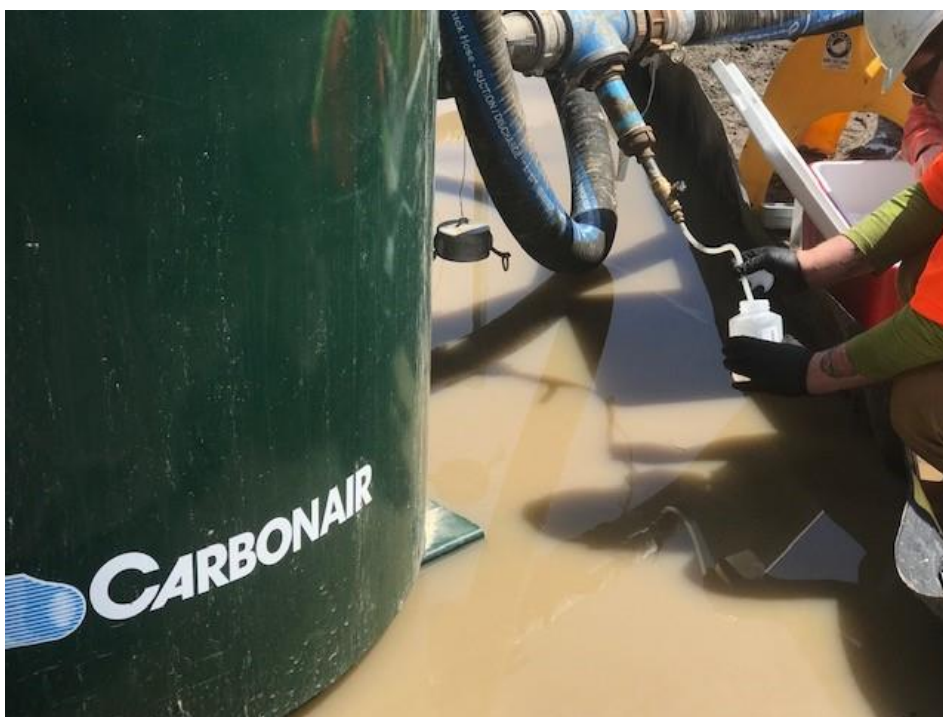
Photograph 32: Water treatment system sample collection (04/17/19).

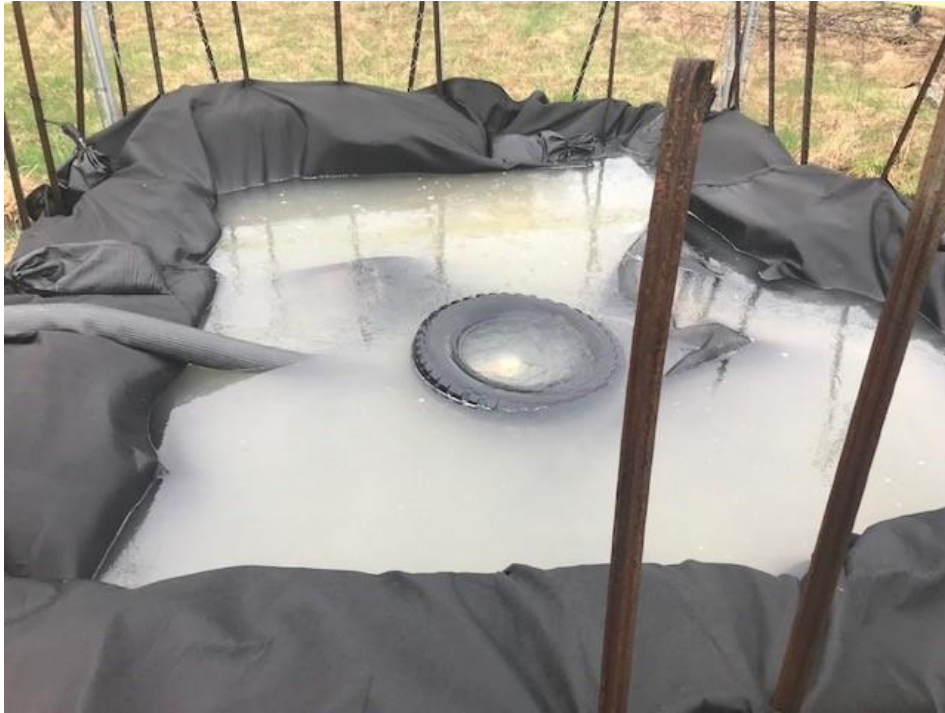
Photograph 33: Water treatment system discharge structure (04/19/19).

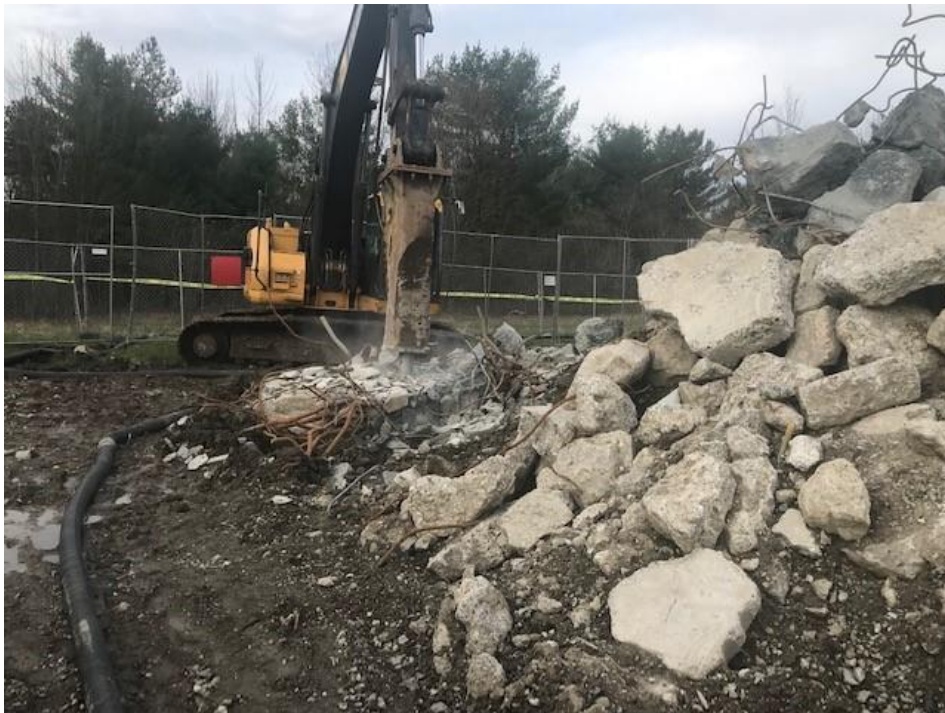
Photograph 34: Concrete crushing to reduce concrete size (04/23/19).

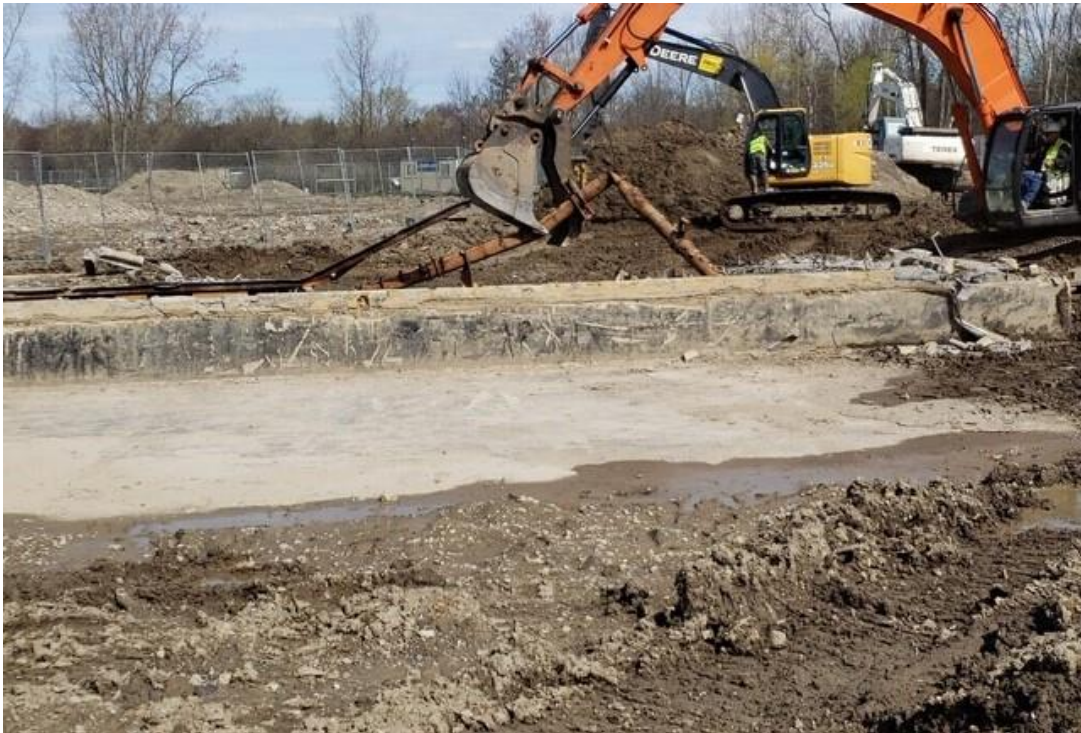
Photograph 35: Demolition at Silo 5 (04/25/19).

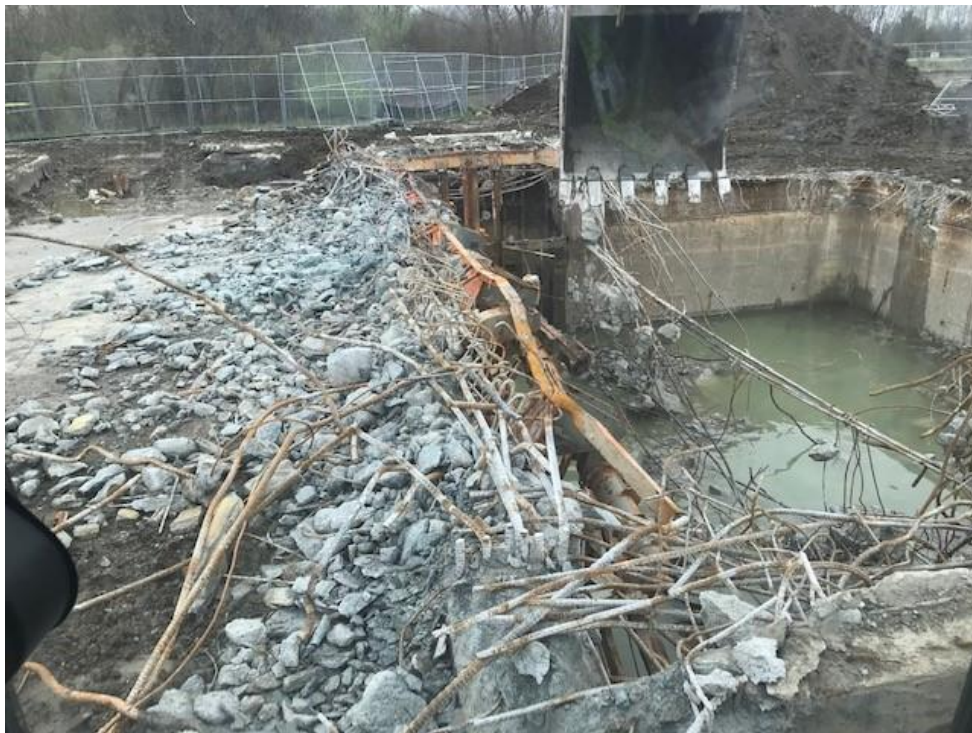
Photograph 36: Demolition continues at Silo 5 (04/30/19).

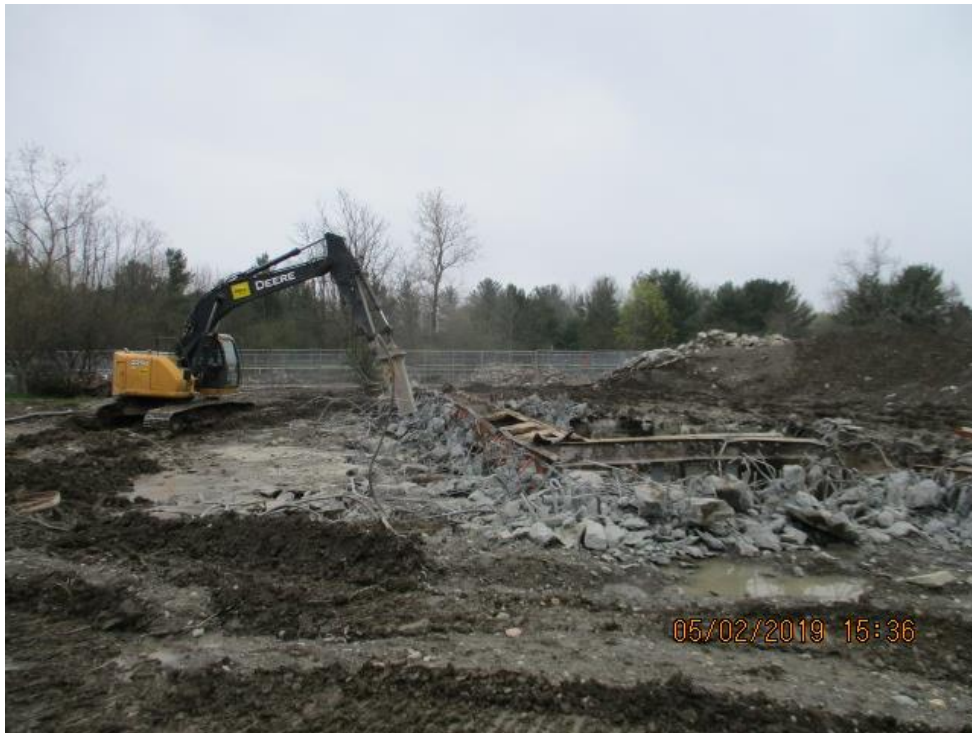
Photograph 37: Demolition at Silo 3 (05/02/19).

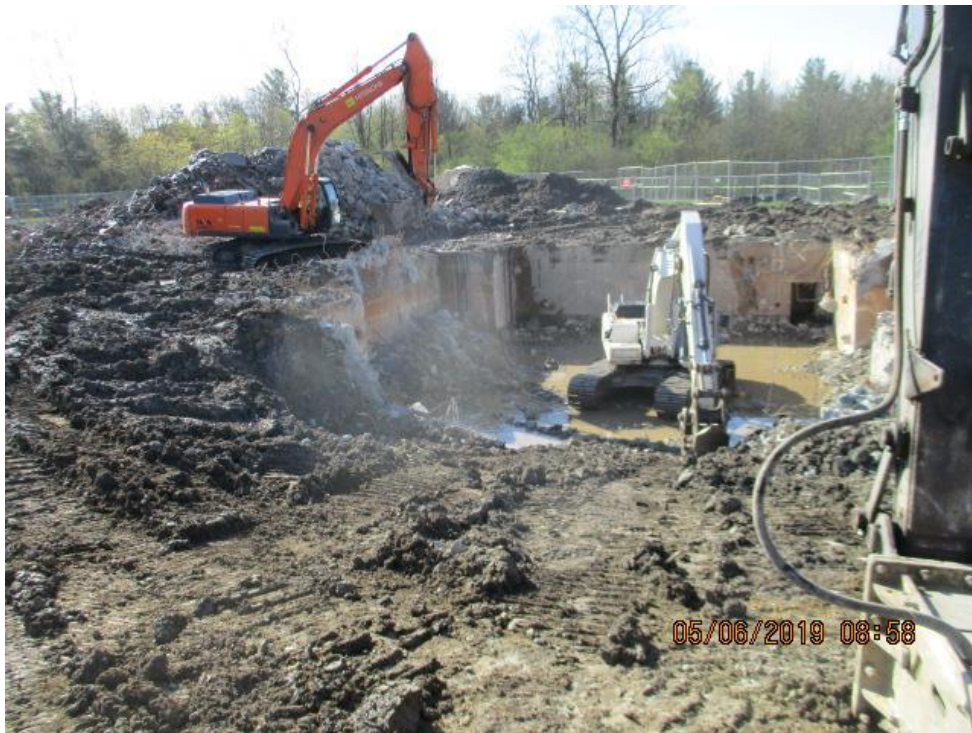
Photograph 38: Demolition of walls at Silo 5 (05/06/19).
