Appendix A

Photograph Log

**APPENDIX A
SITE PHOTOGRAPHS**

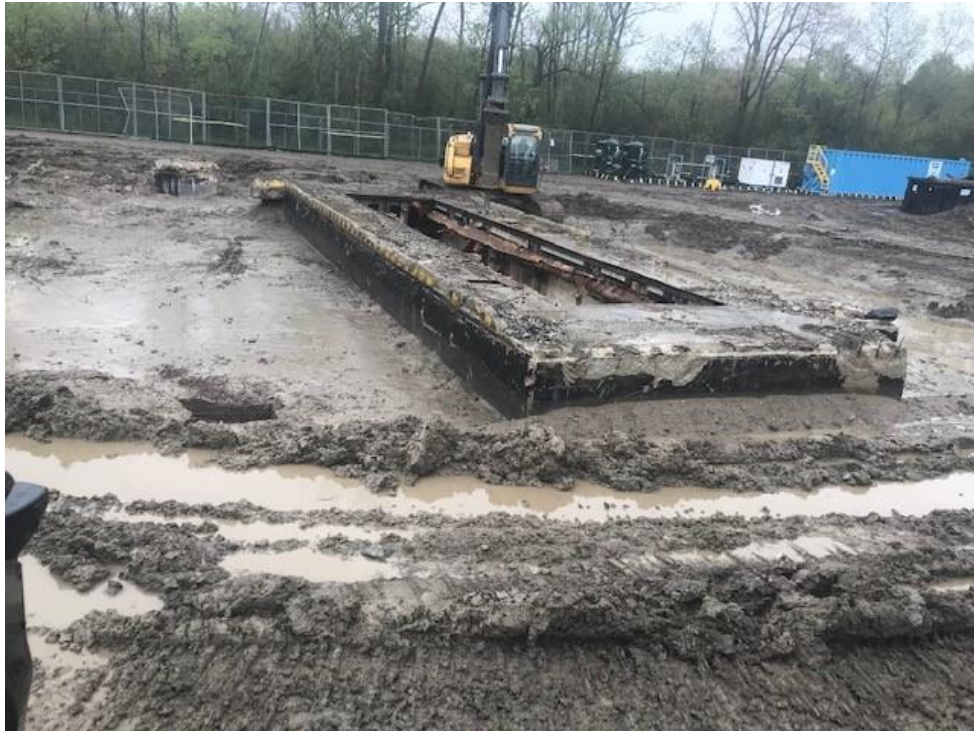
Photograph 39: Demolition of Silo 2 Roof (05/14/19).

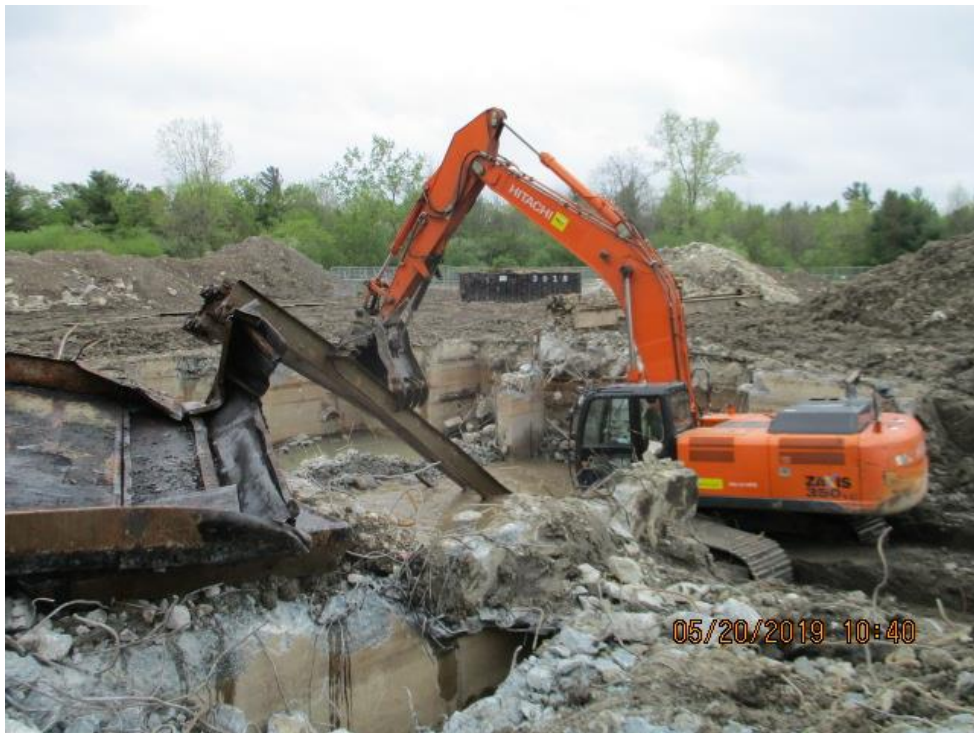
Photograph 40: Silo 2 Elevator Frame Removal (05/20/19).

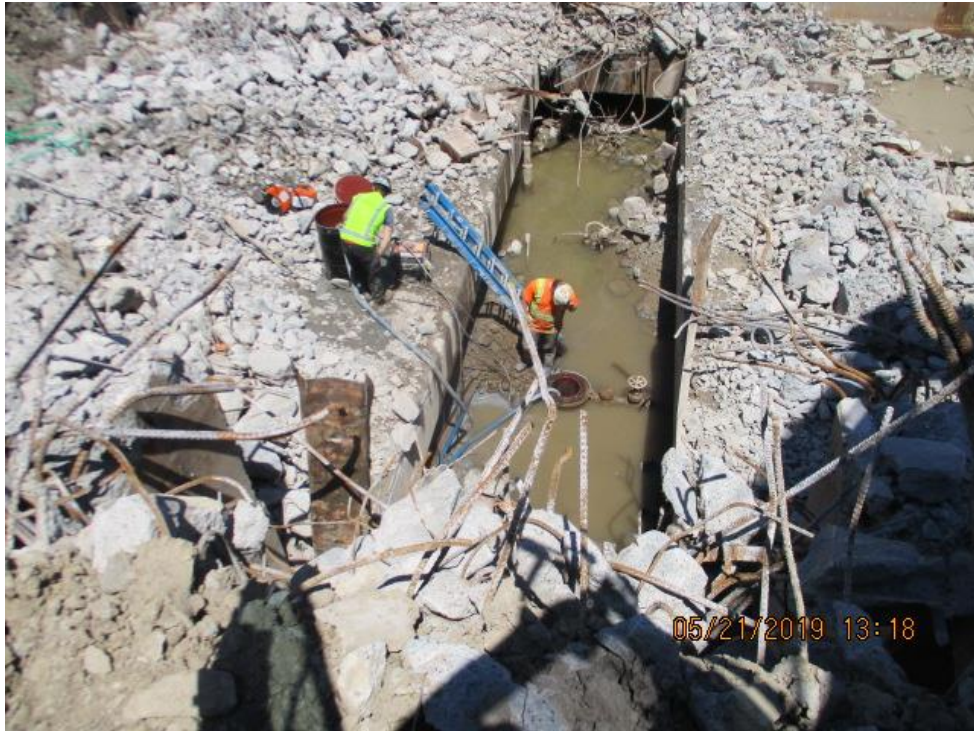
Photograph 41: Pumping hydraulic oil from elevator piston assembly (05/21/19).

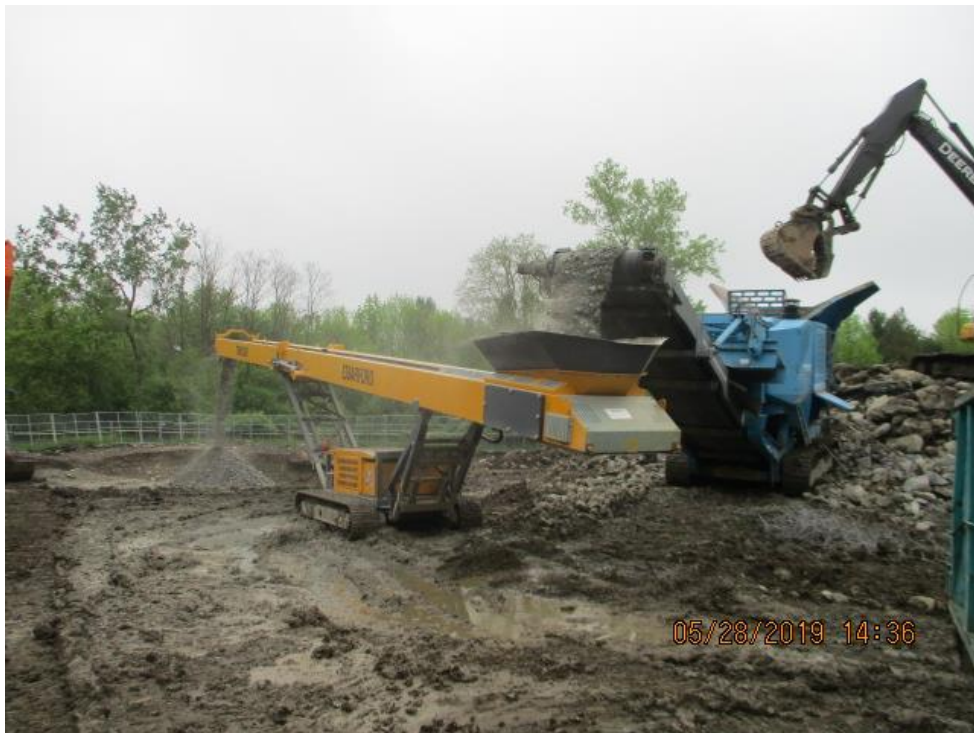
Photograph 42: Crushing concrete into smaller sized pieces for use as backfill (05/28/19).

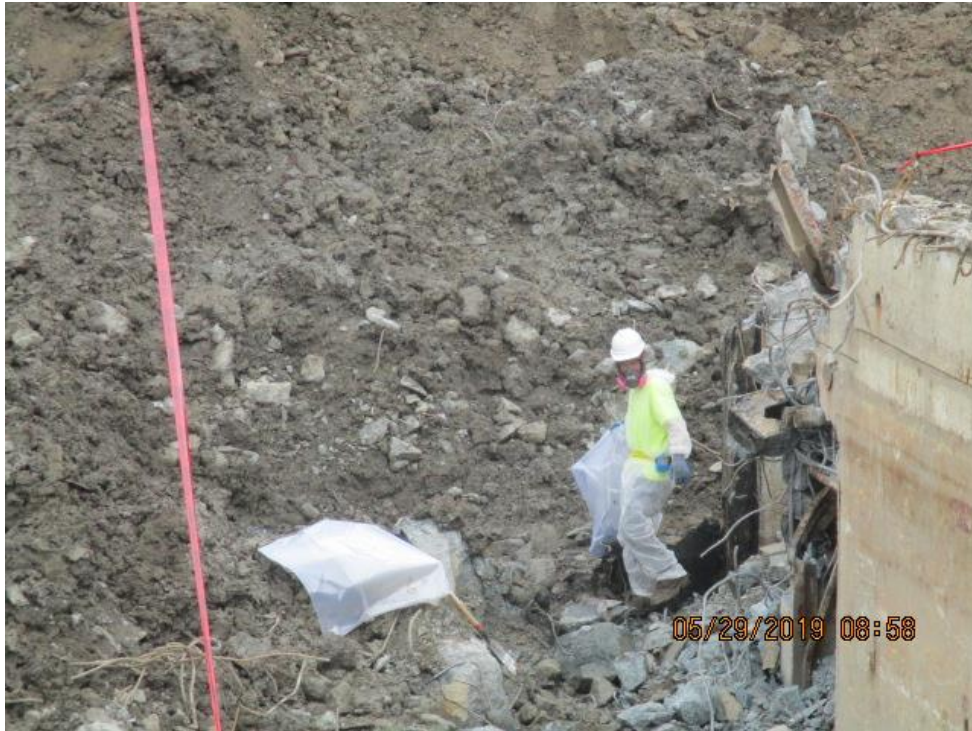
Photograph 43: Asbestos abatement at Silo 2 (05/29/19).

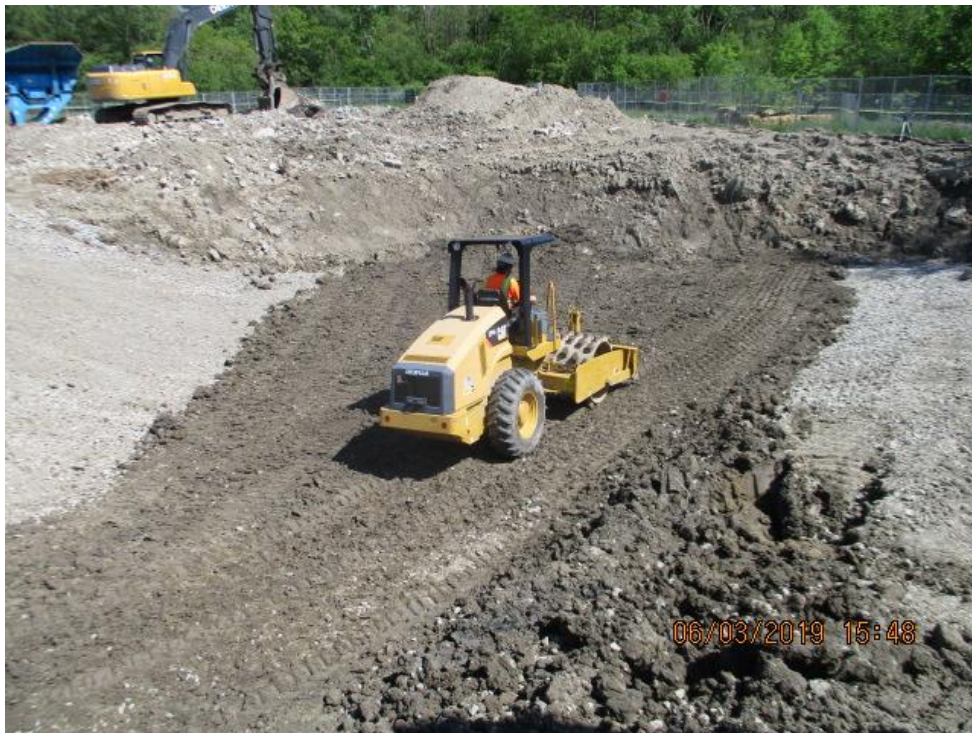
Photograph 44: Backfill Silo 5 with native soil (06/03/19).

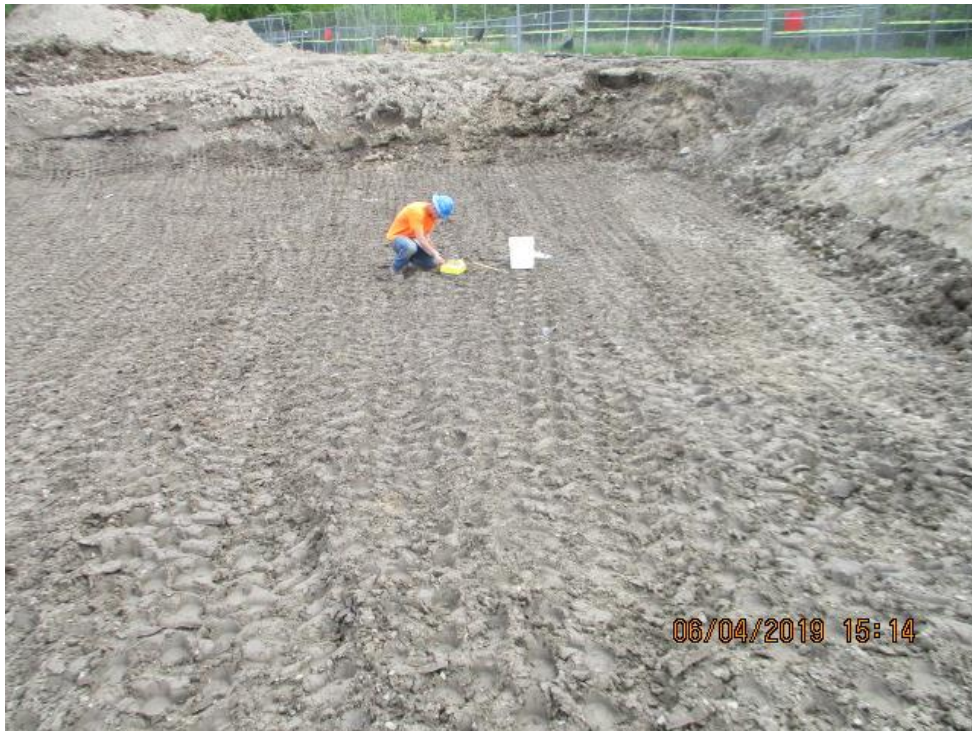
Photograph 45: Backfill compaction testing at Silo 5 (06/04/19).

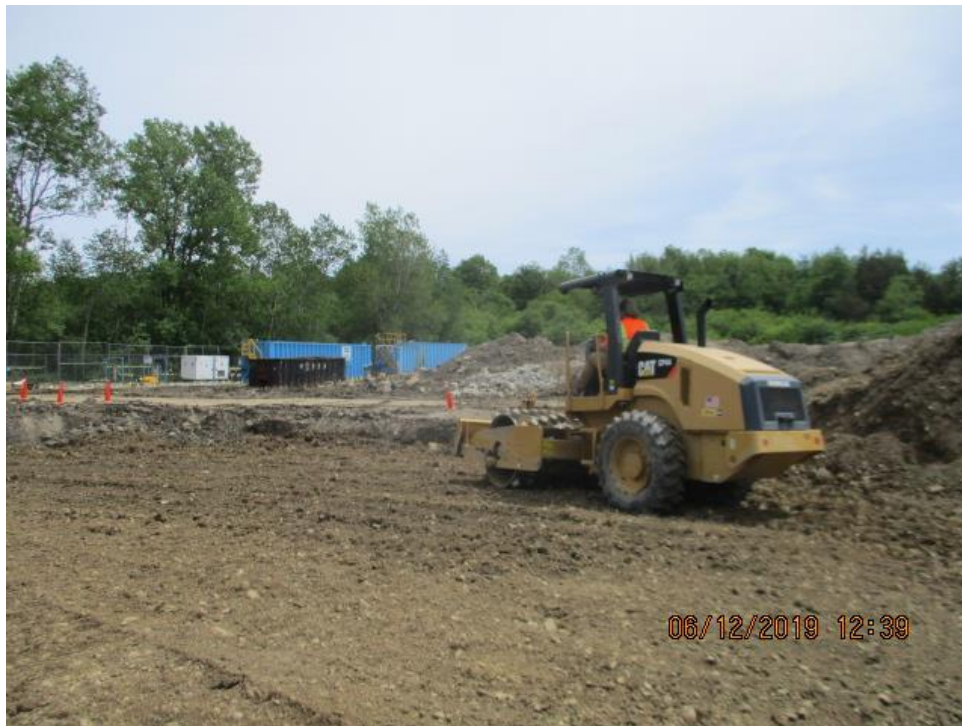
Photograph 46: Backfill Silo 2 with imported fill (06/12/19).

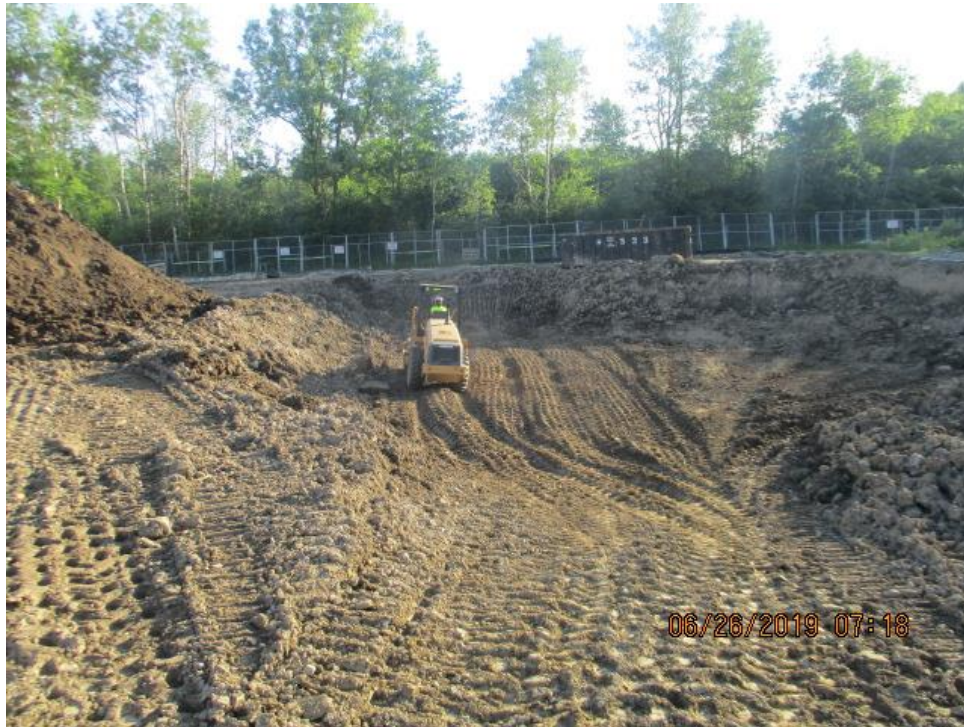
Photograph 47: Compaction of silo (06/26/19).

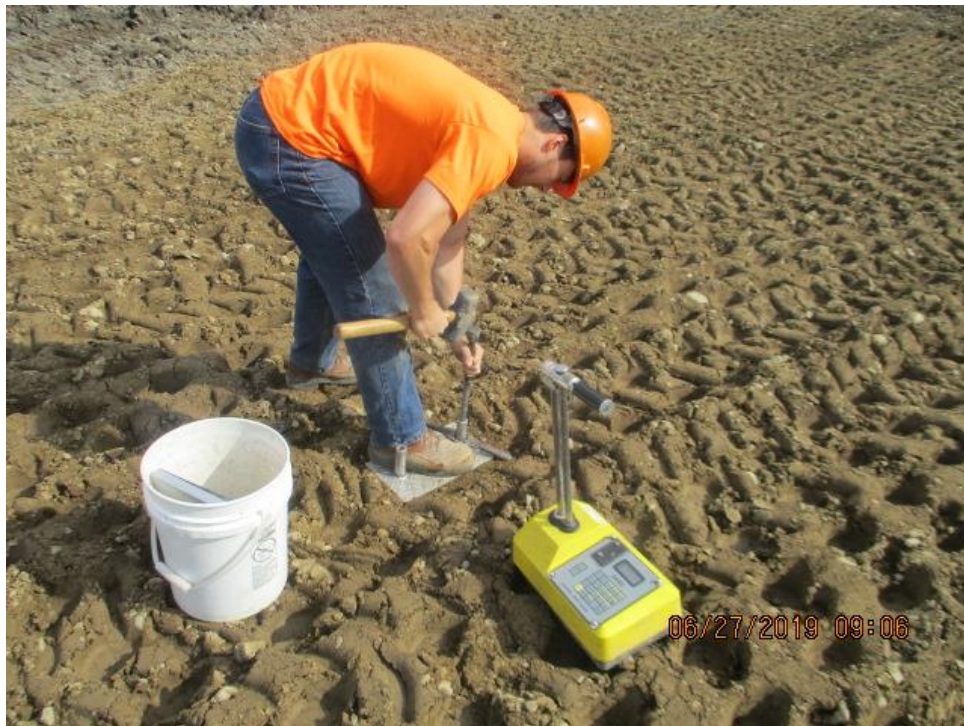
Photograph 48: Backfill compaction testing (06/27/19).

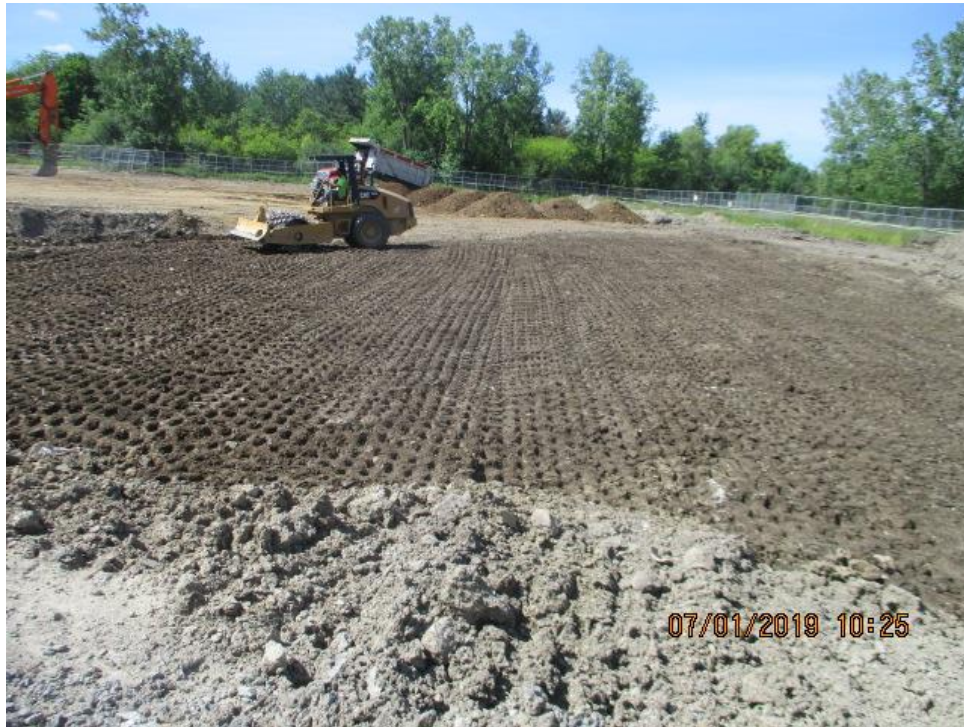
Photograph 49: Backfill compaction of former silo area (07/01/19).

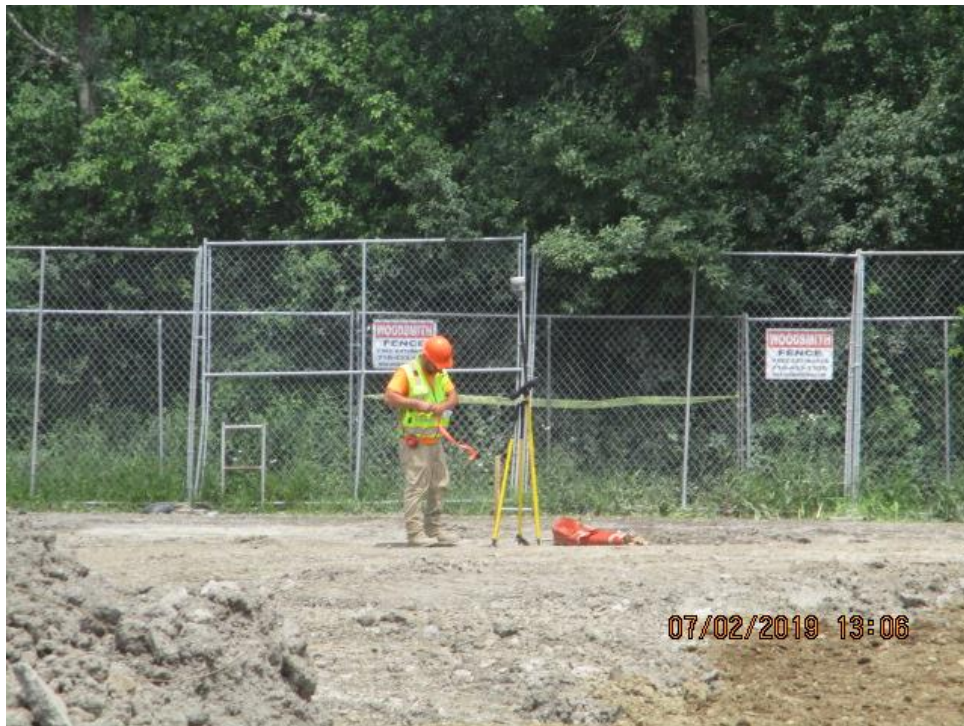
Photograph 50: Survey for final grading (07/02/19).

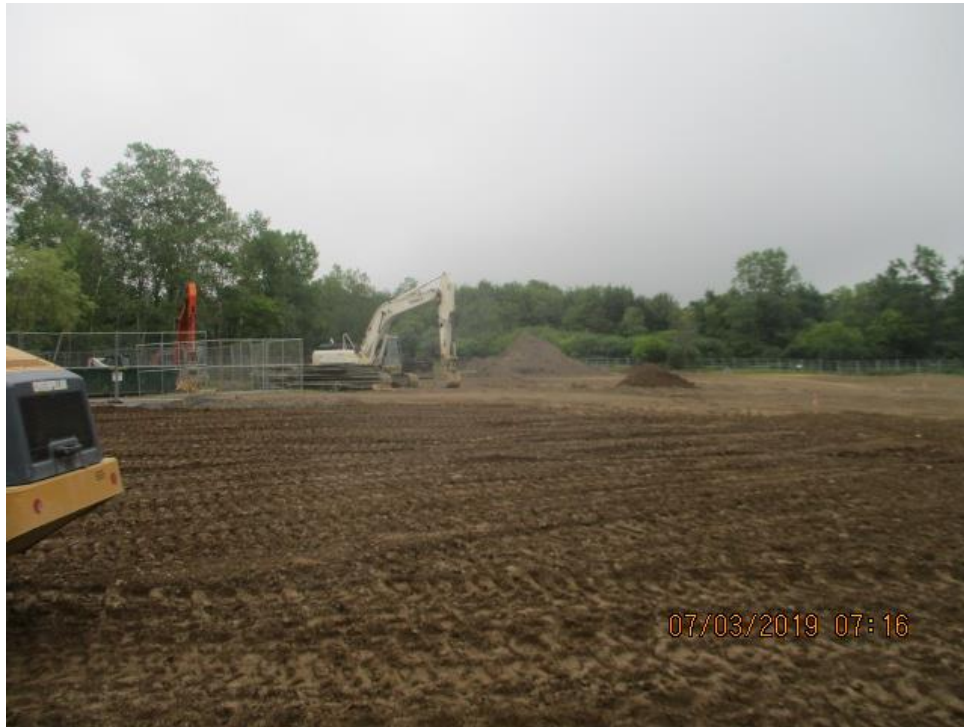
Photograph 51: Overview of former silo area (07/03/19).

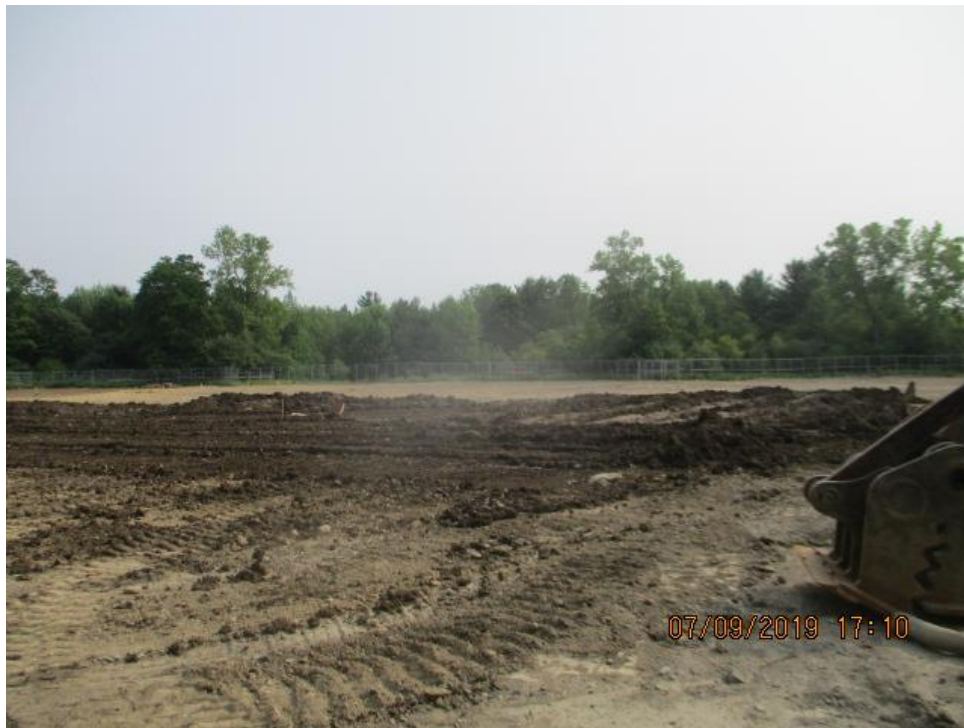
Photograph 52: Placement of native topsoil (07/09/19).

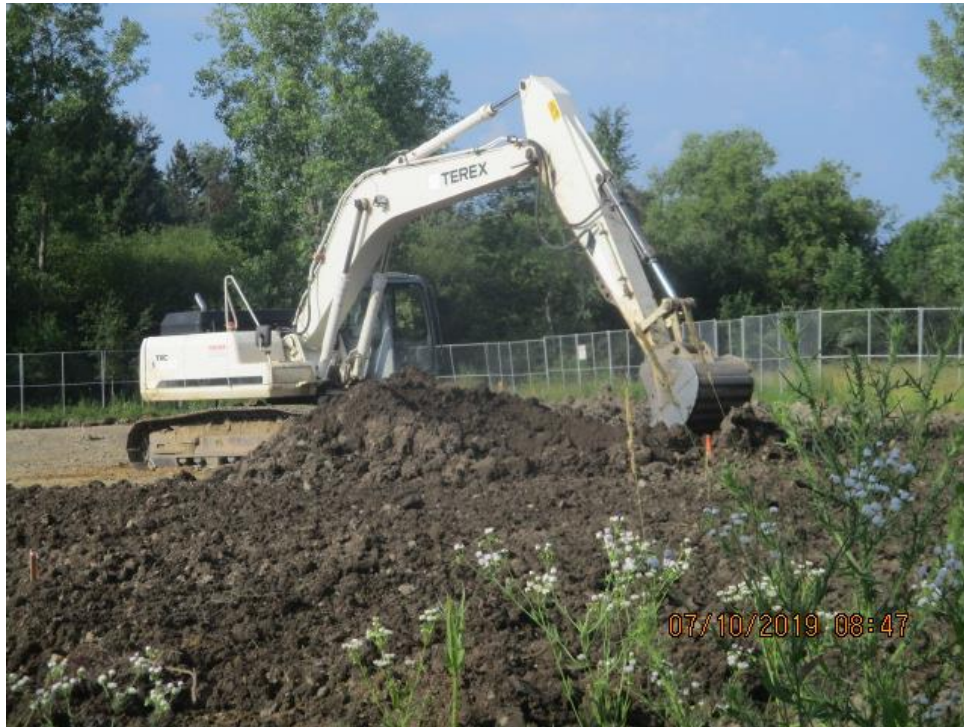
Photograph 53: Native topsoil placement (07/10/19).

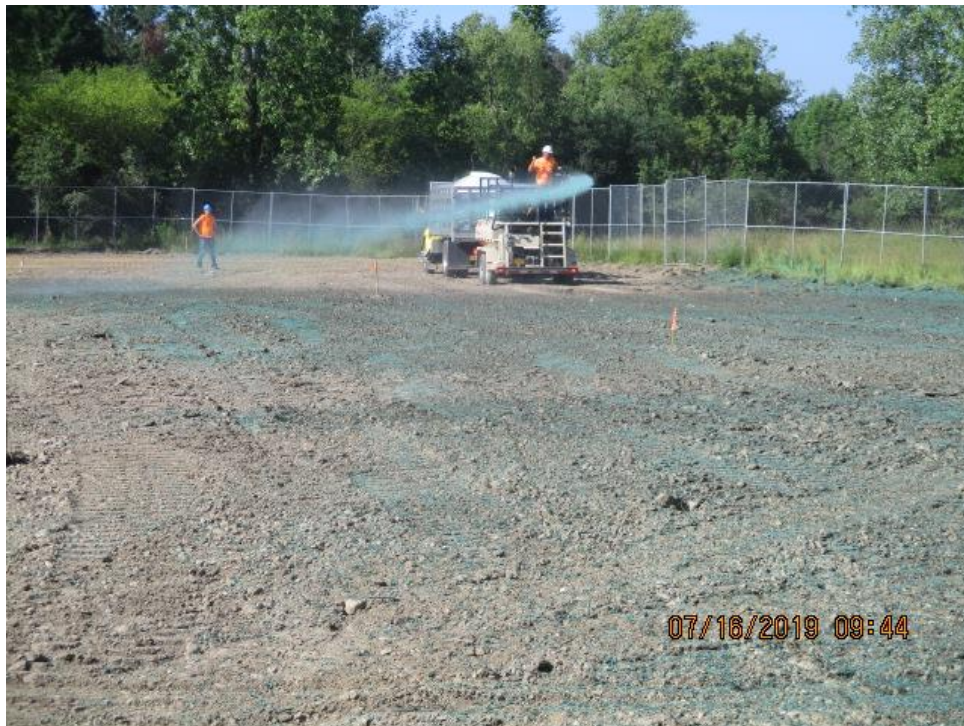
Photograph 54: Hydroseeding site (07/16/19).

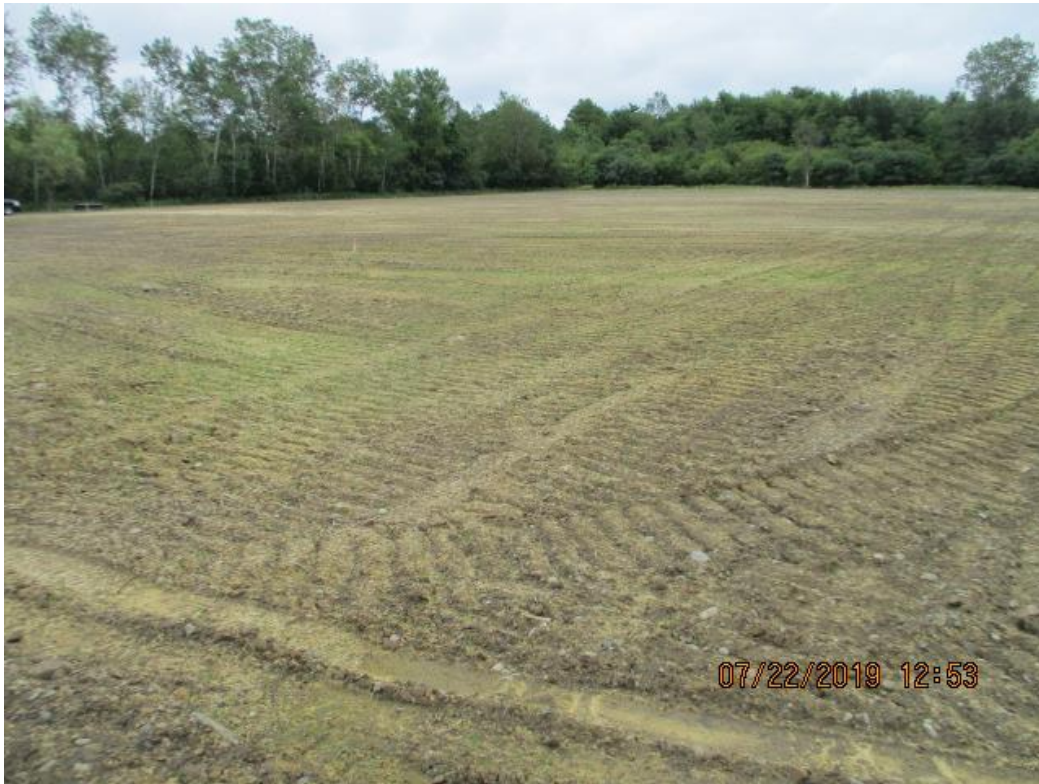
Photograph 55: Grass growing across site (07/22/19).
