APPENDIX K

FIMP COASTAL PROCESS FEATURES

K.1 DESCRIPTION OF FIMP HEP COASTAL PROCESS FEATURES

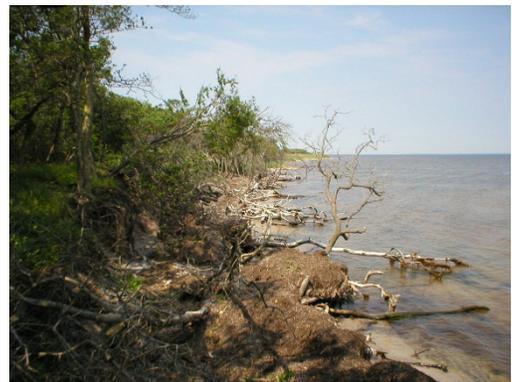
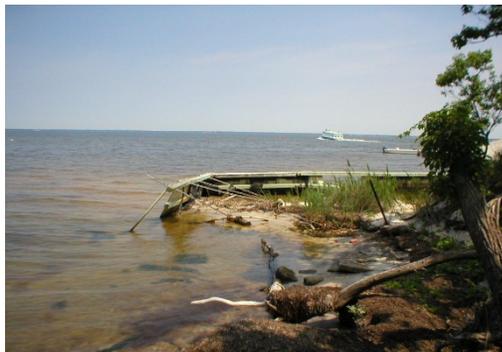
The Sunken Forest site includes all six HEP community model types. The most notable restoration needs at this location are the severely eroding and steep bayside shoreline banks, a bulkhead, and scattered invasive common reed (*Phragmites australis*) also referred to as *Phragmites*, along the bayside shoreline. In addition, an active public marina and numerous buildings and recreational facilities associated with the National Park Service are also located on approximately 25 percent of the site. The site is dominated by maritime upland forest. Sand trails and wooden boardwalks traverse much of the site and provide access to the beach.

Recreational use of the area is high. Trash was noted along the bay and ocean shorelines and evidence of vehicle use of the beach was documented. Vehicle access to the beach is provided via open cuts in the dune located beyond the area surveyed for the CPF. In general, bayside shoreline and estuarine processes have been negatively impacted in this area and appear to be most affected by hard structures such as a marina, bulk heading, buildings and various human activities along the shoreline and in aquatic and intertidal areas. Additionally, the dune development and evolution and cross-island sediment transport processes have also been negatively affected by placements of buildings and walkways within upland and dune areas and overall direct human use of the area. The negative impacts to cross-island transport may be somewhat offset by man-made cuts in the primary dune that allow for vehicle access to beach areas.

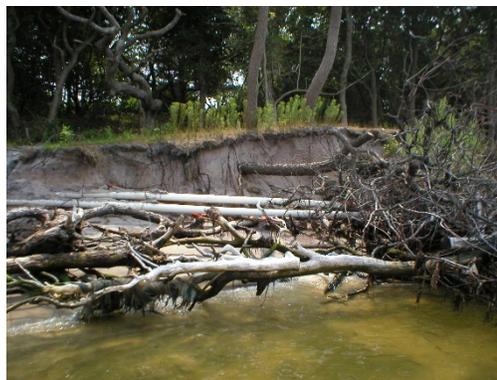
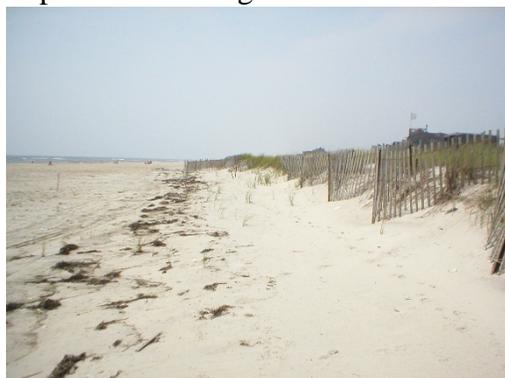
The Reagan site is similar to the Sunken forest in that a predominant restoration need at the site is the severely eroding bayside shoreline banks as well as scattered invasive *Phragmites* along the bayside shoreline. In addition, a significant portion of the site includes the highly developed community of Fire Island Pines. The entire bayside shoreline along this community is bulkheaded and as a result lacks a bayside intertidal zone. Vehicle cuts, pathways, sand fence, hard structures, and walkways from residential areas, heavily impact dunes along the ocean side of the site.

Upland areas adjacent to the residential community include sandy roads and trails, a power station, a helipad, and sand fence. Recreational use of the area is high and evidence of trash and vehicle use of the beach was documented. Access to the beach through the dune is via one wooden boardwalk, several small sand trails, and a major vehicle access point that connects the beach, residential area, and helipad.

Similar to the Sunken Forest site, the bayside shoreline and estuarine processes at the Reagan site have been negatively impacted and appear to be most affected by hard structures such as extensive bulk heading, boat slips, buildings and various human activities in the area, particularly those associated with the highly developed community of Fire Island Pines. Impacts have directly and indirectly affected the shoreline, intertidal, and aquatic areas of the site. Additionally, the dune development and evolution and cross-island sediment transport processes have also been significantly negatively affected by placements of boardwalks, sand fence, residential housing, and other hard structures within upland and dune areas, and overall direct human use of the area. The negative impacts to cross-island transport may be somewhat offset by man-made cuts in the primary dune that allow for vehicle access to beach areas.

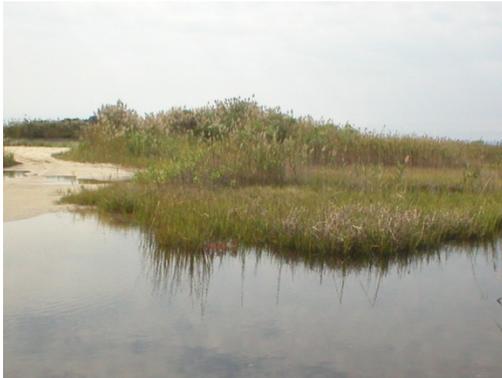
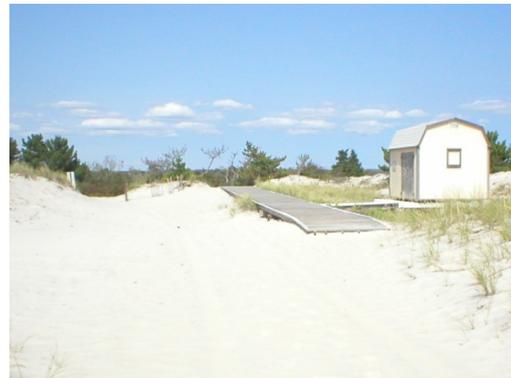
Great Gun recreational use area includes a major boat dock, helipad, wooden boardwalk, and several structures associated with the recreational area (i.e., outhouses, picnic tables, storage sheds). Numerous sand roads and trails are found throughout the site and numerous access roads and trails cut through the dune. The site also is characterized by a tidal marsh system comprised of an inundated saltwater pond and saltmarsh. However, due to tidal restrictions the tidal pond associated with this marsh is relatively stagnant and a significant component of the upper zones of the high marsh is dominated by

This area is a public recreational facility, and use of the area is high. Vegetation loss and substrate disturbance from pedestrian and vehicle use of uplands and dune areas is significant throughout the site. Despite the recreational uses of the area, the dunes and beach are of relatively high quality in terms of vegetation, slope and width. The bayside shoreline and estuarine processes at the site have been negatively impacted and appear to be most affected by hard structures such as extensive bulk heading, boat slips, buildings, a playground/recreational area, and general impact from various human uses the area. Impacts have directly and indirectly affected the shoreline, intertidal, and aquatic areas of the site and in particular have altered hydrologic connection to a relatively large salt marsh community on site. Evidence of erosion is present on the bayside shoreline, but is not as severe as other sites such as Reagan and Sunken Forest. The dune development and evolution and cross-island sediment transport processes have also been significantly negatively affected by placements of boardwalks, sand fence, other hard structures within upland and dune areas, and overall direct human use of the area. However, the negative impacts to cross-island transport may be somewhat offset by man-made cuts in the primary dune that allow for vehicle access to beach.

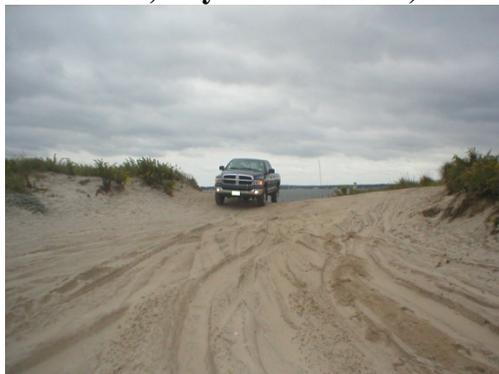
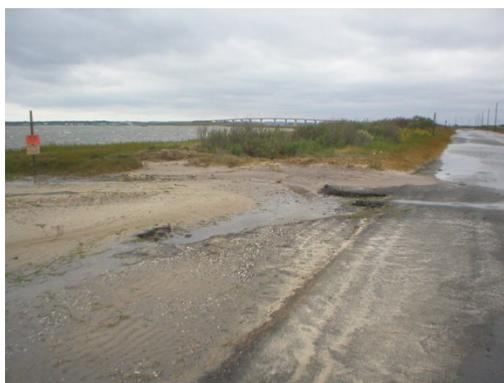
CPF T-7-1, Bayside Shoreline, Salt Marsh, and Upper Beach and Dune

The Tiana CPF currently provides parking and access to the beach for recreational activities. The site is at a relatively narrow portion of the barrier island, however, the dunes and beach in this area are relatively wide and stable. On the bayside, overall the salt marsh is of relatively high quality. However, a portion of the site has been degraded due to flooding and runoff from the paved road, and use of the area as a boat launch point. Recreational use of the area is high and includes vehicle access to the beach. Access to the beach is provided by a large cut in the dune that extends from the end of the asphalt parking area.

Overall the bayside shoreline and estuarine processes at the site appear to be functioning naturally, considering the overall setting of the site. However, a small portion of the salt marsh and bay shoreline has been directly impacted by vehicles accessing the area to launch watercraft and from runoff from the adjacent road surface. The dune development and evolution process is affected by vehicle traffic on the upper beach and beach maintenance activities (i.e., sand deposition and dune building). This activity mimics sand accretion, which may or may not be the “natural trend in this area”. Cross-island sediment transport processes have been negatively affected by beach maintenance activities and other hard structures (i.e., asphalt parking lot and roads) within upland and dune areas. The negative impacts to cross-island transport may be somewhat offset by man-made cuts in the primary dune that allow for vehicle access to beach areas.

The goal of T-7-1 is to restore salt marsh by removing fill material, regrading and replanting to area, restoring the dune at an oceanside access cut and providing access via a dune walkover, and restoring dunegrass/upland in those areas. Specific components of T-7-1 include:

- Remove 0.2 ac of fill bayside
- Regrade 0.2 ac area
- Plant 0.1 ac of regraded bayside shoreline
- Regrade and restore 200 foot wide vehicle access cut in the dune to slope and width of adjacent dune
- Fill cut with 1 ac of sand
- Plant 0.25 ac of restored dune with dune grass
- Install one dune walkover

On the bayside, approximately 0.2 ac of gravel, asphalt, and fill material, would be removed from the salt marsh and upland community. This portion of the site would be regraded and planted as needed to restore salt marsh and a narrow upland community along the road edge. On the oceanside, approximately a 200 foot-wide area of the dune and upper beach located at the vehicle cut would be restored to fore dune conditions such that approximately 200 feet of the existing dune face would be regraded to a slope of approximately 20-25%, planting the dune face

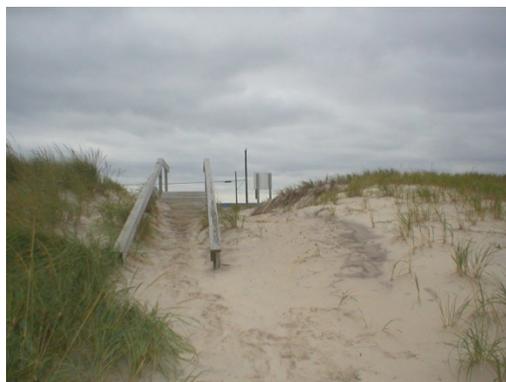
Bayside, the site is characterized by an asphalt parking lot, relatively steep bayside dunes, and impacts to bayside dunes caused by pedestrian access from the parking lot to the bay shoreline. A relatively high quality salt marsh is located in the northeastern portion of the site, however the marsh does contain invasive *Phragmites*.

Recreational use of the bay and ocean shorelines areas is high. No vehicle access points are located within the CPF, but vehicle access is provided elsewhere along the beach and tire ruts have been documented on the beach. The state and Federally-listed seabeach amaranth and piping plover have been documented in the VEGBEACH community in the vicinity of this location.

Overall the bayside shoreline and estuarine processes at the site appear to be functioning naturally, considering the overall setting of the site. A small portion of the salt marsh and bay shoreline has been directly impacted by human use of the area for recreation, but impacts overall are relatively minor. The dune development and evolution process is affected by vehicle traffic on the upper beach, hard structures (i.e., boardwalk), and beach maintenance activities (i.e., sand deposition and dune building). This activity mimics sand accretion, which may or may not be the “natural trend in this area”.
