**US Army Corps  
of Engineers®**  
New York District

# **NEW YORK AND NEW JERSEY HARBOR DEEPENING CHANNEL IMPROVEMENTS**

### **INTEGRATED FEASIBILITY REPORT & ENVIRONMENTAL ASSESSMENT**

## **APPENDIX B3: Structural**

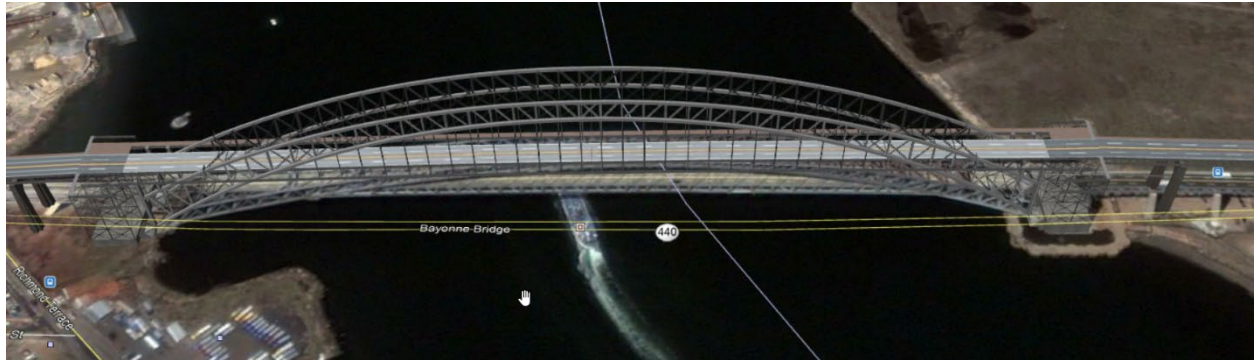
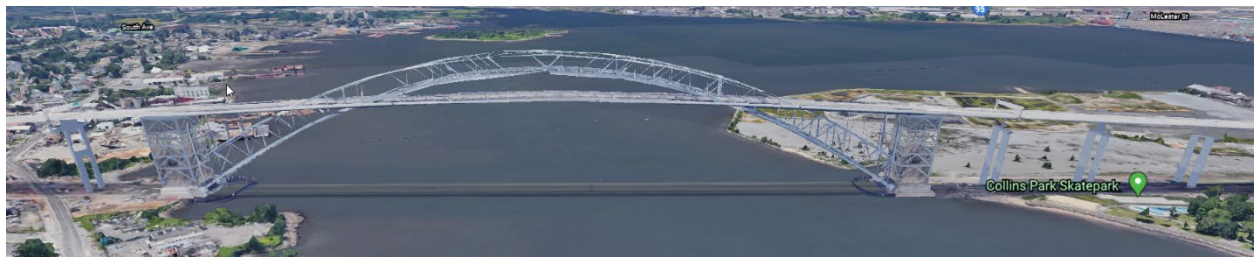
Figure 1.4.1- 1: **KVK-324**, The Bayonne Bridge circa 2004 prior to the bridge raising project.

Figure 1.4.1- 2: **KVK-324**, The Bayonne Bridge circa 2020 after the bridge raising project.

The Bayonne Bridge, **KVK-324**, was recently raised as part of a navigation project to permit larger ships to pass underneath it. As part of the project, the towers on the piers were raised and a precast deck was installed at the higher elevation. The approach ways were replaced and the concrete support piers for the approach ways were also replaced. Also changed from the report by the Master Harbor Partnership is the installation of a visible bumper system above the water at the pier locations.

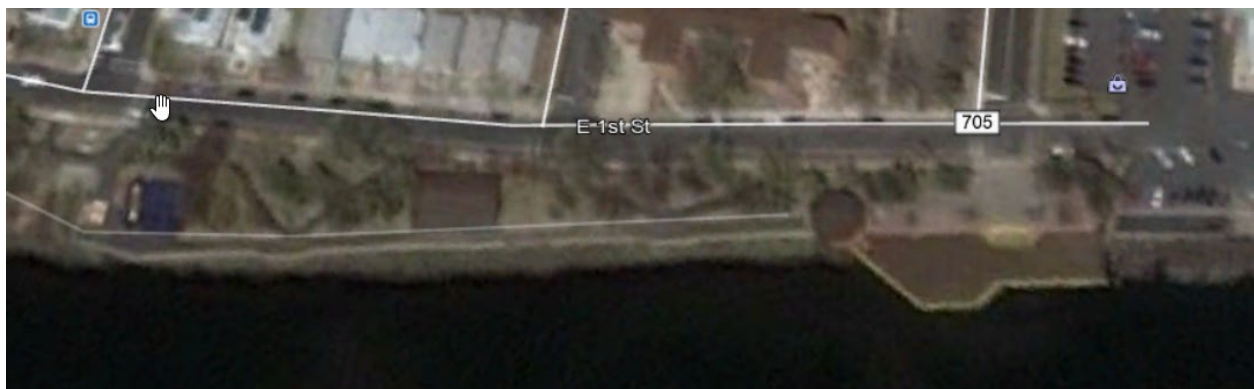
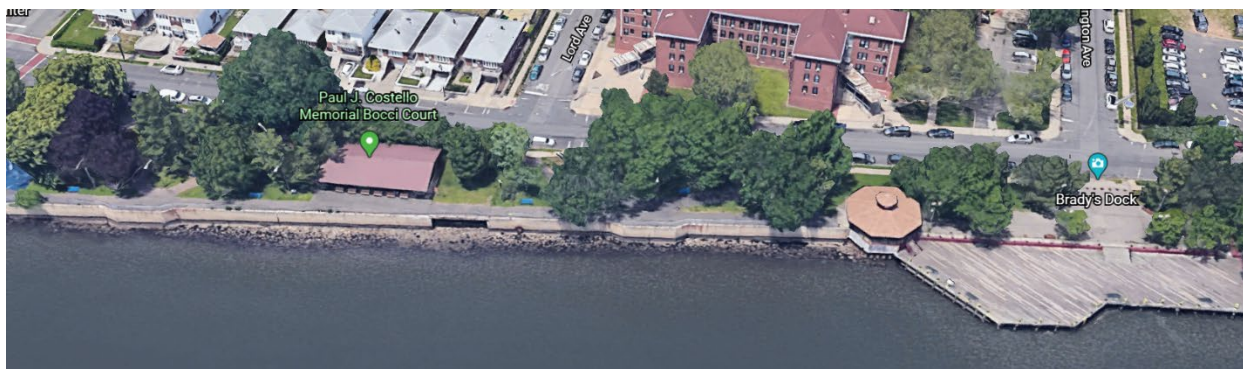
Figure 1.4.1- 3: Lord Ave and Brady's Dock, the eastern portion of **KVK-323** – A, B, & C circa 2004.

Figure 1.4.1- 4: Lord Ave and Brady's Dock, the eastern portion of **KVK-323 – A, B, & C** circa 2020.

The figures above show the eastern portion of **KVK-323-A, B, & C**, the shoreline on the New Jersey side of the Kill Van Kull channel near the end of Lord Ave. The region by Brady's Dock appears to be unchanged from the report by the Master Harbor Partnership. The concrete wall from Lord Ave until Broadway appears to be unchanged as well. There appears to be an undocumented pedestrian bridge or drainage structure at the end of Lord Ave.

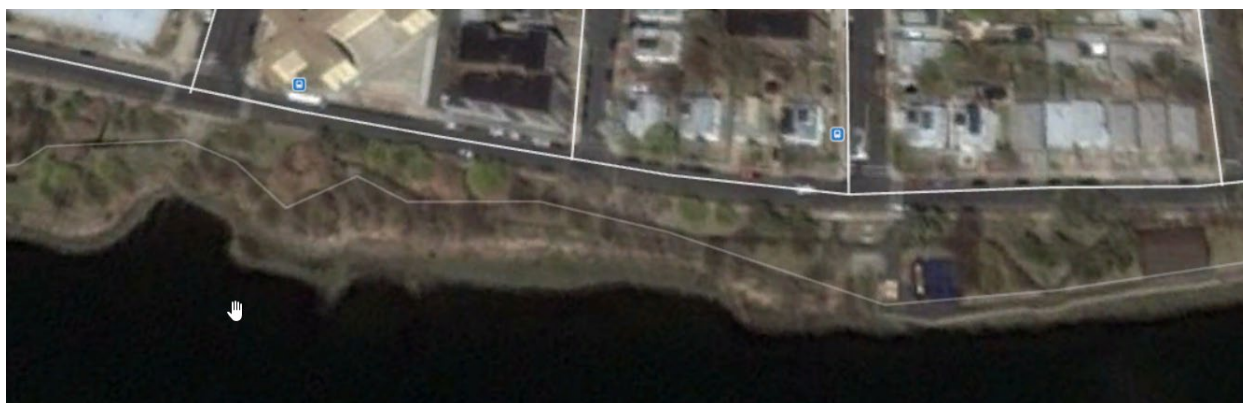
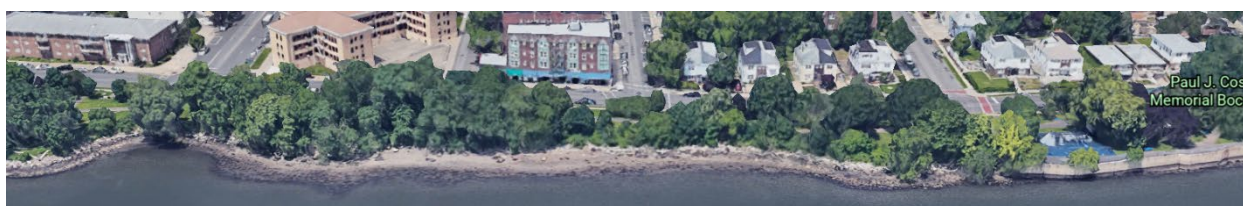
Figure 1.4.1- 5: The middle eastern portion of **KVK-323-A, B, & C** circa 2004. Continued from Figure 1.4.1-3.

Figure 1.4.1- 6: The middle eastern portion of **KVK-323-A, B, & C** circa 2020. Continued from Figure 1.4.1-4.

The middle eastern portion of **KVK-323-A, B, & C** continues to show the remaining retaining wall which terminates at Broadway and 1<sup>st</sup> Street as indicated in the report by the

Master Harbor Partnership. After the termination of the concrete retaining wall the shoreline appears very similar to the report by the Master Harbor Partnership consisting of rock and debris.

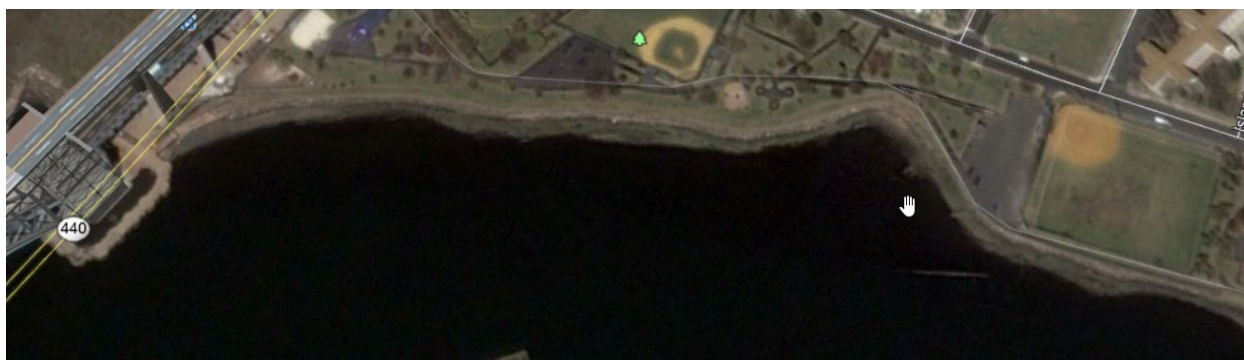
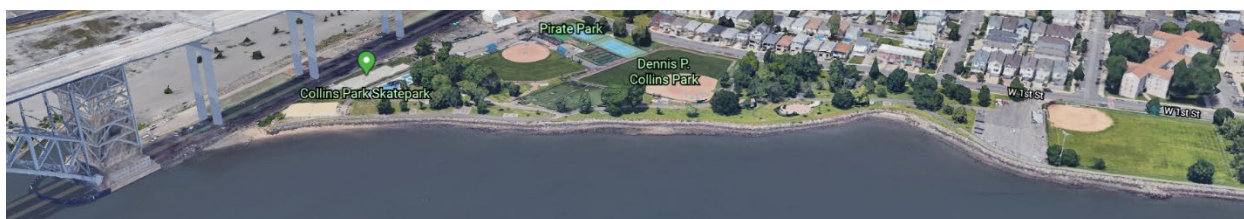
*Figure 1.4.1- 9: The western portion of KVK-323-A, B, & C circa 2004. Continued from Figure 1.4.1-7.*

*Figure 1.4.1- 10: The western portion of KVK-323-A, B, & C circa 2020. Continued from Figure 1.4.1-8.*

The western portion of **KVK-323-A, B, & C** continues to consist of rock and debris and progresses along the New Jersey side up to the Bayonne Bridge. Again, the shoreline remains relatively unchanged with some site improvements undertaken.

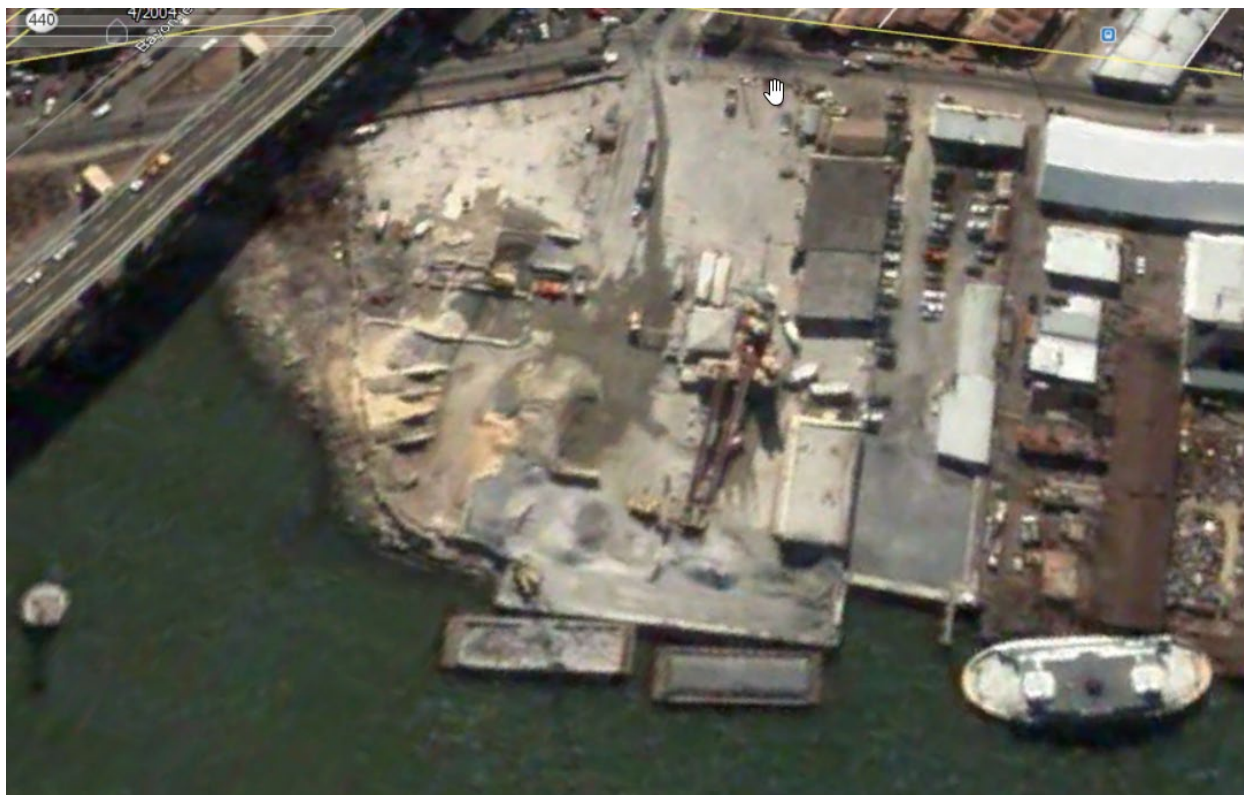
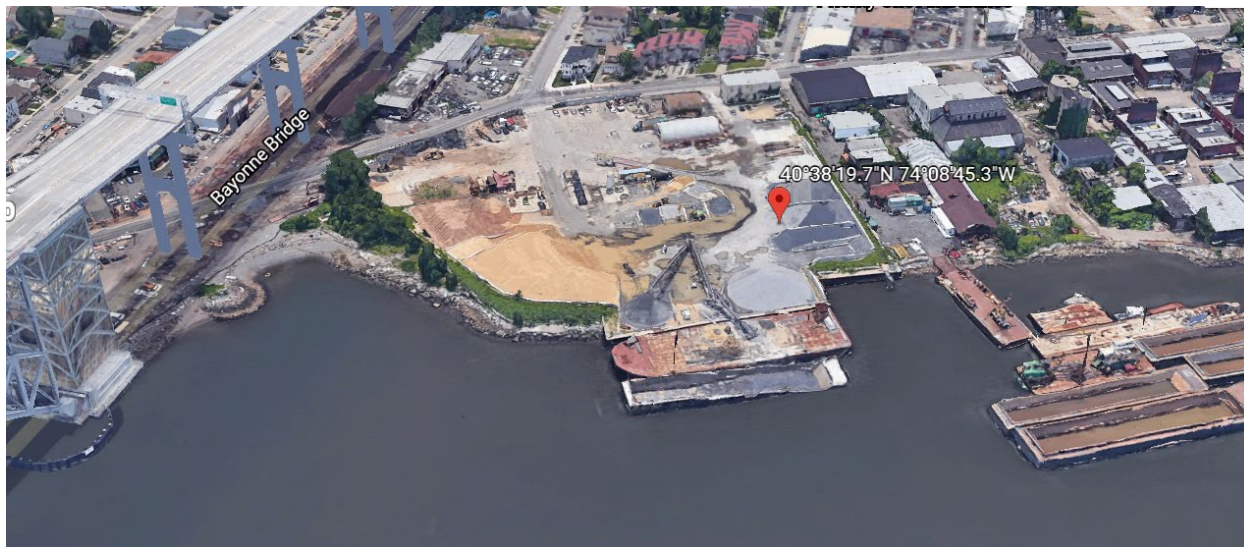
Figure 1.4.1- 11: Scaramix Bulkhead, **KVK-299**, circa 2004.

Figure 1.4.1- 12: The former site of the Scaramix Bulkhead, **KVK-299** circa 2020.

The former site of the Scaramix Bulkhead, **KVK-299**, in Staten Island, NY. The building that was documented in the report by the Master Harbor Partnership appears to have been demolished. The site location is now operating under the name of New York Sand and Stone as a stone/sand supply location with significant stockpiles. The site appears to have stockpiled

material varying in heights from approximately 15'-45'. The bulkhead documented in the report by the Master Harbor Partnership appears largely unchanged.

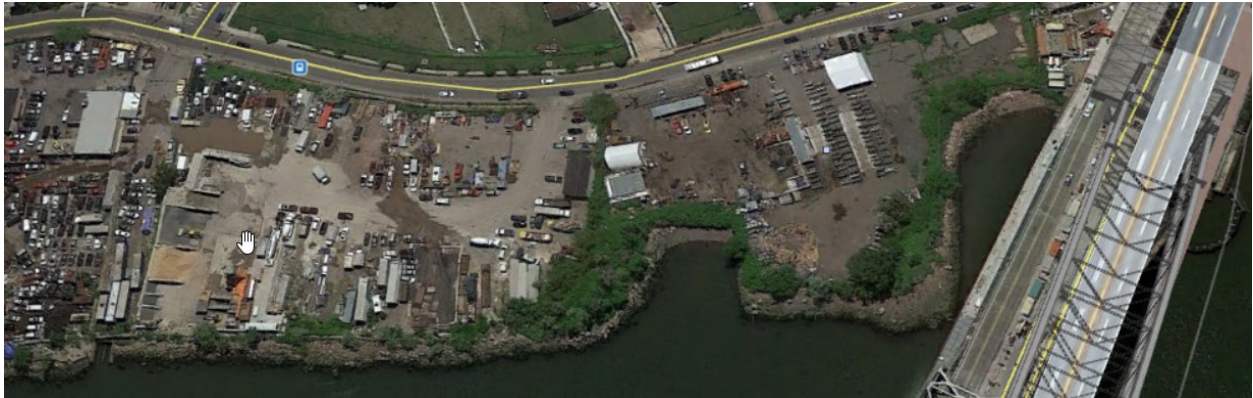
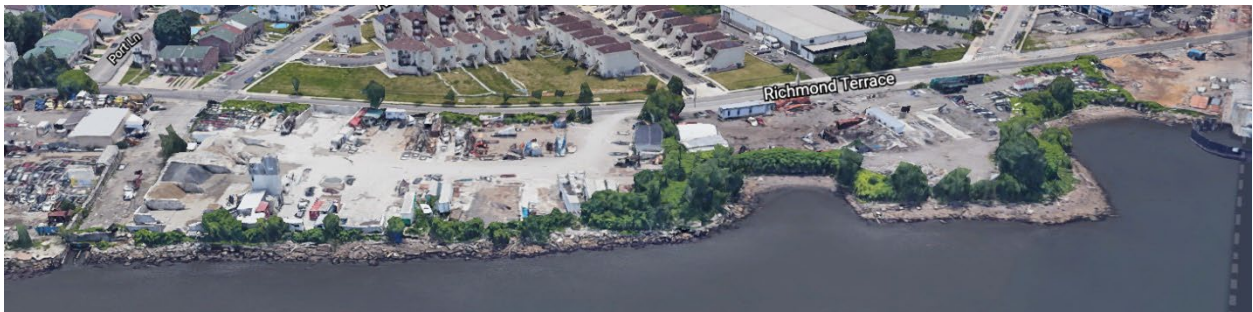
*Figure 1.4.1- 13: The western portion of the Junkyard East of the Bayonne Bridge, **KVK-301**, circa 2004.*

*Figure 1.4.1- 14: The western portion of the Junkyard East of the Bayonne Bridge, **KVK-301**, circa 2020.*

The figure captures the western portion of the Junkyard East of the Bayonne Bridge, **KVK-301**. This area in Staten Island, NY appears to have been transformed into a construction staging area. The shoreline appears to be rock and debris.

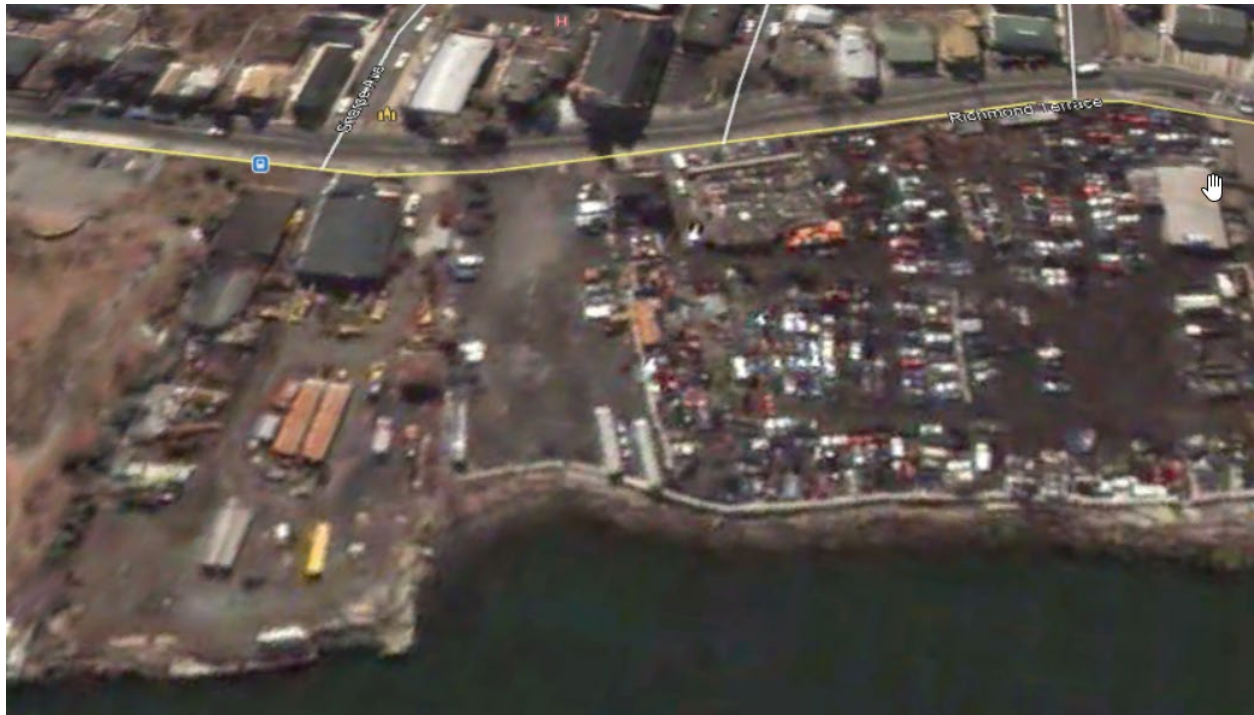
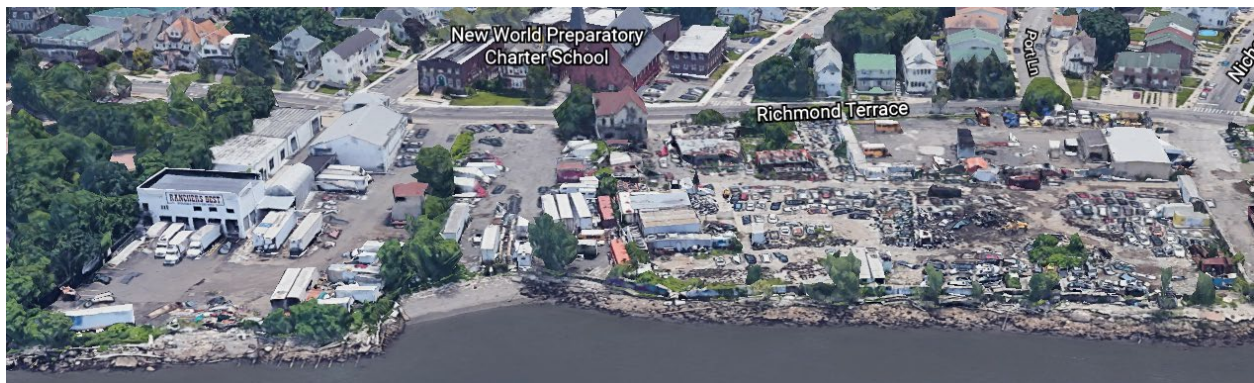
Figure 1.4.1- 15: The photo captures the eastern portion of the Junkyard East of the Bayonne Bridge, **KVK-301**, and the location of Construction Co., **KVK-302**, and the St. Mary's Church Buildings circa 2004.

Figure 1.4.1- 16: The photo above captures the eastern portion of the Junkyard East of the Bayonne Bridge, **KVK-301**, and the location of Construction Co., **KVK-302**, and the St. Mary's Church Buildings.

The eastern portion of the Junkyard East of the Bayonne Bridge, **KVK-301**, and shoreline remains like the report by the Master Harbor Partnership as a mixture of riprap and large stones. The wooden structure documented by the Master Harbor Partnership remains. The site appears to have several makeshift structures onsite created from stacked tractor trailers and shipping containers as well as corrugated metal. These may be subject to some movement from the blasting and ground motion.

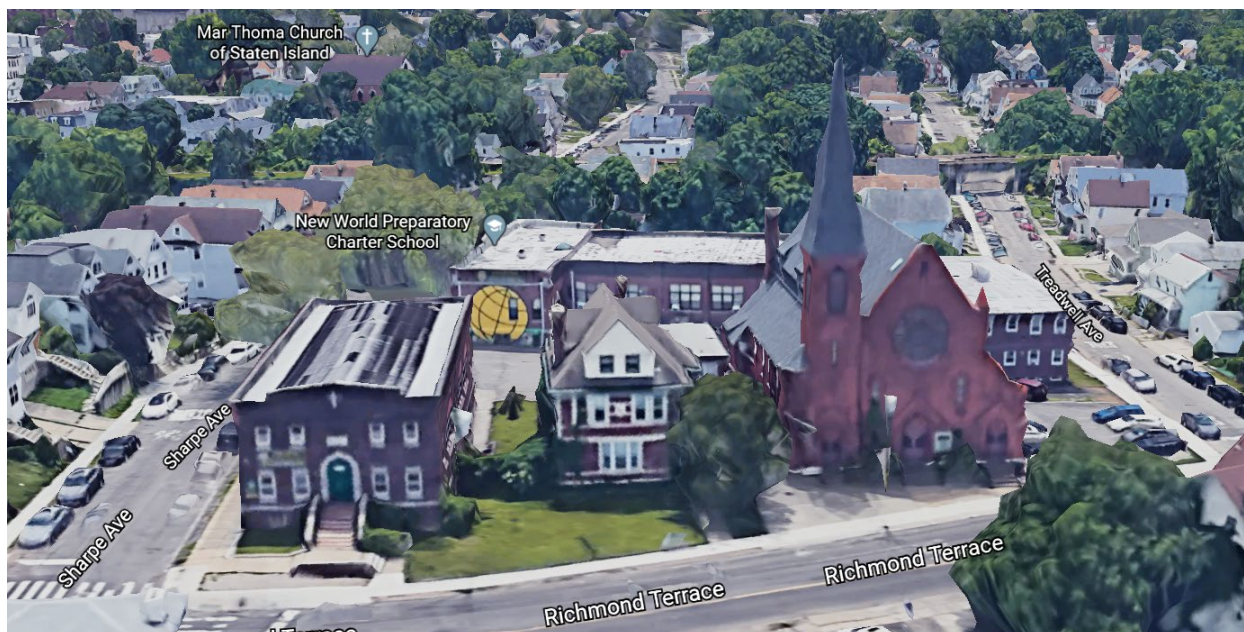
Figure 1.4.1- 20: is a blown-up view of the St. Mary's Church buildings from Figure 1.4.1-16. (St. Mary's Hall, **KVK-89**, (Left) St. Mary's Rectory, **KVK-88**, (Middle), St Mary's Church, **KVK-87** (Right))

St. Mary's Church, **KVK-87**, appears to remain unchanged from the report by the Master Harbor Partnership.

St. Mary's Hall, **KVK-89** was documented to have a possible foundation settlement problem that was documented in the report by the Master Harbor Partnership. The building appears to continue to have this problem and it appears that it may have worsened. Figure 1.4.1-21 captures repaired and subsequently re-cracked masonry. This may indicate continued movement. The St. Mary's Church buildings are all located inland of **KVK-301**, the Junkyard East of the Bayonne Bridge.

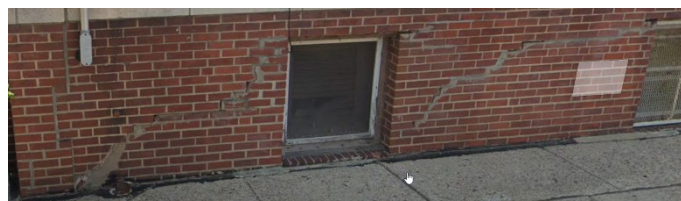
Figure 1.4.1- 21: Rear of St. Mary's Hall, **KVK-89**, along Sharpe Ave.

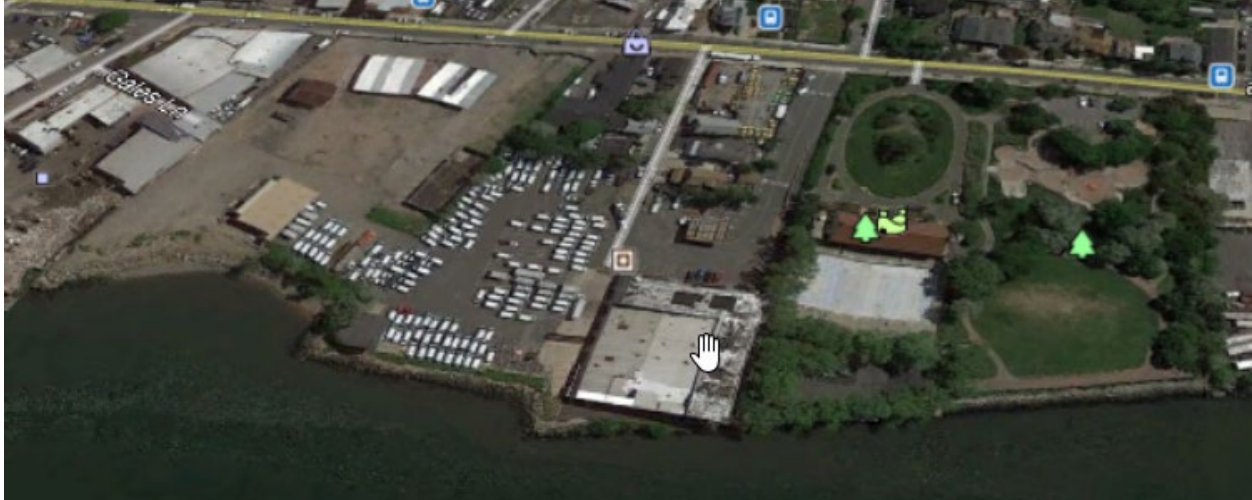
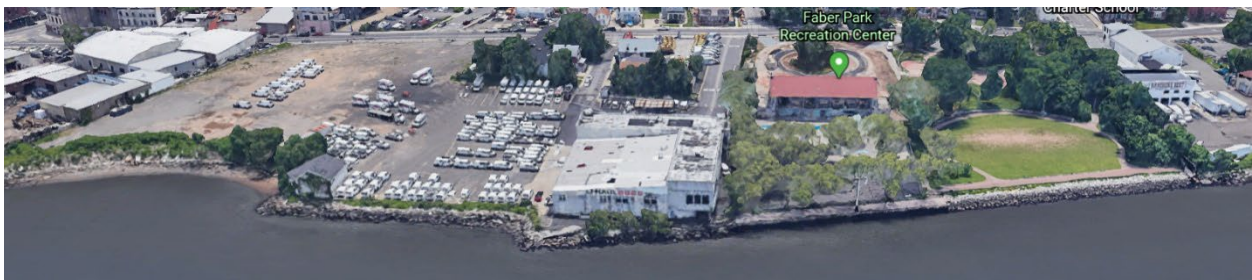
Figure 1.4.1- 22: This photo captures Faber Park, **KVK-303**, (Right), The Atlantic Express Bus Co., **KVK-304**, (middle) and the three buildings between Atlantic Express Bus Co. and Construction Co., **KVK-305** (left).

Figure 1.4.1- 23: This photo captures Faber Park, **KVK-303**, (Right), The Atlantic Express Bus Co., **KVK-304**, (middle) and the site of the three buildings between Atlantic Express Bus Co. and Construction Co., **KVK-305** (left).

The three buildings between Atlantic Express Bus Co. and Construction Co., **KVK-305** have been demolished. The property is being utilized as storage for additional vehicles from the U-Haul rental center. The shoreline of **KVK-305** appears to be unchanged.

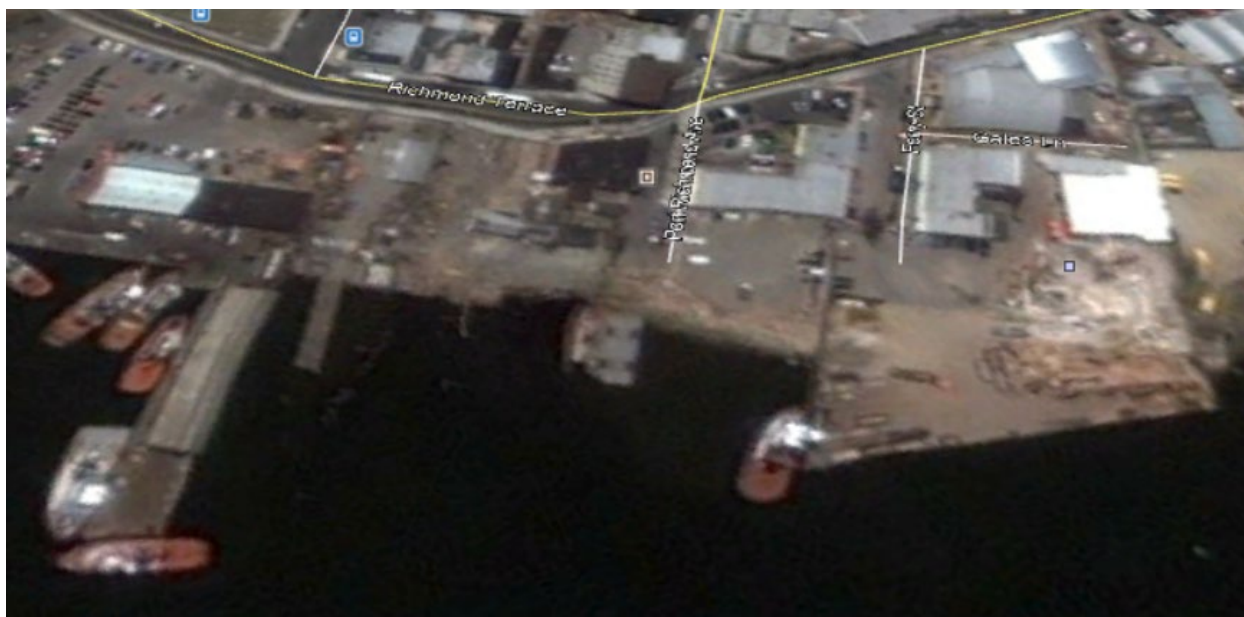
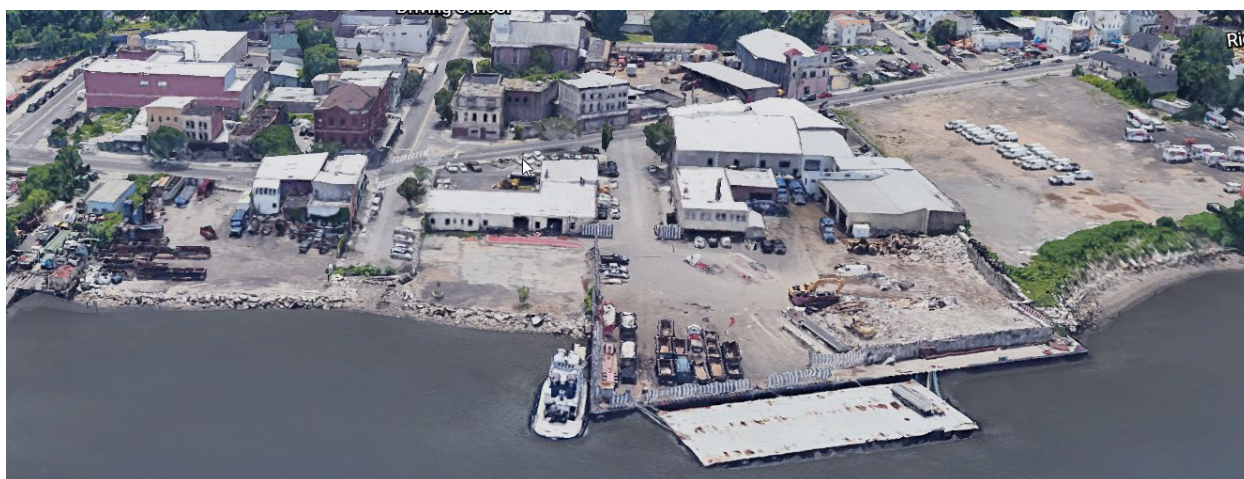
Figure 1.4.1- 24: The buildings of KVK Construction Co., **KVK-306**, and the buildings of **KVK-307** (see Figure 1.4.1-26)

Figure 1.4.1- 25: The buildings of KVK Construction Co., **KVK-306**, and the buildings of **KVK-307** (see Figure 1.4.1-27)

The buildings of KVK Construction Co., **KVK-306**, appear to contain the structures documented in the report by the Master Harbor Partnership along with several additions and a new garage building. The steel sheathing for the bulkhead appears to remain unchanged. The chimney that was reported to have had a dislodged brick fall and break a skylight during past activities remains.

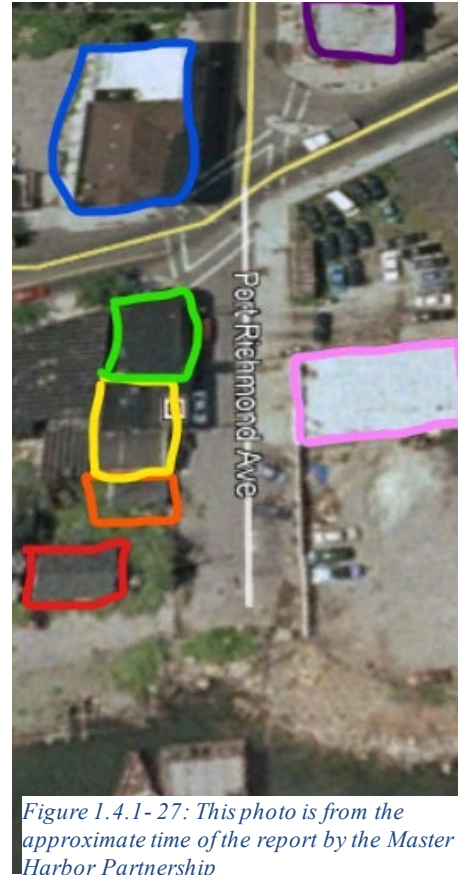
Figure 1.4.1- 27: This photo is from the approximate time of the report by the Master Harbor Partnership

**Building 3.** The shorter portion of the building is approximately half a story taller than the building that was documented in the report by the Master Harbor Partnership. The taller portion of Building 3 appears to remain unchanged from the condition captured in the report by the Master Harbor Partnership. (Yellow outline from Figure 1.4.1-27)

**Building 4.** The building remains largely unchanged from the condition captured in the report by the Master Harbor Partnership. (Green outline from Figure 1.4.1-27)

**Building 5.** The building appears to be currently undergoing a façade repair and has sidewalk bridging installed. (Blue outline from Figure 1.4.1-27)

**Building 6.** Appears to be abandoned. The windows are currently filled with plywood. (Purple outline from Figure 1.4.1-27)

Building 7. This building appears to be in similar condition to what was documented in the report by the Master Harbor Partnership. (Pink outline from Figure 1.4.1-27)

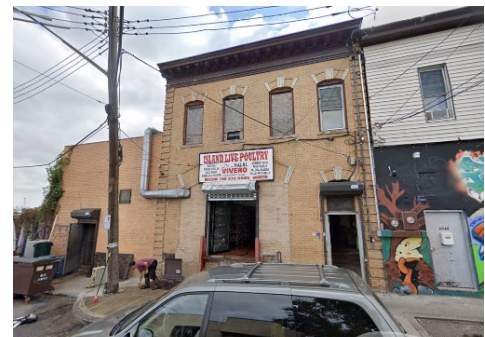
Figure 1.4.1-28: Current view of building 3 on Port Richmond Ave.

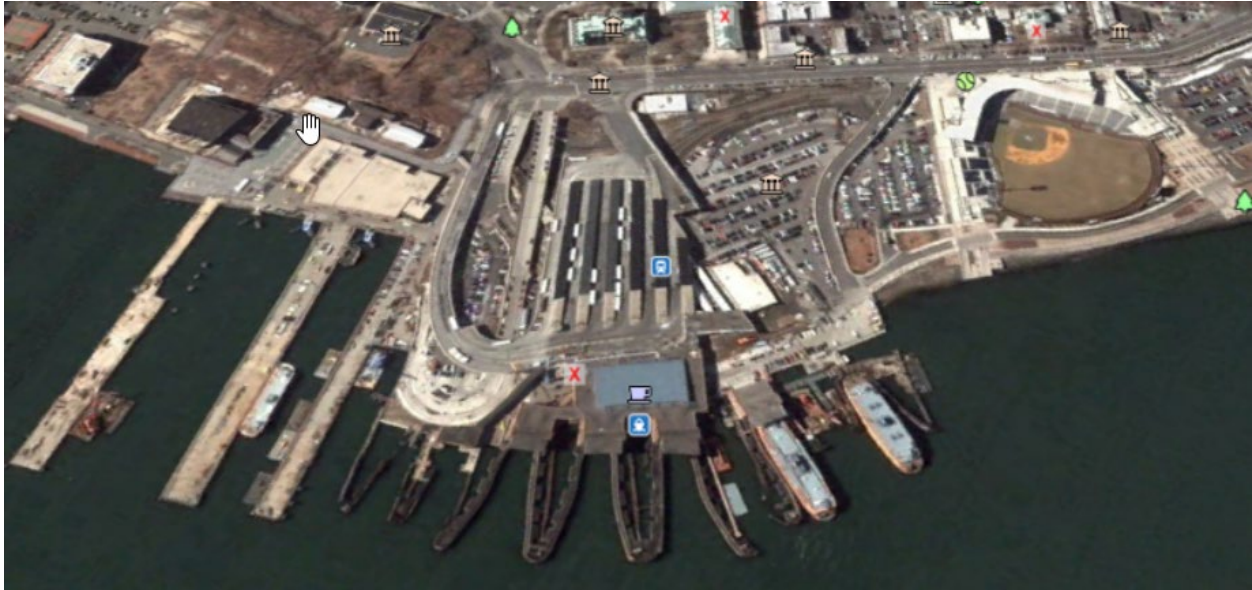
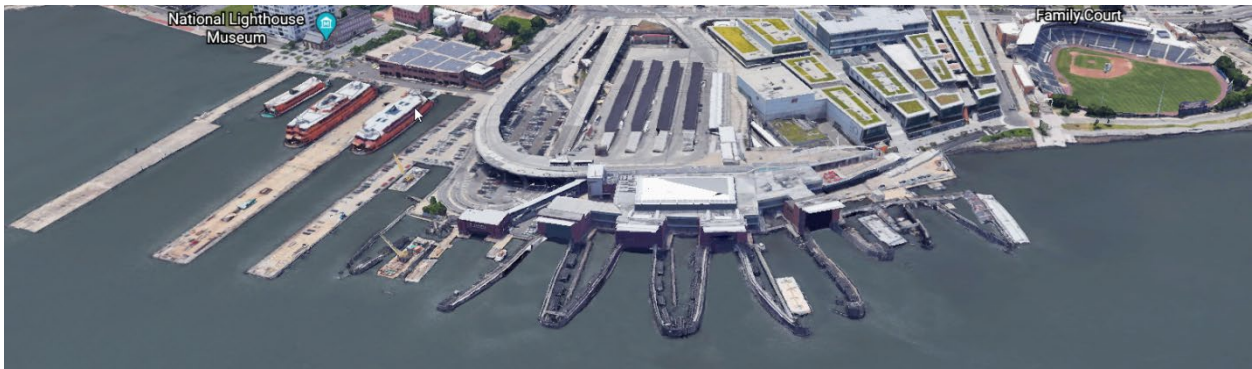
Figure 1.4.2- 1: Captures the location of the Staten Island Ferry Terminal, **KVK-328**, and The Staten Island Yankees Baseball Stadium, **KVK-329** in 2004

Figure 1.4.2- 2: Captures the Staten Island Ferry Terminal **KVK-328**, Empire Outlets, and the Staten Island Yankees baseball stadium **KVK-329**.

The Staten Island Ferry Terminal, **KVK-328**, appears to have a new form of bumper system installed and something done to the piles originally documented in the report by the Master Harbor Partnership. It appears that the current bumper system is a replacement for the pilings that were documented by the Master Harbor Partnership report. It is unclear from the image if the newer system replaced or encompassed part or all of the original pilings.

The Staten Island Yankees Baseball Stadium, **KVK-329** appears to be a relatively unchanged but completed from what was present in 2004. The Master Harbor Partnership report indicated that it was under construction during that review process.

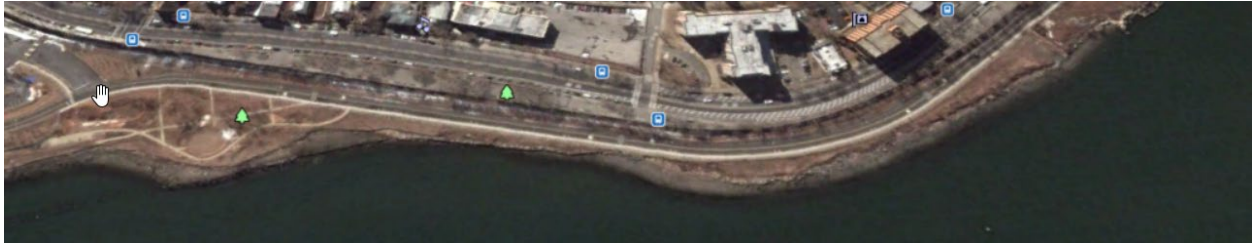
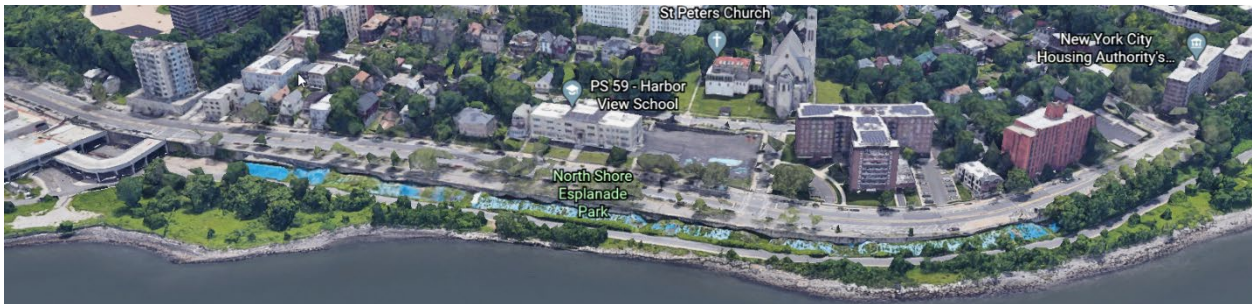
*Figure 1.4.2- 5: The above photo indicates the condition of the shoreline to the west of the Imperial Park parking garage in and is representative of, **KVK-310**, circa 2004.*

*Figure 1.4.2- 6: The above photo indicates the current condition of the shoreline west of the Imperial Park parking garage and is representative of, **KVK-310**, circa 2020*

There are no structures on the water side of Richmond Terrace between the Imperial Park parking garage and building **KVK-4** which appears to be a partially collapsed abandon building visible in Figure 1.4.2-7. Richmond Terrace is supported by a masonry retaining wall from the parking garage until Terrace Street near the NYC Housing Authority buildings where it transitions to a soil slope.

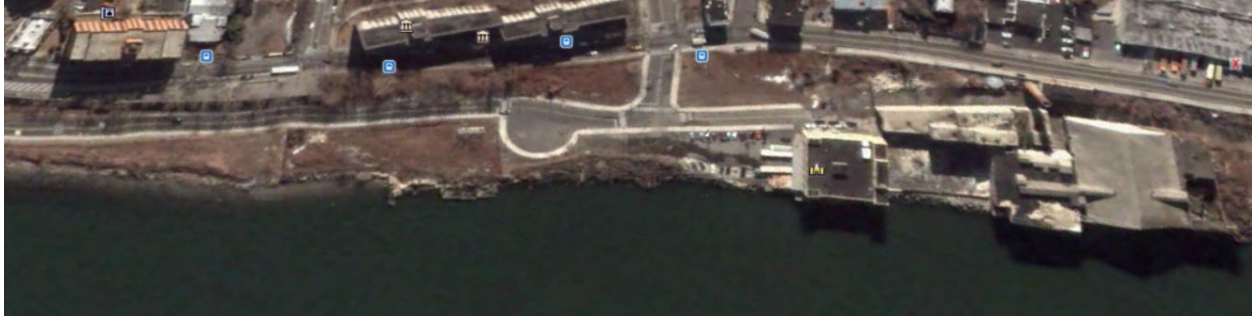
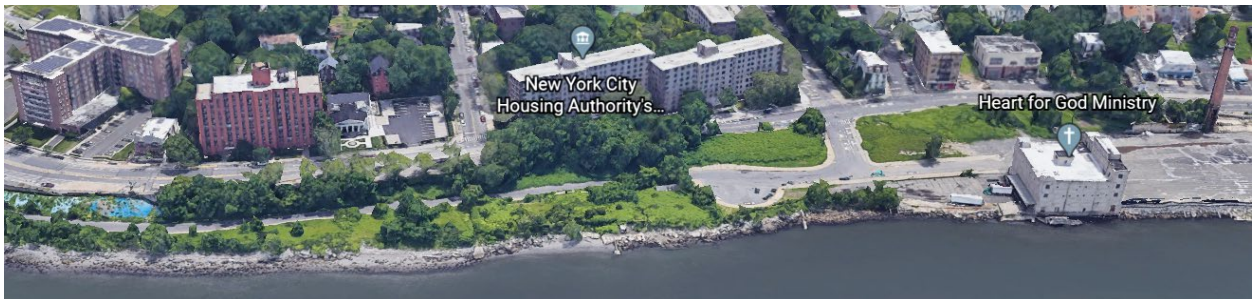
*Figure 1.4.2- 7: The above photo captures the continuation of the shoreline west of the Imperial Park parking garage through **KVK-6***

*Figure 1.4.2- 8:: The above photo captures a continuation of the shoreline west of the Imperial Park parking garage until **KVK-6**.*

These figures indicate that The Greek Revival Mansion, **KVK-3**, appears to be in similar condition to what was documented in the report by the Master Harbor Partnership and that the building at the Foot of Bank Street, **KVK-4**, appears to have further deteriorated and partially collapsed.

15 Bank Street, Staten Island, **KVK-6**, is currently known as the Heart for God Ministry building. It appears to be in similar condition to that which was documented in the report by the Master Harbor Partnership. A small portion of it appears to be supported by piles.

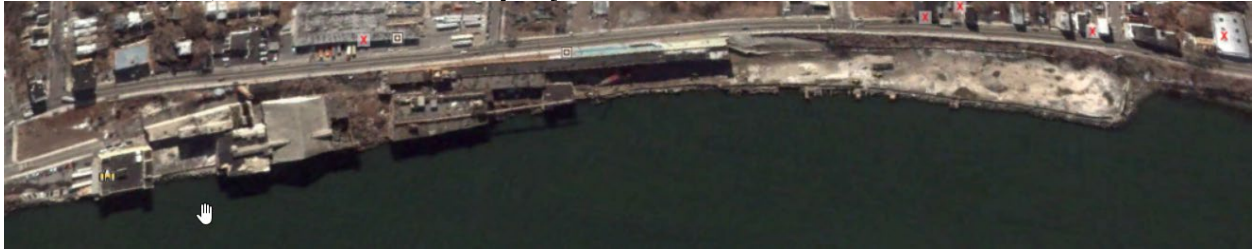
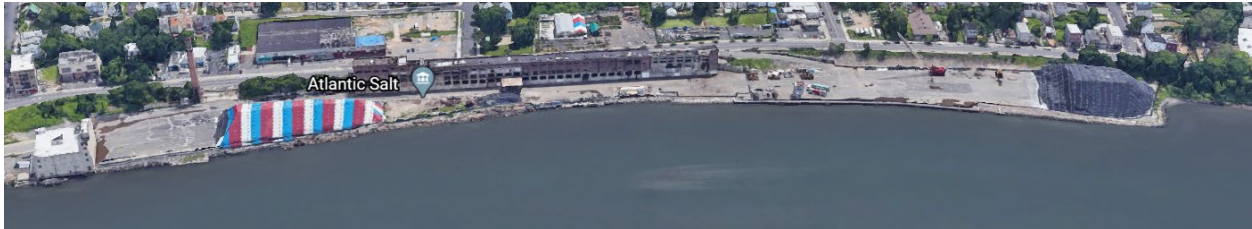
*Figure 1.4.2- 9: The above photo captures the buildings present at the Atlantic Salt Company and the area to the east.*

*Figure 1.4.2- 10: The above captures the buildings present at the Atlantic Salt Company and the area to the east.*

**KVK11A/B**, the long building on the site of the Atlantic Salt Company appears to remain abandon and in similar condition to what was documented in the report by the Master Harbor Partnership.

The chimney located on the grounds of the Atlantic Salt Company appears to be abandoned. The chimney appears to have been repurposed as a support for some kind of electrical equipment and the supporting building demolished. This building would have provided some lateral bracing before it was demolished. With the demolition of the supporting structure and the apparent nonuse of the chimney as well as its susceptibility to vibrations it is recommended that this structure be taken down.

The current recommendation for the chimney at the Atlantic Salt Company property could be updated pending additional information or evaluation. Without evaluation to the contrary it is not possible to ensure that the safety of the public and those working within the facility would not be compromised. The slenderness of the chimney along with its mass make a failure likely to be catastrophic placing those in the surrounding area in danger.

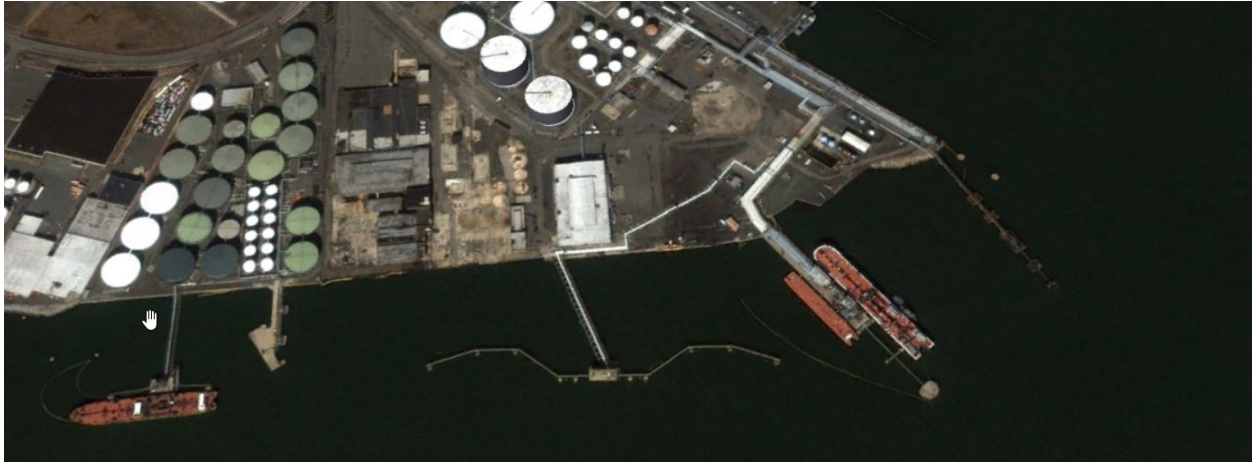
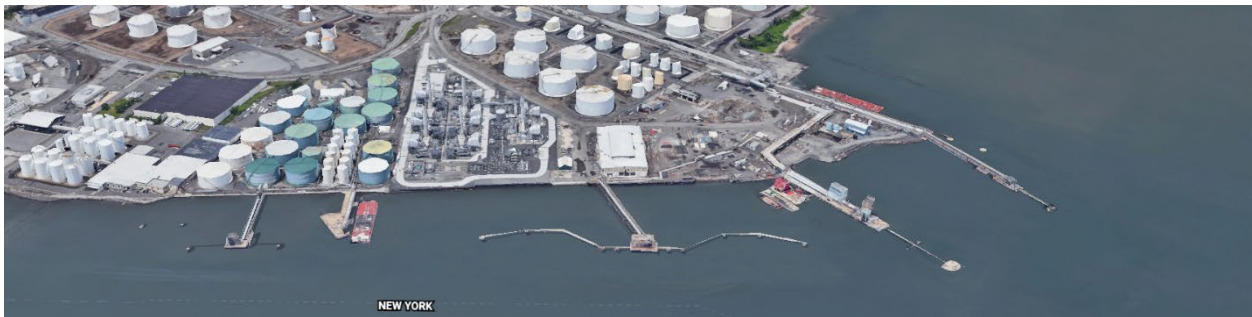
Figure 1.4.2- 11: The above photo captures, KVK-313, Exxon-Western Pier in 2004.

Figure 1.4.2- 12: Exxon-Western Pier, **KVK-313** and adjacent structures.

The “bird shaped” structure to the left of **KVK-313** is not captured in either the report or the map from URS. This bird shaped structure was present at the time of the report by the Master Harbor Partnership. It first appears in the aerial photographs between 1995 and 2001.

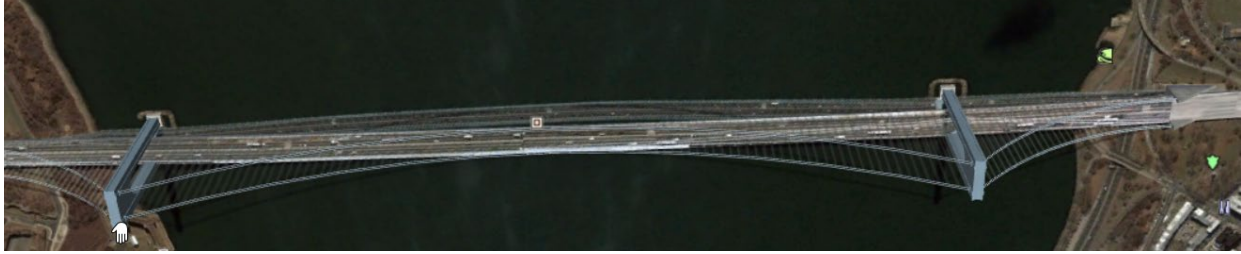
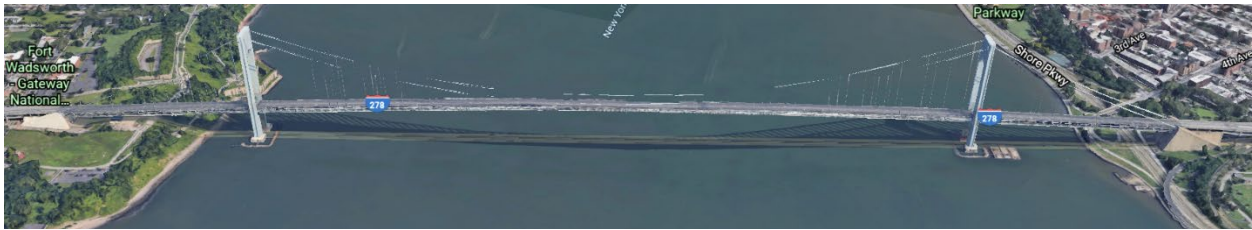
*Figure 1.4.2- 13: The photo captures the Verrazano-Narrows Bridge, **KVK-330**.*

*Figure 1.4.2- 14: The photo captures the current condition of the Verrazano-Narrows Bridge.*

The Verrazano-Narrows Bridge, **KVK-330**, was considered too far from the site of anticipated blasting that was evaluated in the 2003 report by the Master Harbor Partnership. Because of its significance the Master Harbor Partnership report recommended the structure should be further studied. A thorough site-specific study for the Verrazano-Narrows Bridge is recommended at this time because of its significance.
