New York and New Jersey Harbor Deepening Channel Improvements

NAVIGATION STUDY

DRAFT INTEGRATED FEASIBILITY REPORT & ENVIRONMENTAL ASSESSMENT

Structural

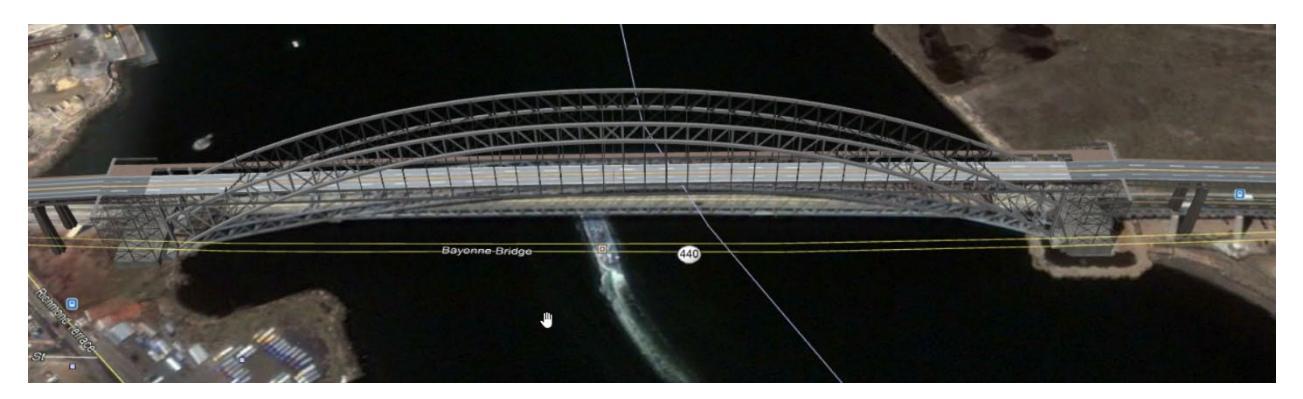
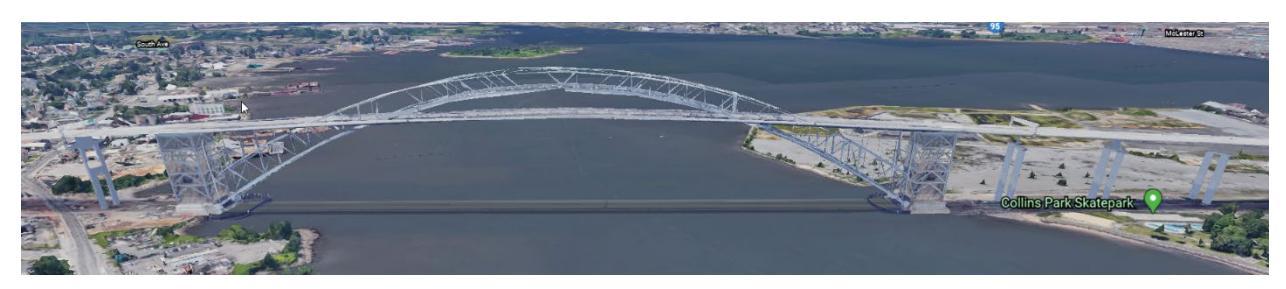
Figure 1.4.1-1: KVK-324, The Bayonne Bridge circa 2004 prior to the bridge raising project.

Figure 1.4.1-2: KVK-324, The Bayonne Bridge circa 2020 after the bridge raising project.

The Bayonne Bridge, **KVK-324**, was recently raised as part of a navigation project to permit larger ships to pass underneath it. As part of the project the towers on the piers were raised and a precast deck was installed at the higher elevation. The approach ways were replaced and the concrete support piers for the approach ways were also replaced. Also changed from the report by the Master Harbor Partnership is the installation of a visible bumper system above the water at the pier locations.

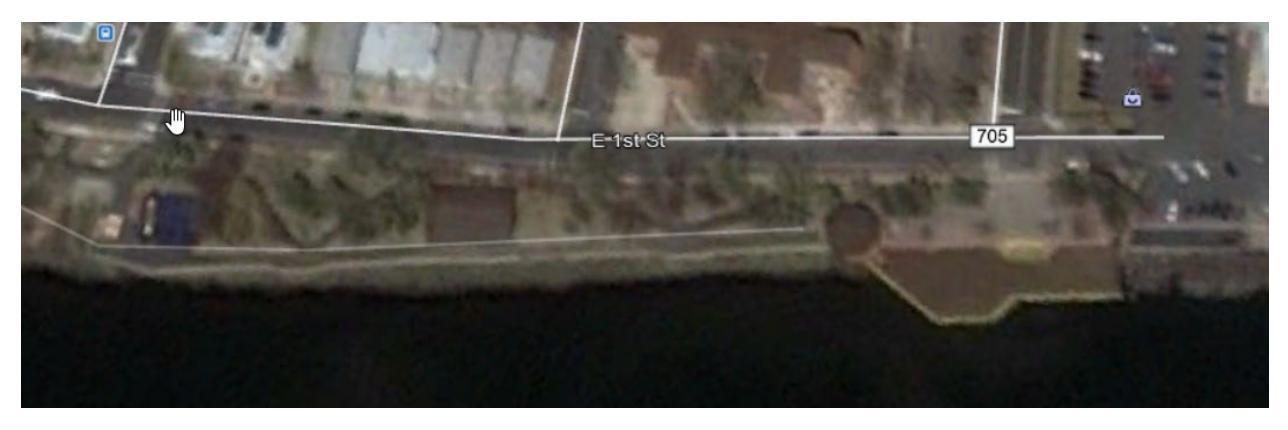
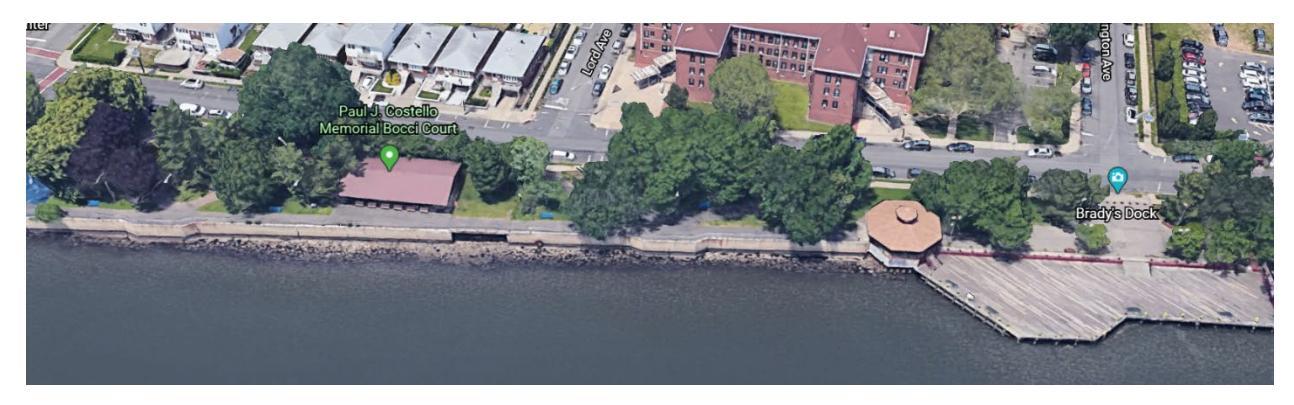
Figure 1.4.1-3: Lord Ave and Brady's Dock, the eastern portion of KVK-323 – A, B, & C circa 2004.

Figure 1.4.1-4: Lord Ave and Brady's Dock, the eastern portion of KVK-323 – A, B, & C circa 2020.

The figures above show the eastern portion of **KVK-323-A**, **B**, **& C**, the shoreline on the New Jersey side of the Kill Van Kull channel near the end of Lord Ave. The region by Brady's Dock appears to be unchanged from the report by the Master Harbor Partnership. The concrete wall from Lord Ave until Broadway appears to be unchanged as well. There appears to be an undocumented pedestrian bridge or drainage structure at the end of Lord Ave.

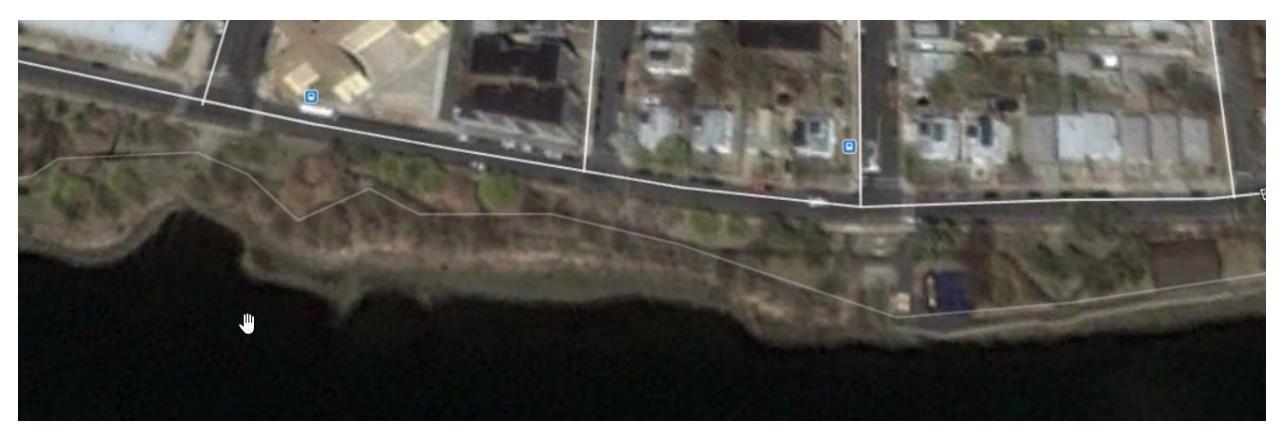
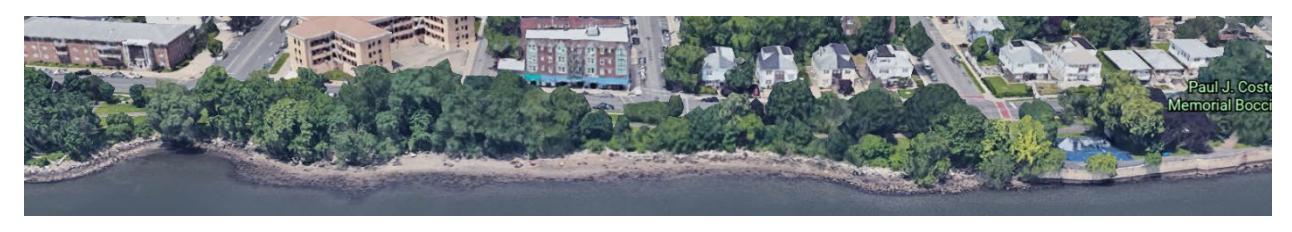
Figure 1.4.1- 5: The middle eastern portion of KVK-323-A, B, & C circa 2004. Continued from Figure 1.4.1-3.

Figure 1.4.1- 6: The middle eastern portion of KVK-323-A, B, & C circa 2020. Continued from Figure 1.4.1-4.

The middle eastern portion of **KVK-323-A**, **B**, **& C** continues to show the remaining retaining wall which terminates at Broadway and 1st Street as indicated in the report by the Master Harbor Partnership. After the termination of the concrete retaining wall the shoreline appears very similar to the report by the Master Harbor Partnership consisting of rock and debris.

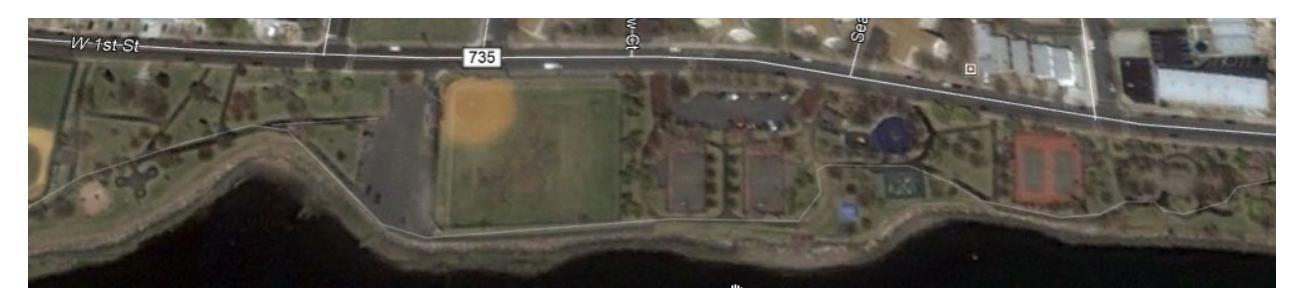
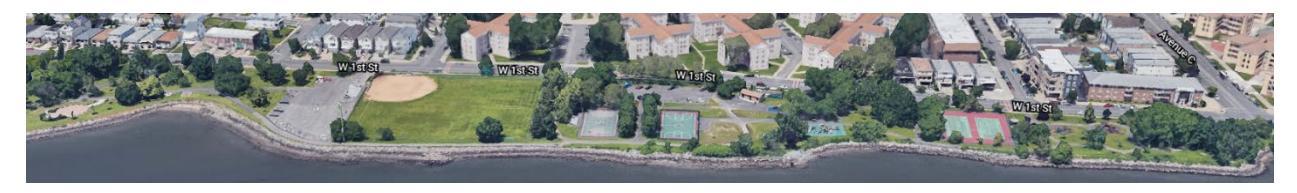
Figure 1.4.1-7: The middle western portion of KVK-323-A, B, & C circa 2004. Continued from Figure 1.4.1-.5.

Figure 1.4.1-8: The middle western portion of KVK-323-A, B, & C circa 2020. Continued from Figure 1.4.1-6.

Continuing to the middle western portion of **KVK-323-A**, **B**, **& C**, the Bayonne shoreline continues to consist of rock and debris as documented in the report by the Master Harbor Partnership. The land between the shoreline and 1st street has had some additional recreation facilities installed but remains largely undeveloped. The distinguishable structures are sheds, baseball dugouts, and likely a public restroom.

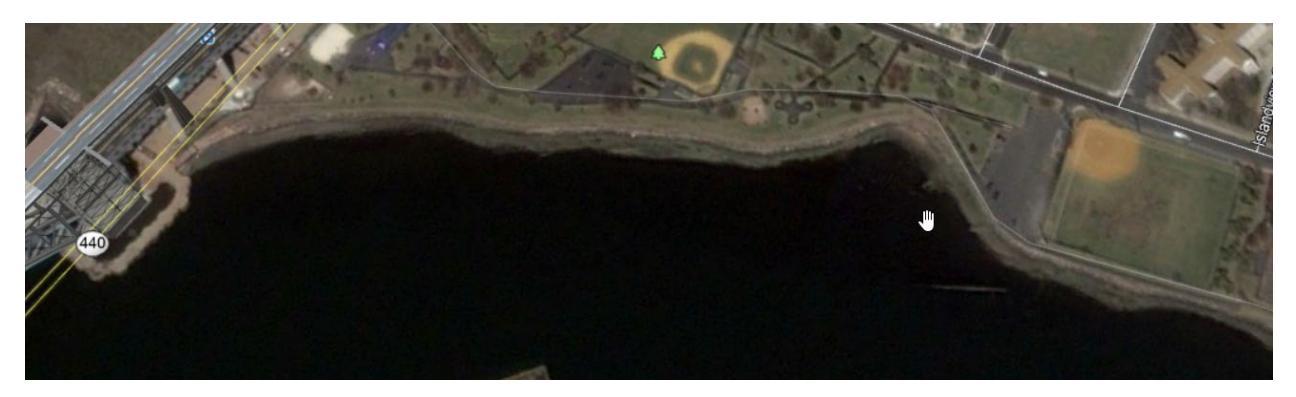
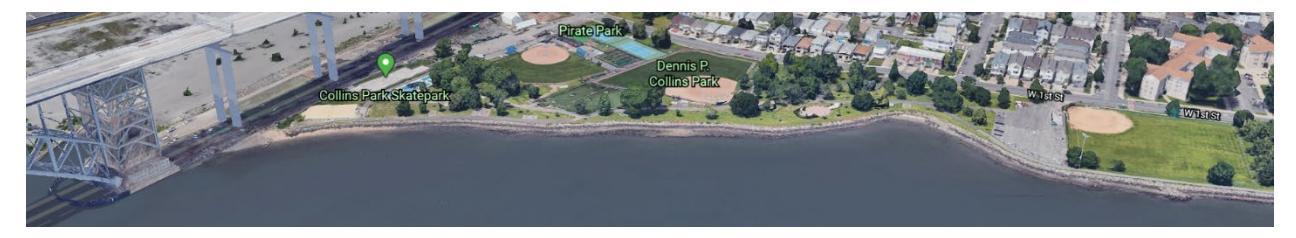
Figure 1.4.1-9: The western portion of KVK-323-A, B, & C circa 2004. Continued from Figure 1.4.1-7.

Figure 1.4.1-10: The western portion of KVK-323-A, B, & C circa 2020. Continued from Figure 1.4.1-8.

The western portion of **KVK-323-A**, **B**, **& C** continues to consist of rock and debris and progresses along the New Jersey side up to the Bayonne Bridge. Again, the shoreline remains relatively unchanged with some site improvements undertaken.

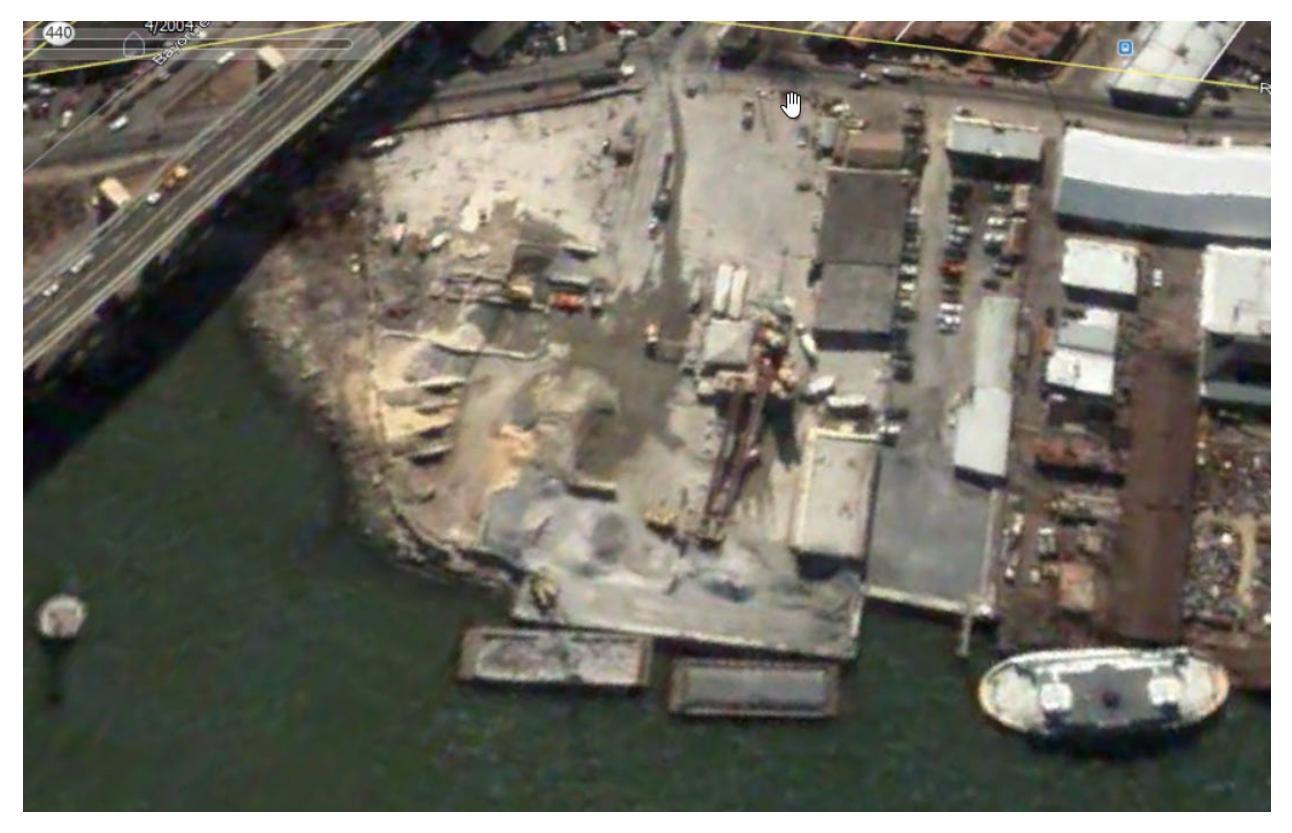
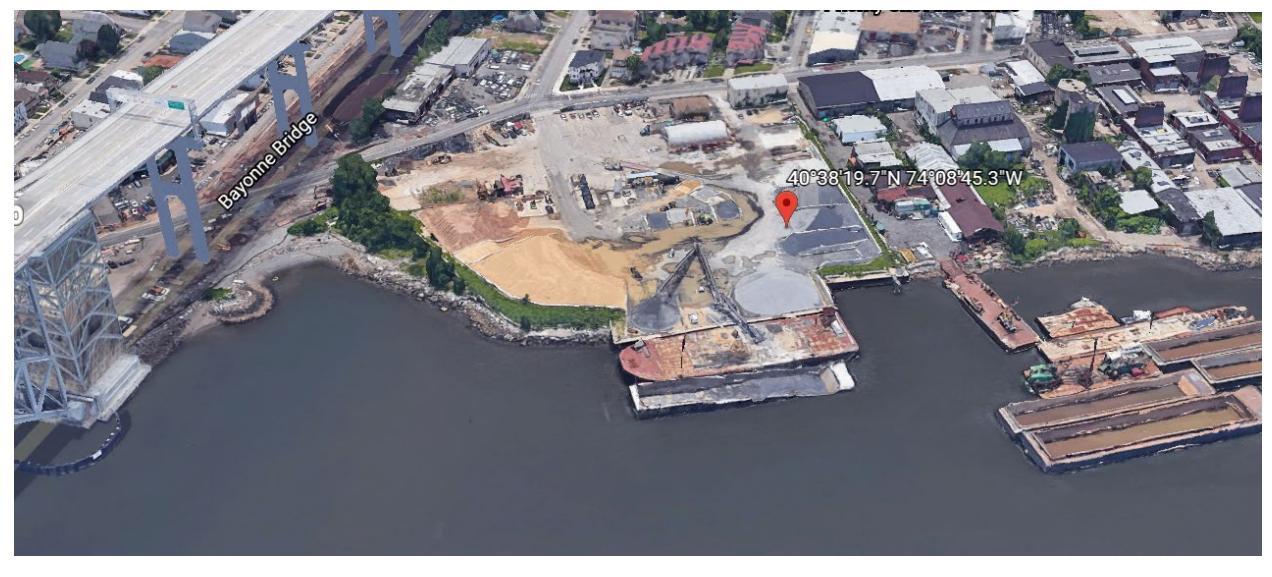
Figure 1.4.1-11: Scaramix Bulkhead, KVK-299, circa 2004.

Figure 1.4.1-12: The former site of the Scaramix Bulkhead, KVK-299 circa 2020.

The former site of the Scaramix Bulkhead, **KVK-299**, in Staten Island, NY. The building that was documented in the report by the Master Harbor Partnership appears to have been demolished. The site location is now operating under the name of New York Sand and Stone as a stone/sand supply location with significant stockpiles. The site appears to have stockpiled

material varying in heights from approximately 15'-45'. The bulkhead documented in the report by the Master Harbor Partnership appears largely unchanged.

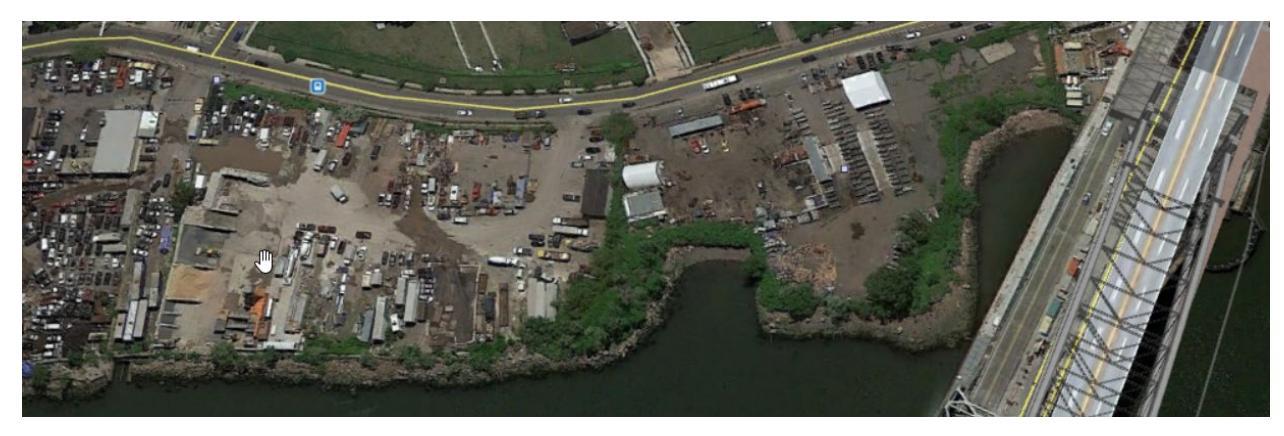
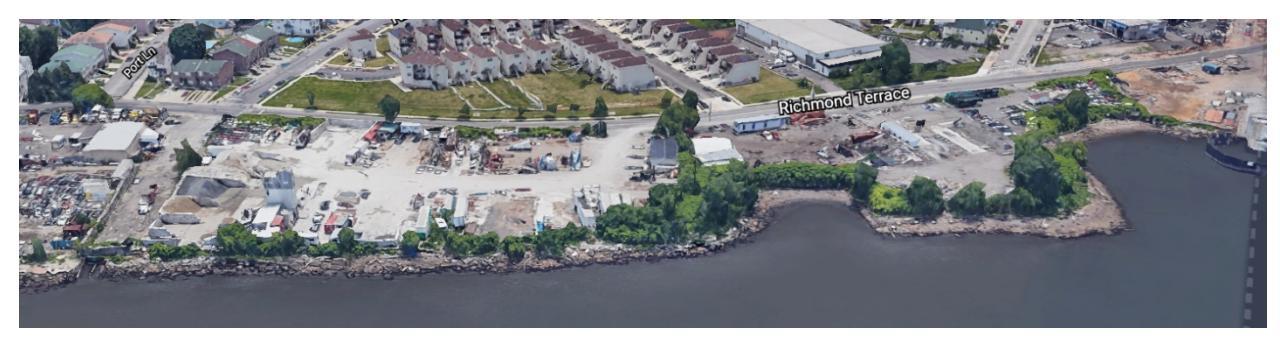
Figure 1.4.1-13: The western portion of the Junkyard East of the Bayonne Bridge, KVK-301, circa 2004.

Figure 1.4.1-14: The western portion of the Junkyard East of the Bayonne Bridge, KVK-301, circa 2020.

The figure captures the western portion of the Junkyard East of the Bayonne Bridge, **KVK-301.** This area in Staten Island, NY appears to have been transformed into a construction staging area. The shoreline appears to be rock and debris.

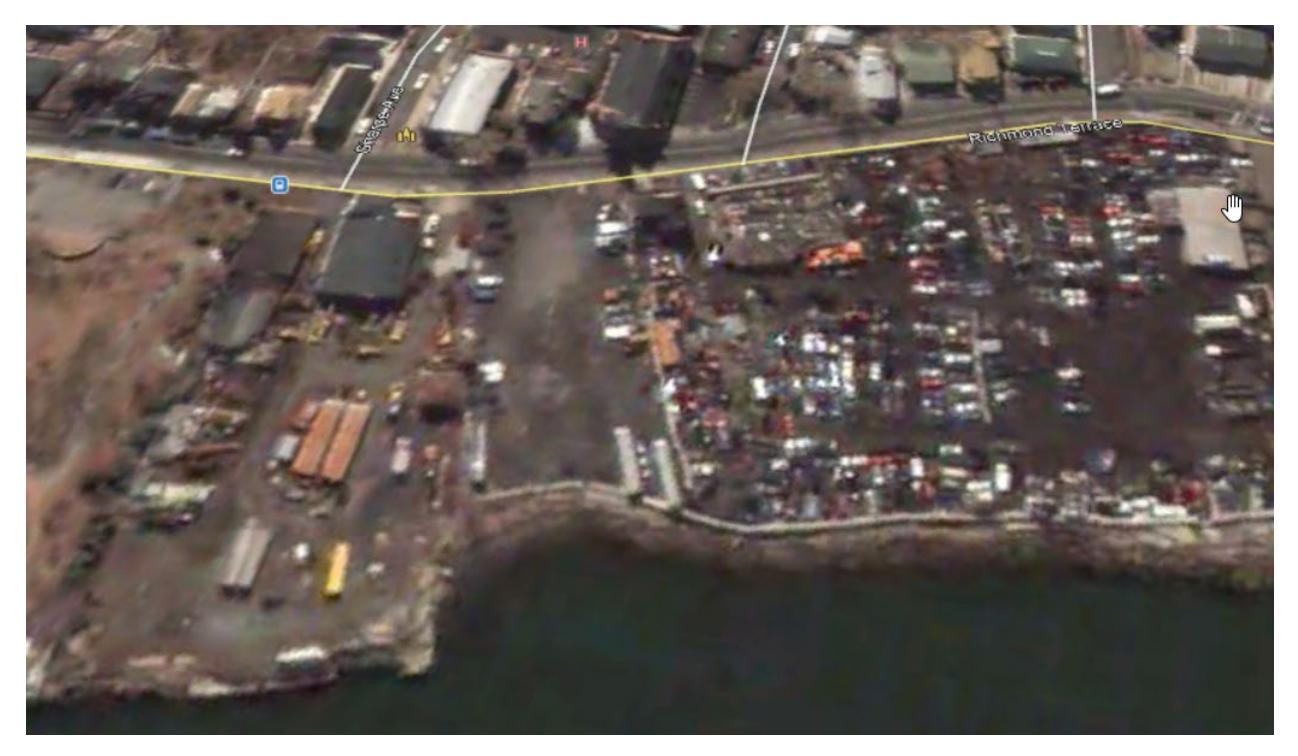
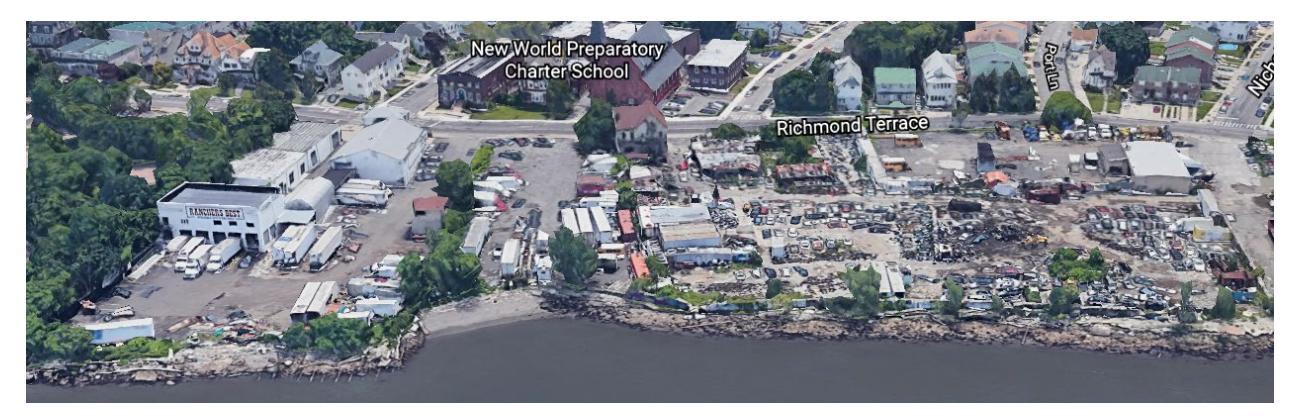
Figure 1.4.1-15: The photo captures the eastern portion of the Junkyard East of the Bayonne Bridge, **KVK-301**, and the location of Construction Co., **KVK-302**, and the St. Mary's Church Buildings circa 2004.

Figure 1.4.1-16: The photo above captures the eastern portion of the Junkyard East of the Bayonne Bridge, **KVK-301**, and the location of Construction Co., **KVK-302**, and the St. Mary's Church Buildings.

The eastern portion of the Junkyard East of the Bayonne Bridge, **KVK-301**, and shoreline remains like the report by the Master Harbor Partnership as a mixture of riprap and large stones. The wooden structure documented by the Master Harbor Partnership remains. The site appears to have several makeshift structures onsite created from stacked tractor trailers and shipping containers as well as corrugated metal. These may be subject to some movement from the blasting and ground motion.

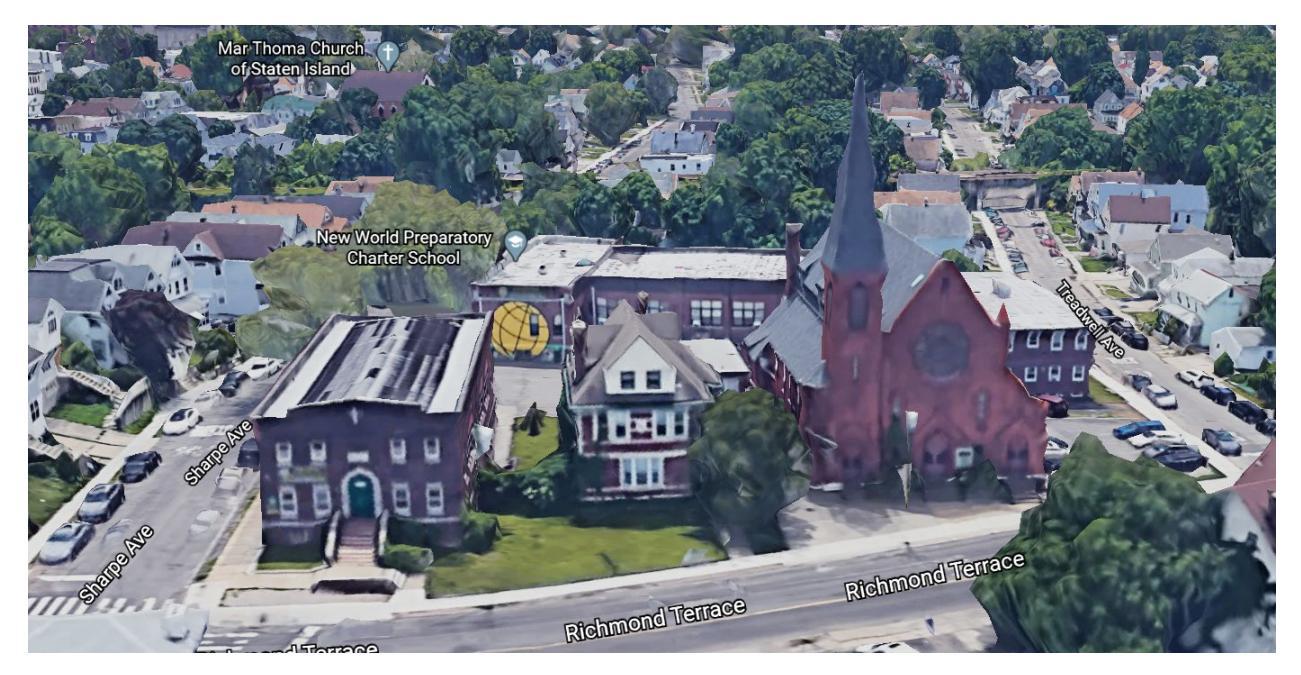
Figure 1.4.1- 20:is a blown-up view of the St. Mary's Church buildings from Figure 1.4.1-16. (St. Mary's Hall, **KVK-89**, (Left) St. Mary's Rectory, **KVK-88**, (Middle), St Mary's Church, **KVK-87** (Right))

St. Mary's Hall, KVK-89 was documented to have a possible foundation settlement problem that

was documented in the report by the Master Harbor Partnership. The building appears to continue to have this problem and it appears that it may have worsened. Figure 1.4.1-21 captures repaired and subsequently re-cracked masonry. This may indicate continued movement. The St. Mary's Church buildings are all

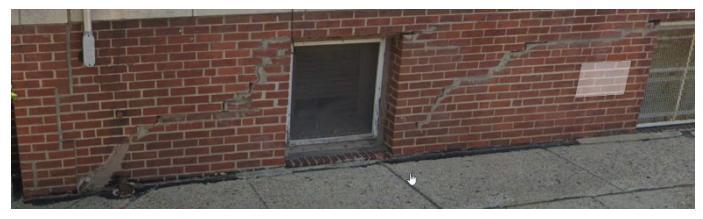
Figure 1.4.1-21: Rear of St. Mary's Hall, KVK-89, along Sharpe Ave.

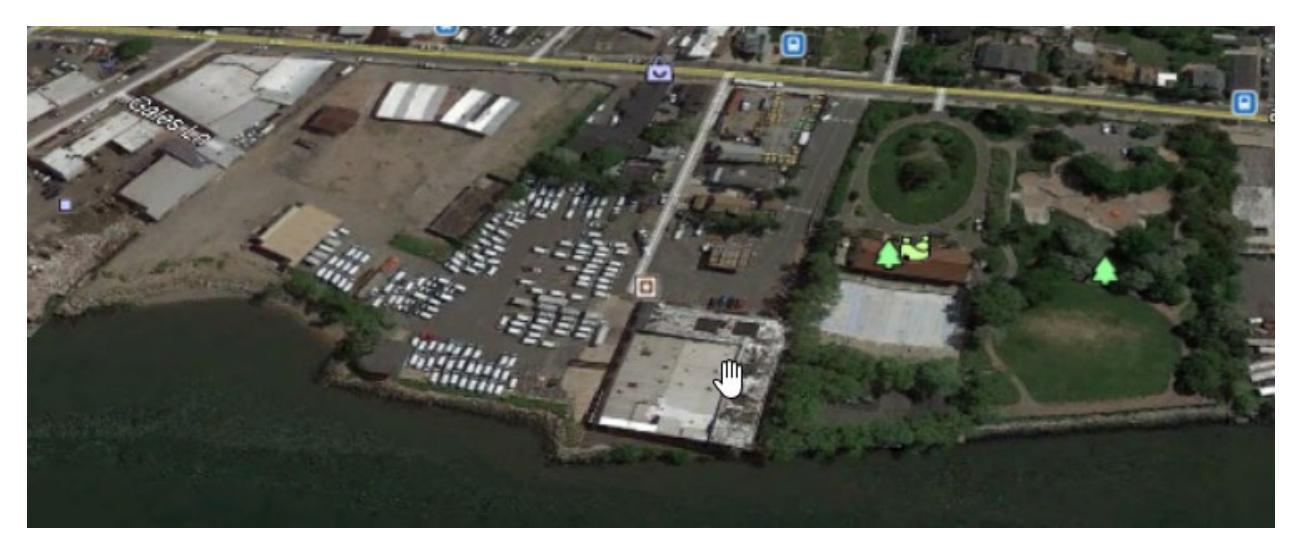
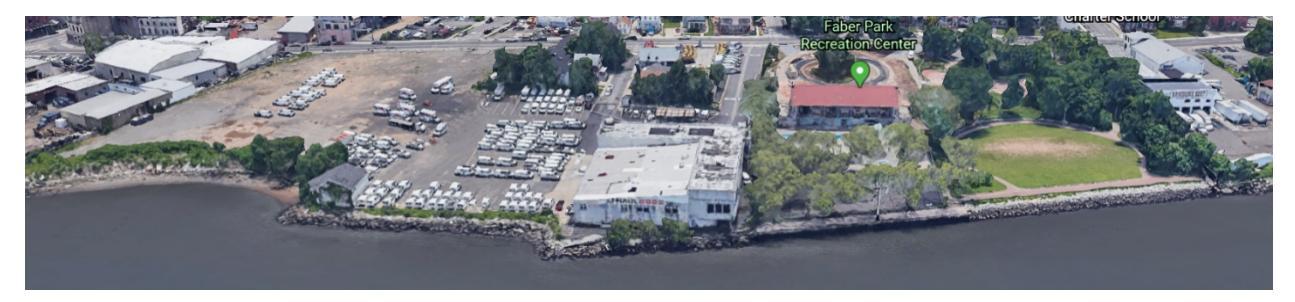
Figure 1.4.1-22: This photo captures Faber Park, **KVK-303**, (Right), The Atlantic Express Bus Co., **KVK-304**, (middle) and the three buildings between Atlantic Express Bus Co. and Construction Co., **KVK-305** (left).

Figure 1.4.1-23: This photo captures Faber Park, **KVK-303**, (Right), The Atlantic Express Bus Co., **KVK-304**, (middle) and the site of the three buildings between Atlantic Express Bus Co. and Construction Co., **KVK-305** (left).

The three buildings between Atlantic Express Bus Co. and Construction Co., **KVK-305** have been demolished. The property is being utilized as storage for additional vehicles from the U-Haul rental center. The shoreline of KVK-305 appears to be unchanged.

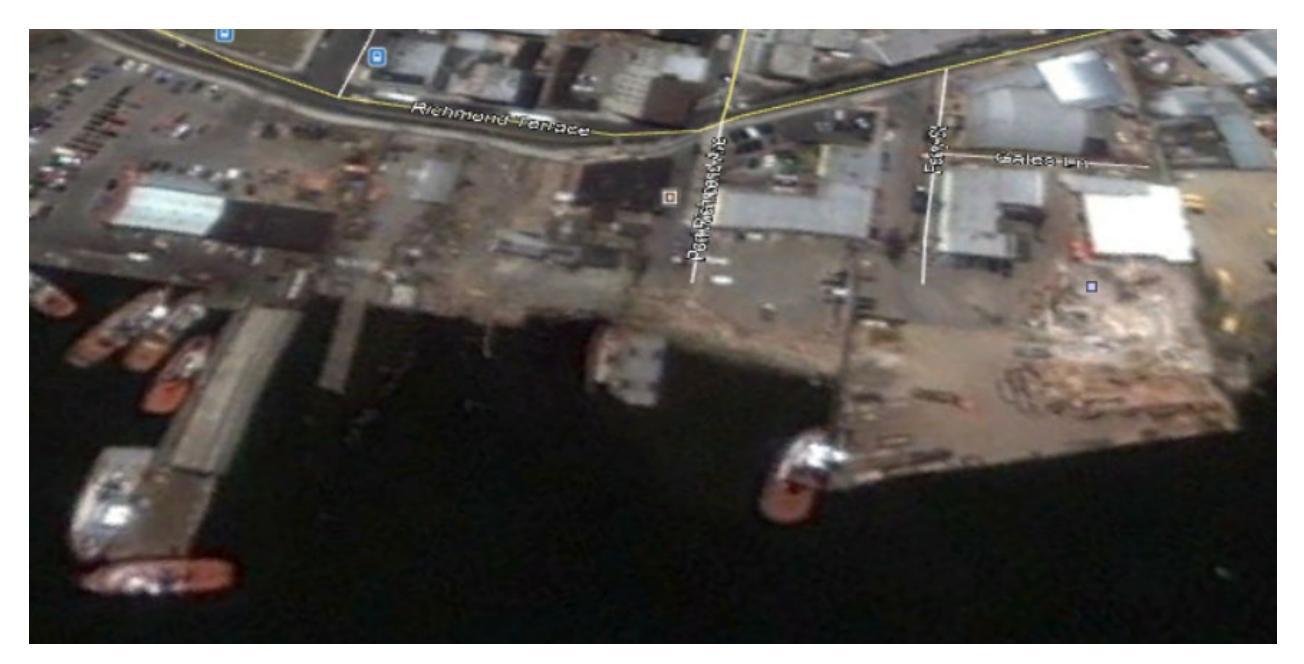
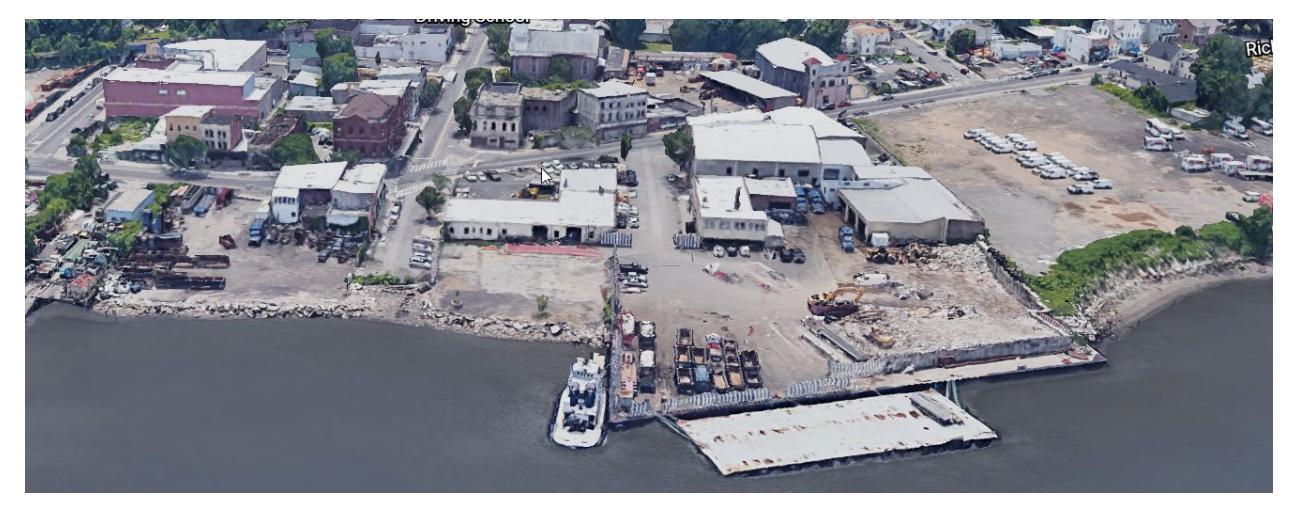
Figure 1.4.1-24: The buildings of KVK Construction Co., KVK-306, and the buildings of KVK-307 (see Figure 1.4.1-26)

Figure 1.4.1-25: The buildings of KVK Construction Co., KVK-306, and the buildings of KVK-307 (see Figure 1.4.1-27)

The buildings of KVK Construction Co., **KVK-306**, appear to contain the structures documented in the report by the Master Harbor Partnership along with several additions and a new garage building. The steel sheathing for the bulkhead appears to remain unchanged. The chimney that was reported to have had a dislodged brick fall and break a skylight during past activities remains.

The other chimney which is located on the grounds of KVK-306 status is unknown. The chimney is documented to have had bricks displaced from it during prior work activities. Because of its slenderness and history, it is recommended that this chimney be demolished to prevent further danger to the neighboring buildings or those that work at or near its location. Again because the structure is more susceptible to magnifying vibrations due to its slenderness.

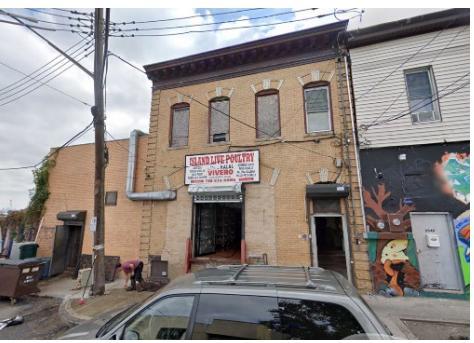
Building 3. The shorter portion of the building is approximately half a story taller than the building that was documented in the report by the Master Harbor Partnership. The taller portion of Building 3 appears to remain unchanged from the condition captured in the report by the Master Harbor Partnership. (Yellow outline from Figure 1.4.1-27)

Figure 1.4.1-28:. Current view of building 3 on Port Richmond Ave.

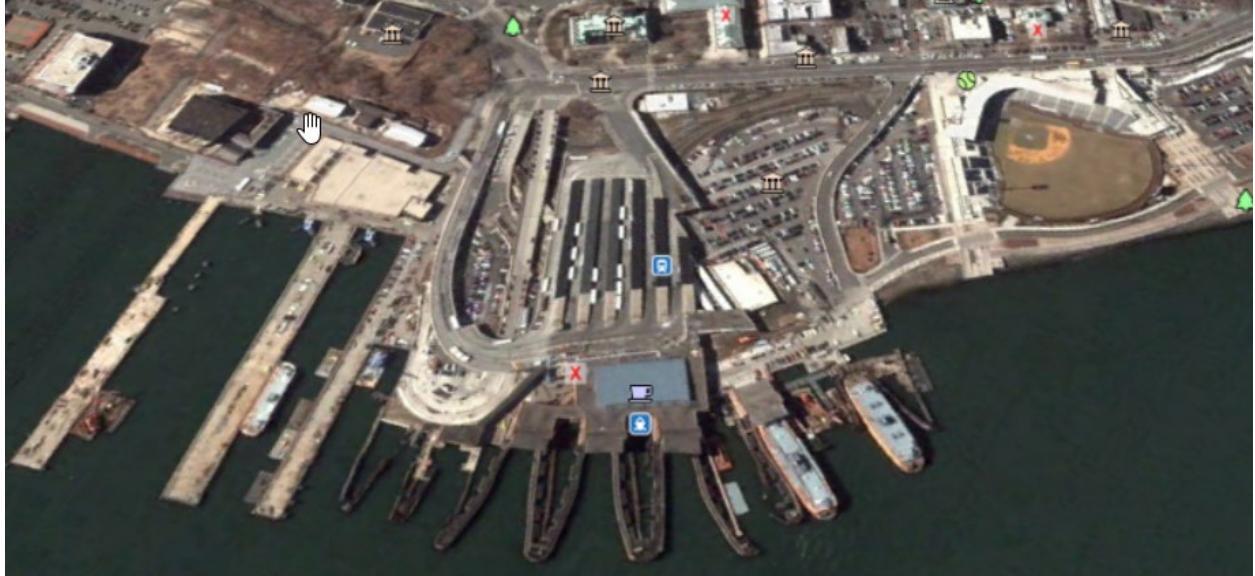
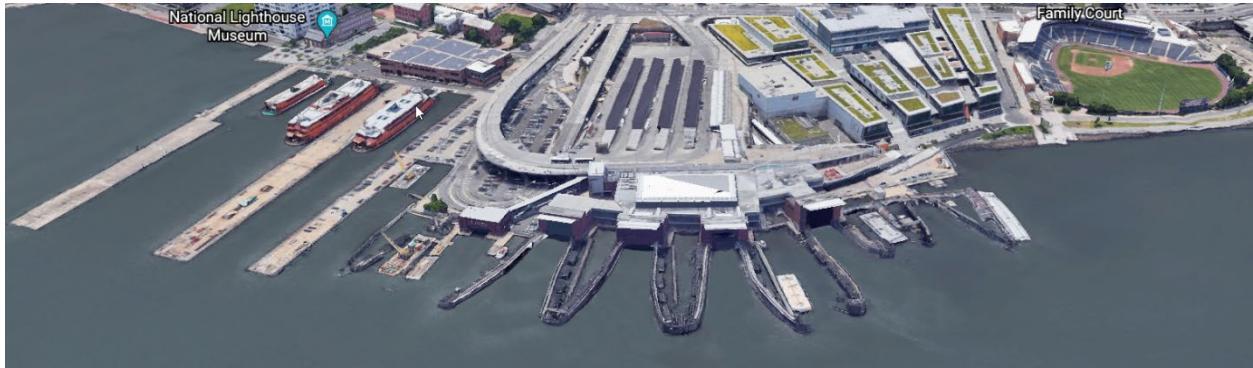
Figure 1.4.2-1: Captures the location of the Staten Island Ferry Terminal, **KVK-328**, and The Staten Island Yankees Baseball Stadium, **KVK-329** in 2004

Figure 1.4.2- 2: Captures the Staten Island Ferry Terminal **KVK-328**, Empire Outlets, and the Staten Island Yankees baseball stadium **KVK-329**.

The Staten Island Ferry Terminal, **KVK-328**, appears to have a new form of bumper system installed and something done to the piles originally documented in the report by the Master Harbor Partnership. It appears that the current bumper system is a replacement for the pilings that were documented by the Master Harbor Partnership report. It is unclear from the image if the newer system replaced or encompassed part or all of the original pilings.

The Staten Island Yankees Baseball Stadium, **KVK-329** appears to be a relatively unchanged but completed from what was present in 2004. The Master Harbor Partnership report indicated that it was under construction during that review process.

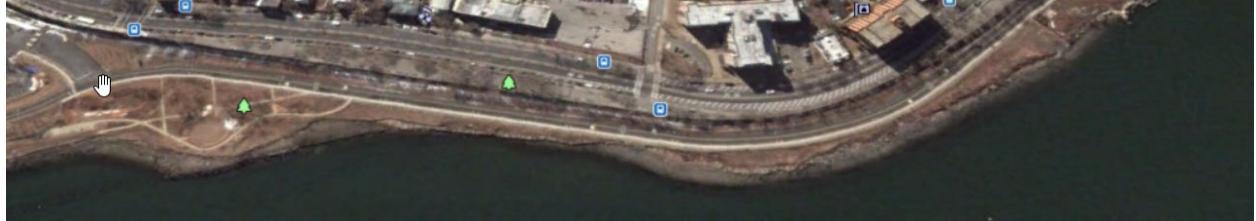
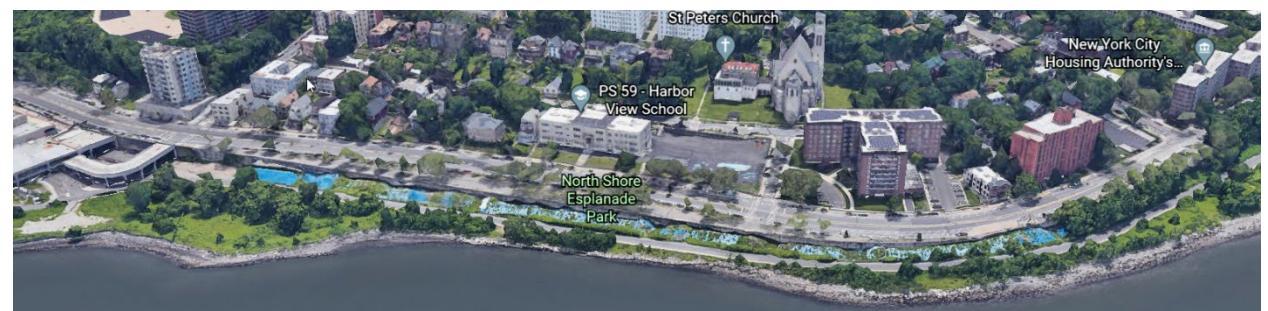
Figure 1.4.2- 5: The above photo indicates the condition of the shoreline to the west of the Imperial Park parking garage in and is representative of **,KVK-310**, circa 2004.

Figure 1.4.2- 6: The above photo indicates the current condition of the shoreline west of the Imperial Park parking garage and is representative of, **KVK-310**, circa 2020

There are no structures on the water side of Richmond Terrace between the Imperial Park parking garage and building **KVK-4** which appears to be a partially collapsed abandon building visible in Figure 1.4.2-7. Richmond Terrace is supported by a masonry retaining wall from the parking garage until Terrace Street near the NYC Housing Authority buildings where it transitions to a soil slope.

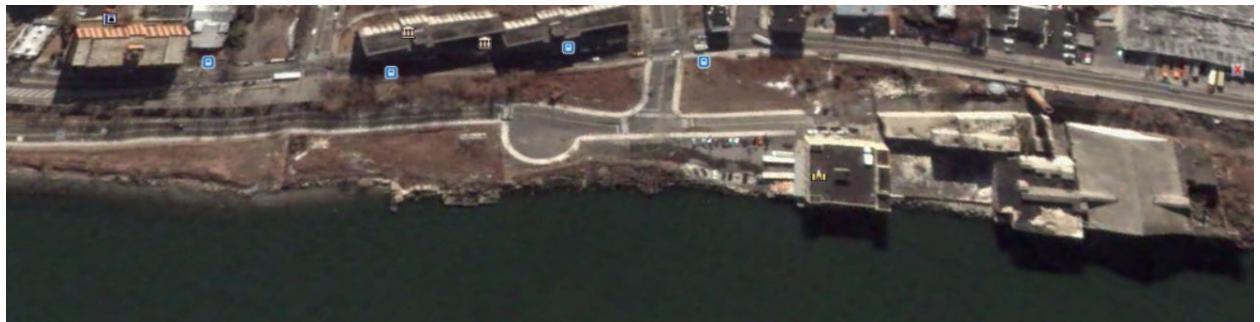
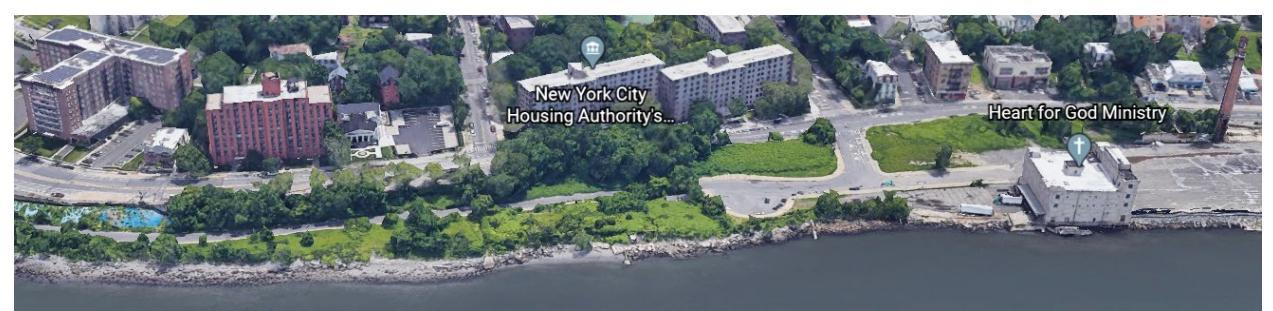
Figure 1.4.2- 7: The above photo captures the continuation of the shoreline west of the Imperial Park parking garage through **KVK-6**

Figure 1.4.2- 8:: The above photo captures a continuation of the shoreline west of the Imperial Park parking garage until KVK-6.

These figures indicate that The Greek Revival Mansion, **KVK-3**, appears to be in similar condition to what was documented in the report by the Master Harbor Partnership and that the building at the Foot of Bank Street, **KVK-4**, appears to have further deteriorated and partially collapsed.

15 Bank Street, Staten Island, **KVK-6**, is currently known as the Heart for God Ministry building. It appears to be in similar condition to that which was documented in the report by the Master Harbor Partnership. A small portion of it appears to be supported by piles.

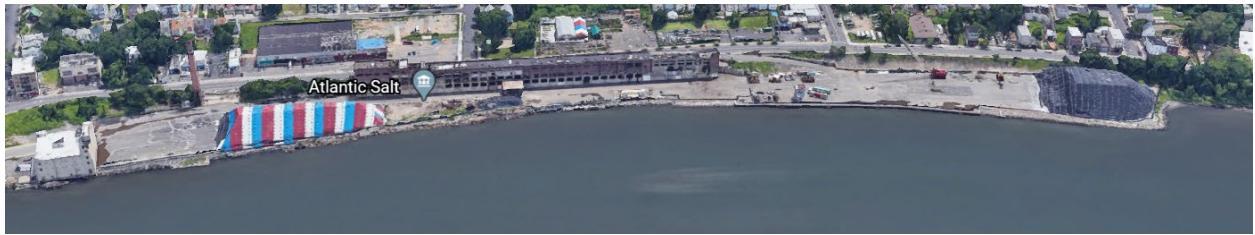
Figure 1.4.2-10: The above captures the buildings present at the Atlantic Salt Company and the area to the east.

KVK11A/B, the long building on the site of the Atlantic Salt Company appears to remain abandon and in similar condition to what was documented in the report by the Master Harbor Partnership.

The chimney located on the grounds of the Atlantic Salt Company appears to be abandoned. The chimney appears to have been repurposed as a support for some kind of electrical equipment and the supporting building demolished. This building would have provided some lateral bracing before it was demolished. With the demolition of the supporting structure and the apparent nonuse of the chimney as well as its susceptibility to vibrations it is recommended that this structure be taken down.

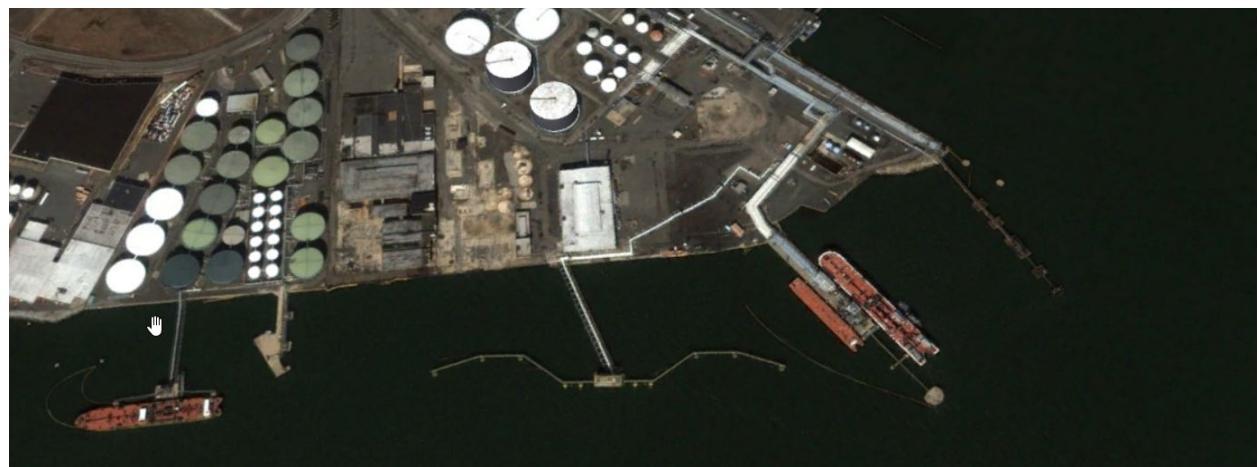
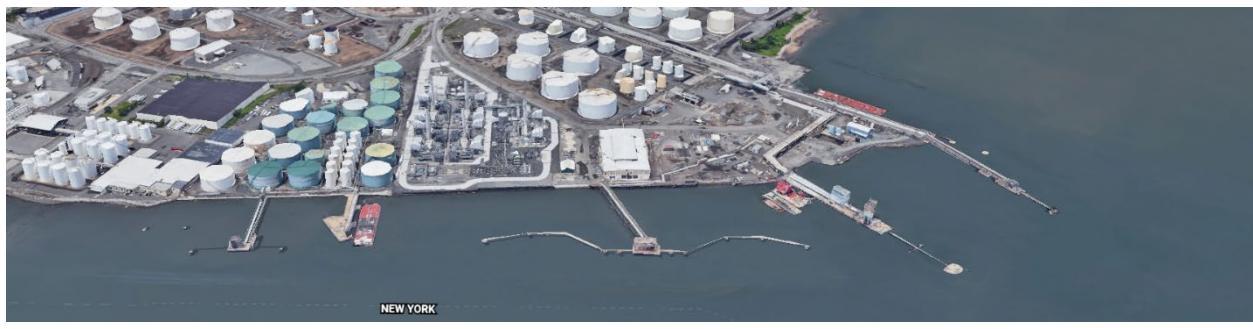
Figure 1.4.2-11: The above photo captures, KVK-313, Exxon-Western Pier in 2004.

Figure 1.4.2-12: Exxon-Western Pier, KVK-313 and adjacent structures.

The "bird shaped" structure to the left of **KVK-313** is not captured in either the report or the map from URS. This bird shaped structure was present at the time of the report by the Master Harbor Partnership. It first appears in the aerial photographs between 1995 and 2001.

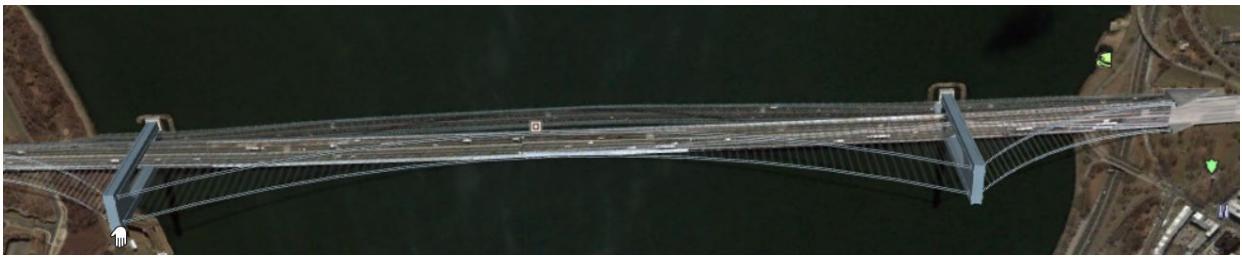
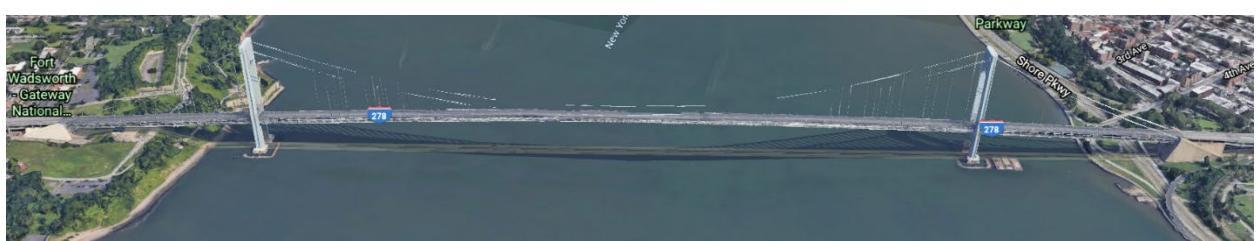
Figure 1.4.2-13: The photo captures the Verrazano-Narrows Bridge, KVK-330.

Figure 1.4.2-14: The photo captures the current condition of the Verrazano-Narrows Bridge.

The Verrazano-Narrows Bridge, **KVK-330**, was considered too far from the site of anticipated blasting that was evaluated in the 2003 report by the Master Harbor Partnership. Because of its significance the Master Harbor Partnership report recommended the structure should be further studied. A thorough site-specific study for the Verrazano-Narrows Bridge is recommended at this time because of its significance.
