**SECOND FIVE YEAR REVIEW REPORT  
FOR NORTHEASTERN INDUSTRIAL PARK  
FUDS PROJECT C02NY000203  
ALBANY COUNTY, NEW YORK**

**Prepared by  
Bluestone Environmental Group, Inc.  
301 Lindenwood Drive, Suite 102  
Malvern, PA 19355**

**Photographic Log**  
**25 October 2022 Landfill Cap and Soil Cover Inspection**  
**AOCs 1 & 7, Northeastern Industrial Park, Guilderland, NY**

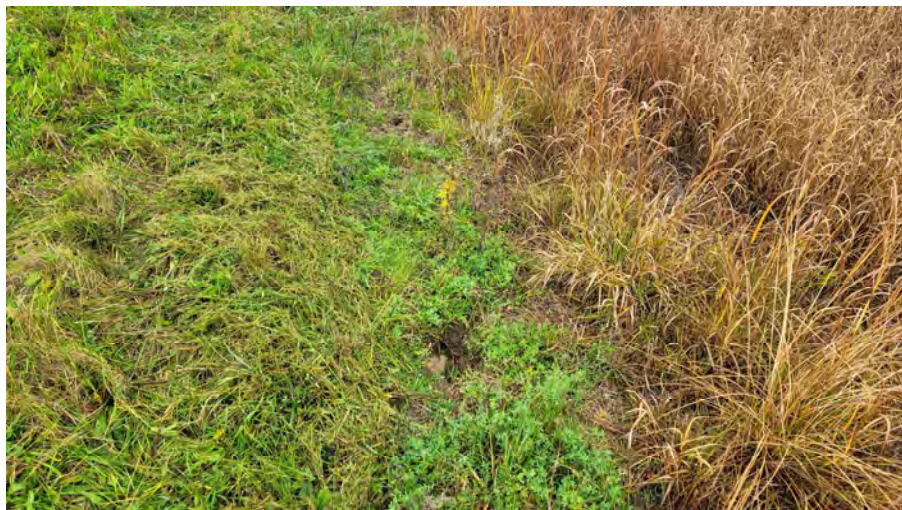
- Healthy vegetation on both landfill cap (Photo IDs: LC3 through LC12) and soil cover area (Photo IDs: SC1 through SC6).
- Animal burrows along eastern edge of landfill cap (Photo ID: LC1).
- No signs of rill erosion.
- Wooden perimeter fence post (second most western) damaged (Photo ID: LC2).
- Southern site perimeter fence near MW-13-01 is still sagging, overgrown, and in need of repair (Photo ID: LC10).

Photo ID: LC1  
Date: 25 October 2022  
Inspector: JM  
Direction of Photograph: East  
Notes: Burrows along eastern edge of landfill cap

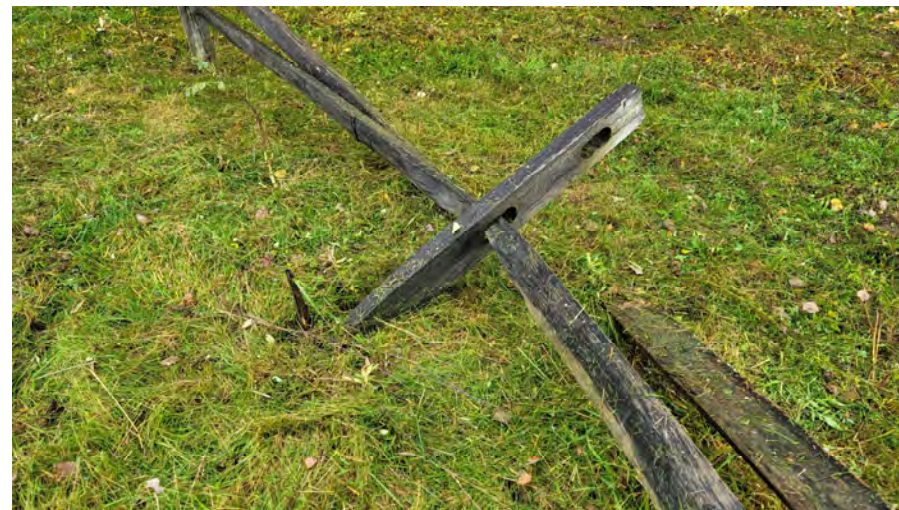
Photo ID: LC2  
Date: 25 October 2022  
Inspector: JM  
Direction of Photograph: East  
Notes: Damaged fence post at landfill cap

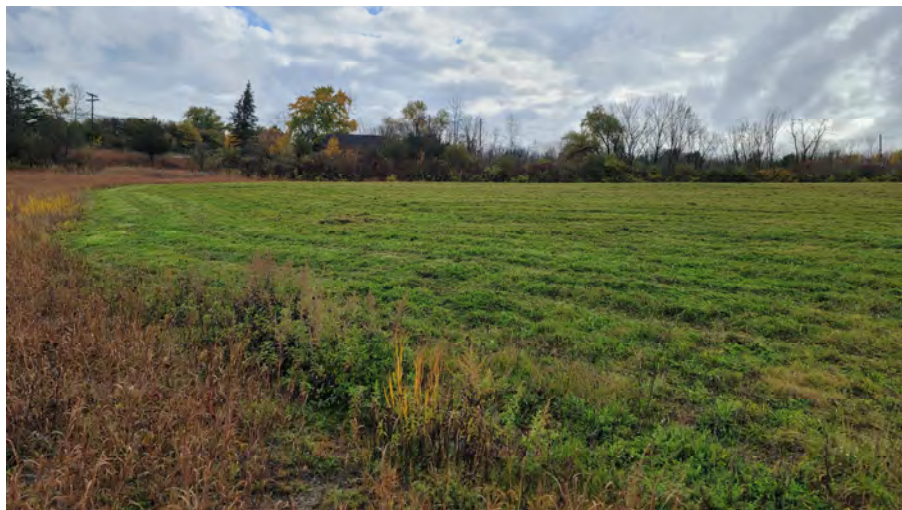
Photo ID: LC3  
Date: 25 October 2022  
Inspector: JM  
Direction of Photograph: South  
Notes: Landfill cap from northeast corner facing south

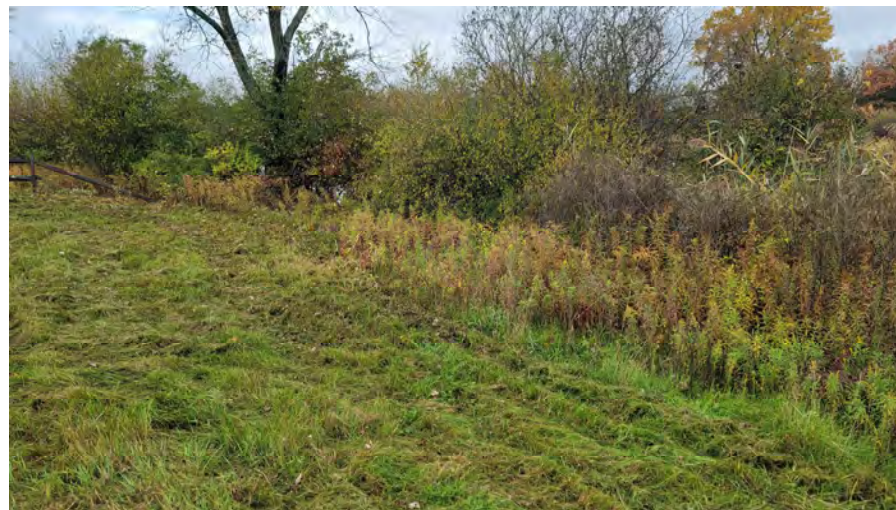
Photo ID: LC4  
Date: 25 October 2022  
Inspector: JM  
Direction of Photograph: Northwest  
Notes: Landfill cap edge from northern boundary facing northwest

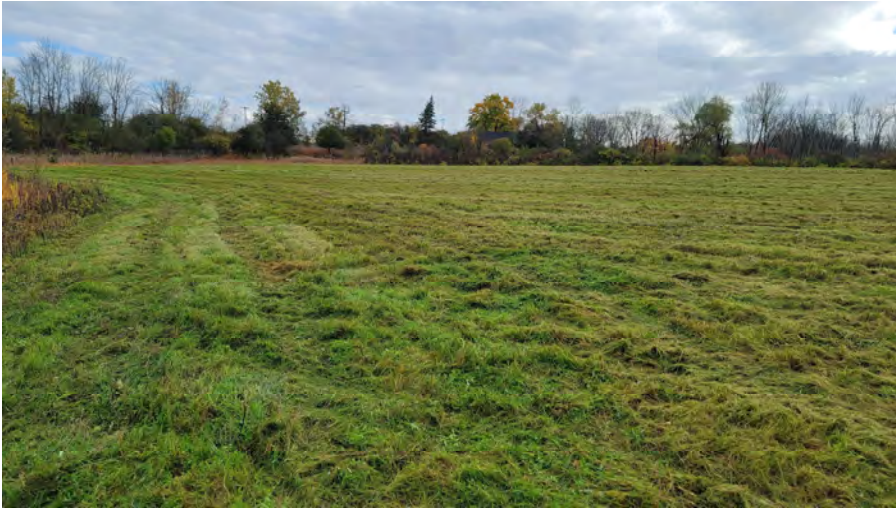
Photo ID: LC5  
Date: 25 October 2022  
Inspector: JM  
Direction of Photograph: East  
Notes: Landfill cap from northern boundary facing east

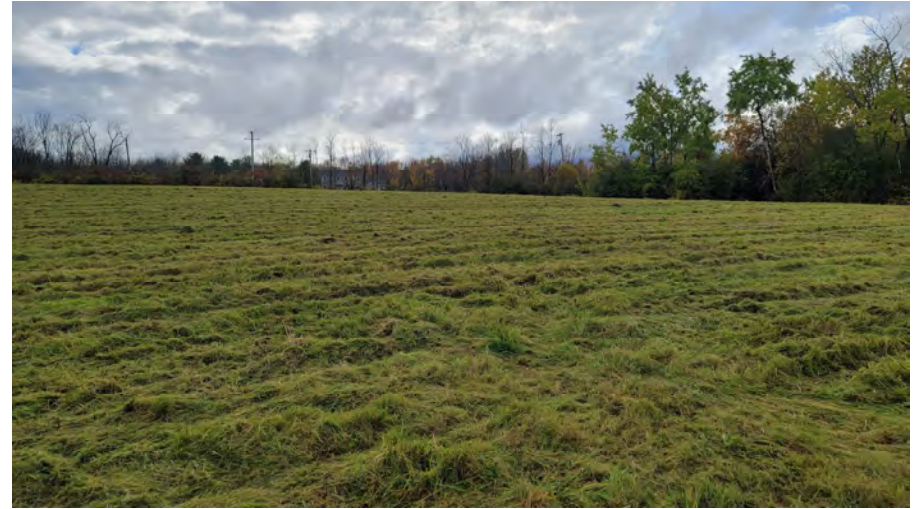
Photo ID: LC6  
Date: 25 October 2022  
Inspector: JM  
Direction of Photograph: South  
Notes: Landfill cap from northern boundary facing south

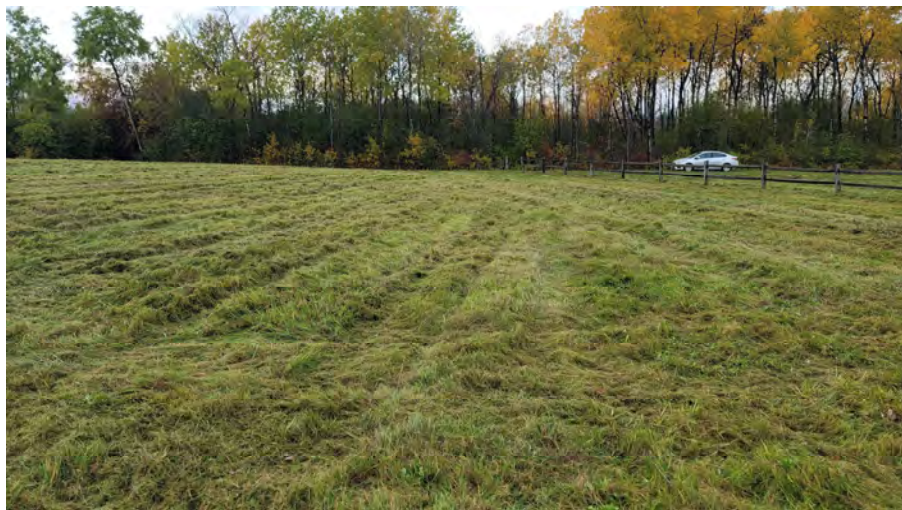
Photo ID: LC7  
Date: 25 October 2022  
Inspector: JM  
Direction of Photograph: West  
Notes: Landfill cap from northern boundary facing west

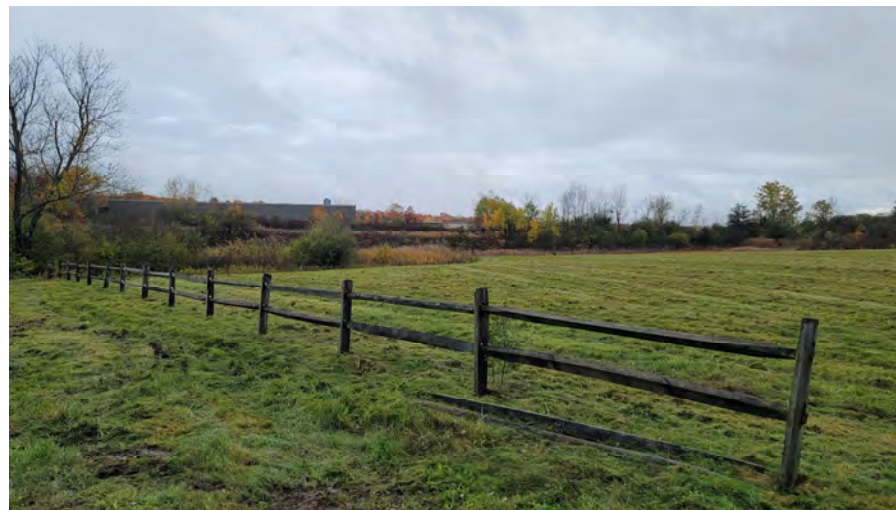
Photo ID: LC8  
Date: 25 October 2022  
Inspector: JM  
Direction of Photograph: East  
Notes: Landfill cap from northwest corner facing east

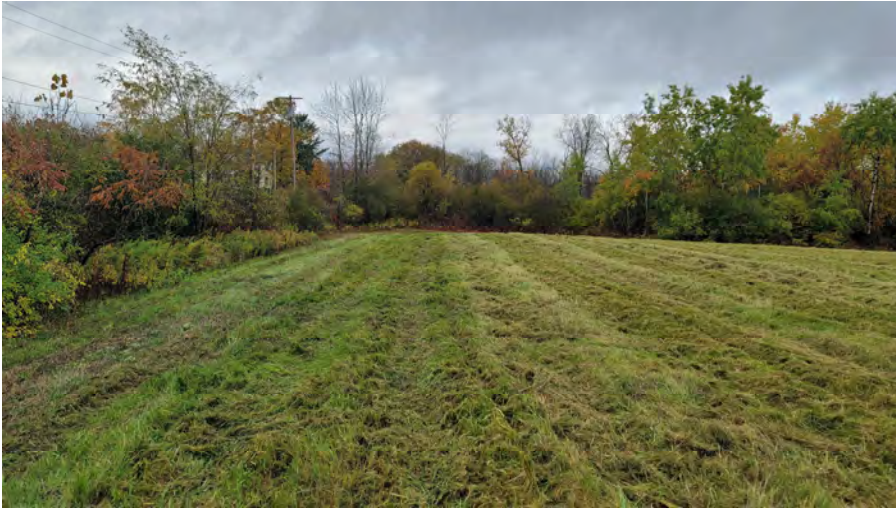
Photo ID: LC9  
Date: 25 October 2022  
Inspector: JM  
Direction of Photograph: West  
Notes: Landfill cap from southern boundary facing west

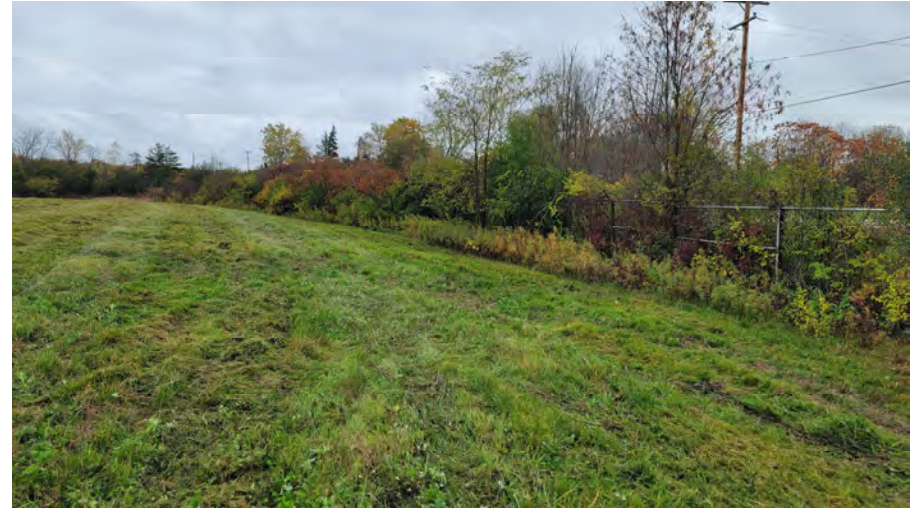
Photo ID: LC10  
Date: 25 October 2022  
Inspector: JM  
Direction of Photograph: East  
Notes: Landfill cap from southwest corner facing east

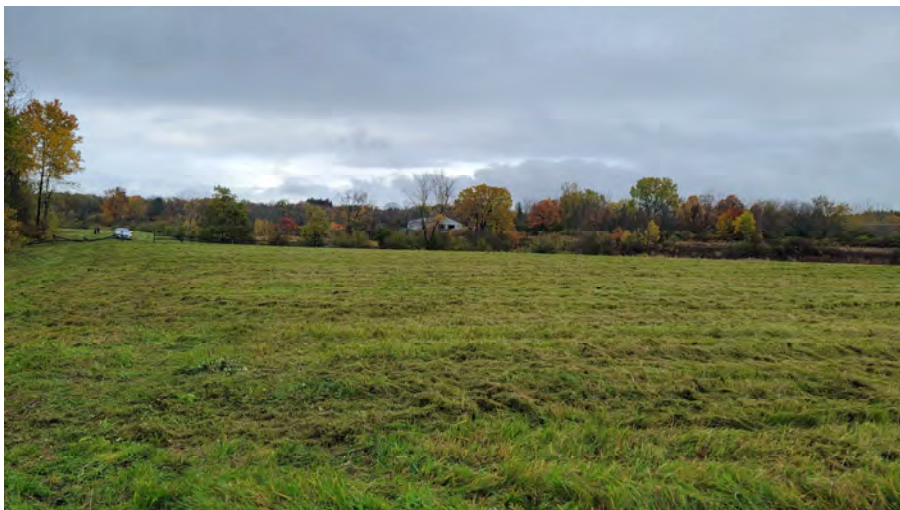
Photo ID: LC11  
Date: 25 October 2022  
Inspector: JM  
Direction of Photograph:  
Notes: Landfill cap from southwest corner facing north (2)

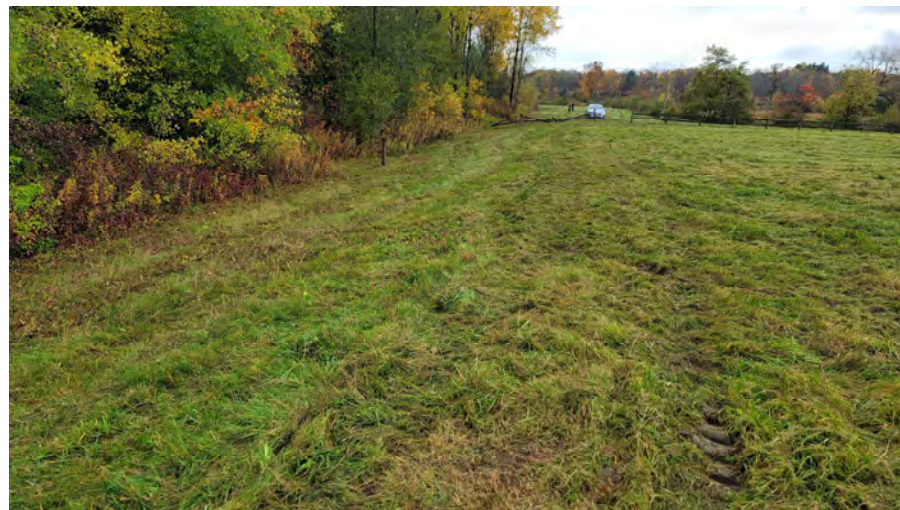
Photo ID: LC12  
Date: 25 October 2022  
Inspector: JM  
Direction of Photograph:  
Notes: Landfill cap from southwest corner facing north

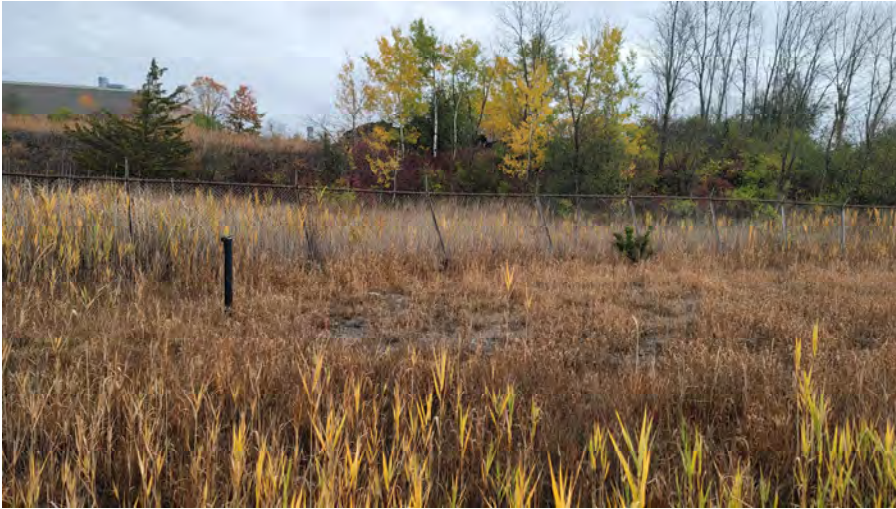
- Eastern cap perimeter fence sagging away from property (Photo ID: LC13).
- Monitoring wells are in good condition and locks are properly secured (Photo IDs: ACE-3, ACE-4, GW-03R, GW-11R, GW-12, and MW-13-01).
- Protective casing cap of GW-12 does not fully close, but is locked and secured (Photo ID: GW-12)
- Stormwater culverts in good condition (Photo IDs: SW1 through SW5).
- No direct changes in land use were noted for the Site or adjacent areas; however, the site interviews revealed that the site is being considered as a candidate location for a new solar panel project.

During the 2018 FYR, it was noted that the metal chain-link perimeter fence appeared to have been cut and bent back, creating a 3-ft x 3-ft hole in the bottom of the fence, approximately 40 feet north of ACE-5. During the annual inspections since 2018, two more holes of similar size were observed in close proximity to ACE-5. However, it was observed that these gaps in the chain-linked fence allowed surface water to flow freely through these points, and prevents fallen leaves, branches, and other vegetation from piling up at the fence and hence blocking surface water flow. It is believed that the fence installers needed to make these holes to maintain proper stormwater management at the site. Additionally, the holes are located in dense wetland vegetation, and trespassers are not of concern. However, as of 2022, the eastern perimeter chain-link fence is now sagging away from the property and is in need of repair (LC13).

Photo ID: LC13  
Date: 25 October 2022  
Inspector: JM  
Direction of Photograph: East  
Notes: Leaning fencing along eastern boundary of the landfill cap

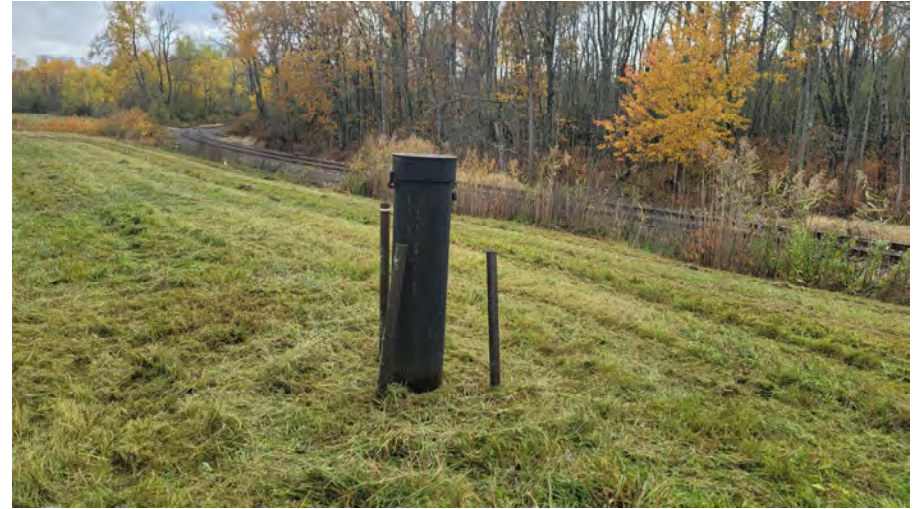
Photo ID: 2-BMW-9  
Date: 25 October 2022  
Inspector: JM  
Direction of Photograph: South  
Notes: Monitoring Well 2-BMW-9

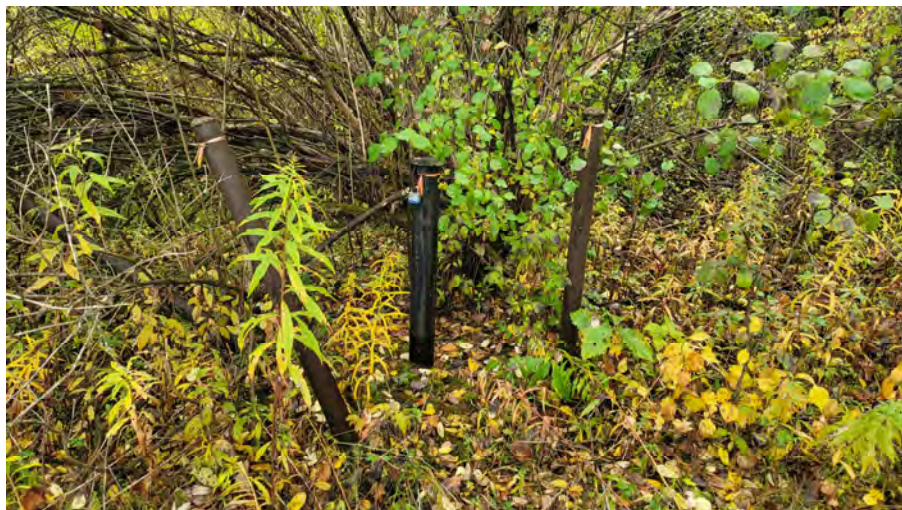
Photo ID: ACE-3  
Date: 25 October 2022  
Inspector: JM  
Direction of Photograph: South  
Notes: Monitoring Well ACE-3

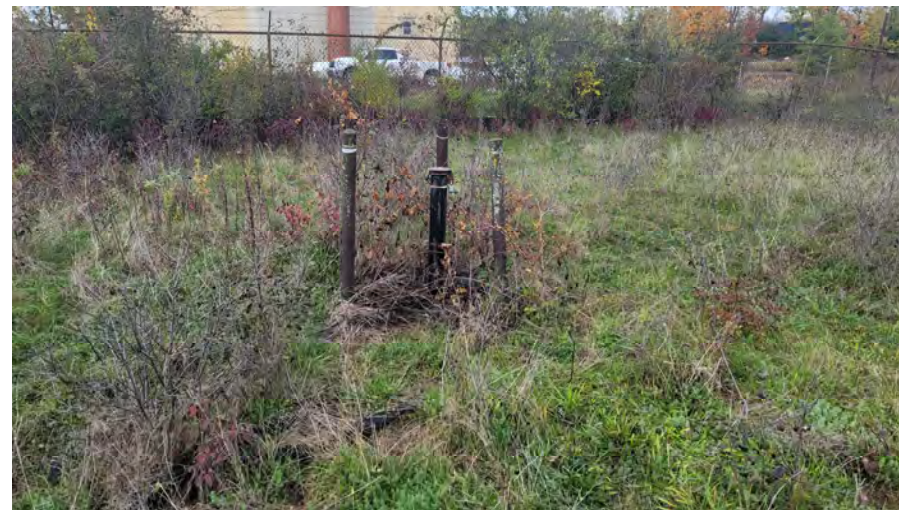
Photo ID: ACE-4  
Date: 25 October 2022  
Inspector: JM  
Direction of Photograph: North  
Notes: Monitoring Well ACE-4

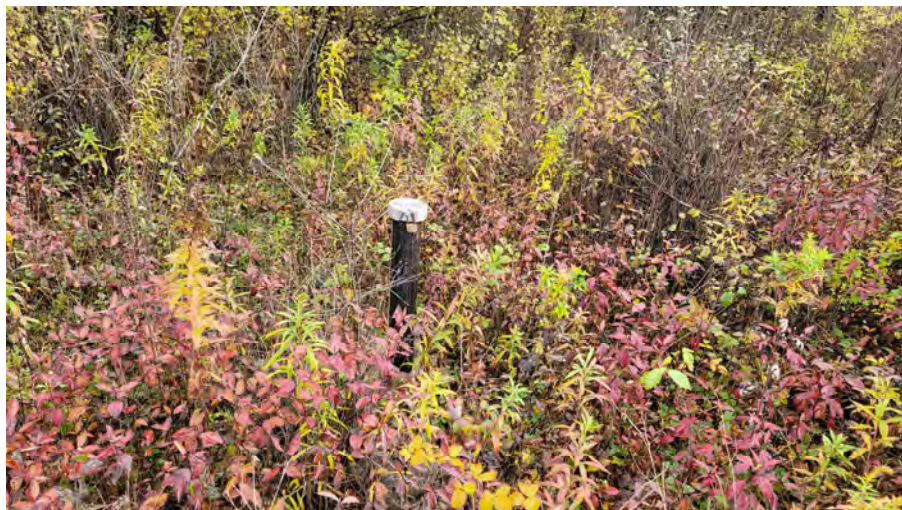
Photo ID: GW-3  
Date: 25 October 2022  
Inspector: JM  
Direction of Photograph: South  
Notes: Monitoring Well GW-3

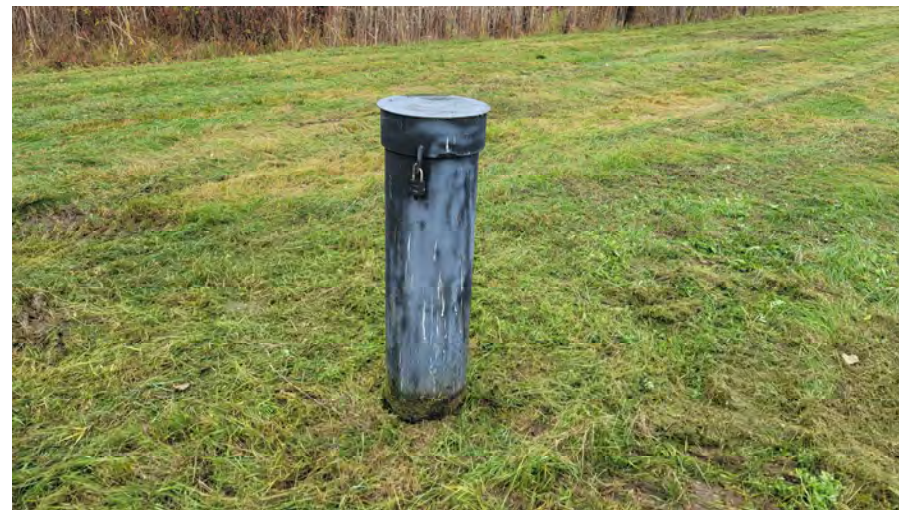
Photo ID: GW-11R  
Date: 25 October 2022  
Inspector: JM  
Direction of Photograph: Northwest  
Notes: Monitoring Well GW-11R

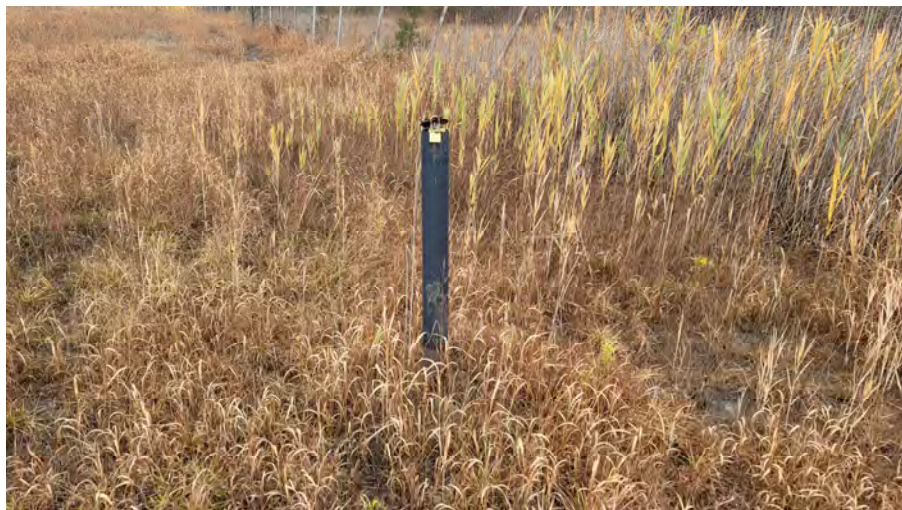
Photo ID: GW-12  
Date: 25 October 2022  
Inspector: JM  
Direction of Photograph: Northeast  
Notes: Monitoring Well GW-12

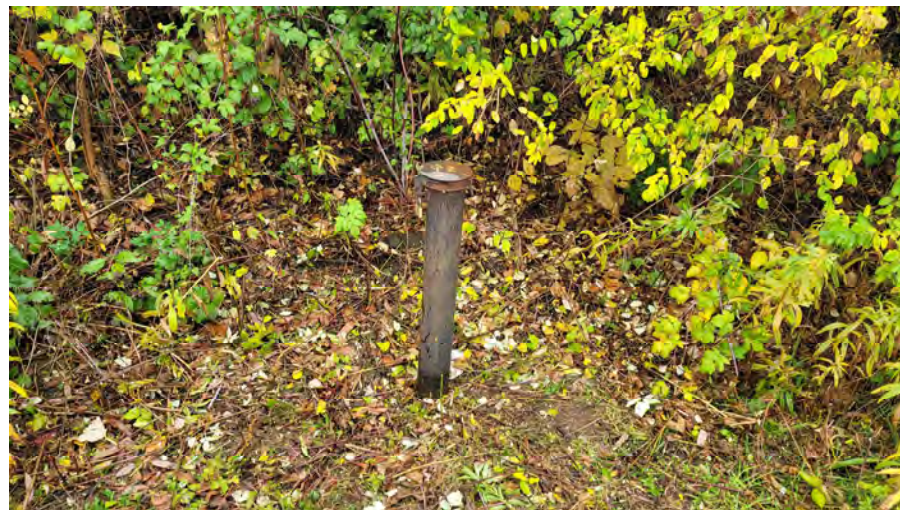
Photo ID: MW-13-01  
Date: 25 October 2022  
Inspector: JM  
Direction of Photograph: South  
Notes: Monitoring Well MW-13-01

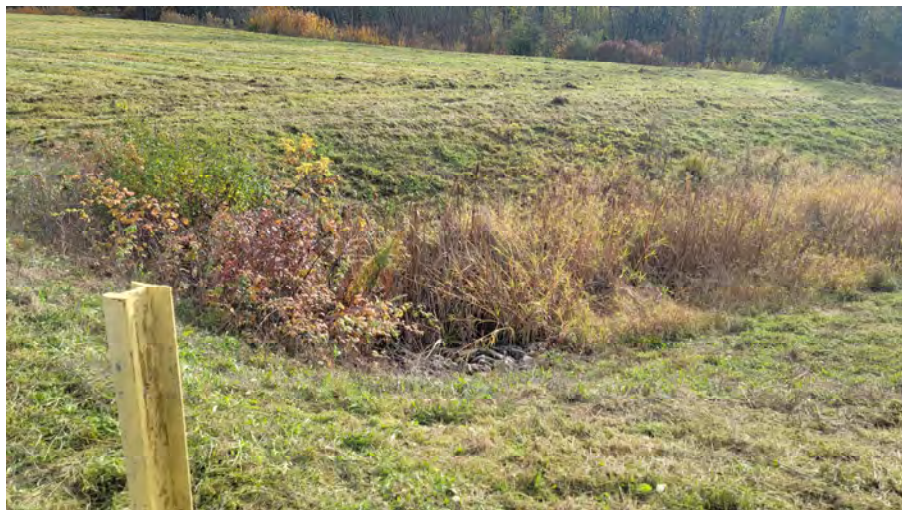
Photo ID: SW1  
Date: 25 October 2022  
Inspector: JM  
Direction of Photograph: South  
Notes: Northern swale from access road facing south

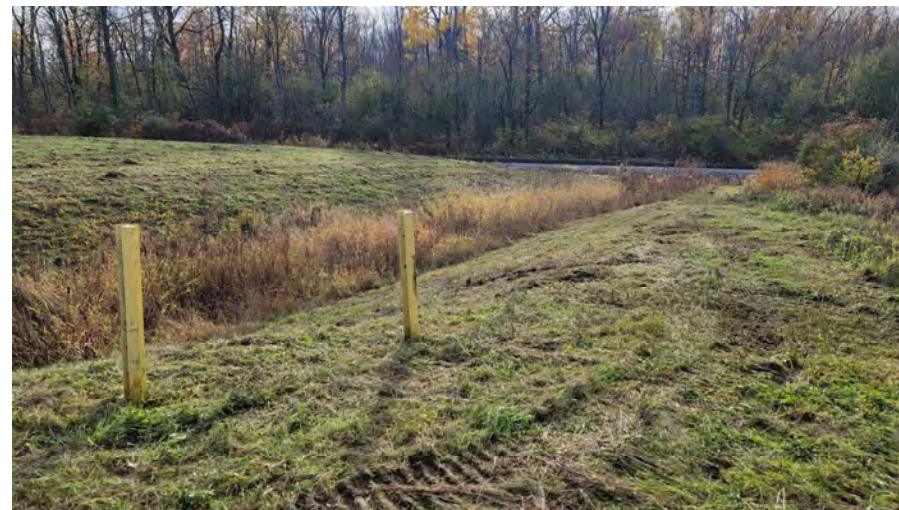
Photo ID: SW2  
Date: 25 October 2022  
Inspector: JM  
Direction of Photograph: Southwest  
Notes: Northern swale from access road facing southwest

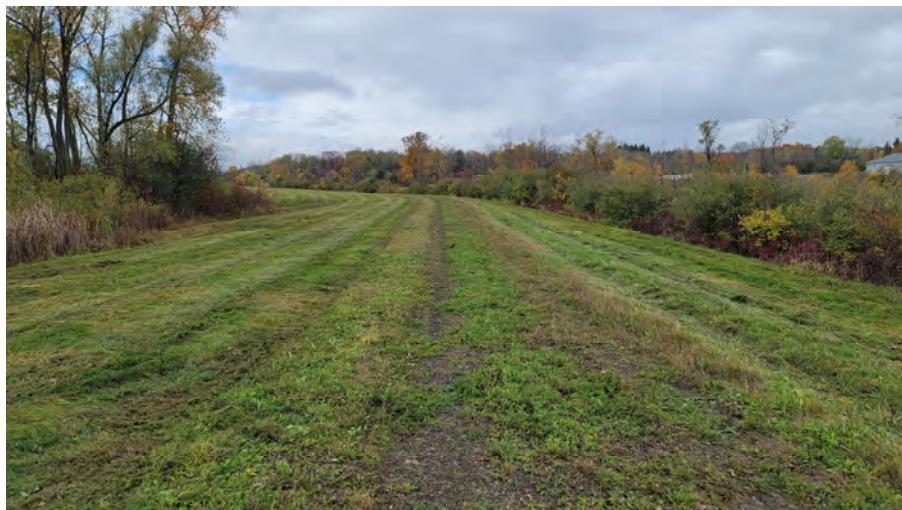
Photo ID: SC1  
Date: 25 October 2022  
Inspector: JM  
Direction of Photograph: North  
Notes: Soil cover along access road facing north from  
ACE-6 and GW-11R wells

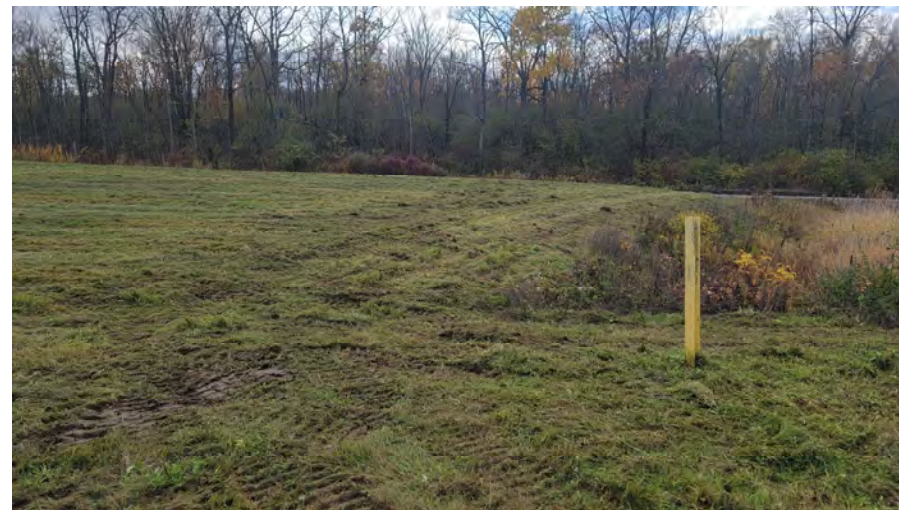
Photo ID: SC2  
Date: 25 October 2022  
Inspector: JM  
Direction of Photograph: West  
Notes: Soil cover and northern swale from gate facing  
west

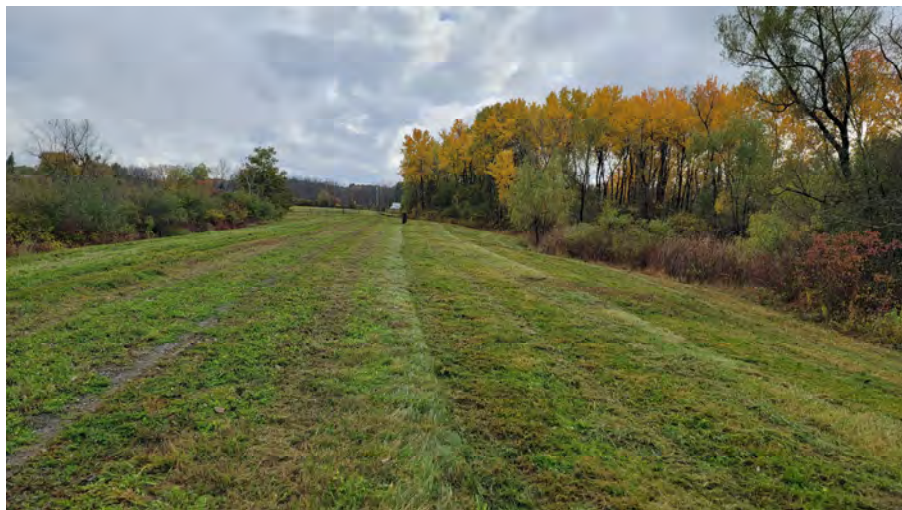
Photo ID: SC3  
Date: 25 October 2022  
Inspector: JM  
Direction of Photograph: South  
Notes: Soil cover from access road at the pond facing south

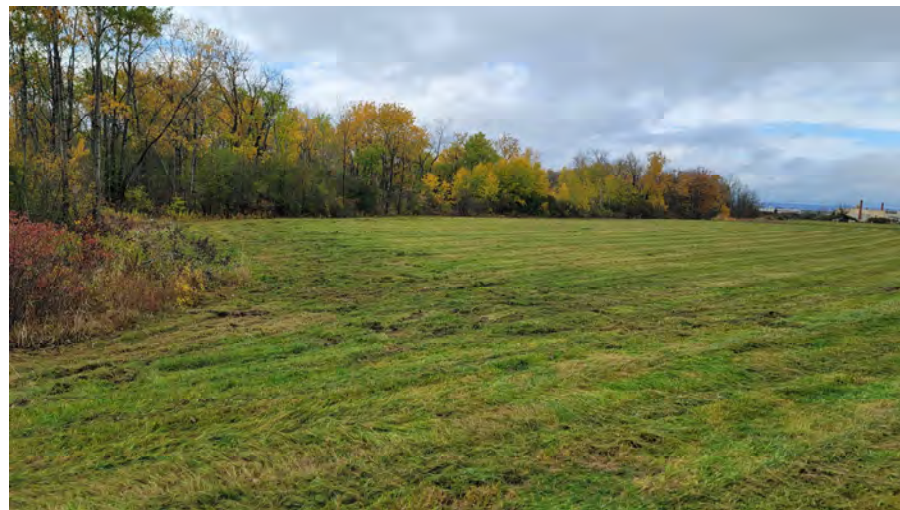
Photo ID: SC4  
Date: 25 October 2022  
Inspector: JM  
Direction of Photograph: West  
Notes: Soil cover from access road at the pond facing west

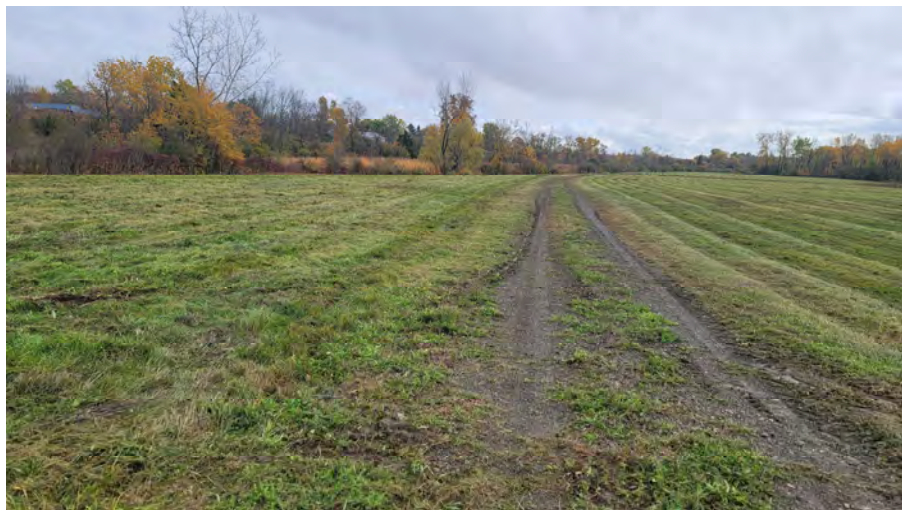
Photo ID: SC5  
Date: 25 October 2022  
Inspector: JM  
Direction of Photograph: Southeast  
Notes: Soil cover from gate facing southeast

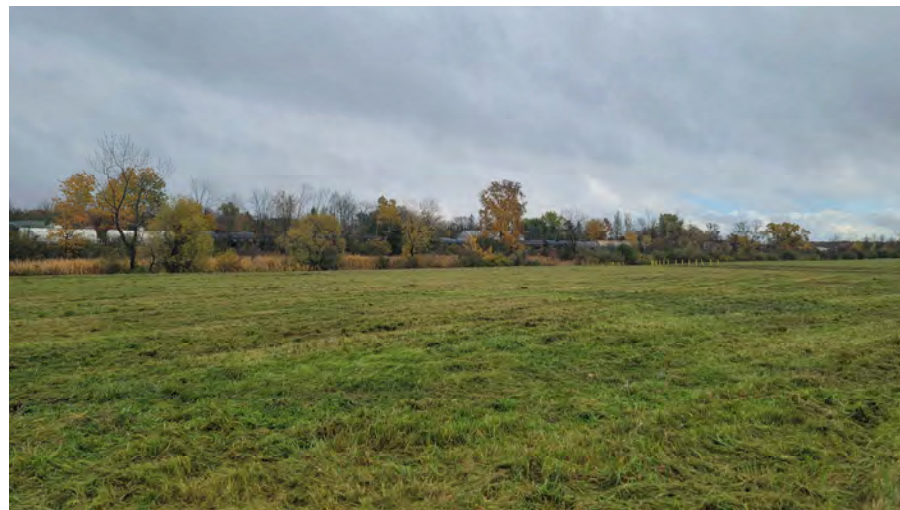
Photo ID: SC6  
Date: 25 October 2022  
Inspector: JM  
Direction of Photograph: East  
Notes: Soil cover from Monitoring Well 2-BMW-9 facing east

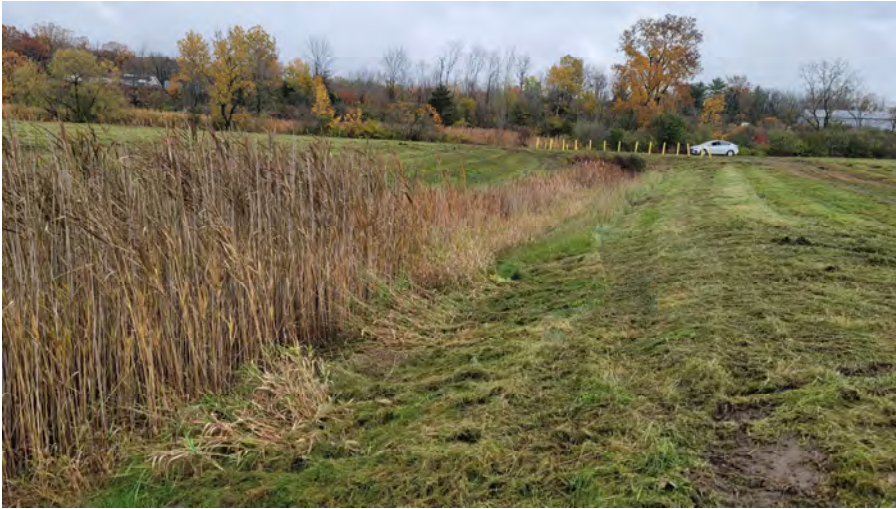
Photo ID: SW3  
Date: 25 October 2022  
Inspector: JM  
Direction of Photograph: East  
Notes: Southern swale facing east

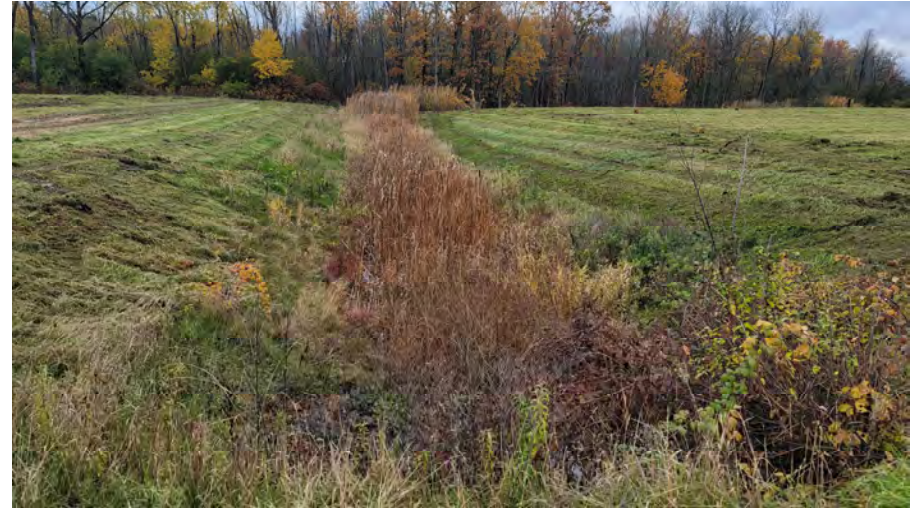
Photo ID: SW4  
Date: 25 October 2022  
Inspector: JM  
Direction of Photograph: West  
Notes: Southern swale from access road facing west

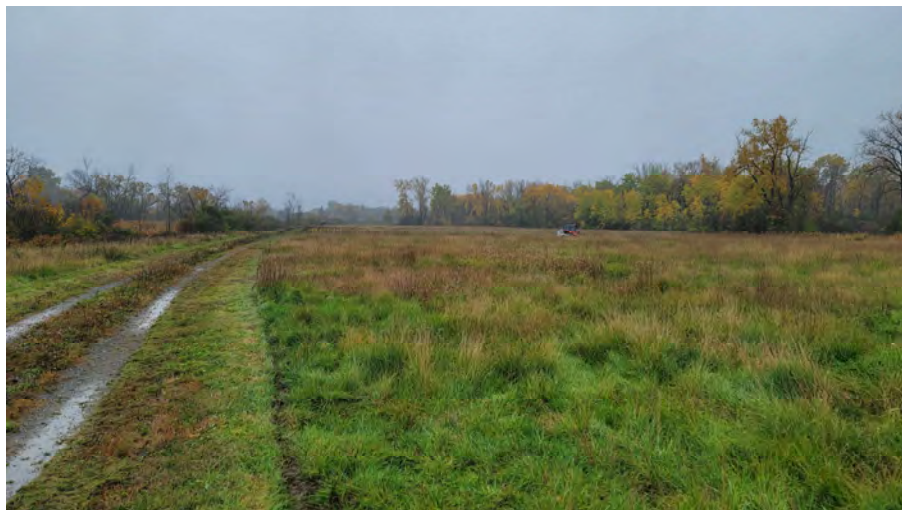
Photo ID: SC7  
Date: 25 October 2022  
Inspector: JM  
Direction of Photograph: South  
Notes: View of soil cover facing south from gate

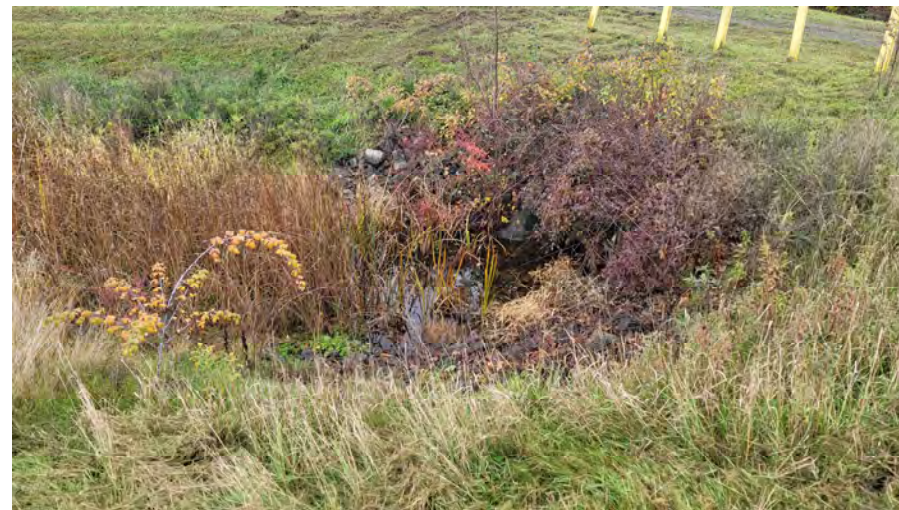
Photo ID: SW5  
Date: 25 October 2022  
Inspector: JM  
Direction of Photograph: North  
Notes: West culvert outlet in southern swale facing north
