**Appendix E-2
Alternatives Development
Jamaica Bay Marsh Islands Package**

**Draft Integrated Feasibility Report &
Environmental Assessment
February 2017**

**Prepared by the New York District
U.S. Army Corps of Engineers**

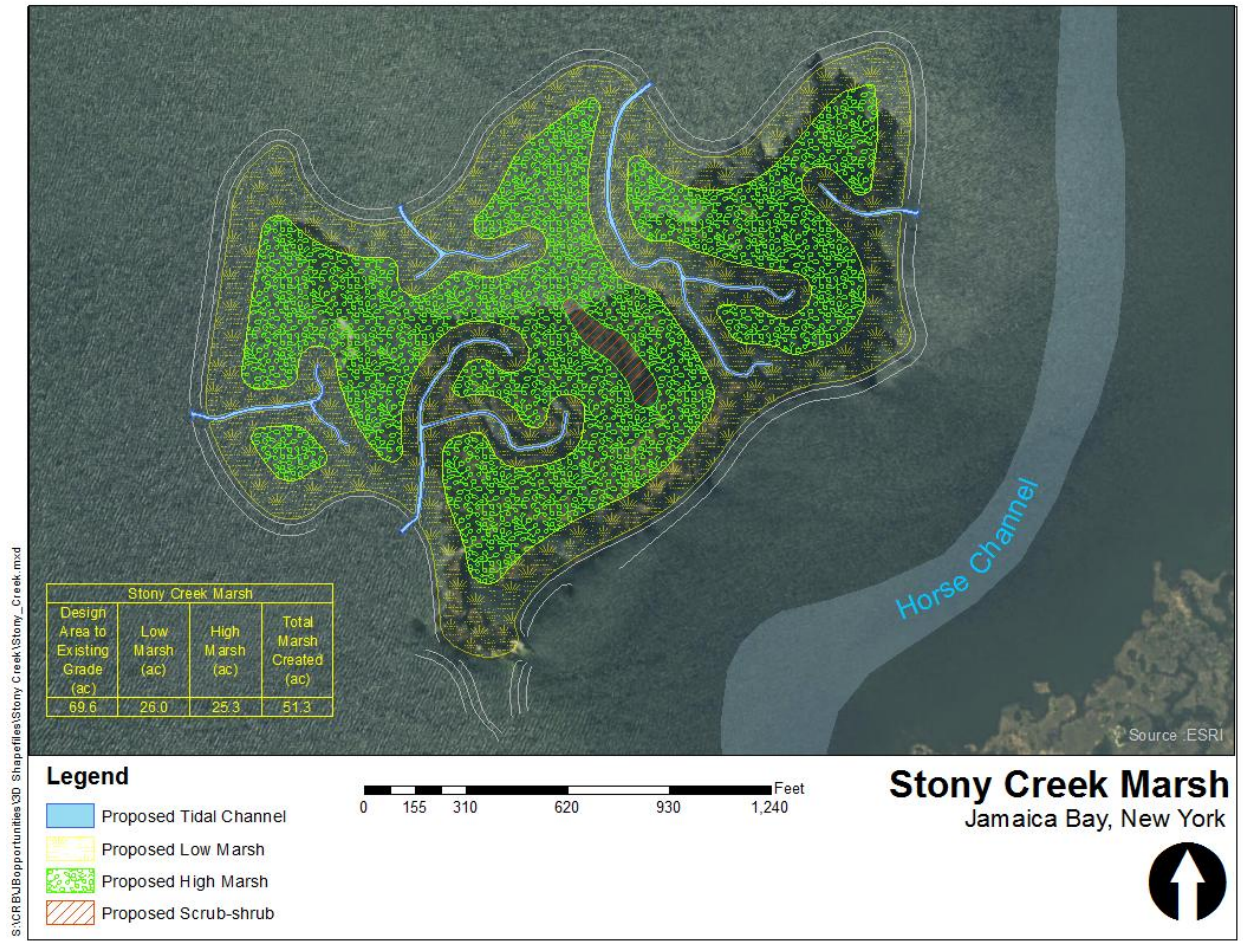
Figure 8-1: Stony Creek Marsh Tentatively Selected Plan

The TSP for Stony Creek marsh (Figure 8-1) represents the most efficient effort of the five (5) marsh island restorations, with an average of 2,970 cubic yards of material needed per acre of marshland restoration. Sustainability issues for this effort are negligible, with the exception of the proximity of Horse Channel along the southeastern boundary of the site. This plan includes the creation of 26 acres of low marsh, 25.3 acres of high marsh, and five (5) tidal channels that, together, will provide both aquatic and wetland habitat. The proposed alternative also incorporates a minimal amount of scrub/shrub habitat, which will provide habitat diversity for the vegetation and wildlife on the island.

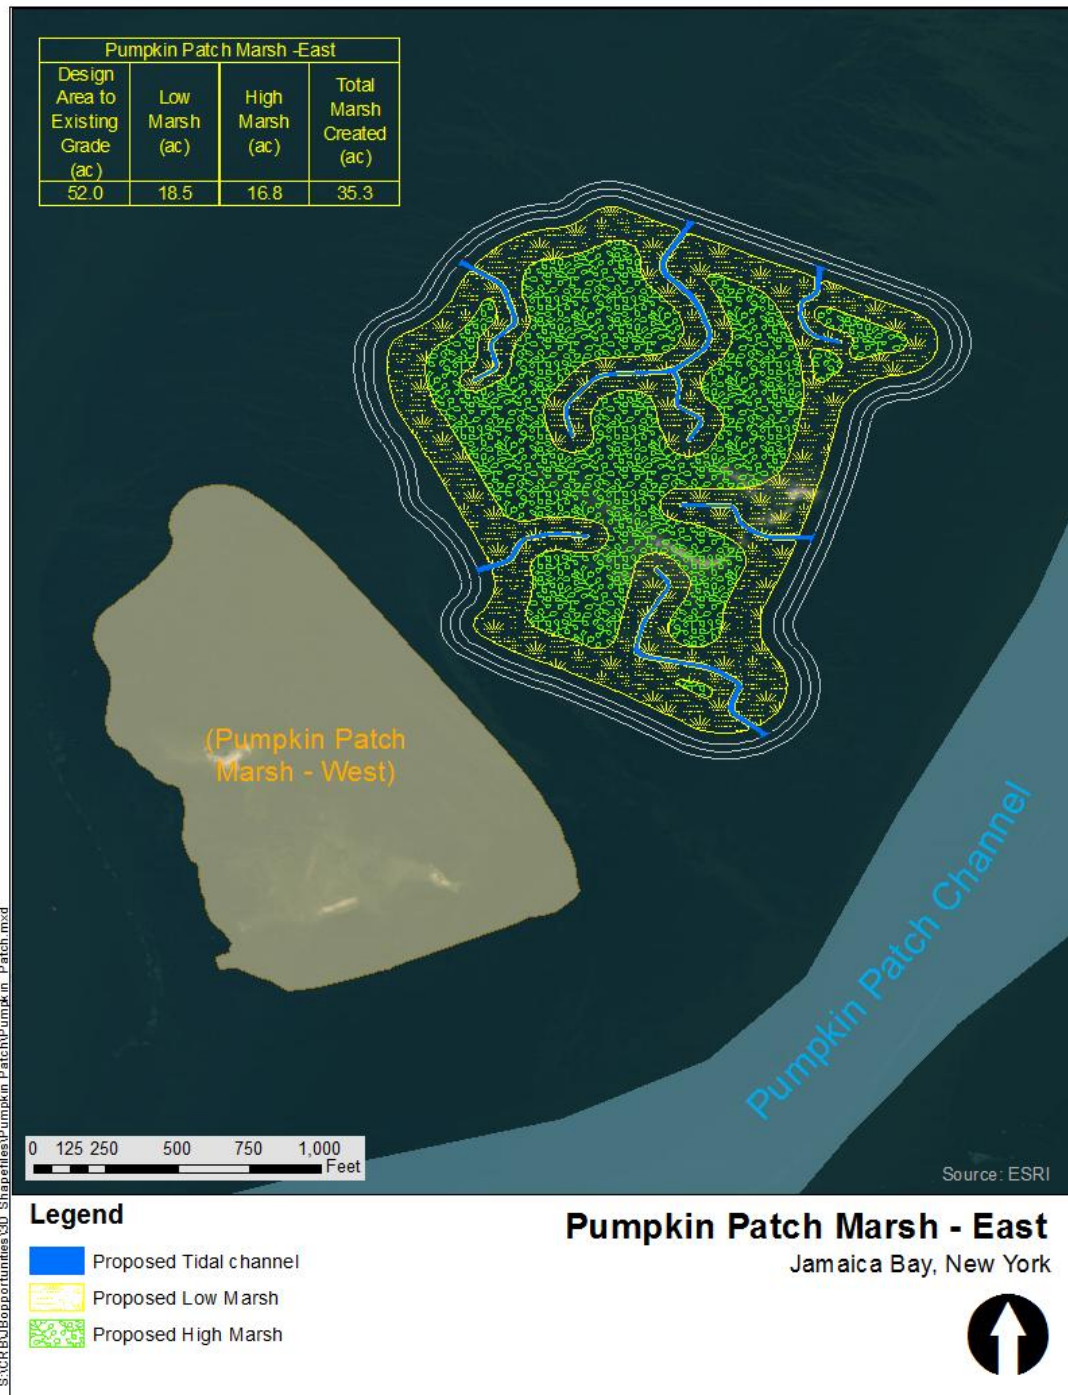
Figure 8-4: Pumpkin Patch East Tentatively Selected Plan

The TSP (Figure 8-4) restores a total of 35 acres of salt marsh with a total of 52 acres to be graded. This restoration includes 18.6 acres of low marsh, 16.8 acres of high marsh, and six (6) tidal channels. The marsh island will provide significantly more wetland habitat than exists currently, especially when considered with the sister marsh island, Pumpkin Patch West. The restoration of these neighboring marsh islands reduces habitat fragmentation in the area.

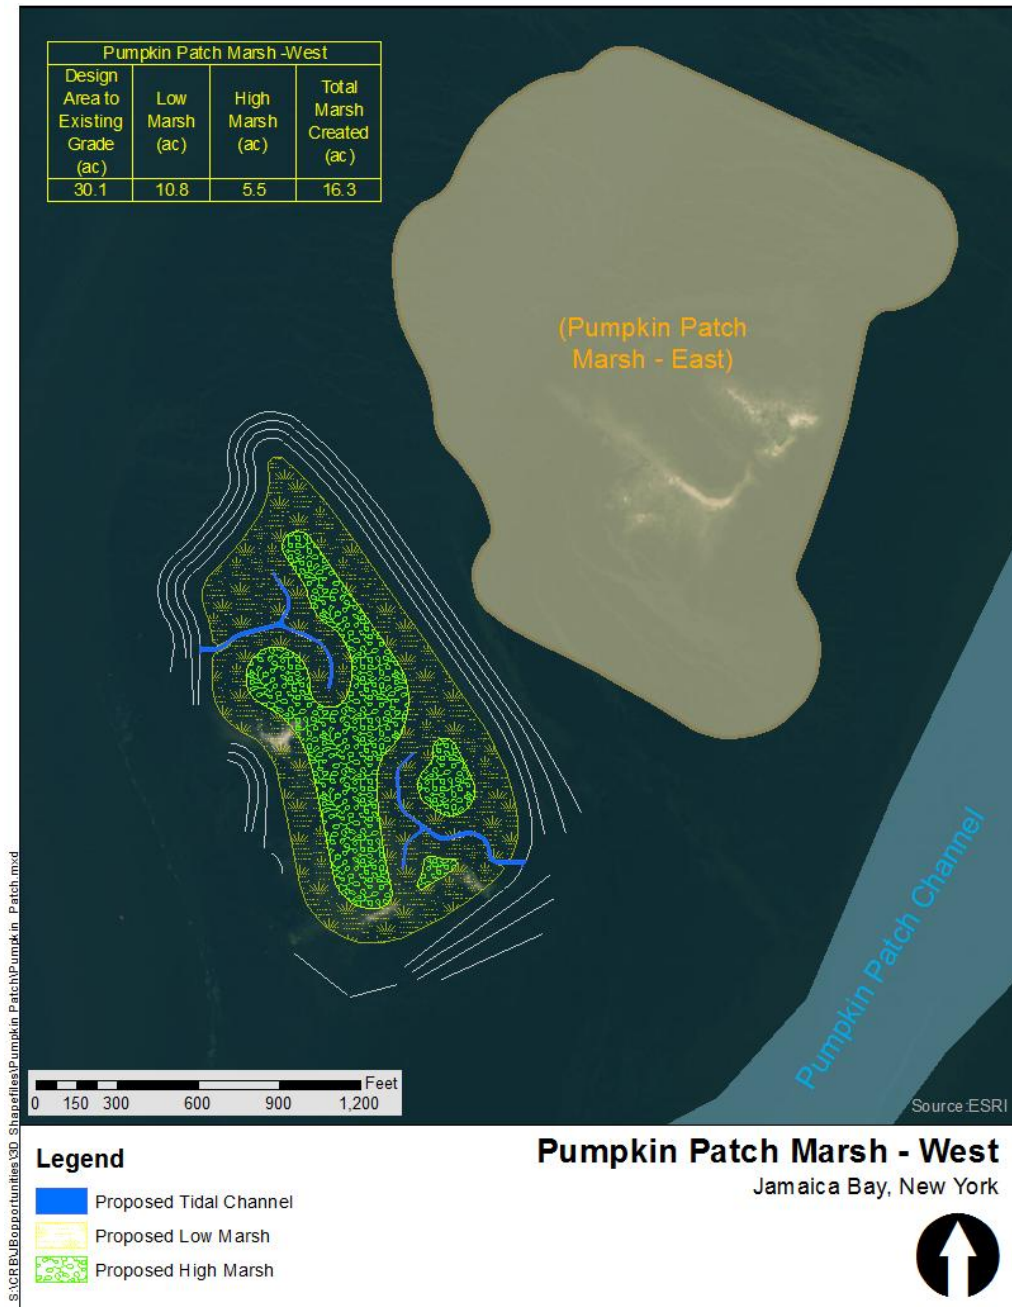
Figure 8-6: Pumpkin Patch West Tentatively Selected Plan

The TSP for Pumpkin Patch West (Figure 8-6) restores a total of 16.3 acres of salt marsh with a total of 30 acres to be graded. This includes 10.8 acres of low marsh and 5.5 acres of high marsh, returning this portion of Pumpkin Patch Marsh to the approximate dimensions of the 1974 footprint. As noted above, the area between Pumpkin Patch East and Pumpkin Patch West may be a candidate for restoration, but should be considered only after the restoration of Elders Point Center and an investigation of the altered hydrodynamics of this area.
