## Draft Engineering Appendix

**US ARMY CORPS  
OF ENGINEERS  
NEW YORK DISTRICT**

**SANDY HOOK TO BARNEGAT INLET,  
BEACH EROSION CONTROL PROJECT,  
SECTION I- SEA BRIGHT TO OCEAN TOWNSHIP:  
ELBERON TO LOCH ARBOUR REACH  
HURRICANE SANDY LIMITED REEVALUATION REPORT  
APPENDIX A: ENGINEERING**

December 2013

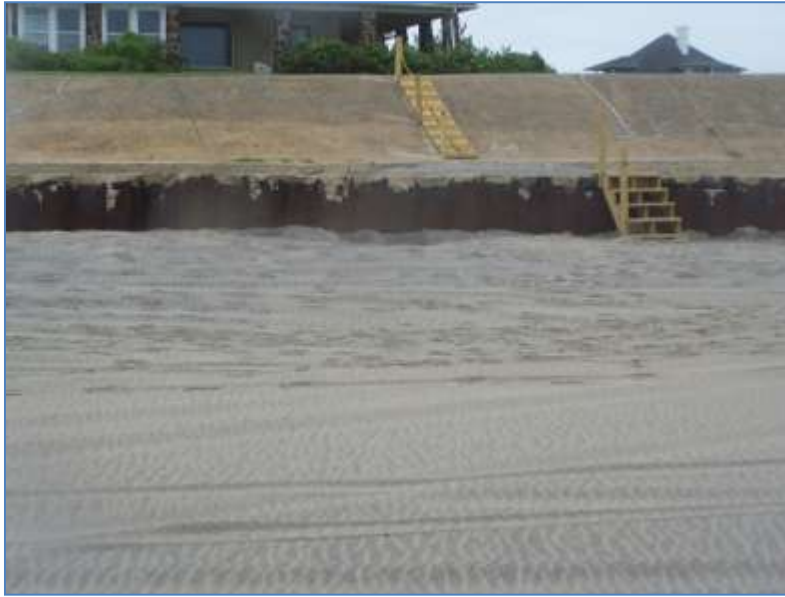
**Figure 6:** Loch Arbour, NJ

**Loch Arbour and Allenhurst:** Site observation visit of Loch Arbour and Allenhurst was conducted on 25 July 2013. As seen in Figures A3 and A4, the seawalls that form the

project reference line were in good condition and should be able to support beach fill placement to the reference line.

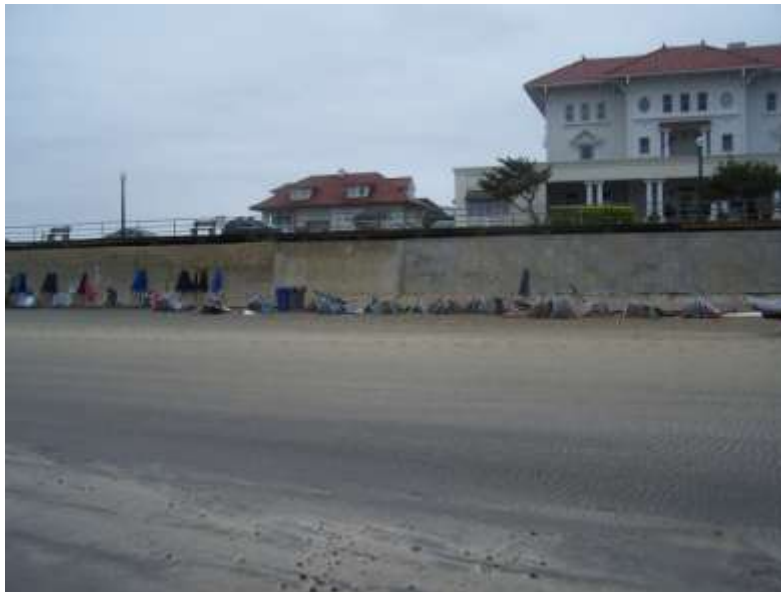
**Figure 7:** Allenhurst, NJ

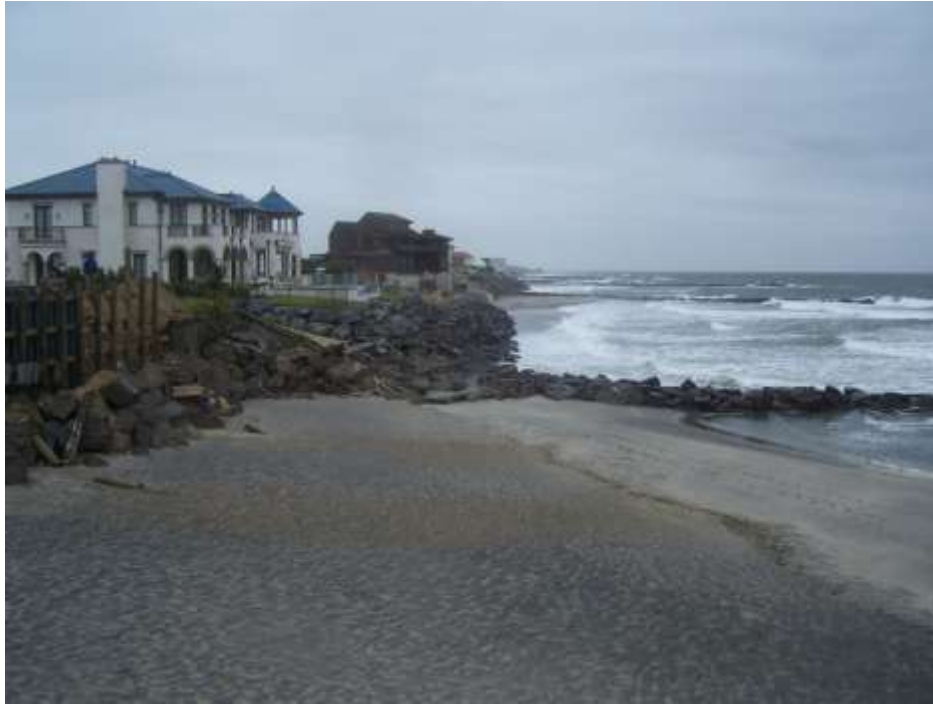
**Figure 8:** Neptune Ave. Deal, NJ

**Deal:** Site observation visit for Deal was conducted on 25 July 2013. Moderate damage to the reference line area was observed, and review of time lapse aerial imagery showed damage to the reference line area that occurred during Hurricane Sandy and had been repaired by the time of the site visit. All existing damage was under repair at the time of the survey.

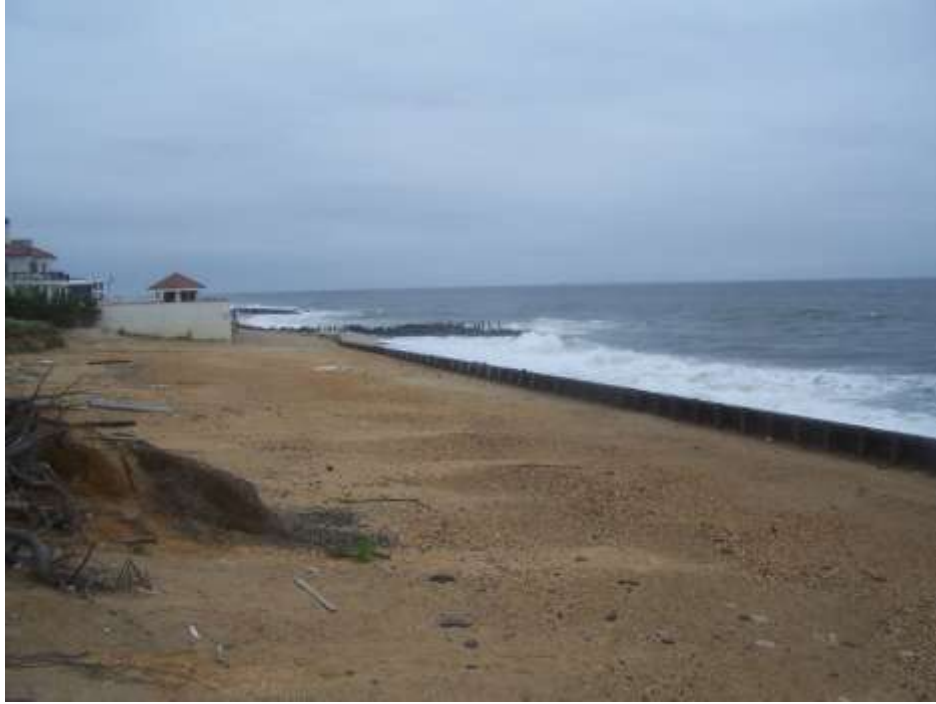
**Figure 9:** Pullman Ave., Elberon, NJ facing north (note elevation of grade landward of bulkhead)

**Elberon:** Site observation visits of Elberon (City of Long Branch) were conducted on 25 July and 6 September 2013. Observations of the reference line area range from good to marginal. The reference line area was marginal in the northern portion Elberon, where wave action from Hurricane Sandy had overtopped the existing wooden bulkhead (which serves as the reference line itself), causing scour and loss of sand. At Pullman Ave., the embankment behind the bulkhead has eroded to the point where first line structures cannot be occupied. At Plaza Court in Elberon, at least one structure is being relocated landward of its original position. Coordination with the City of Long Branch in ongoing with respect to the Corps' concerns about placing beach fill against the bulkhead in its current condition. Small amounts of sand will need to be placed landward of the bulkhead line in areas where the bulkhead has been destroyed or where scouring has occurred to the point where the bulkhead tie backs and dead man have been exposed.

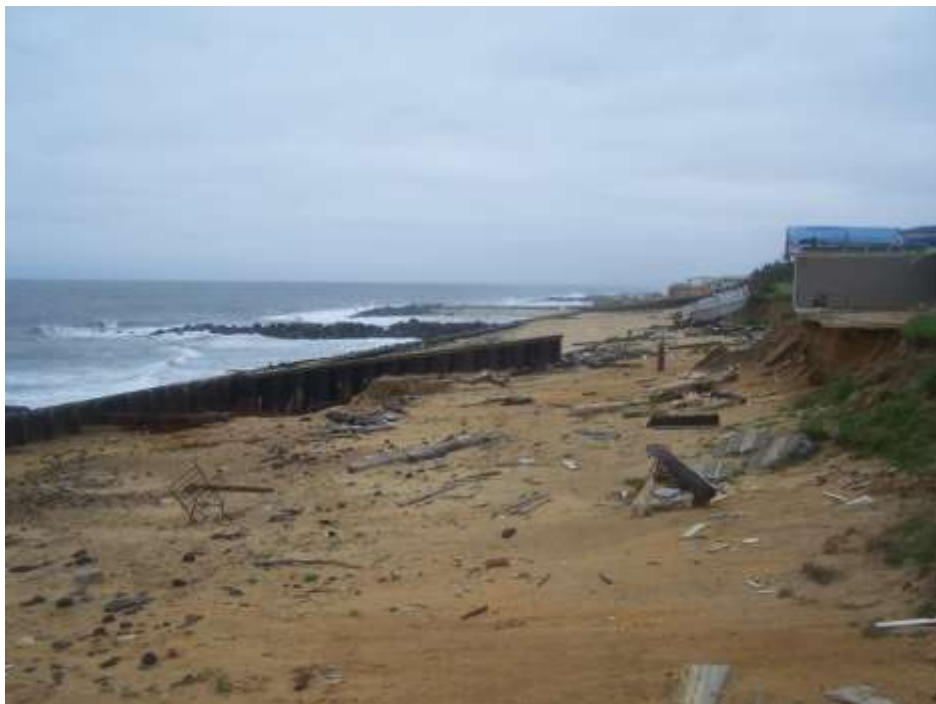
**Figure 10:** Pullman Ave., Elberon, NJ facing south (note loss of sand landward of bulkhead)

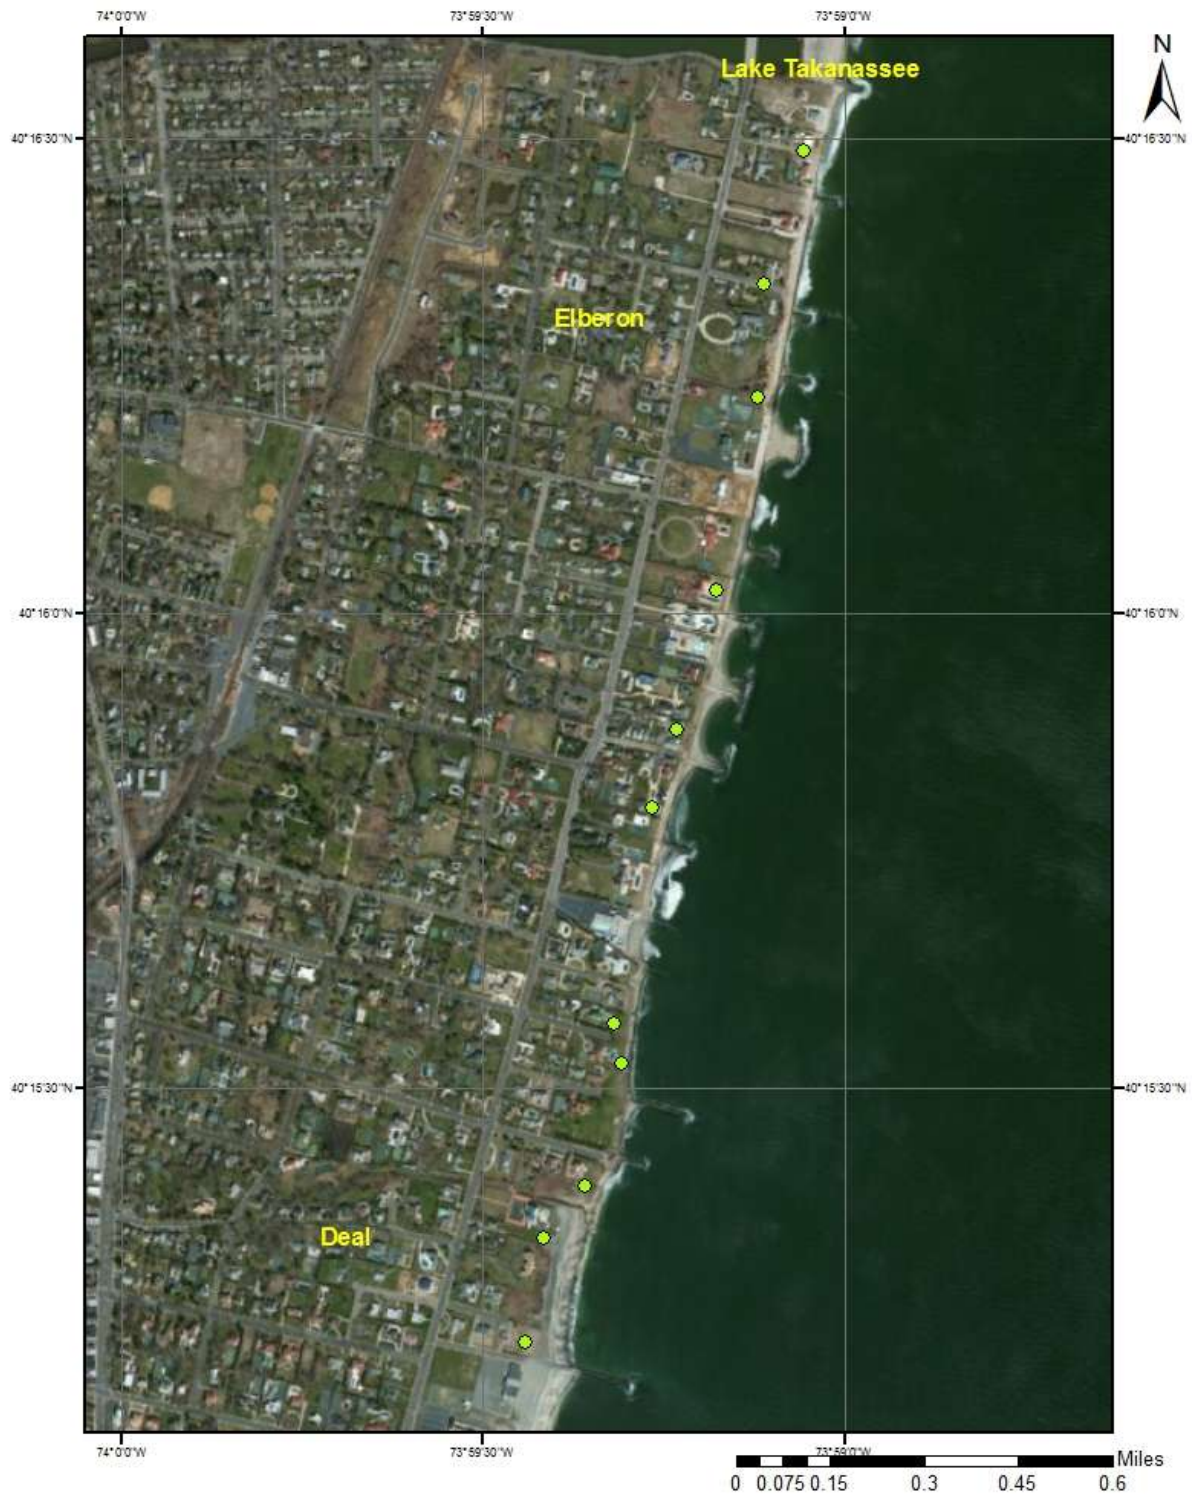
**Figure 11:** Long Range Profile Locations

Beach Profile Surveys: Beach profile surveys of the project area were conducted in March and April 2013. A total of 41 survey profiles were taken for the project area (20 short range profiles and 21 long range profiles).

Survey data from these profiles was imported into InRoads (Bentley software) and then triangulated to develop a three dimensional surface of the existing conditions. A three dimensional surface was also created for the “design” template that included an advance nourishment width of 40’, and using the project reference line as the horizontal alignment. The landward slope of the design fill template was adjusted along the length of the project area to account for existing backshore conditions, and a 1 foot tolerance (to account for constructability concerns) was applied to the template. The triangle volume function of InRoads was then used to determine the cut and fill volumes between the “design” template surface and the “existing conditions” surface. InRoads reports a “cut”, “fill”, and “net” volume difference. Since no reshaping of the existing beach is authorized in order to achieve the design template, only the “fill” volume difference is reported.

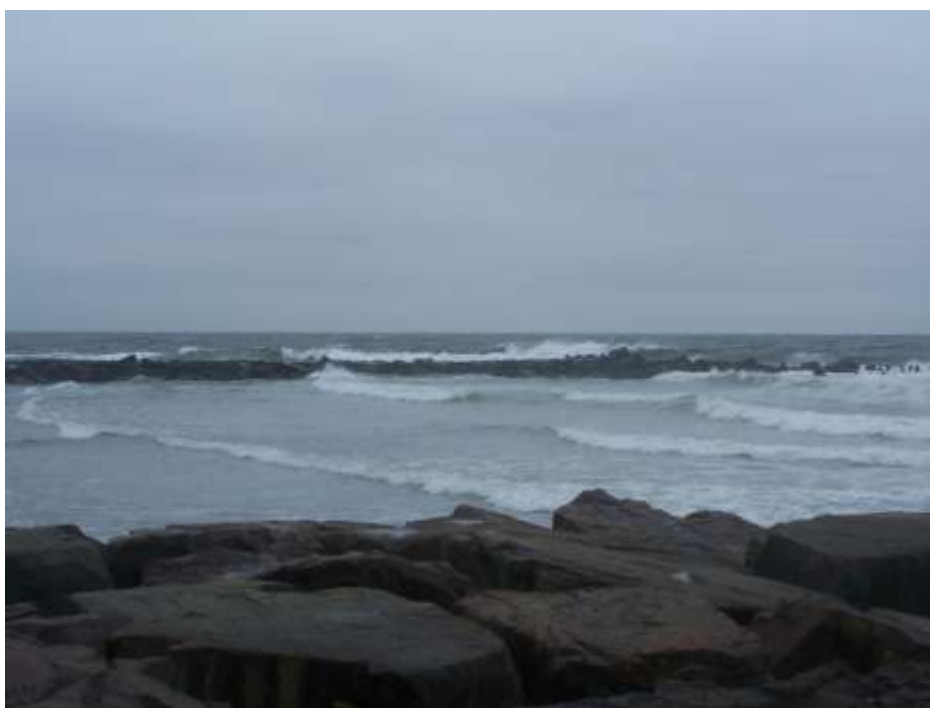
**Figure 15:** Structure 92- Whitehall Street, Deal- Site of Groin Notch #1.

Visual surveys of the groins slated for notching were conducted on 25 July 2013. Five of the six groins were observed to be in good condition, with one groin (Roseld Avenue, Deal) observed to have some degradation in the middle portion of the groin. 25 July 2013 conditions are shown in the below photographs.

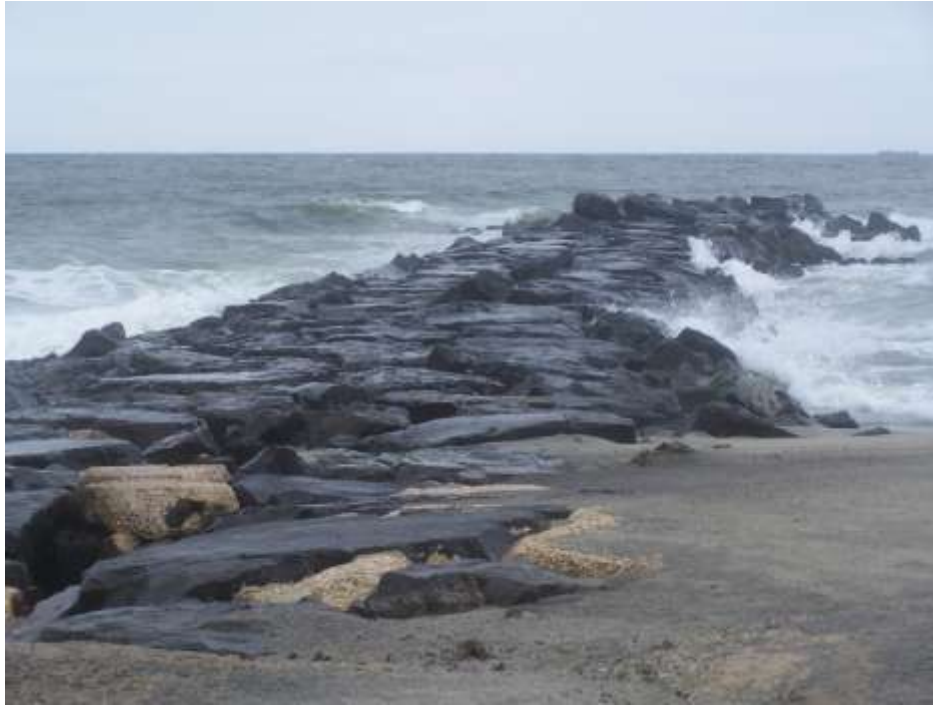
**Figure 16:** Structure 94- Phillips Avenue, Deal- Site of Groin Notch #2

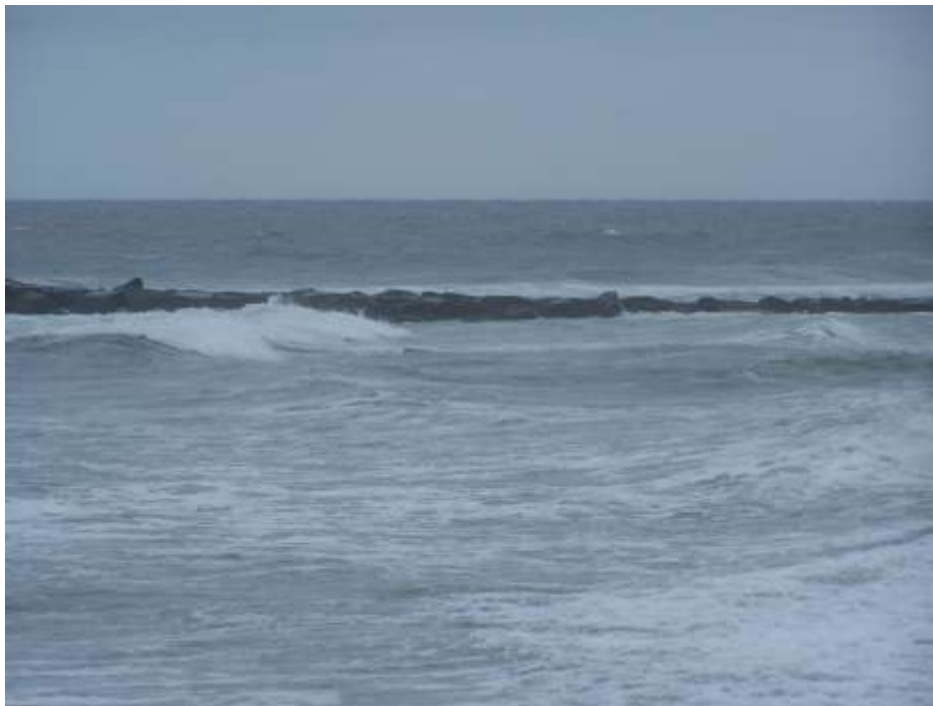
**Figure 17:** Structure 95- Deal Casino, Deal- Site of Groin Notch #3

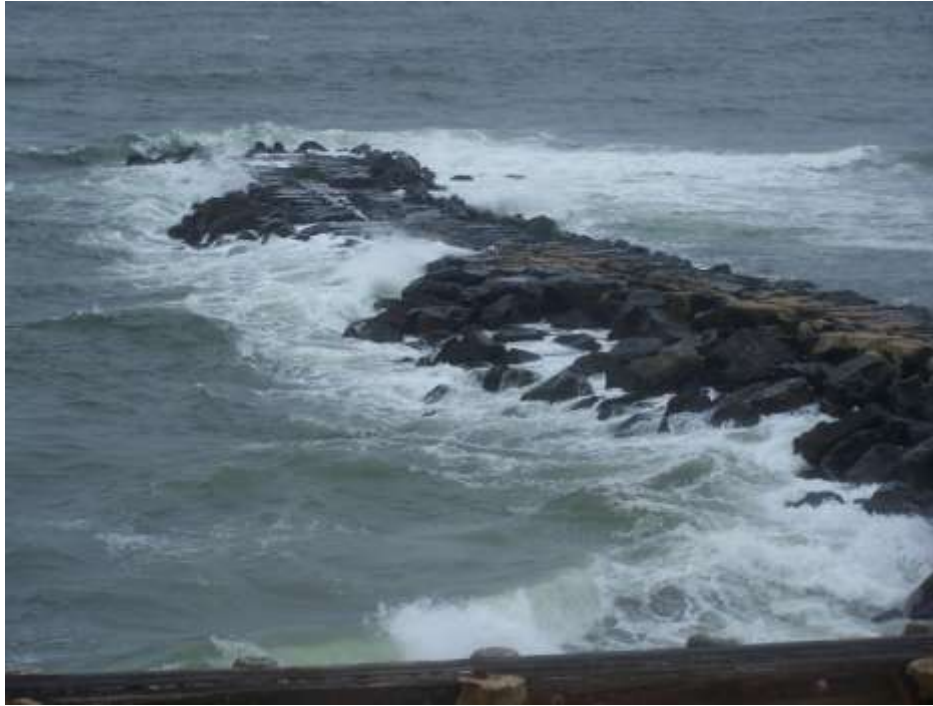
**Figure 18:** Structure 97- Roseld Avenue, Deal- Site of Groin Notch #4 (note degraded conditions in middle)

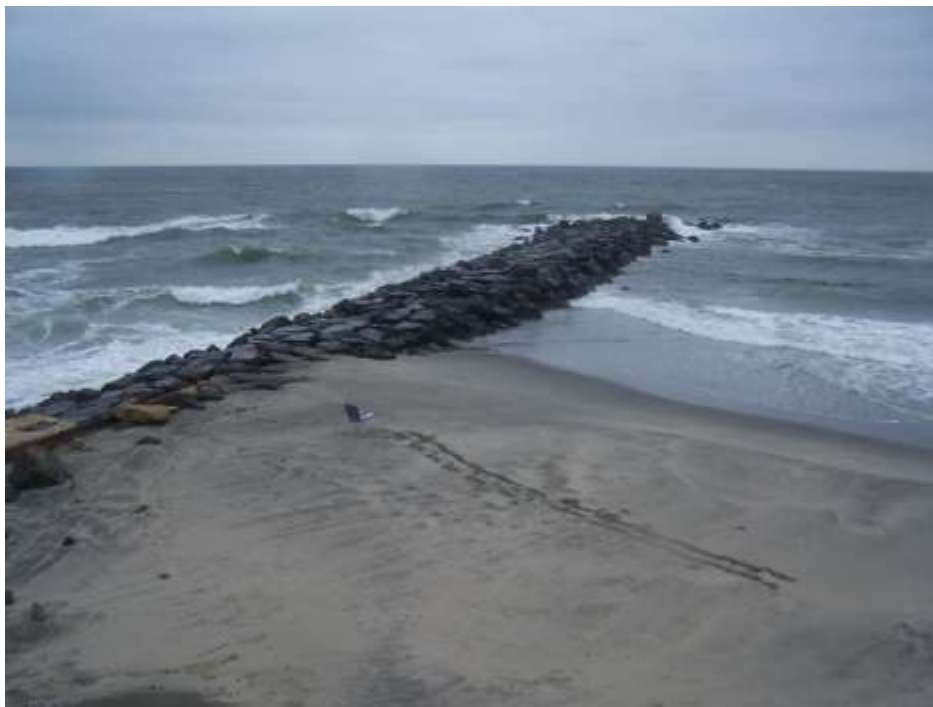
**Figure 19:** Structure 99- Marine Place, Deal- Site of Groin Notch #5; note significant fillet on south (updrift) side of groin

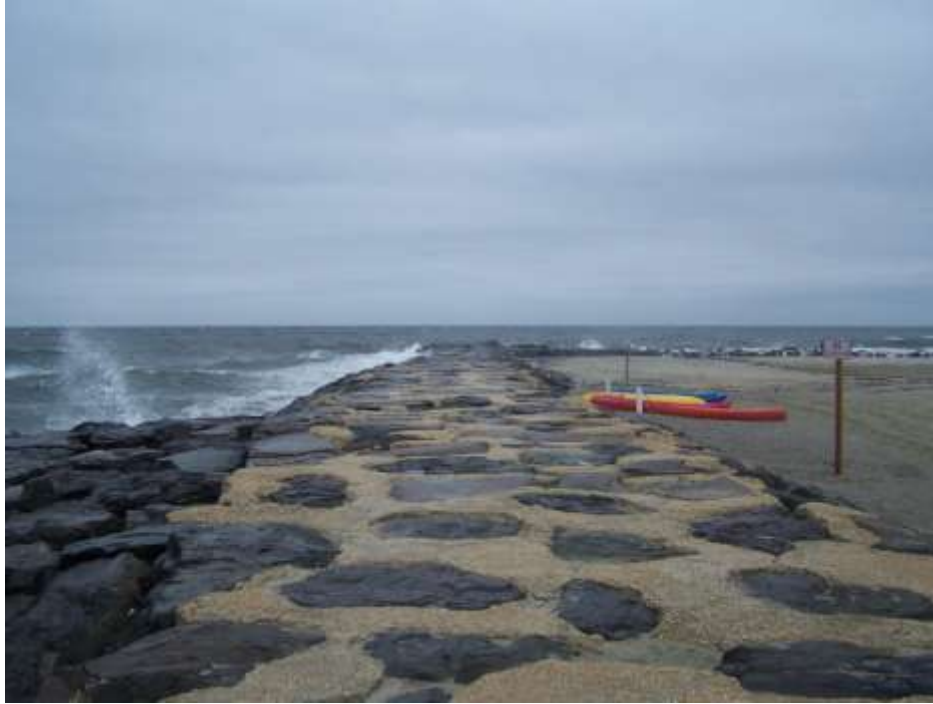
**Figure 20:** Structure 101-Cedar Avenue, Allenhurst- Site of Groin Notch #6
