LIBERTY STATE PARK
JERSEY CITY, HUDSON COUNTY, NEW JERSEY
SUB-SURFACE SOIL CHARACTERIZATION
AUGUST 2003 – FEBRUARY 2004

Project Site Location
 Phase I ESA Liberty State Park
 Army Corps of Engineers, NY District
 Jersey City, New Jersey

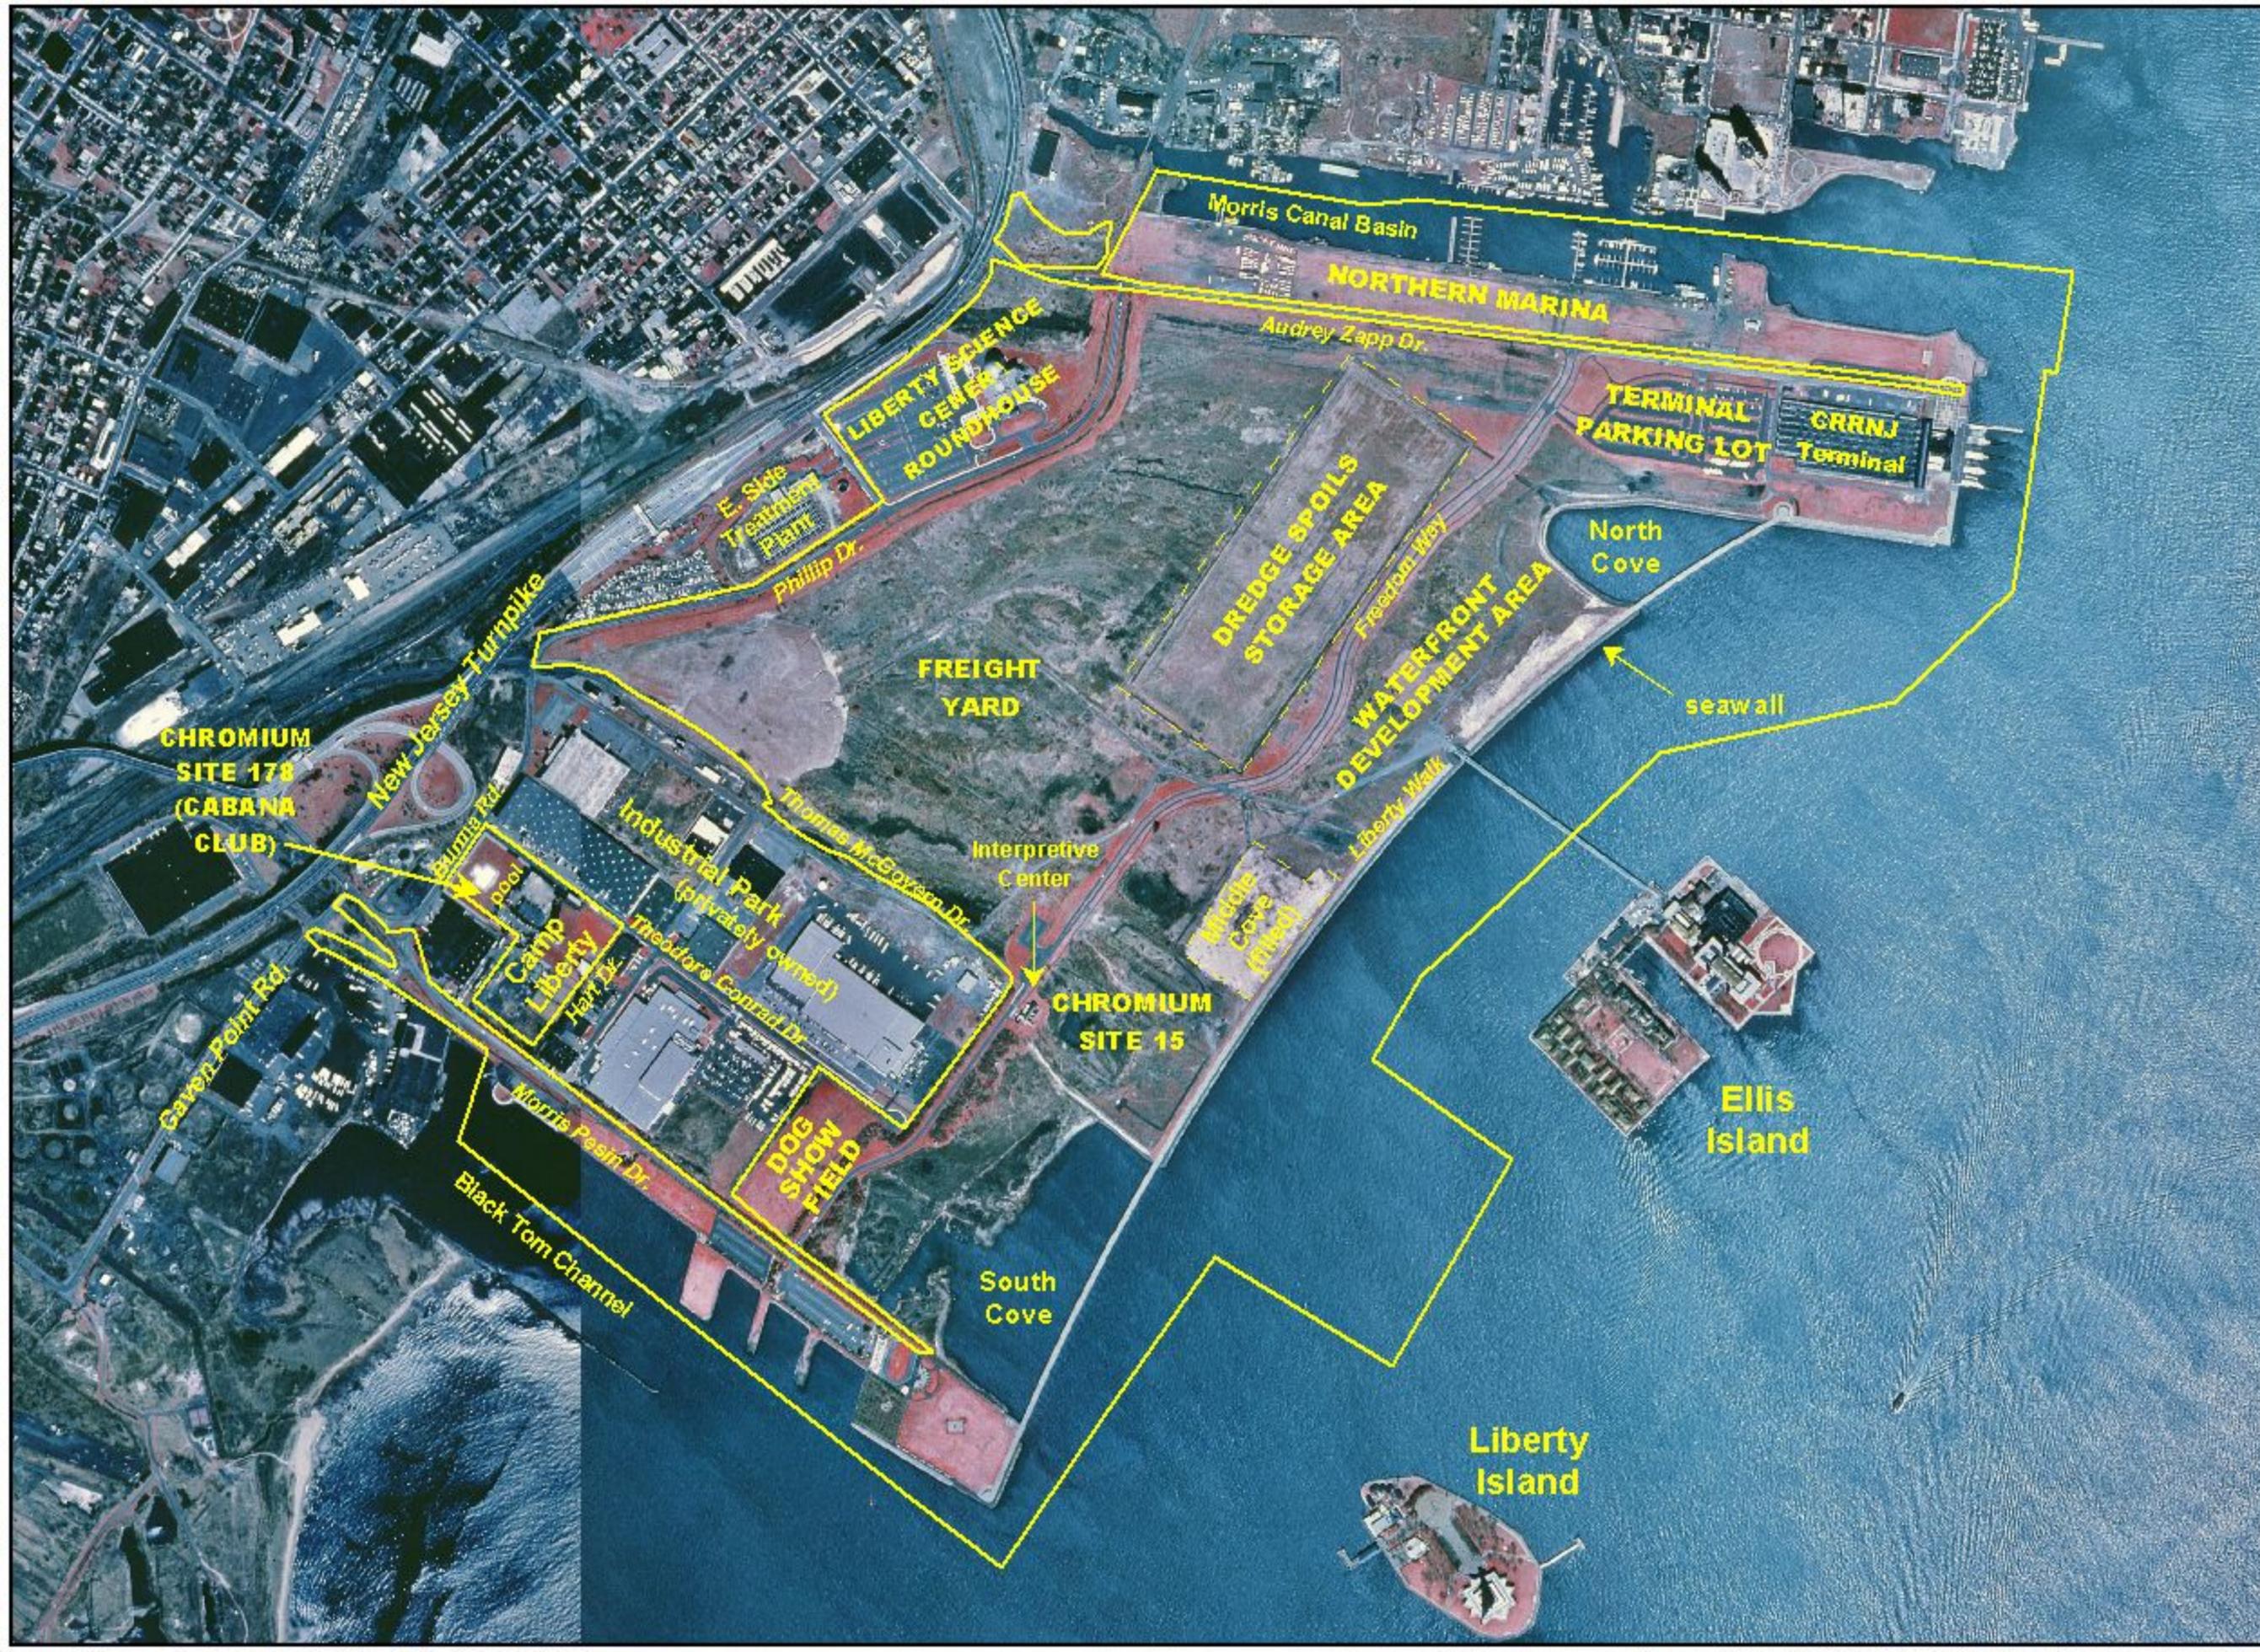
Figure 2
 Project Area Site Plan
 Phase I ESA Liberty State Park
 Army Corps of Engineers, NY District
 Jersey City, New Jersey
