WETLAND DELINEATION REPORT

SOUTH SHORE OF STATEN ISLAND FEASIBILITY STUDY

**STATEN ISLAND,
RICHMOND COUNTY, NEW YORK**

September 2009

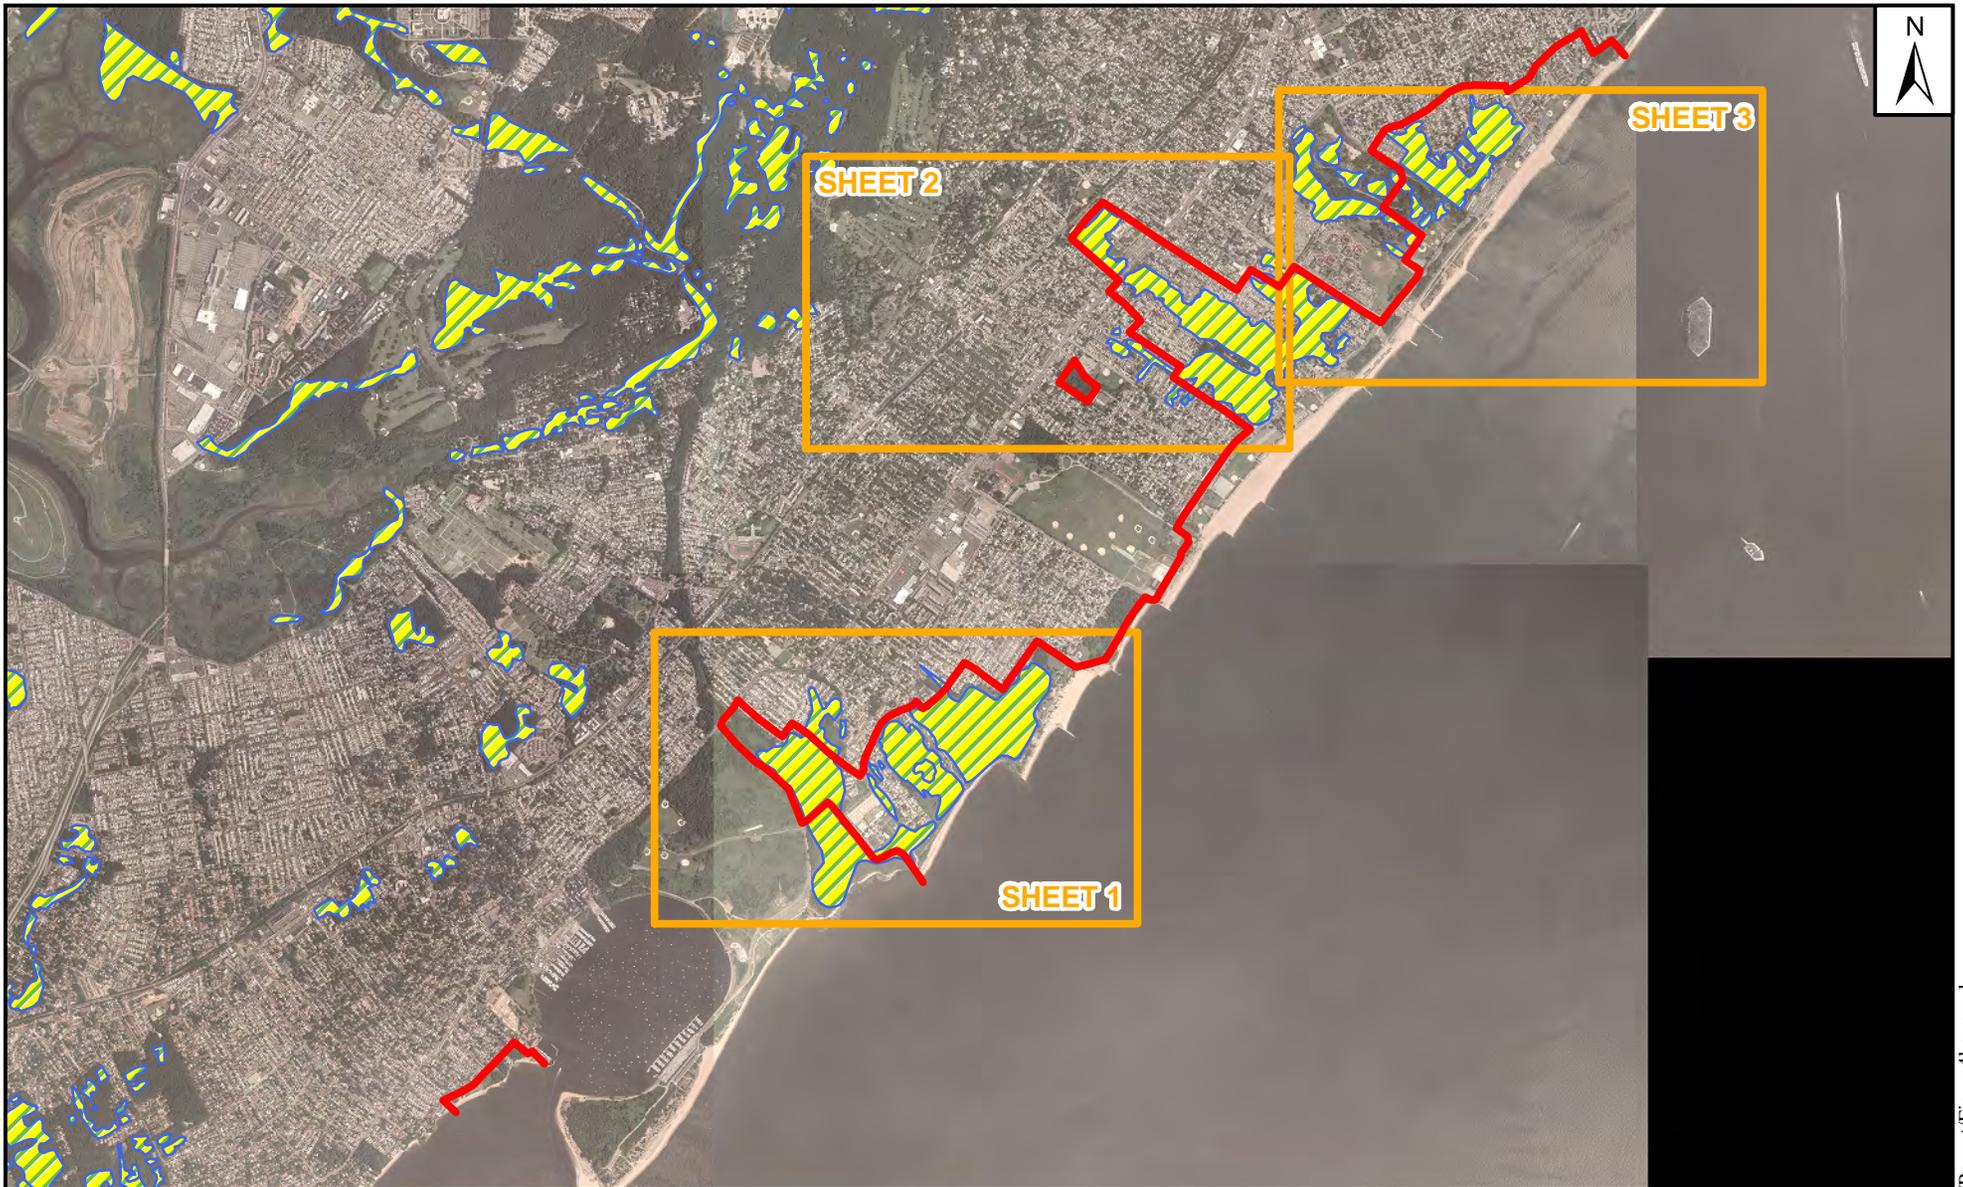
Figure 4 (Sheets 1–3)

Figure 4. NYSDEC Freshwater Wetlands Sheet Boundary Key for South Shore of Staten Island Storm Damage Reduction Feasibility Study, Richmond County, New York.

The NYSDEC Freshwater Wetlands Map (Appendix A, Figure 4, Sheets 1 through 3) identifies a number of state-designated freshwater wetland areas within the Study Area. These wetlands are located in the Oakwood Beach area, the Midland Beach area, and the South Beach area. No state-designated freshwater wetlands were identified within the Crescent Beach survey area.

Although there are numerous, separately mapped areas, the NYSDEC has grouped a number of them together based on their geographic area, and labeled them as four different state-designated wetlands: NA-10, NA-9, NA-8, and NA-7 (Figure 4, sheets 1 through 3). In all, a total of approximately 386 acres of NYSDEC mapped freshwater wetlands are present within the survey area.

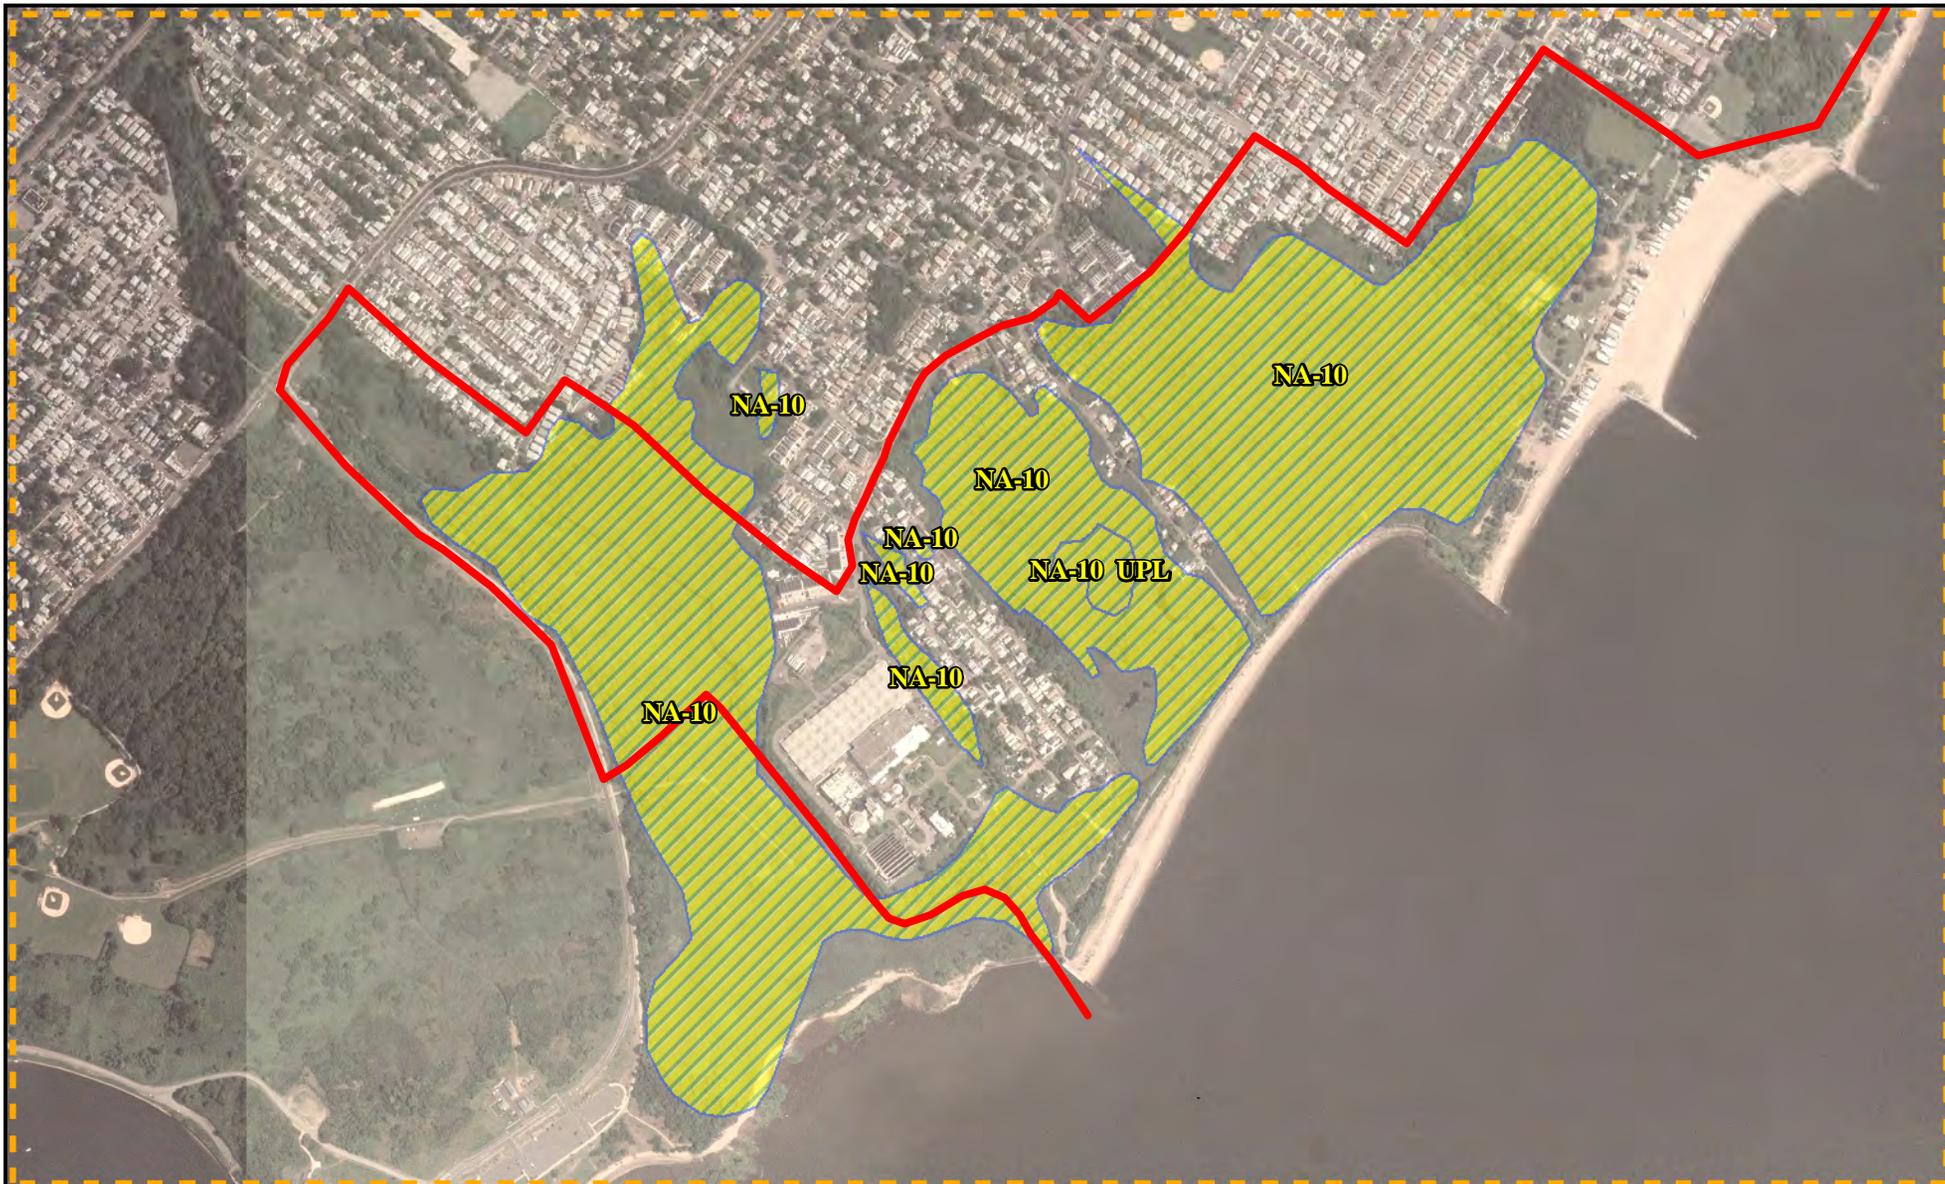
Figure 4. NYSDEC Freshwater Wetlands Location Map for South Shore of Staten Island Storm Damage Reduction Feasibility Study, Richmond County, New York.

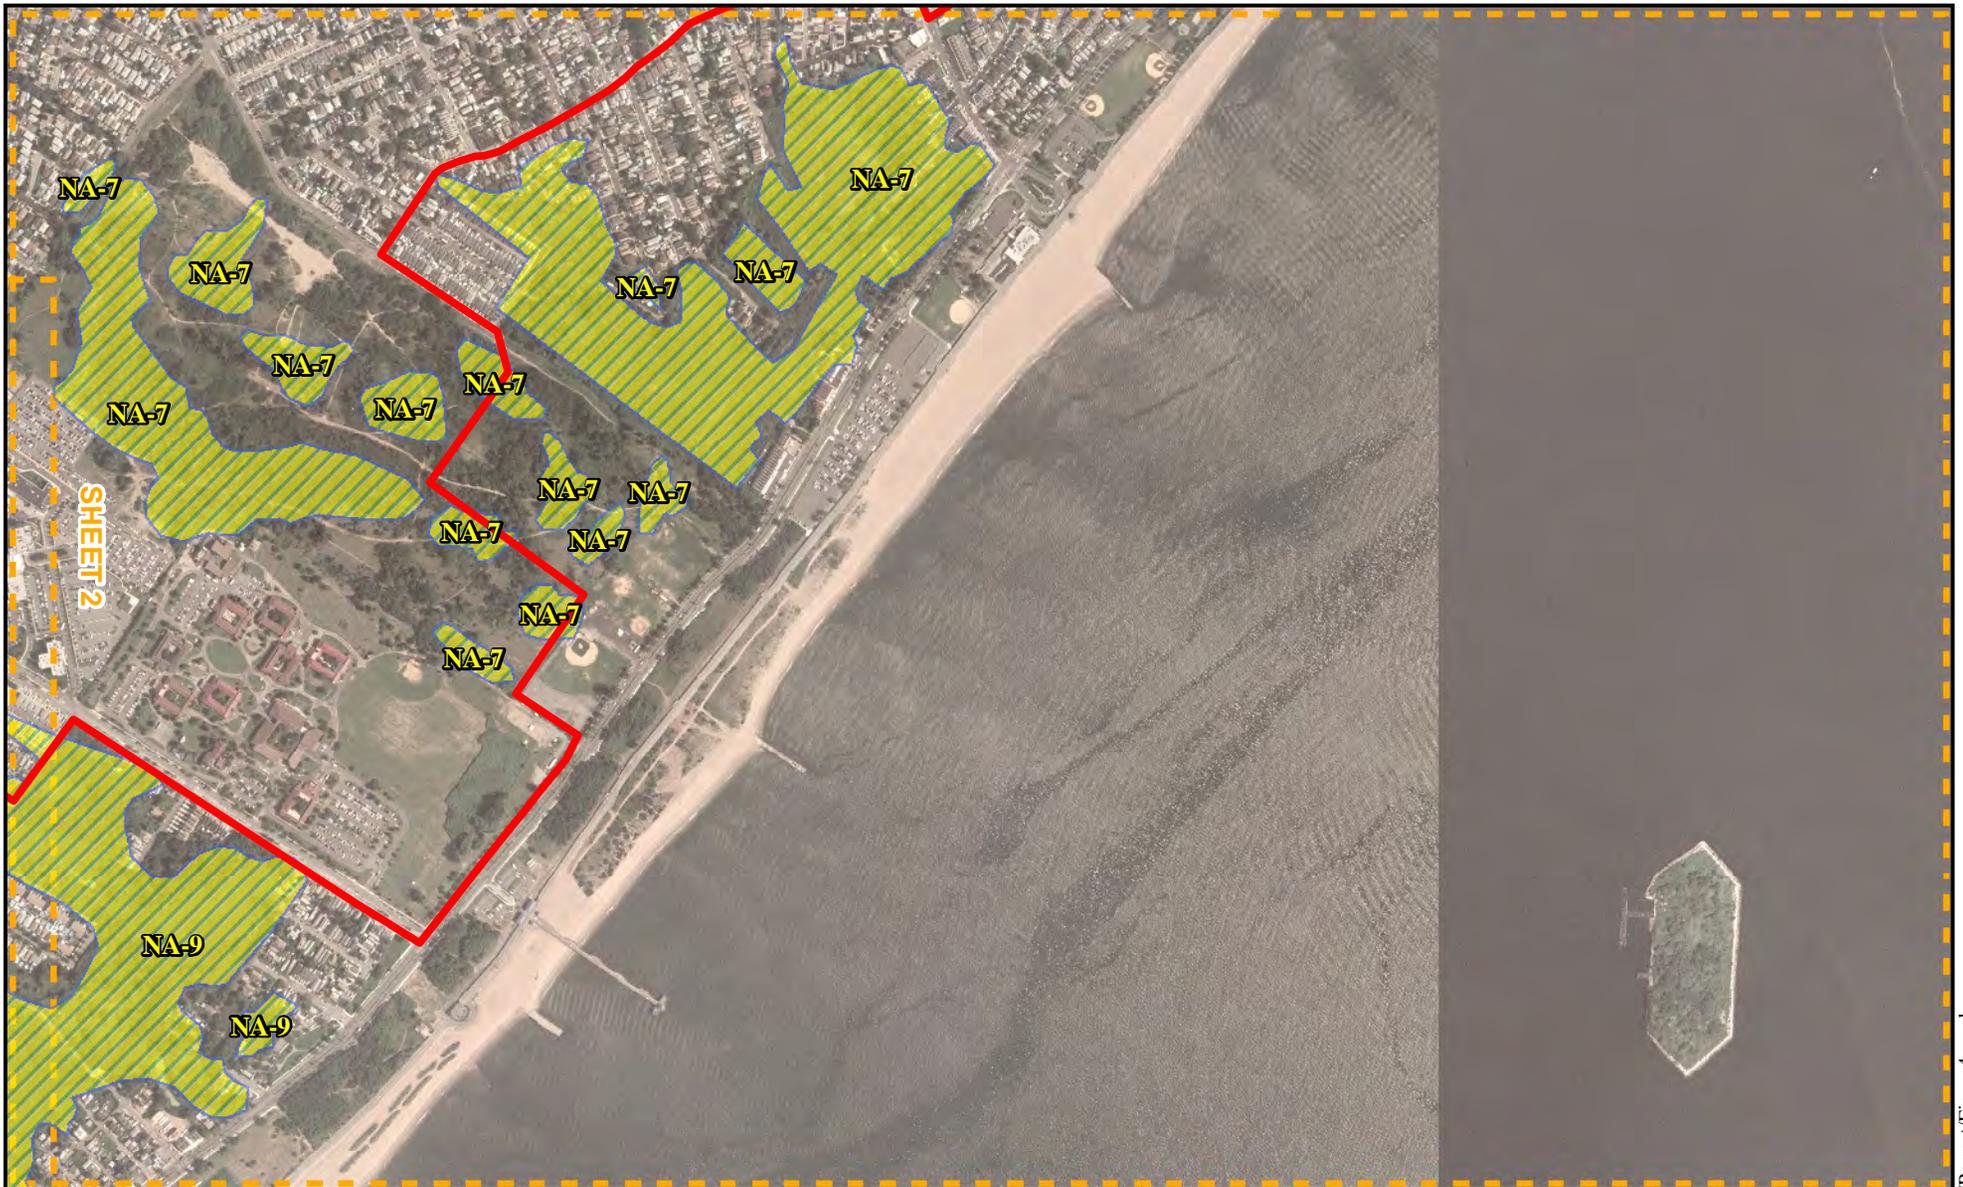
SHEET 2

Figure 4. NYSDEC Freshwater Wetlands Location Map for South Shore of Staten Island Storm Damage Reduction Feasibility Study, Richmond County, New York.

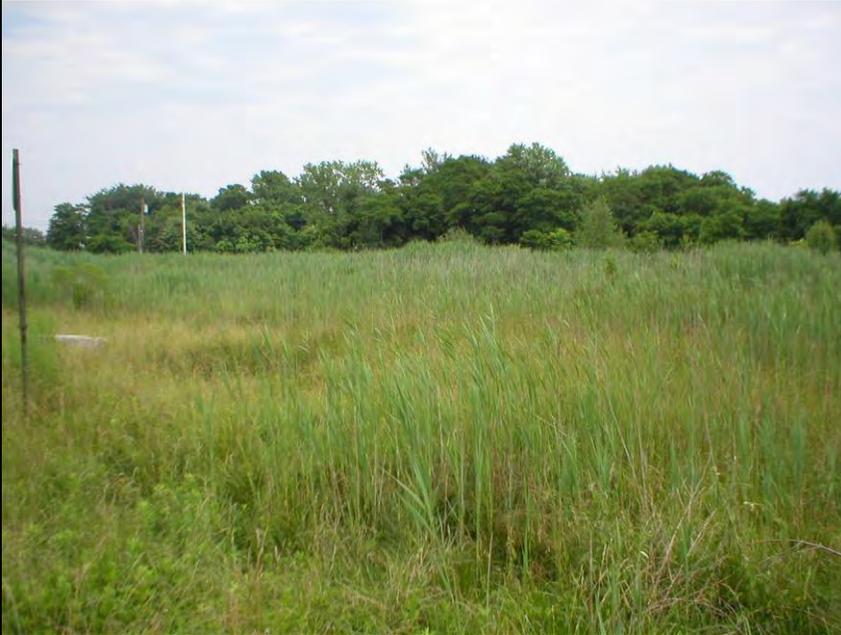
Photographer: Lema
Date: 6/25/09
Photo No.: 1
Direction: West

Comments: Wetland CB1
– Verified in 2009

Wetland CB-1 is a palustrine emergent (PEM5E) community located southeast of the intersection of Tennyson Drive and Glover Street that appears to have been impacted by past fill activities. The herbaceous layer is dominated by common reed (*Phragmites australis*), soft rush (*Juncus effusus*), purple loosestrife (*Lythrum salicaria*), and flat-top fragrant goldenrod (*Euthamia graminifolia*). The composition of hydrophytic plant species exceeds 50% and thereby meets the USACE criterion for wetland vegetation.

Field investigation revealed that the soil in Wetland CB-1 consists of a 3-inch-deep, dark brown (10YR 3/3), sandy loam A horizon. Below this horizon is a 3- to 8-inch-deep, dark grayish brown (10YR 4/2) sandy loam B horizon with large faint yellowish brown (10YR 5/4) mottles. Refusal was met at 8 inches where large stones and gravel were encountered. Hydric soil indicators include the presence of reducing conditions. The primary indicator of wetland hydrology was saturation in the upper 12 inches. A secondary indicator of wetland hydrology included water stained leaves. A portion of this wetland is identified on NWI maps. Wetland CB-1 is not identified on NYSDEC wetland maps.

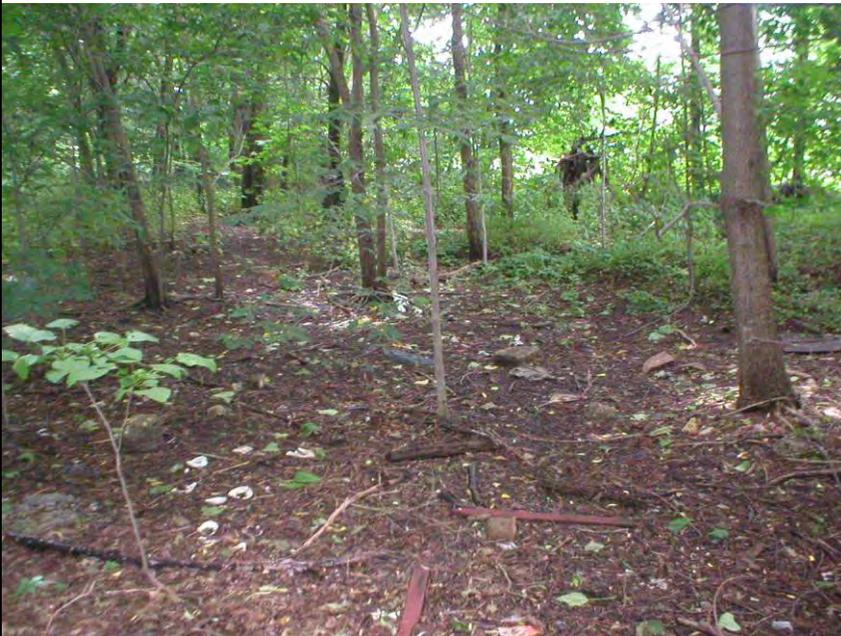
Photographer: Lema
Date: 6/29/09
Photo No.: 2
Direction: East

Comments: Wetland CB2
– Verified in 2009. This portion of the wetland extends into the adjacent forest. The common reed-dominated community is behind the photographer.

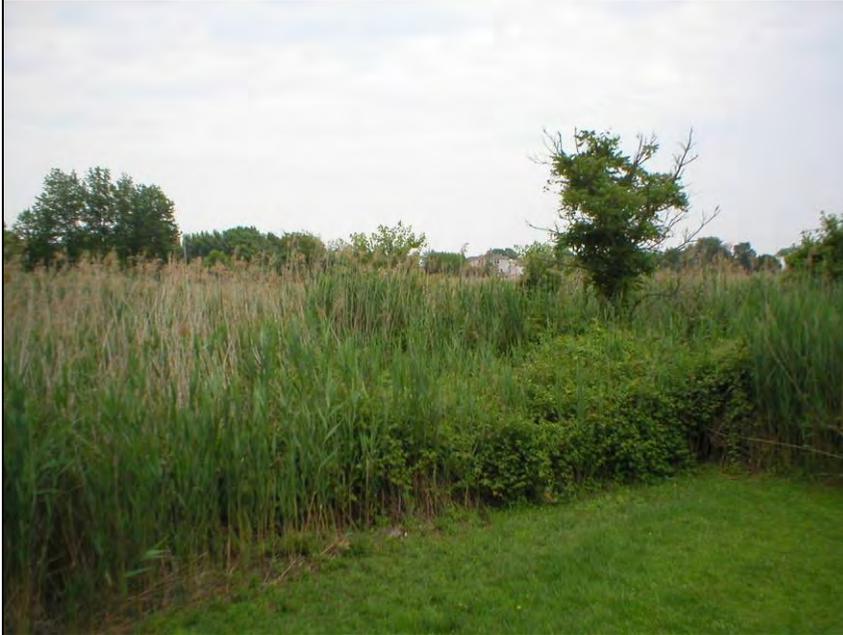
Photographer: Lema
Date: 6/26/09
Photo No.: 3
Direction: East

Comments: Wetland A-1 /W11 – Upland development is visible in the background.

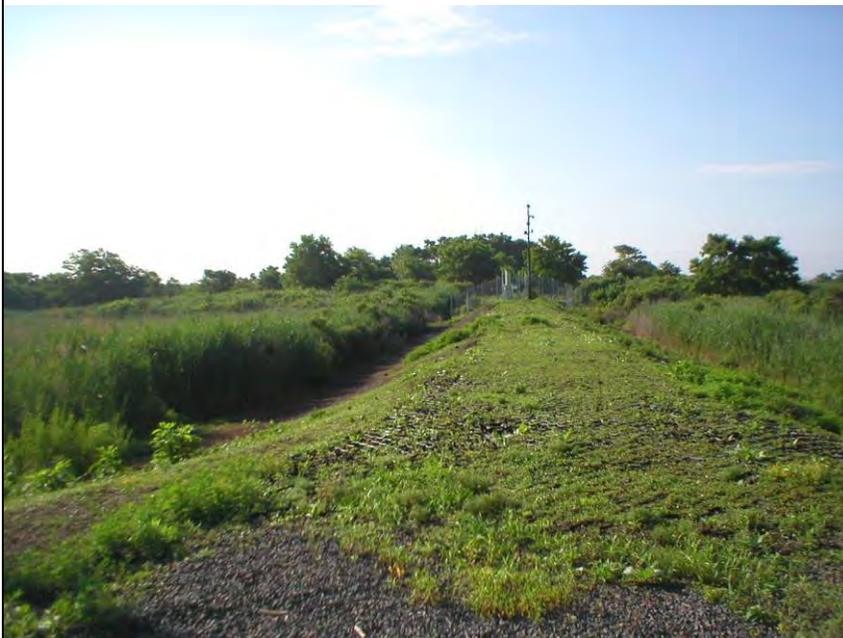
Photographer: Lema
Date: 6/26/09
Photo No.: 4
Direction: Southeast

Comments: Wetland A-1/ W11 – boundary verified in 2009. Picture shows a levee and tide gate on southeast portion of wetland.

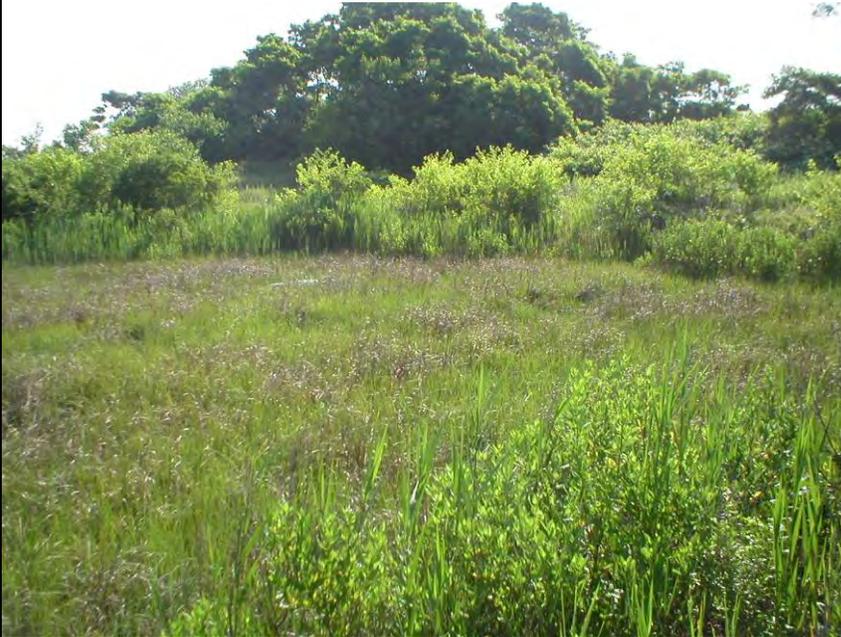
Photographer: Lema
Date: 6/26/09
Photo No.: 5
Direction:

Comments: Wetland A-1 /W11 – verified and extended in 2009 to meet the coastline

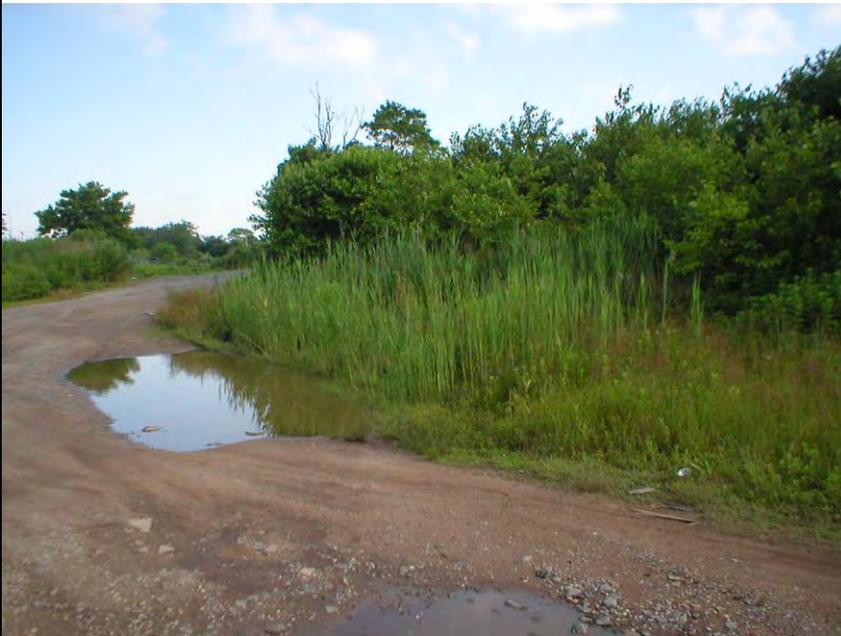
Photographer: Lema
Date: 6/26/09
Photo No.: 6
Direction:

Field investigation revealed that the soil in Wetland A-2 consists of a 12⁺-inch deep black (10YR 1/1), sandy loam B horizon with many distinct red (2.5YR 5/8) and many distinct gray (10YR 6/1) mottles. Hydric soil indicators observed present evidence of reducing conditions. Primary indicators of wetland hydrology include inundation and saturated soils in the upper 12 inches. Secondary indicators including oxidized root channels in the upper 12 inches of the soil horizon. A portion of this wetland is identified on NWI maps.

Comments: Wetland A-2 – verified in 2009, small isolated wetland.

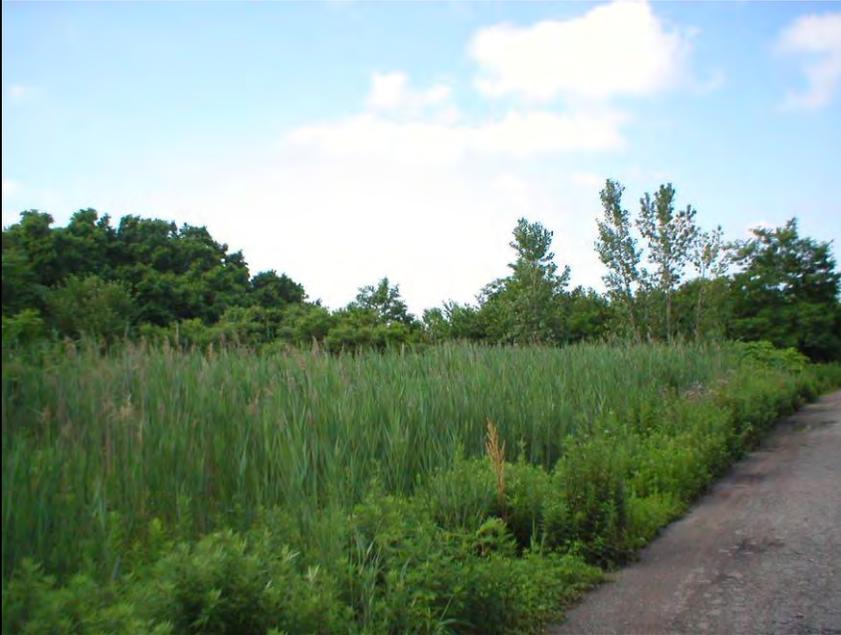
Photographer: Lema
Date: 6/29/09
Photo No.: 7
Direction:

Comments: Wetland A-3 –
verified in 2009. Separated
from WA-1 by the road
(lower right)

Field investigation revealed that the soil in Wetland A-3 consists of a 3-inch-deep, black (7.5YR 2.5/1), sandy loam A horizon. Below this horizon is a very dark grayish brown (10YR 3/2), sand B horizon with many faint pale brown (10YR 6/3) and few distinct yellowish red (5YR 4/6) mottles that extends beyond 12 inches. Hydric soil indicators observed present evidence of reducing conditions. Secondary indicators of wetland hydrology include oxidized root channels in the upper 12 inches of the soil horizon and water-stained leaves. A portion of this wetland is identified on NWI and NYSDEC wetland maps.

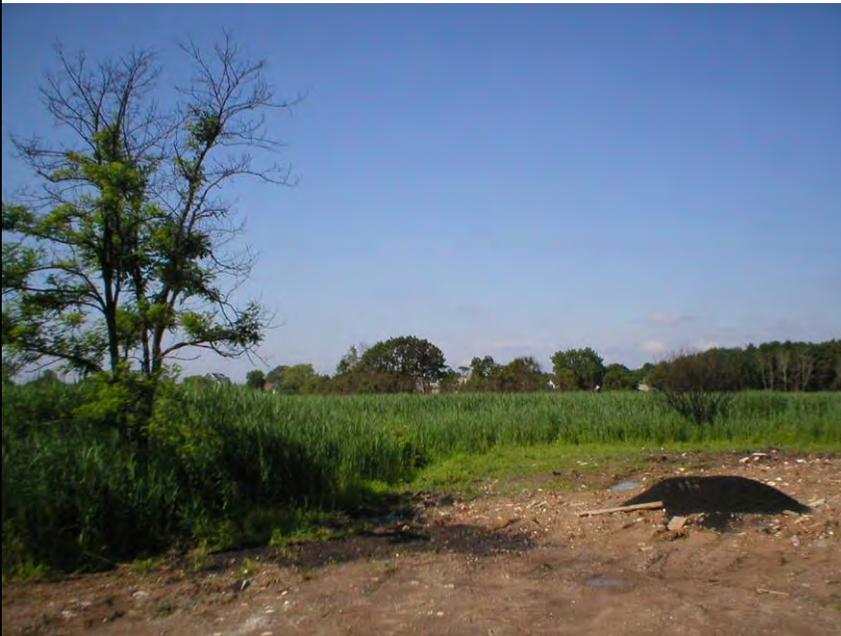
Photographer: Lema
Date: 6/29/09
Photo No.: 8
Direction:

Field investigation revealed that the soil in Wetland A-4 consists of a 0.5-inch-deep, black (10YR 2/1), loamy sand A horizon. Below this horizon is a black (2.5Y 2.5/1), loamy sand B horizon with many distinct red (2.5YR 4/7) and few distinct red (2.5YR 5/8) mottles that extends beyond 12 inches. Hydric soil indicators observed present evidence of reducing conditions. Primary indicators of wetland hydrology include inundation and saturated soils in the upper 12

Comments: Wetland A-4 –
verified in 2009. Typical
large common reed
dominated emergent
wetland.

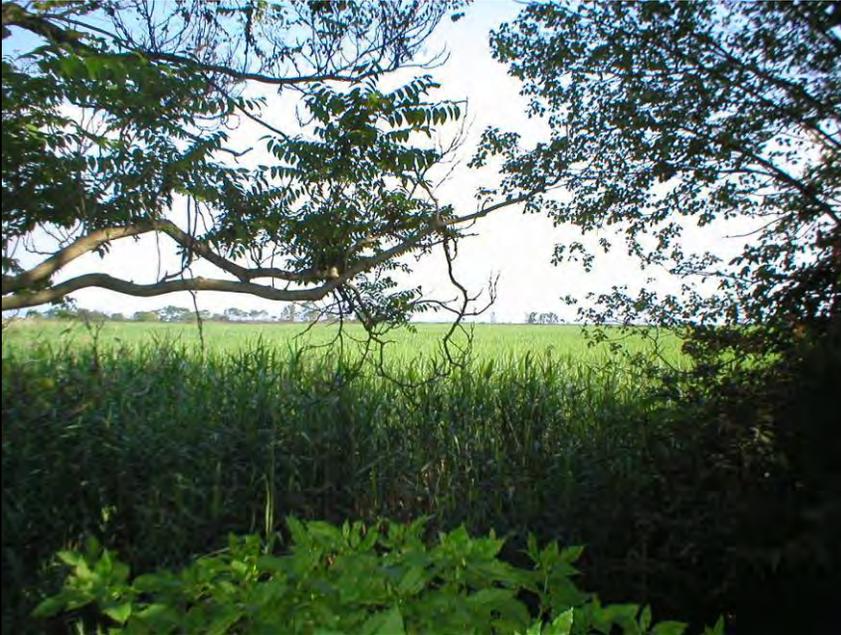
Photographer: Lema
Date: 7/01/09
Photo No.: 9
Direction: Southeast

Comments: Wetland W13 /A5 – Extensive wetland continues to the trees visible on the horizon.

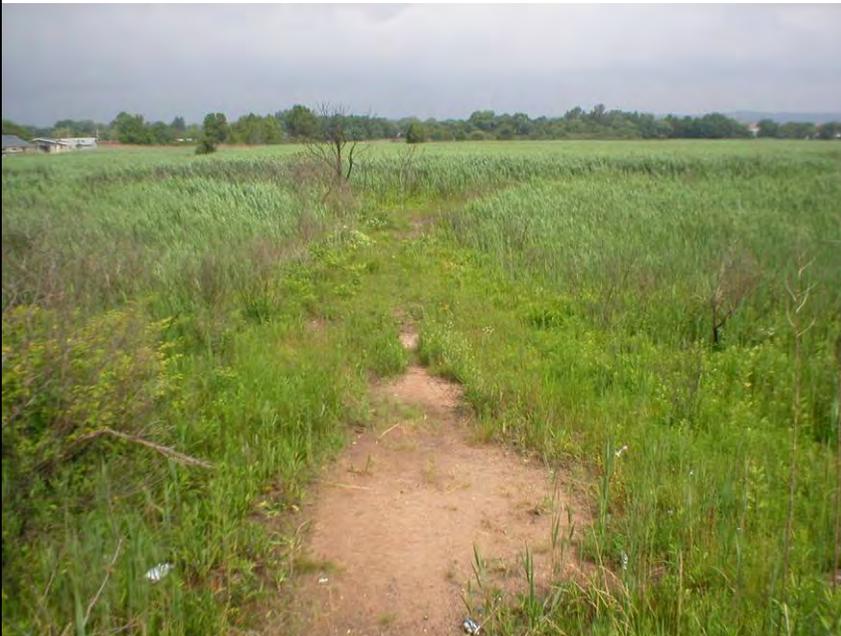
Photographer: Lema
Date: 7/02/09
Photo No.: 10
Direction: Northwest

Comments: Wetland W13 /A5 – The foreground appears to be an abandoned (upland) road into the wetland.

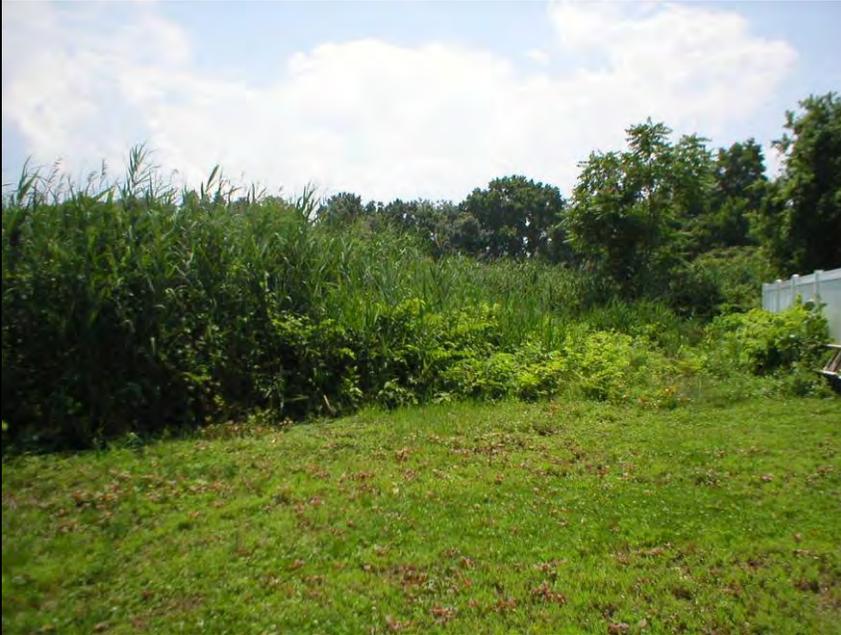
Photographer: Lema
Date: 7/02/09
Photo No.: 11
Direction: South

Comments: Wetland W15—
Foreground is filled and a
maintained residential lawn
community.

Wetland W15 is a large estuarine emergent wetland (E2EM5P) that is in close proximity to wetland W13. It is bordered to the north by Roma Avenue and residential development, while the other boundaries are formed by dense upland scrub-shrub and forest vegetation such as tree of heaven, Japanese knotweed, multiflora rose, and black locust. The vegetation within the wetland is dominated by common reed, with a low density of jewelweed and frost grape around the exterior edges. The composition of hydrophytic plant species in this wetland exceeds 50% and thereby meets USACE criteria for wetland vegetation.

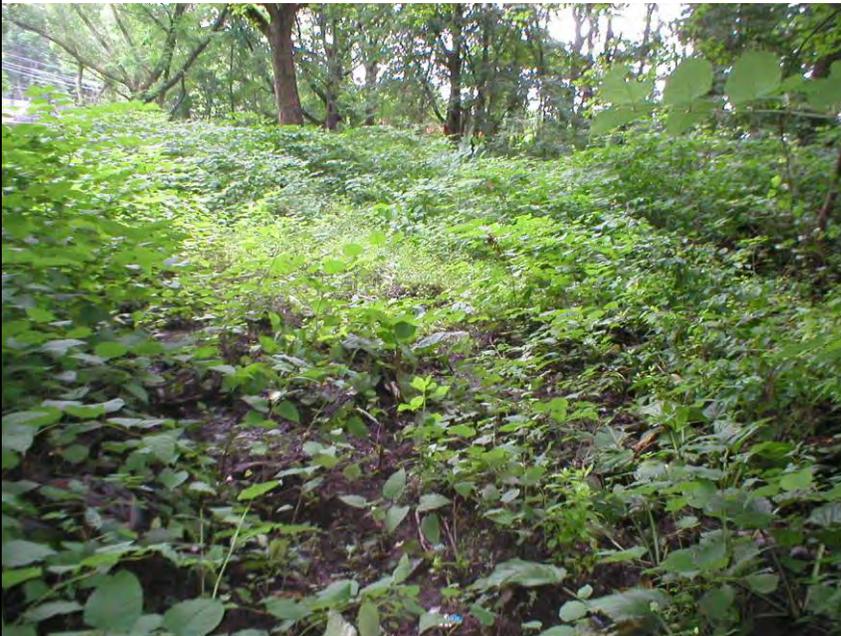
Photographer: Lema
Date: 7/01/09
Photo No.: 12
Direction: East

Comments: Wetland W14—
Entire area appears to be a
depository for fill, the
wetland is composed of
many swales and tire ruts.

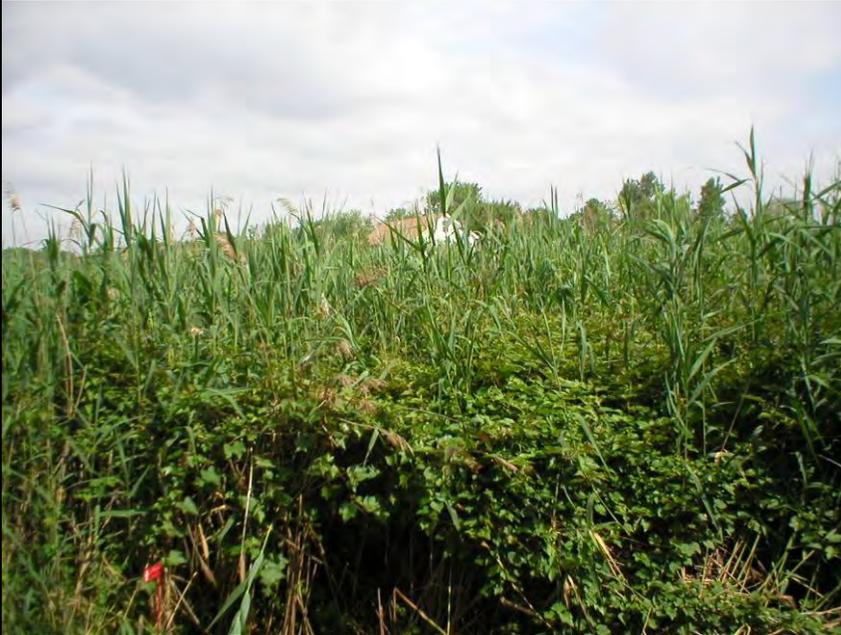
Photographer: Lema
Date: 6/25/09
Photo No.: 13
Direction: Southeast

Comments: Wetland W7 – Upland areas surrounding wetland are composed solely of fill material.

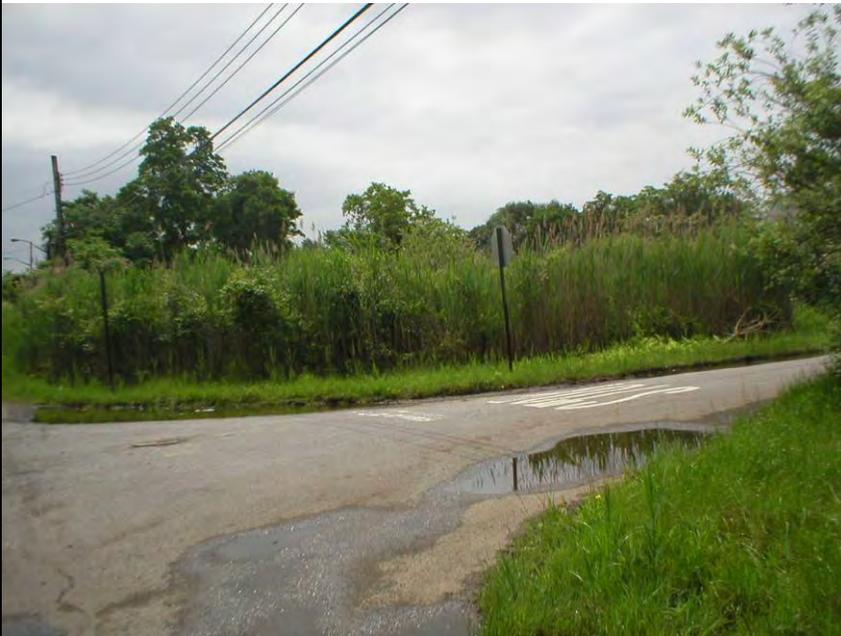
Photographer: Lema
Date: 6/25/09
Photo No.: 14
Direction: South

Comments: Wetland W8 – Separated from W7 by Patterson Ave.

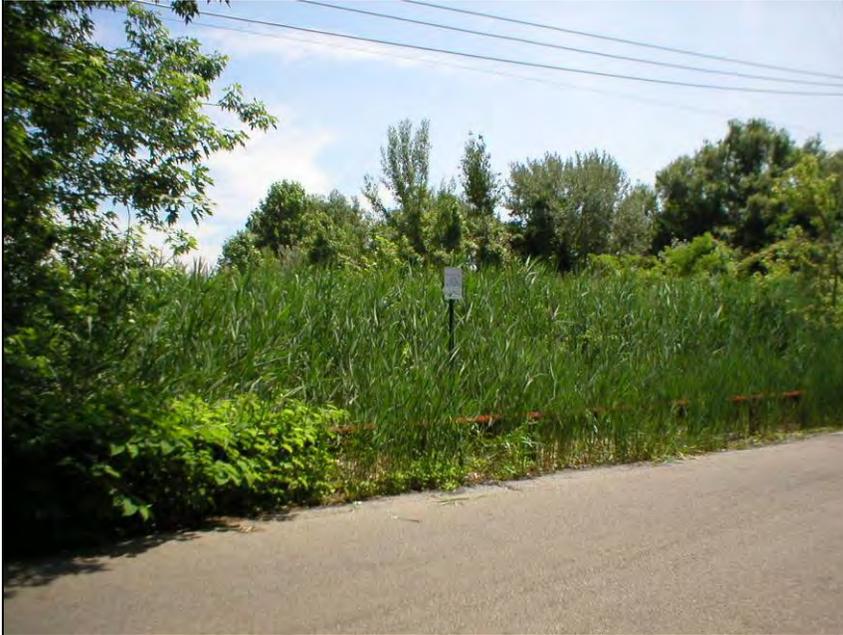
Photographer: Lema
Date: 6/25/09
Photo No.: 15
Direction: North

Wetland W9 is a palustrine emergent wetland (PEM5E) with a palustrine scrub-shrub (PSS1E) component bordered by Olympia Boulevard and Freeborn Street, and hydrologically connected to wetlands W7 and W10 via culverts. The emergent component is entirely dominated by common reed, with the scrub-shrub community consisting of frost grape, spicebush (*Lindera benzoin*), and poison ivy. The hydrophyte composition within both community types exceeds 50% and therefore meets USACE criteria for wetland vegetation.

The primary indicators of hydrology in the wetland were inundation and drift lines. Standing water was observed within 3 feet of Olympia Boulevard. This wetland is clearly visible in aerial photographs and is identified on NWI and NYSDEC wetland maps.

Comments: Wetland W9 – Separated from W7 by Olympia Blvd., and from W10 by Freeborn St.

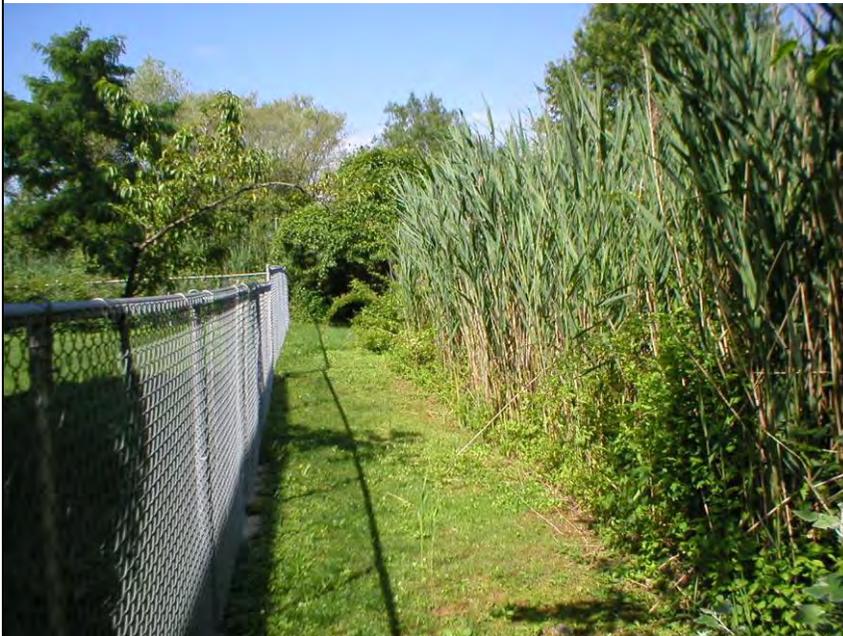
Photographer: Lema
Date: 6/25/09
Photo No.: 16
Direction: Northeast

Comments: Wetland W10– Photo shows upland (filled) residential yard on the left.

Wetland W10 is a large palustrine emergent (PEM5E) wetland between Freeborn Street and Nugent Avenue. This wetland is the northmost wetland surveyed along the stream/drainage channel that provides the hydrology for wetlands W9, W8, W7, and WC-1. The boundary between upland and wetland is obvious, having been filled for road construction and residential development. The dominant species within the emergent community is common reed, with a low density of frost grape along the exterior edges. The composition of hydrophytic species in this wetland exceeds 50% and therefore meets USACE criteria for wetland vegetation.

The primary indicators of wetland hydrology observed included inundation, soil saturation, and drift lines. This wetland is clearly visible in aerial photographs and is identified on NWI and NYSDEC wetland maps.

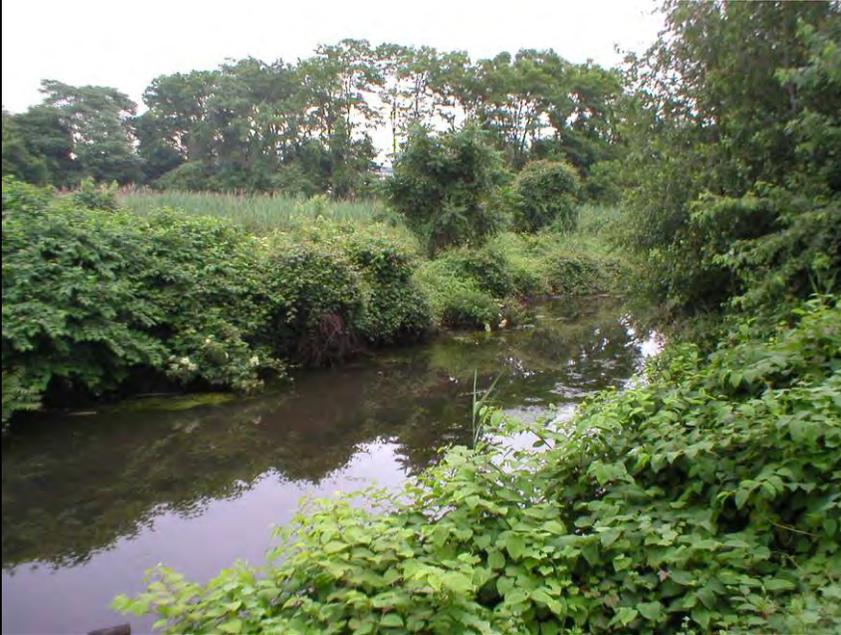
Photographer: Lema
Date: 6/25/09
Photo No.: 17
Direction:

Comments: Stream running through the greater wetland, WC-1 – verified in 2009.

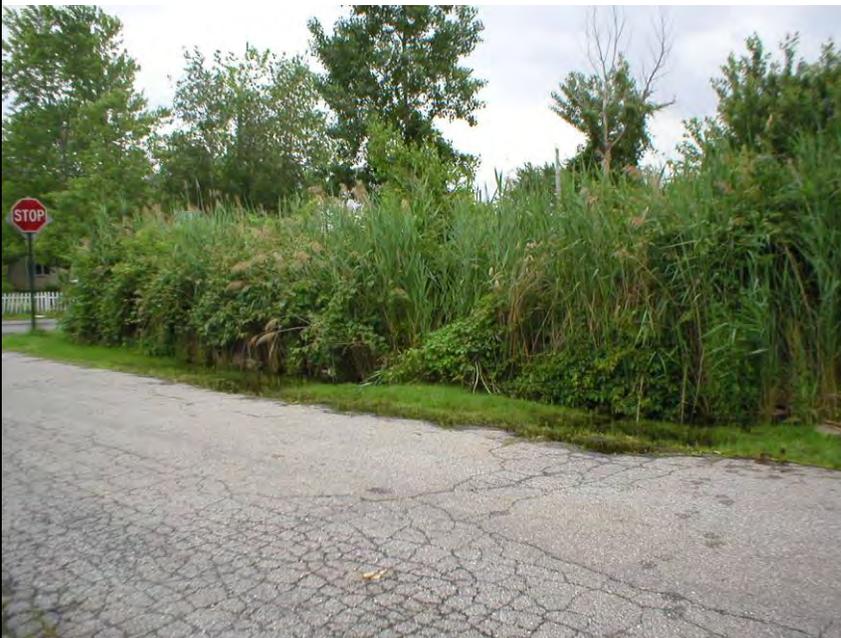
Photographer: Lema
Date: 6/24/09
Photo No.: 18
Direction: West

Comments: Wetland W5 – All areas surrounding this wetland are filled residential sites.

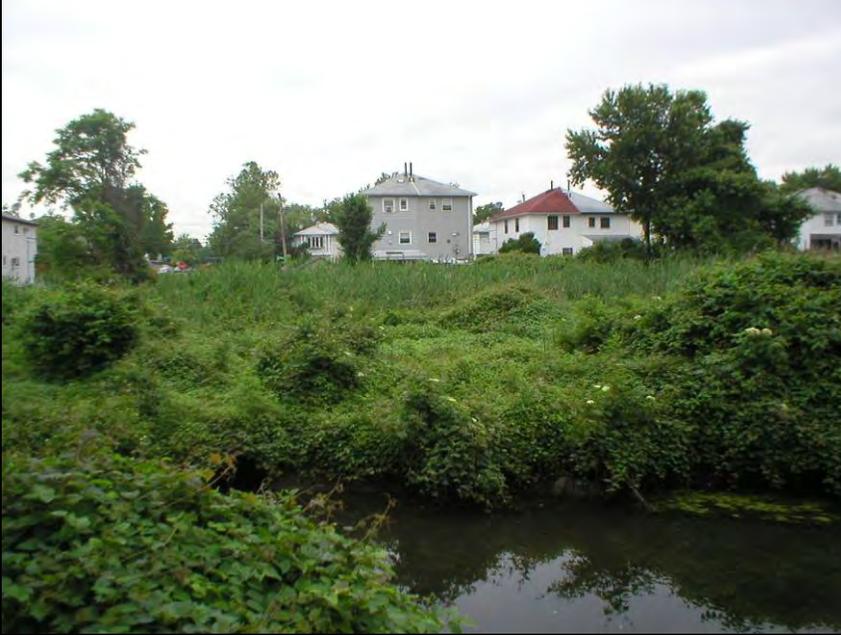
Photographer: Lema
Date: 6/24/09
Photo No.: 19
Direction: Southwest

Comments: Stream through Wetland W3. Note the extremely dense vegetation surrounding the stream.

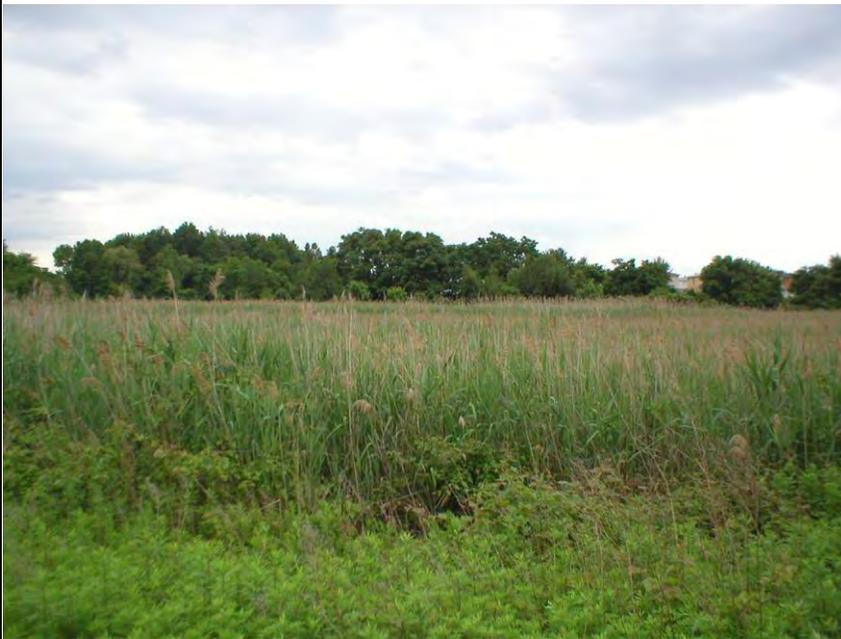
Photographer: Lema
Date: 6/24/09
Photo No.: 20
Direction:

Comments: Wetland W3 – Trees in the background are the opposite edge of the wetland.

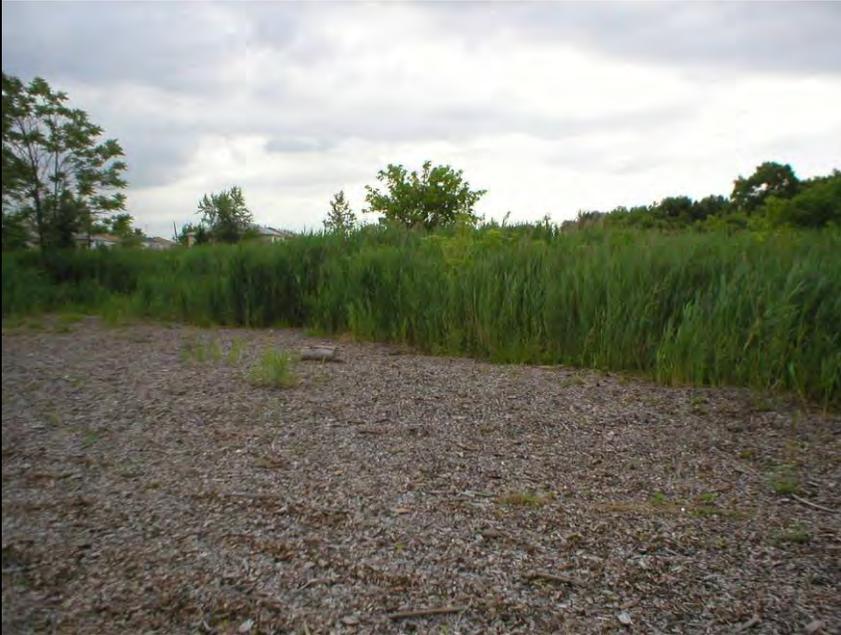
Photographer: Lema
Date: 6/24/09
Photo No.: 21
Direction:

Comments: Common reed dominated area north of Wetland W3. This area was determined not to meet wetland criteria. Note mulch fill in foreground.

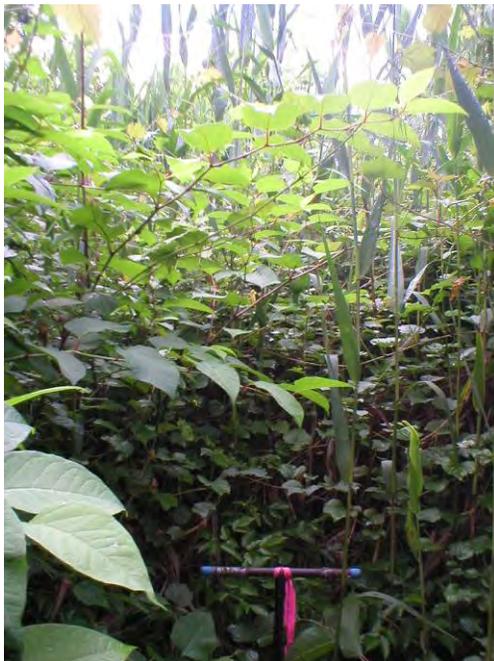
Photographer: Lema
Date: 6/24/09
Photo No.: 22
Direction: Northeast

Comments: Wetland W4– The wetland edge is composed of a dense mix of common reed and Japanese knotweed.

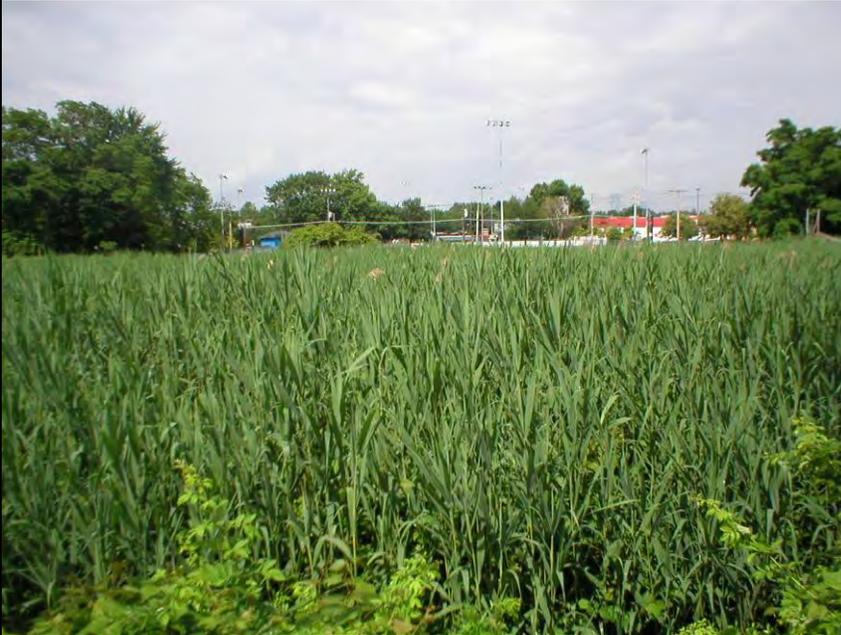
Photographer: Lema
Date: 6/24/09
Photo No.: 23
Direction: Northeast

Comments: Wetland W6 – adjacent to the baseball diamond (background)

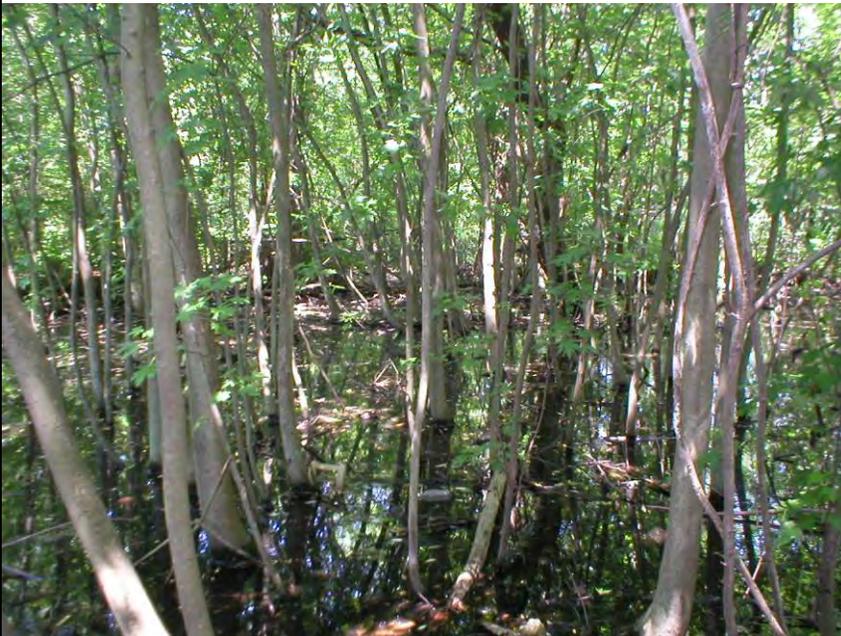
Photographer: Lema
Date: 6/30/09
Photo No.: 24
Direction: Northwest

Comments: Wetland W12– Forested wetland flows into wetland W6, but delineated separately in the field.

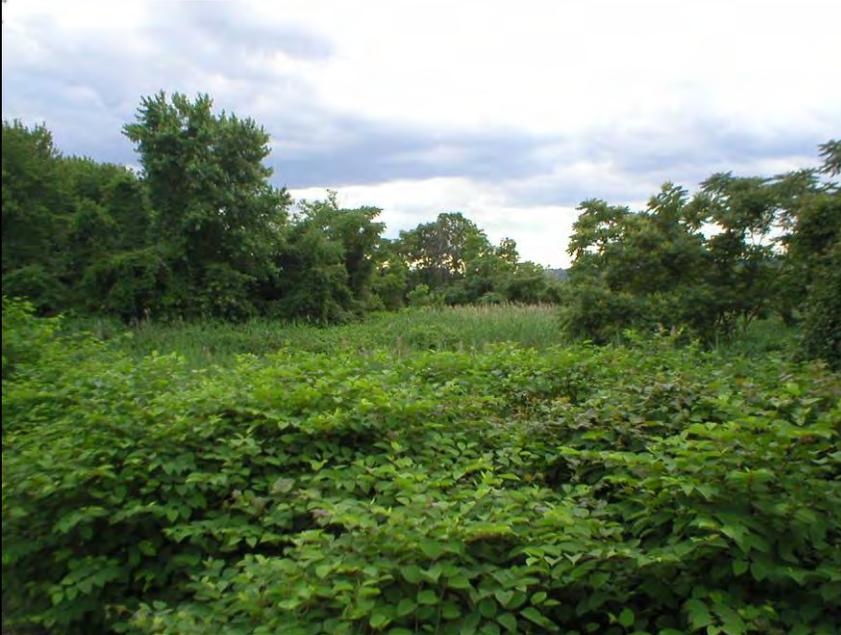
Photographer: Lema
Date: 6/23/09
Photo No.: 25
Direction: Southeast

Comments: Wetland W2 –
Wetland area is narrow
band of common reed in
the background.
