WETLAND DELINEATION REPORT

SOUTH SHORE OF STATEN ISLAND FEASIBILITY STUDY

**STATEN ISLAND,
RICHMOND COUNTY, NEW YORK**

September 2009

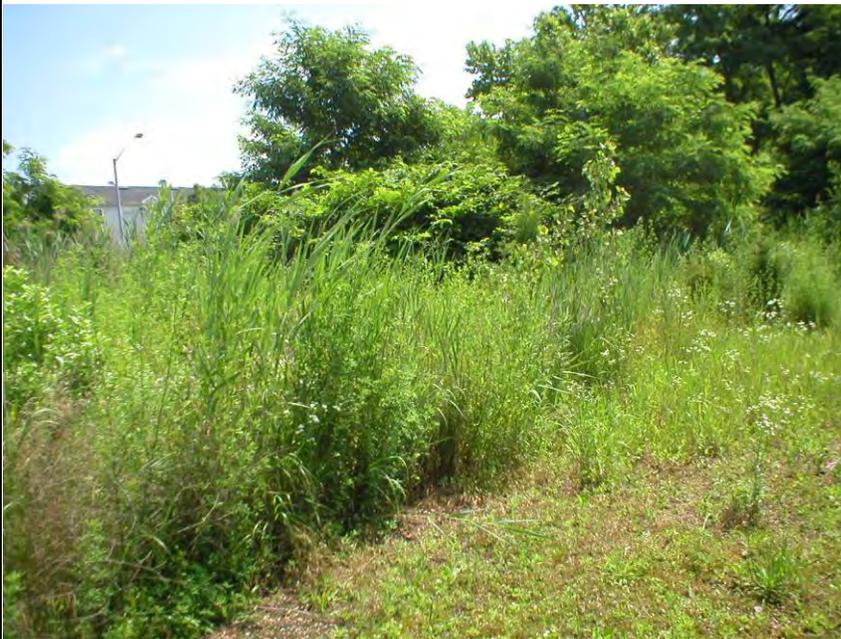
Photographer: Lema
Date: 7/01/09
Photo No.: 26
Direction:

Comments: C-2 – verified
in 2009.

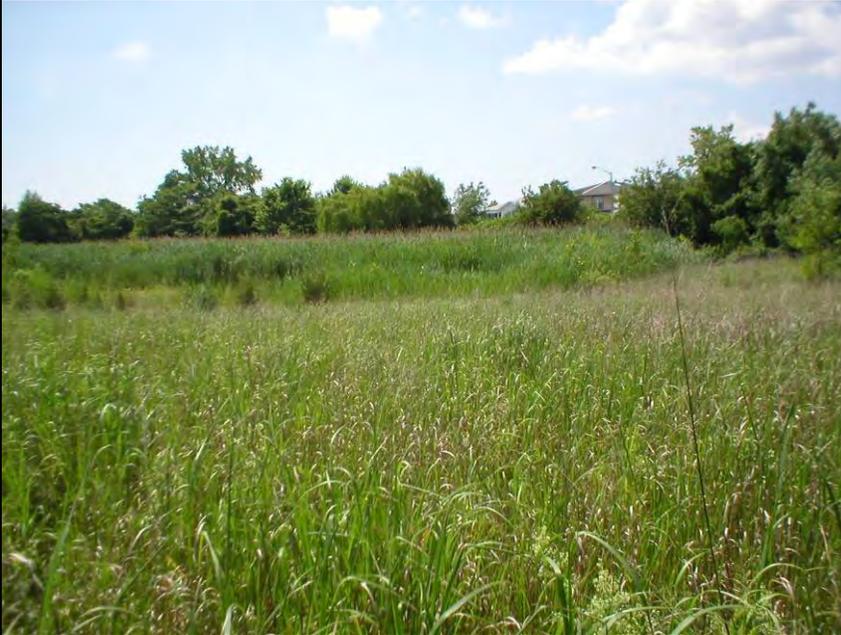
Photographer: Lema
Date: 6/27/09
Photo No.: 27
Direction: Southeast

Comments: Verification and continuation of wetland C-3. This wetland is well defined and includes the foreground.

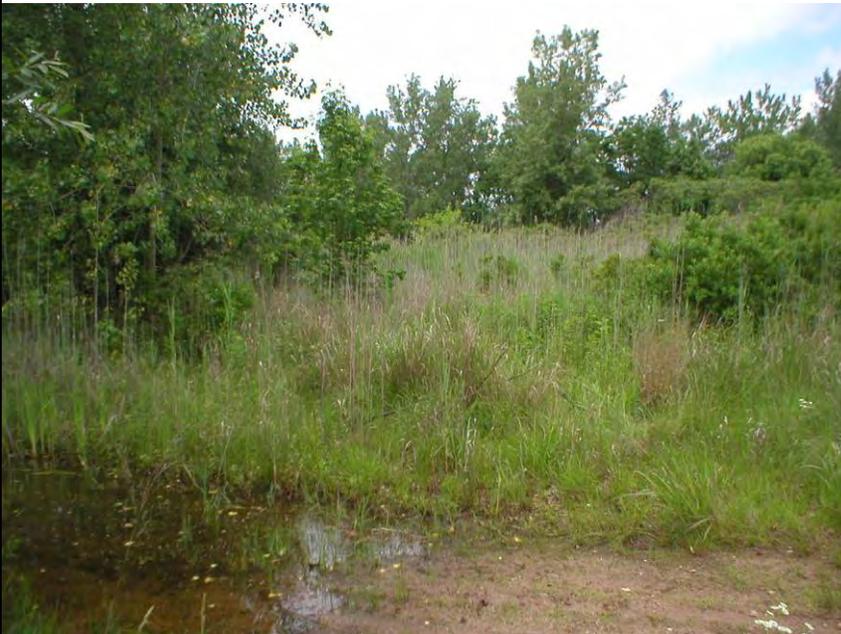
Photographer: Lema
Date: 6/23/09
Photo No.: 28
Direction: North

Comments: Wetland W1. Note a combination of scrub/shrub and emergent wetland components.

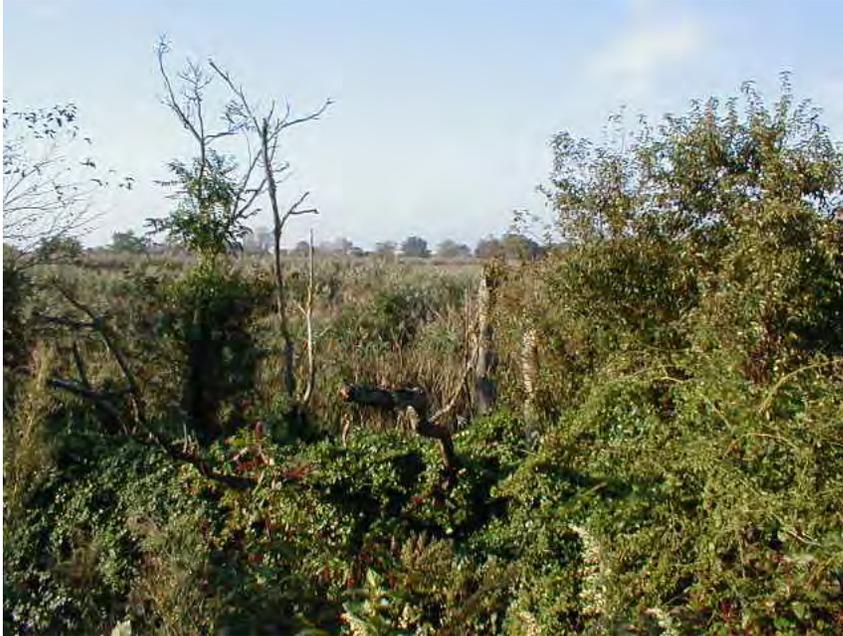
Photographer: Garvey
Date: 10/02/03
Photo No.: 1
Direction: W

Comments: View (photo foreground) of Wetland A1 scrub-shrub fringe, which is located around many parts of the upland/wetland interface. Wetland A1 opens up into a large monotypic stand of common reed (visible in photo background).

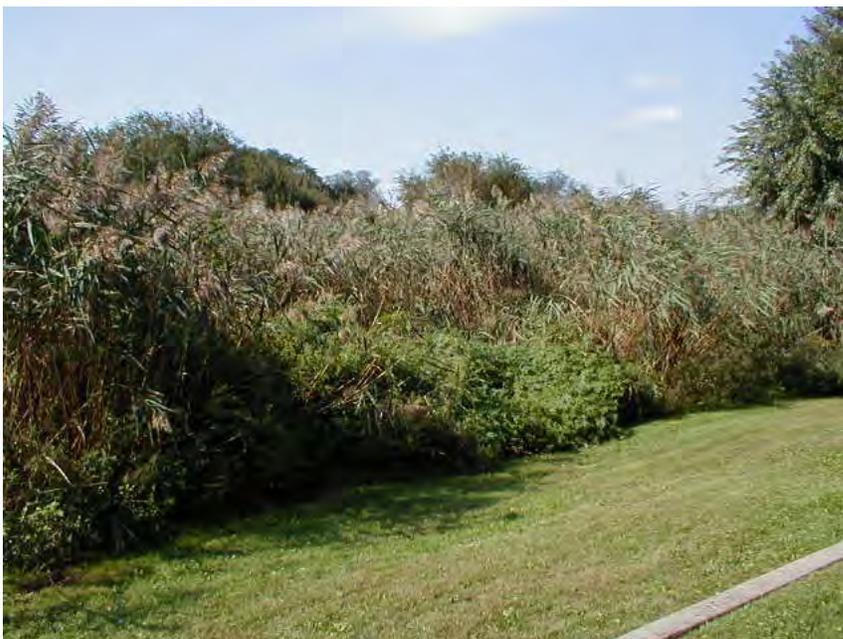
Photographer: Garvey
Date: 10/02/03
Photo No.: 2
Direction: W

Comments: View of Wetland A1 as it borders the Sewage Treatment Facility at Oakwood Beach.

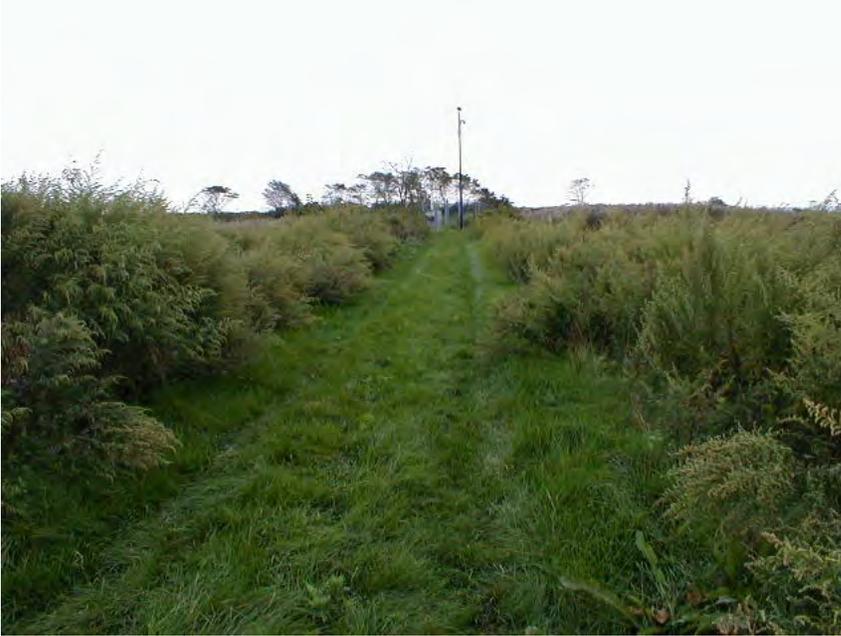
Photographer: Garvey
Date: 10/02/03
Photo No.: 3
Direction: WNW

Comments: View of the existing levee and tide gate at Oakwood Creek. Wetland A1 extends west from Hylan Boulevard and borders both sides of Oakwood Creek as it flows through the tide gate. Wetlands A2 and A3 are located on either side of the existing levee approximately 235 feet from the tide gate.

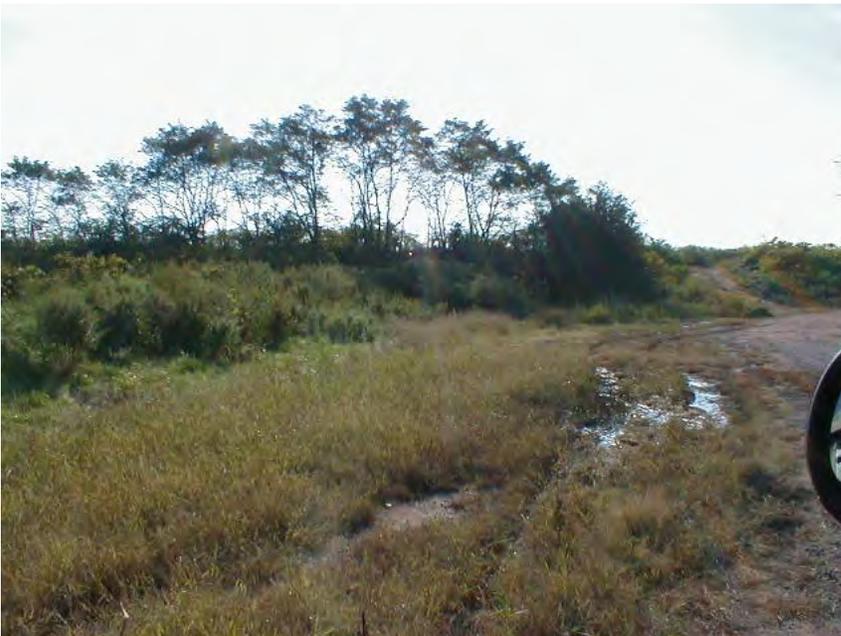
Photographer: Garvey
Date: 10/01/03
Photo No.: 4
Direction: SW

Comments: View of Wetland A2.

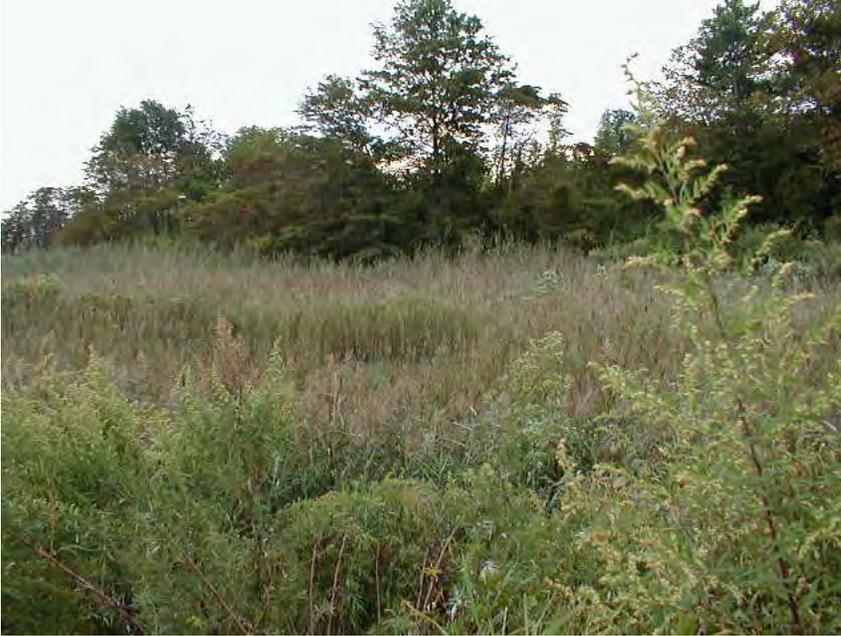
Photographer: Garvey
Date: 10/01/03
Photo No.: 5
Direction: NW

Comments: View of Wetland A3, which is located in a depression on the opposite side of the levee and is dominated by common reed.

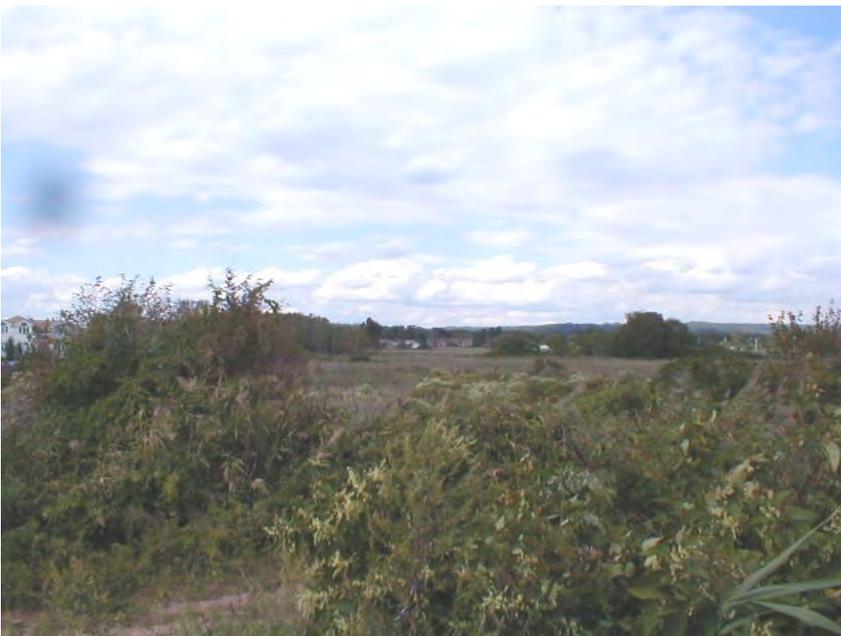
Photographer: Thompson
Date: 10/02/03
Photo No.: 6
Direction: NW

Comments: View over Wetland A4 from an existing levee.

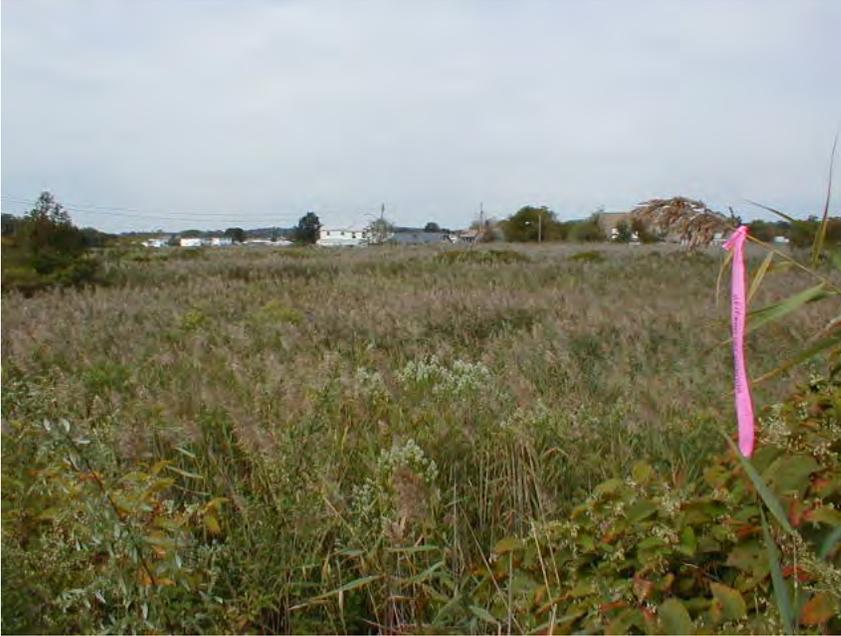
Photographer: Garvey
Date: 10/01/03
Photo No.: 7
Direction: N

Comments: View over Wetland A5. Note the residences clustered along the fringes of the wetland.

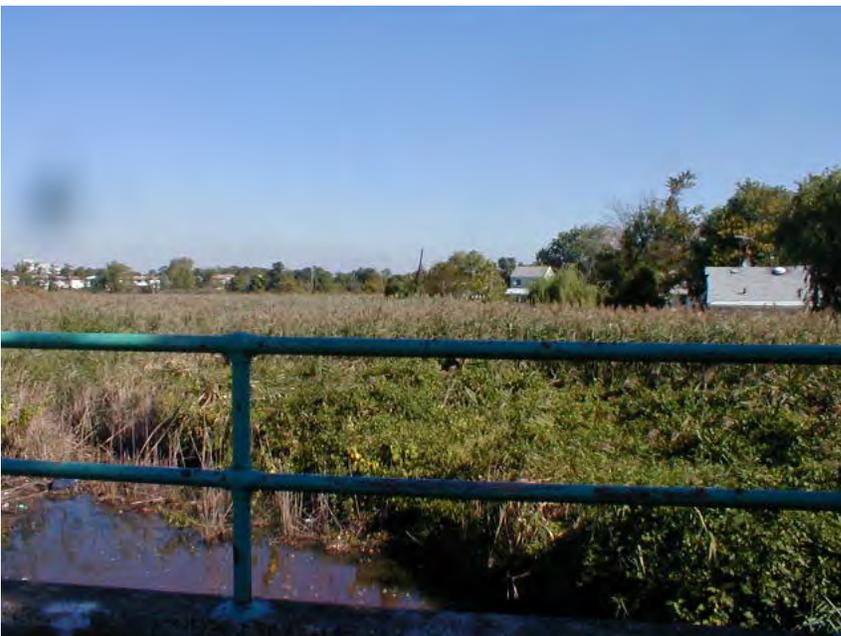
Photographer: Thompson
Date: 9/30/03
Photo No.: 8
Direction: NE

Comments: View of a portion of Wetland C1. Note the large monotypic stand of common reed and the residences clustered along the fringes of the wetland.

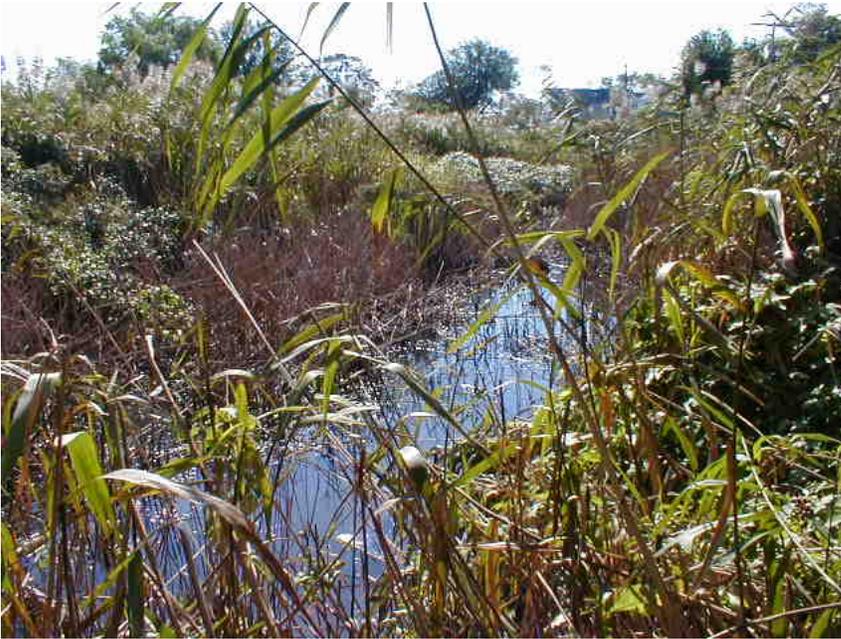
Comments: View of a creek flowing through a portion of Wetland C1.

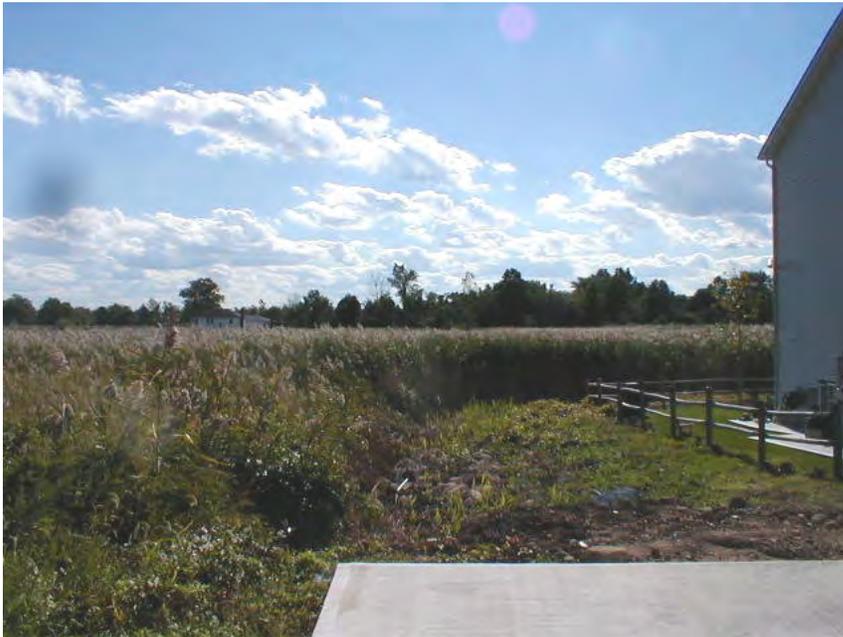
Photographer: Thompson
Date: 10/1/03
Photo No.: 11
Direction: SW

Comments:
Representative view of the *Phragmites*-dominated wetland habitat in Wetlands C1 and C3.

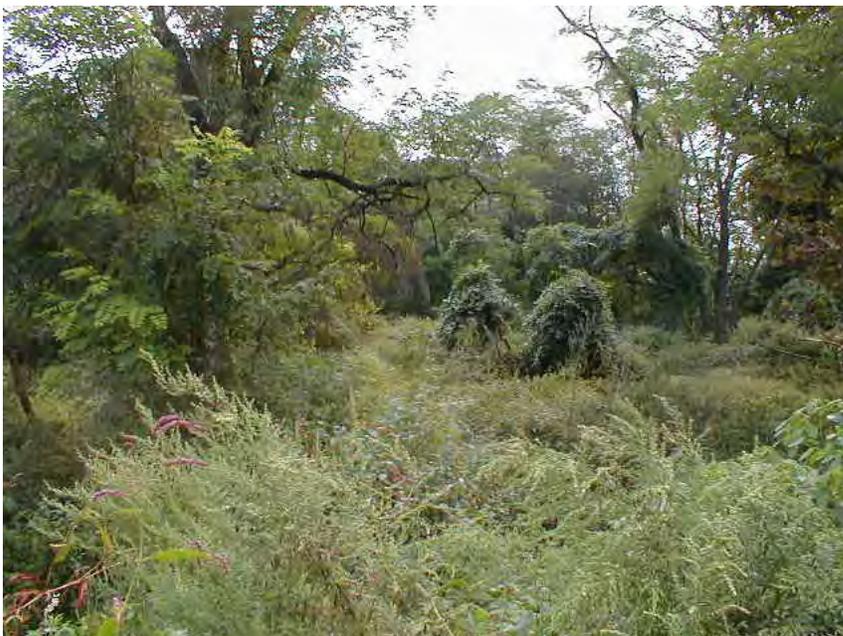
Photographer: Thompson
Date: 10/01/03
Photo No.: 12
Direction: SE

Comments: View of an emergent/forested component of Wetland C3 located on the north side of the wetland.

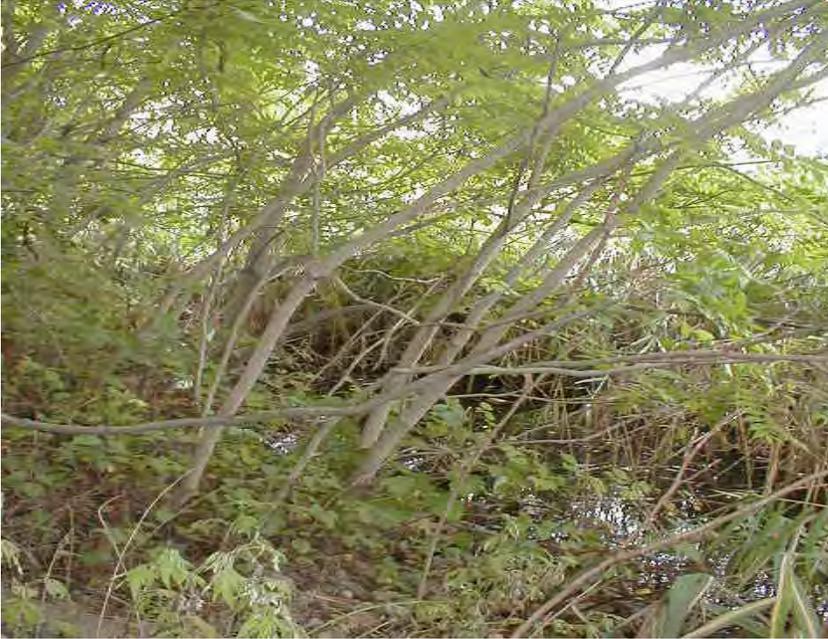
Photographer: Thompson
Date: 10/01/03
Photo No.: 13
Direction: NA

Comments: View of the upland/wetland interface of Wetland C3 where fill material extends down to the wetland.

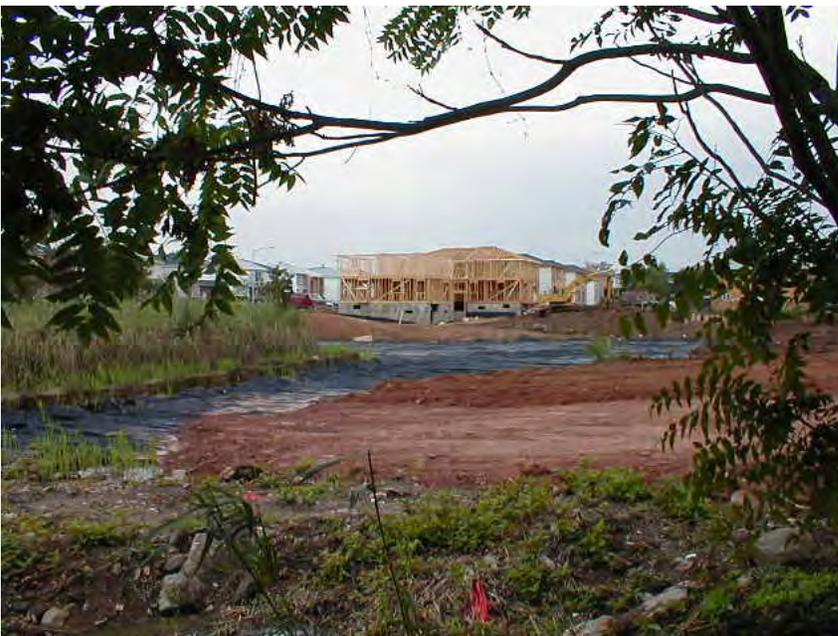
Photographer: Thompson
Date: 10/01/03
Photo No.: 14
Direction: W

Comments: View of the western most point of Wetland C3. A large portion of the wetland has been excavated and fill material has been imported to assist in residential construction.

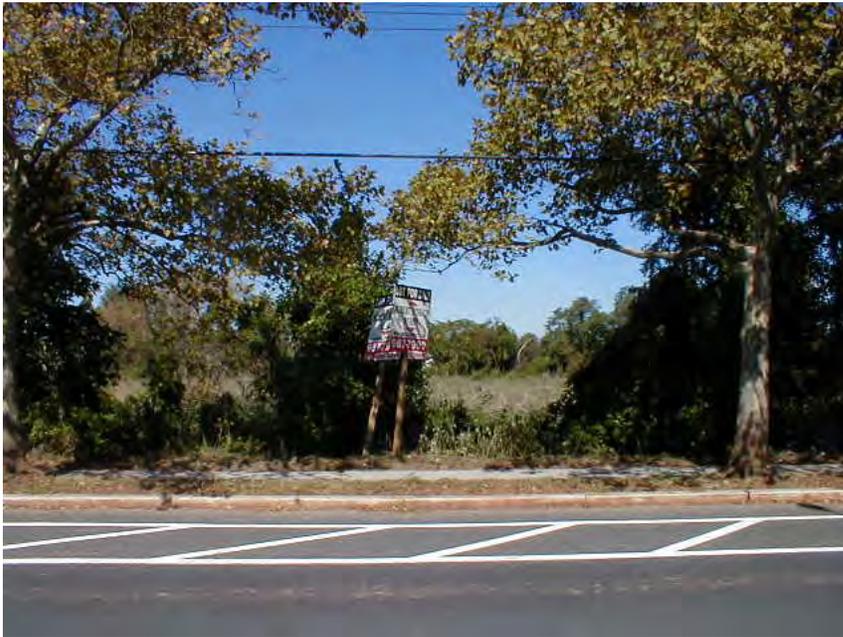
Comments: View of Wetland C4 where it borders Father Capodanno Boulevard.

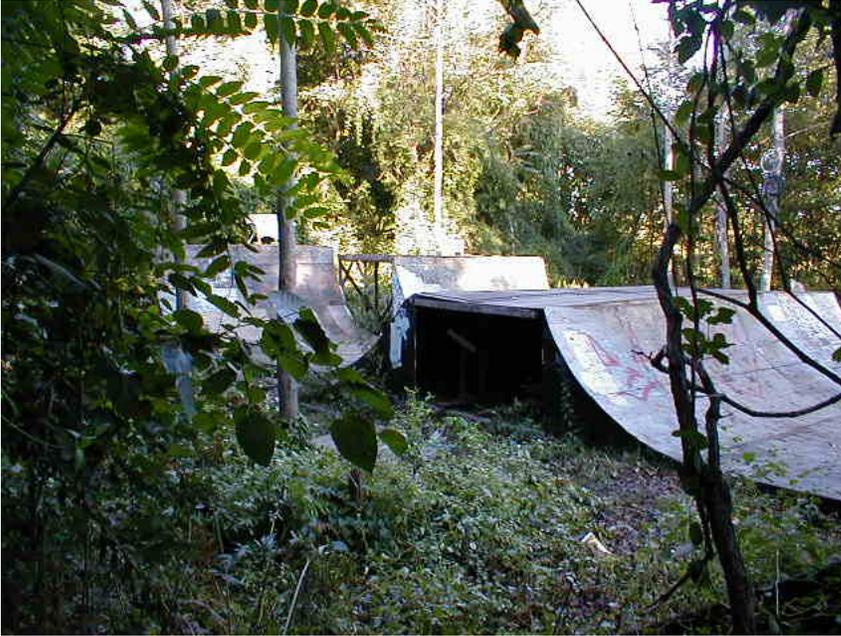
Photographer: Garvey
Date: 9/30/03
Photo No.: 17
Direction: NA

Comments: View of a skateboard park built by local youth along the western boundary of Wetland E1.

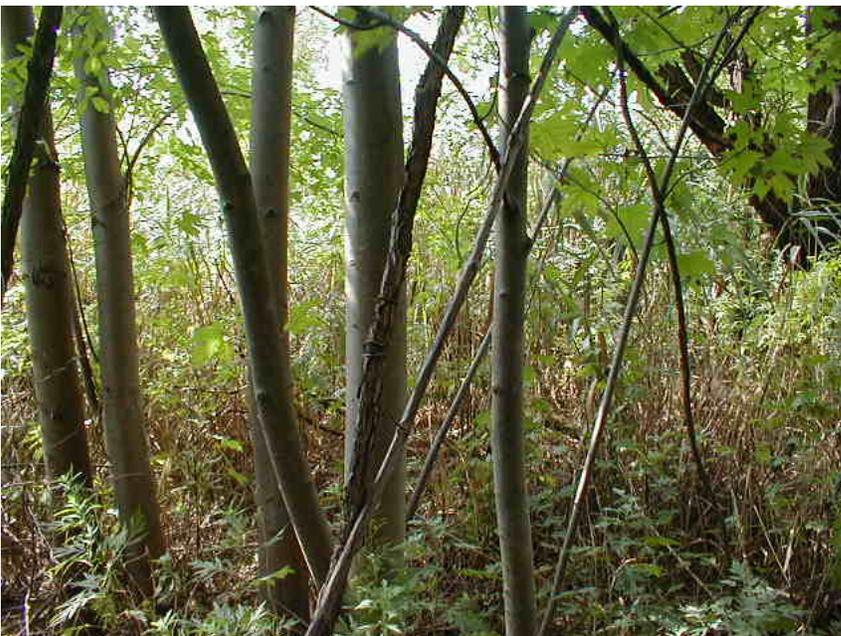
Photographer: Garvey
Date: 9/30/03
Photo No.: 18
Direction: NA

Comments: View of a portion of Wetland E1 where forested and emergent wetland communities meet.

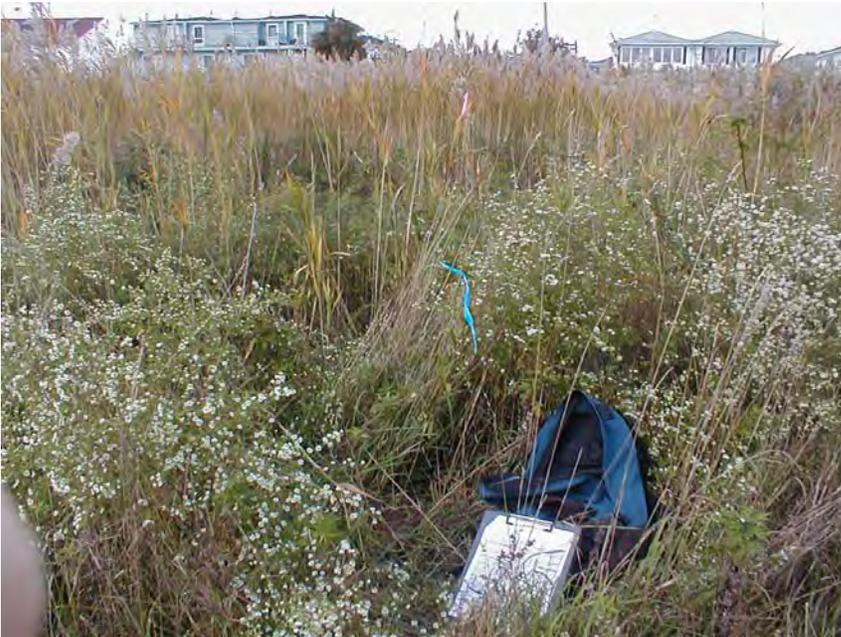
Photographer: Fellion
Date: 10/24/03
Photo No.: 19
Direction: W

Wetland CB-1 is a palustrine emergent (PEM5E) community located southeast of the intersection of Tennyson Drive and Glover Street that appears to have been impacted by past fill activities. The herbaceous layer is dominated by common reed (*Phragmites australis*), soft rush (*Juncus effusus*), purple loosestrife (*Lythrum salicaria*), and flat-top fragrant goldenrod (*Euthamia graminifolia*). The composition of hydrophytic plant species exceeds 50% and thereby meets the USACE criterion for wetland vegetation.

Field investigation revealed that the soil in Wetland CB-1 consists of a 3-inch-deep, dark brown (10YR 3/3), sandy loam A horizon. Below this horizon is a 3- to 8-inch-deep, dark grayish brown (10YR 4/2) sandy loam B horizon with large faint yellowish brown (10YR 5/4) mottles. Refusal was met at 8 inches where large stones and gravel were encountered. Hydric soil indicators include the presence of reducing conditions. The primary indicator of wetland hydrology was saturation in the upper 12 inches. A secondary indicator of wetland hydrology included water stained leaves. A portion of this wetland is identified on NWI maps. Wetland CB-1 is not identified on NYSDEC wetland maps.

Comments: View of Wetland CB1 in the Crescent Beach survey area.

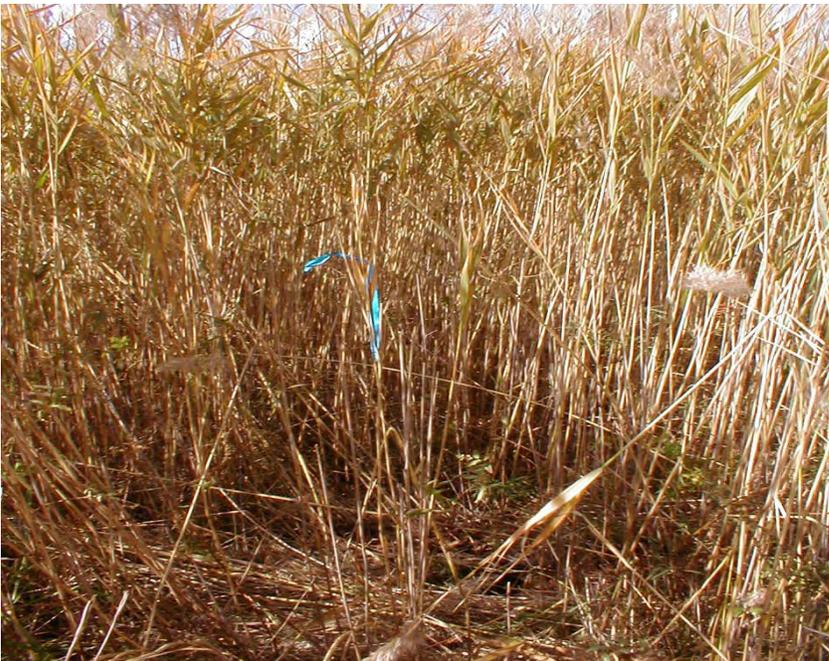
Photographer: Fellion
Date: 10/24/03
Photo No.: 20
Direction: NA

Comments: Typical view of wetland vegetation in Wetlands CB1 and CB2.

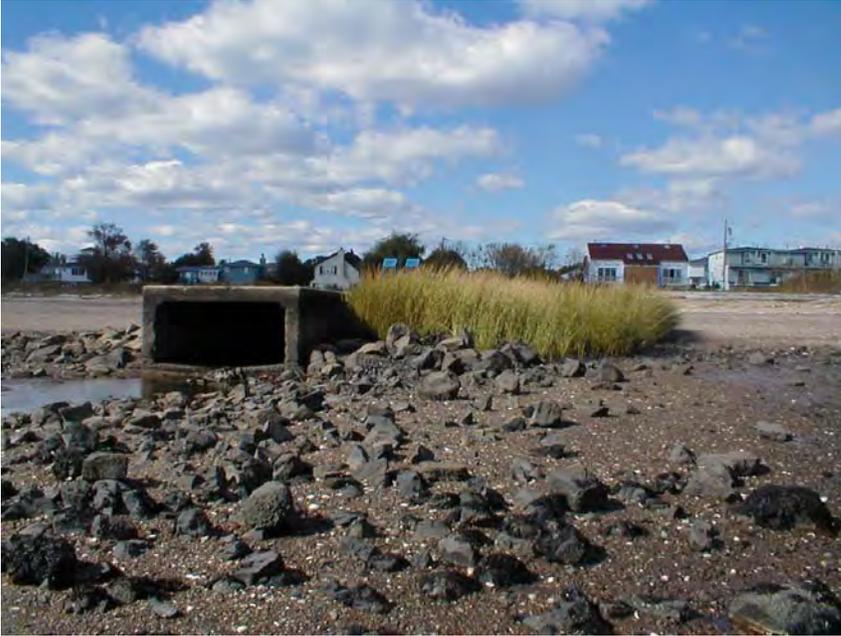
Photographer: Fellion
Date: 10/24/03
Photo No.: 21
Direction: W

Comments: View of Wetland LM1 beside the Armstrong Outfall.

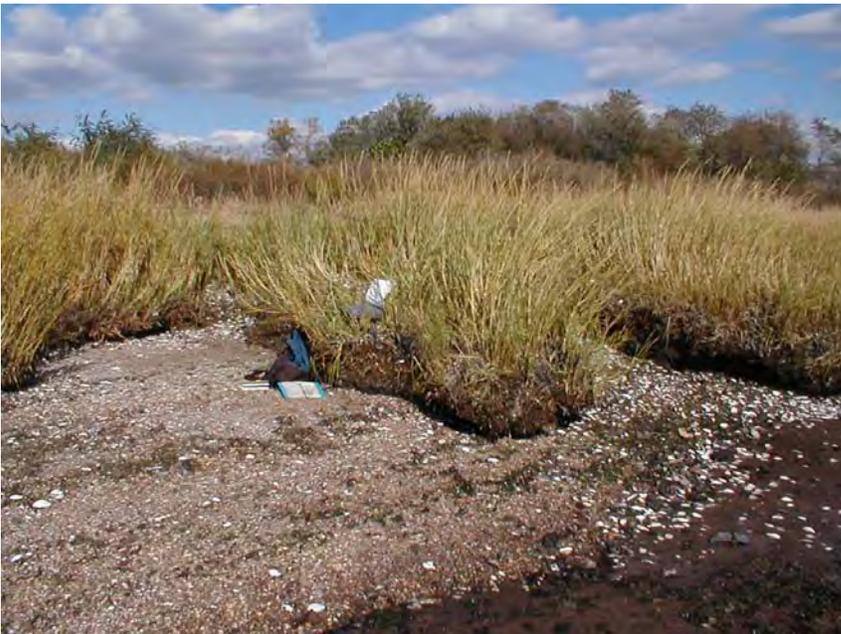
Photographer: Fellion
Date: 10/24/03
Photo No.: 22
Direction: N

Comments: View of Wetland LM2 dominated by salt-marsh cord grass.

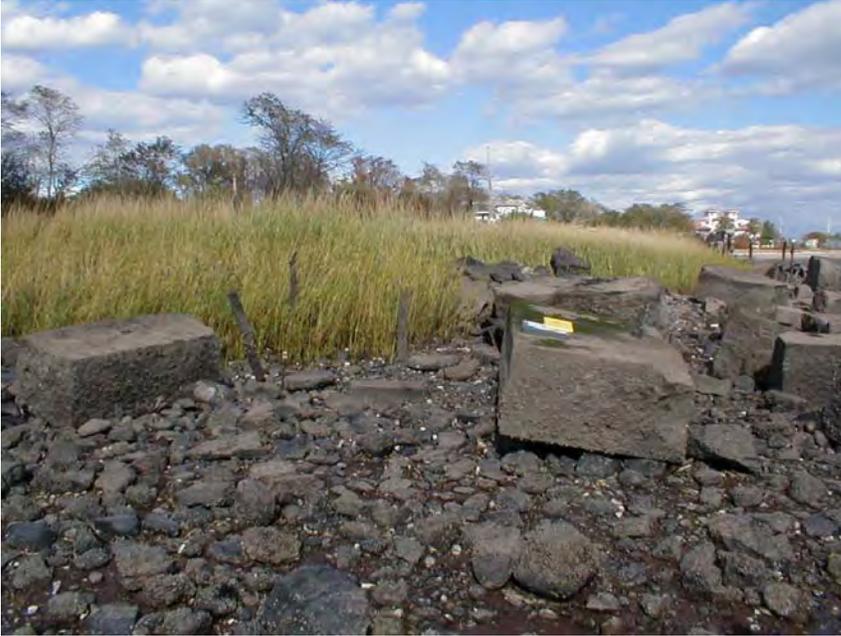
Photographer: Fellion
Date: 10/24/03
Photo No.: 23
Direction: NE

Comments: View of Wetland LM3. Note the rocky intertidal zone (RI-1) extends to the boundary of this wetland.

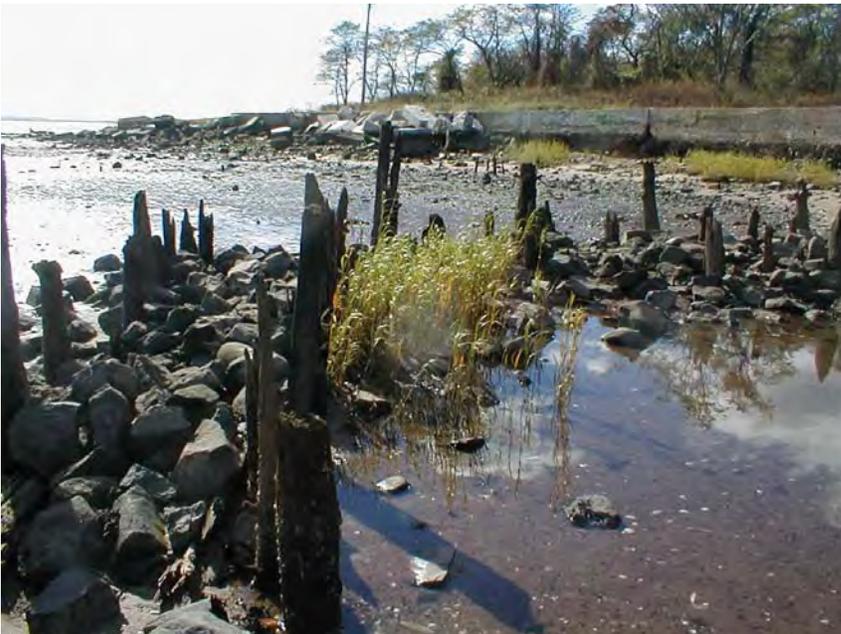
Photographer: Fellion
Date: 10/24/03
Photo No.: 24
Direction: SW

Comments: Wetlands LM4 and LM5 are located against the base of the seawall. Wetland LM6 is a very sparse population of salt-marsh cord grass growing in between the rip-rap associated with the old pilings visible in the photo.

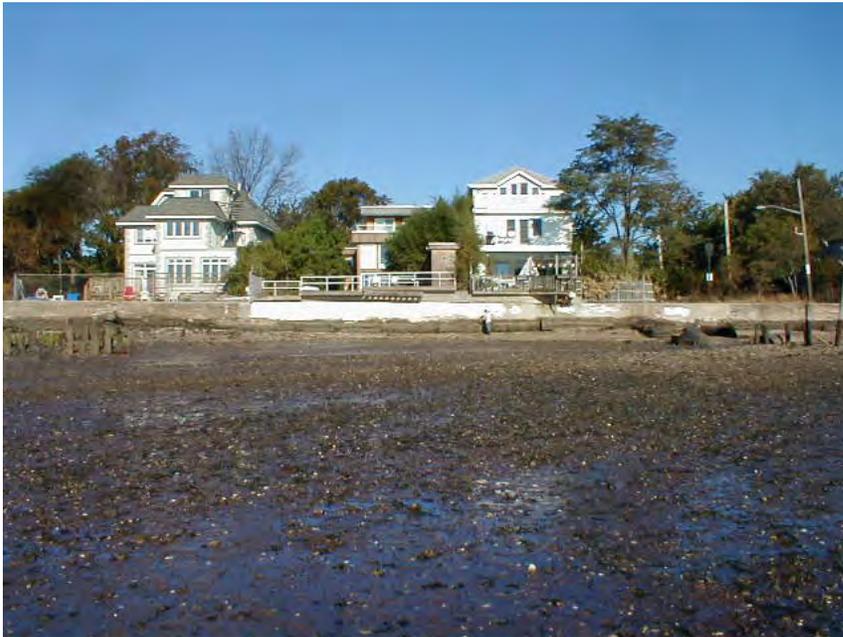
Comments: General view of the residential area located along the seawall at Crescent Beach and the clam flat (CF-1) area.

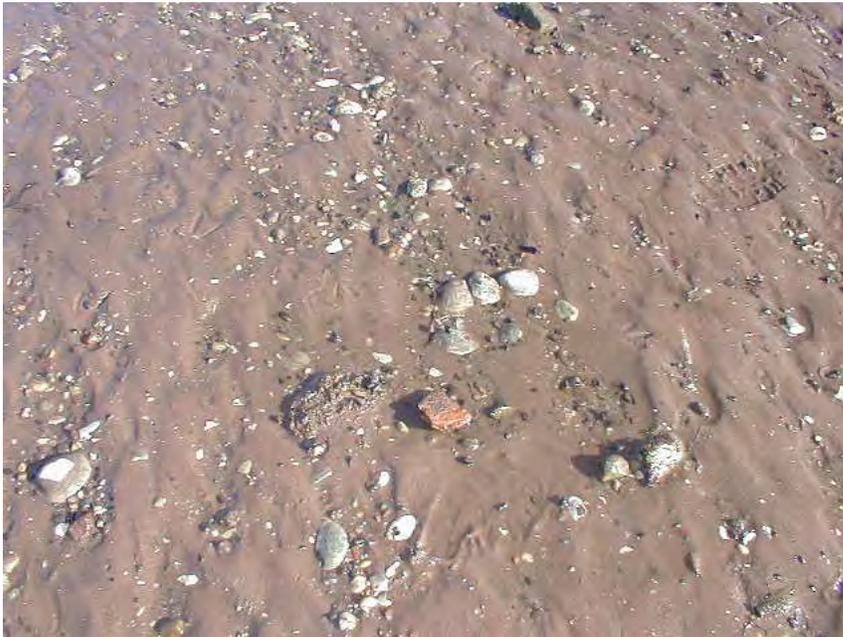
Comments: Close up view of the clam flat (CF-1) at Crescent Beach.

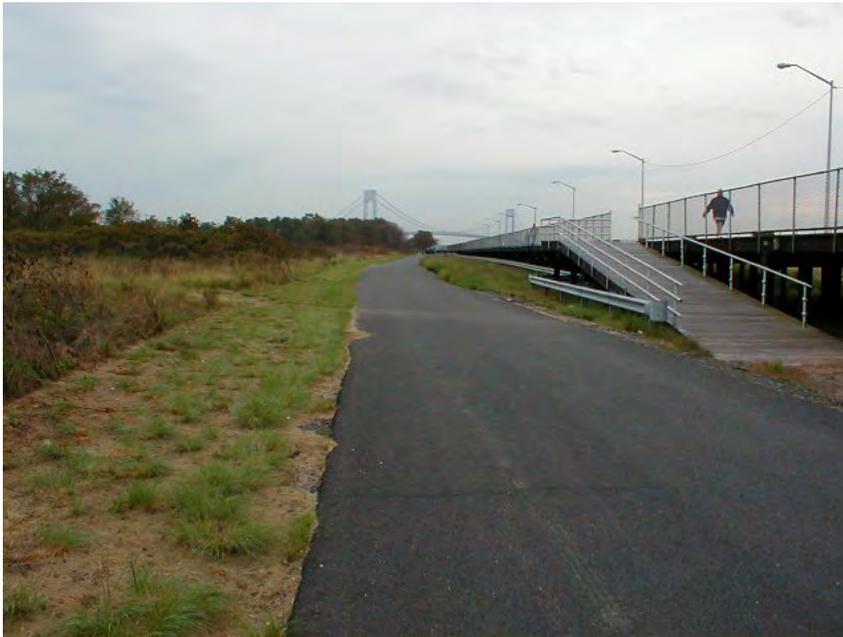
Photographer: Garvey
Date: 10/01/03
Photo No.: 29
Direction: N

Comments:
Representative view of the line of protection survey area along the boardwalk.

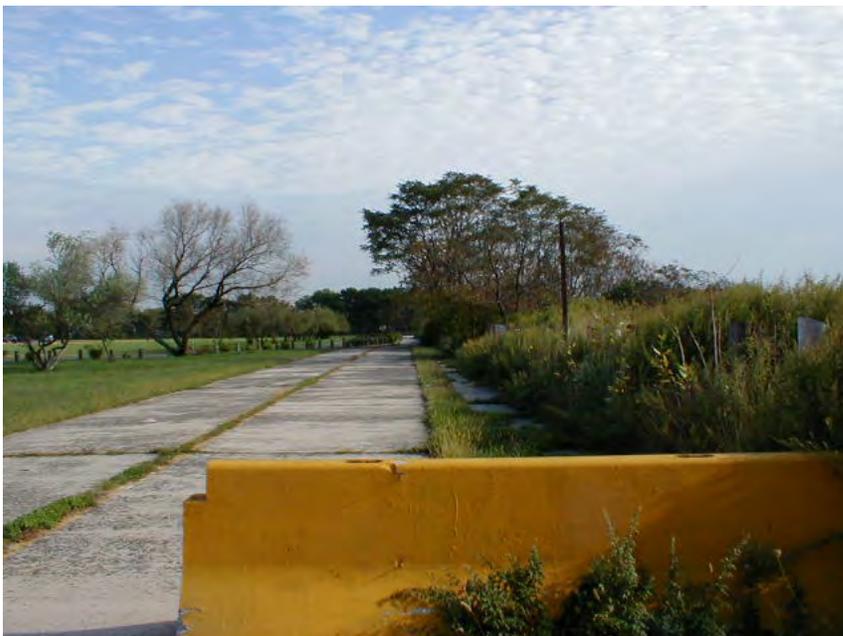
Photographer: Garvey
Date: 10/01/03
Photo No.: 30
Direction: N

Comments:
Representative view of the line of protection survey area along the promenade.

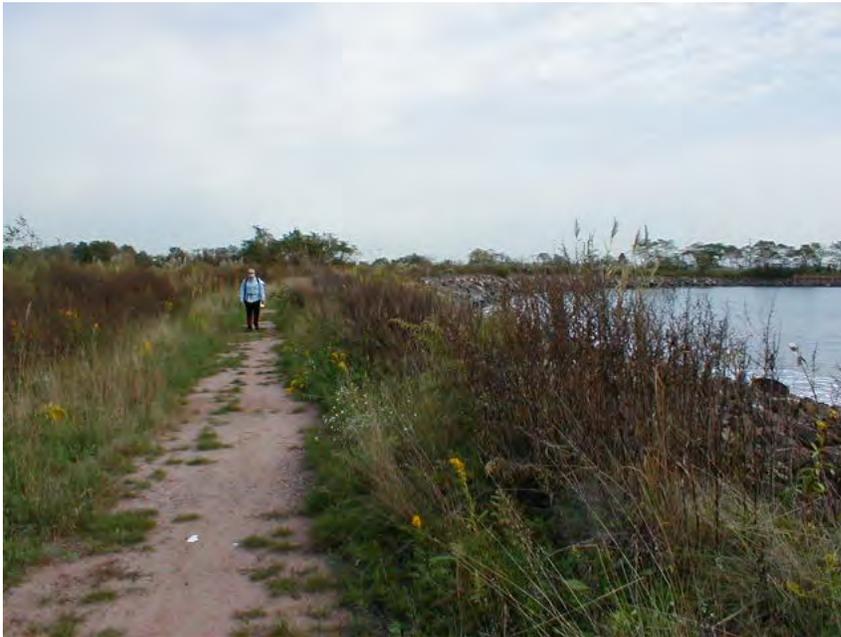
Comments: Typical view along the existing buried seawall located adjacent to Wetlands A4 and W13/A5.

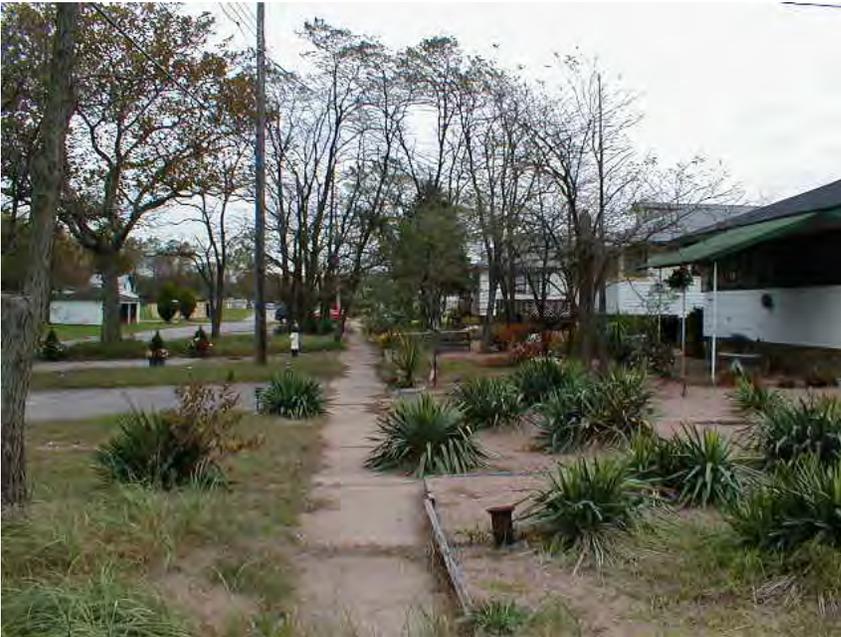
Photographer: Garvey
Date: 10/01/03
Photo No.: 33
Direction: NE

Comments: View of the bungalows along Cedar Grove Beach.
