**FIVE-YEAR REVIEW REPORT FOR
NORTHEASTERN INDUSTRIAL PARK AOC 1 AND 7
FORMER SCHENECTADY ARMY DEPOT FUDS SITE
GUILDERLAND, NEW YORK**

FINAL, JUNE 2018

12-13 October 2017 Photographic Log
2017 Landfill Cap and Soil Cover Inspection
AOC 1, Northeastern Industrial Park, Guilderland, NY

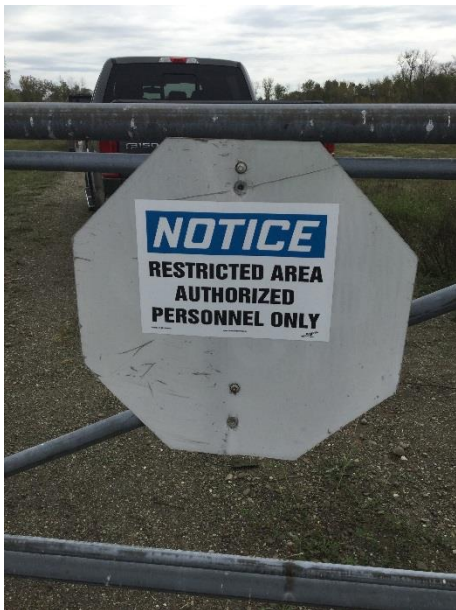
Photo ID: SC1
Project Name: NEIP 5 Year Review
Location: Guilderland, NY
Date: October 11, 2017
Inspector: Aaron Myers
Direction of Photograph: Southeast
Soil Cover: Signage in tact

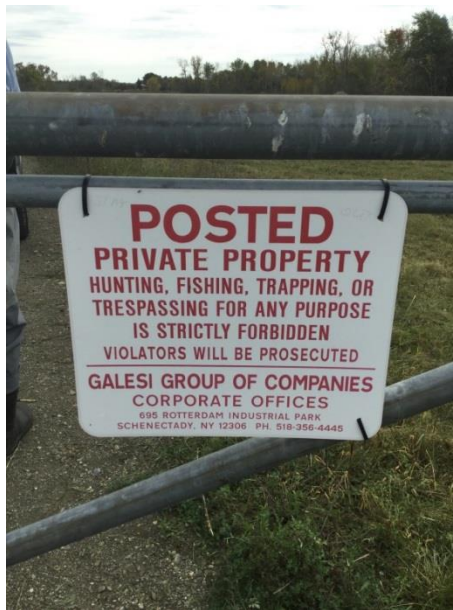
Photo ID: SC2
Project Name: NEIP 5 Year Review
Location: Guilderland, NY
Date: October 11, 2017
Inspector: Aaron Myers
Direction of Photograph: Southeast
Soil Cover: Signage in tact

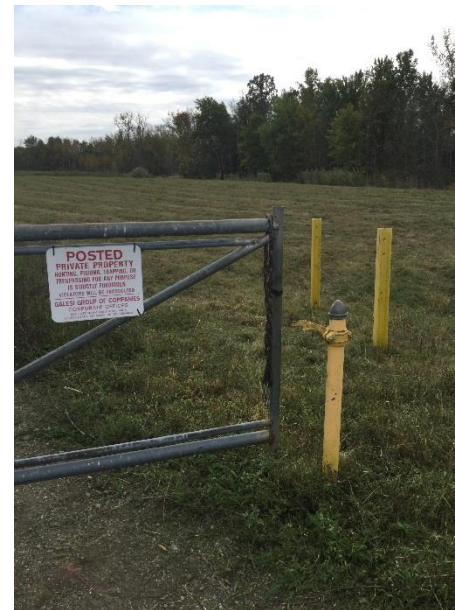
Photo ID: SC3
Project Name: NEIP 5 Year Review
Location: Guilderland, NY
Date: October 11, 2017
Inspector: Aaron Myers
Direction of Photograph: Southeast
Soil Cover: Gate secured

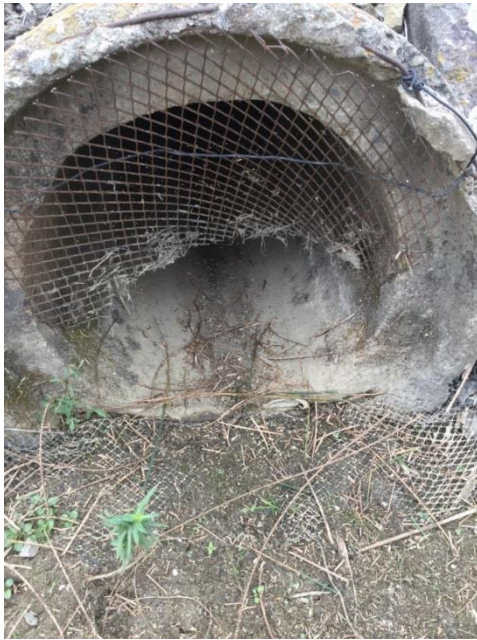
Photo ID: SC4
Project Name: NEIP 5 Year Review
Location: Guilderland, NY
Date: October 11, 2017
Inspector: Aaron Myers
Direction of Photograph: West
Soil Cover: Culvert trash screen damaged

-) Culvert on the west side of channel (facing east) by the gate has a damaged trash screen (previously noted in 2016). The screen should be replaced or fastened more securely in place (Photo ID SC4). *[The trash screen was later repaired on 20 November 2017.]*
-) Vegetation growing through riprap. Not a significant concern, since there are no trees or thick weeds present.
-) Excessive vegetation growth surrounding culvert east of the stormwater channel and gravel path (Photo ID SC18). *[Vegetation was trimmed to allow for more efficient conveyance.]*

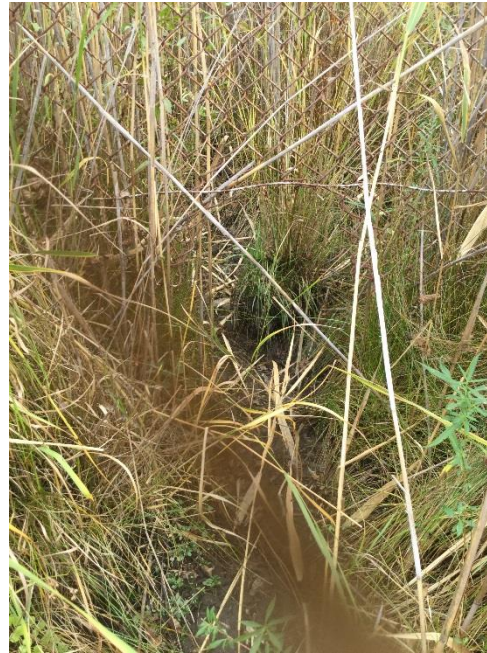
Photo ID: SC7
Project Name: NEIP 5 Year Review
Location: Guilderland, NY
Date: October 11, 2017
Inspector: Aaron Myers
Direction of Photograph: Northeast
Soil Cover: Fence hole near ACE-5

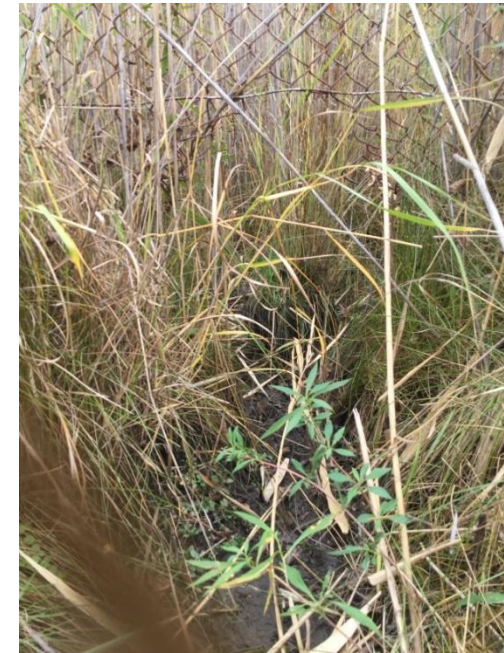
Photo ID: SC8
Project Name: NEIP 5 Year Review
Location: Guilderland, NY
Date: October 11, 2017
Inspector: Aaron Myers
Direction of Photograph: Northeast
Soil Cover: Fence hole near ACE-5

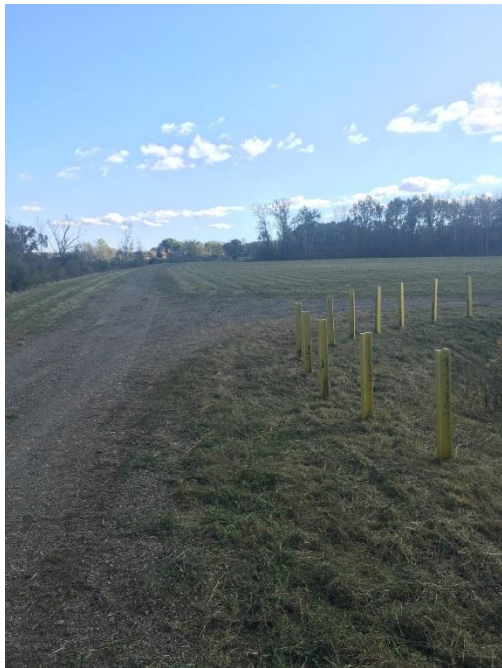
Photo ID: SC10
Project Name: NEIP 5 Year Review
Location: Guilderland, NY
Date: October 12, 2017
Inspector: Aaron Myers
Direction of Photograph: Southeast
Soil Cover: Landscaping completed

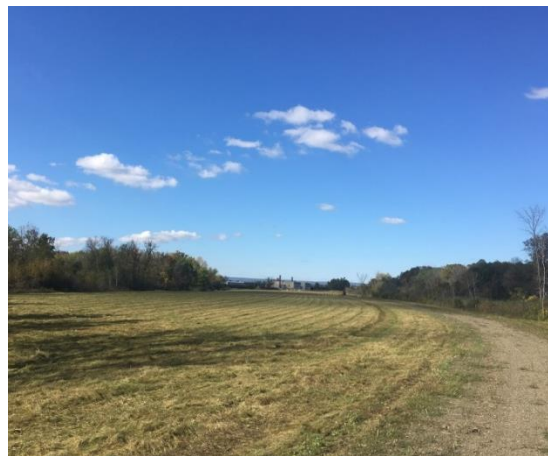
Photo ID: SC11
Project Name: NEIP 5 Year Review
Location: Guilderland, NY
Date: October 12, 2017
Inspector: Aaron Myers
Direction of Photograph: Northwest
Soil Cover: Landscaping completed

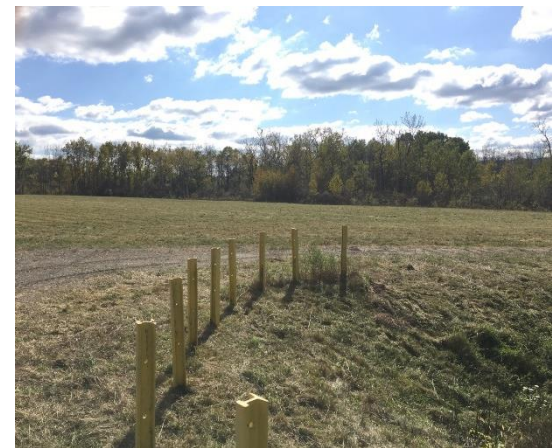
Photo ID: SC12
Project Name: NEIP 5 Year Review
Location: Guilderland, NY
Date: October 12, 2017
Inspector: Aaron Myers
Direction of Photograph: South
Soil Cover: Landscaping completed

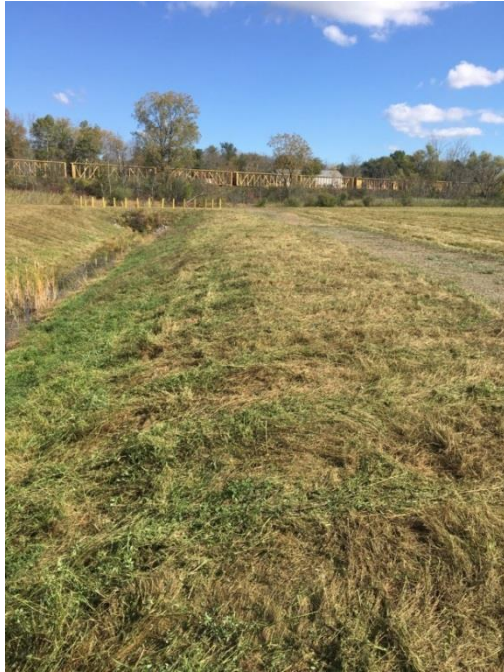
Photo ID: SC13
Project Name: NEIP 5 Year Review
Location: Guilderland, NY
Date: October 12, 2017
Inspector: Aaron Myers
Direction of Photograph: Northeast
Soil Cover: Channel in good condition

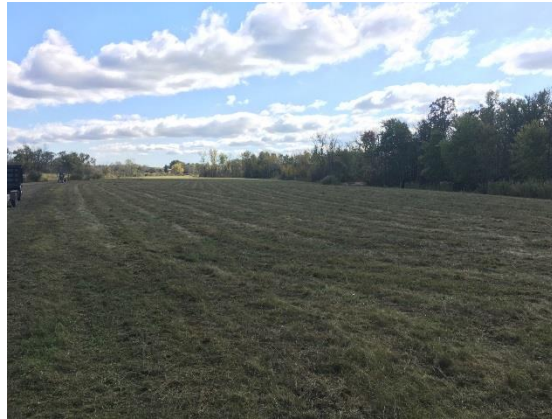
Photo ID: SC14
Project Name: NEIP 5 Year Review
Location: Guilderland, NY
Date: October 12, 2017
Inspector: Aaron Myers
Direction of Photograph: Northwest
Soil Cover: Landscaping completed

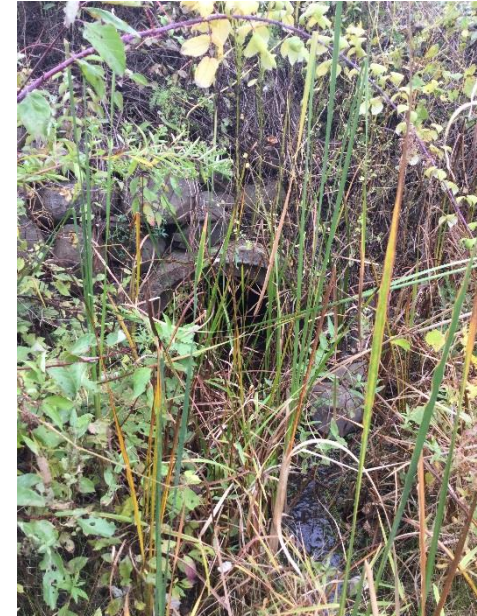
Photo ID: SC18
Project Name: NEIP 5 Year Review
Location: Guilderland, NY
Date: October 11, 2017
Inspector: Aaron Myers
Direction of Photograph: Southwest
Soil Cover: Middle channel's Eastern culvert-excessive vegetation

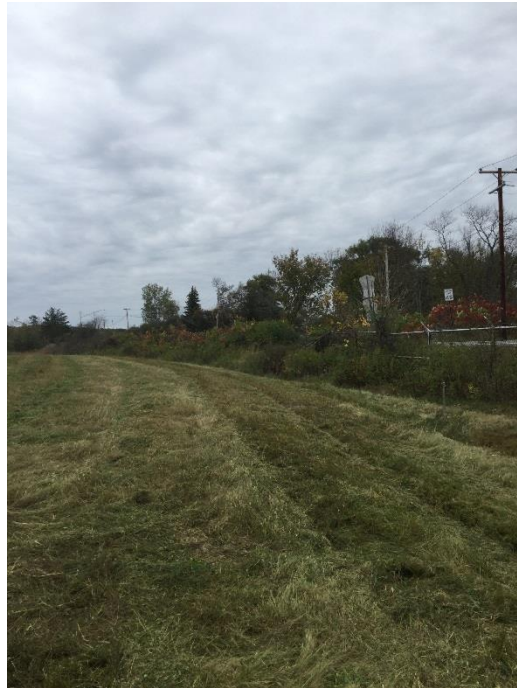
-) Healthy vegetation on both landfill cap and soil cover area.
-) No signs of rill erosion.
-) Wooden perimeter fence is in good condition (barrier between cover area and cap area) (Photo ID LC1).
-) Southern site perimeter fence near MW-13-01 is sagging and should be repaired (Photo ID LC3).
-) Trees are growing through southern fence near MW-13-01 (Photo ID LC5).
-) Monitoring Wells are in good condition and locks are properly secured.
-) Groundhog/rabbit holes in landfill cap area (no cap penetration) (Photo IDs LC9 and LC10).
-) Some bare spots in cap area where the vegetation had been trampled (possible wildlife settlement) (Photo ID LC11). *[These bare spots were later repaired on 20 November 2017.]*
-) Extreme vegetative growth on southern fence (however, this vegetation is not currently impacting the cap).

Photo ID: LC1
Project Name: NEIP 5 Year Review
Location: Guilderland, NY
Date: October 11, 2017
Inspector: Aaron Myers
Direction of Photograph: East
Landfill Cap: Healthy vegetation overall

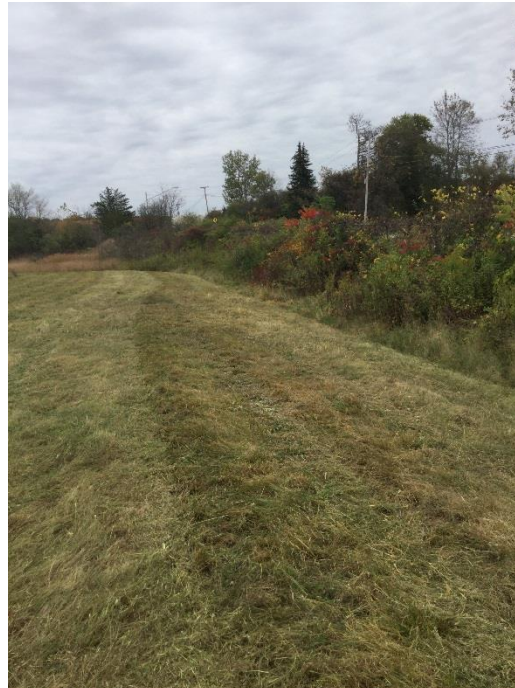
Photo ID: LC2
Project Name: NEIP 5 Year Review
Location: Guilderland, NY
Date: October 11, 2017
Inspector: Aaron Myers
Direction of Photograph: East
Landfill Cap: South slope of soil cap

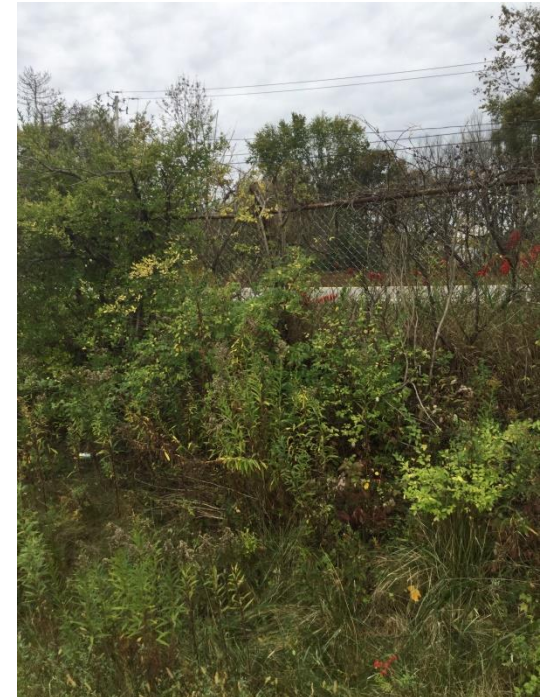
Photo ID: LC3
Project Name: NEIP 5 Year Review
Location: Guilderland, NY
Date: October 11, 2017
Inspector: Aaron Myers
Direction of Photograph: Southeast
Landfill Cap: Sagging fence

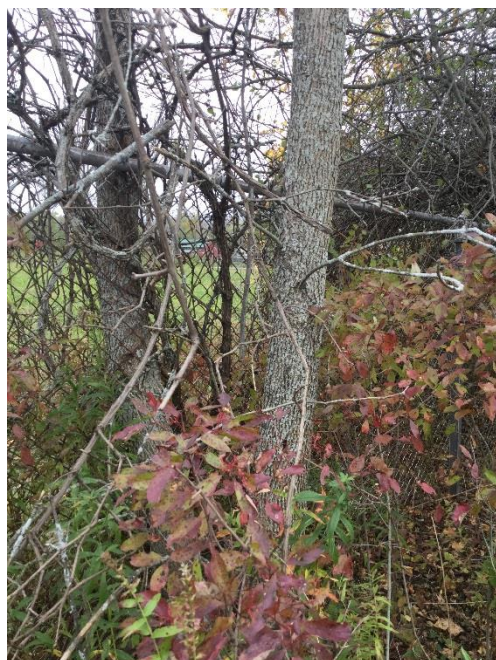
Photo ID: LC5
Project Name: NEIP 5 Year Review
Location: Guilderland, NY
Date: October 11, 2017
Inspector: Aaron Myers
Direction of Photograph: South
Landfill Cap: Tree grown through fence

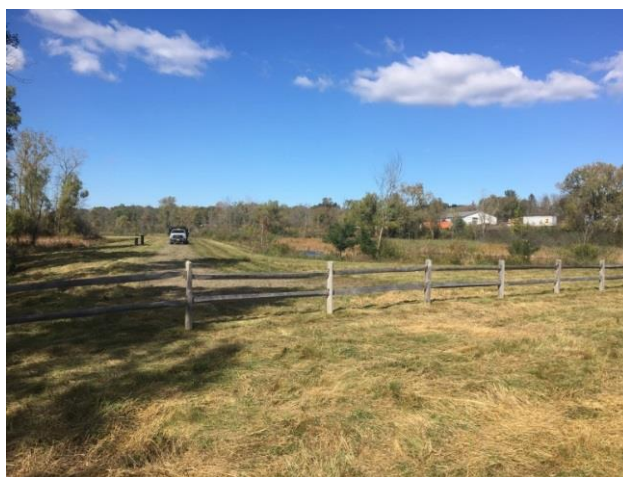
Photo ID: LC7
Project Name: NEIP 5 Year Review
Location: Guilderland, NY
Date: October 11, 2017
Inspector: Aaron Myers
Direction of Photograph: North
Landfill Cap: Wooded fence separating the landfill cap and

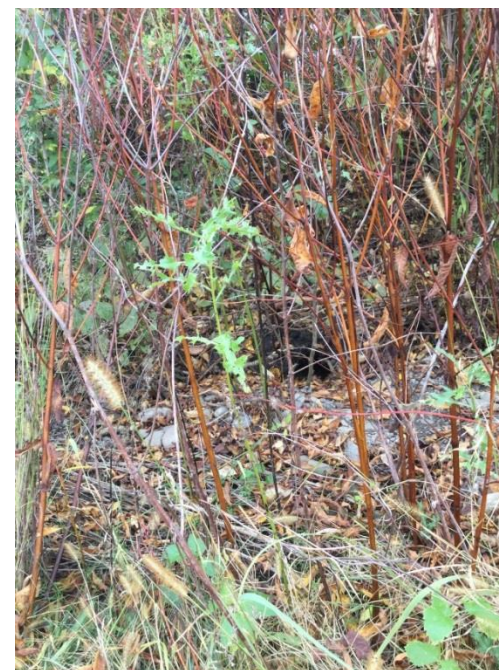
Photo ID: LC9
Project Name: NEIP 5 Year Review
Location: Guilderland, NY
Date: October 11, 2017
Inspector: Aaron Myers
Direction of Photograph: South
Landfill Cap: Wildlife settlement along southern fence

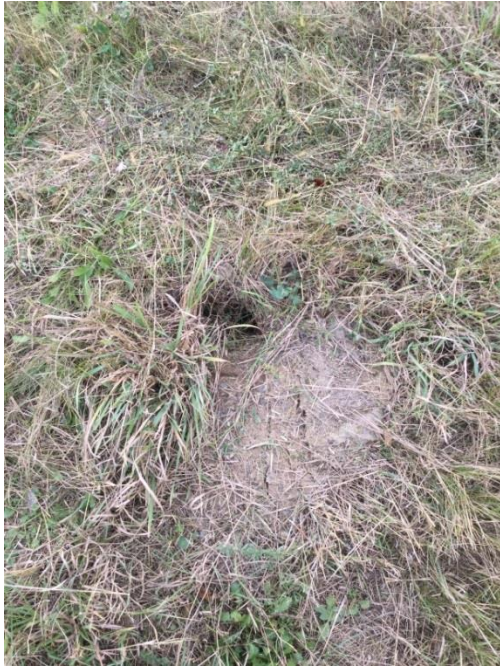
Photo ID: LC10
Project Name: NEIP 5 Year Review
Location: Guilderland, NY
Date: October 11, 2017
Inspector: Aaron Myers
Direction of Photograph: N/A
Landfill Cap: Wildlife settlement

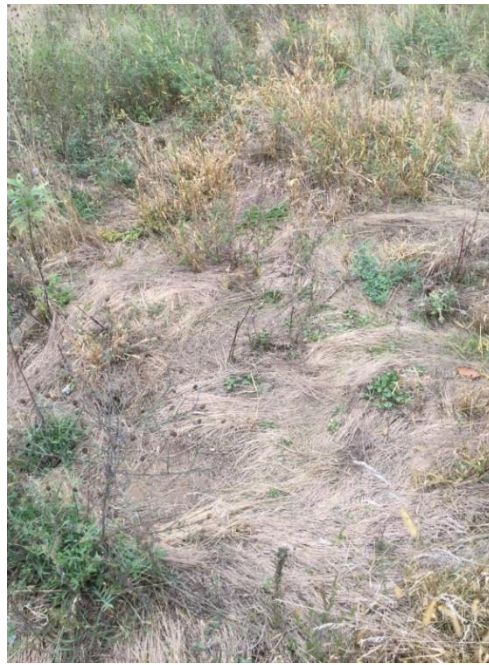
Photo ID: LC11
Project Name: NEIP 5 Year Review
Location: Guilderland, NY
Date: October 11, 2017
Inspector: Aaron Myers
Direction of Photograph: N/A
Landfill Cap: Bare spot/wildlife settlement
