**Silo 6 Investigation and Condemnation Letter,
August 2, 2018**

RE: Silo 6 at the Former Niagara Falls-Buffalo Defense Nike Battery BU-34/35 is located at 601 Willardshire Road near the intersection of North Davis Road in the Town of Aurora, New York.

Encorus Project Number: 18214 – Silo 6 Investigation and Condemnation Letter

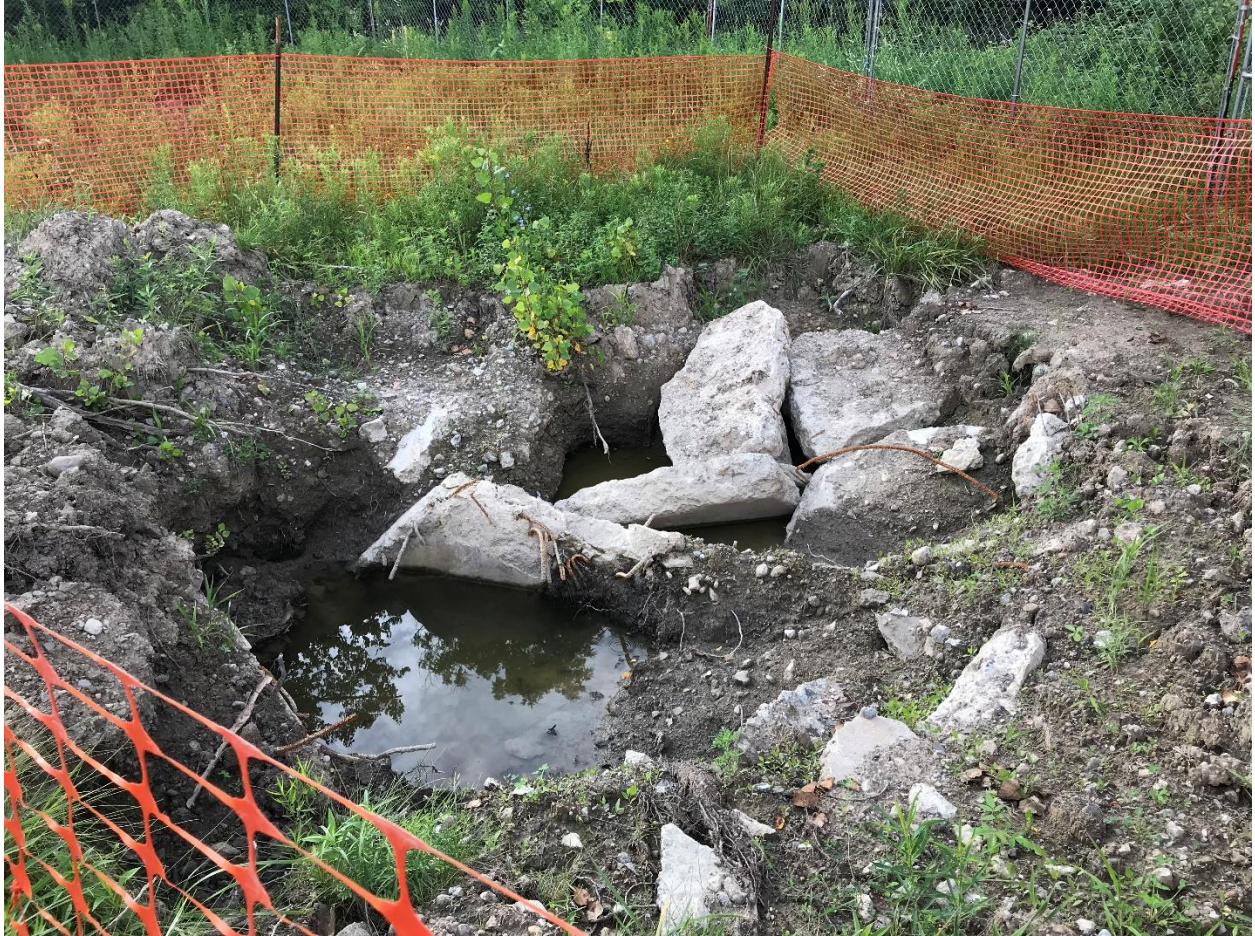
The stairway entry to silo 6 was filled with concrete debris and water (Figure 2). Discussions with TANTARA revealed that several test pits were excavated, and the same concrete debris and water was found. It is my professional opinion that silo 6 is unsafe to occupy in its current state. Based on observed conditions a condemned status and future demolition is found to be warranted to remove the debris contained within silo 6. Regulations for demolition from the governing agency shall be followed. Condemned is defined as follows:

Figure #2 – Silo 6 Stair Entry Filled with Concrete Debris and Water
