APPENDIX Q SITE VISIT PHOTO LOG AND GEOPHYSICAL SURVEY RESULTS

Nike BU-34/35: Launch Area and Control Area Site Visit April 25, 2017

SUBSURFACE ANOMALY MAP GEO-GRAF GEOPHYSICAL INVESTIGATION FINDINGS

FORMER NIKE BU 34/35 LAUNCH AREA, EAST AURORA, NEW YORK

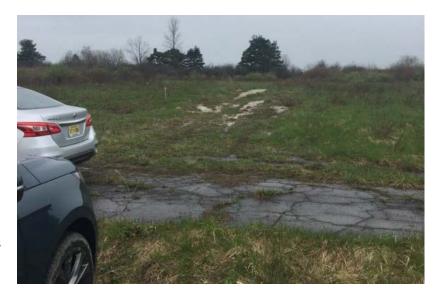
• Conducted a geophysical survey (electromagnetic, radiofrequency, and ground penetrating

radar) of the area (approximately 100-ft by 100-ft surrounding the former Generator Building) to determine if the USTs are still present beneath the surface.

- Geophysical survey did not reveal any indication of a UST in the area.
- No mounding was observed in the area as depicted on the historical photograph.

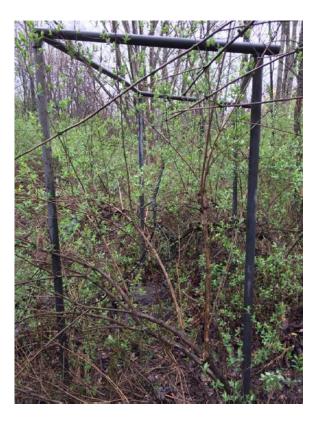
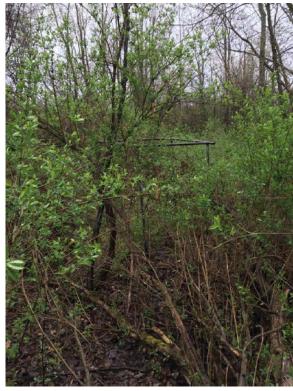
• Conducted a visual inspection of the former location to confirm the building and associated structures. Tubular metal framing and a concrete foundation were located.

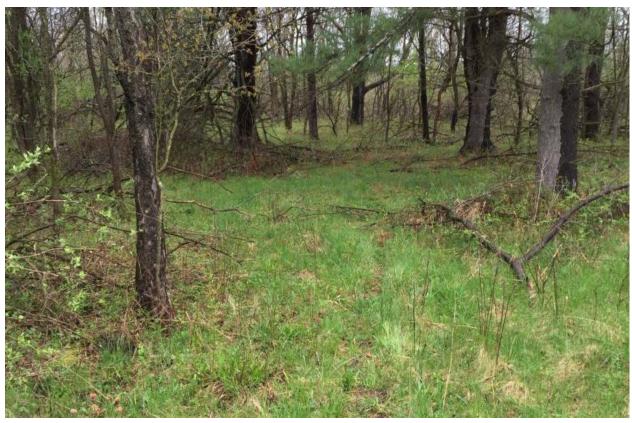
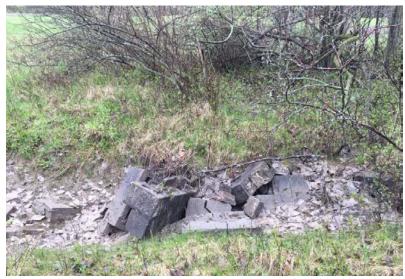
- Conducted a visual inspection of this area, looking for evidence of Army activity in this area.
- No evidence of Army activity was observed in this area. Some Army debris was observed within the channel along the southern border of the property.
- GPS coordinates will be obtained from existing maps and used to help locate the area.

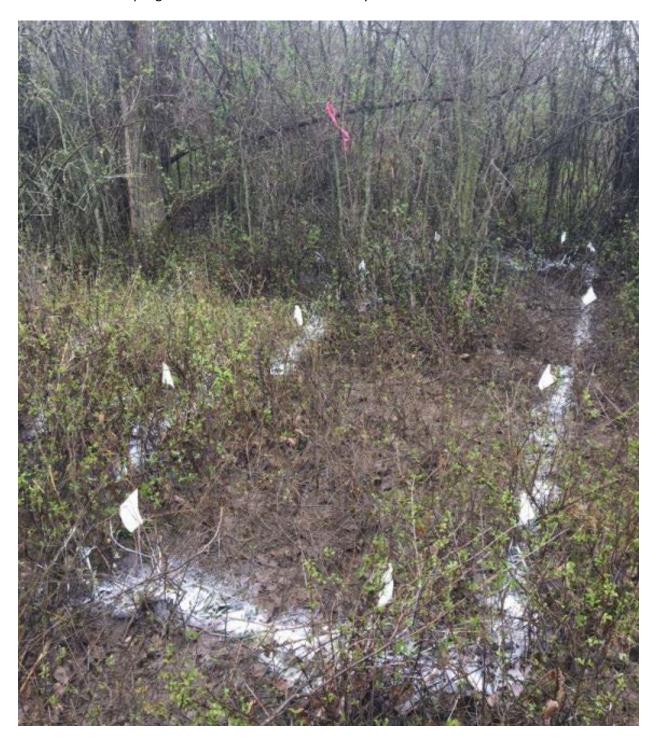
- Conducted a geophysical survey (electromagnetic, radiofrequency, and ground penetrating radar) of the area (approximately 100-ft by 100-ft surrounding the former Generator Building) to determine if the USTs are still present beneath the surface.
- Geophysical survey revealed that a UST was in fact still located in the area adjacent to the former Generator Building (see attached Figure)
- Note: sampling near the UST has not revealed any indication of a release.

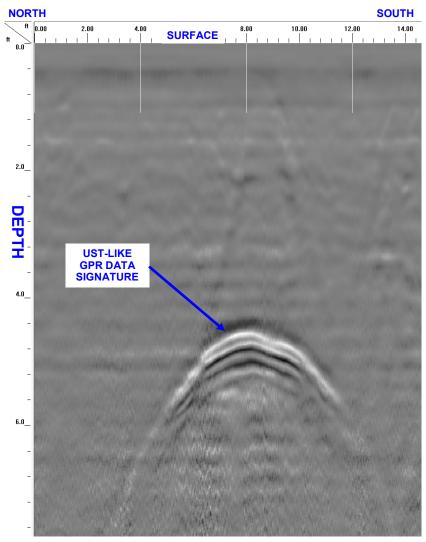
Figure 1-GPR Data Profile

Representative GPR data profile excerpt-*Area* 6. The profile extends from north to south over the detected tank (refer to the *SAM*). Shown in this profile are the UST-like GPR data signatures indicative of a 64"-diameter tank oriented east-west. Estimated depth to the top of the tank based on GPR data approximations is 5' below grade. 400 *MHz* GPR antenna system, edited from 50 *ns*.

UST-like GPR data signatures indicative of a possible 4,000-gallon (64" x 21') tank, oriented eastwest, were delineated within the accessible sections of the investigated area within Area 6 (Launch Area). The location of the tank was field-marked by GGI in white paint/flags and was documented by Tidewater personnel. Estimated depth to the top of the tank based on GPR data approximations is 5' below grade.

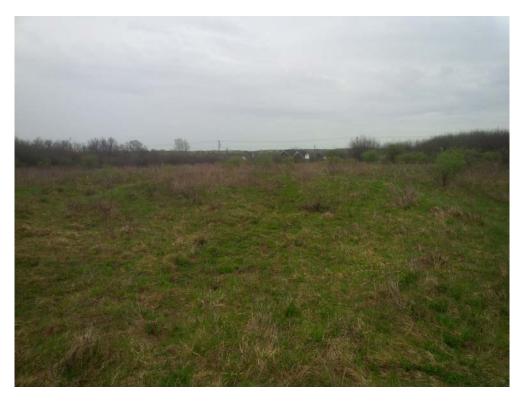
Figure 3 – Site Photograph – Area 2

- Conducted a geophysical survey (electromagnetic, radiofrequency, and ground penetrating radar) of the area (approximately 100-ft by 100-ft surrounding the former Generator Building) to determine if the USTs are still present beneath the surface.
- Geophysical survey did not reveal any indication of a UST in the area.
- No mounding was observed in the area as depicted on the historical photograph.

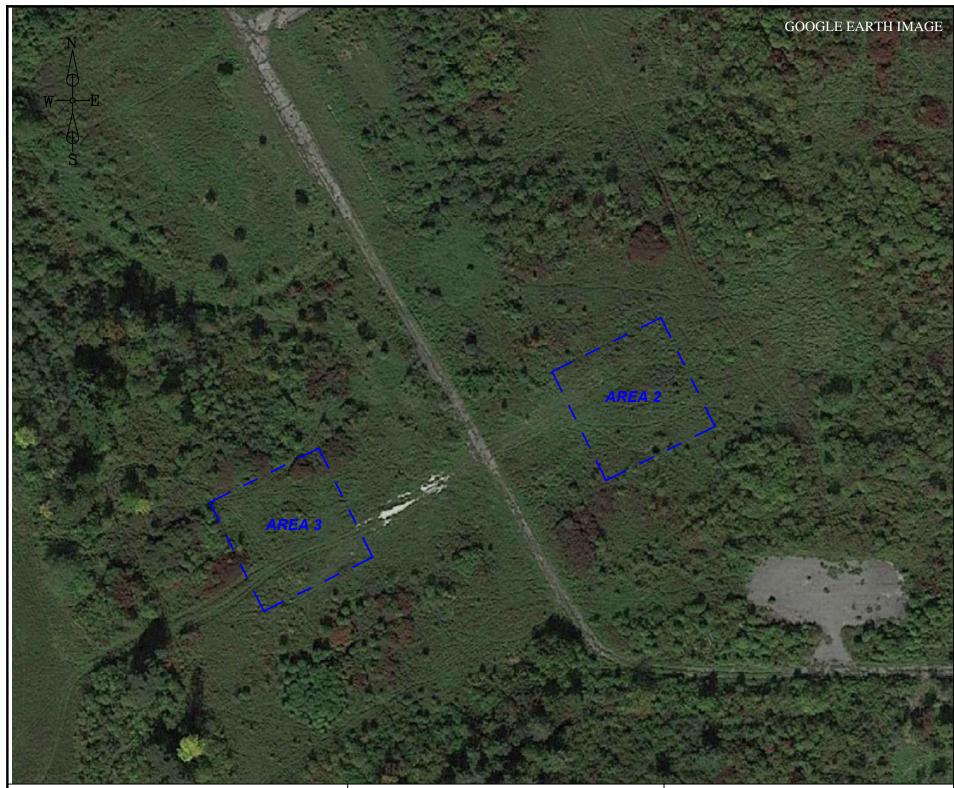
AREAS 2 & 3 FORMER DIESEL **GENERATOR LOCATIONS**

No UST-like GPR data signatures were detected within the accessible sections of the investigated

No significant subsurface anomalies were detected within the accessible sections of the investigated

The estimated maximum GPR signal penetration achieved at this site is approximately 8' below grade. Thus, features existing at or below this depth will go undetected.

GGI did not perform a utility investigation at this site. A utility investigation to locate and field-mark underground utilities prior to any intrusive efforts is strongly recommended.

GGI recommends careful ground-truthing to verify and correlate all investigation findings. Recommended ground-truthing methods are hand digging o Soft-Dig (pot-holing) excavating.

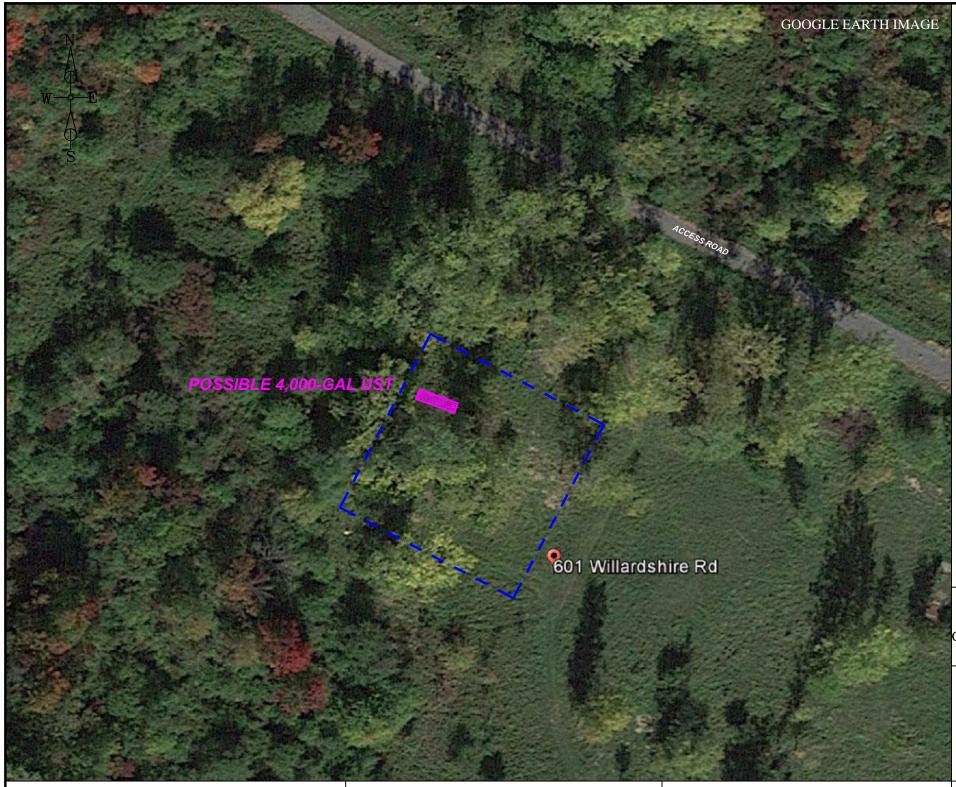
AREA 6 - FORMER **GENERATOR BLDG**

UST-like GPR data signatures indicative of a possible 4,000-gallon (64" x 21') tank oriented east-west were detected within the accessible sections of the investigated area. Estimated depth to the top of the tank based on GPR data approximations is 5' below grade.

No additional significant subsurface anomalies were detected within the accessible sections of the investigated area.

The estimated maximum GPR signal penetration achieved at this site is approximately 8' below grade. Thus, features existing at or below this depth will go undetected.

GGI did not perform a utility investigation at this site. A utility investigation to locate and field-mark underground utilities prior to any intrusive efforts is strongly recommended.

GGI recommends careful ground-truthing to verify and correlate all investigation findings. Recommended ground-truthing methods are hand digging o Soft-Dig (pot-holing) excavating.
