**LOWER PASSAIC RIVER RESTORATION PLANNING
SUMMARY OF RESTORATION OPPORTUNITIES**

1. Kearny Point
2. Oak Island Yards
3. Unnamed Tidal Creek Pulaski Skyway (Lawyer's Creek)
4. Jacobus Avenue-Kearny
5. Un-named Tidal Creek-NJ Turnpike
6. Kearny Marsh (Cedar Creek marsh)

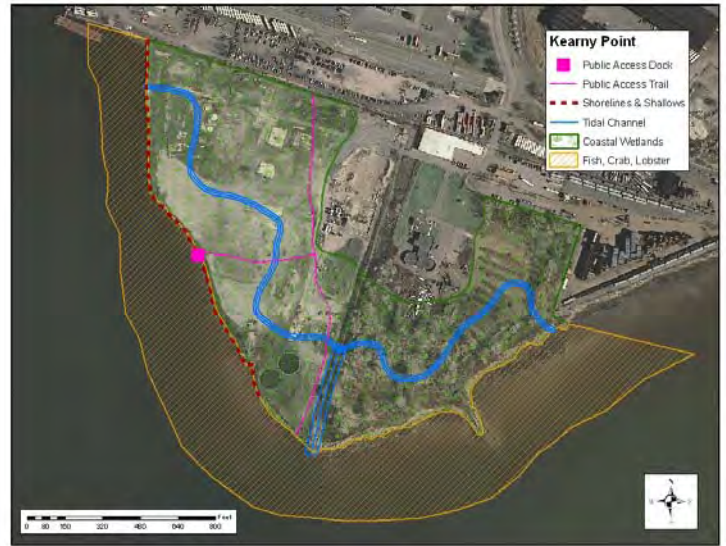
1. Kearny Point

Site Description: The Kearny Point restoration site is a decommissioned industrial facility built entirely of historic fill.

Coastal Wetlands - Re-establish the degraded portion of wetlands that exist along the eastern portion of the point and create new wetlands along the western portion of the point (totaling ≈34.22 acres). Deepen and extend existing tidal channels creating ≈3,519 linear feet of connective sections, re-grade fill, remove invasive species and increase the density of indigenous species.

Shorelines and Shallows - Removing the riprap and bulkhead and re-grading the shoreline with rocky structure and stable slope along the western portion of the point to restore ≈1697.09 linear feet of habitat.

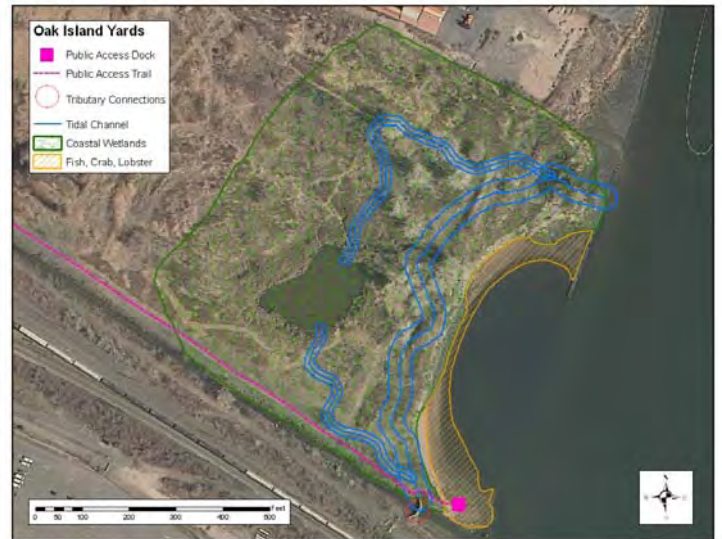
Habitat for Fish, Crabs, and Lobsters – Addition of artificial complex structure to the ≈ 0.93 acre subtidal and intertidal zones will facilitate connections to SAV and marsh habitat.

Public Access – Upgrade existing pedestrian path on southern perimeter of property, construct floating dock for kayak and canoe launch.

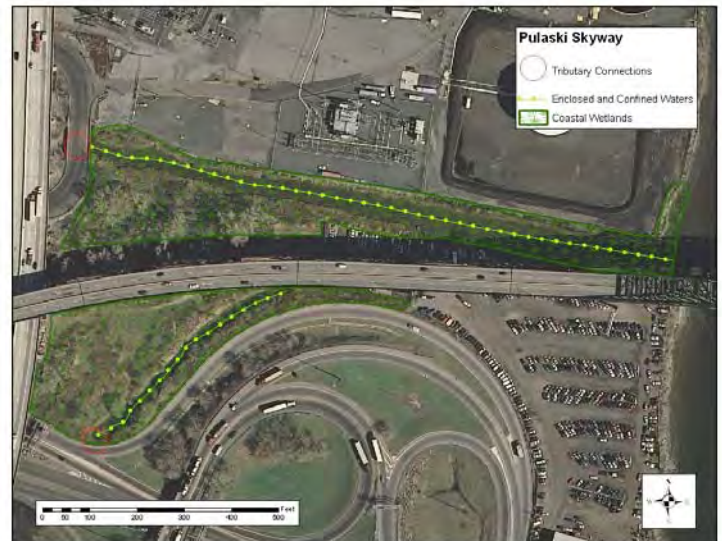
Site Description: Pulaski Skyway (Lawyer’s Creek) is one of the 5 Major Tributaries of the Lower Passaic River. This site is an estuarine system containing a degraded fringe wetland. The intertidal is narrow and filled with hard surface debris. The substrate is primarily open water mudflats with some boulder and riprap. The property immediately north of this site is an active industrial facility (Public Service Gas and Electric Co.) which contains an expanse of paved surface, building structures and equipment.

Coastal Wetlands – Restoration of ≈6.25 acres of marsh, through invasive species removal and native species re-vegetation.

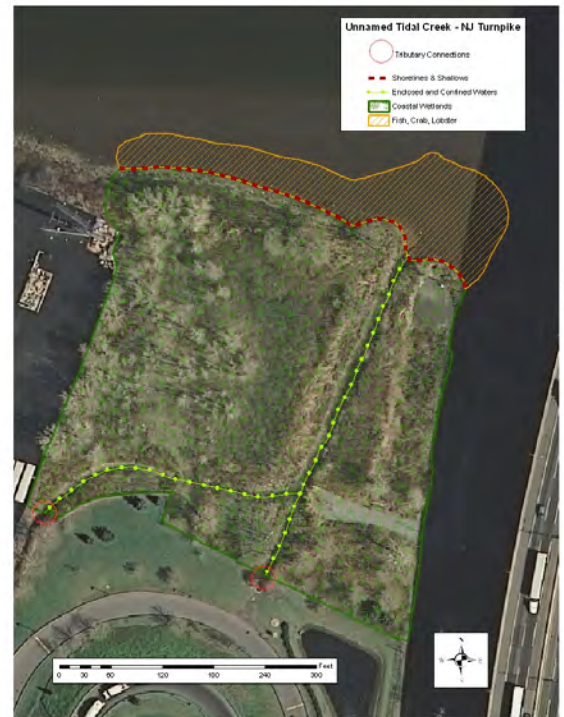
Site Description: This site is adjacent to the Blanchard St./Fairmont Chemical Development Area. It contains a degraded wetland and an unnamed tidal creek with limited flow (possible fresh water source) which runs north to south along the center of the property. The substrate is primarily mudflats and vegetation is visible from the aerial photos.

Coastal Wetlands – Remove fill and re-grade to wetland elevations. Removing invasive vegetation and re-plant with native species to create ≈4.09 acres of coastal wetlands.

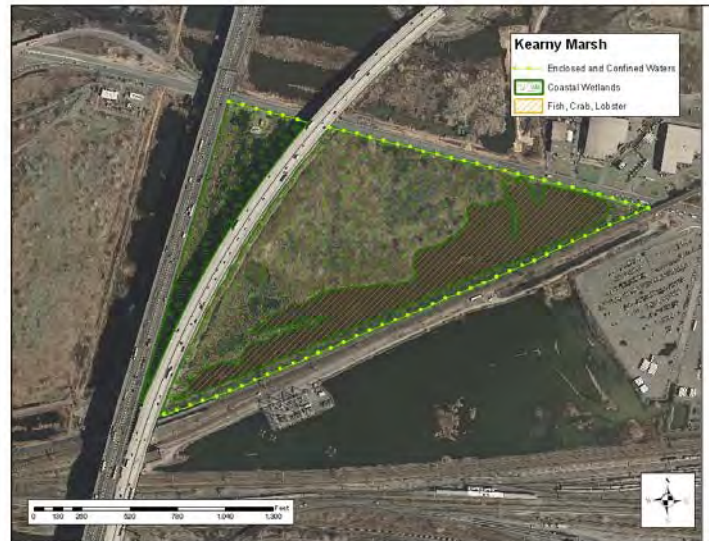
Sediment Contamination – Contaminations to the marsh sediment have been well documented in the literature. Potential dredging and capping of contaminated materials based on sediment sampling.

Habitat for Fish Crab and Lobsters – Addition of complex structure to create functionally related habitats amongst mudflats, low marsh and high marsh to create ≈ 12.10 acres of habitat.

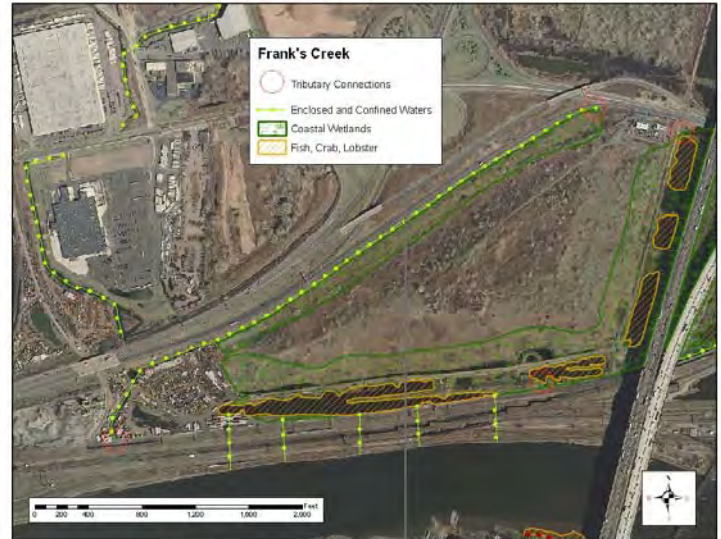
7. FRANKS CREEK SITE (1-D LANDFILL)

Coastal Wetlands – Some re-grading should take place along the existing water bodies to re-establish wetland elevations and soften the edges along the maintenance roads. Due to the existing hilly topography on this property, re-grading should be limited to fringe marsh habitat. Density of emergent vegetation should be increased by removing invasive species and re-planting with native to create ≈ 44.82 acres of wetlands.

Habitat for Fish, Crabs, and Lobsters – New marsh and mudflat habitats and improvements to existing habitats should be designed in a manner to allow connections between and amongst them to create ≈ 10.15 acres of habitat.

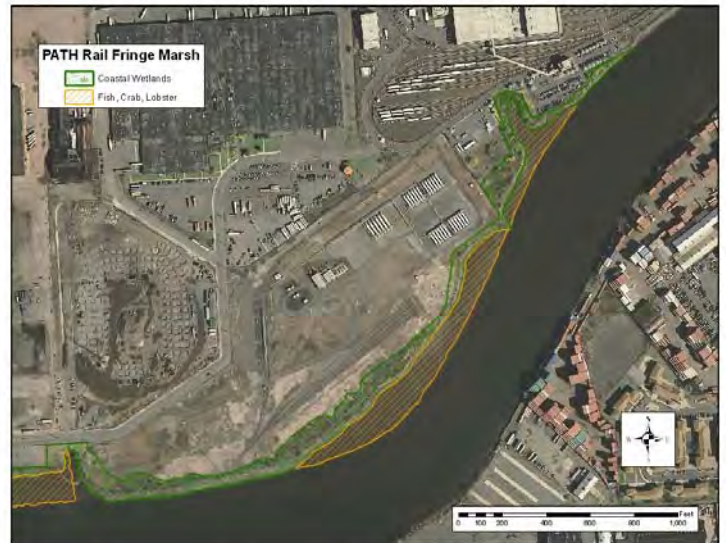
Sediment Contamination – Potential dredging and capping of contaminated materials based on sediment sampling.

Habitat for Fish, Crabs, and Lobsters – Integrate complex structure to create functionally related habitats and connections between mudflats, SAV and marsh to create ≈ 4.47 acres of habitat.

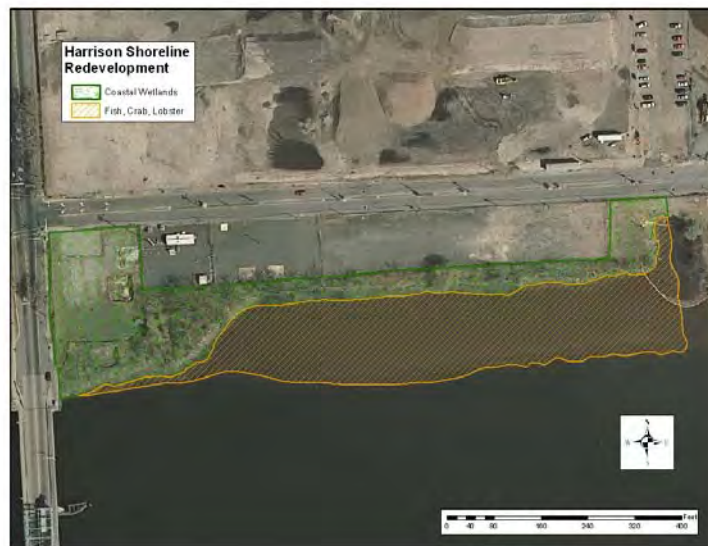
Sediment Contamination – Potential dredging and capping of contaminated materials based on sediment sampling.

Habitat for Fish, Crabs, and Lobsters – Integrate complex structure to create functionally related habitats and connections between mudflats, SAV and marsh to create ≈ 2.58 acres of habitat.

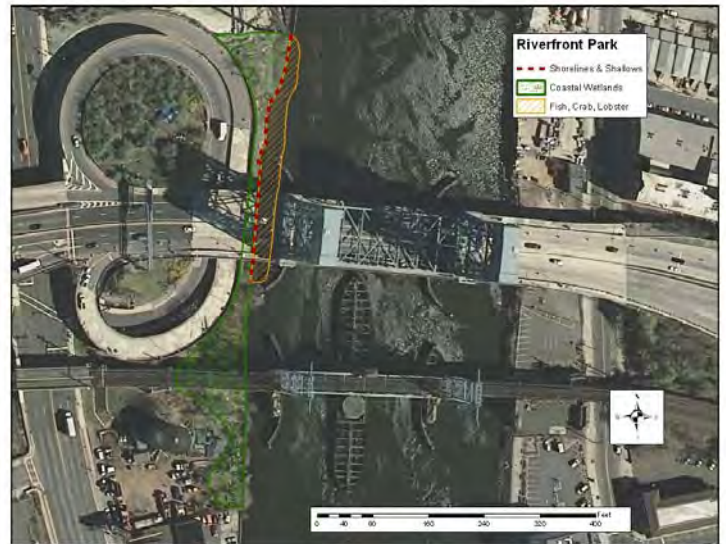
Shorelines and Shallows – Remove fill and re-grade shorelines to wetland elevations. Remove rip rap and bulkhead to allow subtidal sedimentation in an area where bulkheads have caused erosion. Re-structure shoreline with stable slope and rocky structure to restore ≈ 369.83 linear feet of habitat.

Habitat for Fish, Crabs, and Lobsters – Complex structure should be added to the small shoreline and mudflats section just north of the Interstate 280 bridge to create 0.20 acres of habitat. This would help to facilitate connections between the mudflats and the newly created SAV and the marsh.

Public Access - Newly named, Essex County Riverfront Park will consist of a walking path along the bank of the Passaic River from Brill Street to Oxford Street. The park will also include a soccer field and baseball field with synthetic grass surfaces, tennis and basketball courts, a passive meadow, walking paths, two playground areas and a small parking area. There will be a public greenway located on the west side of the park that will be expanded to nine city blocks long spreading from Van Buren Street to Brill Street.

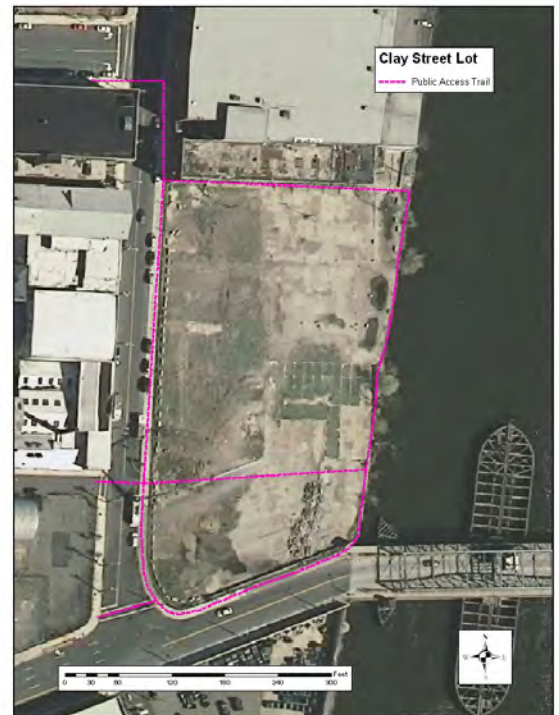
Site Description: This site is a vacant lot which contains un-remediated BTEX groundwater and soil contamination. This site contains bulkhead along the entire Passaic River perimeter, remnants of building foundations and appears to contain a significant amount of fill.

Sediment Contamination - Potential dredging and/or capping of contaminated sediment based on sediment sampling.

Public Access – Create a park with pedestrian paths based off of existing street network and access to the waterfront and in collaboration with Newark Riverfront Development Framework. Paths will run the perimeter of the property and compliment design guidelines for waterfront public access easement.

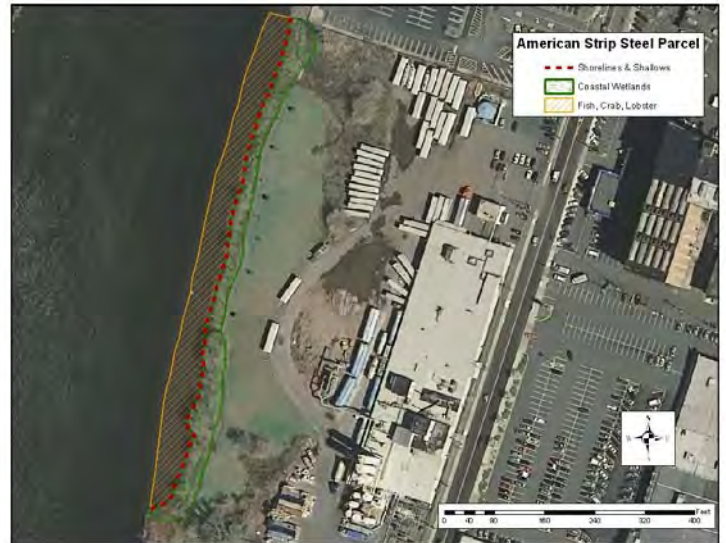
Coastal Wetlands – Protect and restore the existing fringe marsh habitat. Density of emergent vegetation should be increased by removing invasive species and re-planted with natives to create ≈ 0.59 acres of wetland.

Habitat for Fish, Crabs, and Lobsters – Addition of complex structure to the mudflat will facilitate connections between SAV and fringe marsh habitat to create ≈ 0.78 acres of habitat.

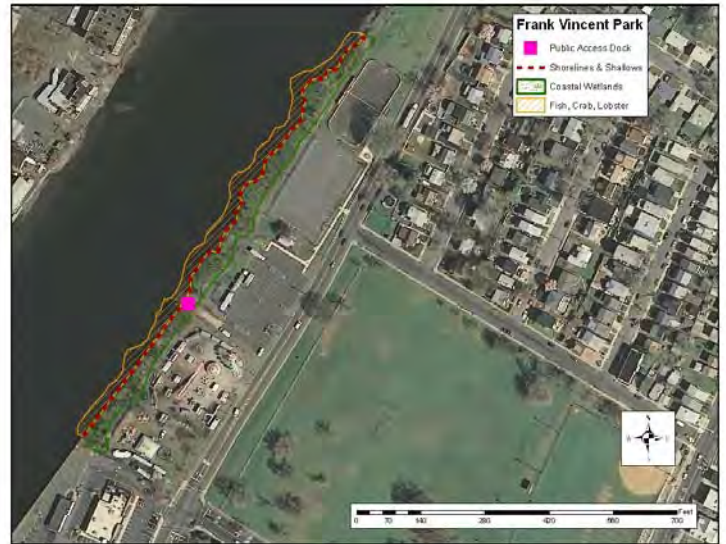
Habitat for Fish, Crabs, and Lobsters – Removal of manmade structures where possible. Addition of complex structure to the mudflats will facilitate connections between the mudflats and fringe marsh to create ≈0.66 acres of habitat.

Public Access – Plans exist for a boat launch upgrade as part of the Town of Kearny Passaic Avenue Redevelopment efforts.

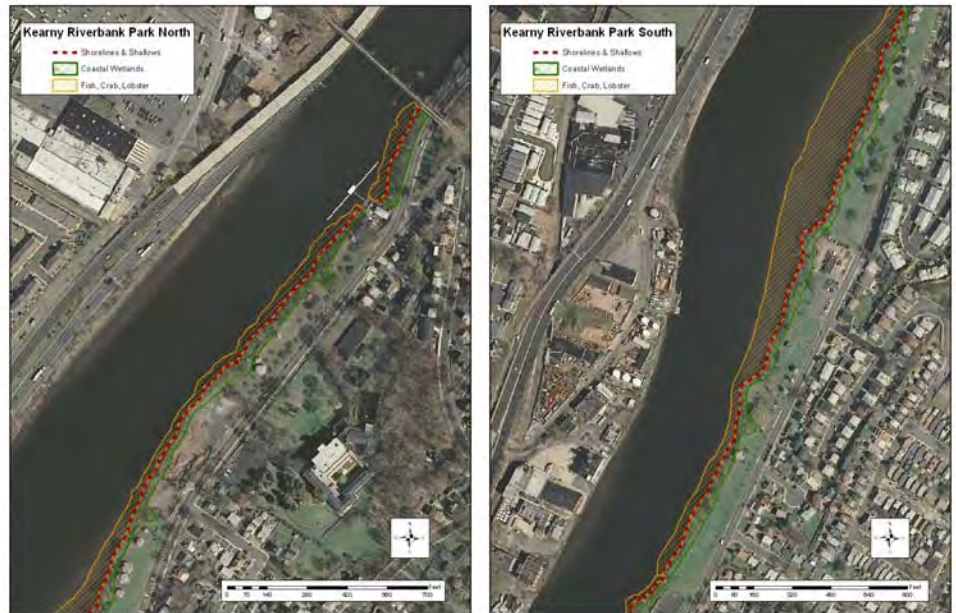
Coastal Wetlands – Removing invasive flora, replanting with indigenous species to create ≈ 4.3 acres of wetland.

Habitat for Fish, Crabs, and Lobsters – Removal of manmade structures (where possible). Addition of complex structure to the mudflats will facilitate connections between the mudflats and fringe marsh to create ≈ 7.3 acres of habitat.

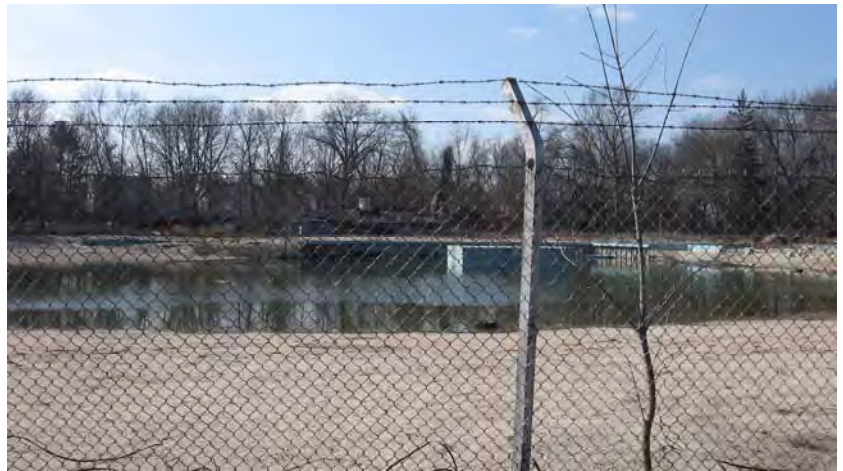
21. SADDLE RIVER ARCOLA POOL SITE

Site Description: This reach of the Saddle River has a relatively mild channel slope. Wetland/flood retention areas can be found along the relatively undeveloped overbanks of this reach. Periodic maintenance has been performed by the local governments within this reach. The excessive backwater caused by the downstream constrictions, inadequate channel capacity and a mild bottom slope contribute to the flooding in this reach. Near the stream bank this site is predominantly suburban residential in nature. The residences are generally buffered from the banks by lands which are part of the Bergen County Park System.

Tributary Connections – Restoration of ≈ 2.72 acres of forested flood plain will re-connected this site to the adjacent habitat. This will involve excavation of remaining concrete, clean fill of the pool, and planting of native species. Removal of debris.

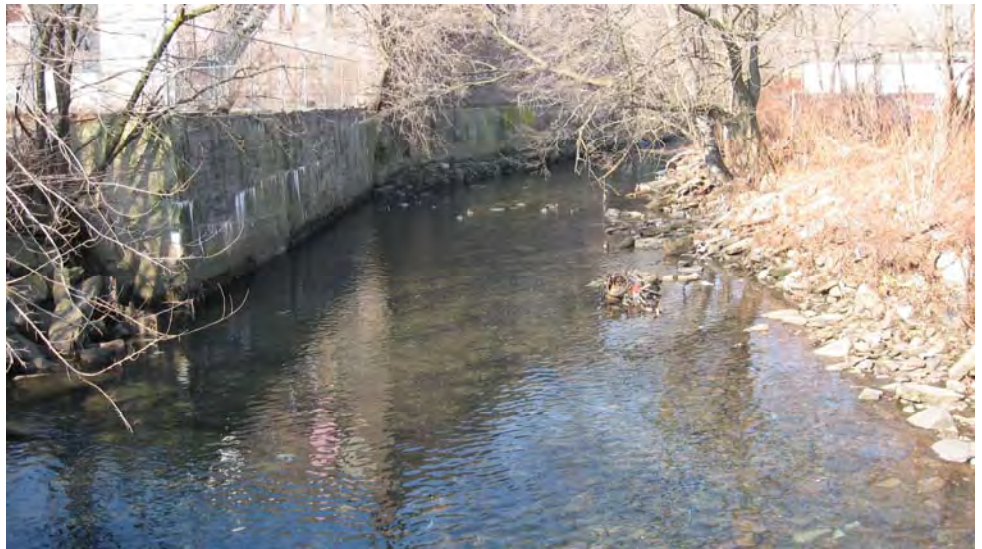
Tributary Connections – Stream bank restoration to $\approx 3,729.71$ linear feet in Passaic and $\approx 3,569.12$ linear feet in Belleville should improve failing rip rap and concrete banks and create natural shoreline. Areas that contain natural stream bank (≈ 7.42 acres in Passaic and ≈ 16.92 acres in Belleville) should be preserved as floodplain areas and may provide good restoration opportunities.

Public Access – Improvements to $\approx 2,797.90$ linear feet of existing pedestrian paths Belleville.

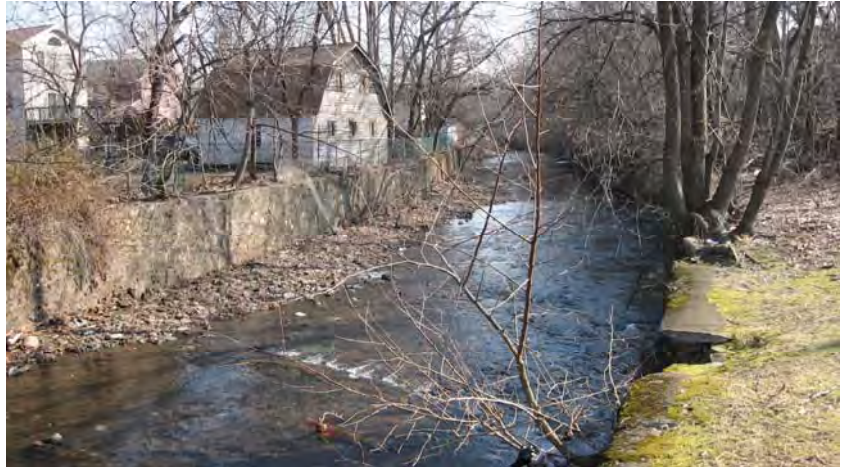
25. SECOND RIVER BLOOMFIELD

Site Description: This site contains a thin forested strip of public land on both sides of the river with natural slopes (no bulkhead). Concrete stream banks are deteriorating, increasing erosion. Area is highly urban so restoration of flood plain property is unlikely.

Public Access – Improvements to $\approx 1,209.93$ linear feet of existing pedestrian paths and park.

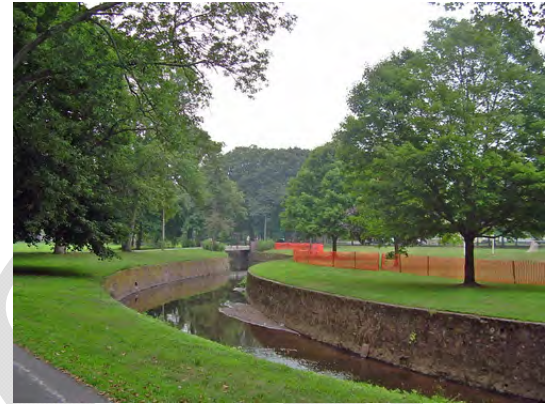
Tributary Connections – Failing concrete banks are increasing erosion. Opportunity exists to create and re-vegetate natural slopes. Enhancement and utilization of ≈ 9.03 acres of forested flood plain would decrease the severity of flooding, this may require re-grading to flood plain elevations, removal of invasive species and re-planting with natives. North of Watsessing Park the river is completely channalized and underground; restoration of $\approx 5,123.81$ linear feet of stream corridor should include naturalizing the stream bank and cleaning and assessing capacity of culverts and passages.

Public Access – Improvements to 2,559 linear feet of existing paths, parks, ball fields and signage.

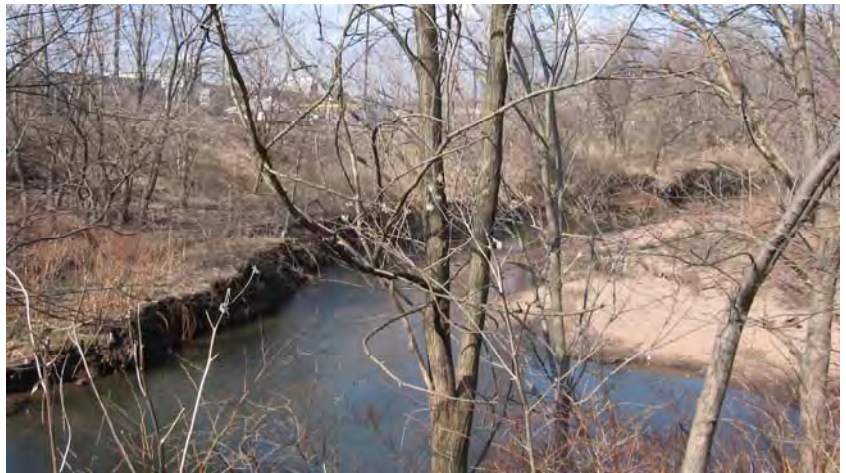
Tributary Connections – Restoration of $\approx 6,383.54$ linear feet of river corridor and re-connection of ≈ 14.21 acres of forested floodplain. Potentially, re-grade elevations to counter balance sedimentation. Preserve and restore riparian buffer, remove invasive species and re-plant with natives. Re-assess culvert capacity in channelized and underground portions.

Public Access – Creation of Greenway in collaboration with City of Clifton and Passaic River Coalition. Greenway would provide recreation and wildlife preservation. School is located near site with underutilized parking lots. This area has great potential for park and playgrounds.
