# Draft Wetland Mitigation Plan

River Bend Golf Course – New Berlin, NY

The Wetland Trust Susquehanna Basin Headwaters In-Lieu Fee Program

19 May 2015

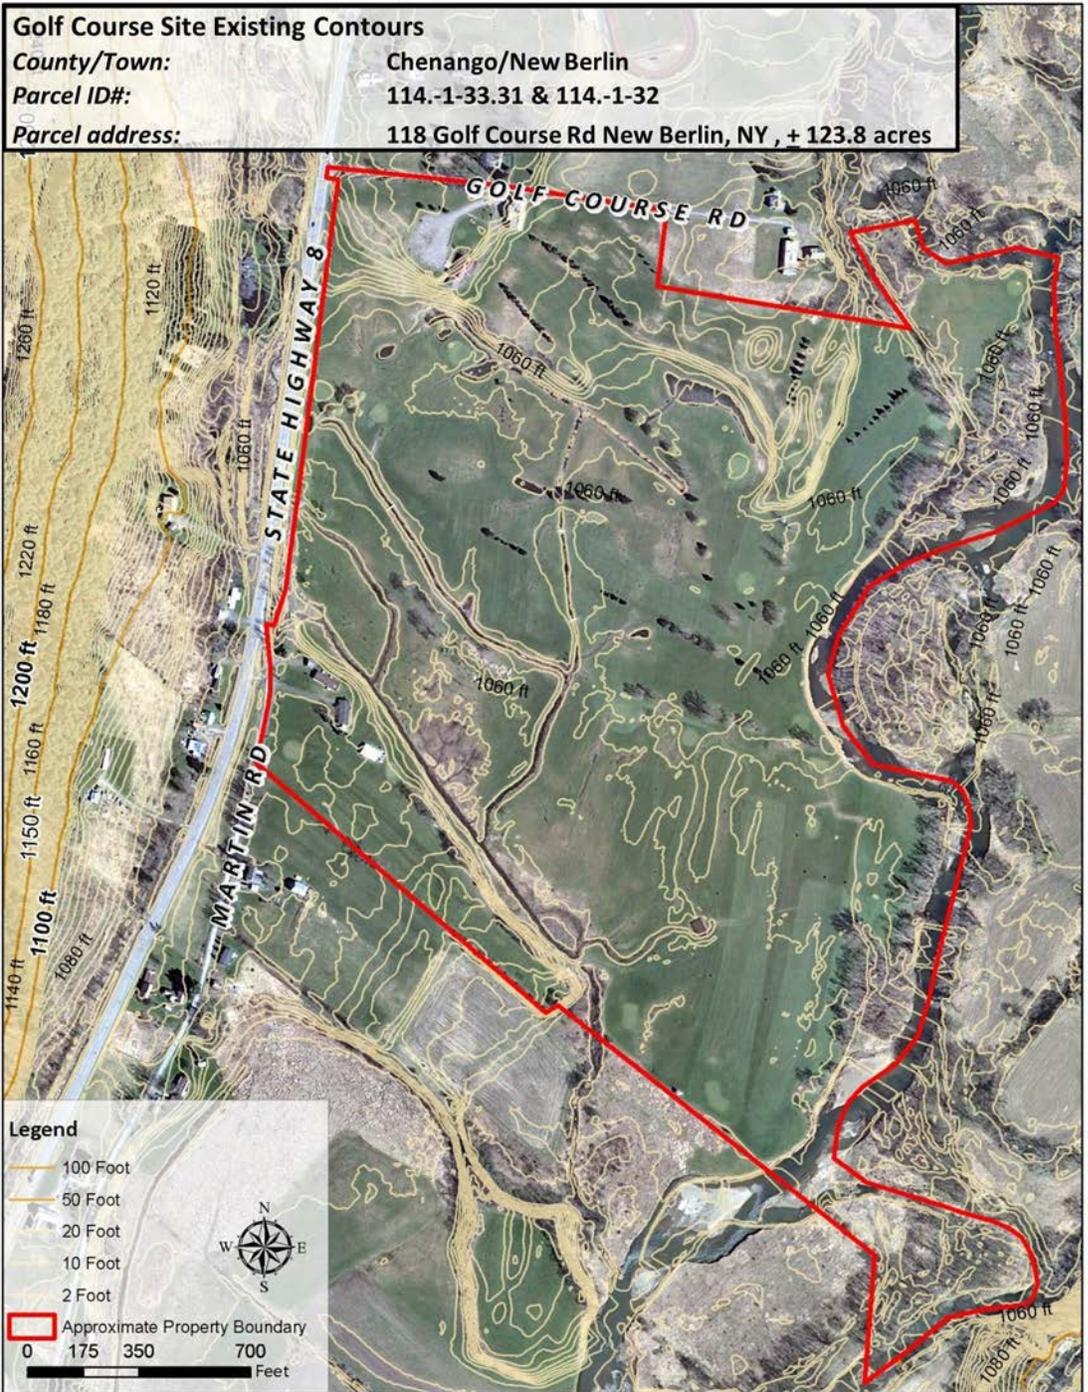
**Figure 2 View of the ILF Site.**

The Unadilla River lies along the eastern property boundary. Several golf greens can be seen throughout the property, with the large majority of the property maintained as open space. Several linear drain features can be seen crossing the property, and ultimately draining into the Unadilla River to the southern portion of the property.

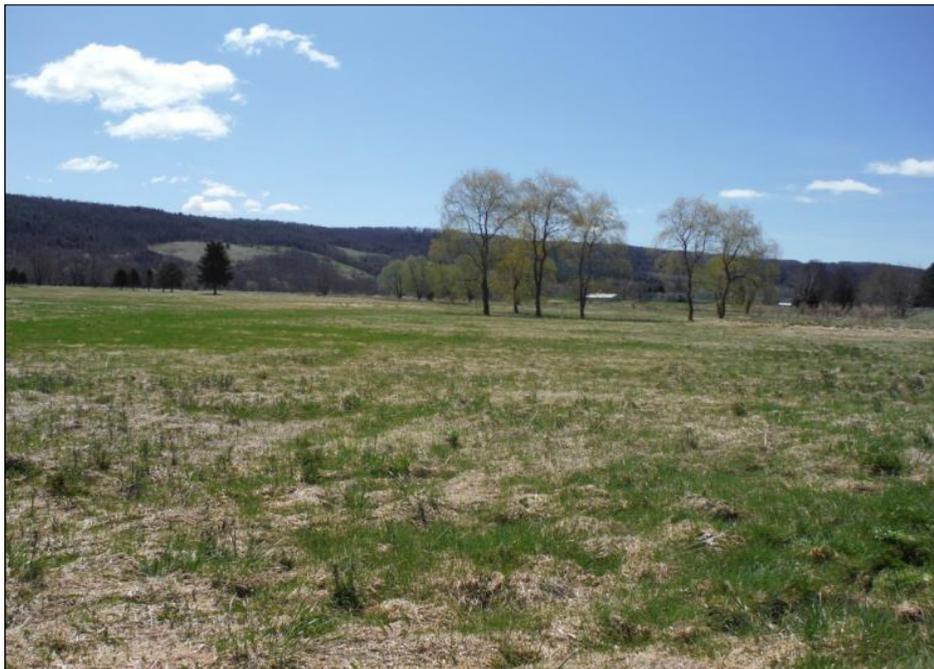
Looking east toward the Unadilla River on 5 May 2014. Shows typical upland areas.

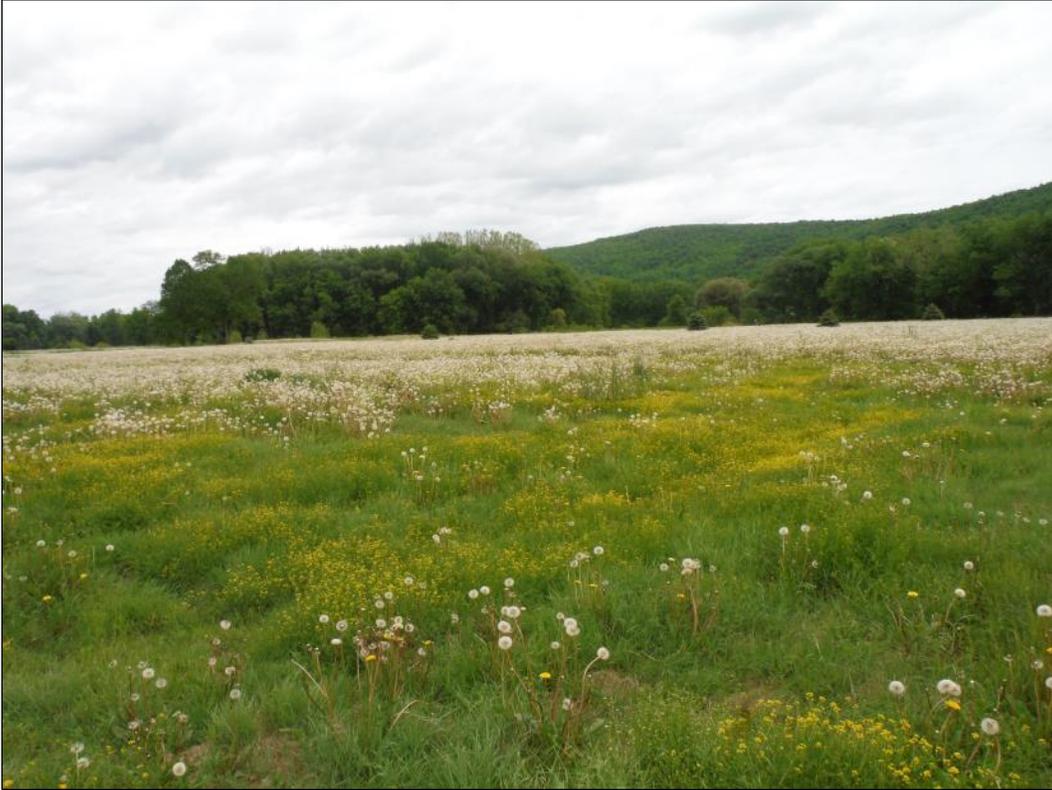
Southeastern portion of the property was dominated by upland plants upon field visitation in 2014.

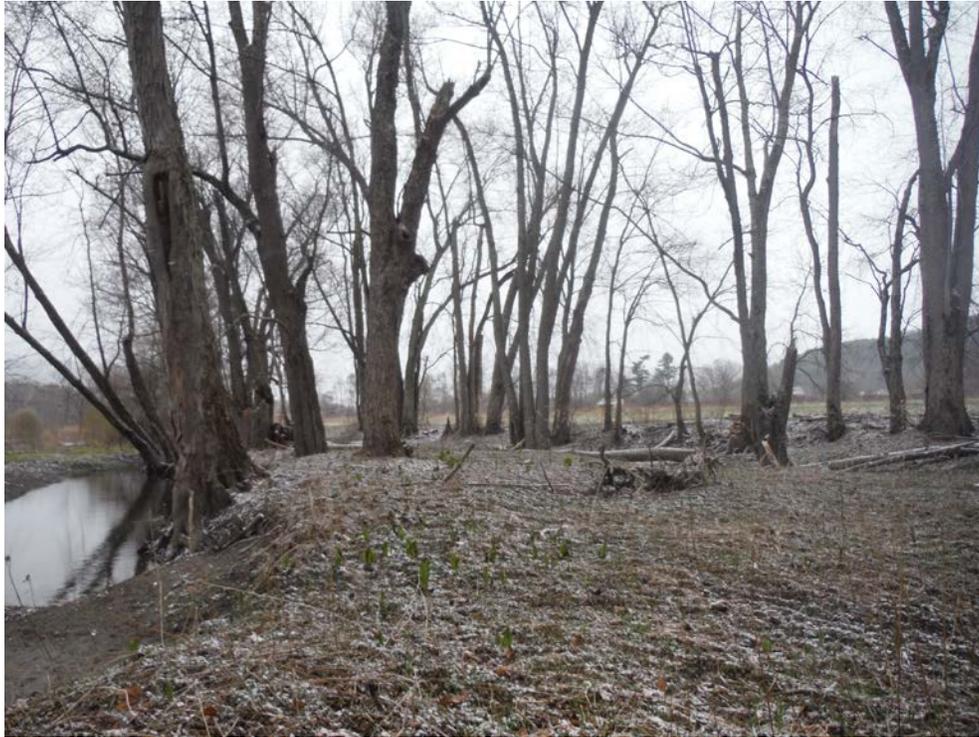
Floodplain forest adjacent to Unadilla River

The floodplain forest wetlands on the property (4.69) are spatially separated from the main work areas depicted in the site plan (Figure 3). These wetlands are subject to periodic flooding from the Unadilla River, particularly in early spring following snow-melt. Drift lines were common during field visits (April to October, 2014). These wetlands provide an important buffer to the Unadilla River, and they are dominated by red maple (*Acer rubrum*) (FAC), American Sycamore (*Platanus occidentalis*) (FACW), and Freeman maple (*Acer x freemanii*). Freeman maple (no indicator status) is one of the more dominant of the trees in the floodplain forest; it is a naturally occurring fertile hybrid of red and silver maple (*A. rubrum* (FAC) & *A. sacharinum* (FACW)). Common herbaceous species in the floodplain forest include skunk cabbage (*Symplocarpus foetidus*) (OBL), ostrich fern (*Matteuccia struthiopteris*) (FAC), spotted jewelweed (*Impatiens capensis*) (FACW), and sensitive fern (*Onoclea sensibilis*) (FACW).

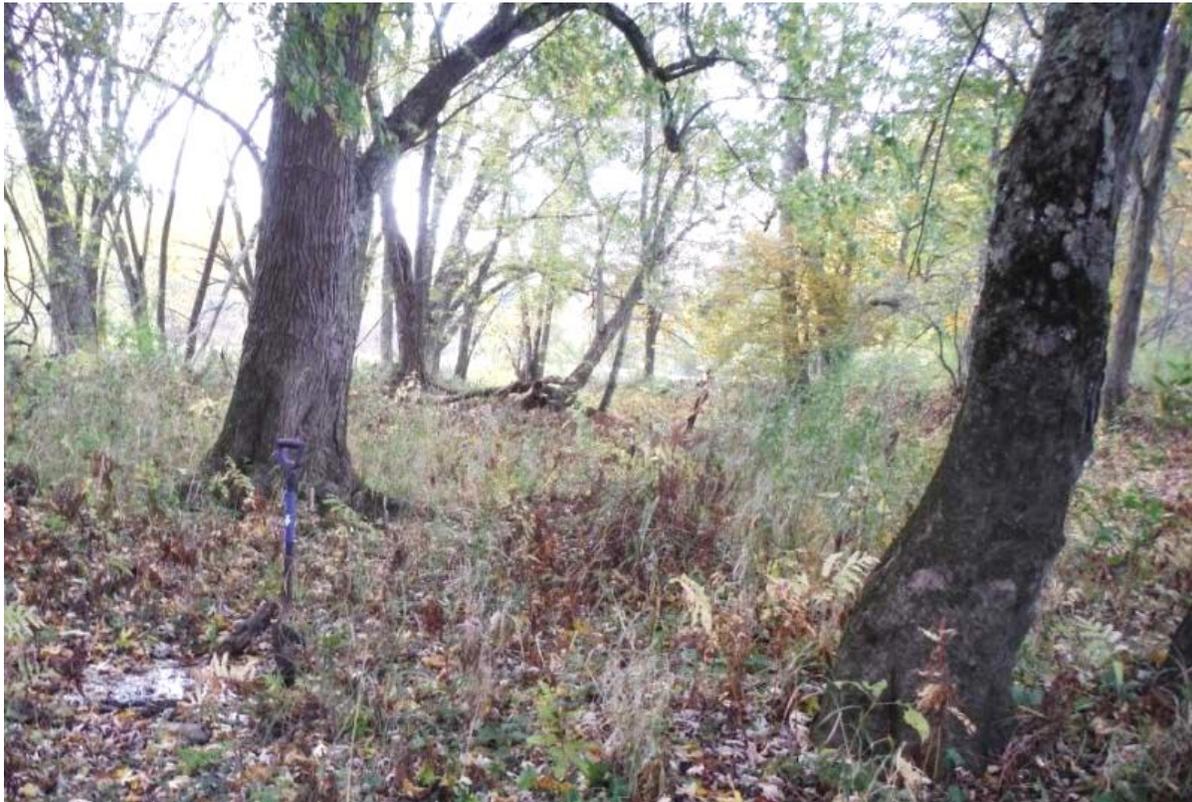
A forested wetland with large American Sycamore (*P. occidentalis*) and Freeman maple (*A. x freemanii*) shown along the Unadilla River in August 2014.

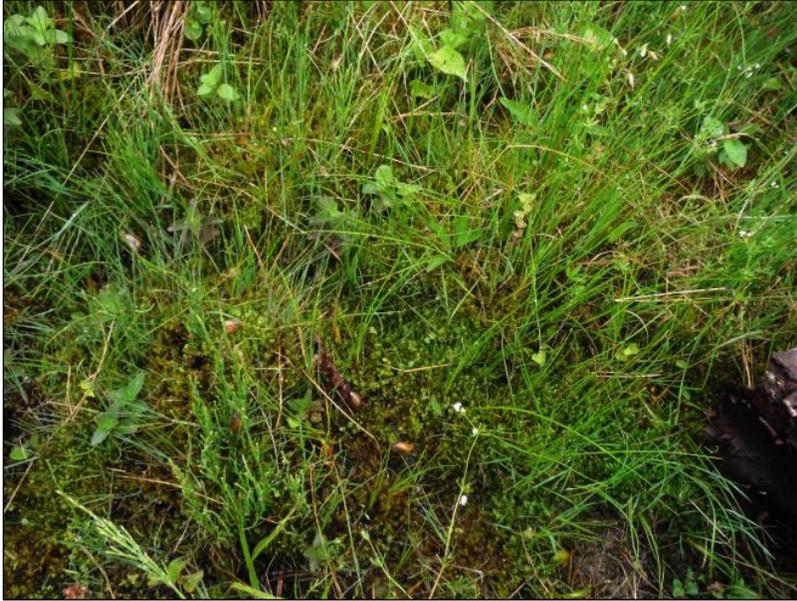
One sloping wet meadow was located on the property and is dominated by common spike-rush

(*Eleocharis palustris*) (OBL) with small patches of wetland vegetation typical of rich sloping fens, an endangered community in New York State. Other notable species include creeping spike-moss (*Selaginella apoda*) (FACW), limestone meadow sedge (*Carex granularis*) (FACW), and smooth saw-grass (*Cladium mariscoides*) (OBL).

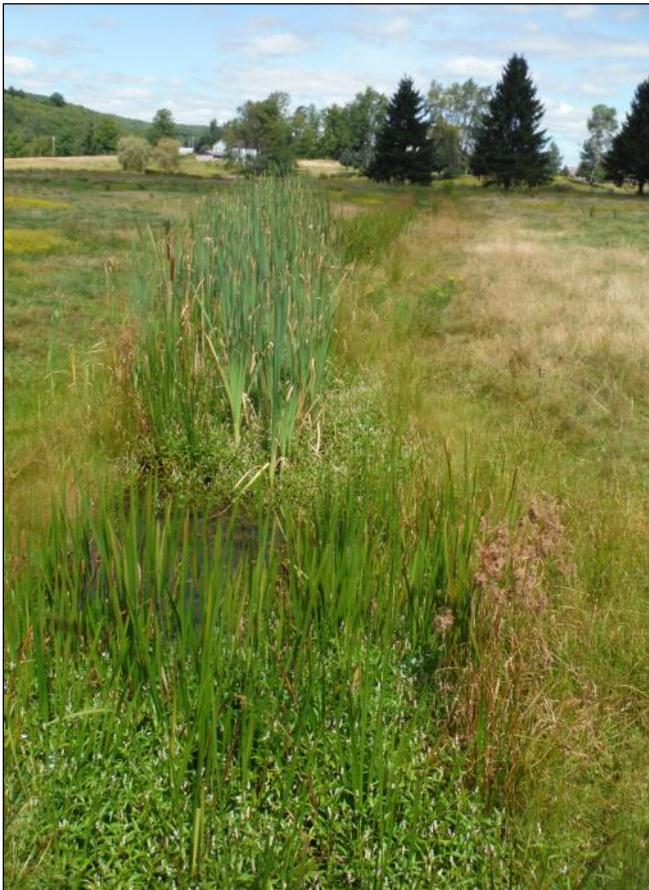
Other existing emergent wetlands on the property as depicted in Figure 3 are dominated by broad-leaved cattail (*Typha latifolia*) (OBL), lamp rush (*Juncus effusus*) (OBL), American bur-reed (*Sparganium americanum*) (OBL), lakebank sedge (*Carex lacustris*) (OBL), and tussock sedge (*Carex stricta*) (OBL). Some sparse shrub cover is present (typically <15% cover by area) along margins of linear wetland features including willow species (*Salix* spp.), red osier dogwood (*Cornus alba*) (FACW), and silky dogwood (*Cornus amomum*) (FACW). A linear PEM wetland (left) is shown. View is looking north.

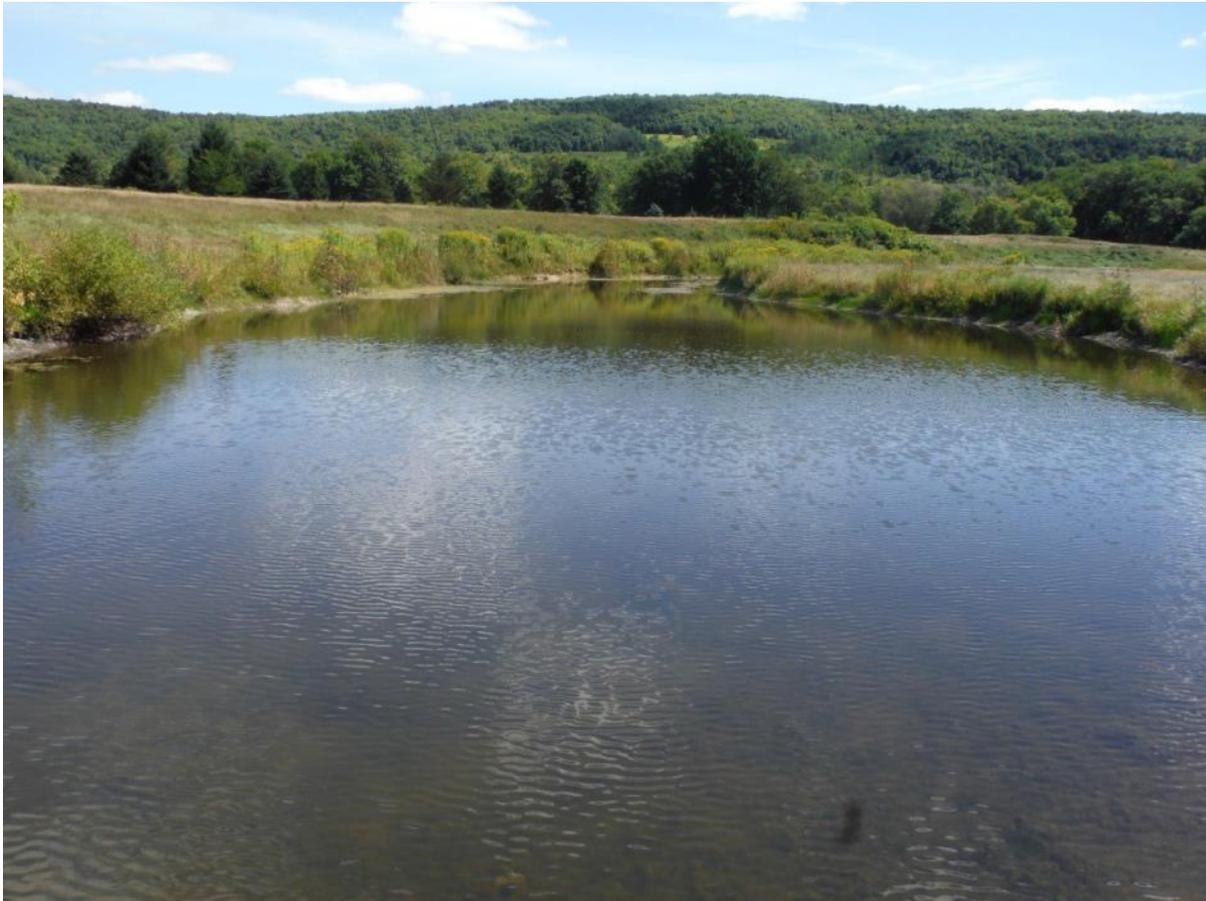
Open water ponds (0.78 acres) on the property contain several species of fish, and offer wading and dabbling birds with feeding opportunities.

9 October 2014 looking east towards the Unadilla River.

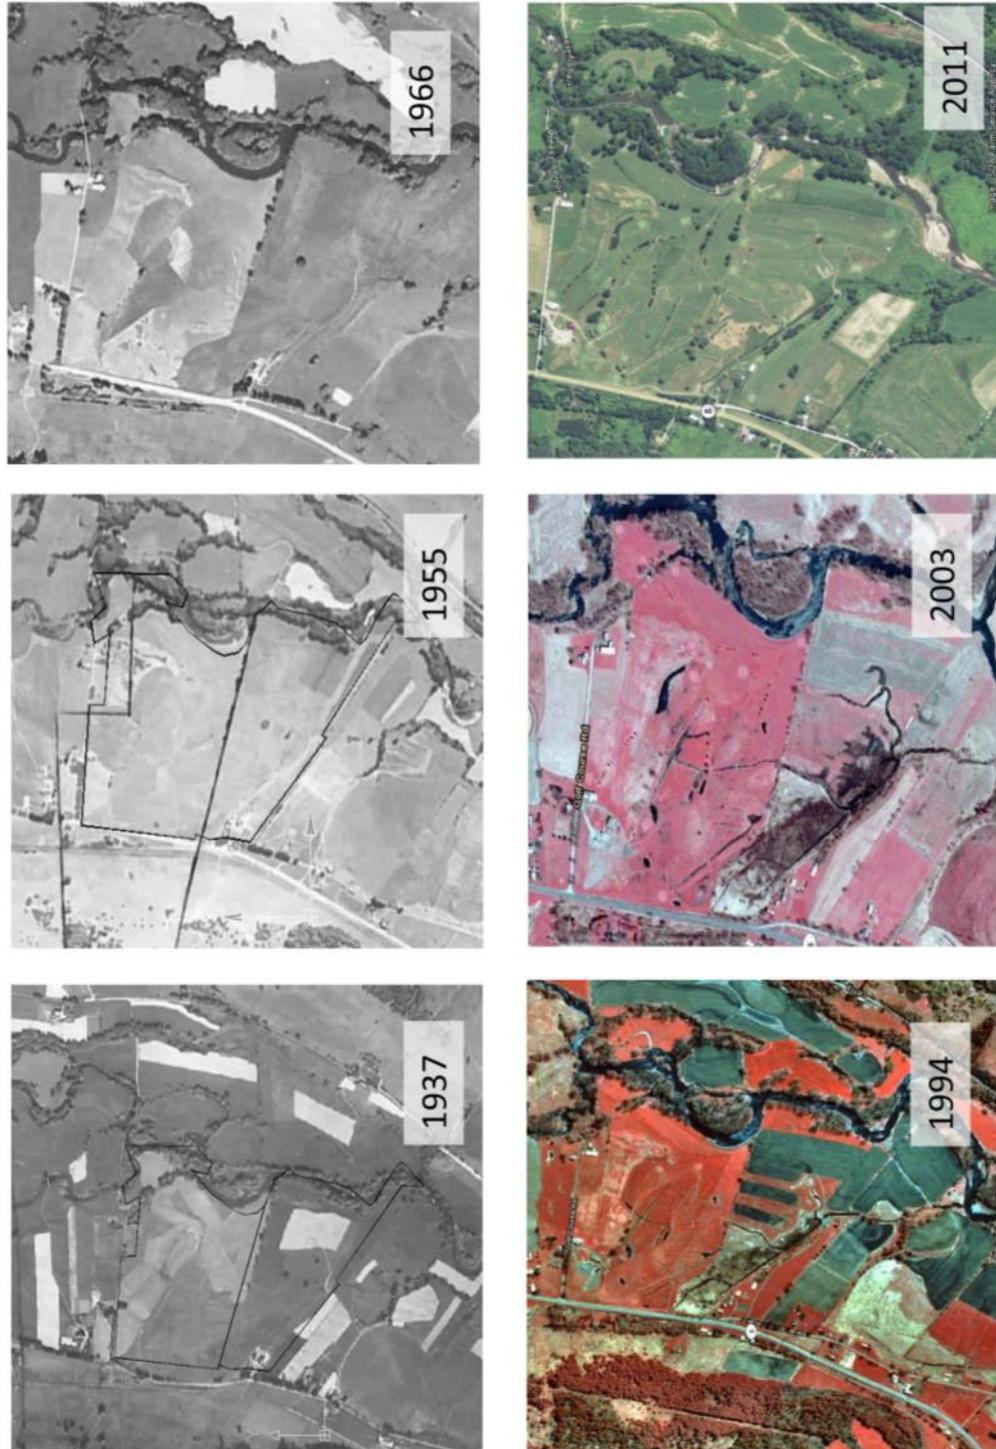
**Figure 4 Site History.** A written synopsis of changes is provided on the following page.

The 1937 aerial photo showing the original 9 hole golf course on the northern parcel (black outline). Vegetation was completely cleared from the southern parcel, with most large portions of the property indicative of agricultural use including previous tillage. The adjacent roadway that bounds the westerly border of the site conformed to the base of the hillside and ditching and surface drainage features apparent in later years cannot yet be identified. By 1955, Route 8 is notably straighter and drainage features appears in conjunction with the installation of a box culvert under the newly formed roadway. The 1966 aerial photo shows the initial drainage ditch that originates at the Route 8 culvert and travels eastward for a short distance before hooking abruptly to the south. At the property line the ditch turns eastward and drains southeast into the Unadilla River. The drainage ditch that appeared in 1966 appears to be abandoned by 1994 (shown here), however, significant additional drainage ditching is identified across both parcels redirecting surface flows southeast. Historically the site was comprised of two distinct parcels and remained that way until approximately 2003, when the golf course acquired the southerly parcel.

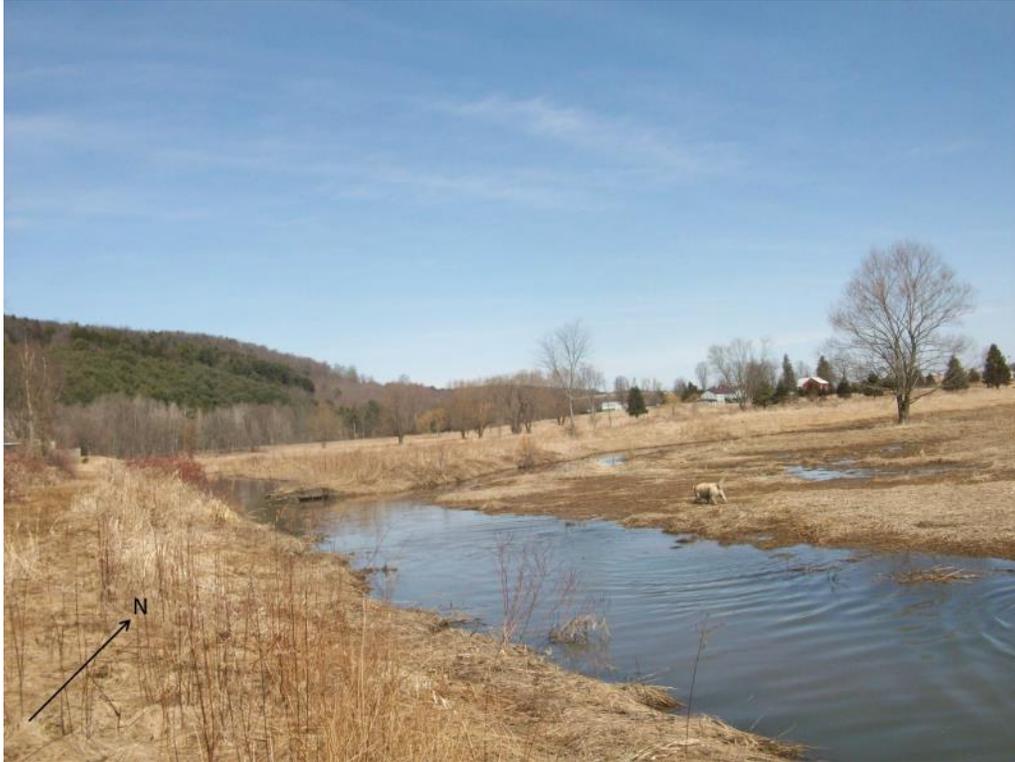
View is looking Northwest at a point of hydrological convergence (linear PEM wetlands converging to an unnamed tributary to the Unadilla River).

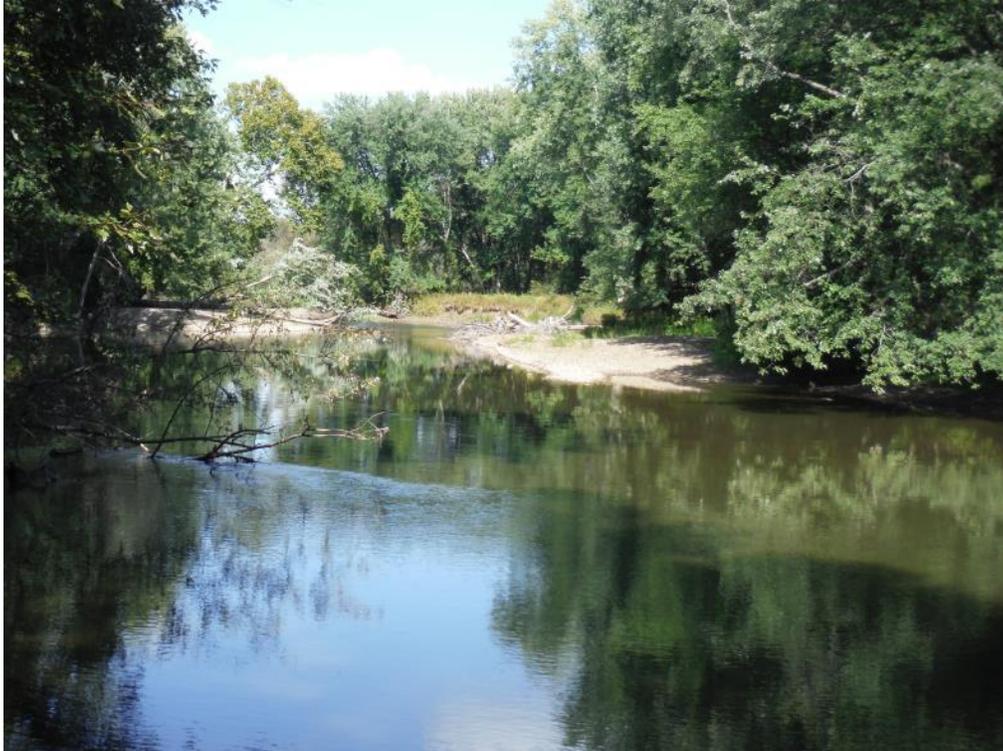
View of the Unadilla River at the eastern border of the mitigation site during September 2014.

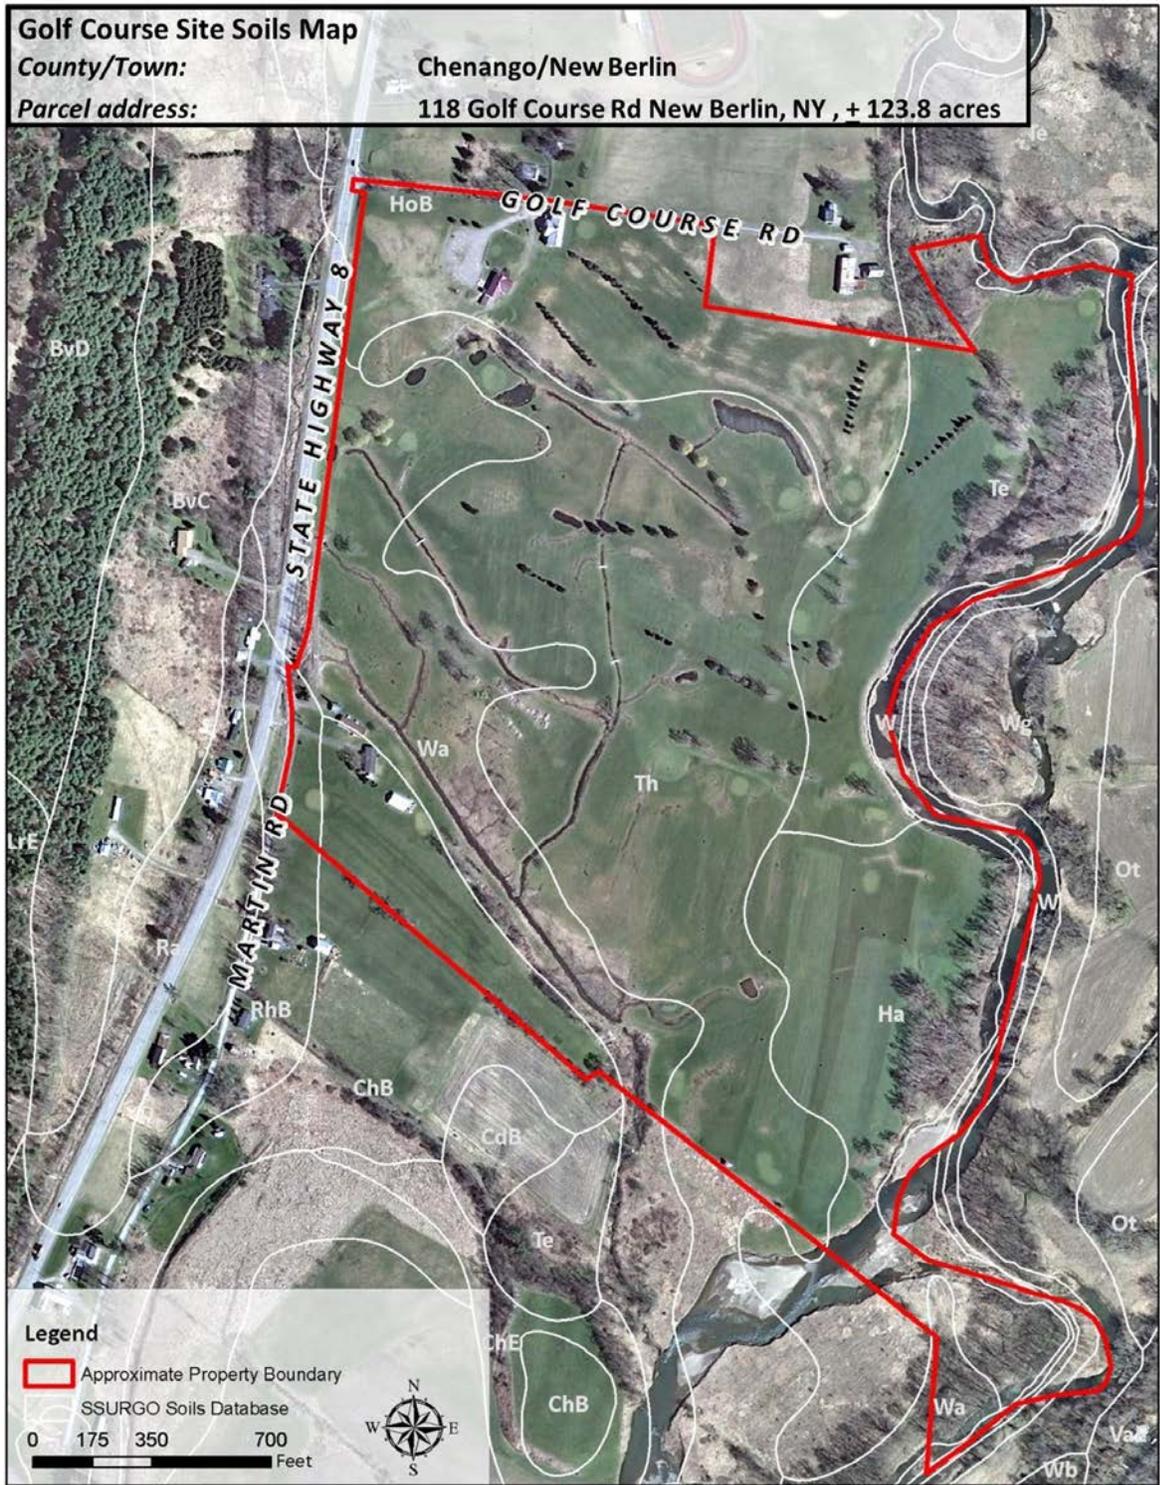
Figure 5 Soils Map.

Based on the Soil Survey of Chenango County, New York (USDA Official Soil Series Descriptions) several soil series are mapped on-site including Teel and Hamlin silt loams, Wayland soils complex, and Howard gravelly loam. A soils map is provided in Figure 5. Soil conditions in the field appear to conform to the mapped soil series.

The Wayland (Wa) series consists of deep, poorly drained, nearly level soils formed in recent alluvium. These soils are in low areas or slackwater areas on flood plains. Saturated hydraulic conductivity is moderately high or high in the mineral soil. Wayland silt loams are considered hydric soils.

The Teel series (Te, Th) consists of very deep, moderately well drained soils on floodplains. They formed in nearly level, silty alluvial deposits. Permeability is moderate. The water table extends up into the lower part of the subsoil in the winter and spring. These soils formed in alluvium predominantly from areas of glacial drift that contains limestone, fine grained sandstone and granite. Slope ranges from 0 to 3 percent. Teel Silt loams are typically not hydric soils, except when modified by localized hydrologic inputs.

The Hamlin (Ha) series consists of very deep, well drained soils formed in alluvium on flood plains and high bottoms. Permeability is moderate in the upper and substratum. The soils formed in post glacial alluvium mainly from areas of siltstone, shale and limestone.

Howard soils (HoB) consist of very deep, well drained and somewhat excessively drained soils formed in medium textured glacial outwash deposits. The soils are on valley terraces, outwash plains, kame moraines, and eskers.

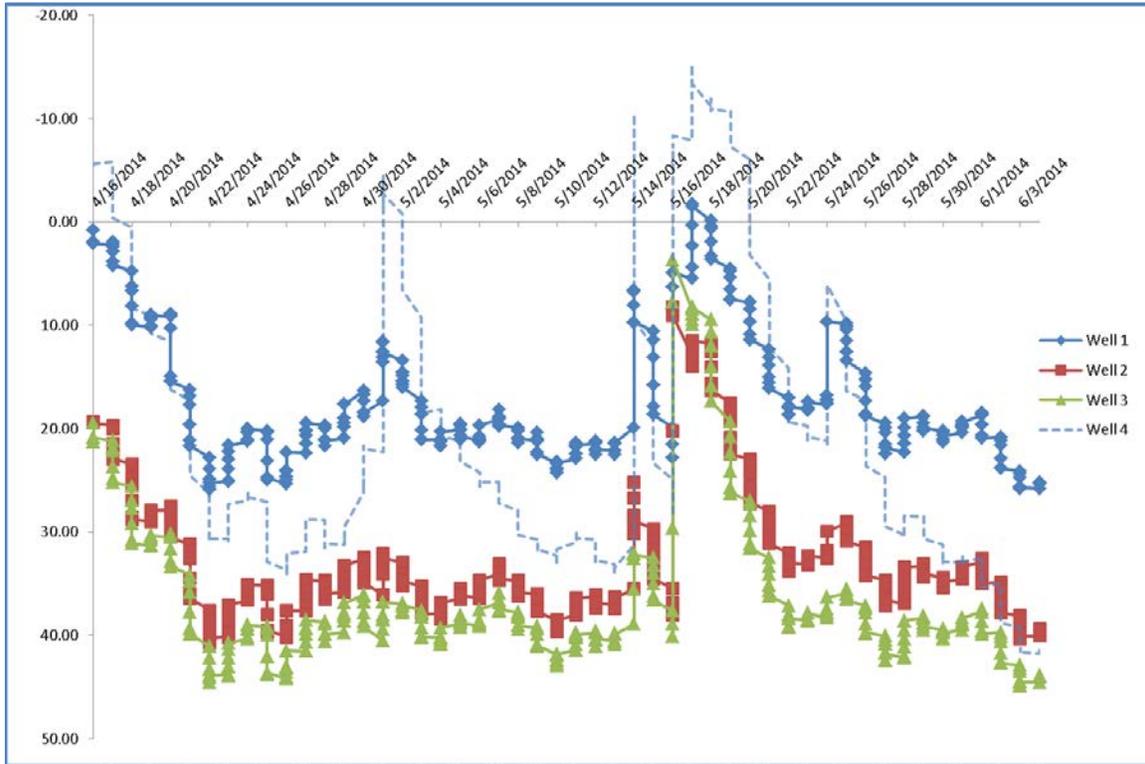
**Figure 8. Monitoring Well Data.**

Data are expressed as groundwater depth from soil surface at each monitoring location in inches (April 16 – June 4, 2014), with soil surface at 0.00”.

collection began in 2014 and will be recorded throughout the monitoring period; if the seasonal high water table elevation is inadequate to re-establish hydric soil conditions in the upper 12” in consultation with the IRT we will review the need to install a groundwater dam to further raise the water-table.
