RESULTS OF THE MARCH 2000 REMOTS[®] AND SIDE-SCAN SONAR SURVEY OF HARS REMEDIATION AREAS 1, 2, AND 3

Science Applications
International Corporation
Admiral's Gate
221 Third Street
Newport, RI 02840

U.S. Army Corps of Engineers
New York District,
Operations Division
26 Federal Plaza
New York, NY 10278-0090

Contract No. GS-35F-4461G
SAIC Project No. 01-0440-04-2672-440
Report No. 4 of the Historic Area Remediation Site Studies
SAIC Report No. 494

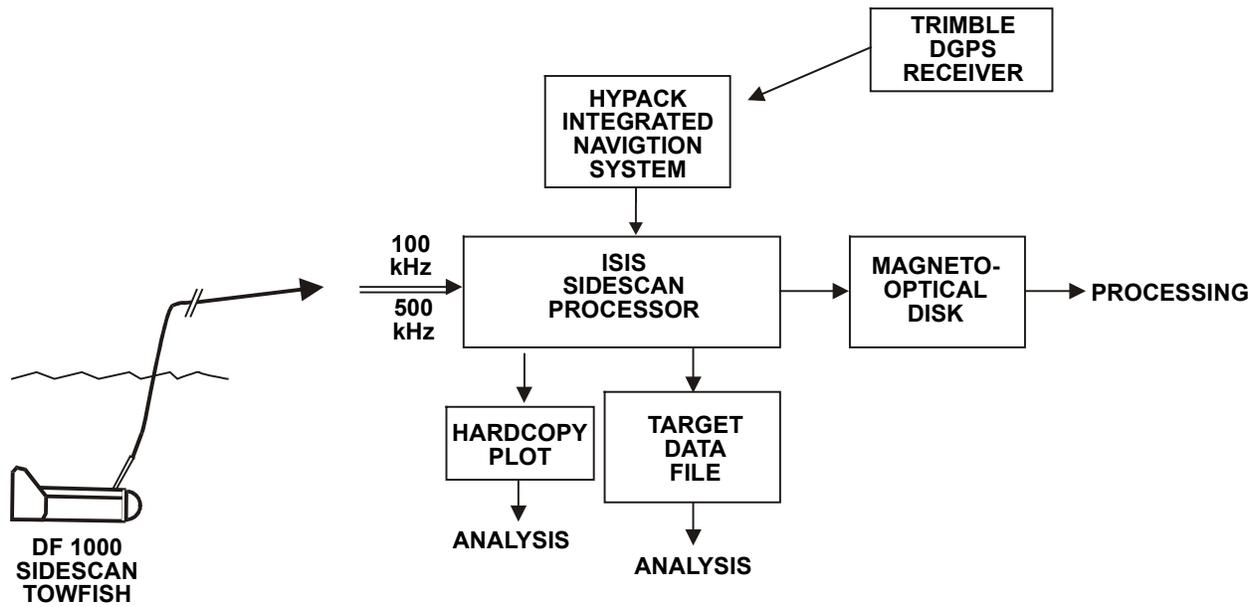
Figure 2-1. Schematic Diagram of the side-scan sonar system.

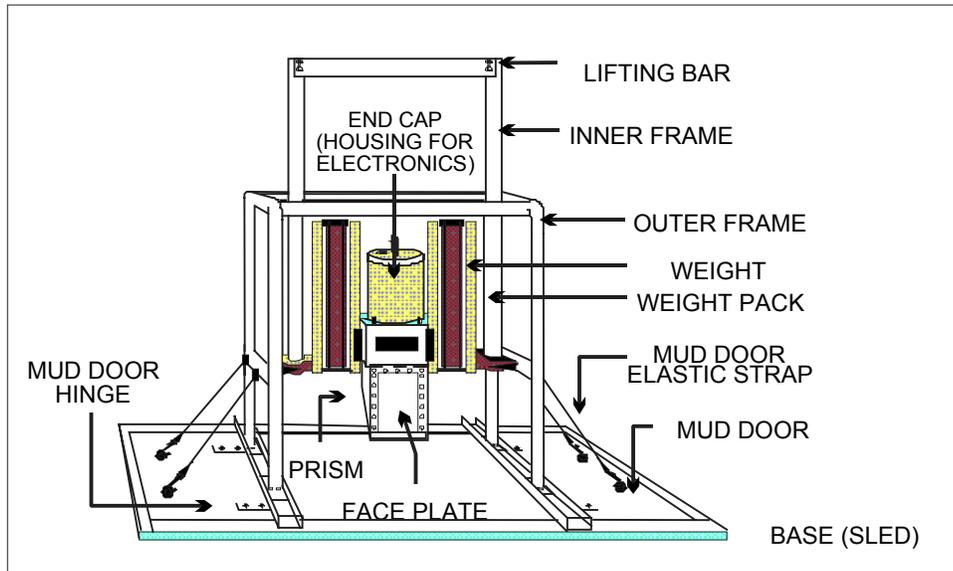
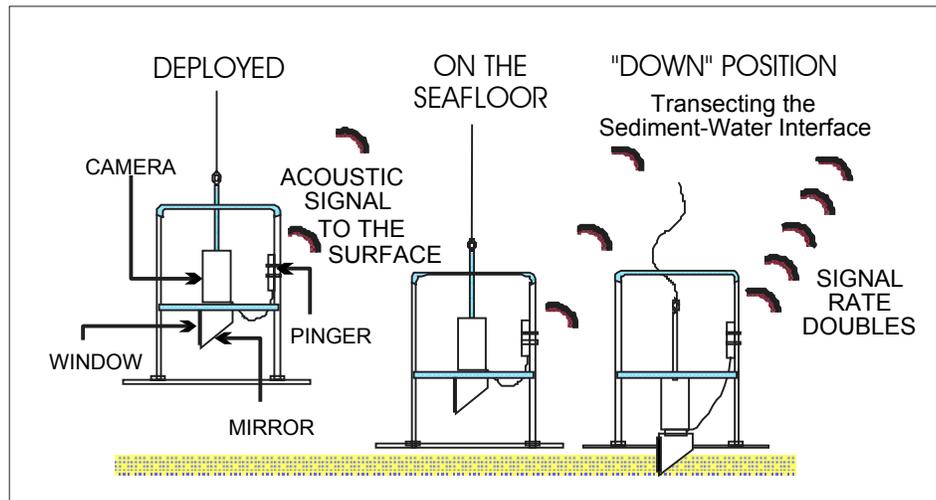
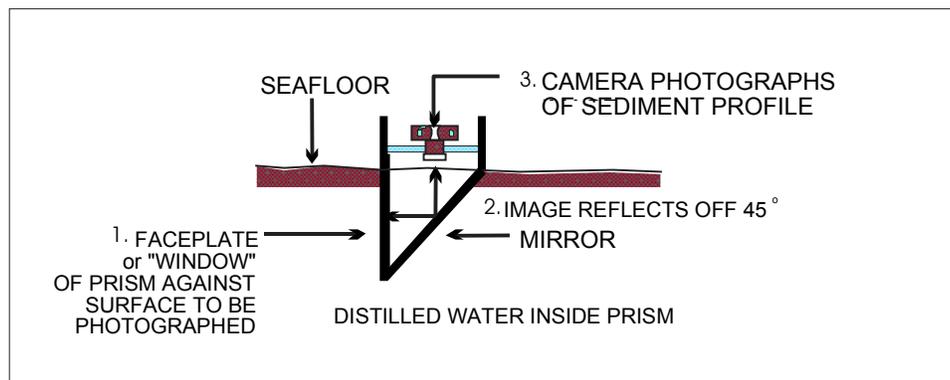
Figure 2-5. Schematic diagram of Benthos, Inc. Model 3731 sediment-profile camera and sequence of operation on deployment.

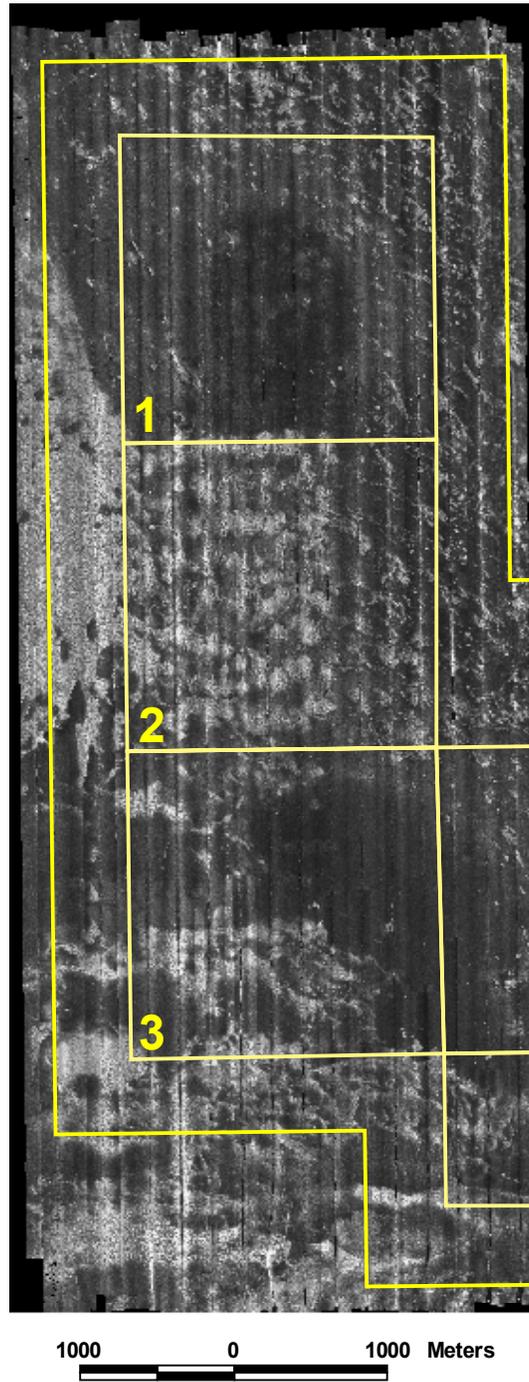
HARS Priority Remediation Areas 1, 2, and 3 Side-Scan Sonar Mosaic

Figure 3-1. Side-scan sonar mosaic of acoustic imagery collected at the HARS during the March 2000 interim monitoring survey. The boundaries of the individual PRA's and the Buffer Zone have been plotted for reference.

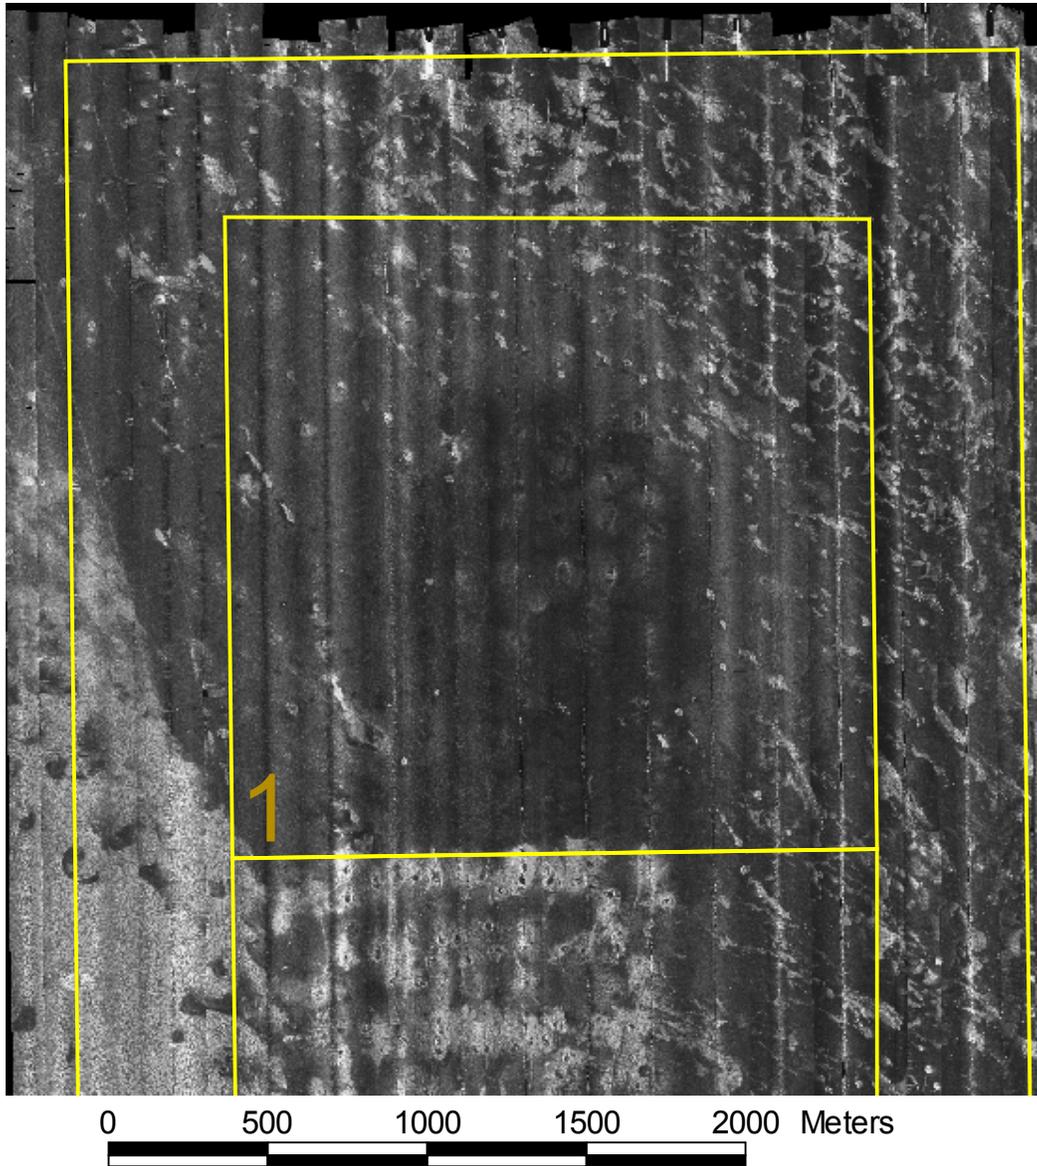
**HARS Priority Remediation Area 1
Side-Scan Sonar Mosaic**

Figure 3-2. Expanded view of the side-scan mosaic within PRA 1. A circular region of low reflectance sediments was observed in the center of the cell and is consistent with dredged material placement records. The boundaries of the PRA and the HARS Buffer Zone have been plotted for reference.

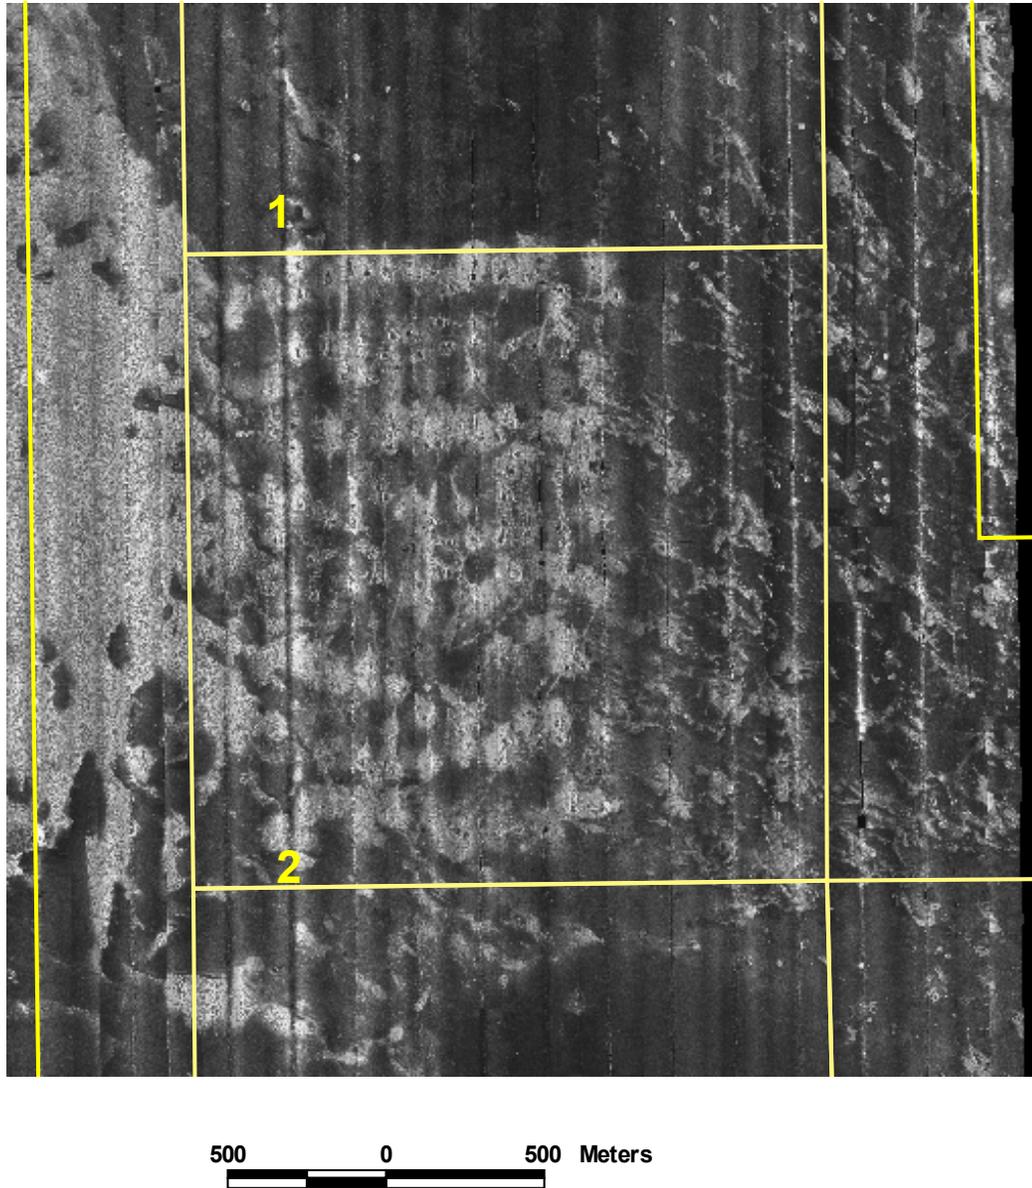
**HARS Priority Remediation Area 2
Side-Scan Sonar Mosaic**

Figure 3-3. Expanded view of the side-scan mosaic within PRA 2. The mottled region in the western portion of the PRA is the result of the placement of hard material from the Kill Van Kull dredging project. The boundaries of the PRA and the HARS Buffer Zone have been plotted for reference.

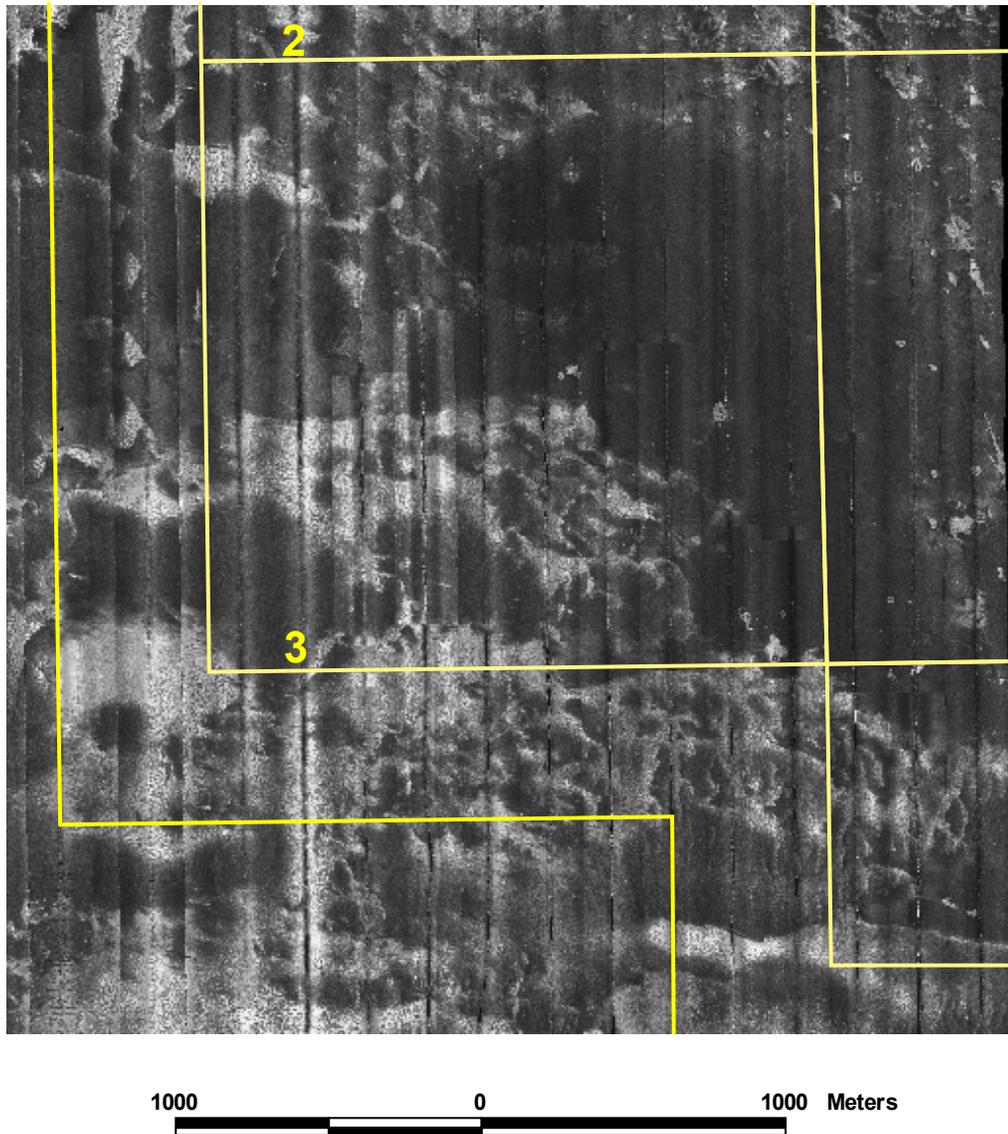
**HARS Priority Remediation Area 3
Side-Scan Sonar Mosaic**

Figure 3-4. Expanded view of the side-scan mosaic within PRA 3. Low reflectance sediments were observed in the eastern portion of the PRA. Large scale sand wave features observed in the southern buffer zone exhibited higher reflectance. The boundaries of the PRA and the HARS Buffer Zone have been plotted for reference.

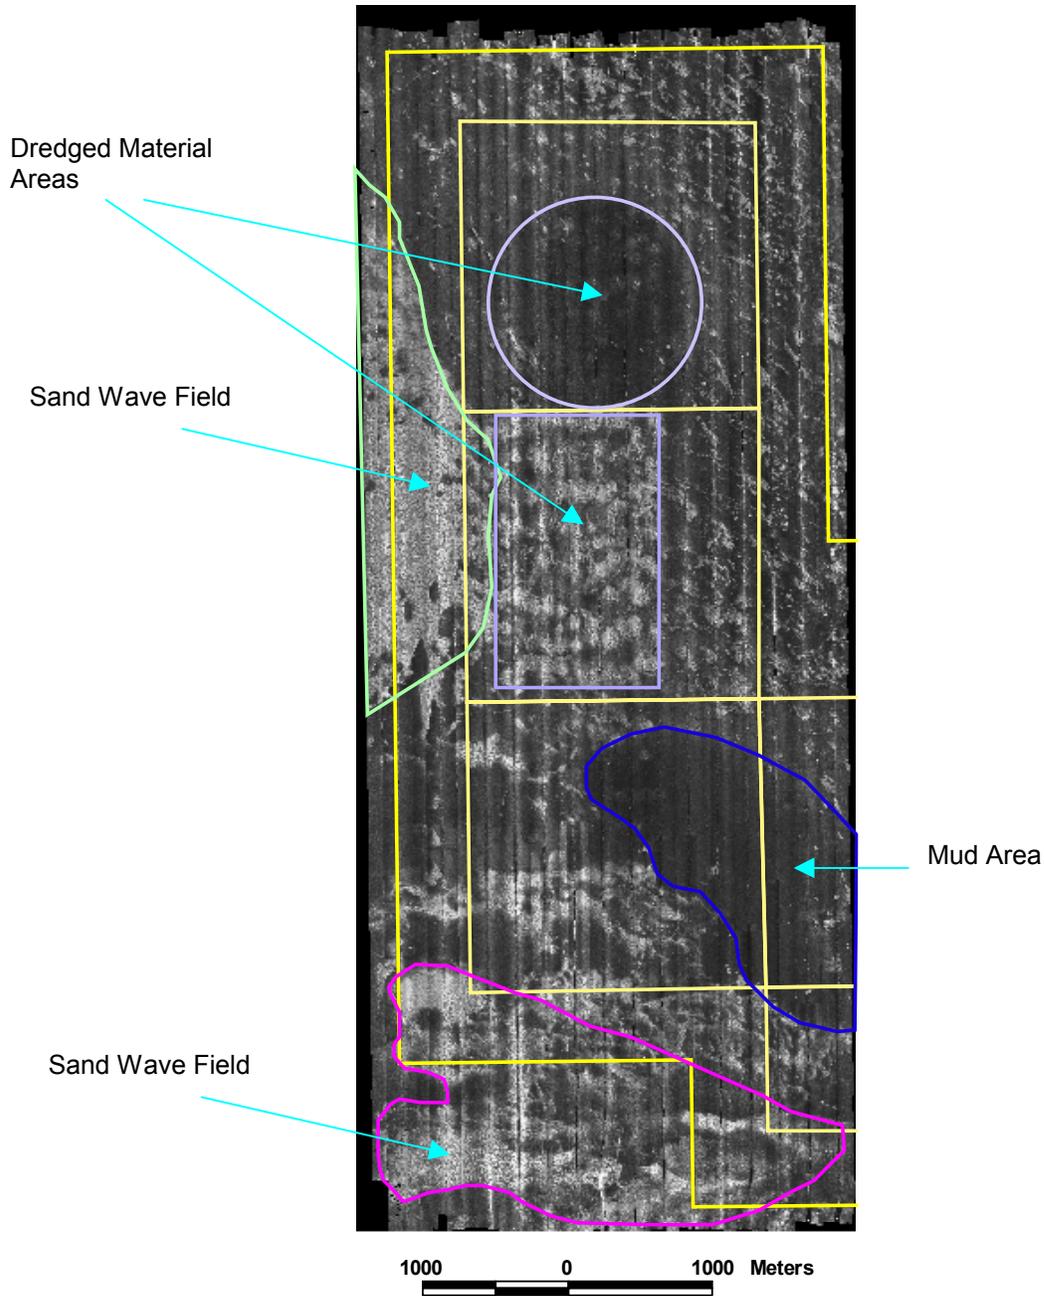
**HARS Priority Remediation Areas 1, 2, and 3
Side-Scan Sonar Mosaic
Sediment Types**

Figure 3-5. Delineation of the primary sedimentary environments of the HARS as interpreted from the side-scan mosaic. Areas covered with dredged material, sand, and fine-grained sediments have been identified. The boundaries of the individual PRAs and the HARS Buffer Zone have been plotted for reference.

Sand waves were observed sporadically throughout the survey area, and two major sand wave fields were identified (Figure 3-5). Sand waves and ripples are characterized by a distinct white and black striping in the side-scan images (Figures 3-22 through 3-24). Both major areas of sand waves produced a distinctive acoustic pattern where the crests of the waves can be followed across the overlapping survey lanes. The majority of the sand waves in the two major areas ranged from 1-4 m in length. The northeast-southwest orientation of the sand ripples is consistent with the predominant northwest-southeast tidal flow in the New York Bight.

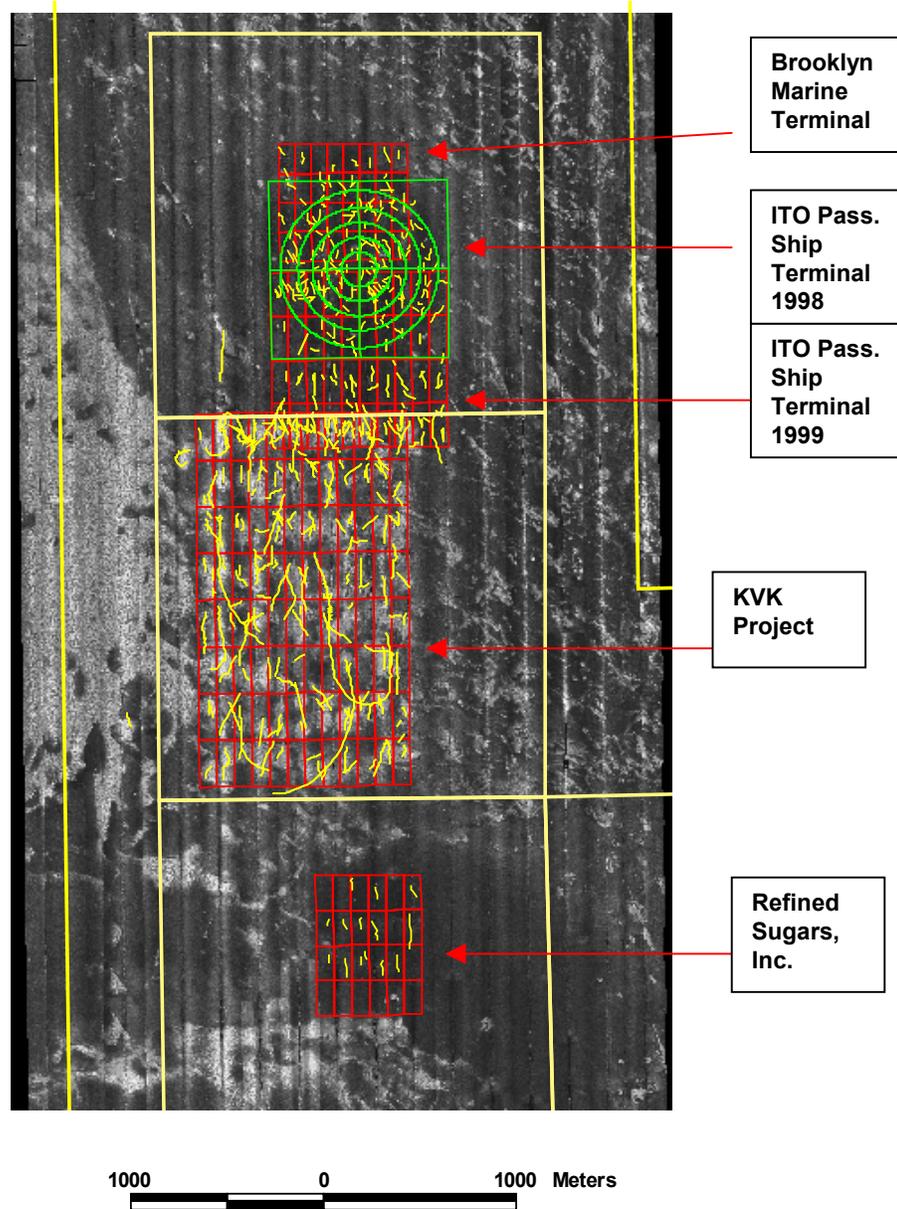
**HARS Priority Remediation Areas 1, 2, and 3
Side-Scan Sonar Mosaic
ADISS Disposal Events**

Figure 3-6. Location of individual disposal events (yellow wavy lines) as recorded by ADISS in relation to the side-scan mosaic. Disposal "target grids" used to direct the placement of dredged material for five different dredging projects (see labels) are also illustrated. The boundaries of PRAs 1, 2 and 3 and the surrounding HARS buffer zone are plotted for reference.

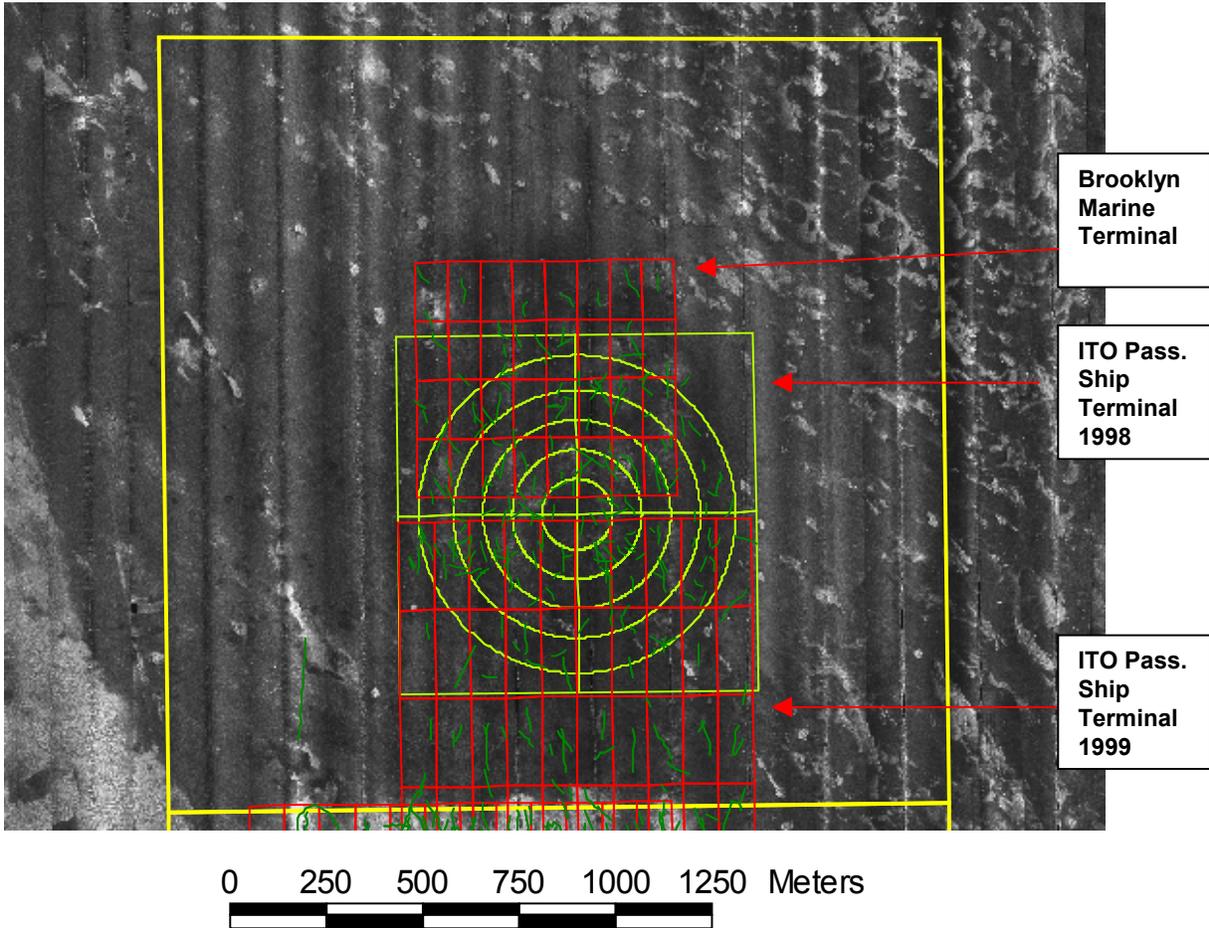
**HARS Priority Remediation Area 1
Side-Scan Sonar Mosaic**

Figure 3-7. Expanded view of disposal locations from the ITO Passenger Ship Terminal and Brooklyn Marine Terminal projects in PRA 1. The boundaries of the individual PRAs and the HARS buffer zone have been plotted for reference.

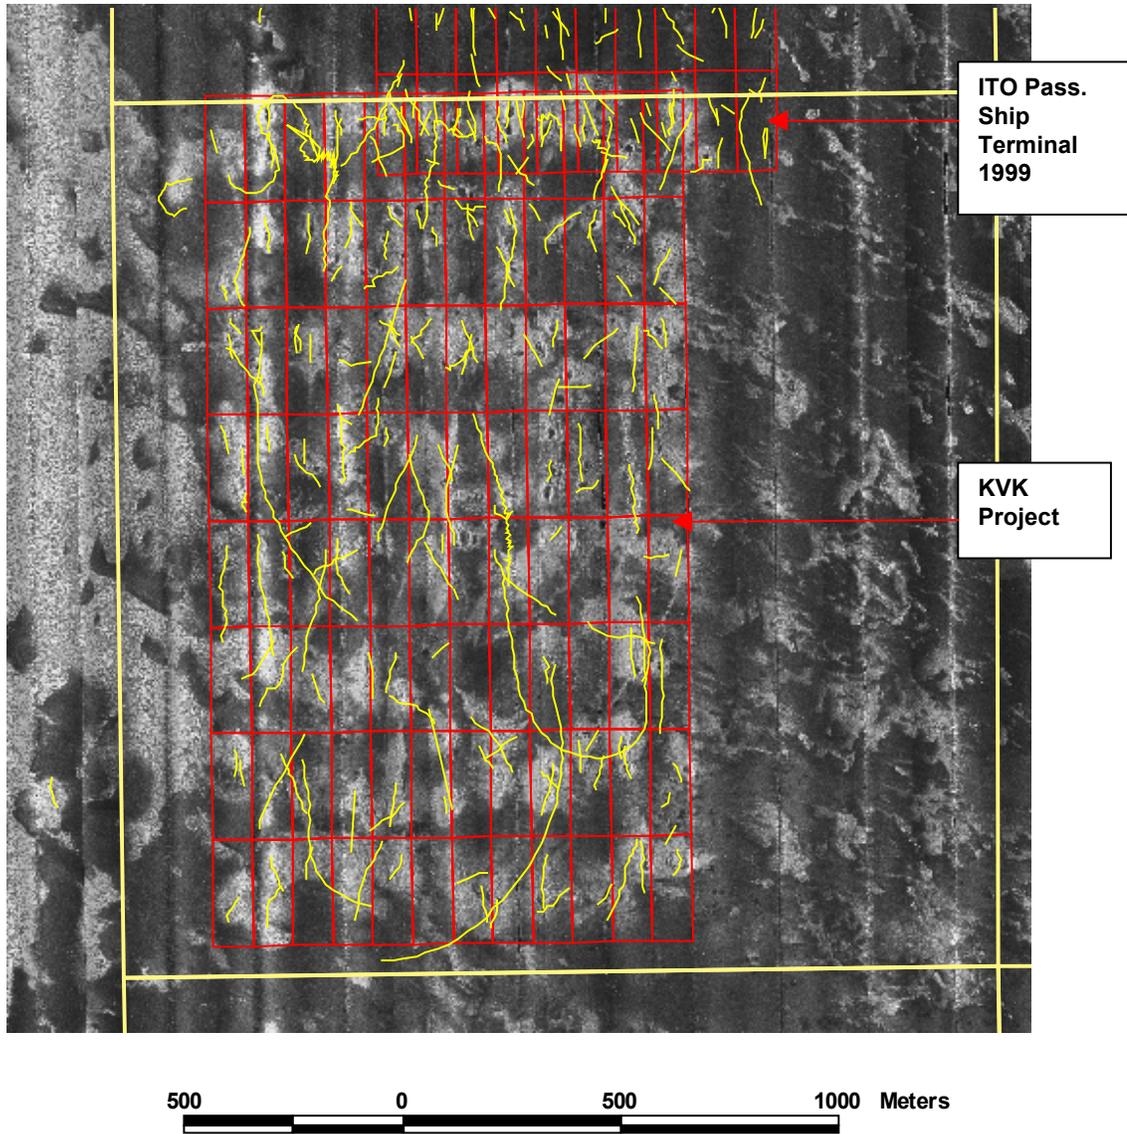
**HARS Priority Remediation Area 2
Side-Scan Sonar Mosaic**

Figure 3-8. Expanded view of disposal locations from the KVK and ITO Passenger Ship Terminal dredging projects in PRA 2. The boundaries of the individual PRAs and the HARS buffer zone have been plotted for reference.

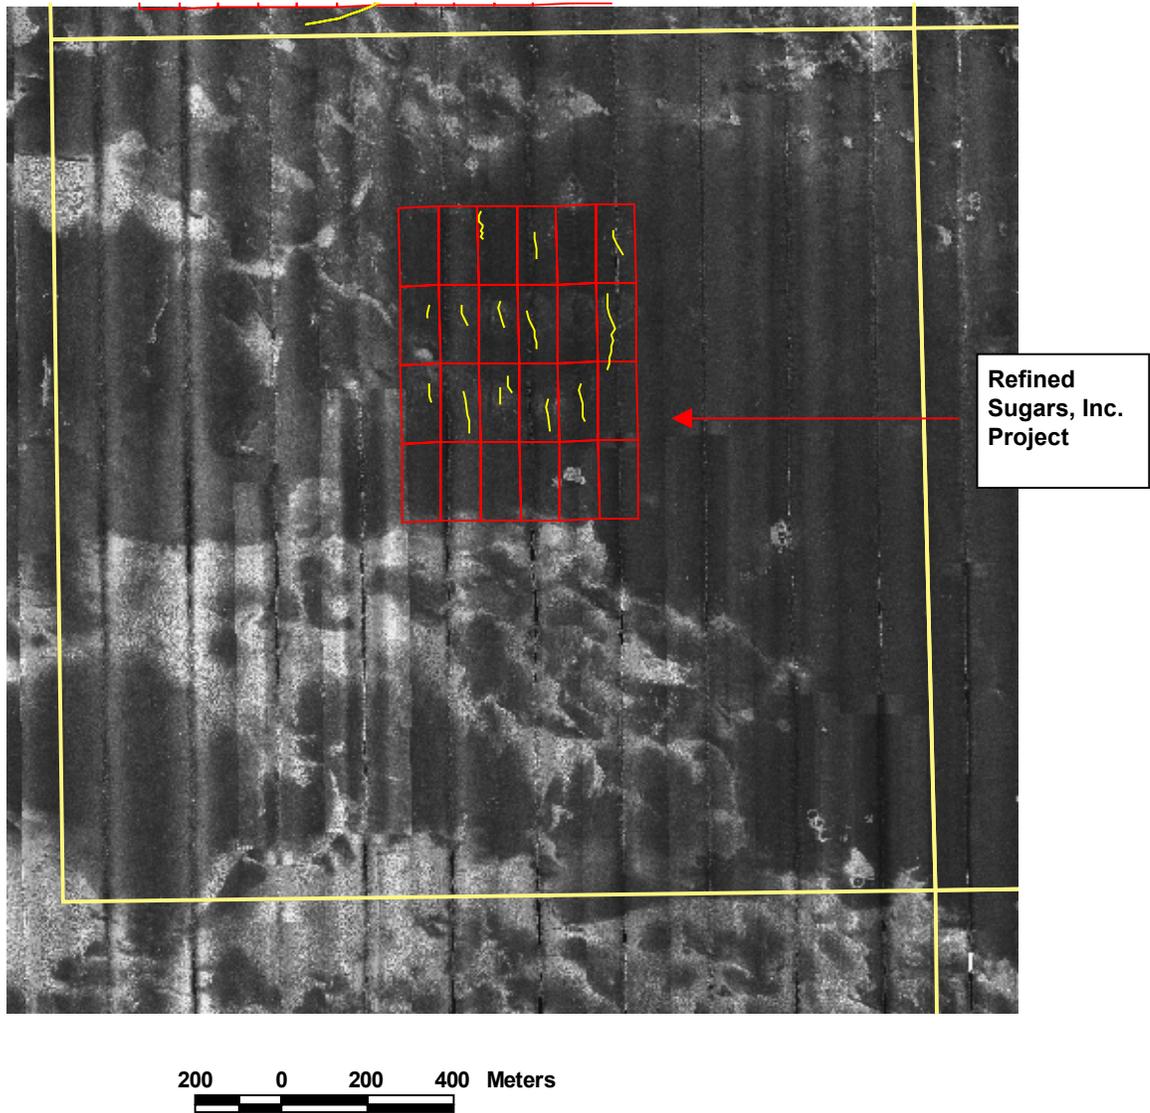
**HARS Priority Remediation Area 3
Side-Scan Sonar Mosaic**

Figure 3-9. Expanded view of disposal locations from the Refined Sugars, Inc. project in PRA 3. The boundaries of the individual PRAs and the HARS buffer zone have been plotted for reference.

There was a relatively small area in PRA 3 (Area C in Figure 3-16) that received dredged material from the Refined Sugars, Inc. dredging project (see Figure 3-9). Additional dredged material deposits were observed in PRA 3 outside the Refined Sugars, Inc. disposal grid; these

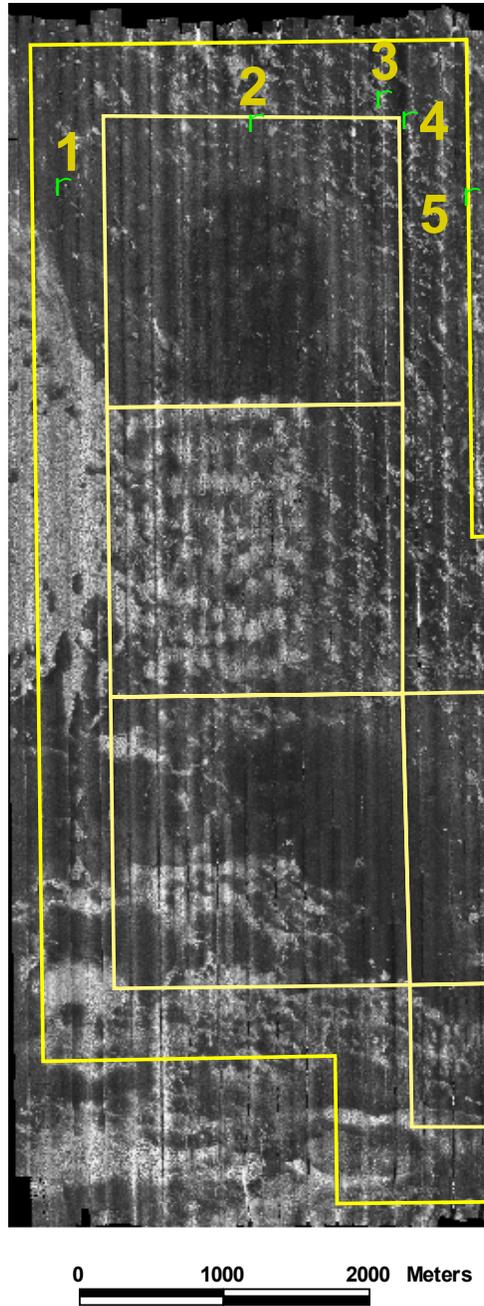
**HARS Priority Remediation Areas 1, 2, and 3
Side-Scan Sonar Targets
Shipwreck Locations**

Figure 3-10. The location of five shipwrecks observed during the March 2000 side-scan sonar survey at the HARS. The boundaries of the individual PRAs and the HARS Buffer Zone have been plotted for reference.

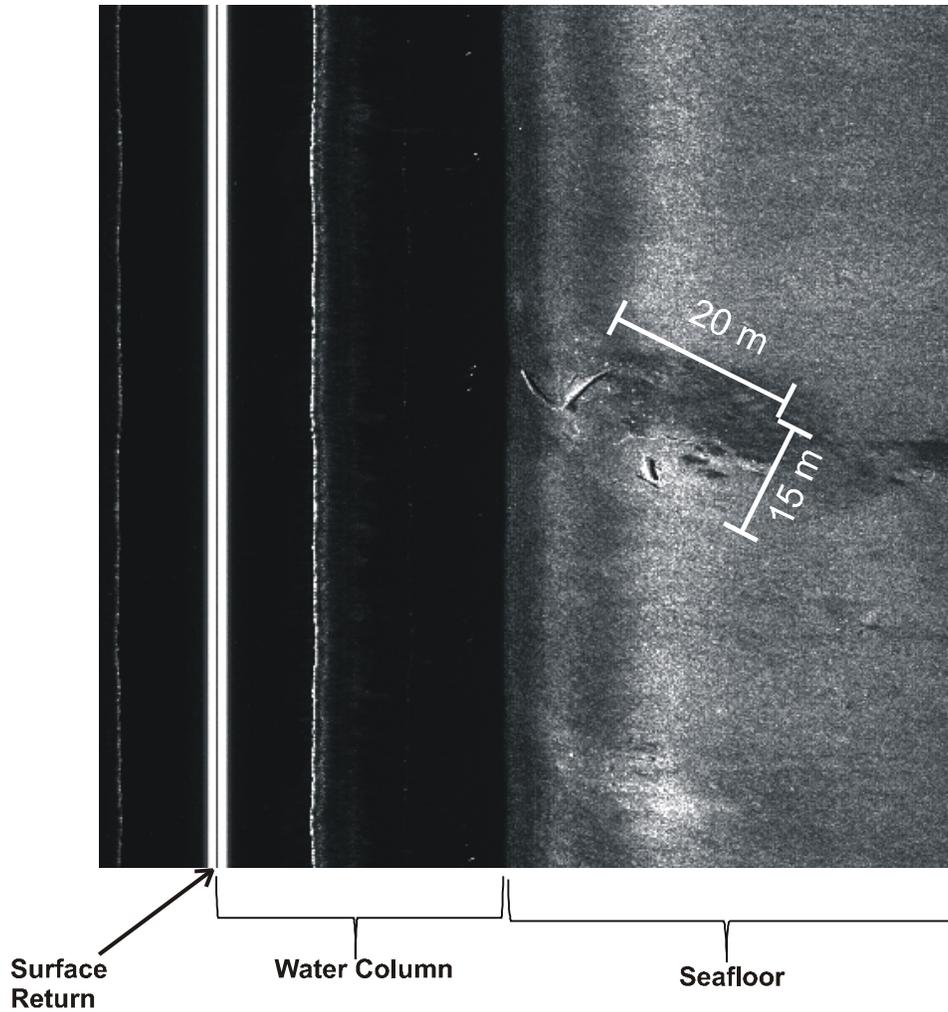
**HARS Priority Remediation Areas 1, 2, and 3
Side-Scan Sonar Targets
Shipwreck No. 1**

Wreck No. 1 was observed at a depth of 24 m (78 ft) in the HARS buffer zone west of PRA 1. In the side-scan sonar images, the wreck appeared to be partially exposed, the presence of surrounding debris suggested it was not fully intact (Figure 3-11). Overall, the area covered with debris from Wreck No. 1 measured approximately 20 m by 15 m.

Figure 3-11. Side-scan sonar image of wreck No. 1. Located in the buffer zone west of PRA, this wreckage debris field covers a 15×20 m area of the seafloor.

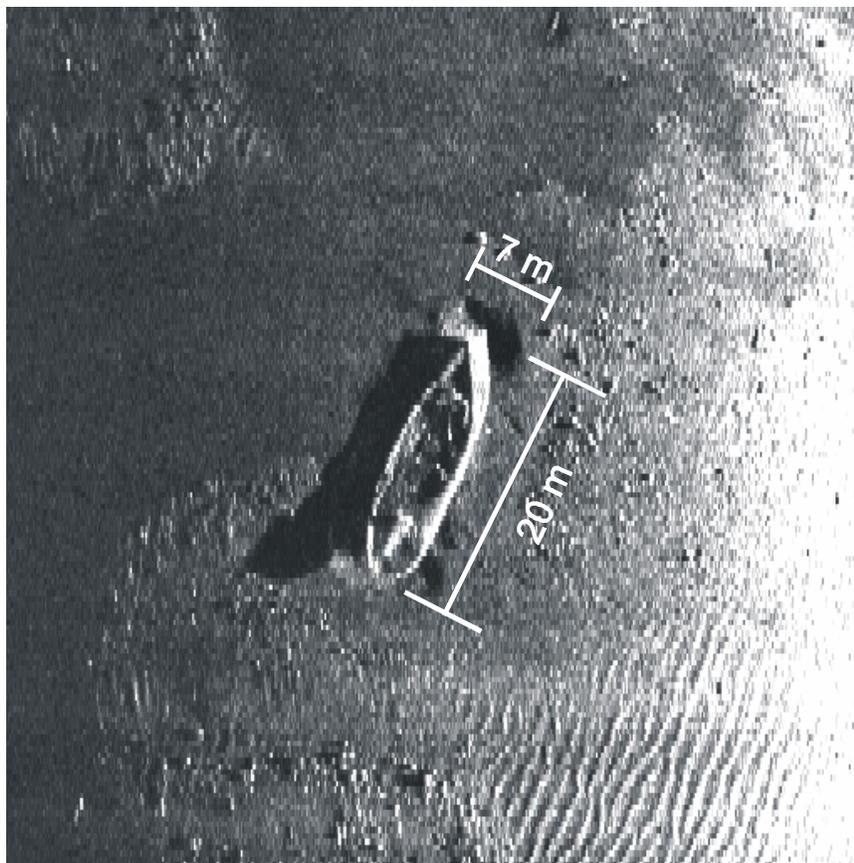
**HARS Priority Remediation Areas 1, 2, and 3
Side-Scan Sonar Targets
Shipwreck No. 2**

Figure 3-12. Side-scan sonar image of wreck No. 2. This intact wreck observed near the northern border of PRA 1 measures 20 m long and 7 m wide.

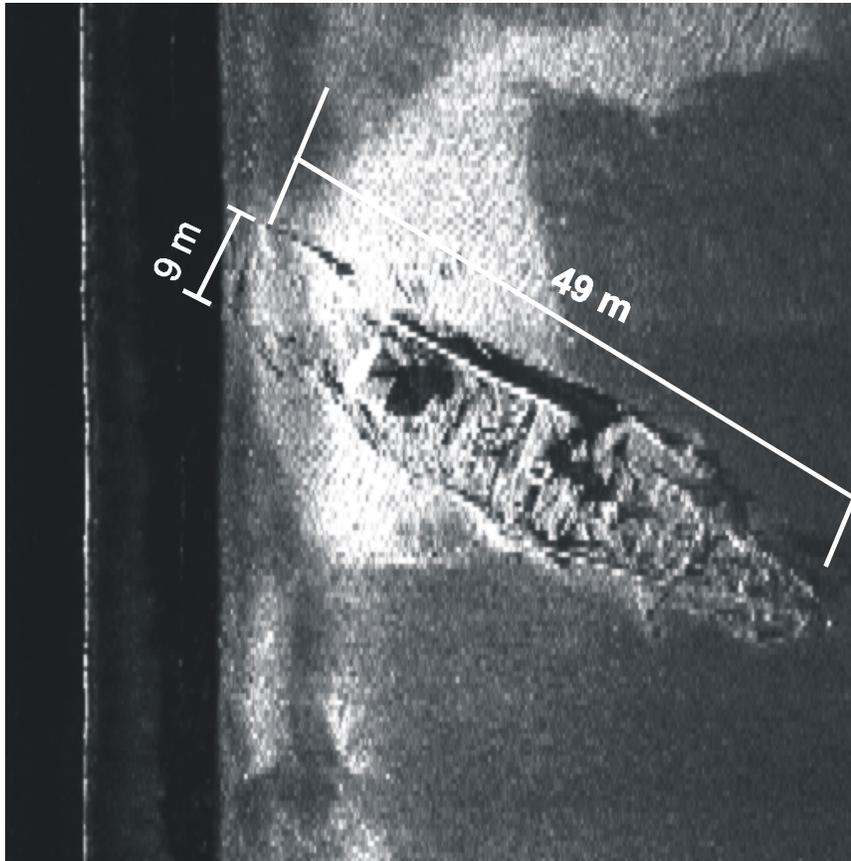
**HARS Priority Remediation Areas 1, 2, and 3
Side-Scan Sonar Targets
Shipwreck No. 3**

Figure 3-13. Side-scan sonar image of wreck No. 3. Located near the northeast corner of PRA 1, this clearly visible wreck measures 49 m long and 9 m wide. There is evidence of scouring and the migration of sand over the stern of this vessel.

Wreck No. 3 was clearly depicted in the side-scan records. This was the largest wreck observed in the survey, measuring 49 m long by 9 m wide (Figure 3-13). The vessel sits almost flat on the seafloor in approximately 19 m (61 ft) of water. A small shadow cast to one side of the vessel indicates that it sits above the seafloor to some degree. There was evidence of scouring and the migration of sand over of the stern of this vessel.

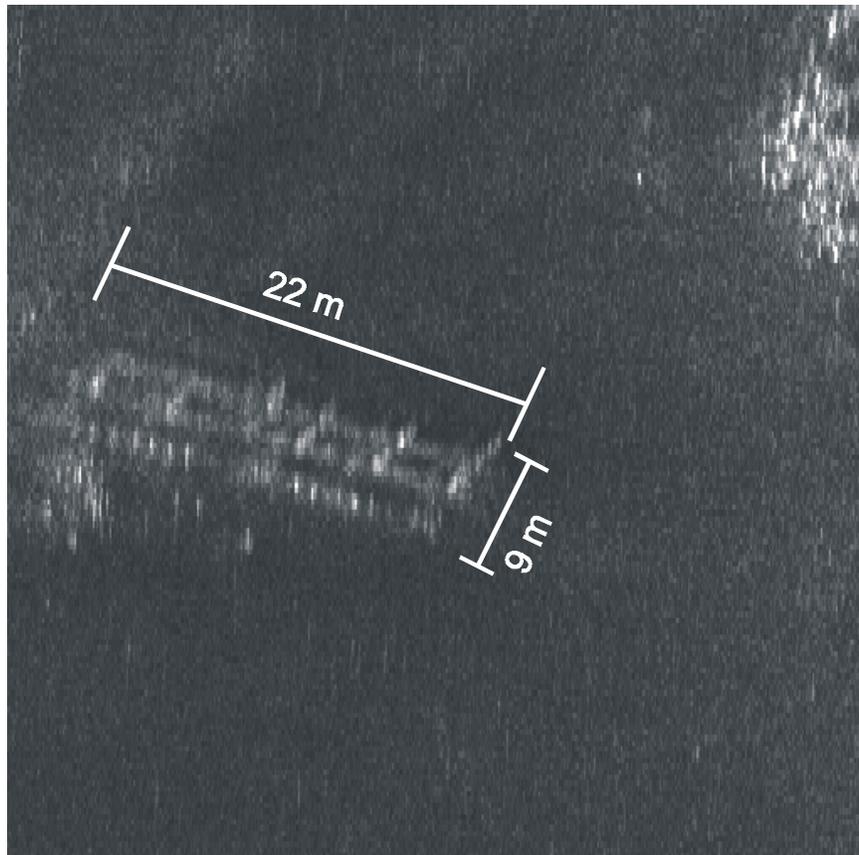
**HARS Priority Remediation Areas 1, 2, and 3
Side-Scan Sonar Targets
Shipwreck No. 4**

Figure 3-14. Side-scan sonar image of wreck No. 4. The remains of this pocket barge were located near the northeast corner of PRA 1. The wreck measures 22 m × 9 m and five pockets are clearly visible.

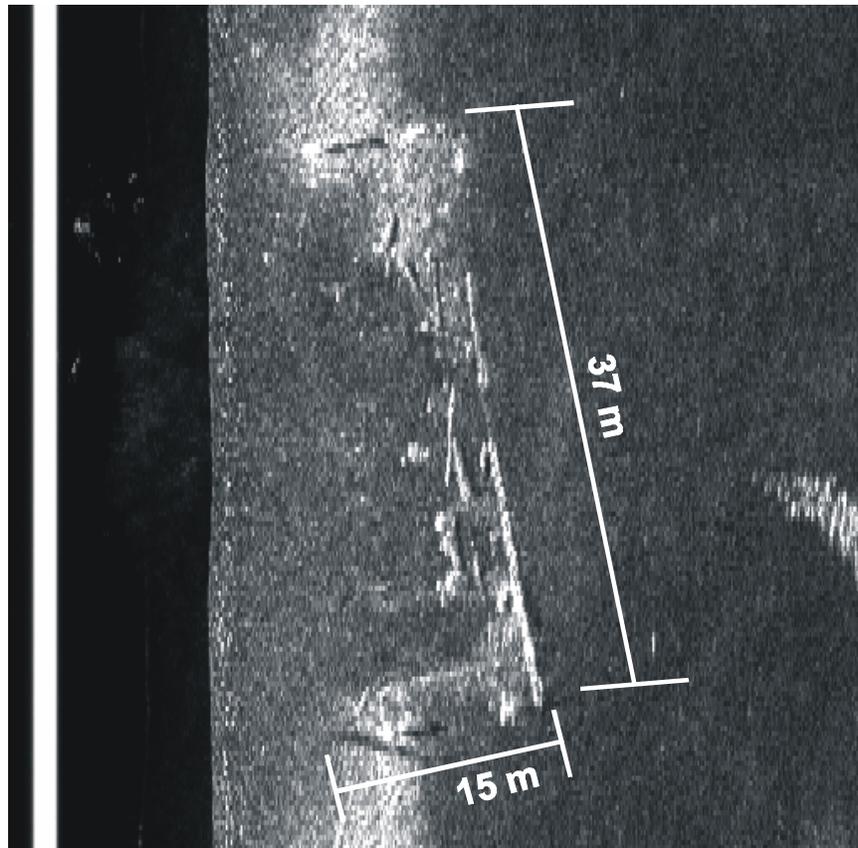
**HARS Priority Remediation Areas 1, 2, and 3
Side-Scan Sonar Targets
Shipwreck No. 5**

Figure 3-15. Side-scan sonar image of wreck No. 5. Located near the outer boundary of the buffer zone east of PRA 1, debris from this wreck covers an area of the seafloor measuring 37 m × 15 m.

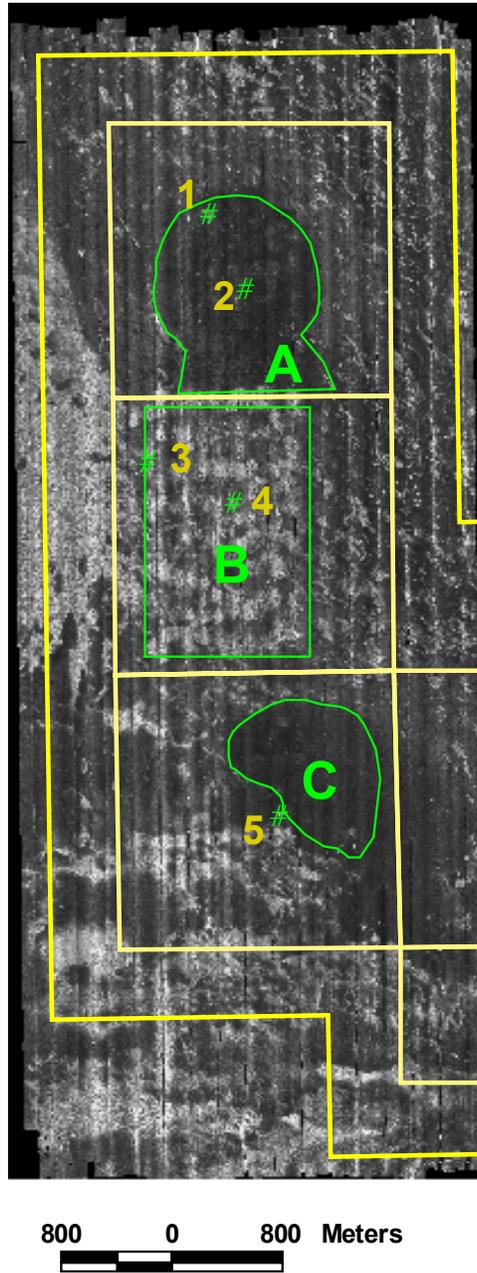
**HARS Priority Remediation Areas 1, 2, and 3
Side-Scan Sonar Targets
Dredged Material Placement Locations**

Figure 3-16. Dredged material placement has been concentrated in three areas of the HARS since its inception. The locations of five example dredged material deposits presented in the following series of figures have been plotted.

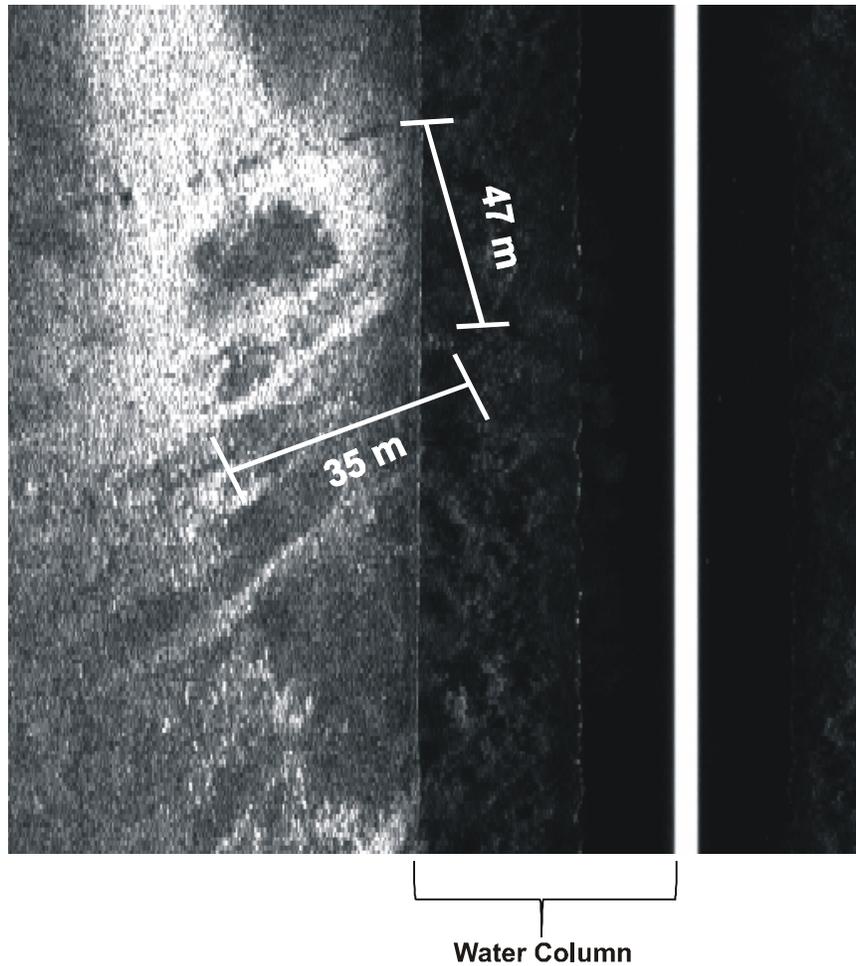
**HARS Priority Remediation Areas 1, 2, and 3
Side-Scan Sonar Targets
Dredged Material No. 1**

Figure 3-17. Side-scan sonar image of dredged material deposit No. 1. This low-relief disposal event of soft sediments observed in PRA 1 was placed during the ITO Passenger Ship Terminal Project. Overall, the visible spread of the disposal covers an area of the seafloor approximately 47 m × 35 m.

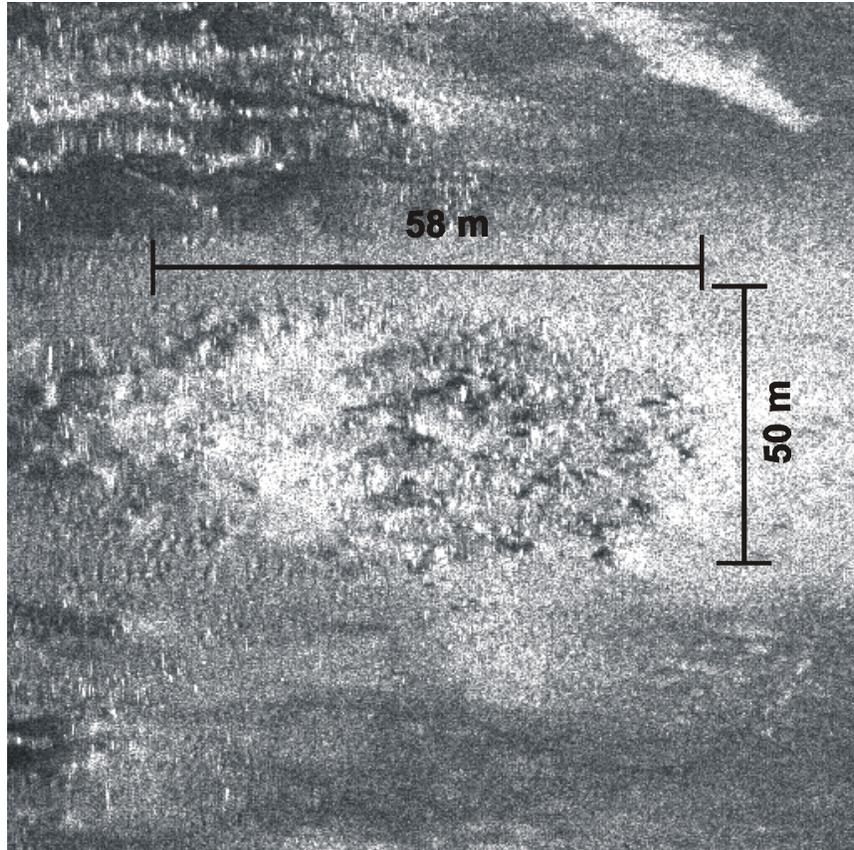
**HARS Priority Remediation Areas 1, 2, and 3
Side-Scan Sonar Targets
Dredged Material No. 3**

Figure 3-19. Side-scan sonar image of dredged material deposit No. 3. Example dredged material placement event observed in PRA 2 and related to the KVK dredging program. This event covered a 50 m × 58 m area of the seafloor and is composed of high-relief, rocky debris.

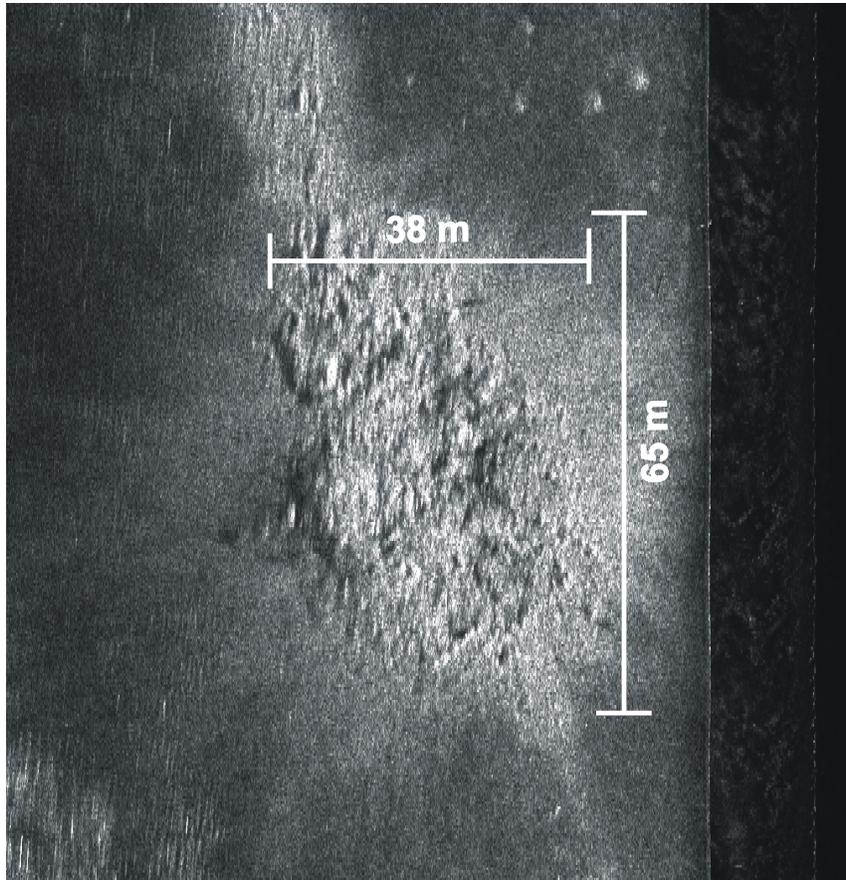
**HARS Priority Remediation Areas 1, 2, and 3
Side-Scan Sonar Targets
Dredged Material No. 4**

Figure 3-20. Side-scan sonar image of dredged material deposit No. 4. Also from the KVK project and located in PRA 2, this is an example of a rocky dredged material deposit placed on fine-grained ambient sediments.

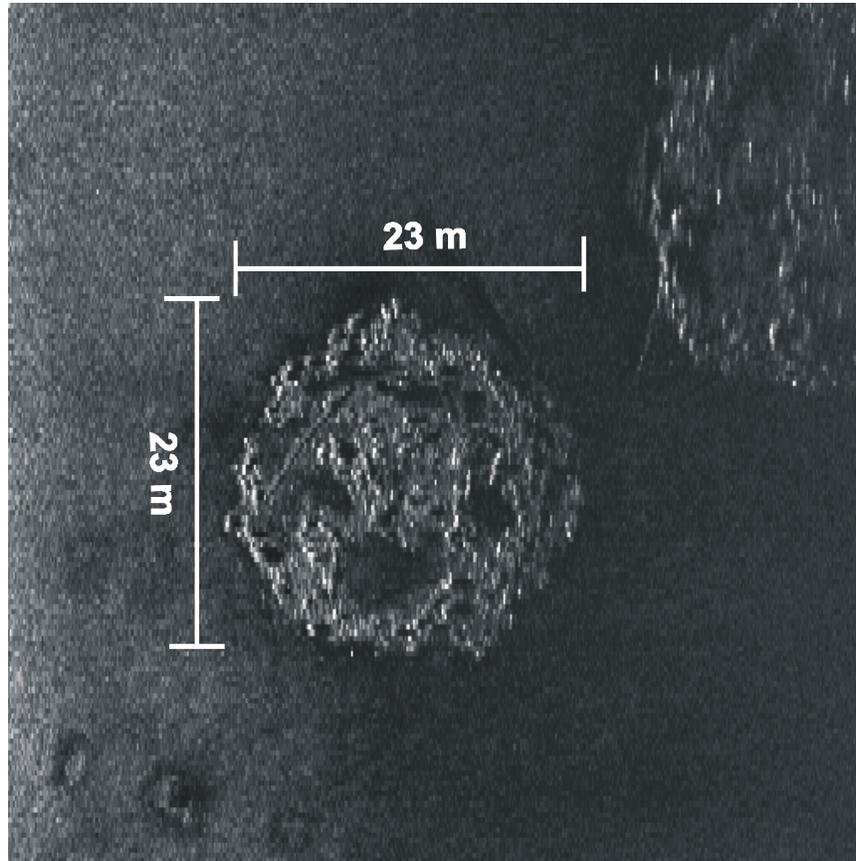
**HARS Priority Remediation Areas 1, 2, and 3
Side-Scan Sonar Targets
Dredged Material No. 5**

Figure 3-21. Side-scan sonar image of dredged material deposit No. 5, an example of a relic dredged material placement event observed in PRA 3.
