RESULTS OF THE MARCH 2000 REMOTS[®] AND SIDE-SCAN SONAR SURVEY OF HARS REMEDIATION AREAS 1, 2, AND 3

Science Applications
International Corporation
Admiral's Gate
221 Third Street
Newport, RI 02840

U.S. Army Corps of Engineers
New York District,
Operations Division
26 Federal Plaza
New York, NY 10278-0090

Contract No. GS-35F-4461G
SAIC Project No. 01-0440-04-2672-440
Report No. 4 of the Historic Area Remediation Site Studies
SAIC Report No. 494

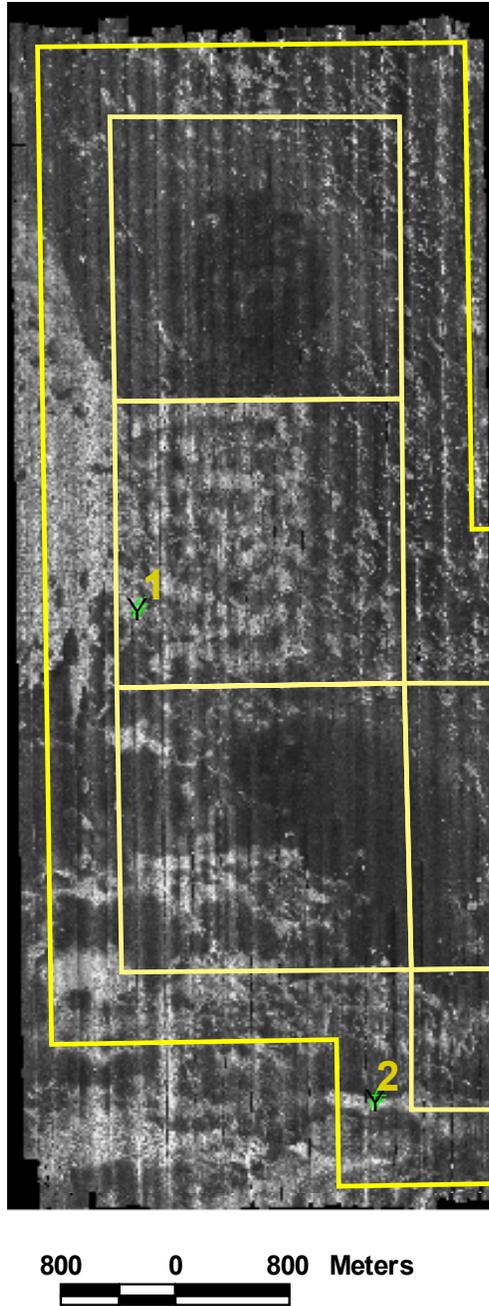
**HARS Priority Remediation Areas 1, 2, and 3
Side-Scan Sonar Targets
Sand Ripple Locations**

Figure 3-22. Large areas of the seafloor in the HARS were covered with hard sandy sediments. Examples of sand ripples produced by the local current regime are presented in the following two figures.

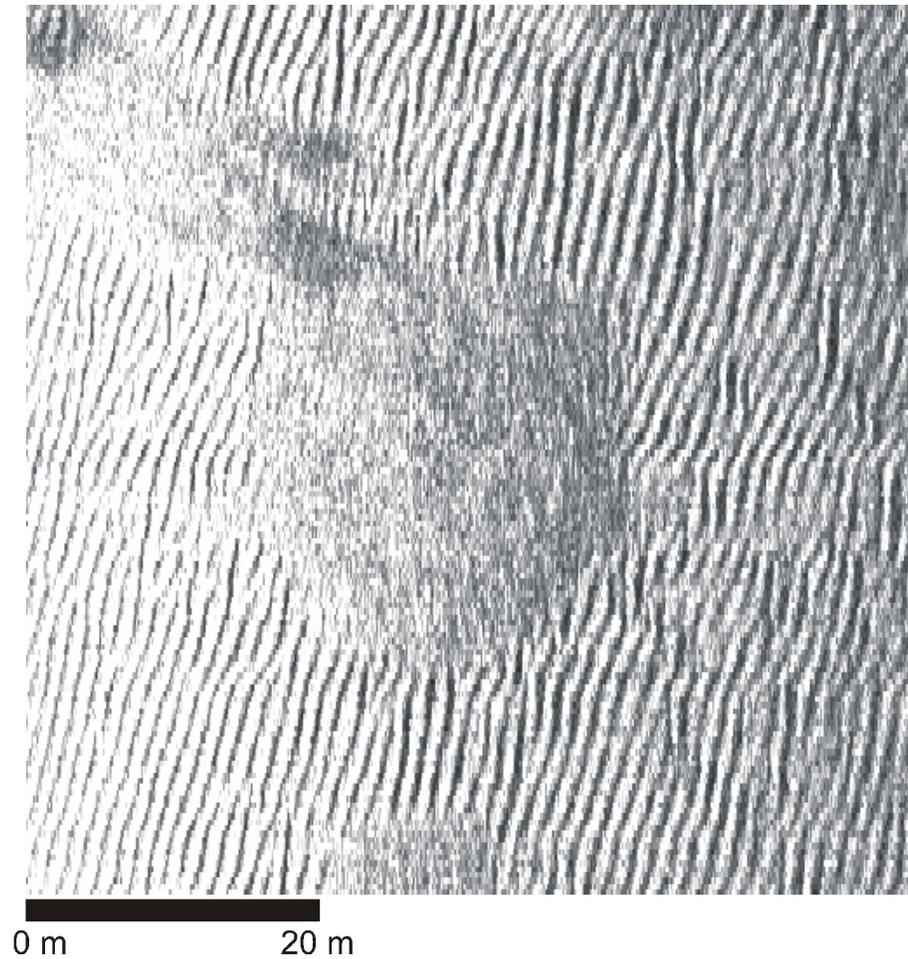
**HARS Priority Remediation Areas 1, 2, and 3
Side-Scan Sonar Targets
Sand Ripple No. 1**

Figure 3-23. Side-scan sonar image of sand ripple area No. 1. Sand ripples located in PRA 2.

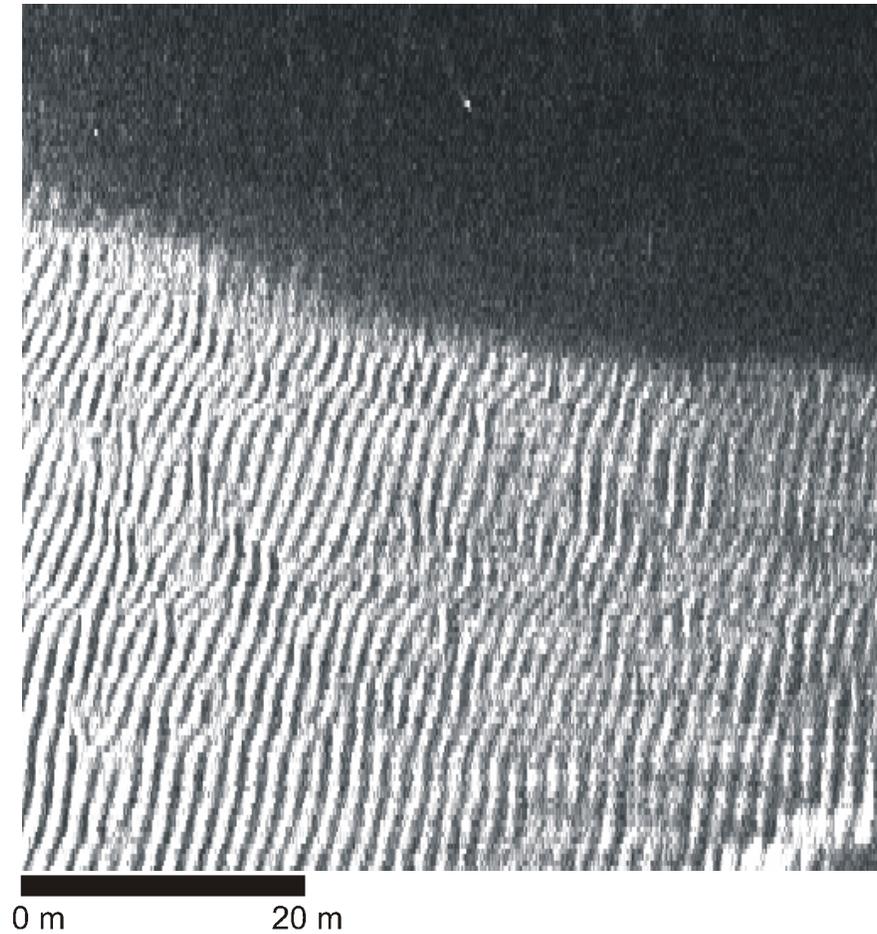
**HARS Priority Remediation Areas 1, 2, and 3
Side-Scan Sonar Targets
Sand Ripple No. 2**

Figure 3-24. Side-scan sonar image of sand ripple area No. 2. Sand ripples located in PRA 3 in the region of the large waveforms of the Shrewsbury Rocks geological feature.

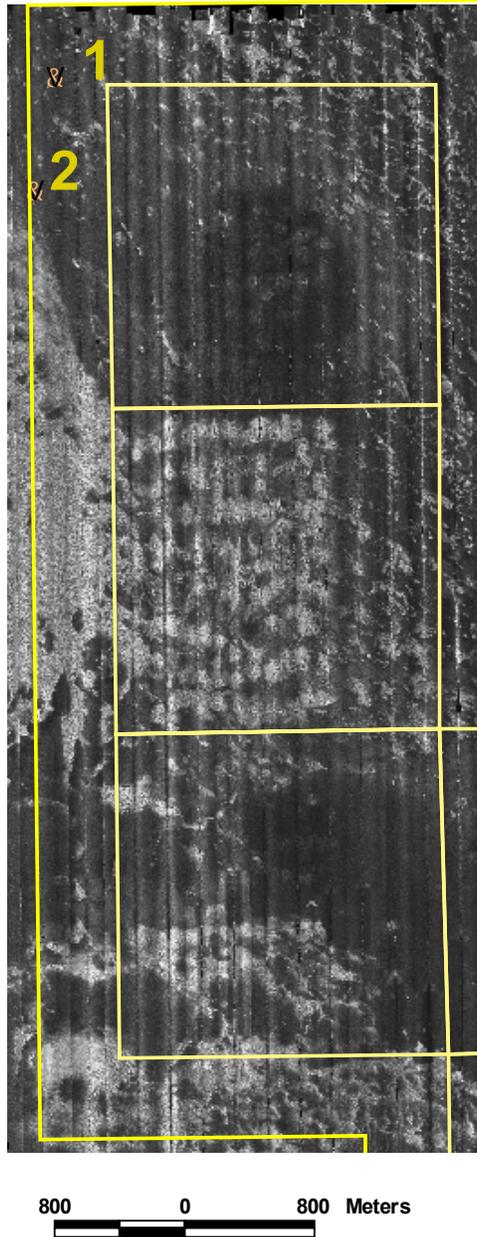
**HARS Priority Remediation Areas 1, 2, and 3
Side-Scan Sonar Targets
Trawl Scars Locations**

Trawl scar marks were observed in the northern portion of the survey area, within the broad and relatively flat elongated basin in the HARS buffer zone outside PRA 1 (Figure 3-25). In general, the trawl scar features lacked much detail (Figures 3-26 and 3-27). These linear "scar" features are formed by the digging and scouring action of trawler net doors being towed along the seafloor behind a fishing vessel. It is difficult to determine the age of the observed features.

Figure 3-25. Evidence of commercial fishing activity in the vicinity of the HARS was observed in the form of trawl scars on the seafloor. Numbers 1 and 2 indicate the locations of example images shown in Figures 3-26 and 3-27.

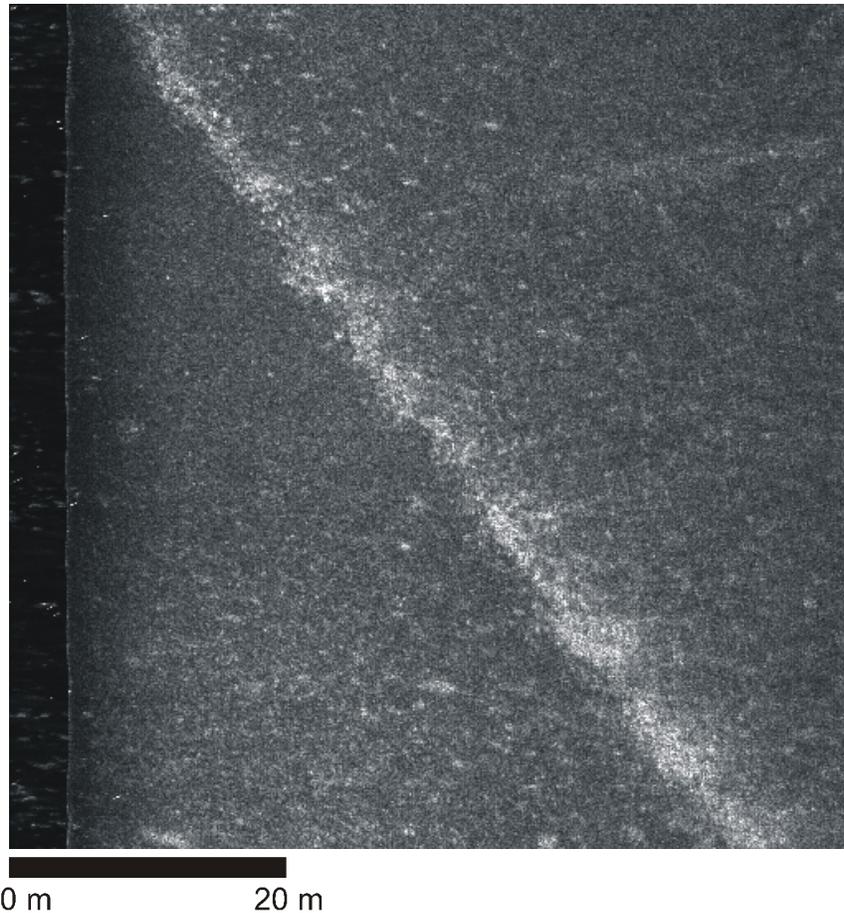
Figure 3-27. Side-scan sonar image of trawl scar No. 2. Example of a trawl scar in the buffer zone.

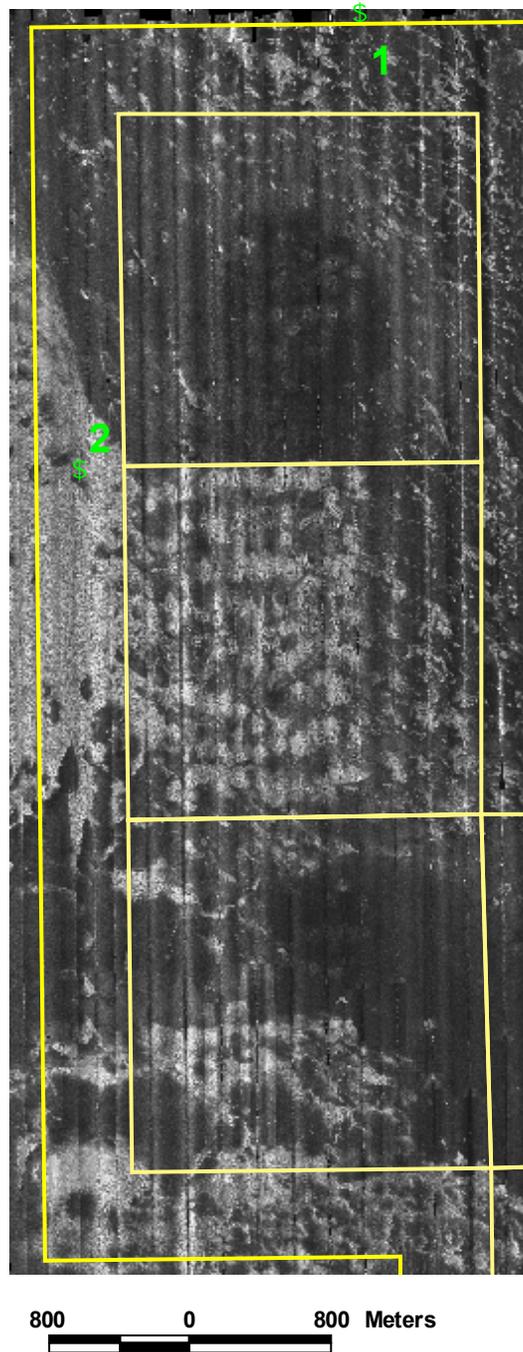
Lobster trap lines present in the northern half of the survey area (Figure 3-28) were observed in the sonar records (Figures 3-29 and 3-30). The lobster trap buoys could be seen on the surface of the water as the survey vessel passed by them. As the towfish passed by the traps, they appeared as small hard returns on the side-scan records. The lobster trap lines each contained multiple traps spaced fairly equally apart (Figures 3-29 and 3-30).

Figure 3-28. Lobster fishing gear was observed on the seafloor in the vicinity of the HARS. Individual locations are indicated by numbers 1 and 2 and illustrated in Figures 3-29 and 3-30.

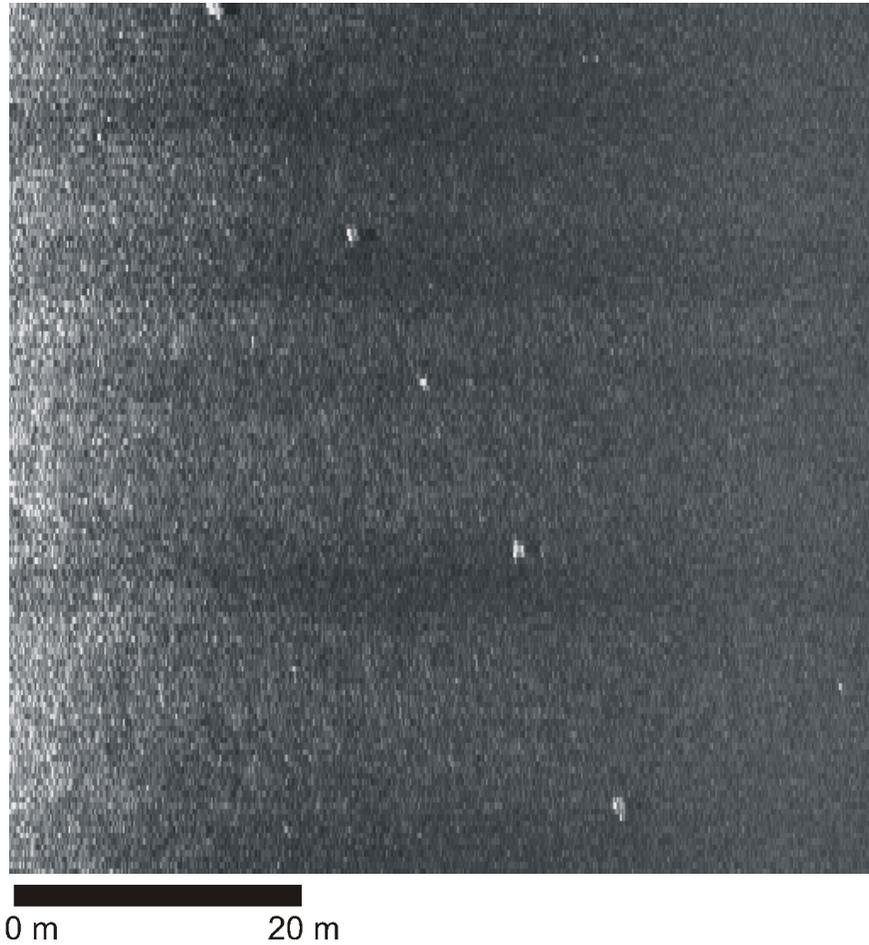
Figure 3-29. Side-scan sonar image of a line of lobster traps (No. 1 location in Figure 3-28).

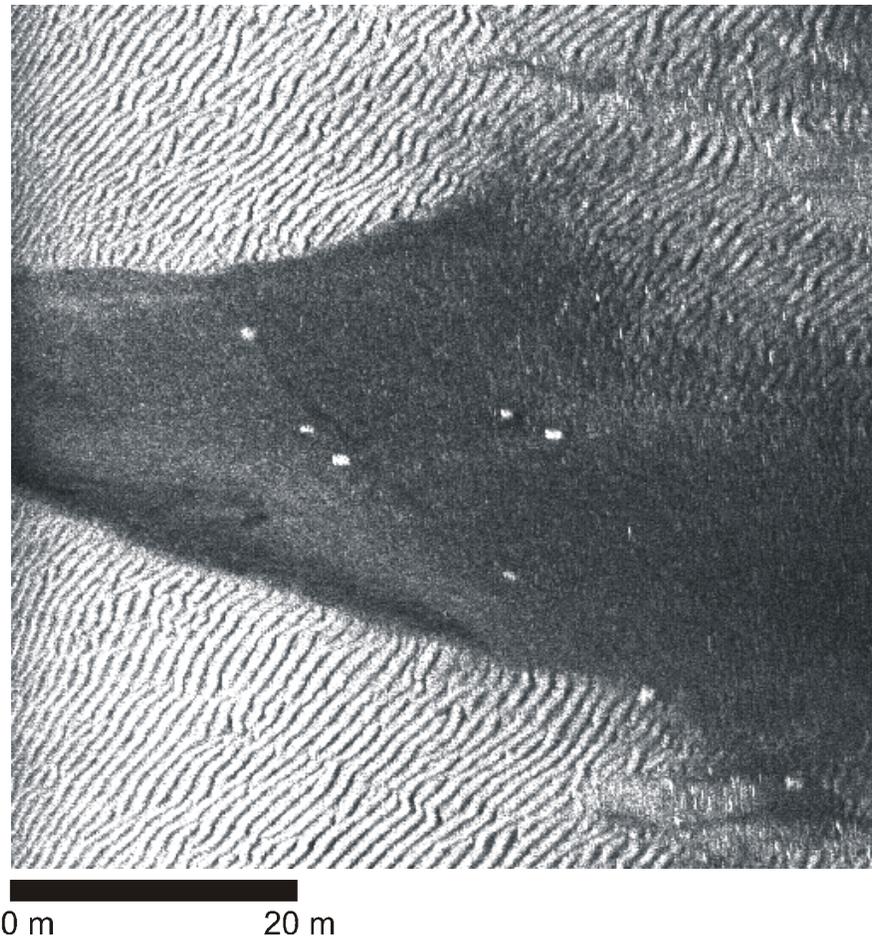
Figure 3-30. Side-scan sonar image of several lobster traps (No. 2 location in Figure 3-28).

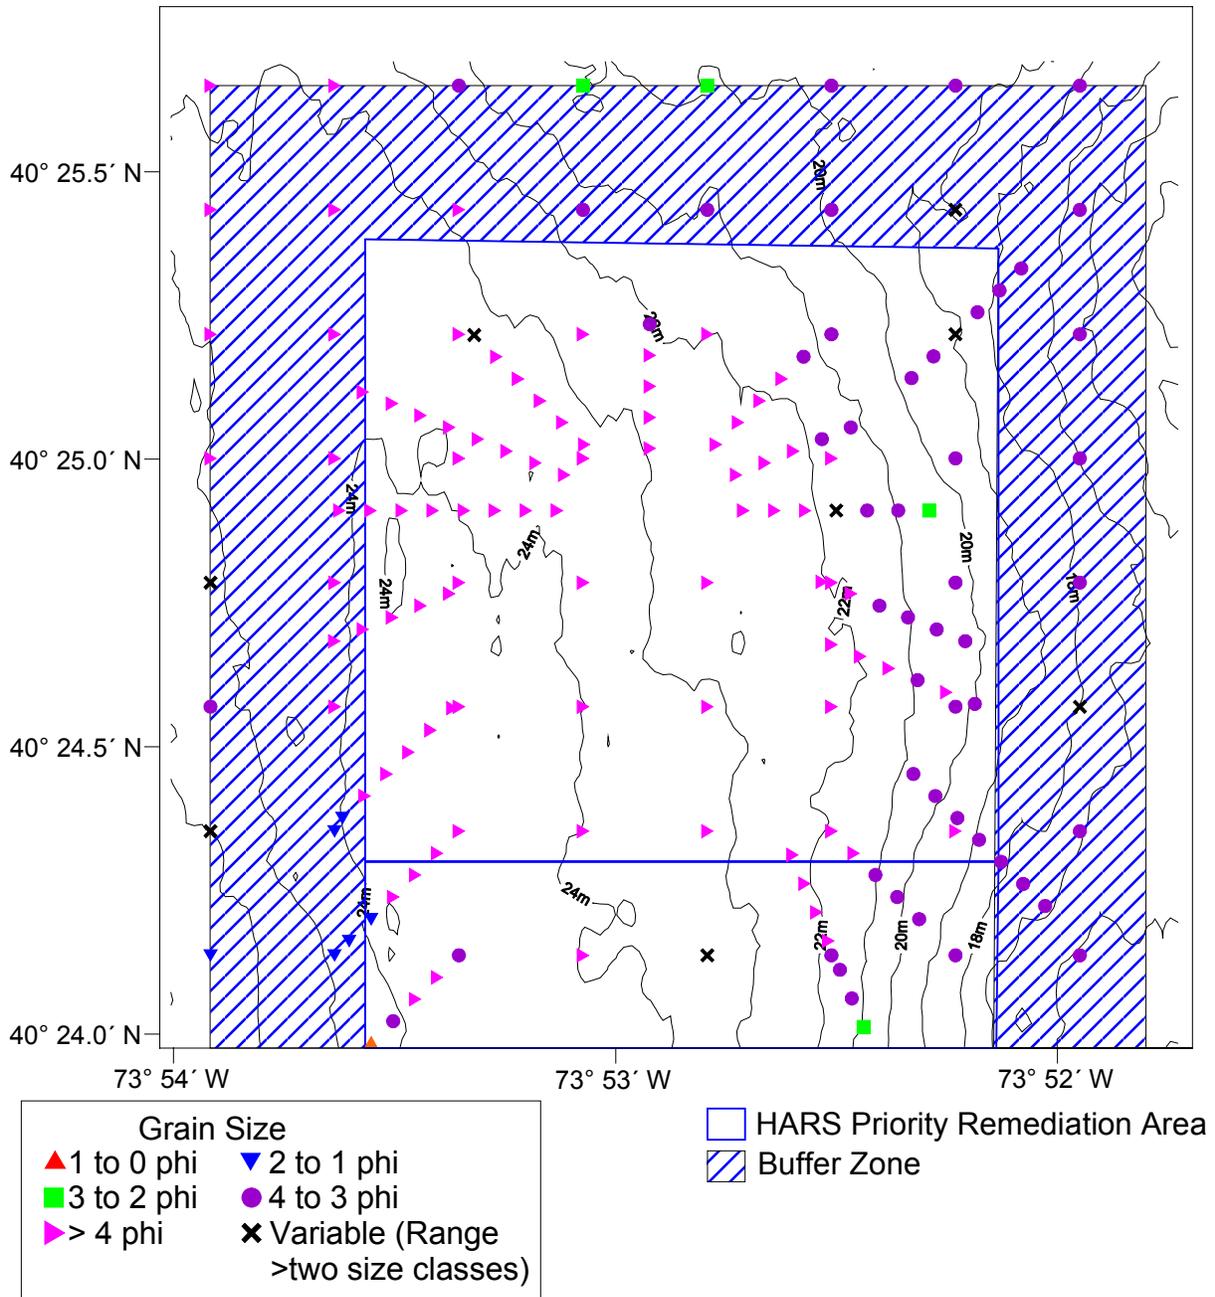
The silt-clay (>4 phi) was found primarily below the 22 m depth contour, within the elongated basin which is the dominant topographic feature of PRAs 1 and 2 (Figure 3-32). Most of this fine-grained material is the result of past dredged material placement in and around the former Mud Dump Site; the "relic" dredged material has settled within the basin and persists there. Placement of fine-grained remediation material within PRAs 1 and 2 on a regular basis since April 1998 has also contributed to the observed dominance of silt-clay on the seafloor in the surveyed area.

Sands were found on the sloping bottom representing the sides of the basin and within the HARS buffer zone (Figure 3-32). On the sloping bottom comprising the eastern and northern sides of the basin, very fine sand (4 to 3 phi) and fine sand (3 to 2 phi) were dominant (Figure 3-32). On the western side of the basin, within the buffer zone outside of PRAs 1 and 2, both medium (2 to 1 phi) and coarse (1 to 0 phi) sands were observed. Most of the sands were rippled, suggesting a slightly higher energy level associated with these shallower areas (Figure 3-33).

Figure 3-32. Map of grain size major mode at each station in the HARS survey area based on REMOTS® analysis.

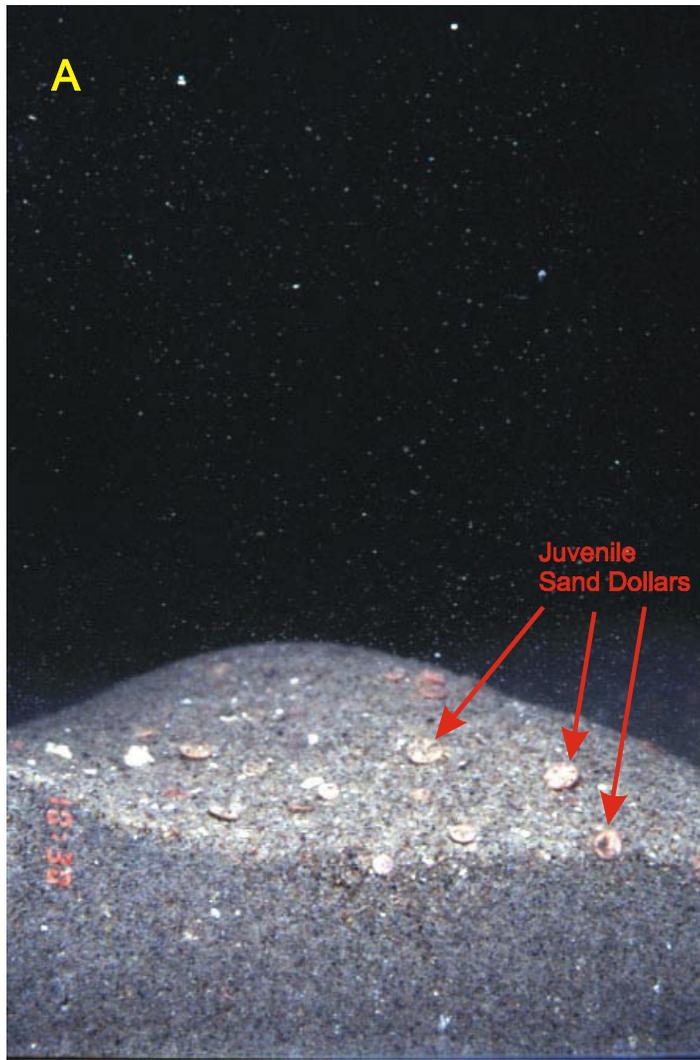
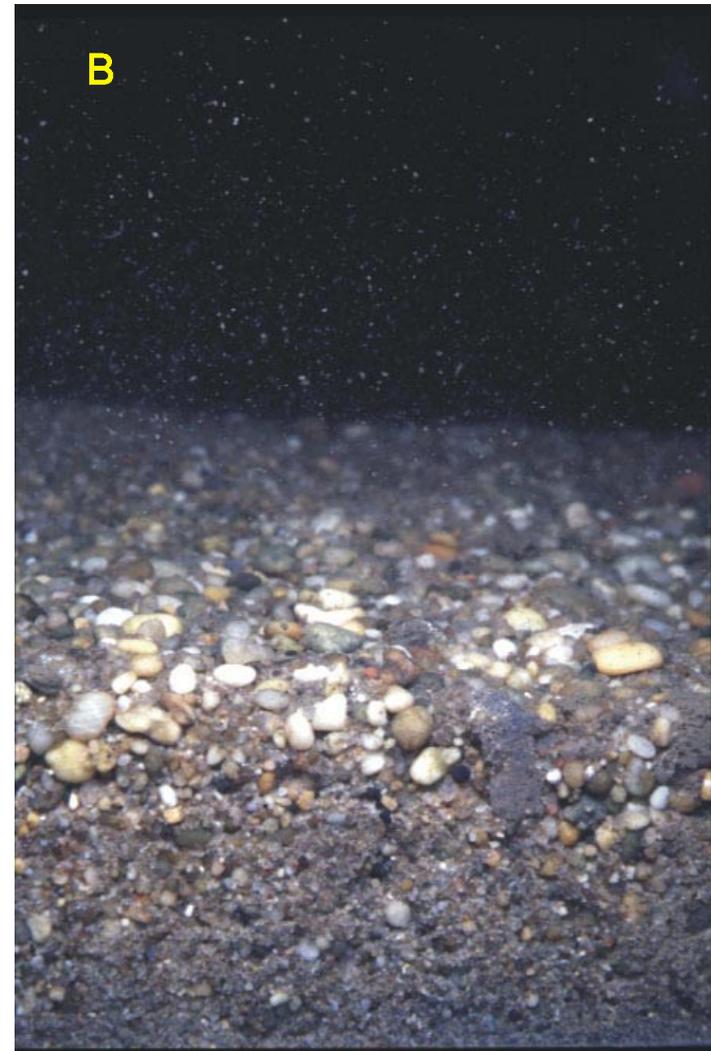
Figure 3-33. Two REMOTS[®] images showing sandy sediments in the surveyed area. Image A from Station C-2800 shows the rippled, very fine sand (4 to 3 phi) which characterized the sloping bottom to the east of the elongated basin. Image B from Station H-0 shows coarse sand (1 to 0 phi) observed in the HARS buffer zone along the west side of PRA 1 and 2.

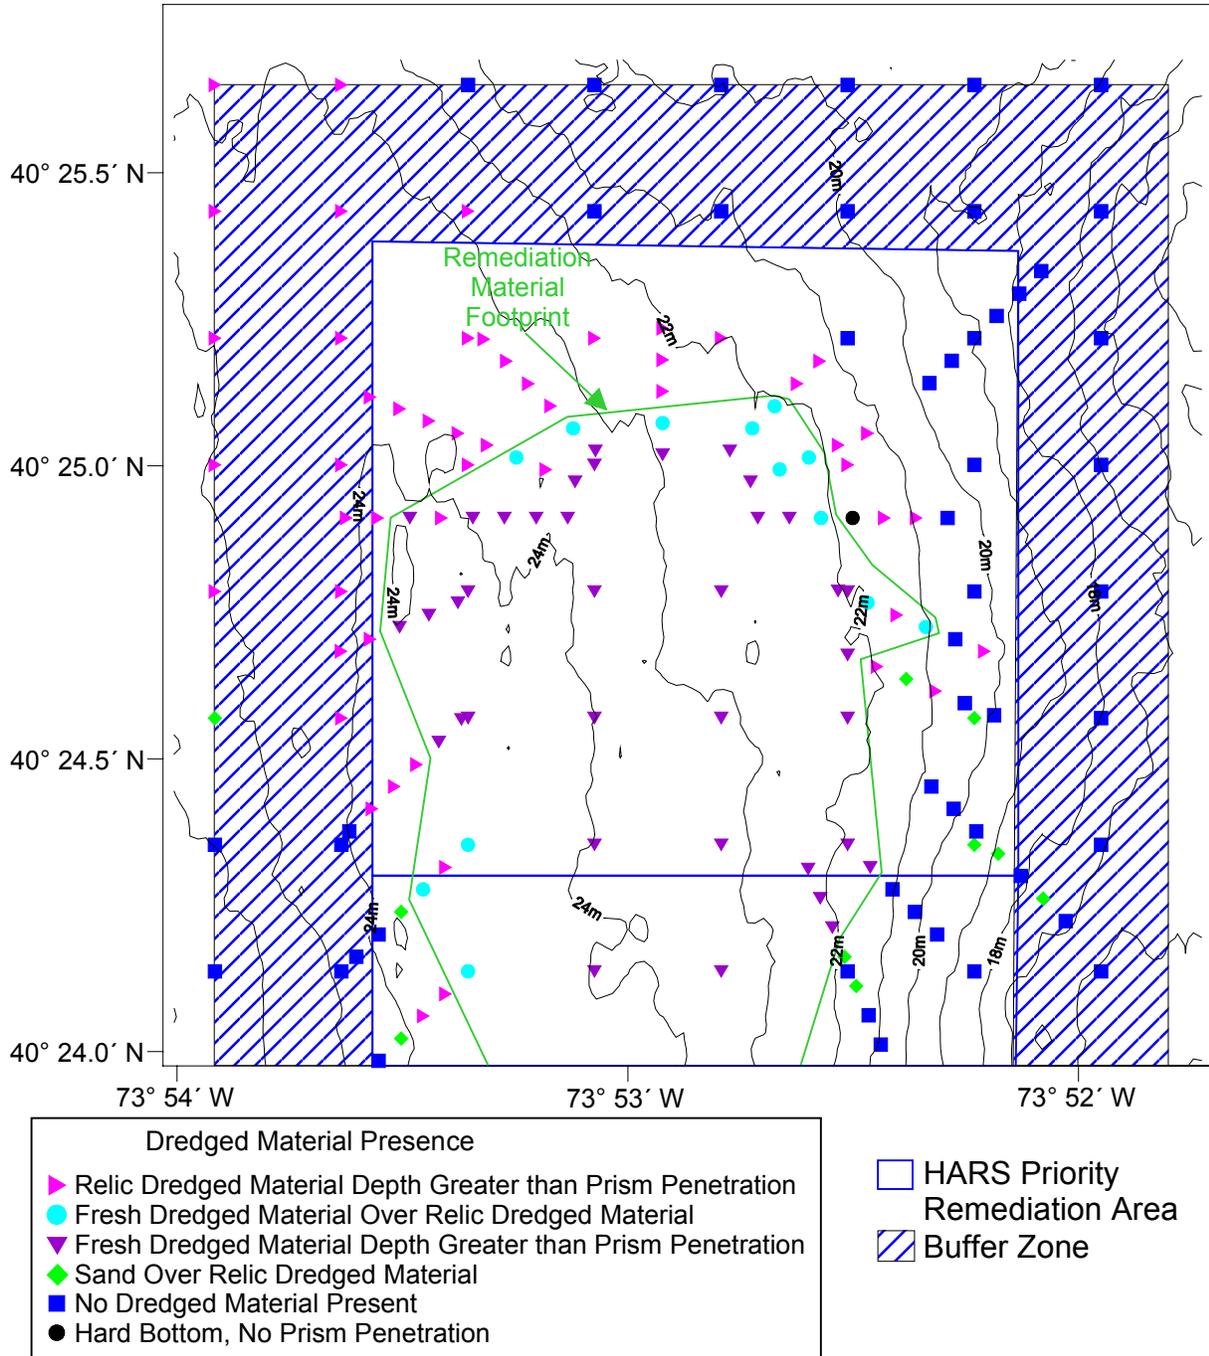
Figure 3-34. Map showing the presence of relic and fresh dredged material in the surveyed area

The second type of dredged material was characterized by a light grey color and soft texture that helped make it clearly distinguishable from the black relic dredged material (Figure 3-36). The penetration of the REMOTS[®] camera prism in the fresh dredged material typically was greater than in the relic material, providing another diagnostic feature (e.g., comparison of Figures 3-35 and 3-36). The "fresh" dredged material was observed in the center of PRA 1 and within the northern portion of PRA 2 and represents remediation material placed in this area since April 1998 as a result of several dredging projects. The footprint of the remediation material is defined in Figure 3-34.

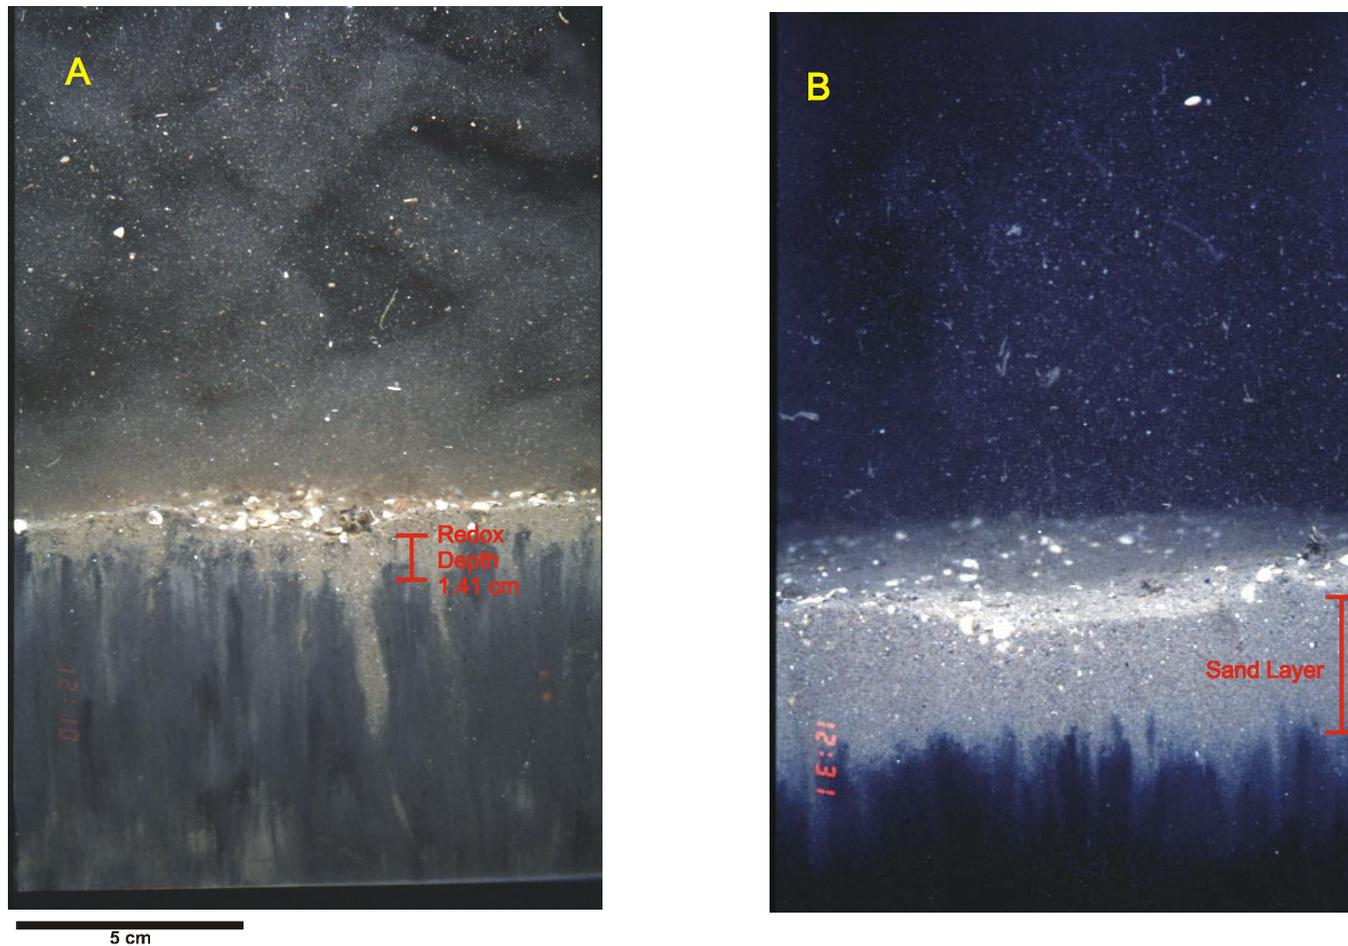
Figure 3-35. Two representative REMOTS[®] images illustrating the relic dredged material observed at a large number of stations outside the remediation material footprint. In image A from Station C-400, the black, relic dredged material has a shallow redox layer and extends from the sediment surface to below the camera's imaging depth. Image B from Station 2ESE-200, shows a layer of sand over black relic dredged material. Note the presence of numerous small white shells and shell fragments at the sediment surface in both images.

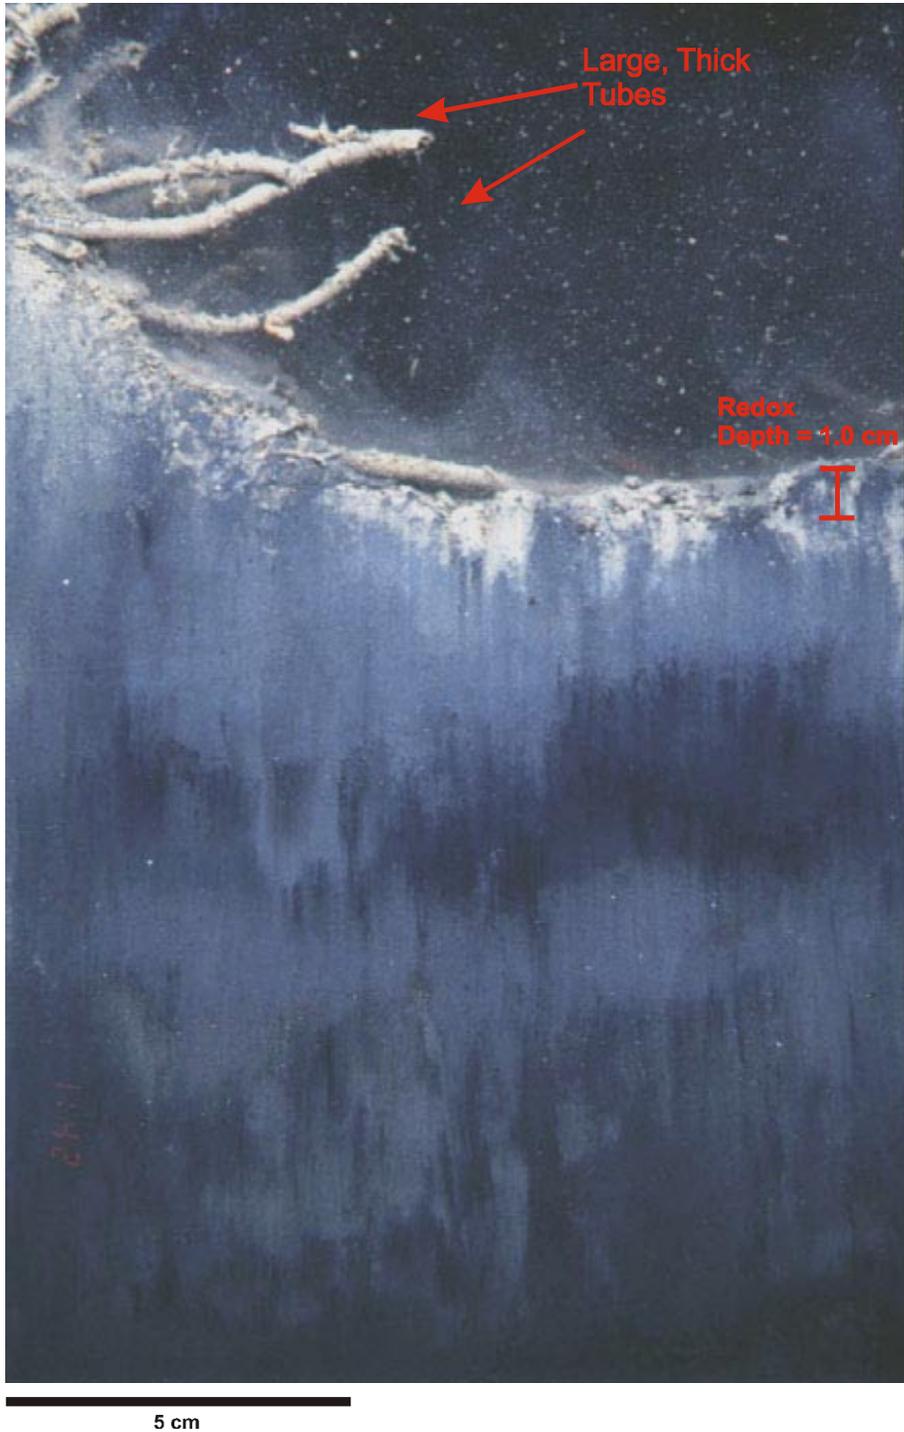
Figure 3-36. REMOTS[®] image showing the “fresh” dredged material found in PRA 1. This image from station F-1200 shows the lighter grey material extending from the sediment surface to below the camera’s imaging depth. Note the deeper camera penetration in this material compared to the relic dredged material shown in Figure 3-24. Several large, thick polychaete tubes are visible at the sediment surface.

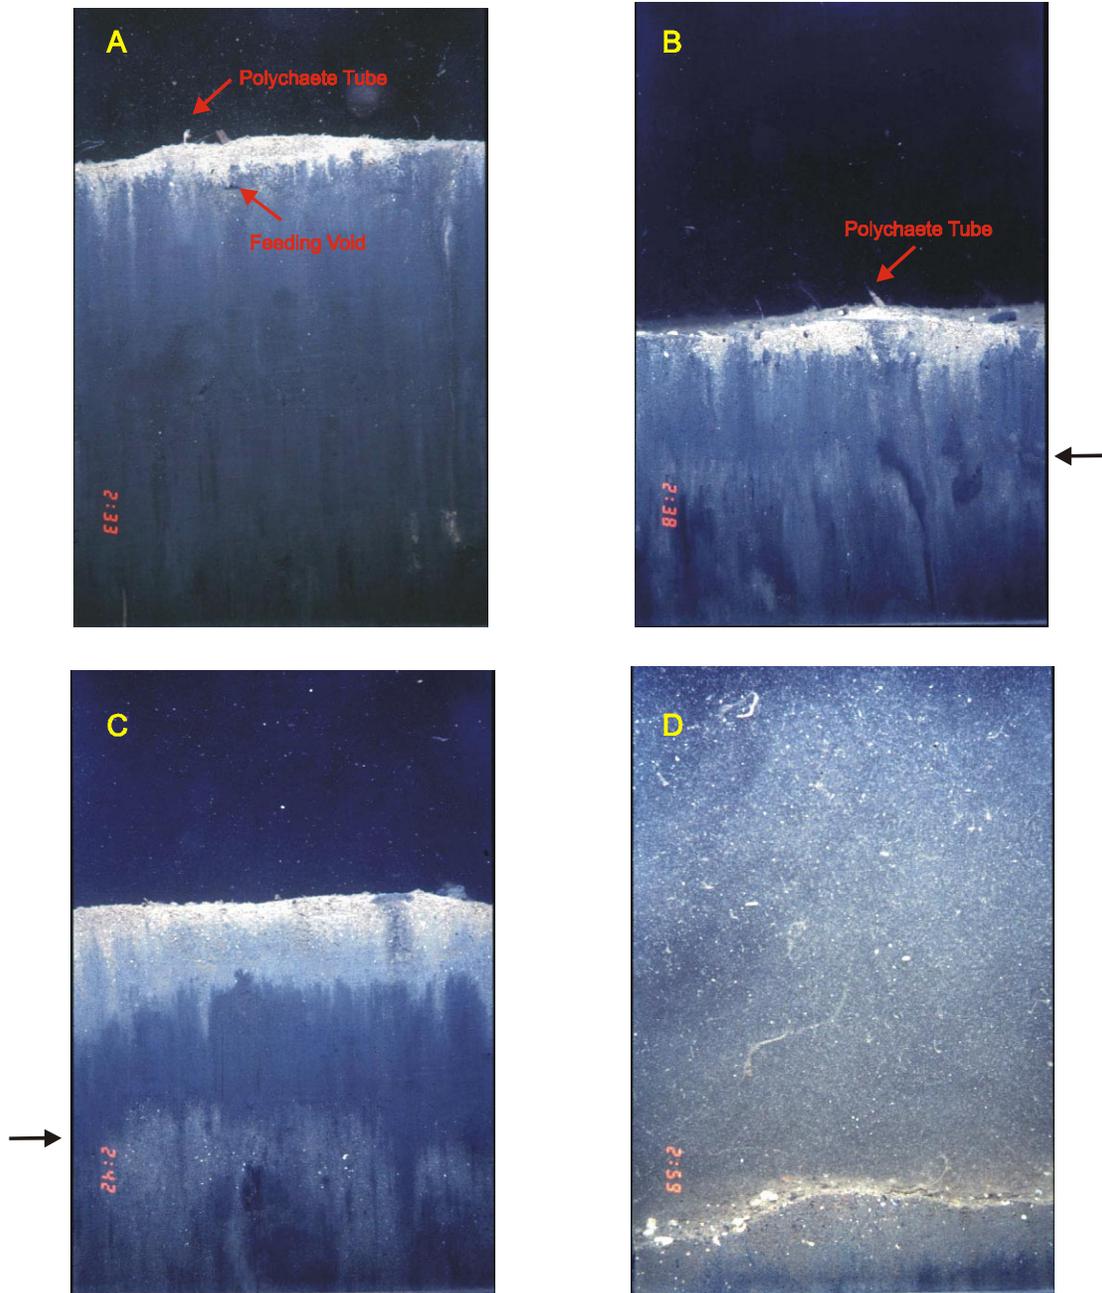
Figure 3-37. Four REMOTS® images from the NE transect. Image A, from station NE-300 shows remediation material extending from the sediment surface to below the camera's imaging depth. Images B and C, from stations NE-400 and NE-500, show discrete layers of remediation material overlying relic dredged material on the mound apron leading to the edge of the remediation material footprint (point of contact between the two layers is marked with an arrow). Image D, from station NE-600 shows "ambient" relic dredged material extending from the sediment surface to below the camera's imaging depth. In this image, the camera has not penetrated very deeply into the sediment; most of the image shows sediment which has been dispersed into the overlying water by the camera prism.

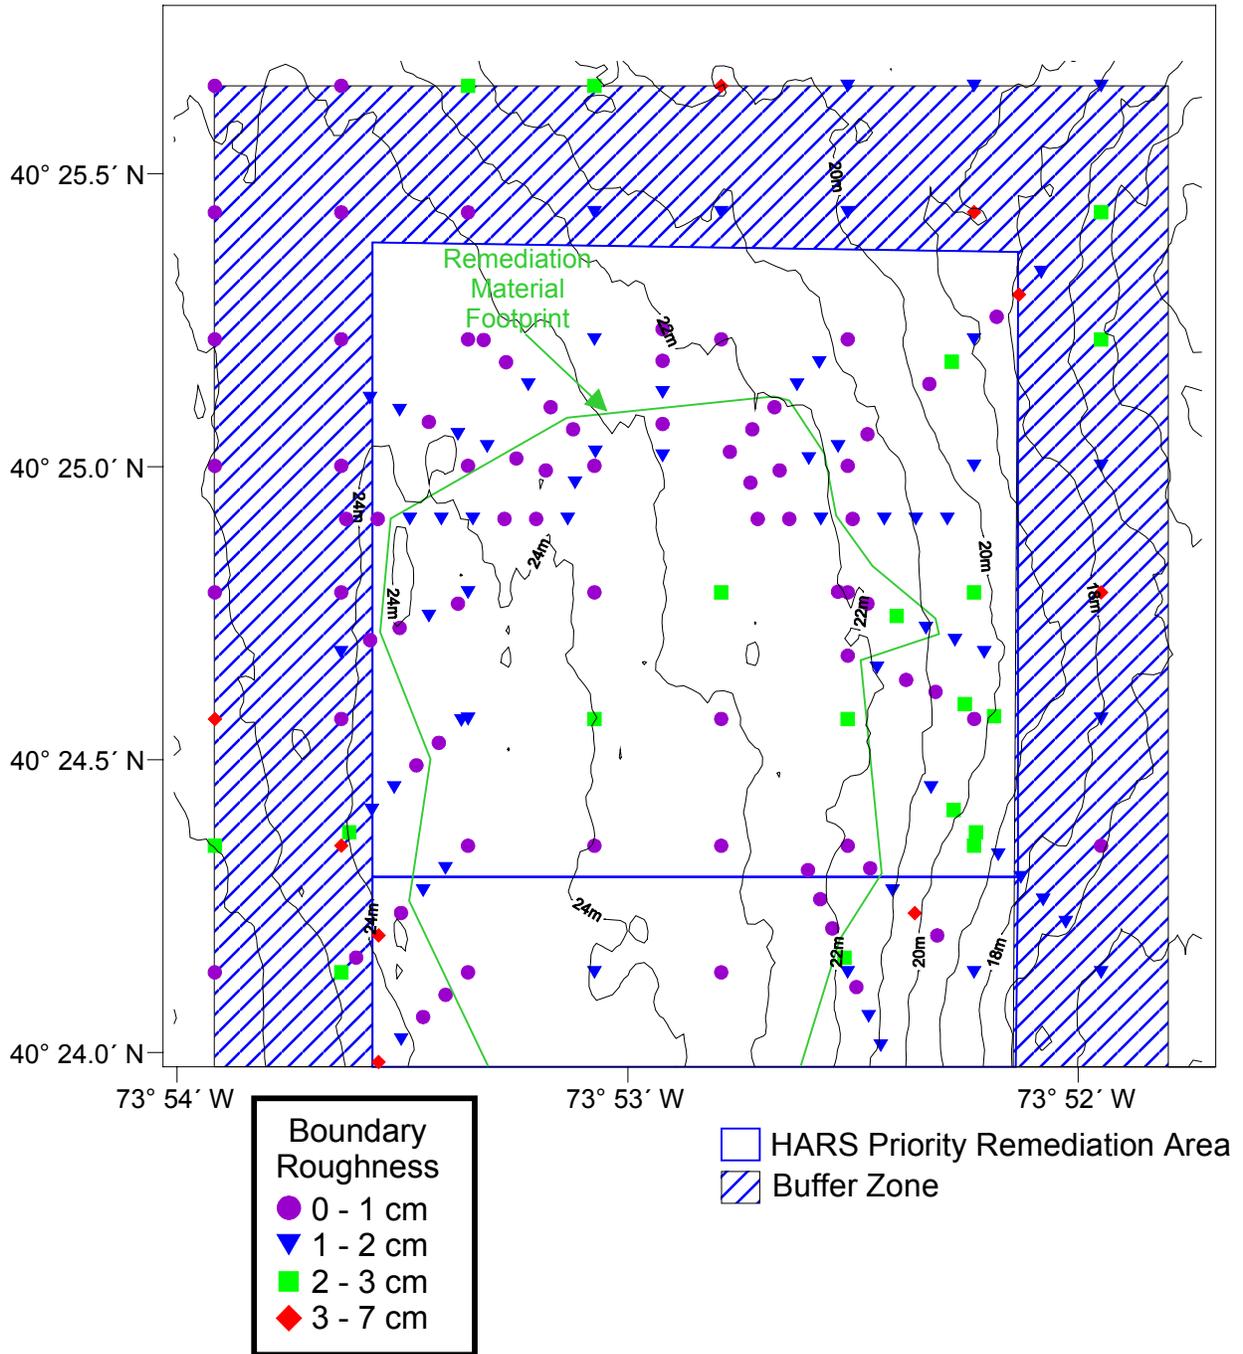
Figure 3-38 shows the spatial distribution of small-scale boundary roughness in the project area; the mapped values are averages for the replicate images obtained at each station. Approximately 80% of the boundary roughness values were less than 2 cm, with the majority of values falling in the range 0.5-1.0 cm (Figure 3-39). Five of the nine stations having higher small-scale boundary roughness (between 3 and 7 cm) were located in shallower water on the eastern sloped side of the elongated basin. These stations all had rippled fine sand and may experience higher energy conditions due to the shallower water. The other four stations having relatively high boundary roughness were located on the western side of the station grid and were characterized by coarser sand.

Figure 3-38. Map of average small-scale boundary roughness values at the sampled stations.

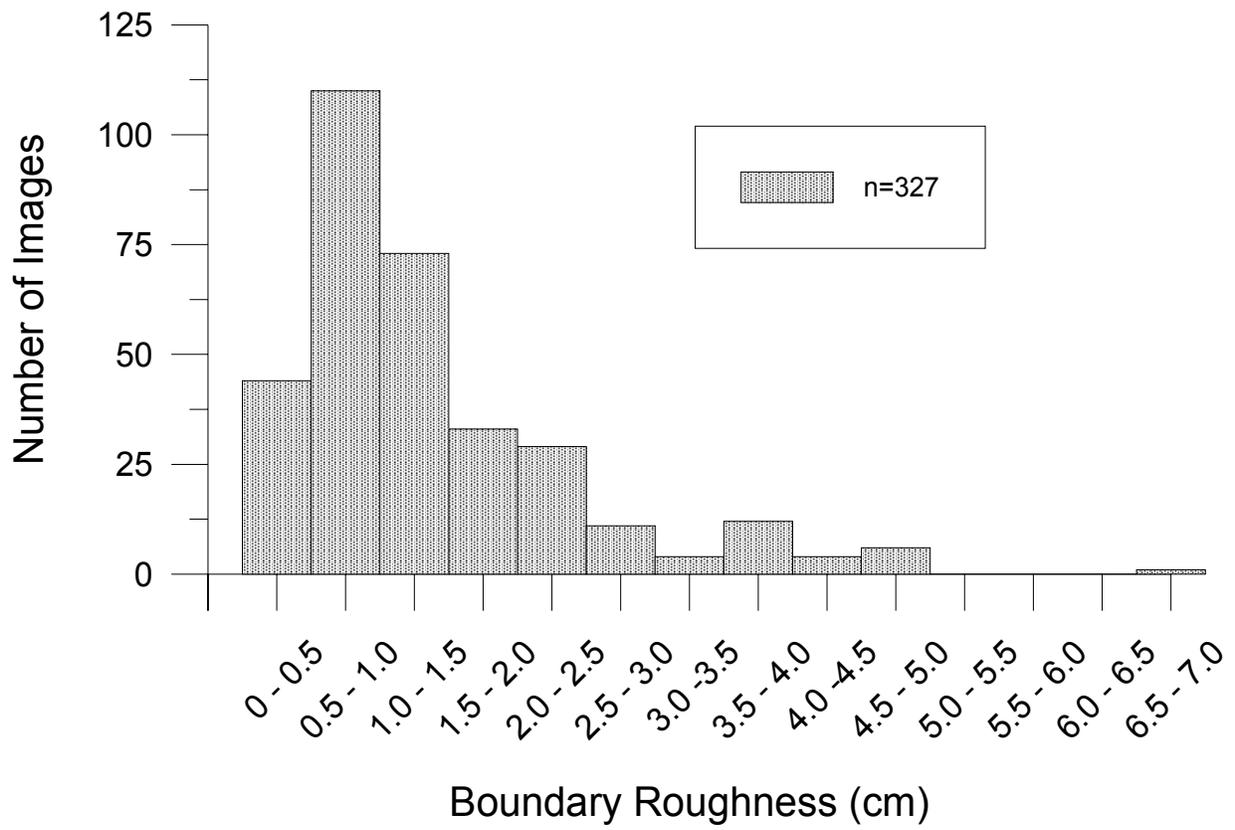
Figure 3-39. Frequency distribution of small-scale boundary roughness values for all of the replicate REMOTS[®] images that were analyzed.

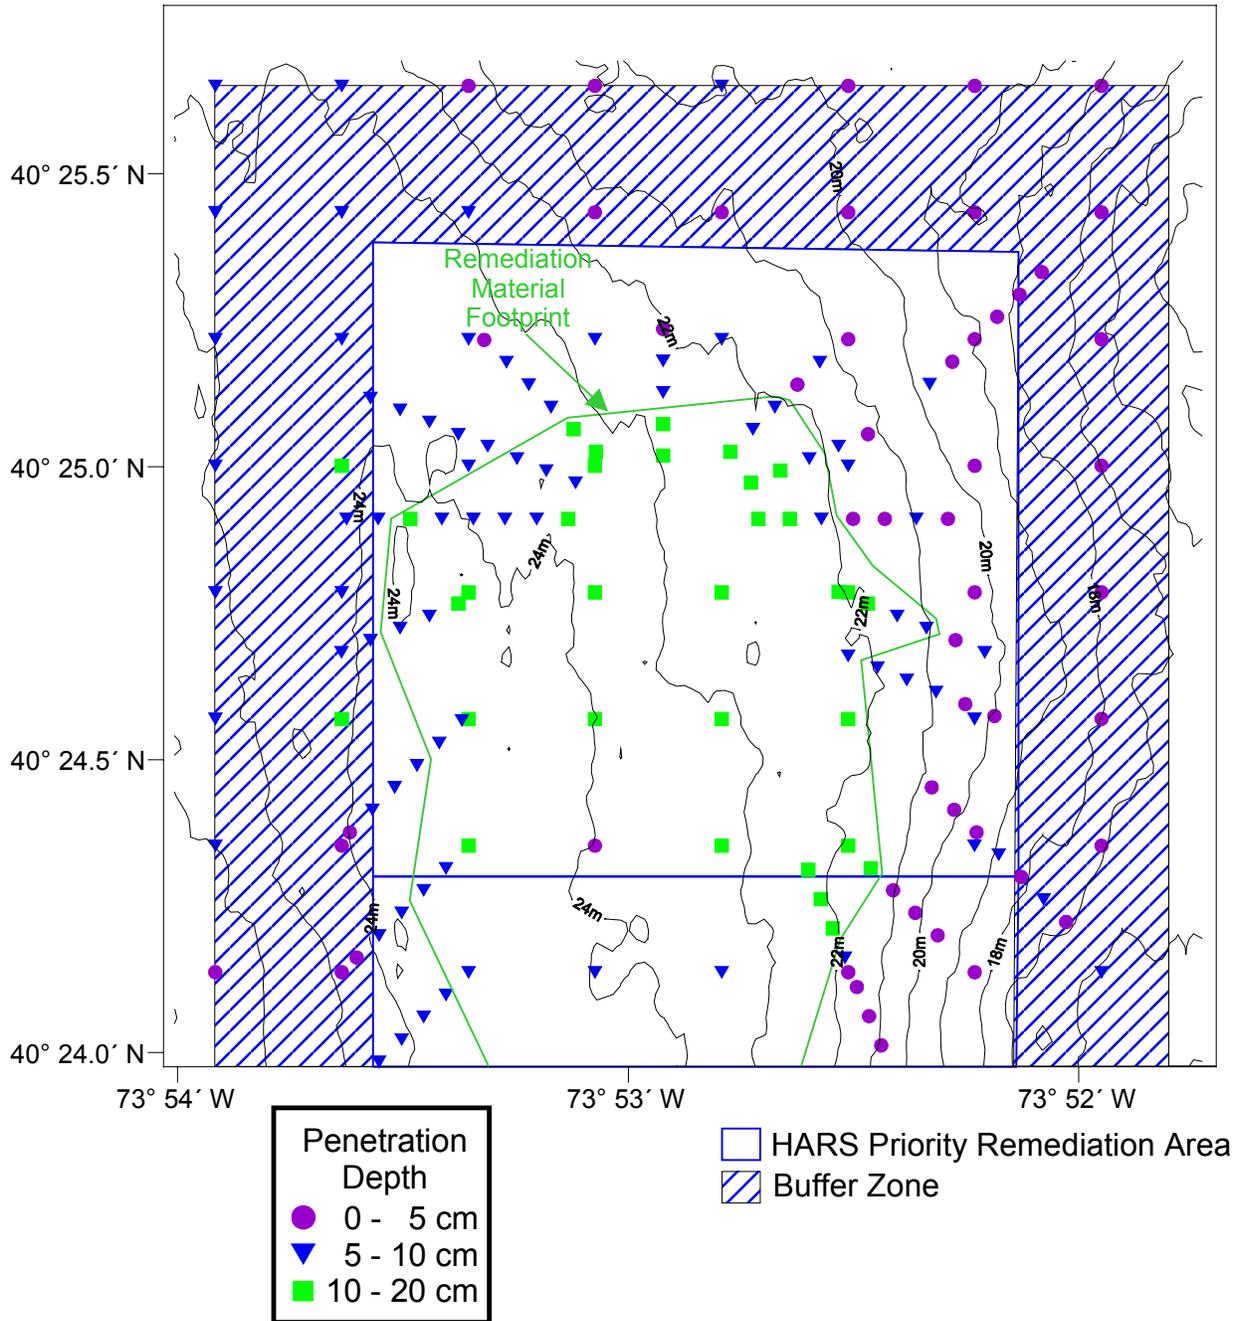
As might be expected, the deepest prism penetration (in the range of 10 to 20 cm) was found at the stations having “fresh” remediation dredged material in PRAs 1 and 2 (Figure 3-40). Intermediate penetration values (5 to 10 cm) generally were found at stations having relic dredged material within the basin, while the shallowest penetration was at the sandy and rocky stations located on the sloping sides of the basin (Figure 3-40).

Figure 3-40. Map of average prism penetration depths in the survey area.
