RESULTS OF THE MARCH 2000 REMOTS[®] AND SIDE-SCAN SONAR SURVEY OF HARS REMEDIATION AREAS 1, 2, AND 3

Science Applications
International Corporation
Admiral's Gate
221 Third Street
Newport, RI 02840

U.S. Army Corps of Engineers
New York District,
Operations Division
26 Federal Plaza
New York, NY 10278-0090

Contract No. GS-35F-4461G
SAIC Project No. 01-0440-04-2672-440
Report No. 4 of the Historic Area Remediation Site Studies
SAIC Report No. 494

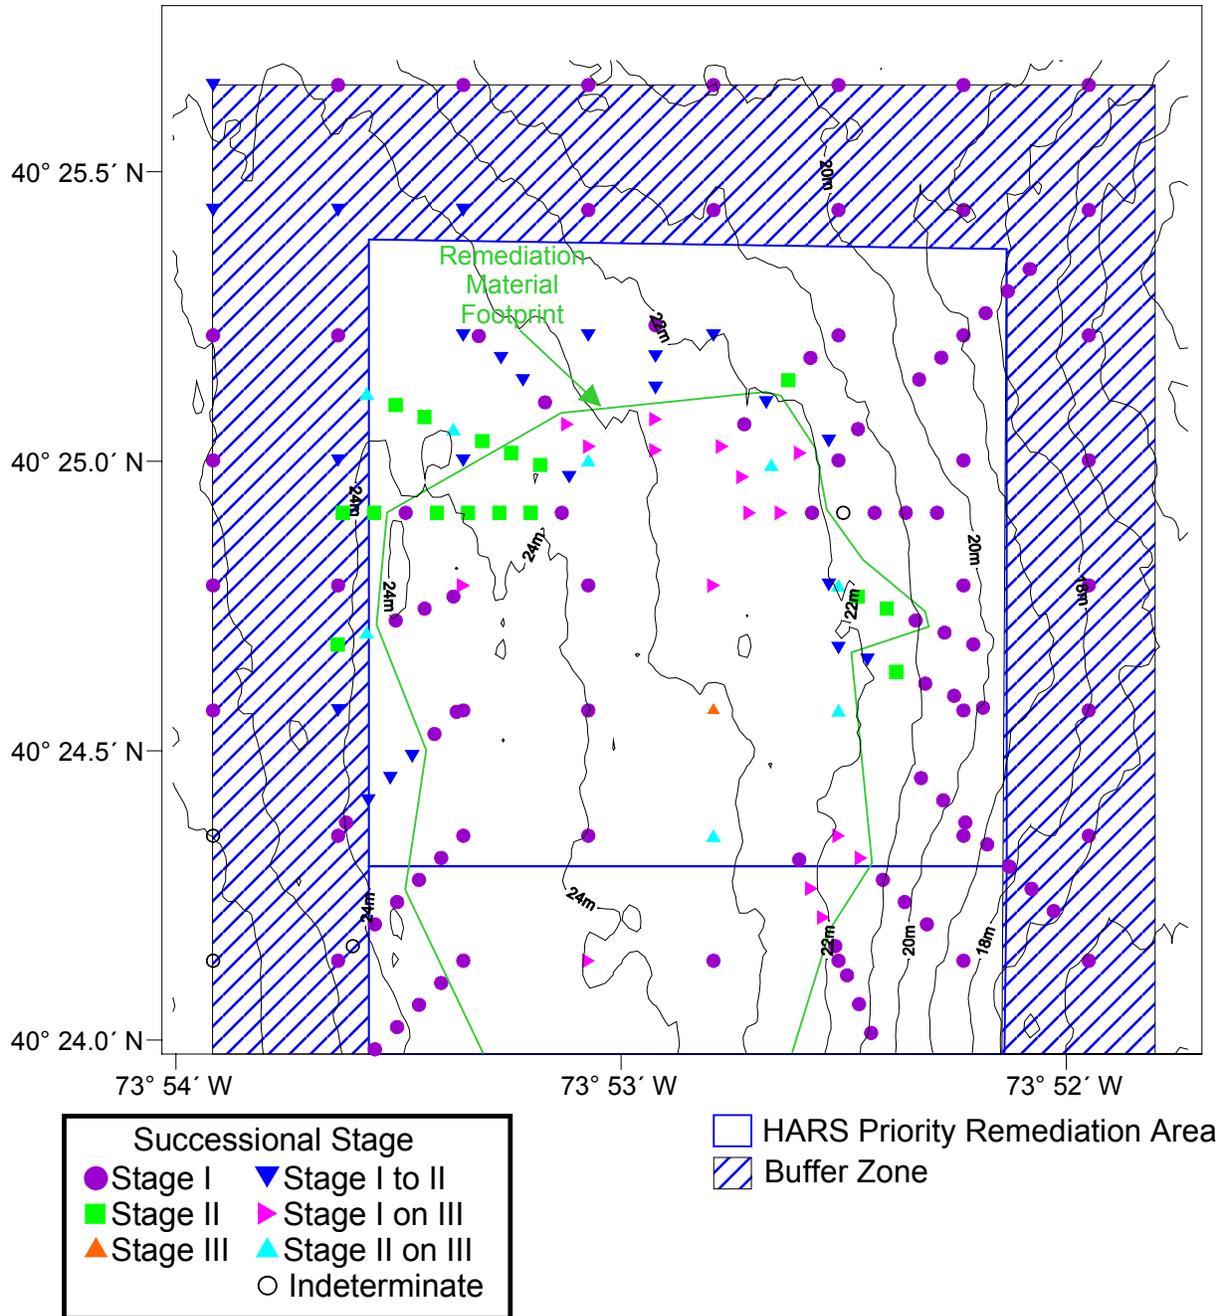
A mixture of Stage I, Stage II and Stage III organisms occurred across the surveyed area (Figure 3-41). Stage I was the dominant successional stage, occurring in 210 (63%) of the replicate images (Figure 3-42). Stage I was observed most consistently at the sandy stations located on the eastern sloped side of the elongated basin, as well as at stations having relic dredged material (Figure 3-41). Stage I going to II was found in 49 of 332 (15%) of the replicate images, Stage II was found in 27 images (8%), while Stage I on III was found in 22 (7%) of the images (Figure 3-42). It is notable that a significant number of stations within the remediation material footprint were characterized by advanced successional stages (e.g., Stages II and III), either alone or in combination with Stage I (Figures 3-41 and 3-43). These results suggest that the remediation material has been recolonized successfully by a relatively diverse benthic community.

Figure 3-41. Map of infaunal successional stages in the surveyed area.

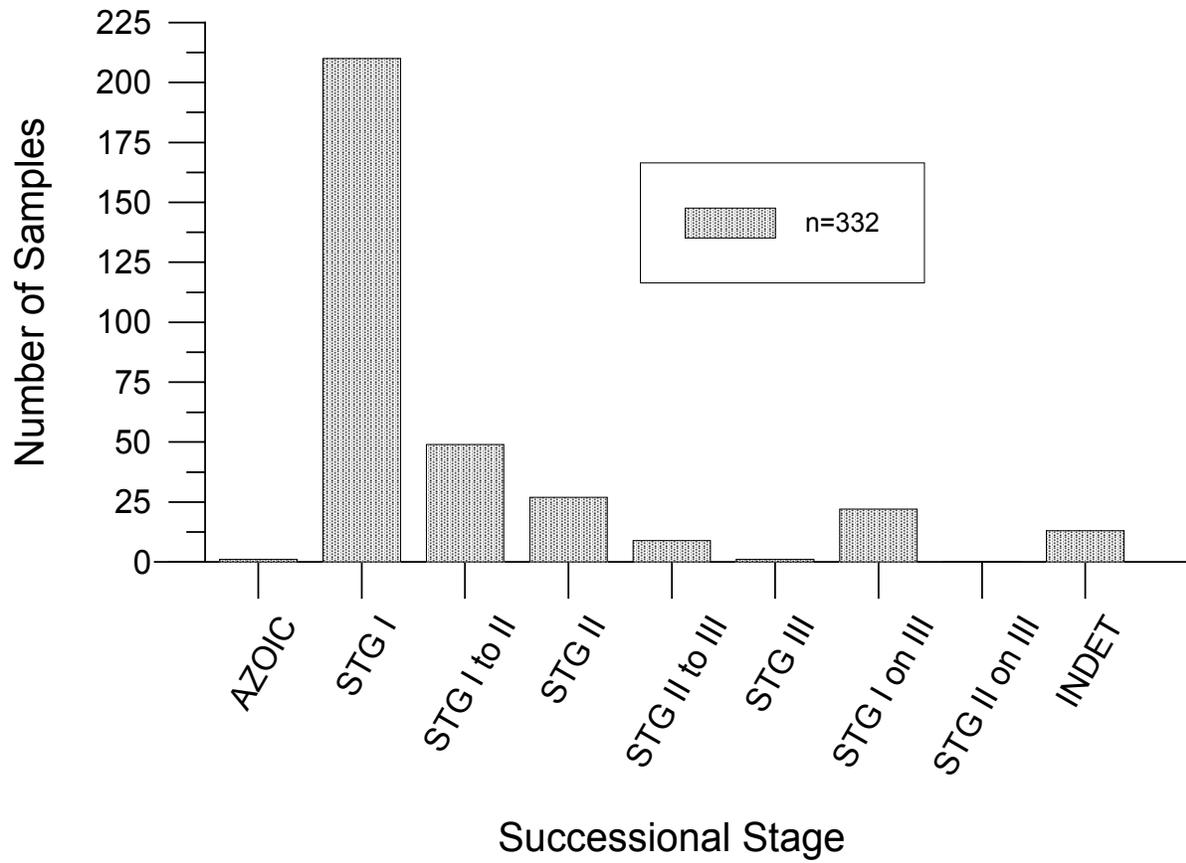
Figure 3-42. Frequency distribution of infaunal successional stages for all of the replicate REMOTS[®] images that were analyzed.

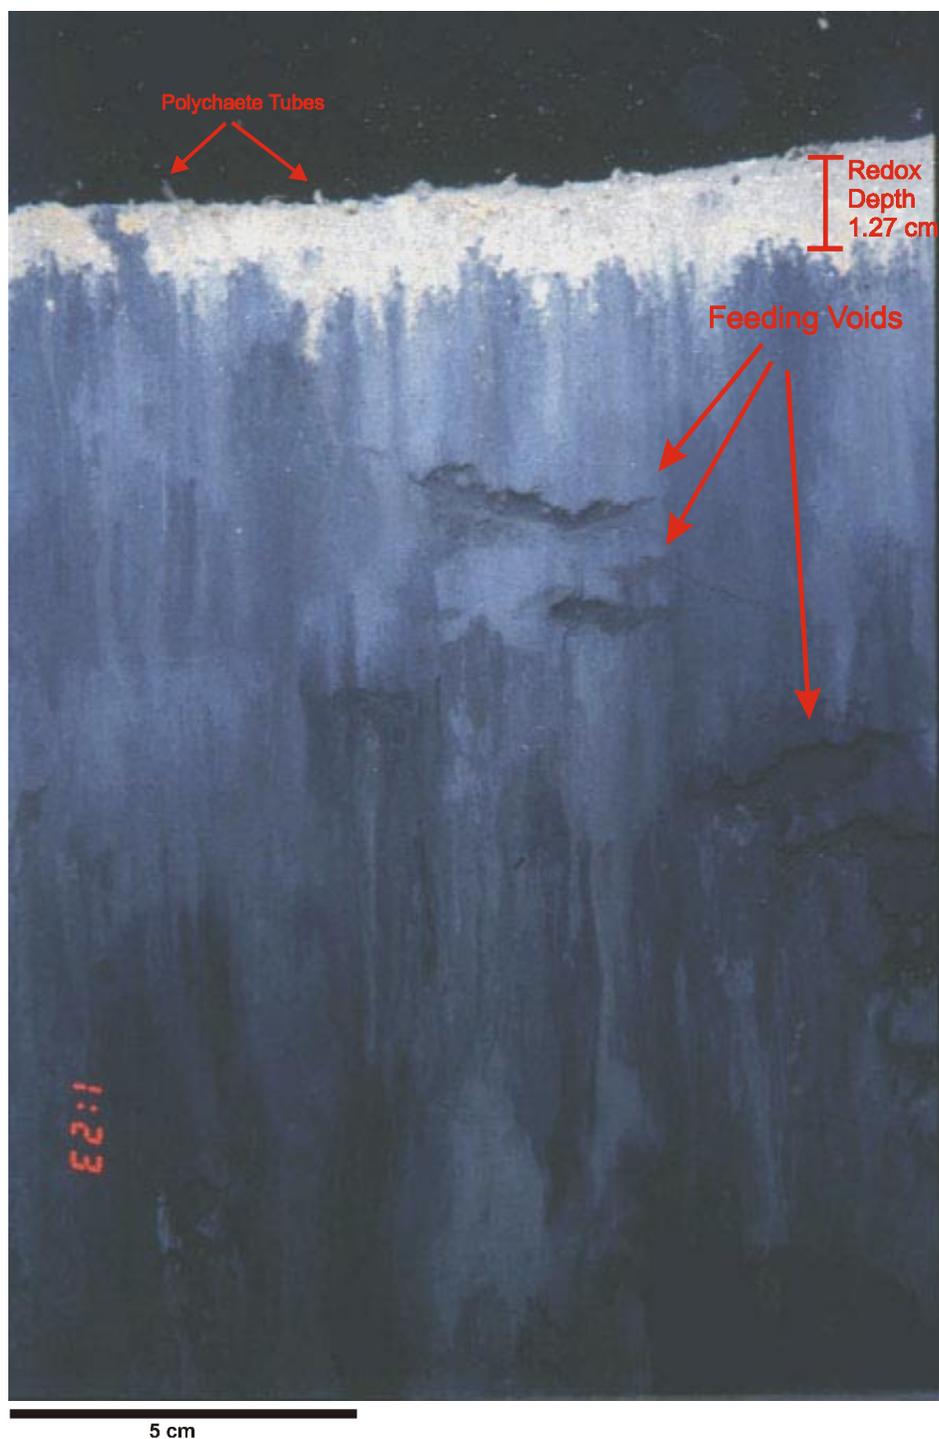
Figure 3-43. REMOTS® image from station ENE-300 showing fine-grained remediation material. A number of Stage I polychaete tubes are visible at the sediment surface, and Stage III feeding voids occur at depth, resulting in a Stage I on III successional designation. The redox layer (RPD) is shallow in this newly placed material.

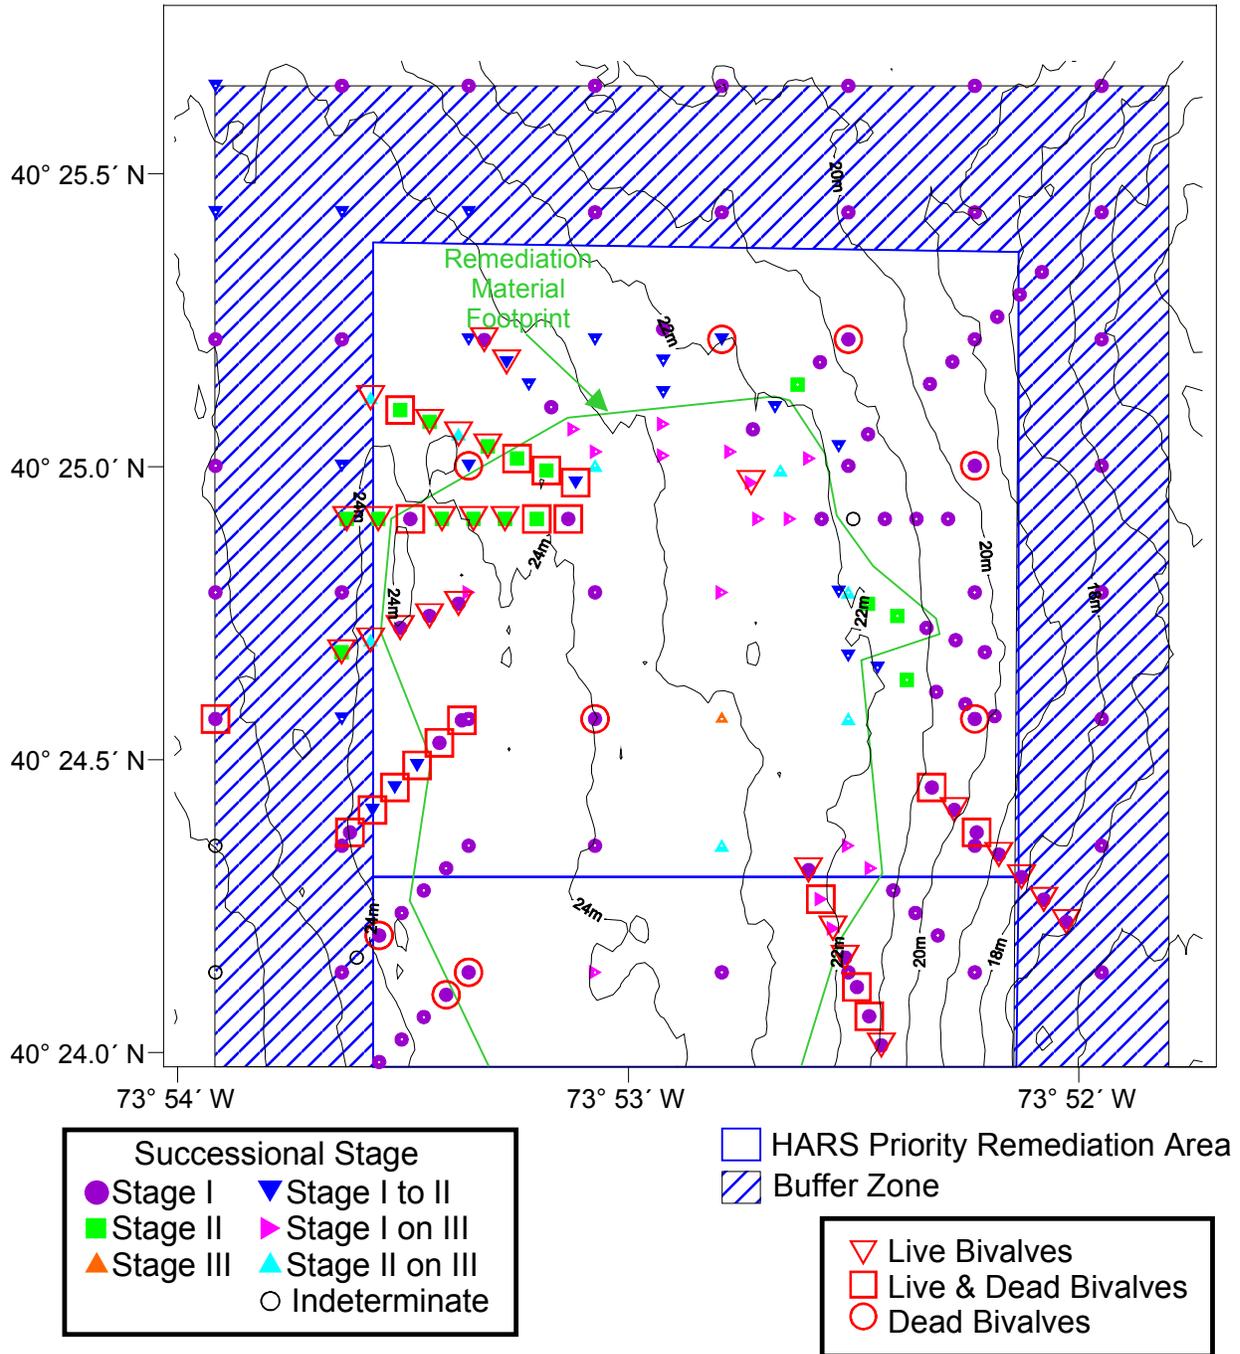
Figure 3-44. Map showing the presence of the bivalve *Nucula proxima* at stations in the surveyed area.

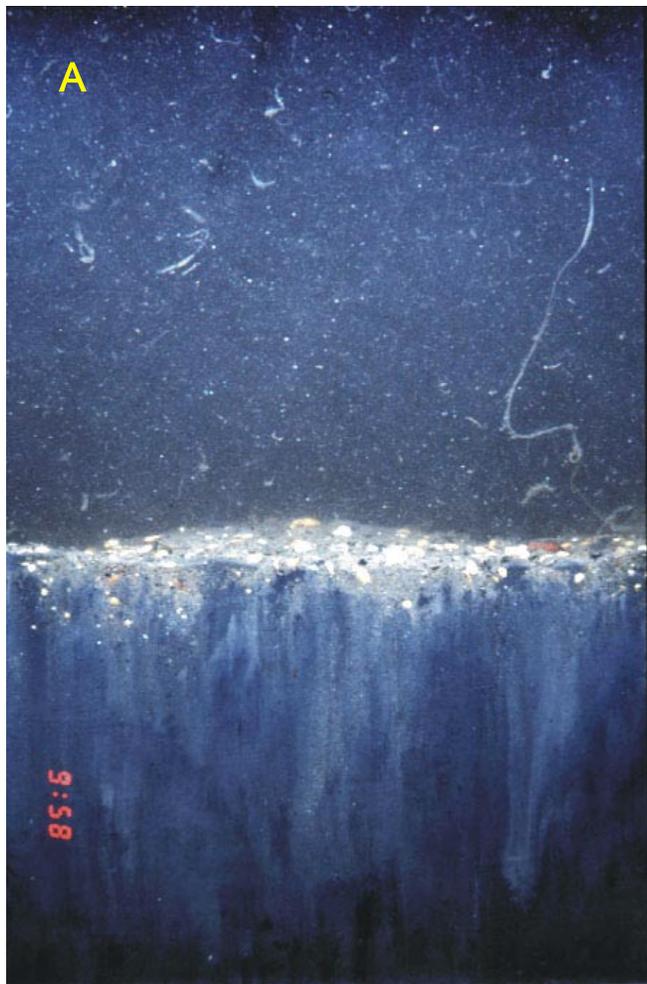
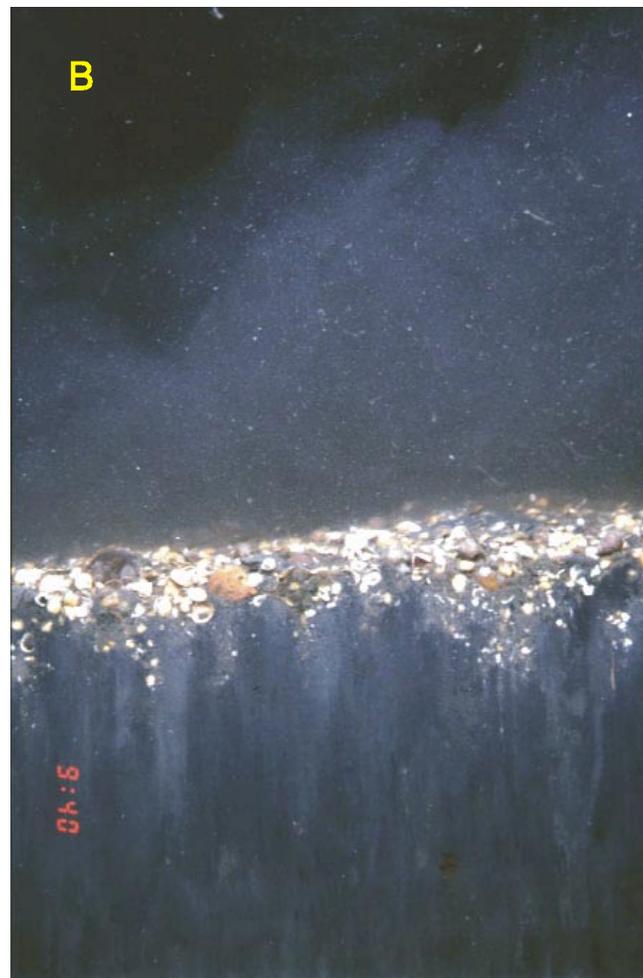
Figure 3-45. Two REMOTS[®] images showing the shallow surface-dwelling bivalve *Nucula proxima*. Image A, from station WSW-1000 shows a dense *Nucula* population in the upper 2 cm of the sediment column. Image B, from station SW-1100 shows a dense surface layer of dead *Nucula* shells.

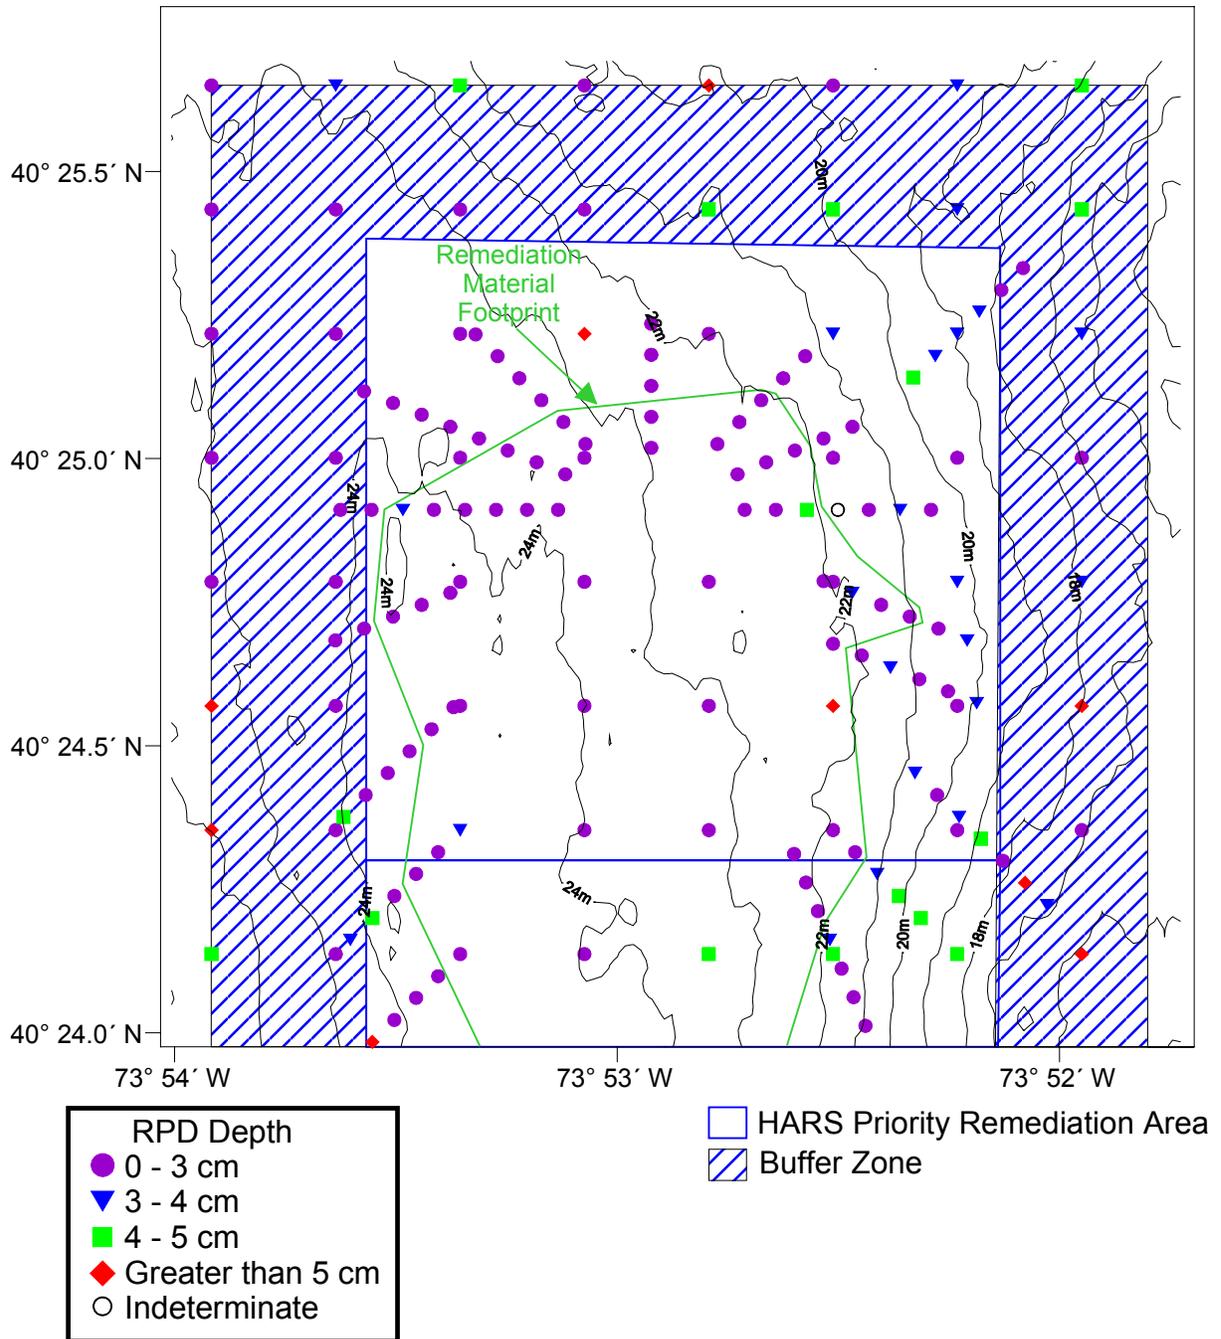
Figure 3-46. Average Redox Potential Discontinuity (RPD) depths at stations in the survey area.

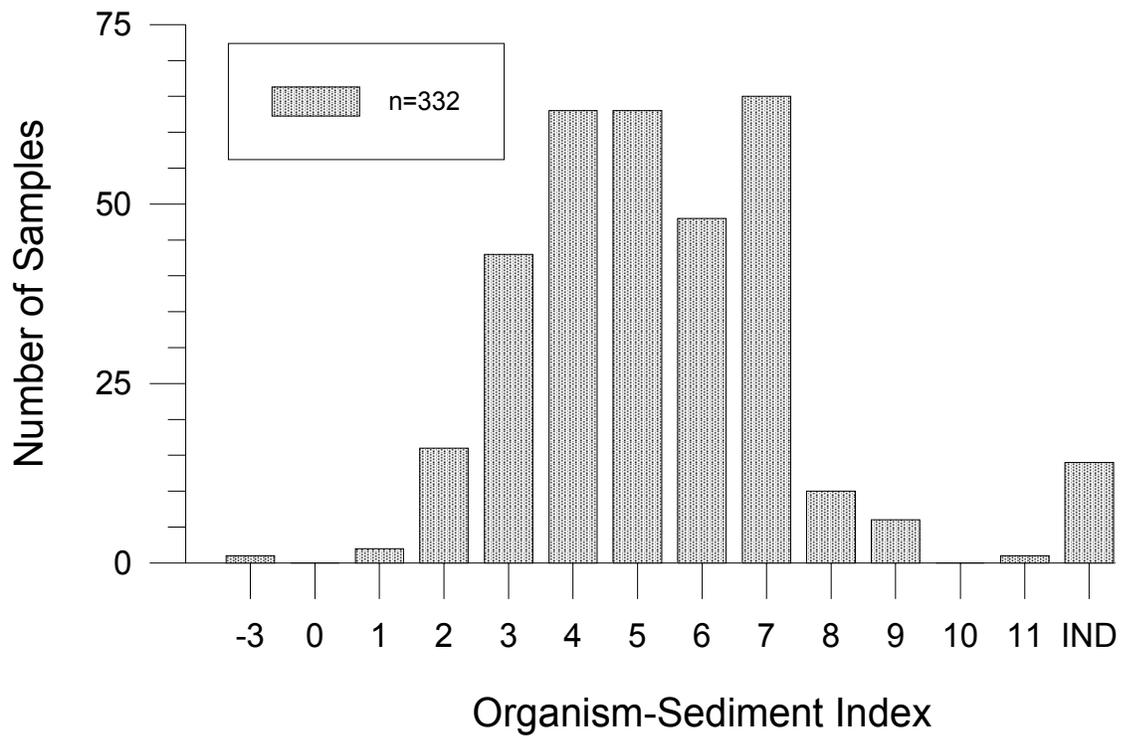
Figure 3-49. Frequency distribution of Organism-Sediment Index values for all of the replicate REMOTS[®] images analyzed.

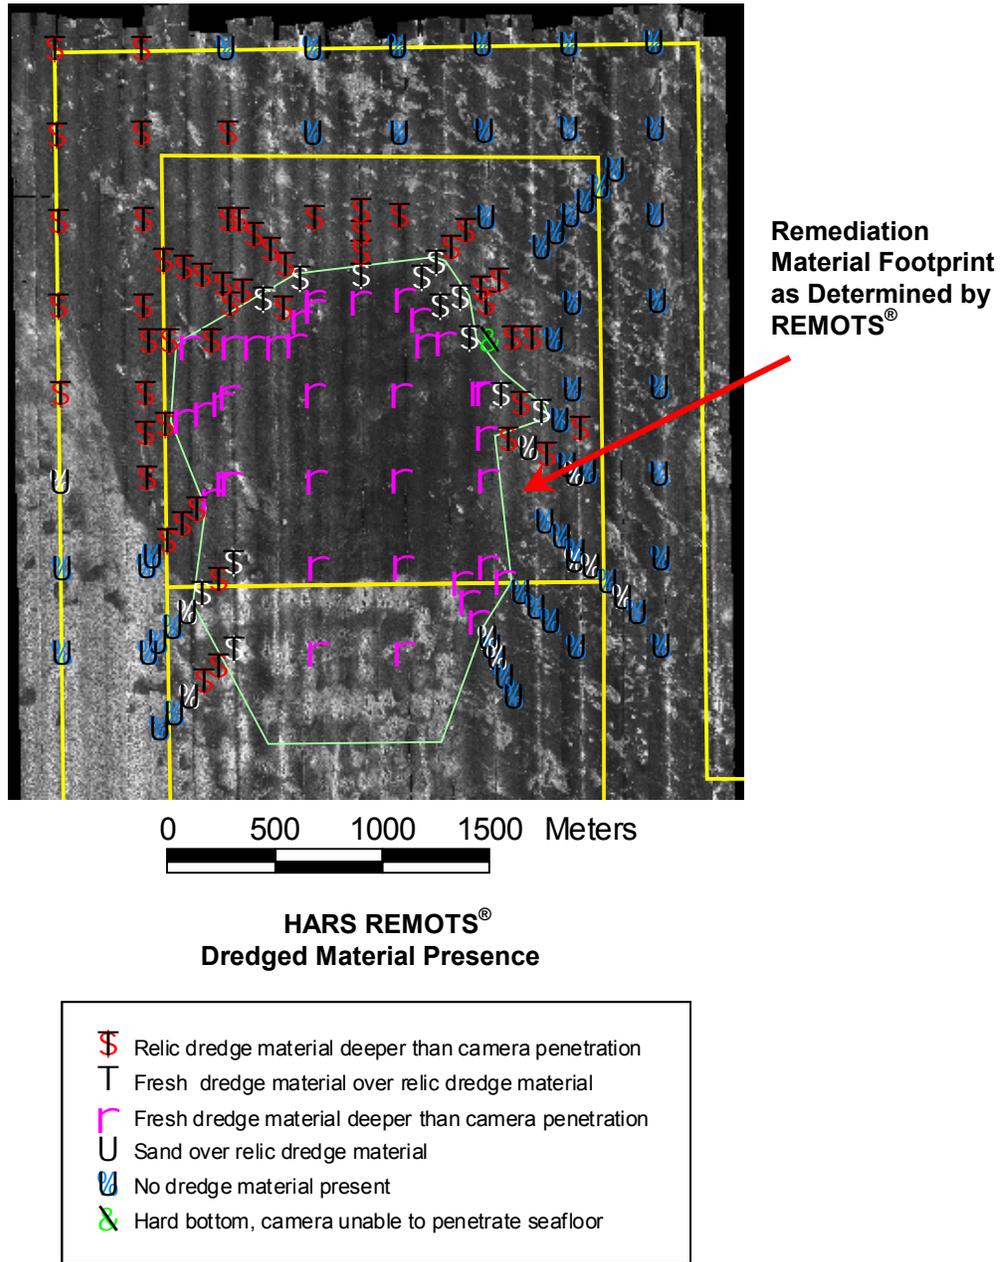
Figure 4-2. REMOTS® dredged material distribution results plotted over the side-scan sonar mosaic.
