**MONITORING DREDGED MATERIAL
PLACEMENT OPERATIONS AT THE HISTORIC AREA
REMEDIATION SITE DURING THE PASSENGER SHIP
TERMINAL PROJECT, March–May 2004**

June 2004

SAIC Report No. 660

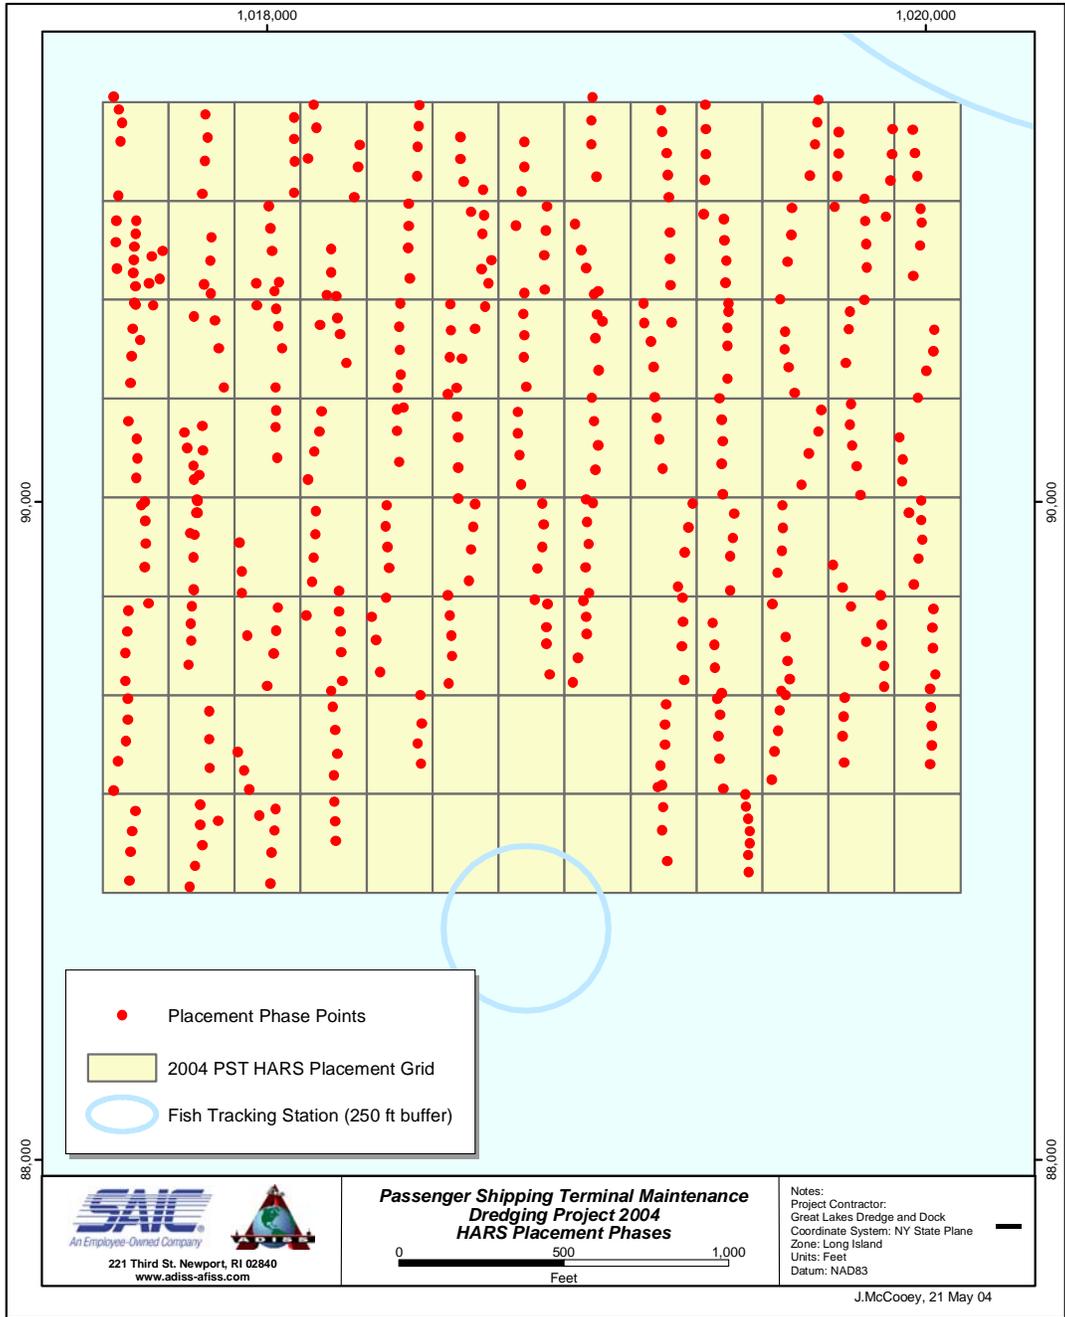
Figure 4. Summary of 102 placements at the Historic Area Remediation Site, Priority Area #1 during the Passenger Ship Terminal project, March-May 2004.

Plots of each placement and draft record were placed on the ADISS web site <http://www.adiss-afiss.com/>, and could be accessed by choosing a trip number. All showed the accurate placement within the designated target grid. Figure 4 illustrated a summary plot of all 101 recorded trips. The maintenance material dredged from the PST project contained significant volumes of water, decreasing the disposal time over the target cells to seconds instead of minutes. The quick release time resulted in accurate placement of material within the chosen target cells.
