Corps repairs 1895 dam at West Point

By JoAnne Castagna
New York District

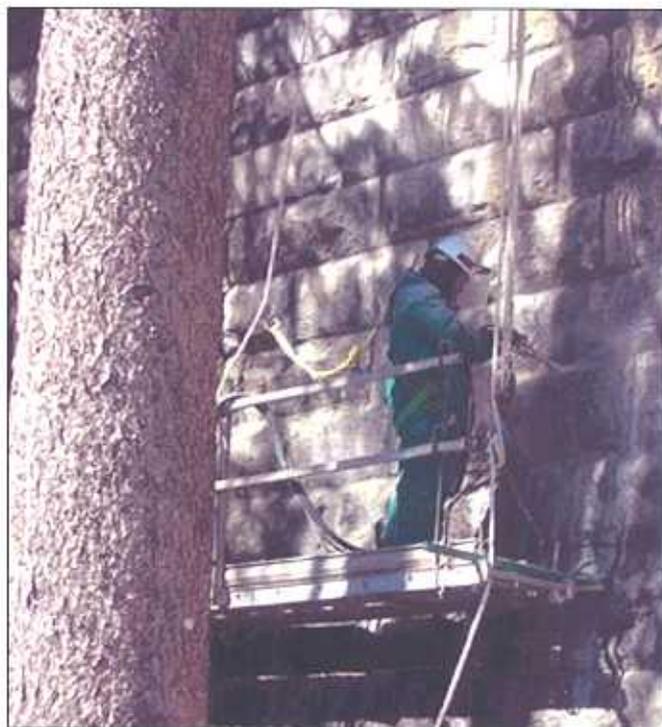
A contractor removes calcite build-up from Lusk Dam's masonry with a high-pressure spray of silica suspended in water.

dam's first cleaning in its 100 years of service. The joints on the downstream face of the dam were cleaned of efflorescence, which is crystallization that had accumulated on its surface. Leaks that had been covered by crystallization were located, cleaned, and sealed. The cleaning gave the Corps a "fresh face" to observe and categorize leaks currently present at the dam, and determine any further repairs that may be needed.

"Efflorescence is caused by calcium carbonate in the dam's mortar dissolving in the reservoir water," said Marty Goff, project engineer. "The water up there is slightly acidic so it reacts chemically with the mortar between the dam's stones. When efflorescence builds up on the stones, it becomes difficult to determine the location of leaks because water from the leak moves under the efflorescence crust and away from the leak source. By cleaning away the efflorescence we're able to see the actual location of the leak."

Goff said that it took a month to clean the dam, and that the cleaning technique they used was like cleaning a shower stall that has lime build-up. The dam's stones were cleaned by sandblasting with small coarse-grained silica (glass-like particles) under water pressure to remove the calcite build-up along the seams of the dam's stones.
