**UPPER ROCKAWAY RIVER WATERSHED
FLOOD CONTROL AND ECOSYSTEM RESTORATION STUDY
MORRIS COUNTY, NEW JERSEY**

ECOSYSTEM RESTORATION SCREENING REPORT

**Prepared by: U.S. Army Corps of Engineers
New York District
Planning Division
26 Federal Plaza
New York, New York 10278-0090**

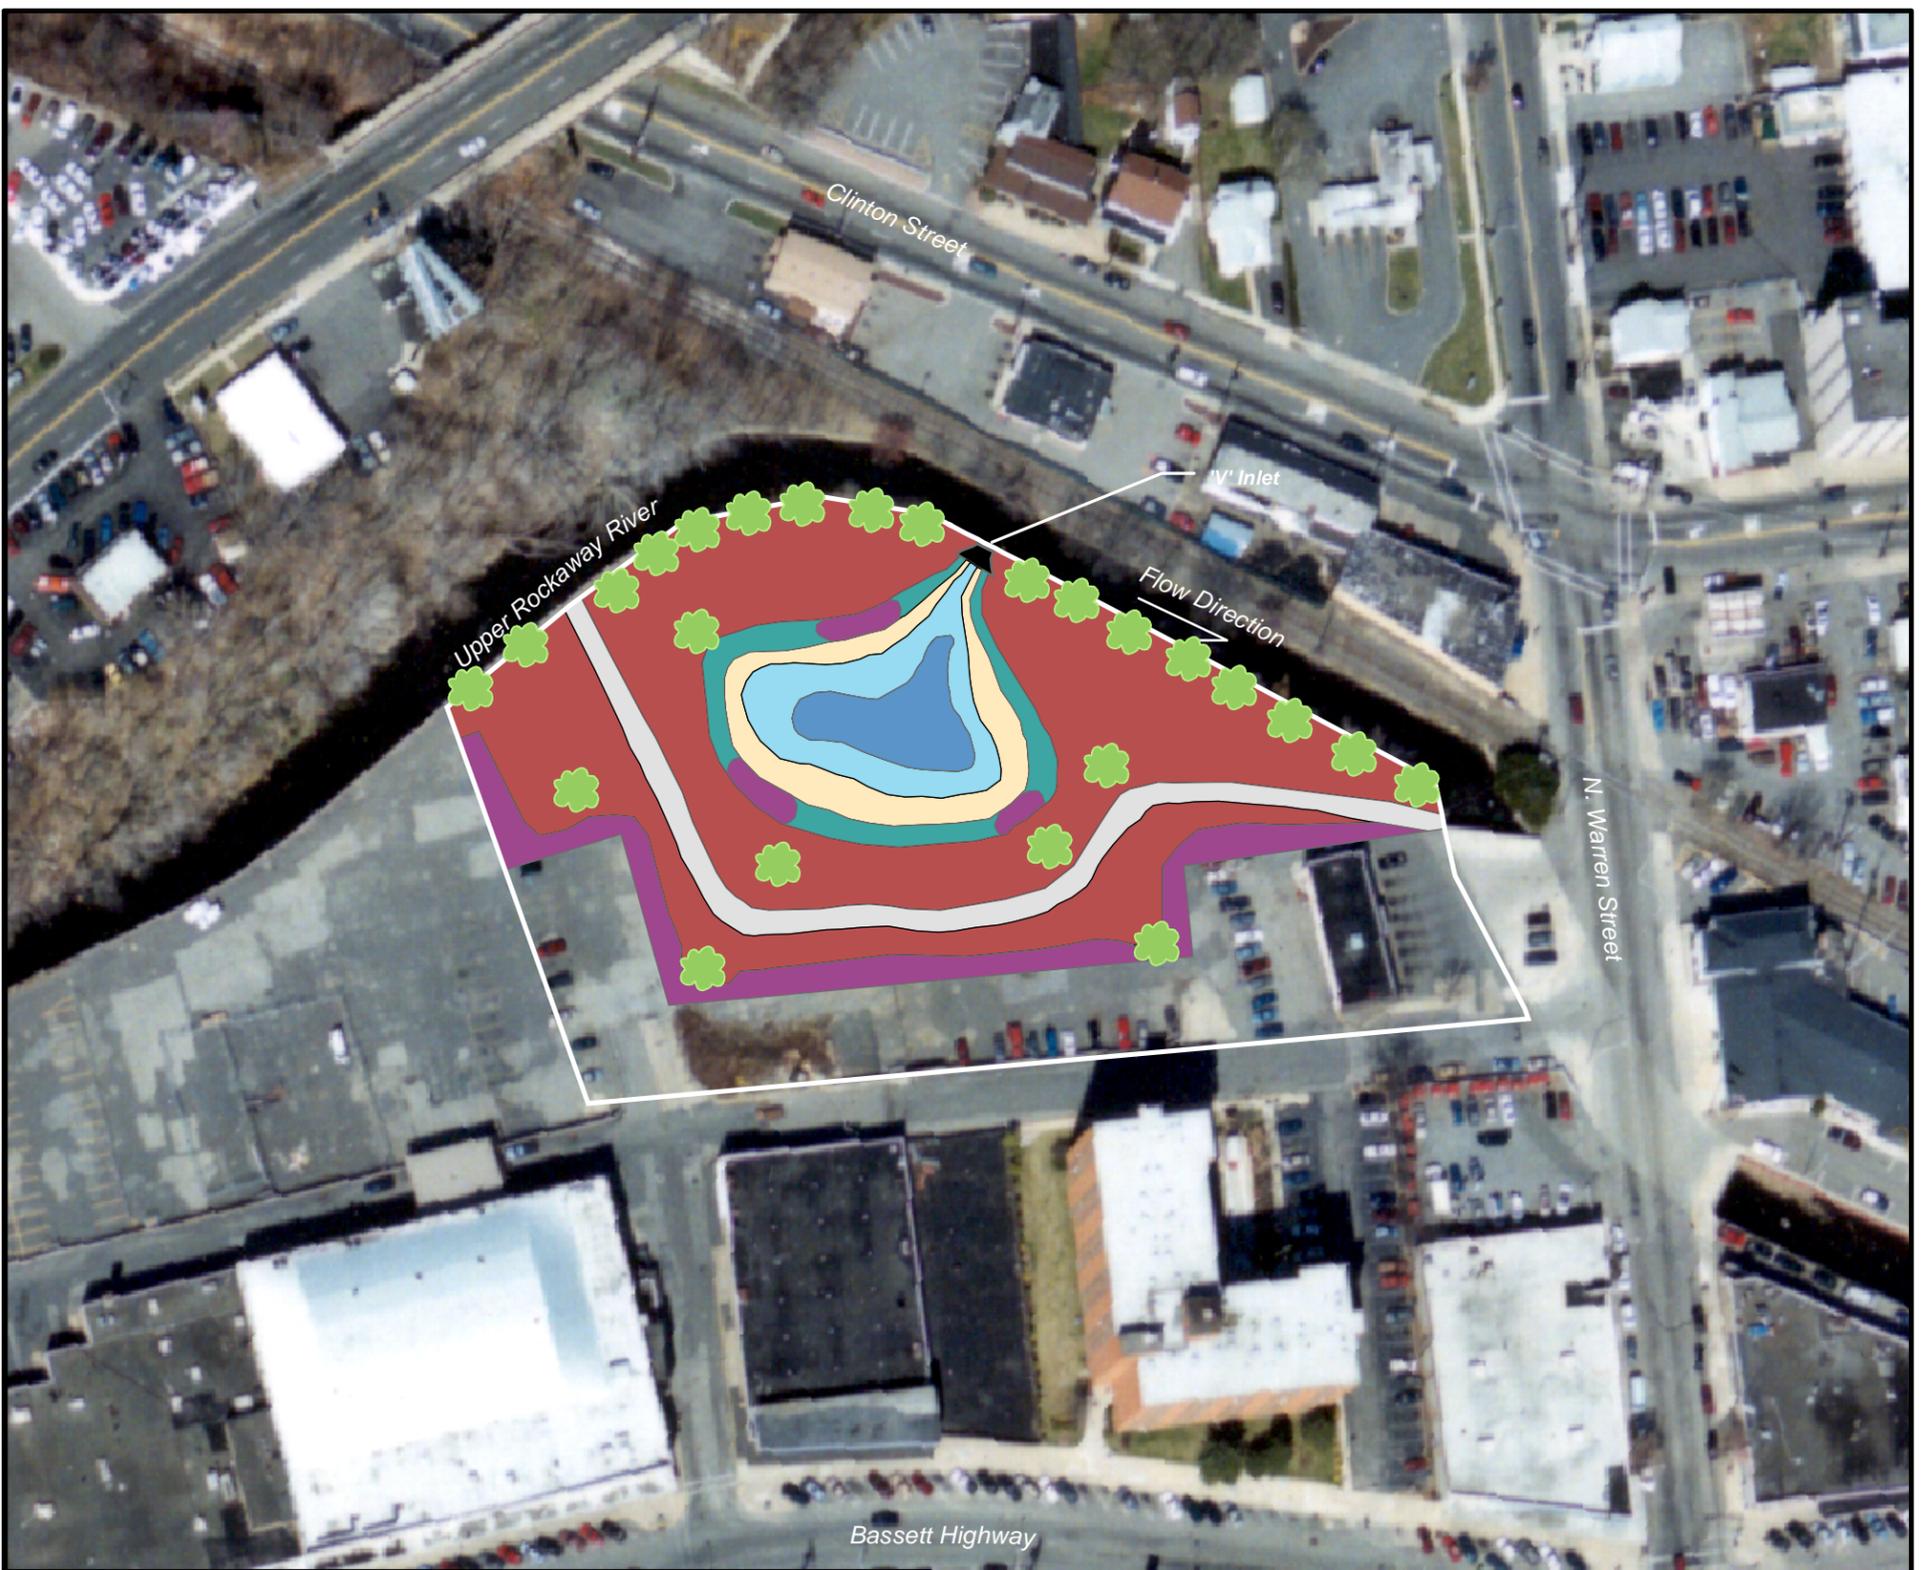
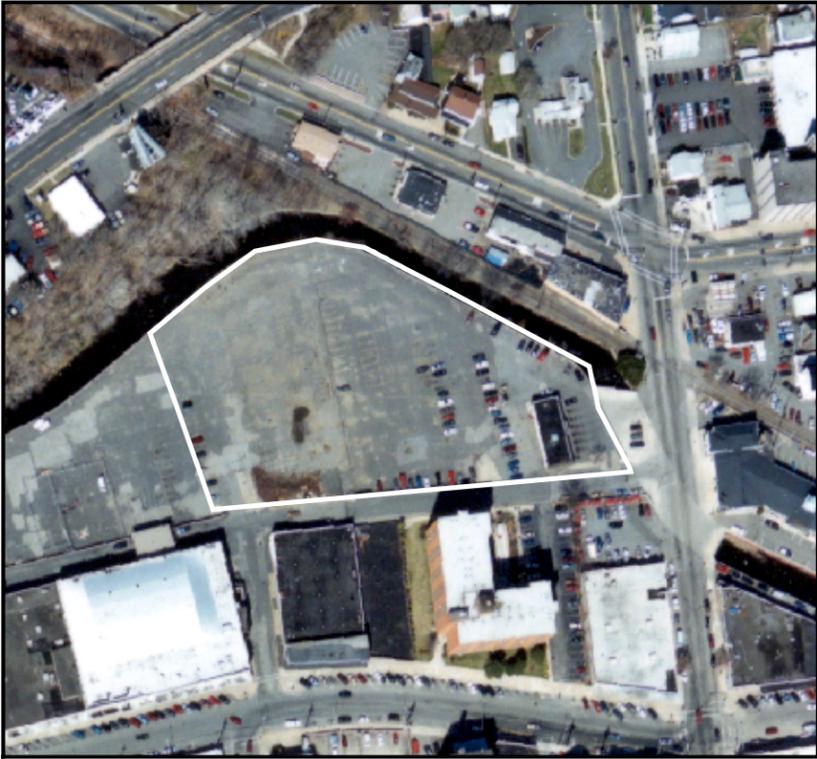
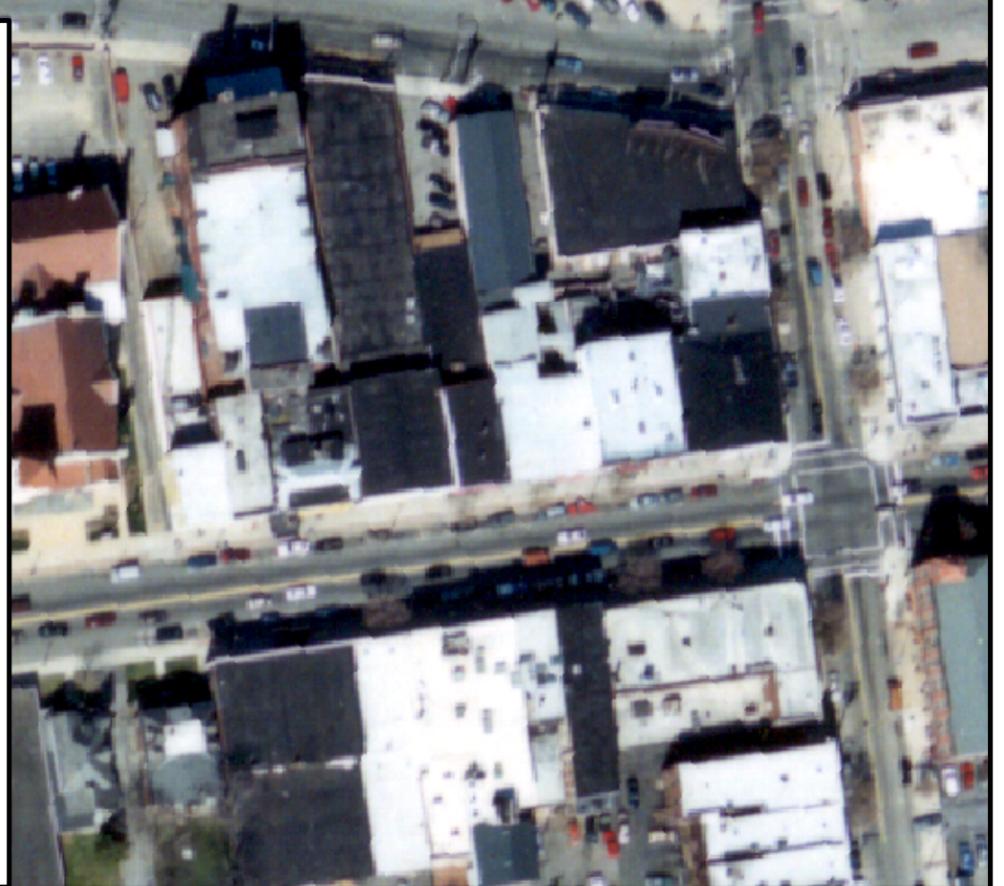
Figure 4. Site JB-5: Conceptual Restoration Design for the Upper Rockaway Flood Control and Ecosystem Restoration Study.

The proposed restoration action at this site would involve the removal of the asphalt; excavation of the underlying fill material to create a narrow channel, small pond, and emergent wetlands; and, reestablishing areas of upland herbaceous and scrub-shrub vegetation (Figure 4). A V-shaped inlet will be established through the existing concrete wall, which will allow regular water exchange between the river and the created pond. The side slopes would be contoured to enable planting native emergent wetland plant species. The excavated fill material will be used on-site to create an elevated walking path, allowing controlled access to the restored site, and aesthetic enhancement. In addition, topsoil would be added to the site to promote a healthy growth of herbaceous and scrub-shrub cover. As recommended by the USFWS, a butterfly garden and wildlife garden may be created within the restoration site to enhance butterfly usage in the area.

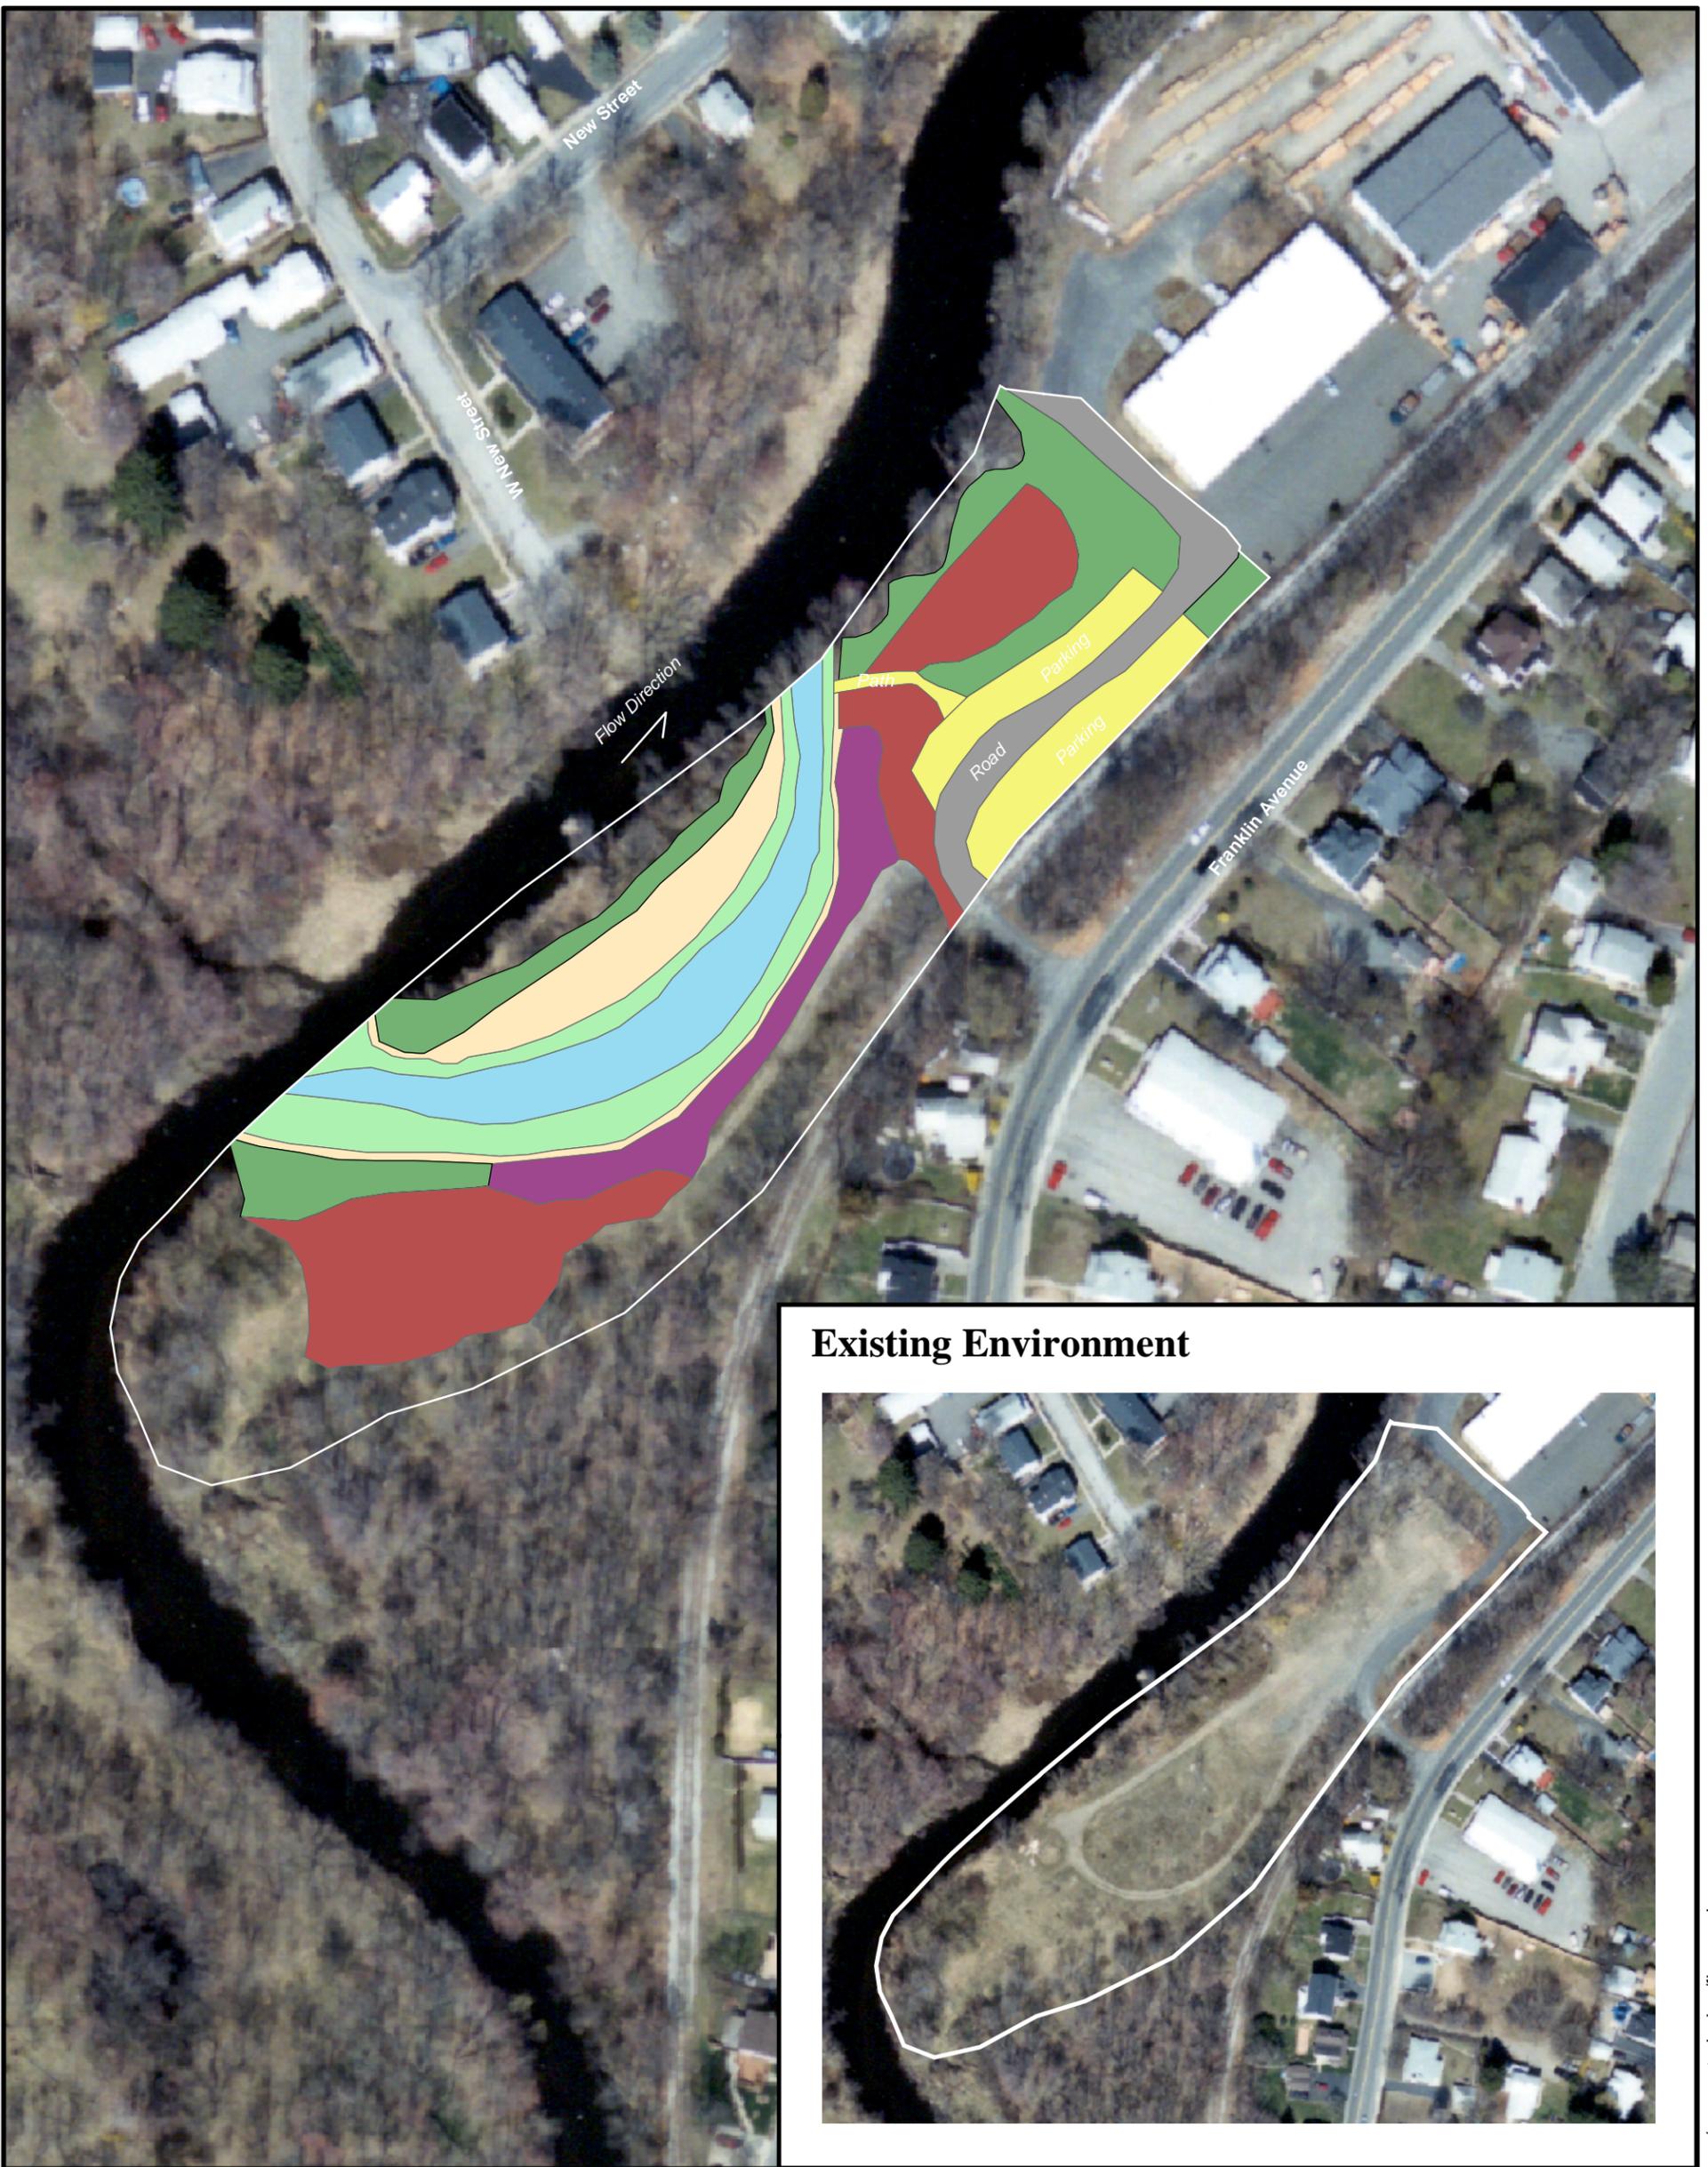
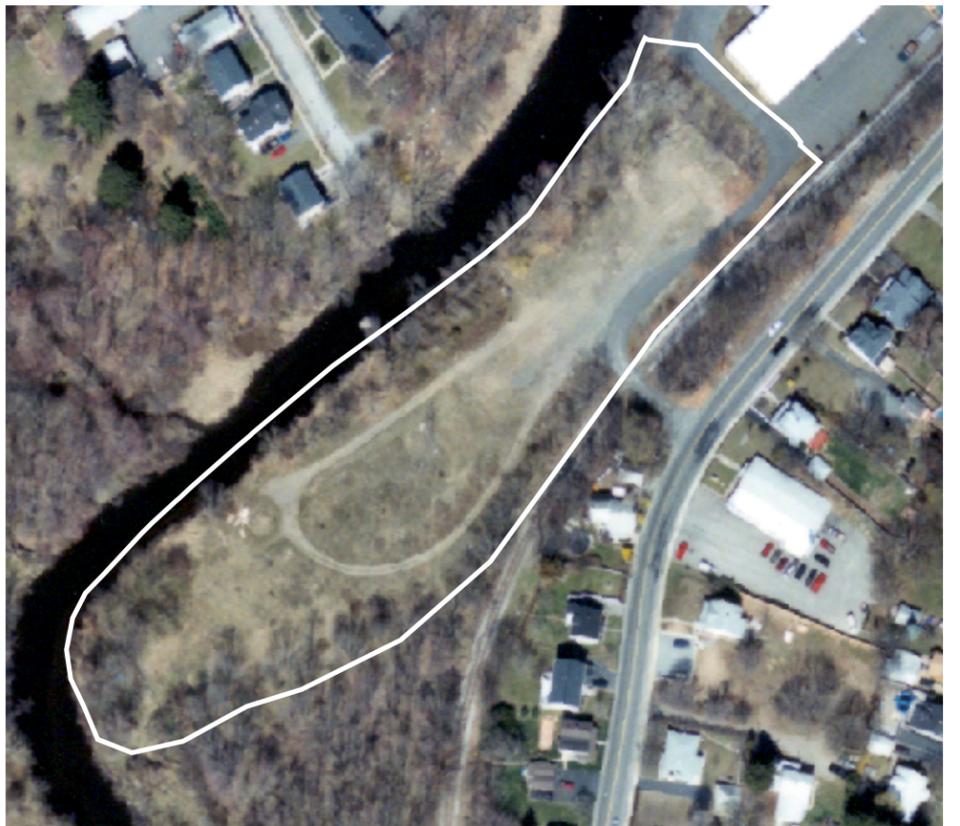
Figure 5. Site MR2-1: Conceptual Restoration Design for the Upper Rockaway Flood Control and Ecosystem Restoration Study.

Based on the site visit, it appears that the river was channelized through this area in the past and that the excavated material was side-cast along the eastern bank of the river to create an artificial earthen berm and/or exaggerated streambank. The berm is approximately 25 feet wide and between 6 to 8 feet above the normal river surface, and there is no evidence that the river water is able to breach the berm. These past activities have significantly altered the hydrology in this

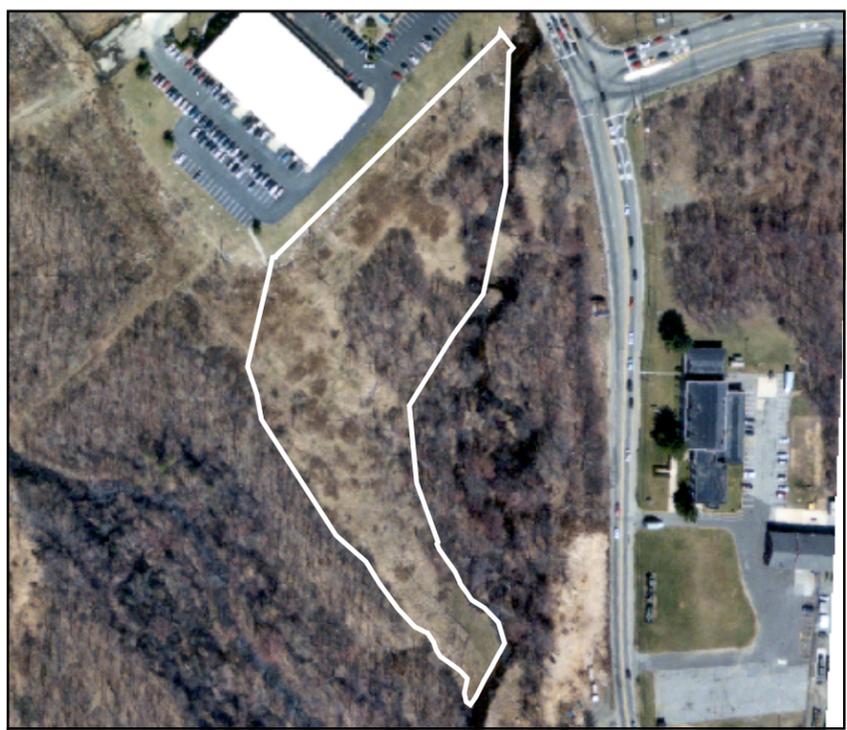
Figure 7. Site JB-8: Conceptual Restoration Design for the Upper Rockaway Flood Control and Ecosystem Restoration Study.

Site JB-8 is an approximately 3.9 acre parcel of land located on an active powerline right-of-way in Wharton, near the intersection of Mount Pleasant Avenue and West Clinton (Route 15). The site is bordered on the northeast by the West Clinton Bridge, on the east by Green Pond Brook, on the south by the Rockaway River and a large forested wetland, and on the northwest by the roller rink parking lot. The site is dominated by common reed (*Phragmites australis*), a highly opportunistic, fast colonizing plant species that is regularly found in disturbed wetland areas.

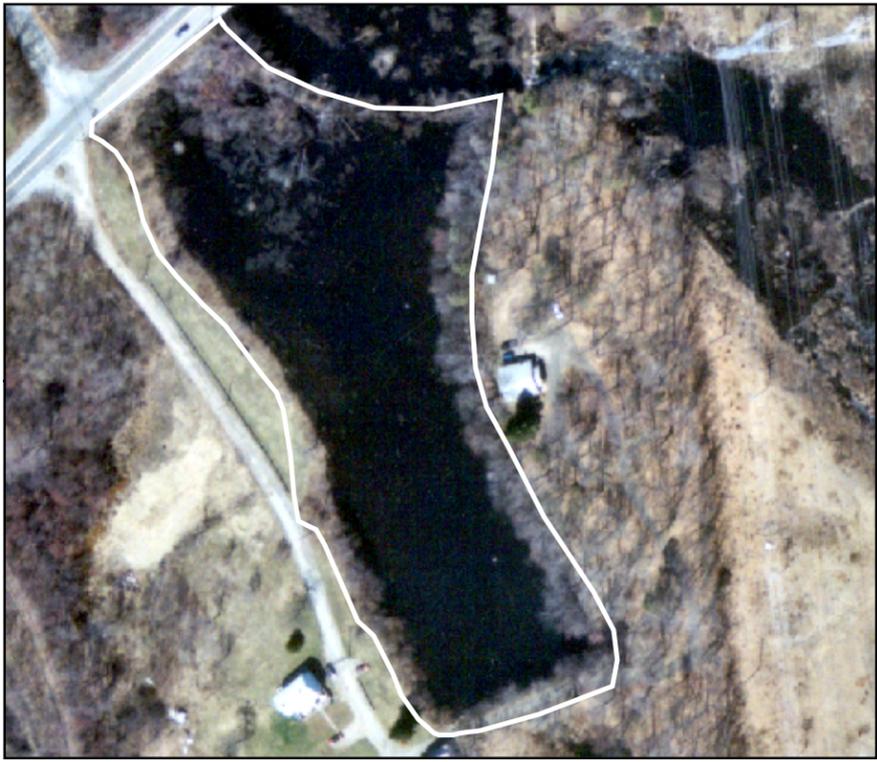
Existing Environment

- Created Open Water/Emergent
- Created Open Water/Submerged Aquatic Vegetation
- Created Deep Water
- Created Scrub-shrub

Additional surveys will be necessary to identify the elevations of the reconstructed berm and deepwater habitats prior to the development of a detailed restoration plan. Specifically, detailed hydrologic and hydraulic (H&H) engineering studies, topographic survey, wetland survey, and bathymetric survey are likely to be required.

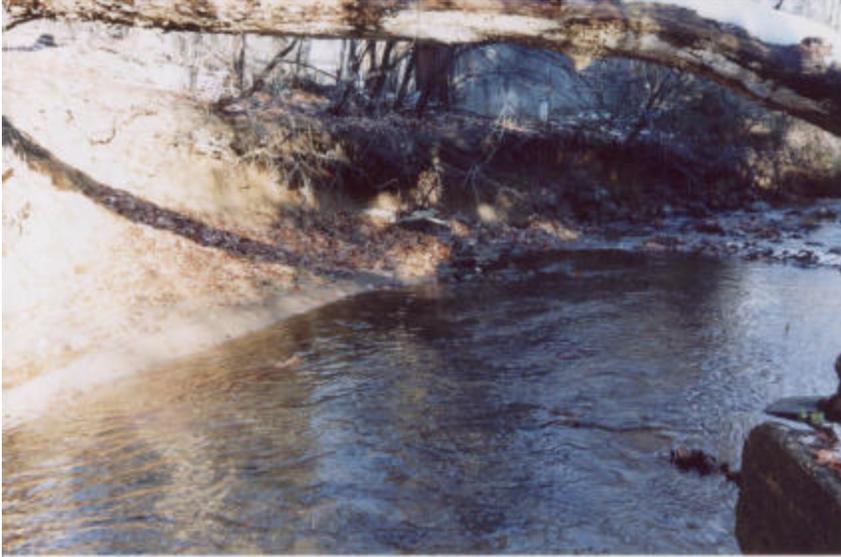
Comments: Downstream slope of site MB-3.

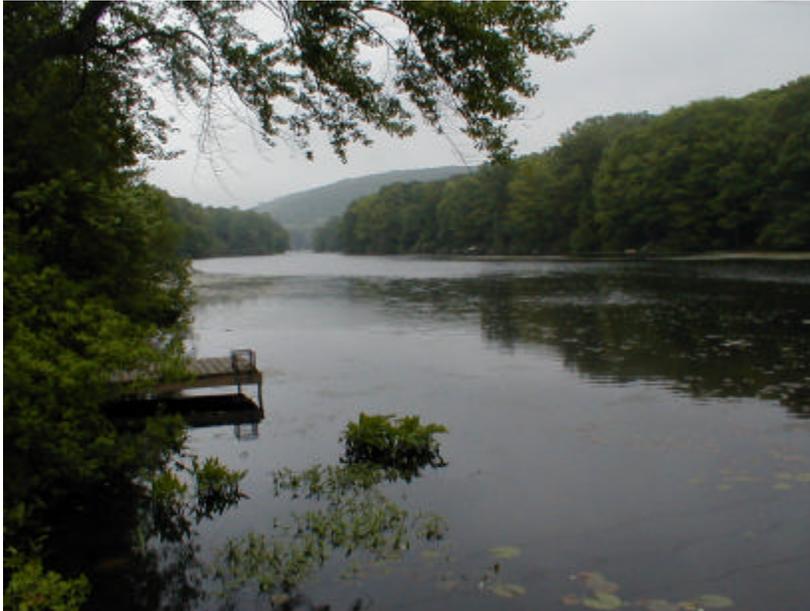
Photographer: S. Kiernan
Date: June 11, 2003
Photo No.: 1.
Direction: North

Comments:
View of Longwood Lake, site LW-1, facing North from banks. The lake was formerly approximately 15' deep in the center, and is currently approximately 10' in depth in the center according to local residents.

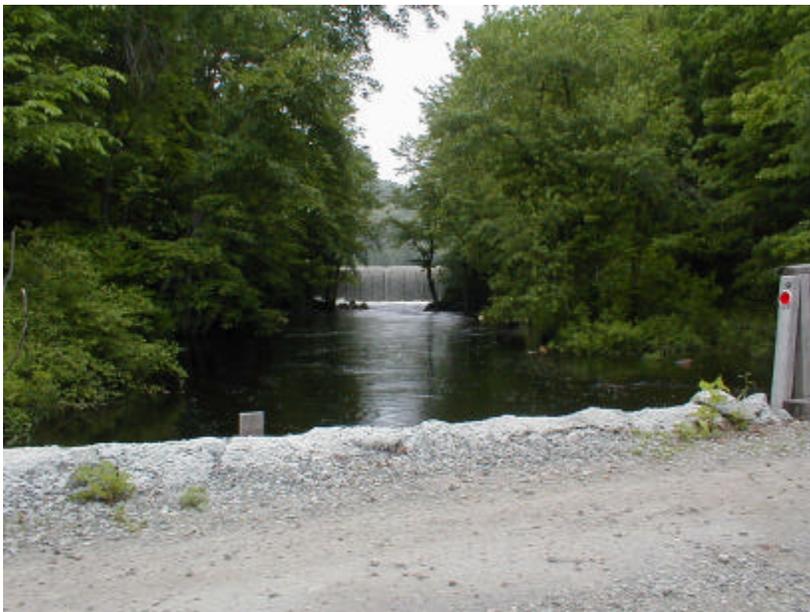
Photographer: S. Kiernan
Date: June 11, 2003
Photo No.: 2.
Direction: North

Comments:
View of Longwood Lake Dam from the access road for the Rod and Gun Club. Note tree canopy cover downstream of the dam.

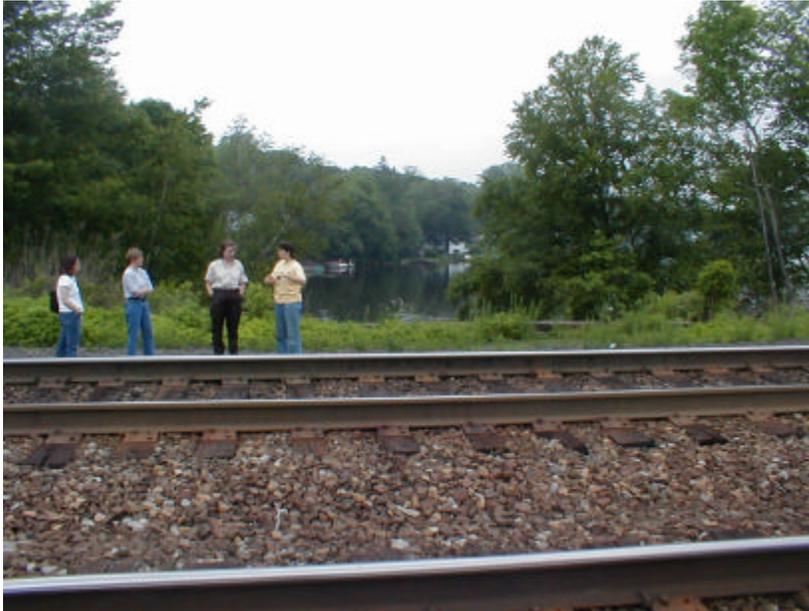
Photographer: S. Kiernan
Date: June 11, 2003
Photo No.: 3.
Direction: Northeast

Comments:
View of Indian Lake from the NJ Transit railroad line. A culvert currently exists to the right of the people, which connects Indian Lake and Lake Estling.

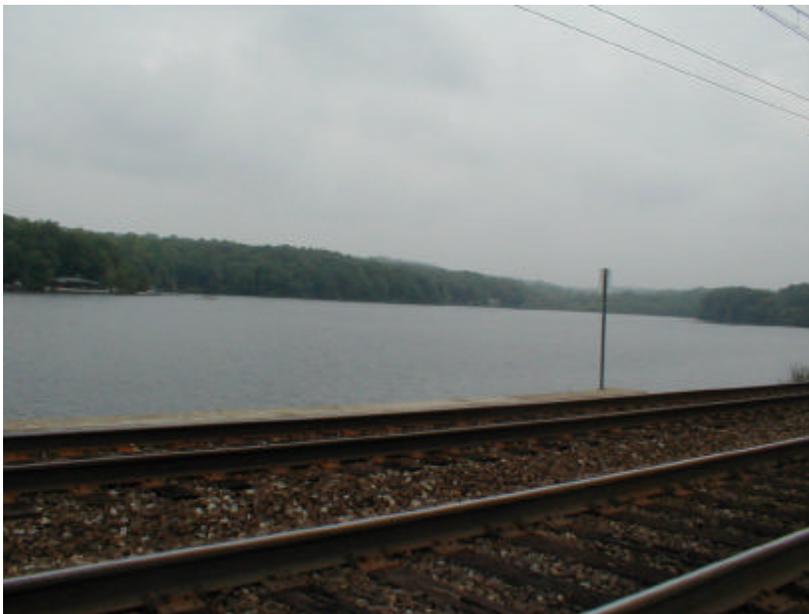
Photographer: S. Kiernan
Date: June 11, 2003
Photo No.: 4.
Direction: Southwest

Comments:
View of Lake Estling from the NJ Transit rail line. The culvert top is visible (white) beginning at the metal post.

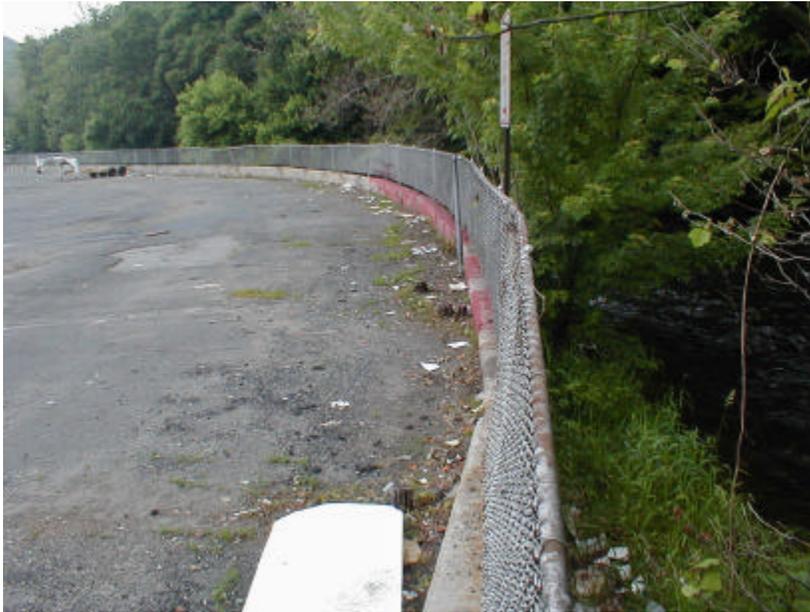
Photographer: S. Kiernan
Date: June 11, 2003
Photo No.: 5.
Direction: Northeast
(Upstream)

Comments:
View of site JB-5, located in downtown Dover. The site is currently a municipal parking lot. The Rockaway River is adjacent to the chain link fence on the right. Note the elevation difference between the asphalt parking lot and the small floodplain and River surface.

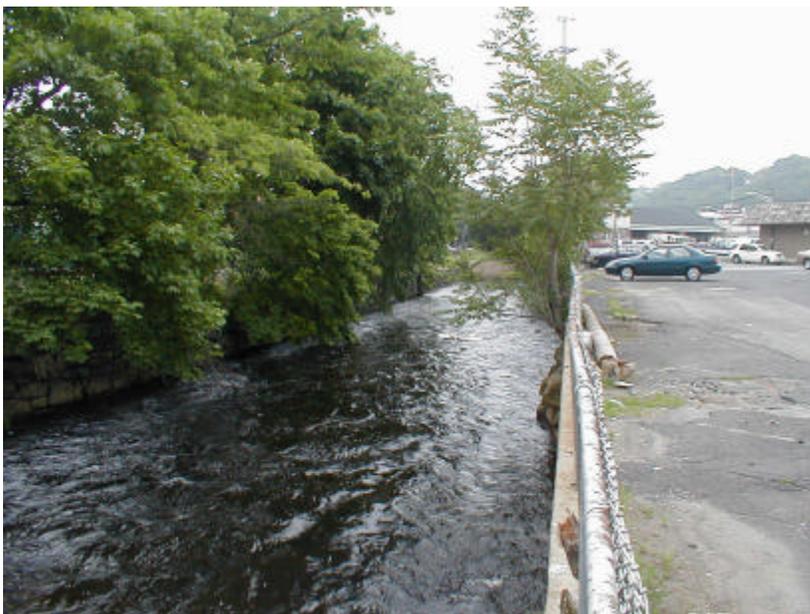
Photographer: S. Kiernan
Date: June 11, 2003
Photo No.: 6.
Direction: Southwest
(Downstream)

Comments:
View facing downstream of site JB-5.

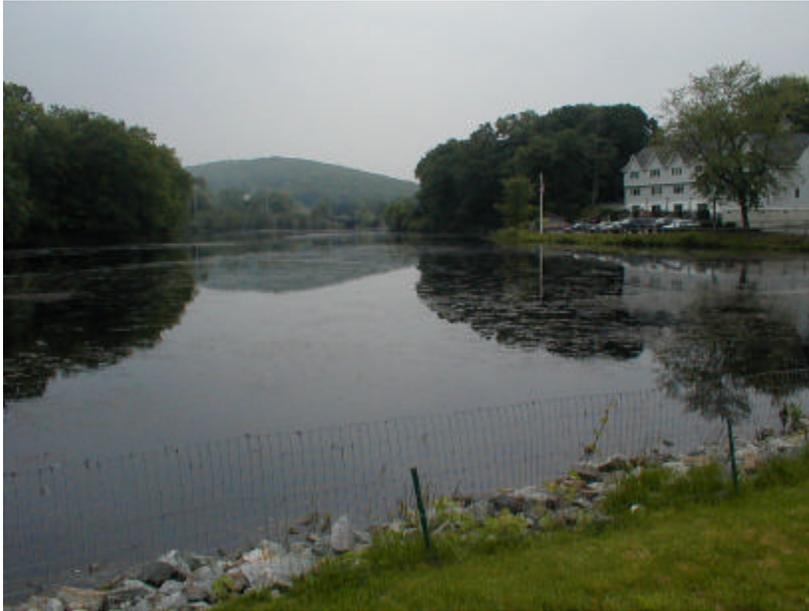
Photographer: S. Kiernan
Date: June 11, 2003
Photo No.: 7.
Direction: East
Comments: View facing upstream of Washington Forge Pond site (JB-1) in Wharton. Note slowing moving water flow and *Eurasian milfoil* near surface.

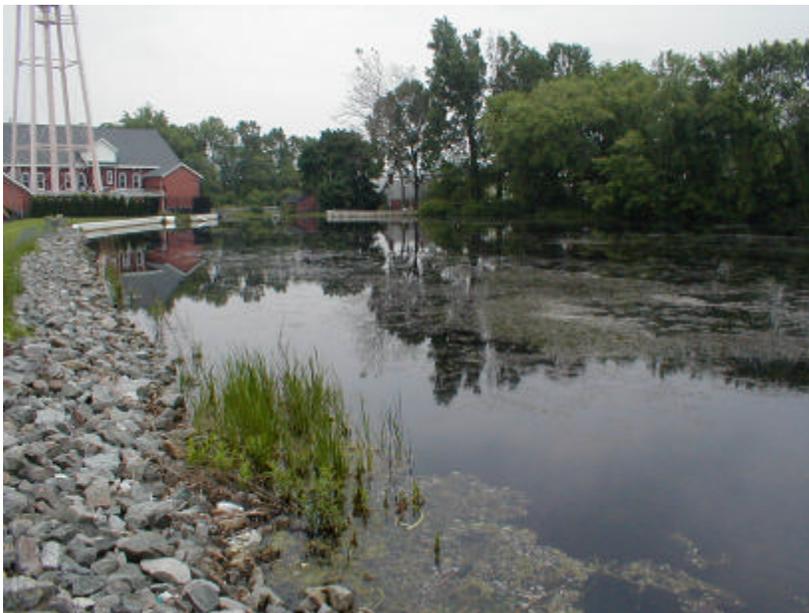
Photographer: S. Kiernan
Date: June 11, 2003
Photo No.: 8.
Direction: Northeast
Comments: View of Washington Forge Pond facing downstream towards the dam. Note *Loosestrife* and *Eurasian Milfoil* near banks.

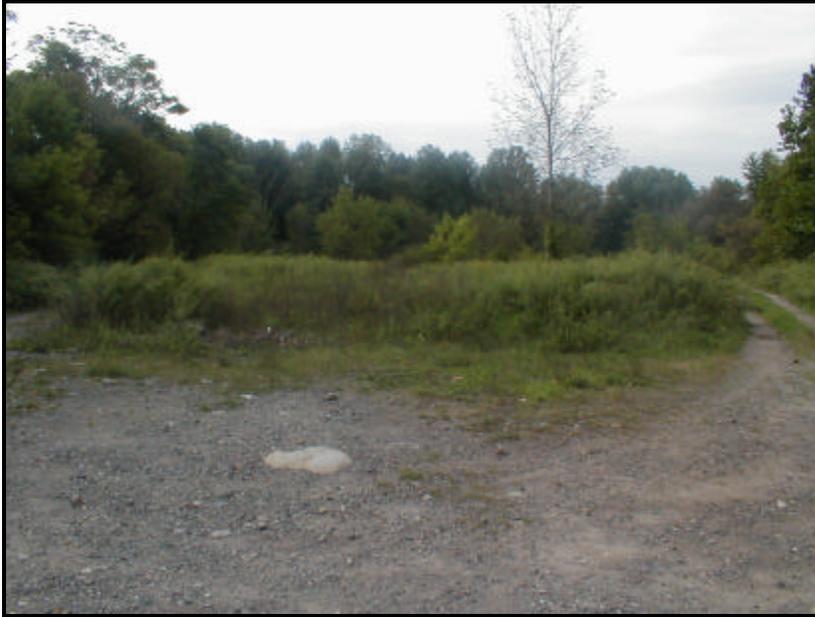
View of MR2-1 site facing upstream. The River is located to the right behind the trees. Note the dirt/gravel, which extends around 2/3rd of the length of the property.

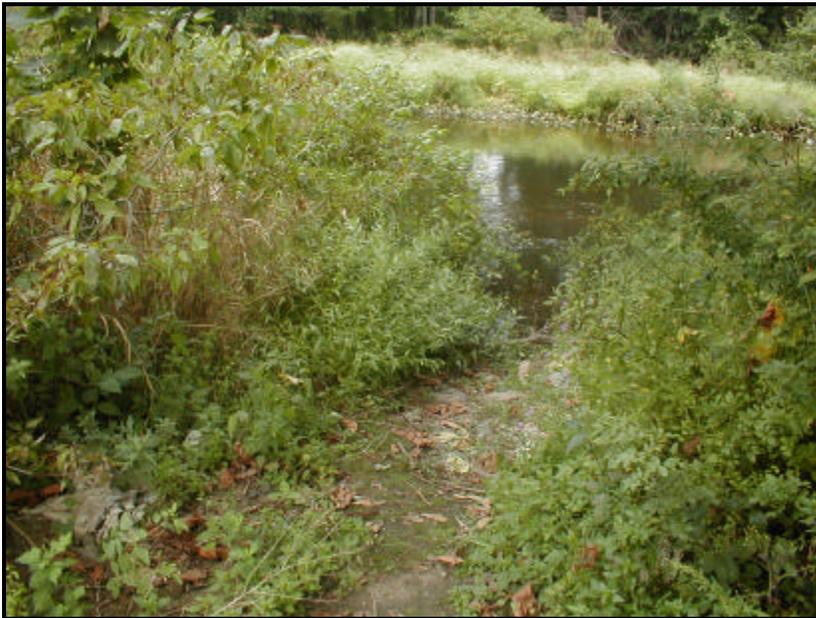
Photographer: S. Kiernan
Date: 9/22/03
Photo No.: 3
Direction:
Comments:
View facing river from the end of the dirt road at MR2-1. This could be an approximate location of the initial inlet.

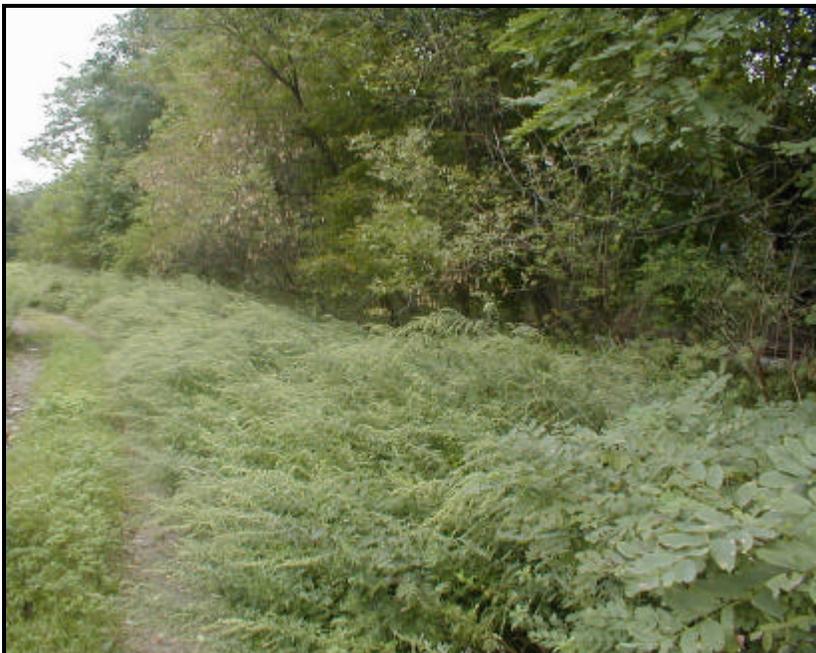
Photographer: S. Kiernan
Date: 9/22/03
Photo No.: 4
Direction:
Comments:
Facing the entrance to the site from the dirt road, the railroad tracks are located to the right of the trees.

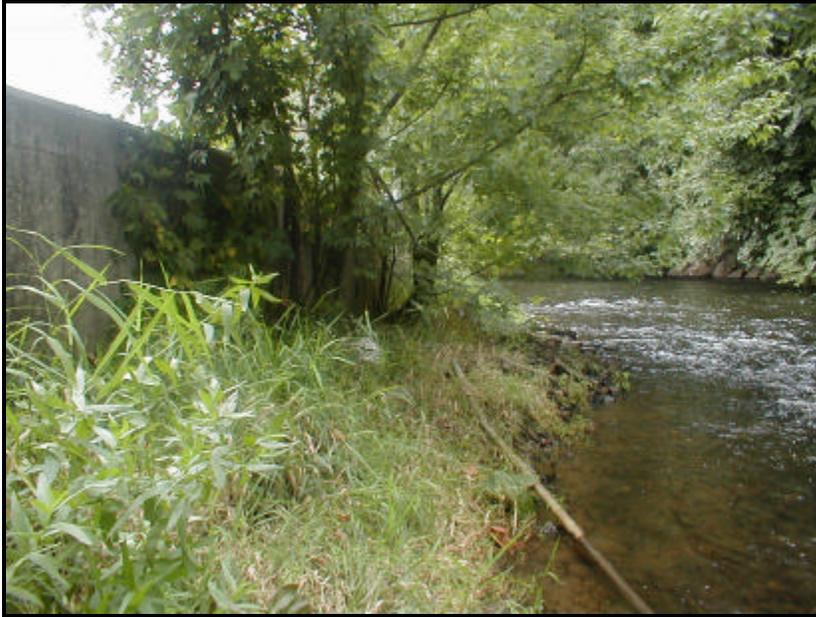
Photographer: S. Kiernan
Date: 9/22/03
Photo No.: 5
Direction:
Comments: Facing upstream at site JB-5 in downtown Dover. Note elevation changes between river, floodplain, and wall.

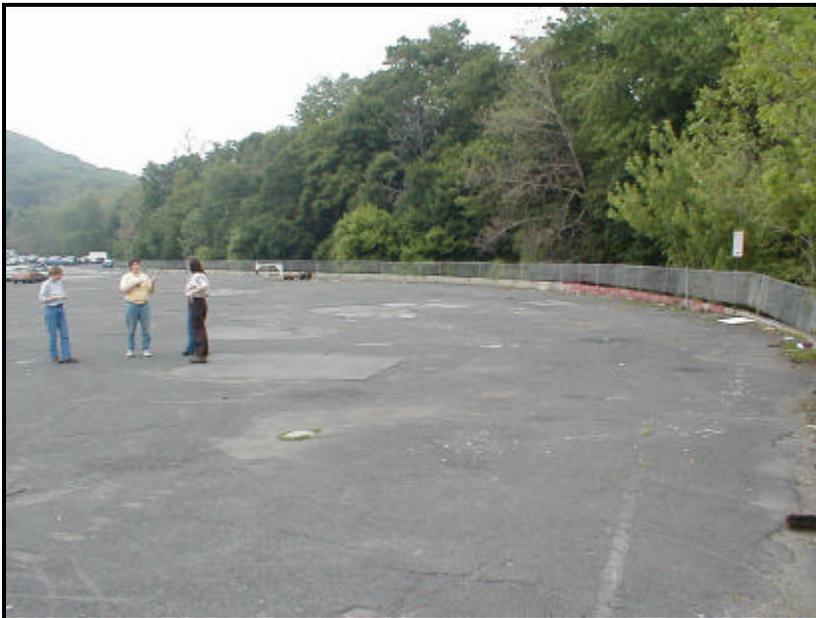
Photographer: S. Kiernan
Date: 9/22/03
Photo No.: 6
Direction:
Comments: View of parking lot area at JB-5. The river is located to the right of the chain link fence.

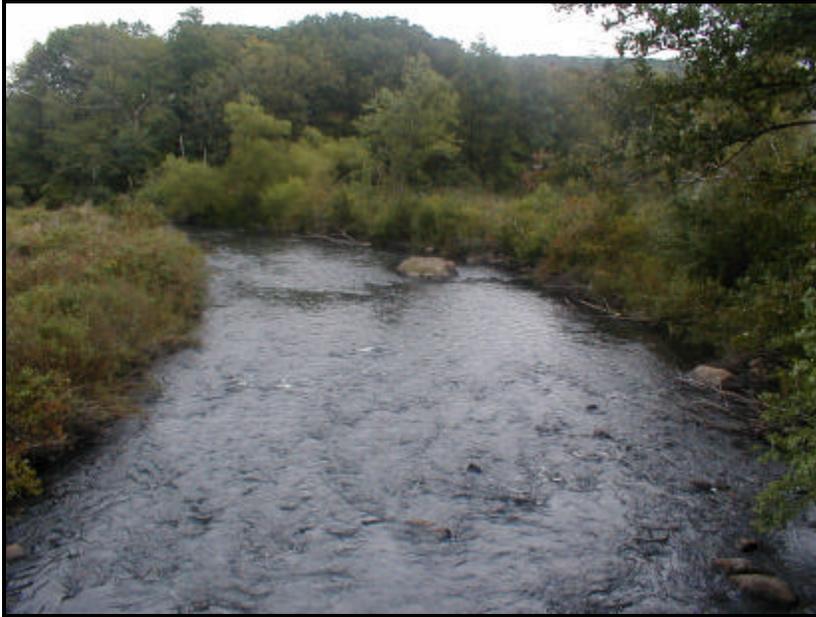
View from West Dewey Avenue Bridge facing downstream at site UR-1, Mill Pond. Note river curve and berm structure along the river on the right (near large rock).

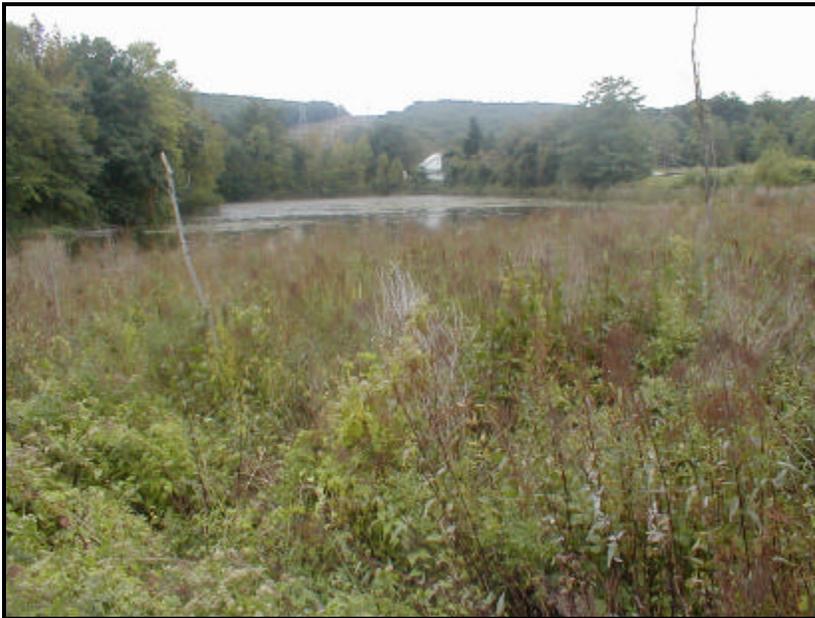
Comments:
Facing the Mill Pond from the berm with
back to the river.

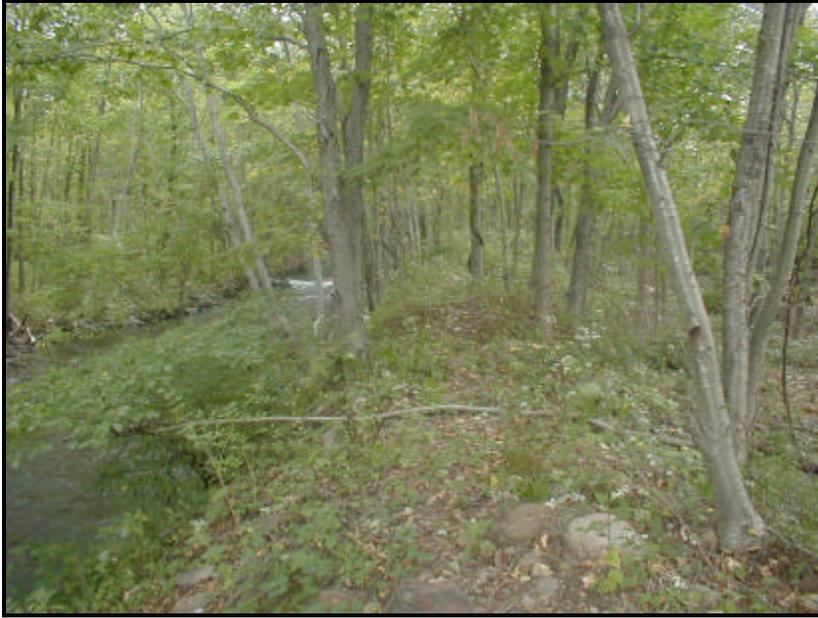
View facing upstream at Site JB-3, behind the Shop Rite complex. Note berm and slope to riverbank.

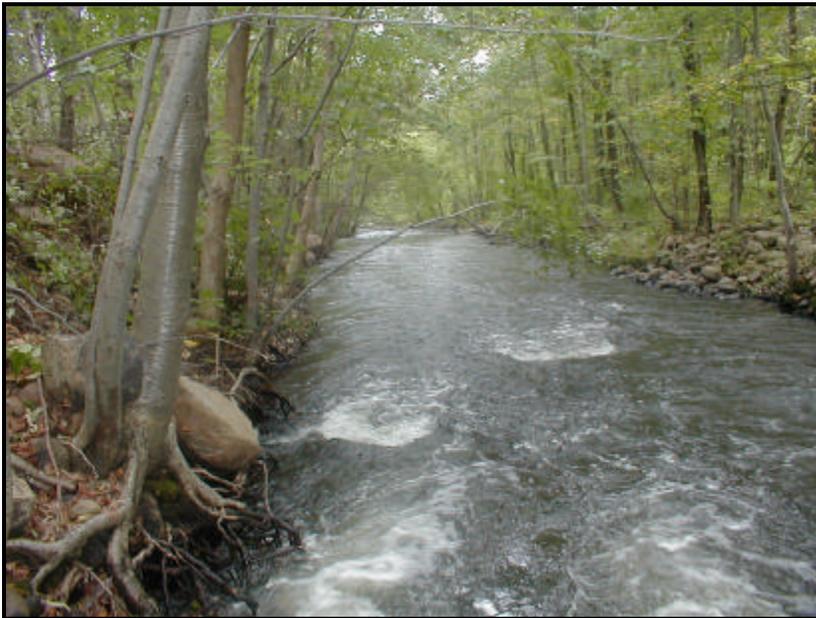
Photographer: S. Kiernan
Date: 9/22/03
Photo No.: 13
Direction:
Comments: Facing downstream from bottom of berm. Note rapid water flow and armored opposite bank.

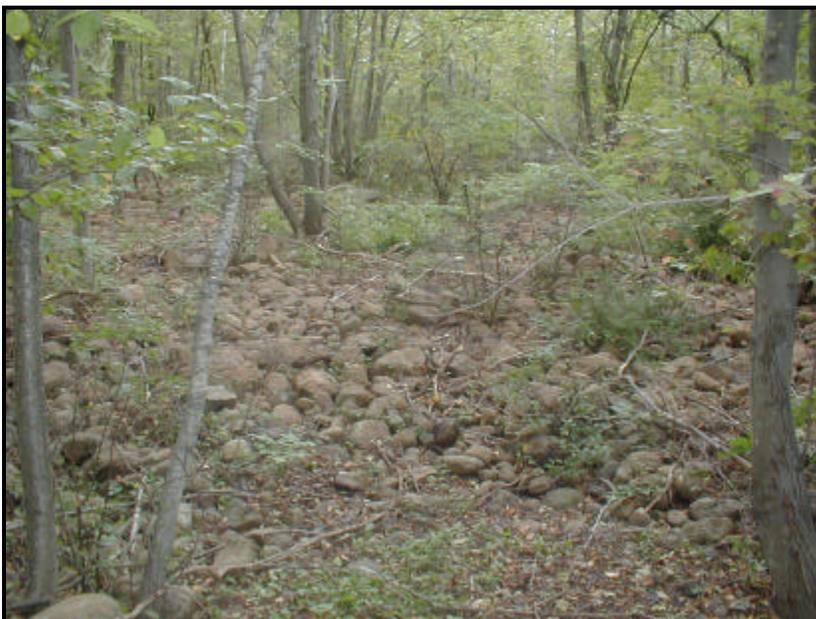
Photographer: S. Kiernan
Date: 9/22/03
Photo No.: 14
Direction:
Comments: View of the former riverbed at a low spot in the berm. Potential location for breach.

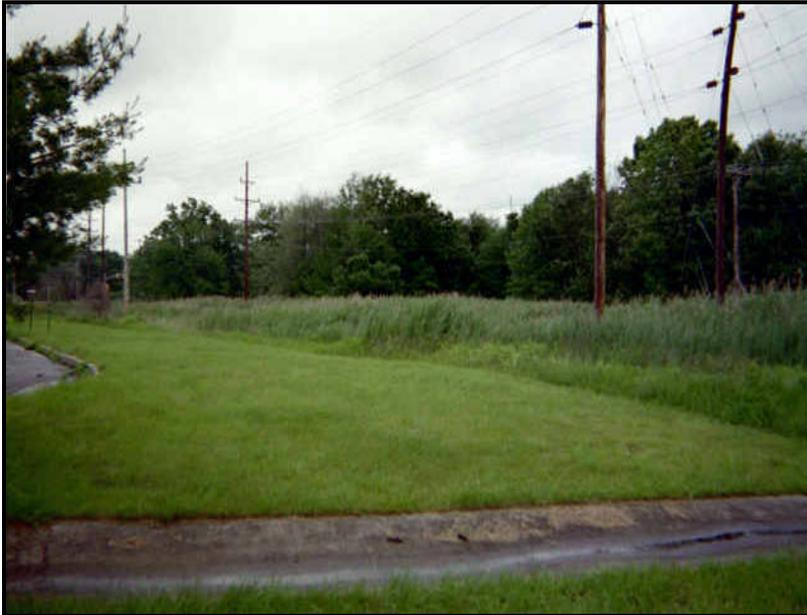
Photographer: S. Kiernan
Date: 9/22/03
Photo No.: 15
Direction:
Comments:
View of the *Phragmites* at site JB-8, facing upstream towards the West Clinton Avenue bridge. Note the power lines and parking lot drainage.

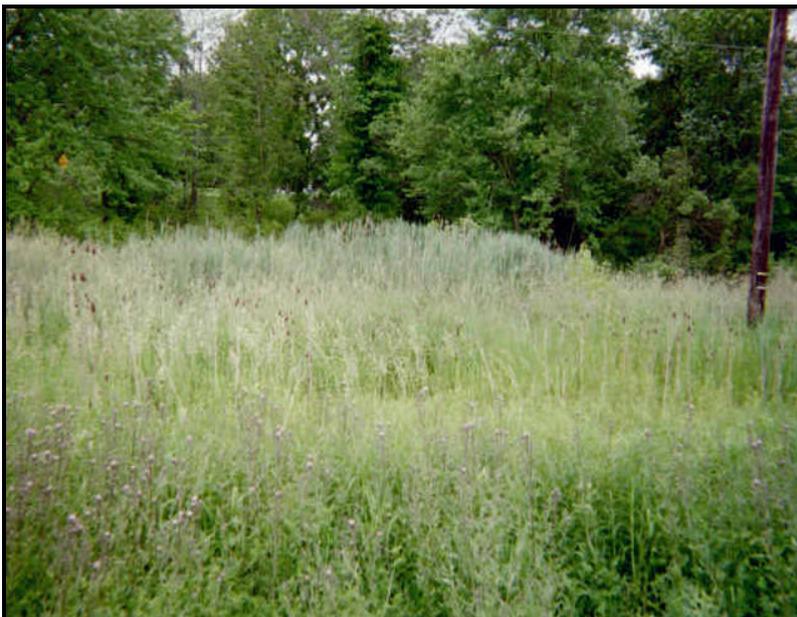
Photographer: S. Kiernan
Date: 9/22/03
Photo No.: 16
Direction:
Comments:
View of *Phragmites* facing downstream of West Clinton Avenue.
