US Army Corps
of Engineers
New York District

MILLSTONE RIVER BASIN, NEW JERSEY

Reconnaissance Study For Flood Control & Ecosystem Restoration

Section 905(b) (WRDA 86) Preliminary Analysis

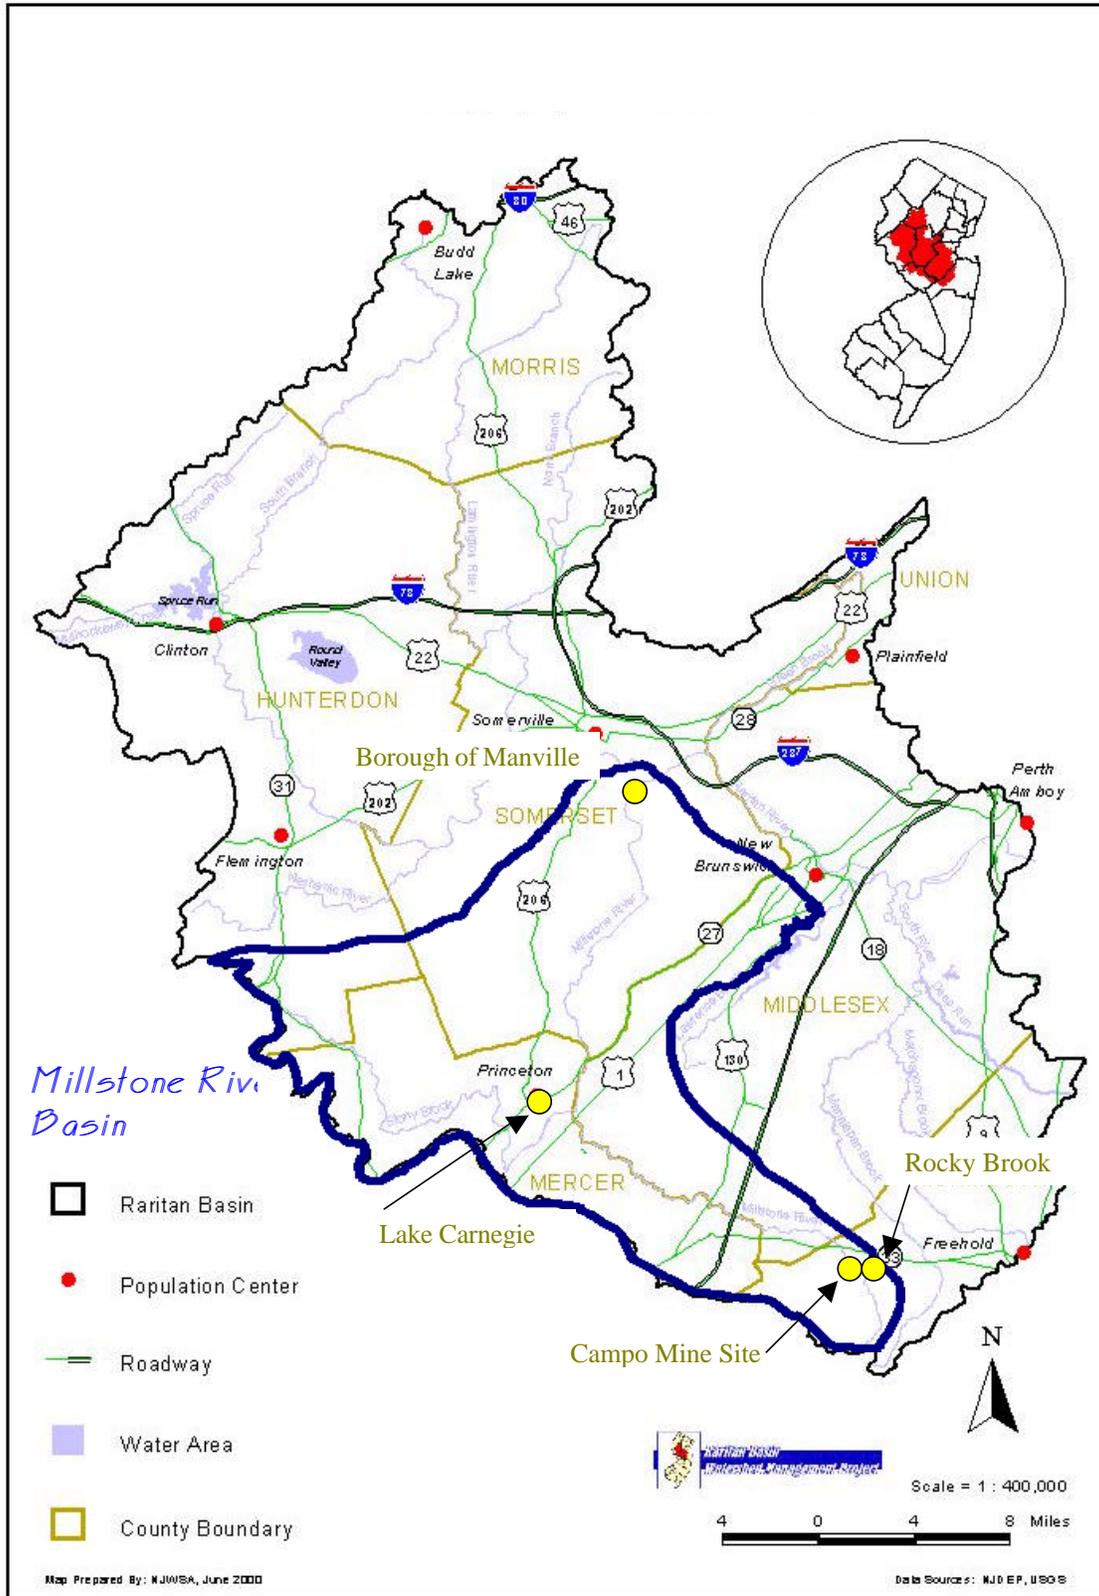
**FIGURE 1
STUDY AREA**

The study area is the Millstone River Basin. The Basin is located in north-central New Jersey, halfway between Philadelphia and New York City. The Basin includes the Millstone River and its major tributaries located in the New Jersey counties of Mercer, Middlesex, Monmouth, Hunterdon, and Somerset. The 238-square mile Basin is a major tributary of the Raritan River. Stony Brook, which is the largest tributary to the Millstone River, is located near Princeton Township, New Jersey. This subbasin has a drainage area of 56 square miles. Figure 1 depicts the location of the Millstone River Basin within the Raritan River Basin.

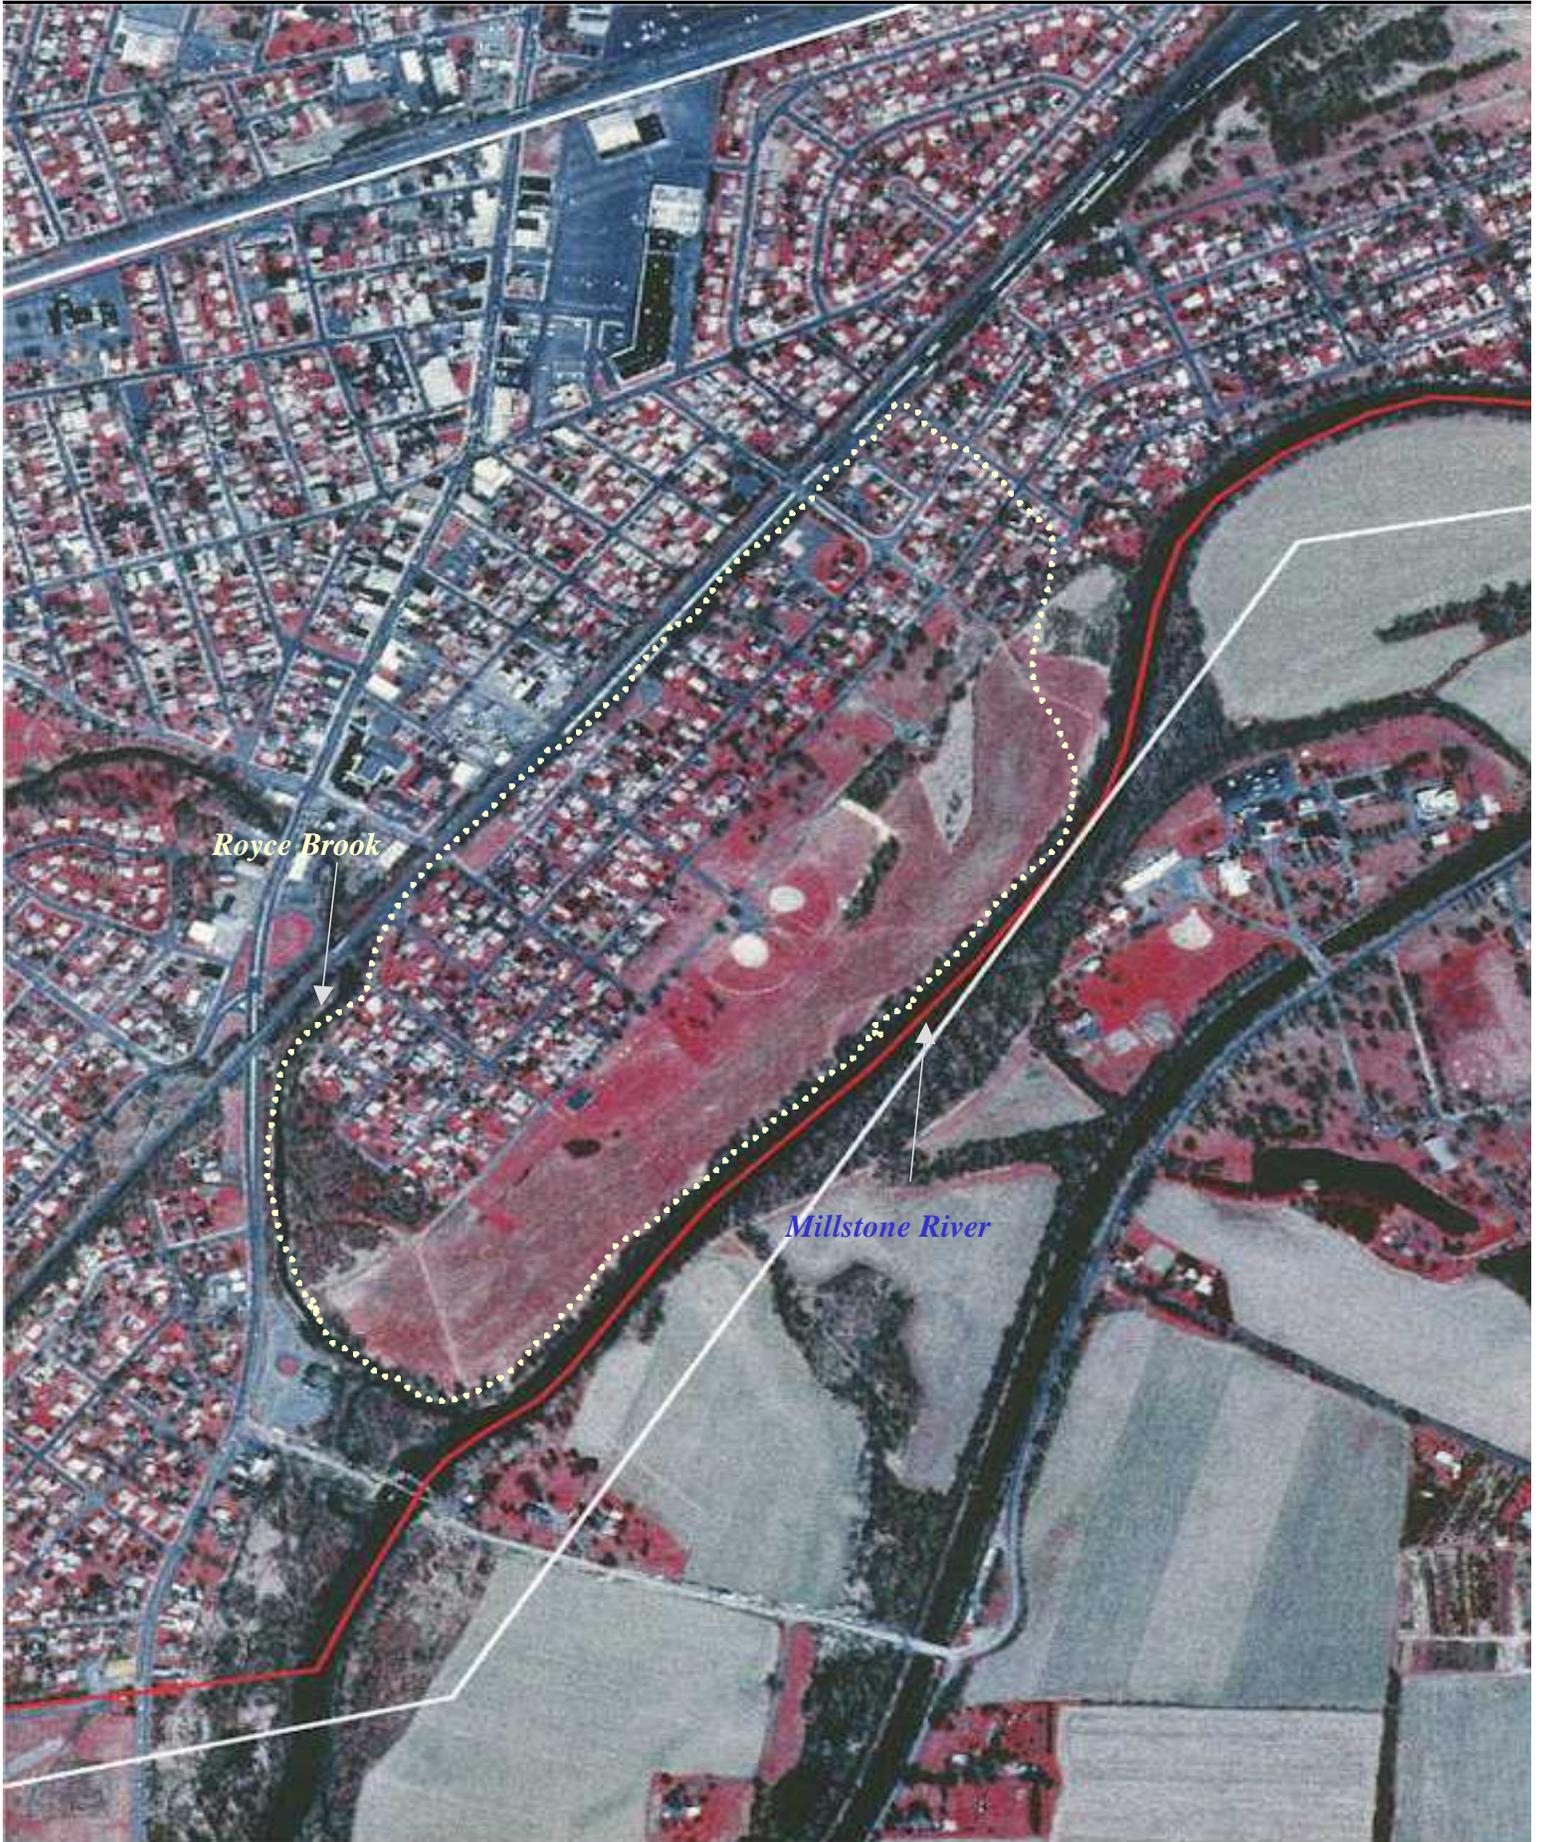
FIGURE 2
Borough of Manville
Lost Valley Residential District

Acquisition Plan. An acquisition plan for the 241 structures located in the 100-year floodplain was analyzed. The acquisition plan would entail the permanent evacuation of existing floodprone structures through land and structure acquisition. Structures would be demolished or relocated out of the 100-year floodplain. If contiguous parcels with adequate physical properties to support ecosystem enhancements were identified, the purchased properties may be enhanced to restore the 100-year floodplain to a less degraded more natural condition.

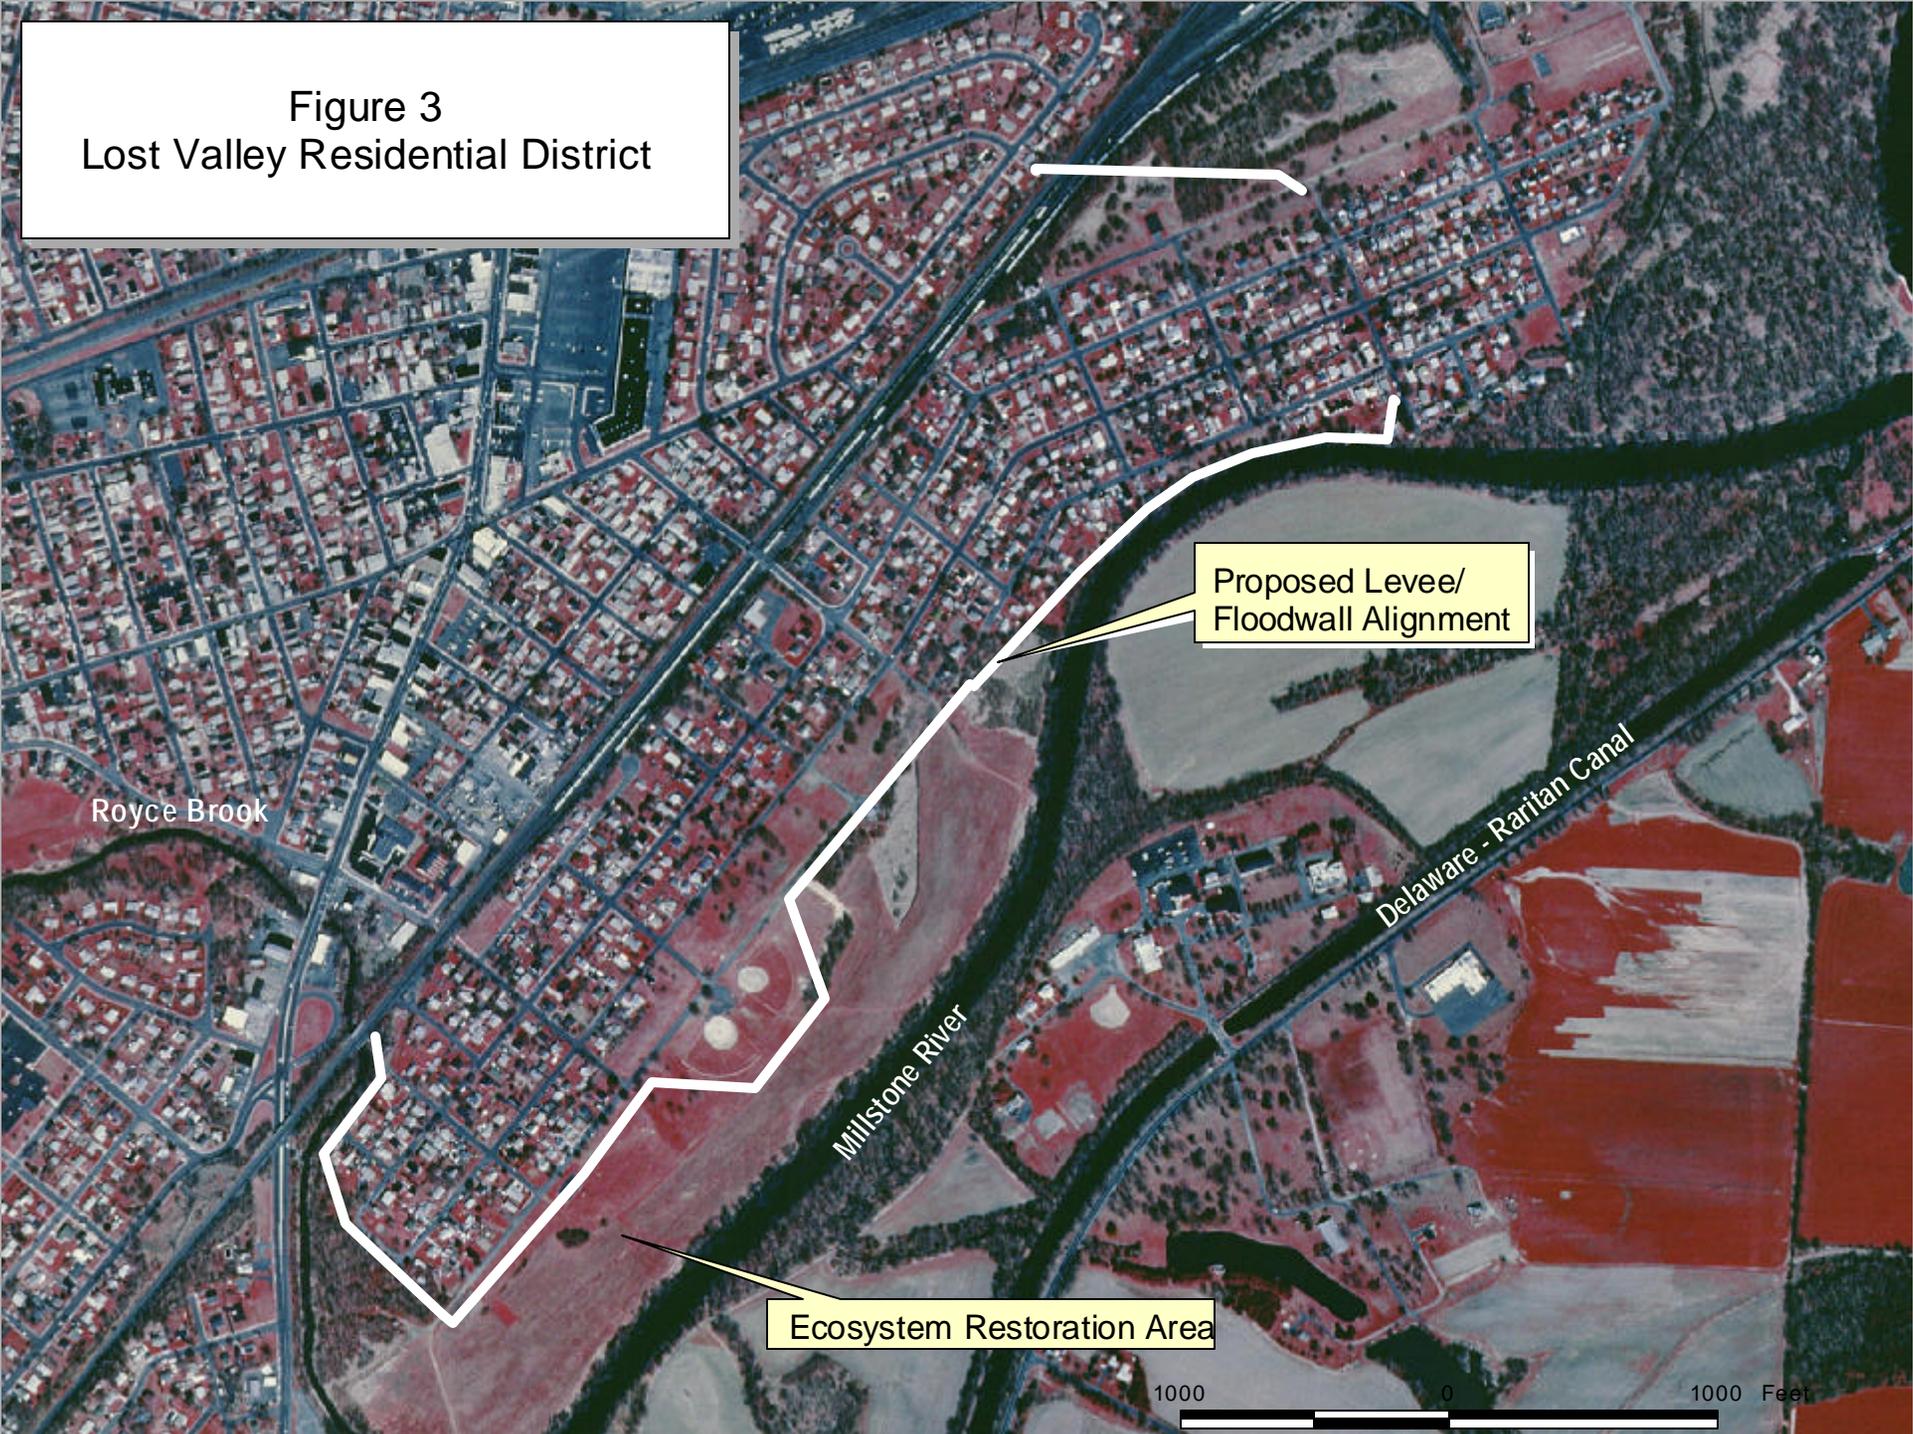
Figure 3
Lost Valley Residential District

Approximately 7,100 feet of levee and floodwall with an average height of 13 feet would be necessary to protect the Lost Valley District up to the 50-year event. The levee and floodwall alignments would consist of two parts: one, along the Millstone River, and a second, shorter levee segment to prevent inundation from the Raritan River. However, at the design elevation,

the shorter levee segment would tie into the railroad tracks, eliminating the need to raise the tracks. The Structural Plan 2 levee and floodwall layout is shown in Figure 3. This plan would also require a road closure gate at Kyle Street or filling the Kyle Street under pass to prevent potential flooding from Royce Brook. A stormwater pump station is included with this plan to ensure drainage of the areas behind the line levee and floodwall.

Both structural plans would include enhancement of the riparian corridor between the levee and floodwall and the rivers. Based on the preliminary layouts approximately 28 acres could be ecologically enhanced. Wetlands and riparian buffer areas could be established. The details of the ecological improvements are discussed in the next section.

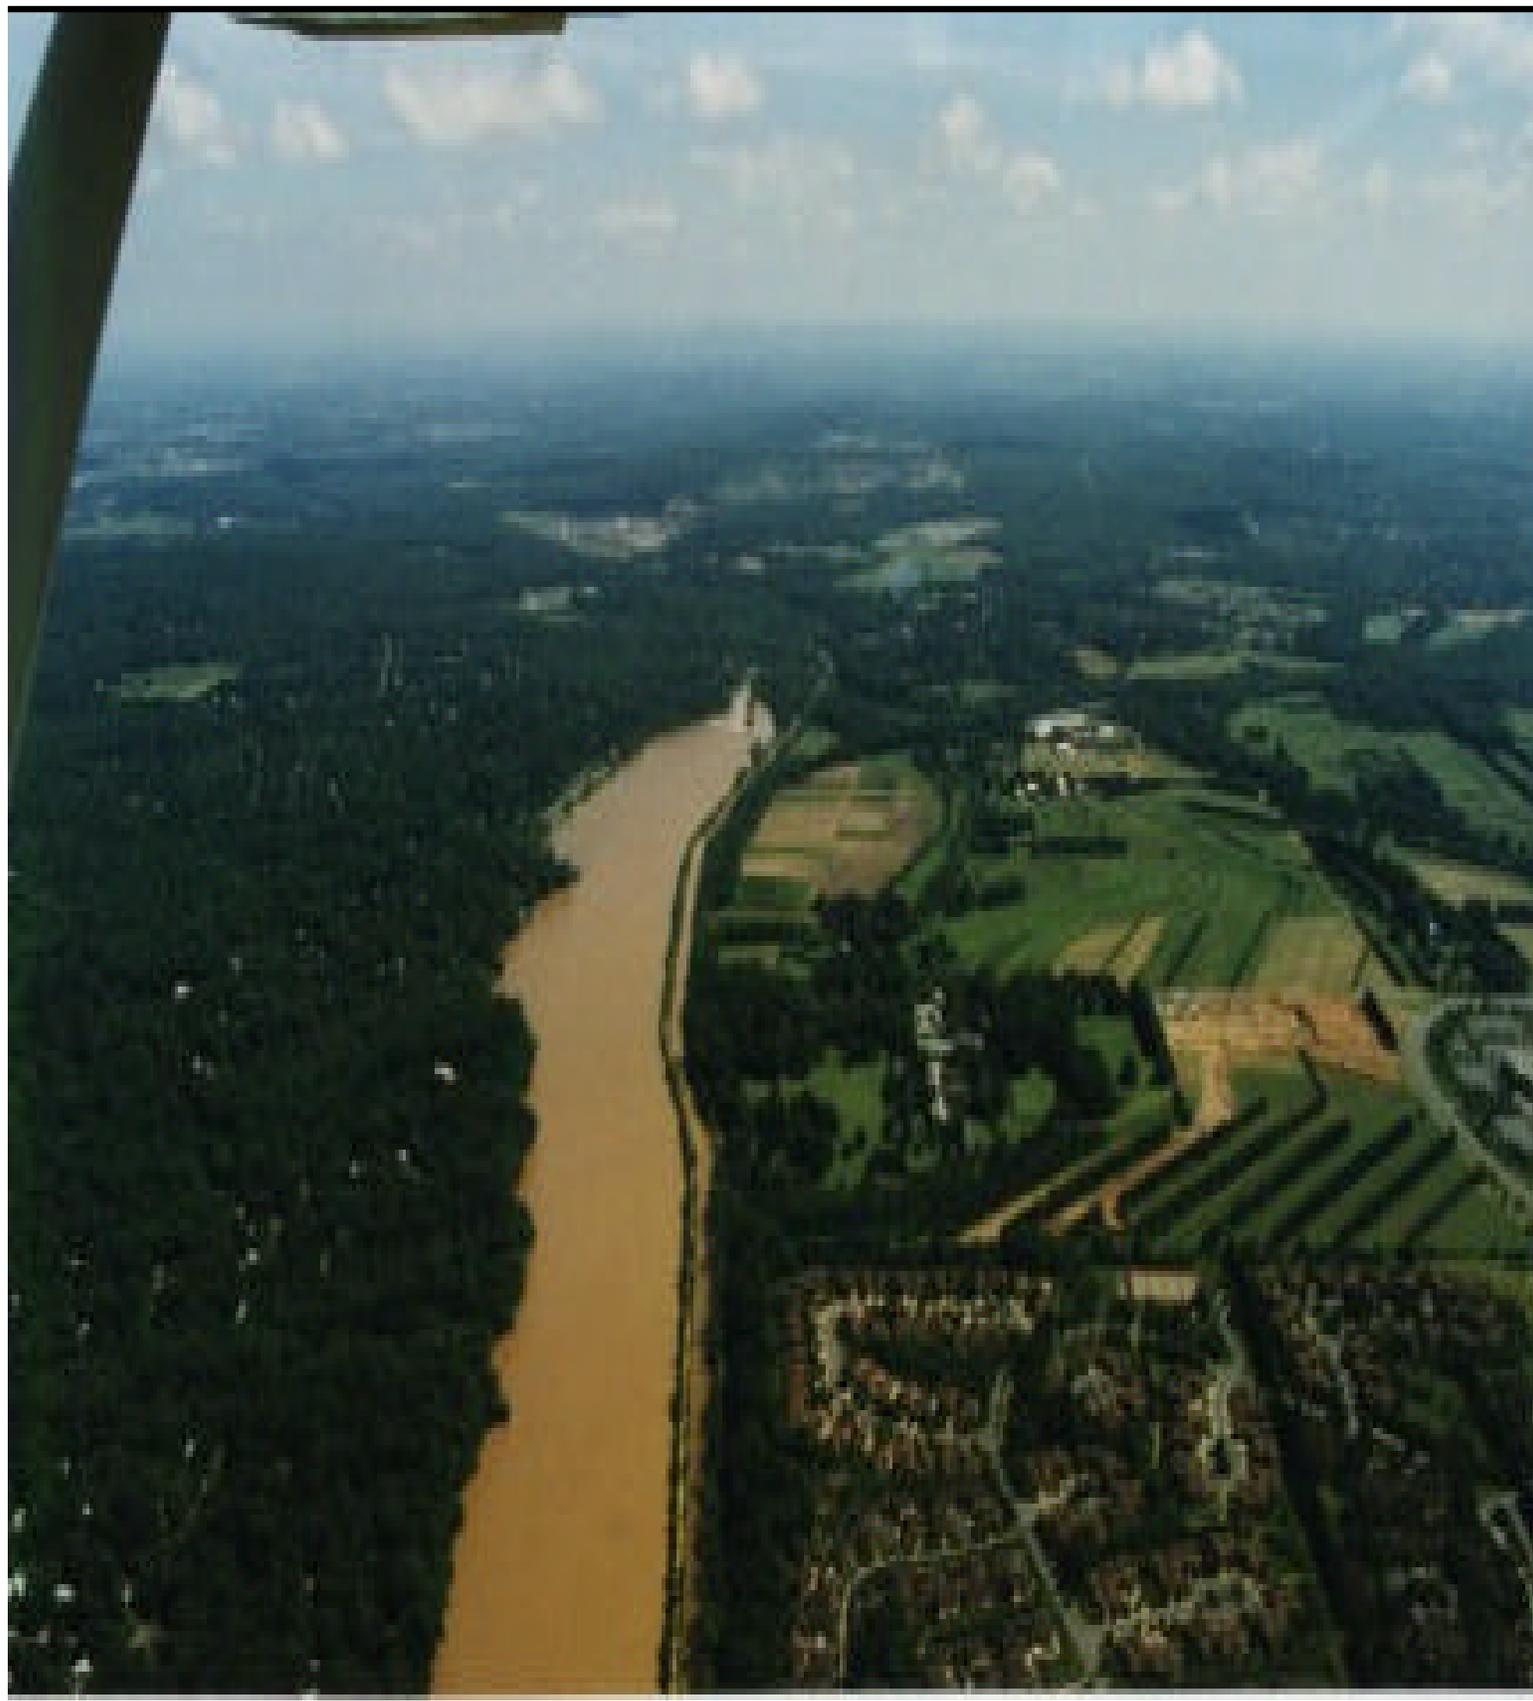
FIGURE 4
Carnegie Lake

In an effort to limit the transport of sediment to Carnegie Lake, 12 sediment retention facilities were constructed in the Stony Brook watershed in 1954. These basins capture a portion of the sediment load but continue to require maintenance. Previous studies have identified the Stony Brook Basin as the primary contributor of sediment to Carnegie Lake. The soft shale soils of the Stony Brook watershed are easily eroded and transported into the stream system. Sediment input from stream banks, agricultural practices and residential development also contribute significant sources of sediment.

Nutrient runoff and input to the lake is also high. Nutrient inputs appear to be greater from the upper Millstone River, Harry's Brook, and Stony Brook. Agricultural (row crops, dairy farms) and non-agricultural (septic systems, lawns, impervious areas) activities contribute to elevated phosphate and nitrate levels within the lake.

Fish habitat within Carnegie Lake is diminished by reduced water quality and continual sedimentation. Sediment inputs increase turbidity, reduce primary production, and smother spawning beds and benthic habitat. Open water mud flats and shallow areas created by sediment aggradation elevate summer temperatures and reduce dissolved oxygen levels. These shallow areas are populated with mono-typic stands of invasive r-selected weed species.

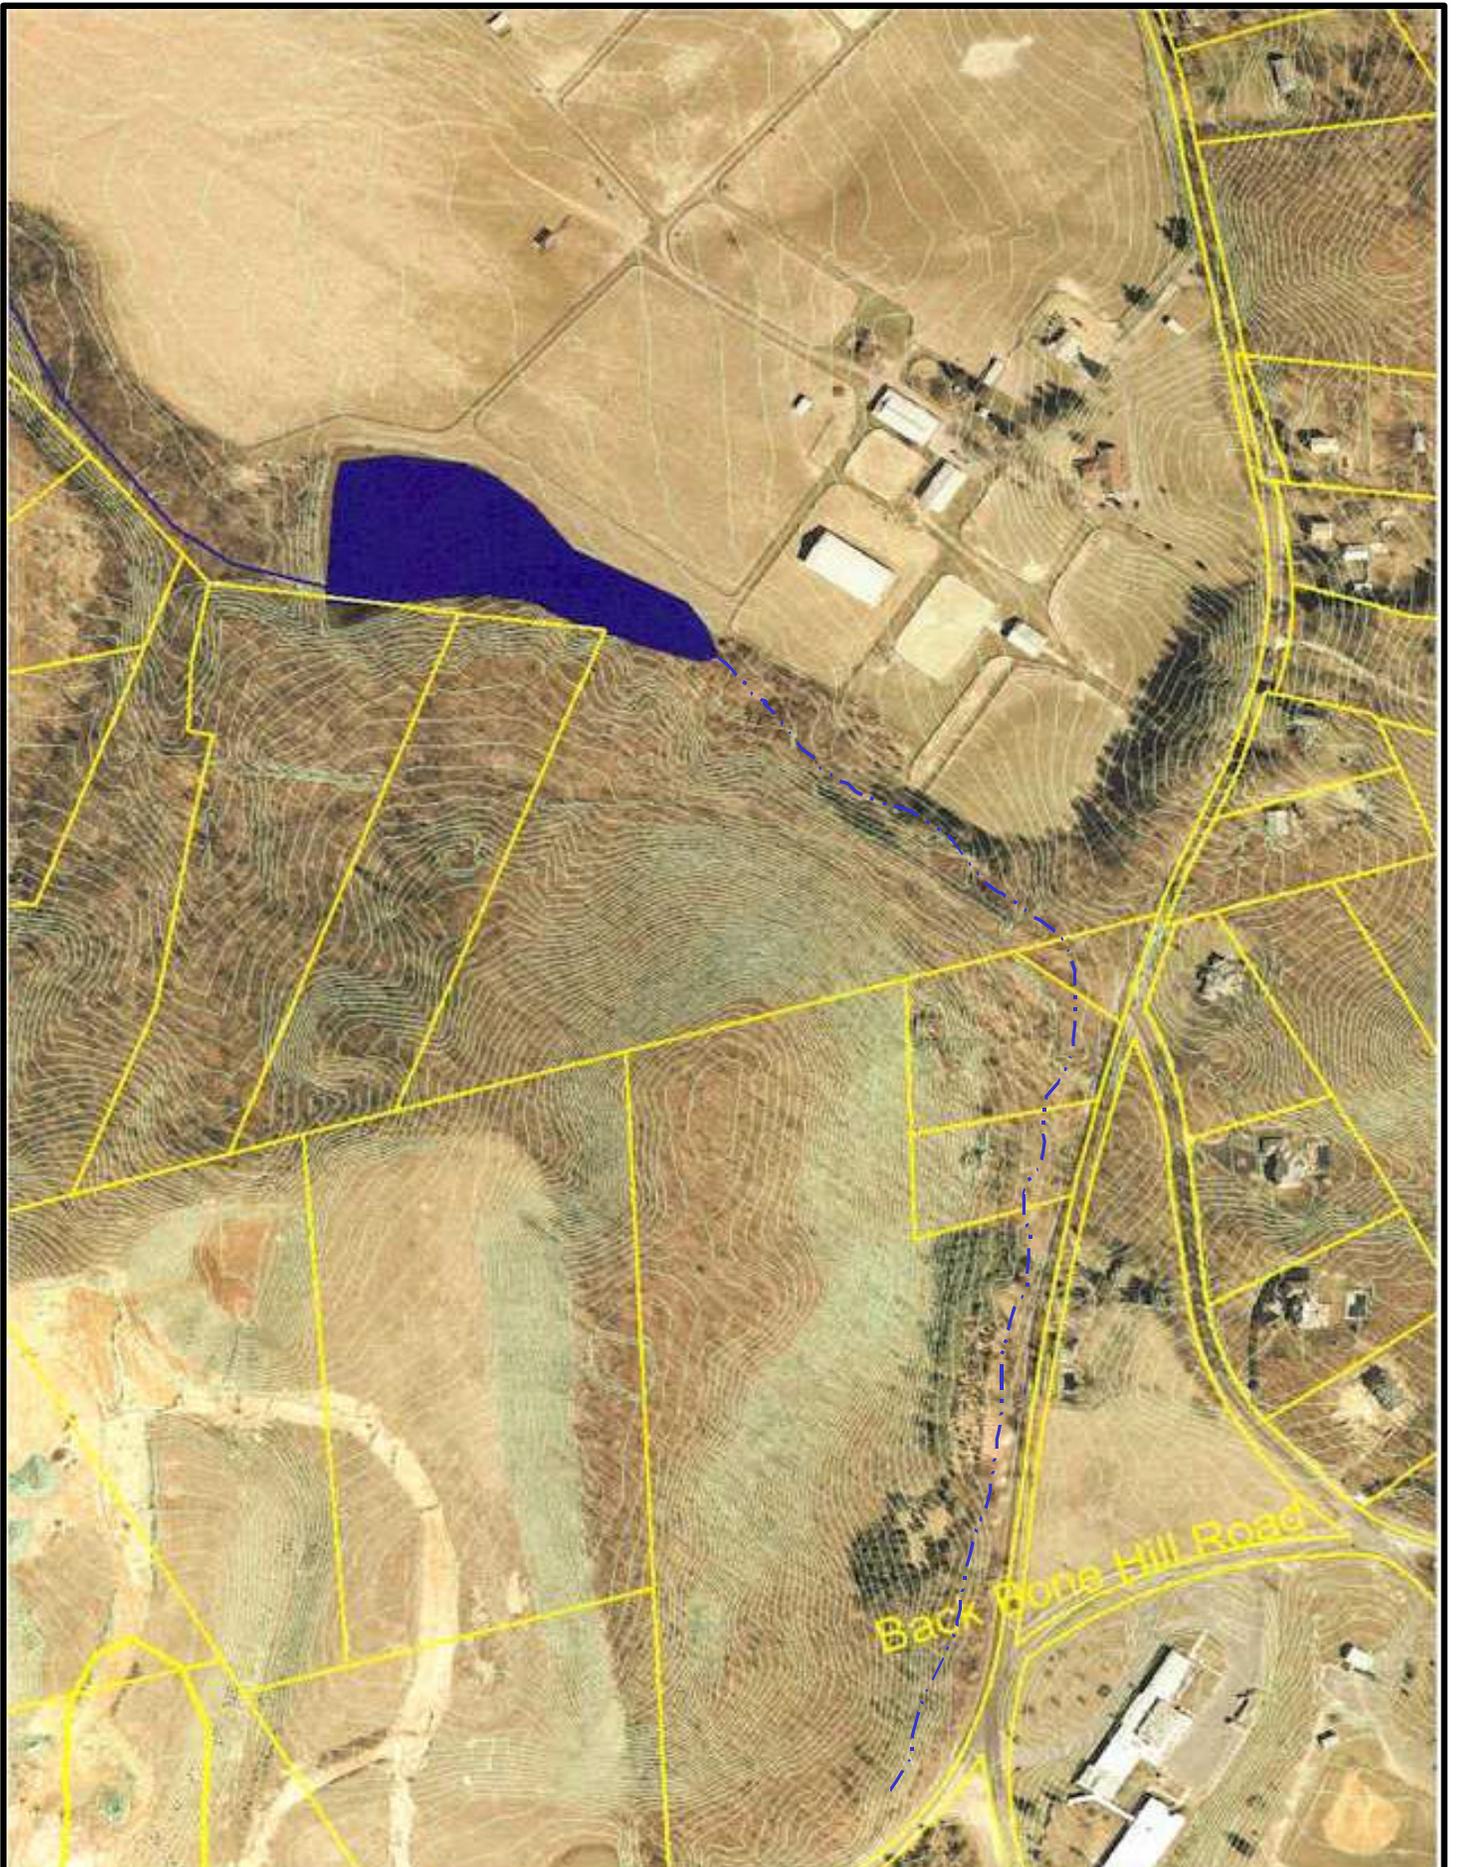
FIGURE 5
Rocky Brook Subbasin

The downstream portion of Rocky Brook has been protected from the excess bedload by an in-line pond. This pond captured the majority of the sediment transported by the stream during Hurricane Floyd and continues to trap excess bedload. Sediment capture degraded the pond ecosystem. Sediment-laden streamflow has raised the turbidity in the pond, in-filled creating shallow areas and increased the ambient summer water temperature. As a result, the amphibian, reptile, and fish habitat of the pond is severely degraded.

Millstone Township has plans for a regional detention structure to help restore Rocky Brook's hydrologic regime. A comprehensive riparian corridor restoration, including stream channel and pond restoration in conjunction with regional detention would significantly restore the headwater aquatic ecosystem to a less-degraded, more-natural condition. First, the in-line pond could be enlarged and retrofitted to enhance sediment retention. This improvement would ensure the continued protection of downstream aquatic resources during implementation of upstream restoration measures. Next, a more natural stream pattern and channel geometry could be reestablished to facilitate a dynamic stream equilibrium.

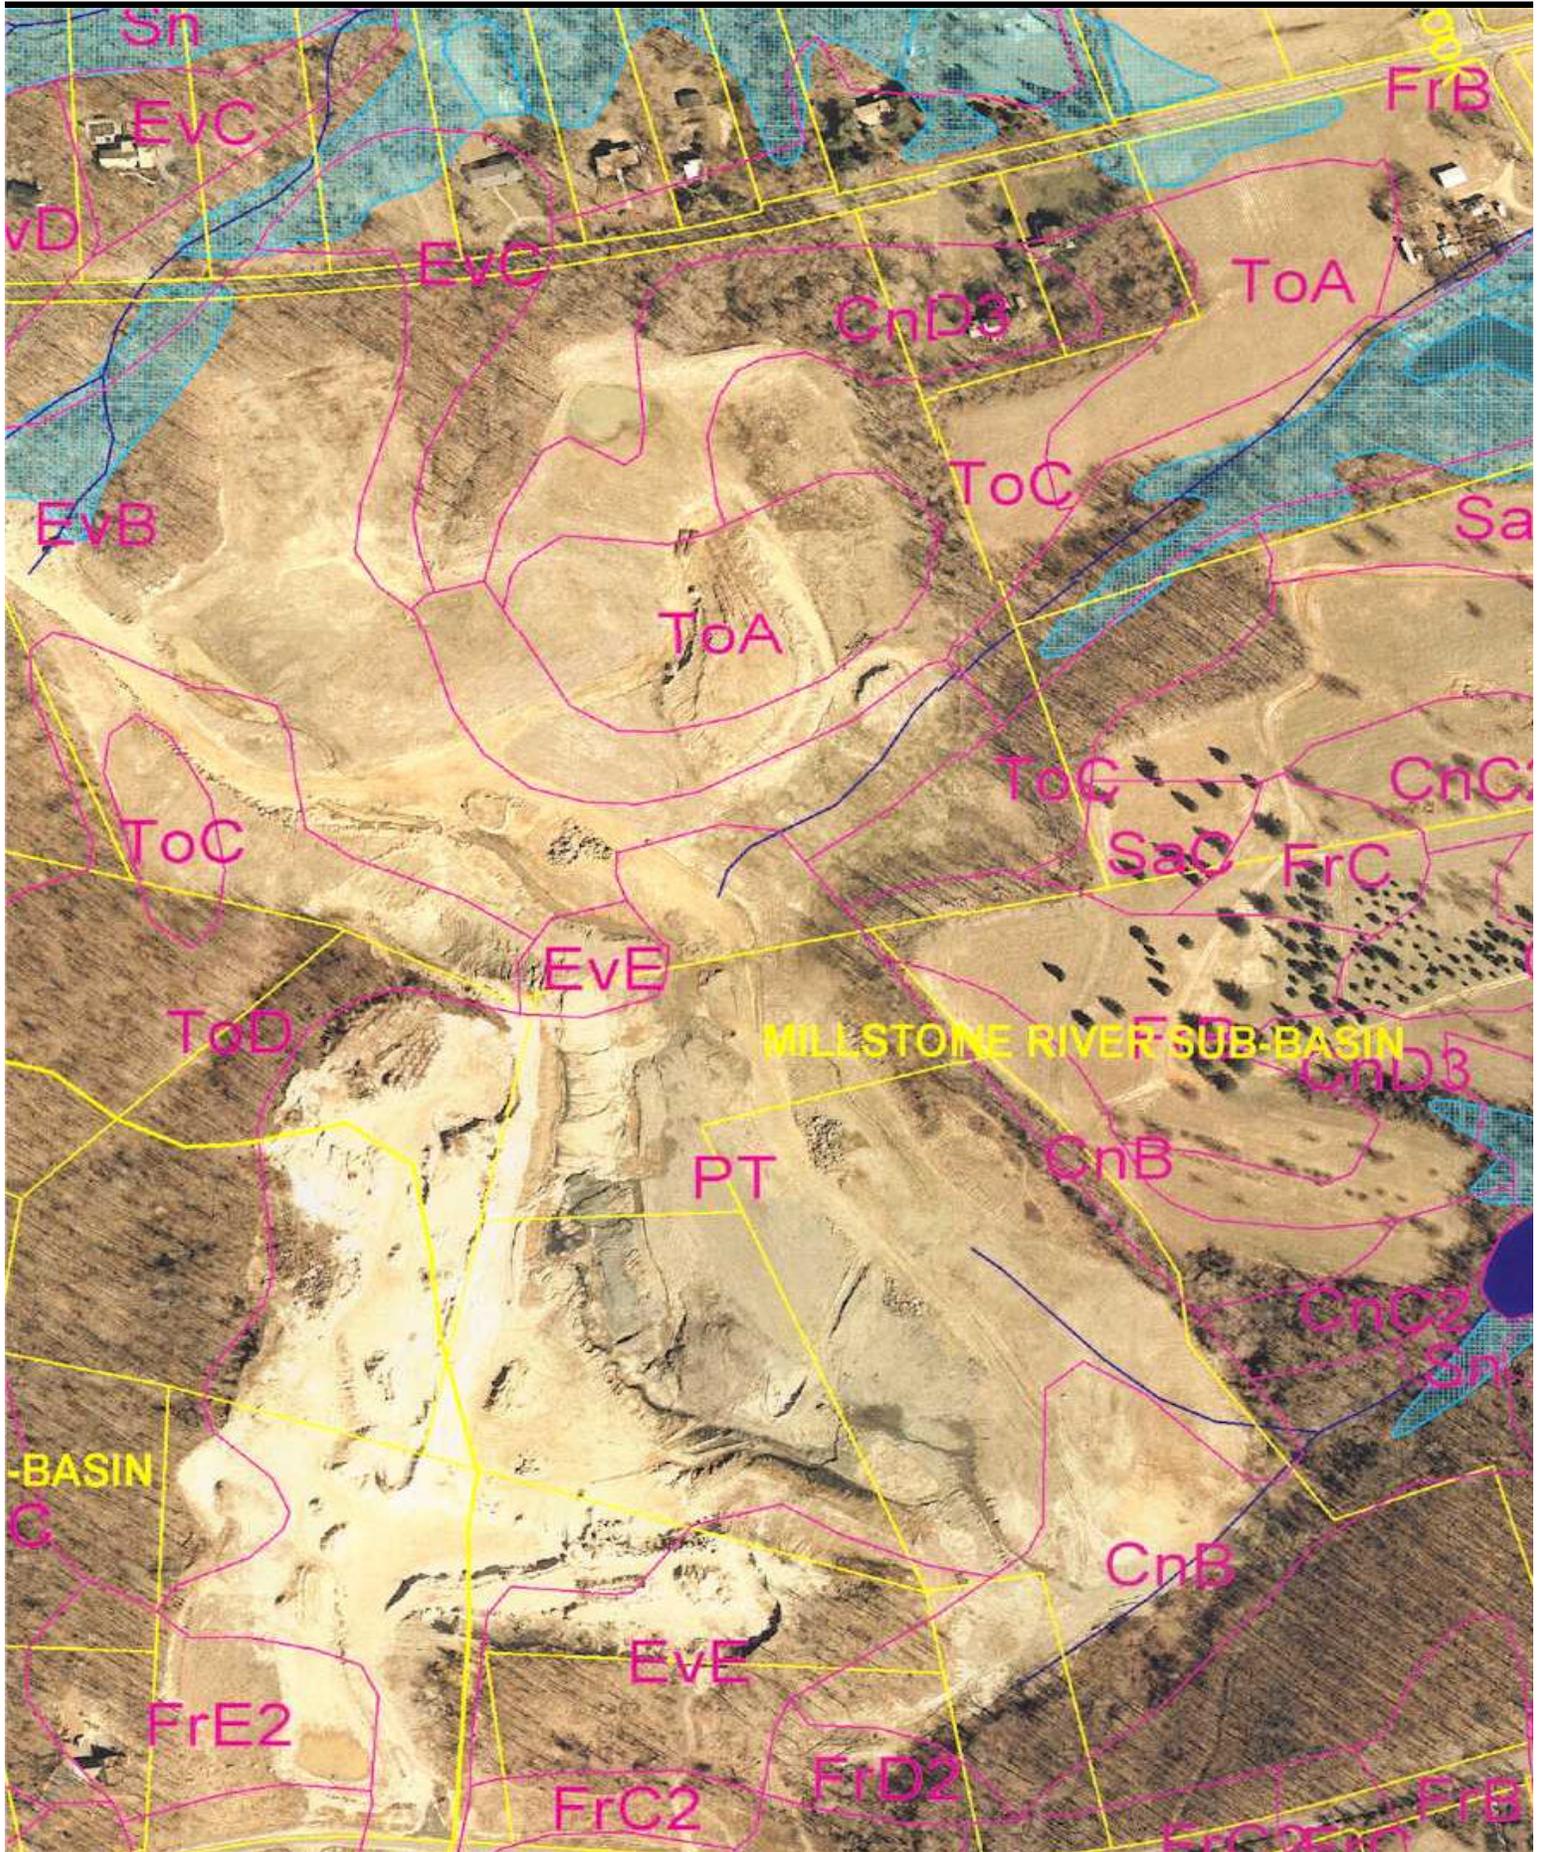
FIGURE 6
Campo Mine

Campo Mine Site - Disturbed Land Restoration: The Campo Mine site is a 90-acre inactive sand mine adjacent to the Millstone River in Millstone Township. Figure 6 is an aerial depiction of the Campo Mine Site. The site is almost devoid of vegetation with 20 to 30 foot highwalls and sand piles. Several first order streams were destroyed during mining. Unconsolidated sandy soil is actively eroding and transported into the remaining three tributaries that drain the site. This sediment is overloading the transport capacity of these streams and causing aggradation. Within the exposed sand layers are deposits of marl - low permeability clay. Wetland creation at this site would be possible by diverting up gradient drainage to target wetland creation areas lined with the marl.

The entire 90 acres would be restored. Restoration would create as much as 10 percent emergent wetland areas, 10 percent infiltration / recharge structures, 30 percent riparian corridor with the remainder of the site in transition areas and forest. Exposed highwalls would be backfilled and regraded with of the site restored to a more natural landscape characteristic, i.e. riparian wetlands, bottomland forest outcrop, and dry ridge highlands. Passive recreation and public education opportunities via trails and interpretive stations would also be included, based on the interest of the local sponsor.
