# Montauk Point, New York

## Hurricane & Storm Damage Reduction

### Final Feasibility Report & Environmental Impact Statement

**FINAL - October 2005**

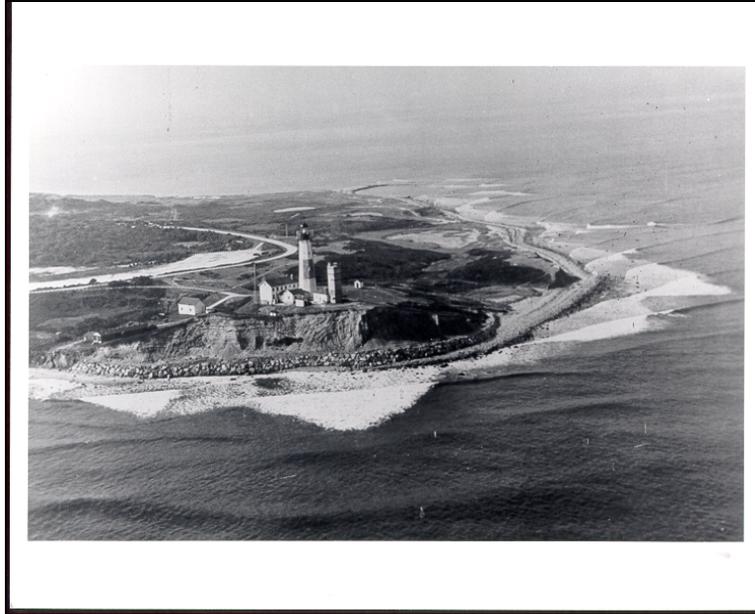
Figure 5 - Montauk Point With Revetment, Circa 1946

1946 A 700-foot stone revetment is constructed at the bluff toe, with vegetative plantings along the upper half of the cliff (New York District, 1944). The crest elevation is +20 feet MSL, tapering down to +15 feet MSL at both ends. The crest width is 23-feet with a core and double armor layer of 4 to 8-ton stone. The base layer is 8-ton stone. Since its construction, this entire seawall has completely failed and is now 10 to 70-feet seaward of the existing bluff toe. Most of the stone is at an elevation of about mean high water, with remnants present as rubble along the seaward extent of the present structure toe.

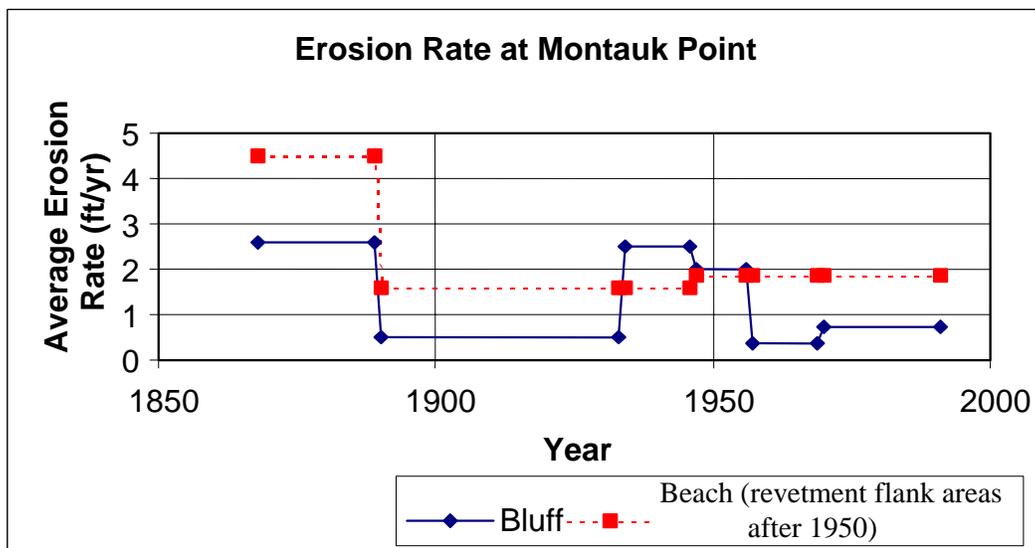
Figure 10 - Average Erosion Rates Since 1868 at Montauk Point (New York District, 1993)

Long-term erosion rates along two cross sections using reported historic shorelines and aerial photography were analyzed (Figures 10 & 11). The data was plotted in cross-section view (Figure 12). The historical long-term shoreline recession rate was found to be 2.2-feet per year for the beach and bluff toe and 1.2-feet per year for the top of bluff. In the past 125 years of record (1868-1993), the bluff has receded 150-feet and beach has receded about 330-feet. Erosion rates since 1993 in critical areas of erosion are not pertinent due to the construction of a successfully performing revetment, which is curtailing shoreline retreat. It has been estimated that the average annual erosion rate for the bluff and beach is 6 cubic yards per foot per year, resulting in a total of 5,000 cubic yards of erosion per year in the critical erosion area. The historical data shows that the beach recession rate adjacent to the revetment has been reduced by about 50% since the construction of coastal structures, whereas the bluff recession has stabilized at about 25% of the pre-1945 revetment recession rate due to the terracing construction above the revetment.

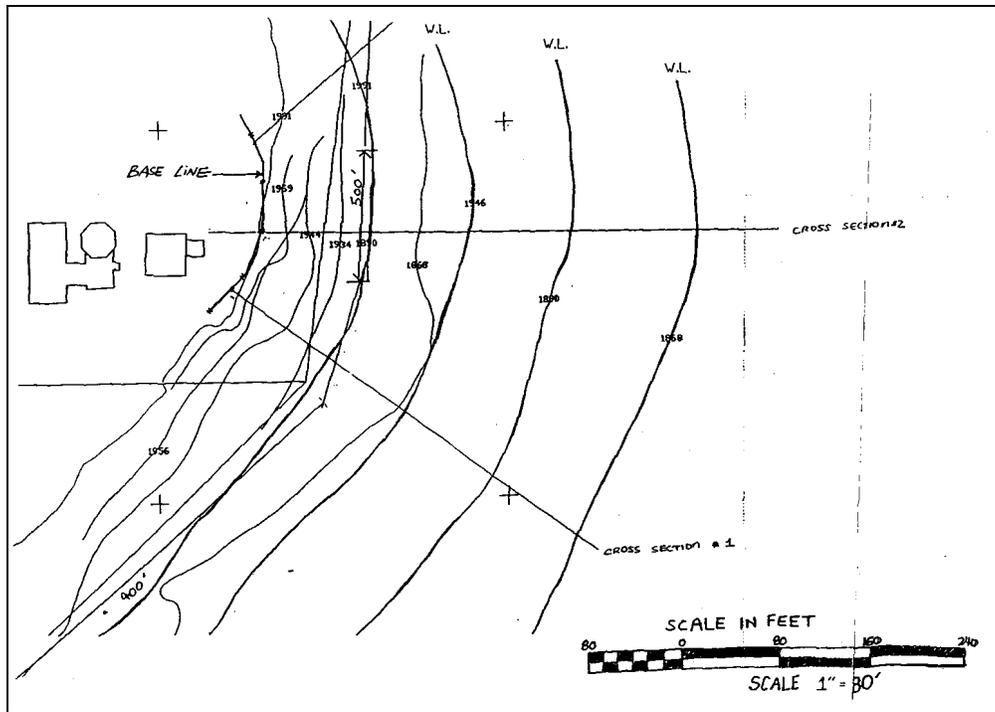
Figure 11 - Shoreline Changes 1865-1992 (New York District, 1993)

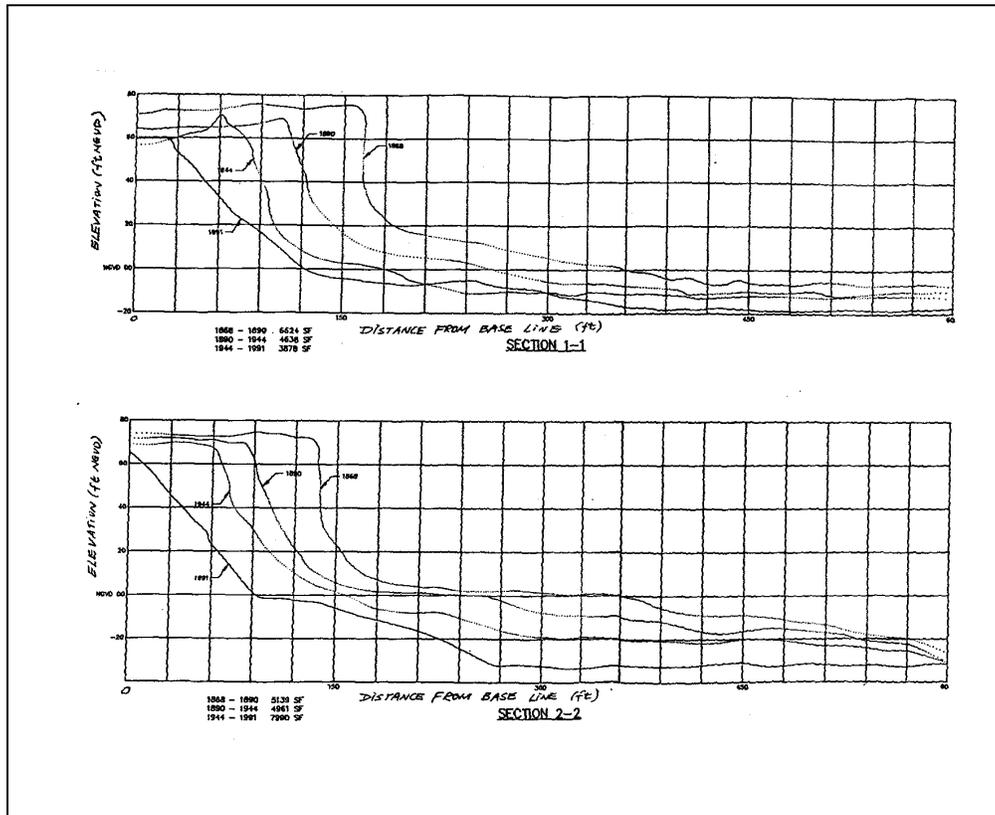
Figure 12 - Shoreline Changes, Cross-Sections

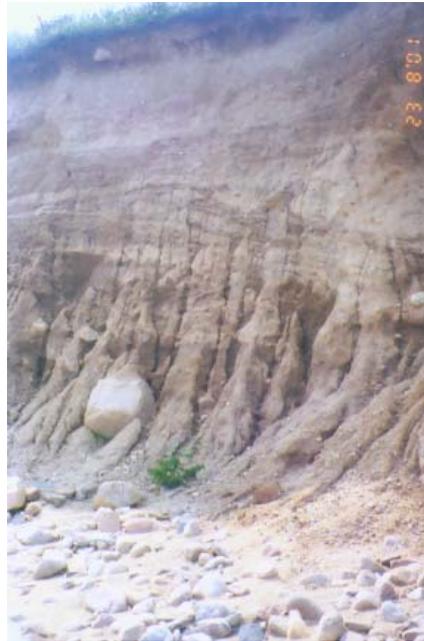
Figure 13 - Typical bluff cross-section with glacial till at Montauk Point

The till exposed in the wave cut bluffs surrounding Montauk Point is a well graded mixture of boulders, sand, gravel, and **underlying** silt pre-consolidated by the weight of glacial ice (Figure 13). It has a long stand up time for near vertical slopes but gradually erodes and fails with time under annual rainfall and runoff (Figure 14). Under large magnitude wave actions with high storm surges, the dense till will be scoured and result in toe failures of the mid to upper bluff above the revetment for the till and overlying granular soils. The **slope** stability analysis of existing conditions was performed for sections representing the steepest slopes that are near and surrounding the lighthouse. Results indicated that the slopes and the present conditions are at equilibrium with little or no safety margin.

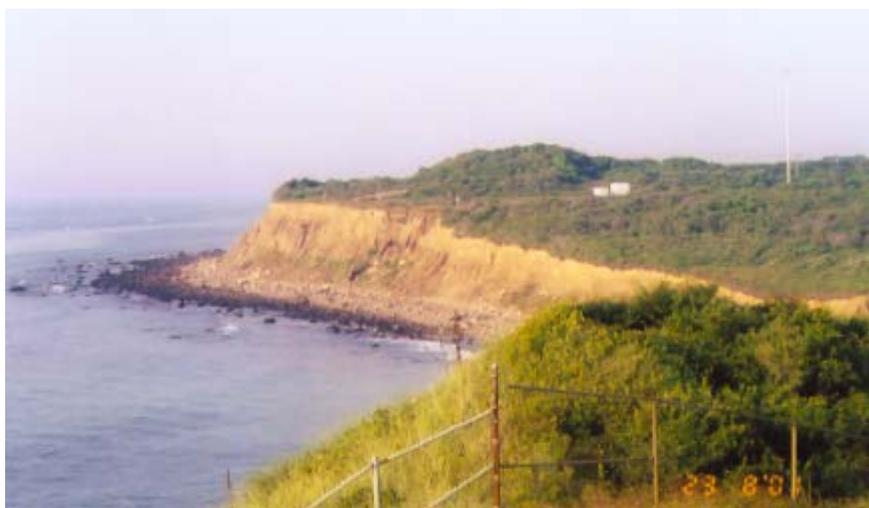
Figure 14 - Eroded bluff south of Turtle Cove with wave-eroded toe and consequent bluff failure

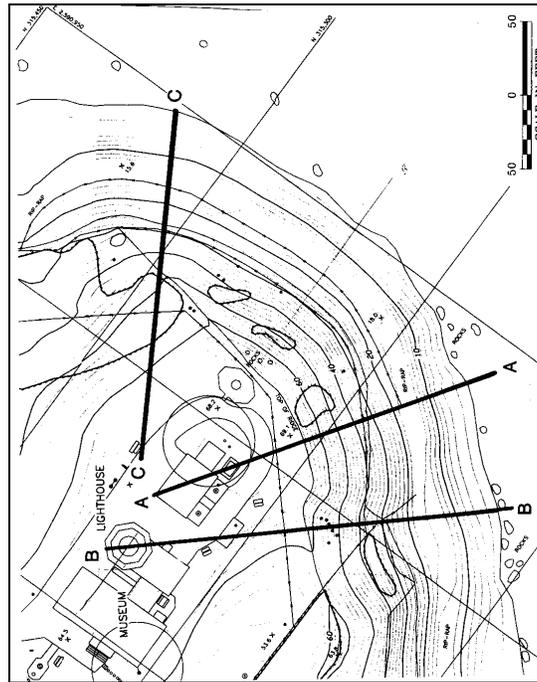
Figure 15 - Locations of cross-sections for slope stability modeling

The stability analysis of existing conditions was performed along three cross sections (Figure 15). These sections represent the steepest slopes that are near and surrounding the lighthouse. Section A-A is the steepest of the three sections.

The stability analysis on each section indicates that the slopes and the present conditions are at equilibrium with little or no safety margin. This is indicated by a factor of safety of approximately 1.0 for Sections A-A and B-B. The upper parts of the slopes, which are near the angle of repose for the granular soils, show the highest potential for failure if existing conditions are even slightly disturbed. At Section A-A, the upper slopes would consistently fail if terracing and vegetation stabilization measures, maintained by the Montauk Point Historical Society, were not practiced.

It is noted that Section C-C is stable with a minimum slope stability factor of safety of 1.25 due to the lower bluff elevation and milder slopes. However, a much larger failure surface and volume of material starting at the shoreline also has a low factor of safety (1.094) in section A-A and can fail with external disturbance, although much less likely due to the very compacted state of the soils near the toe of the bluff below elevation +15 feet NGVD +/-.

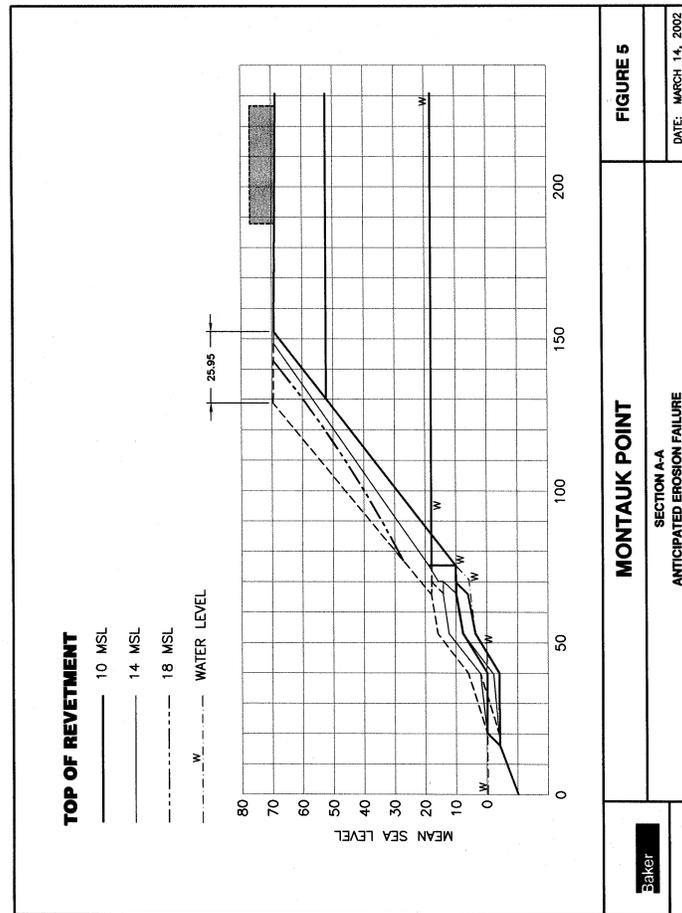
Figure 16 – Slope Profile Changes

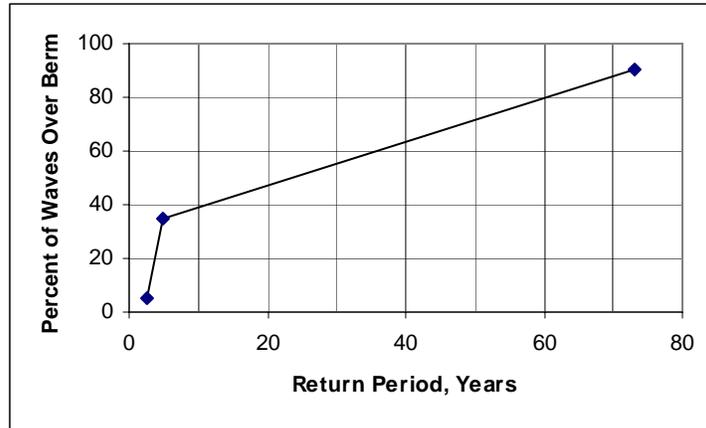
Figure 27- Percent of wave runup exceeding existing berm elevation

Figure 27 also confirms that wave runup (from the highest segment of the wave group for the more frequent storms, all the way to nearly all the waves on the 73-year return period storm) exceeds the crest elevation of the existing structure, from the 2-year through the 500-year storm, even when permeability is accounted for.

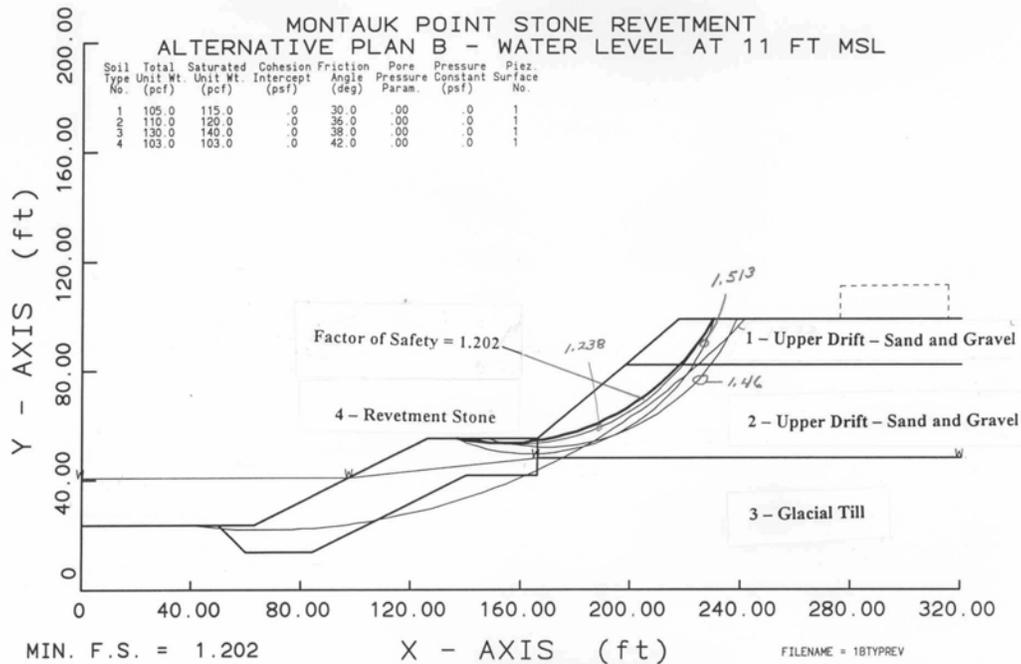
Figure 28 – Slope Stability Analysis for Stone Revetment Alternative 2B

Slope stability analysis was performed on Alternative 2B to evaluate “with project conditions”. Figure 28 shows that the factor of safety for the critical failure surface is 1.46 through the revetment and 1.202 in the bluff above the revetment.

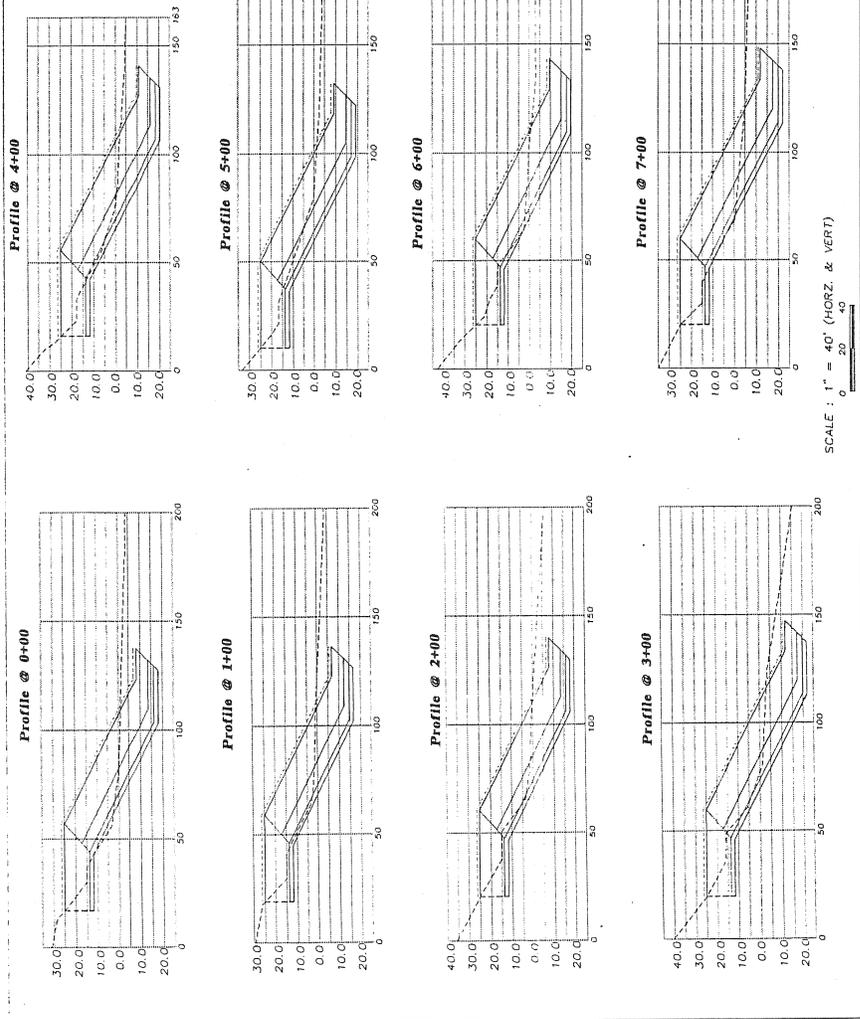
Profile @ 5+00

NEW YORK STATE DEPARTMENT OF TRANSPORTATION  
 MONTAUK POINT  
 LONG ISLAND, NEW YORK  
 FEASIBILITY STUDY  
 STONE REVETMENT  
 ALTERNATIVE 2B  
 PROFILES  
**Figure 31**

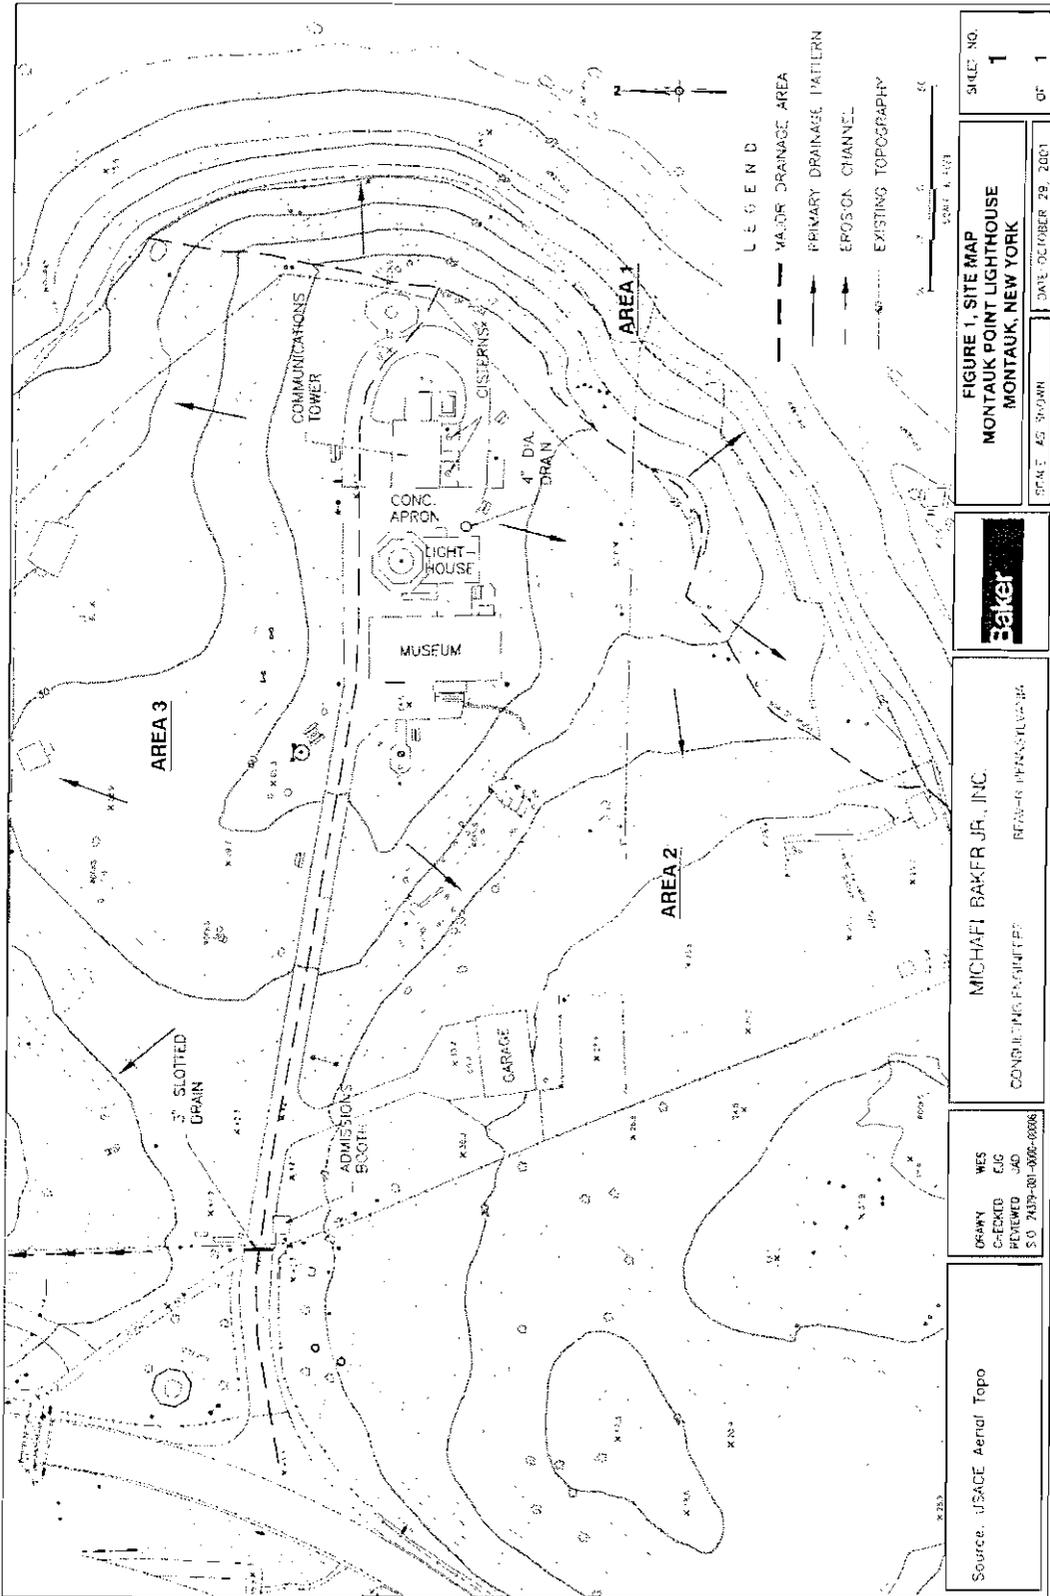
Figure A-3. Site Plans and Drainage

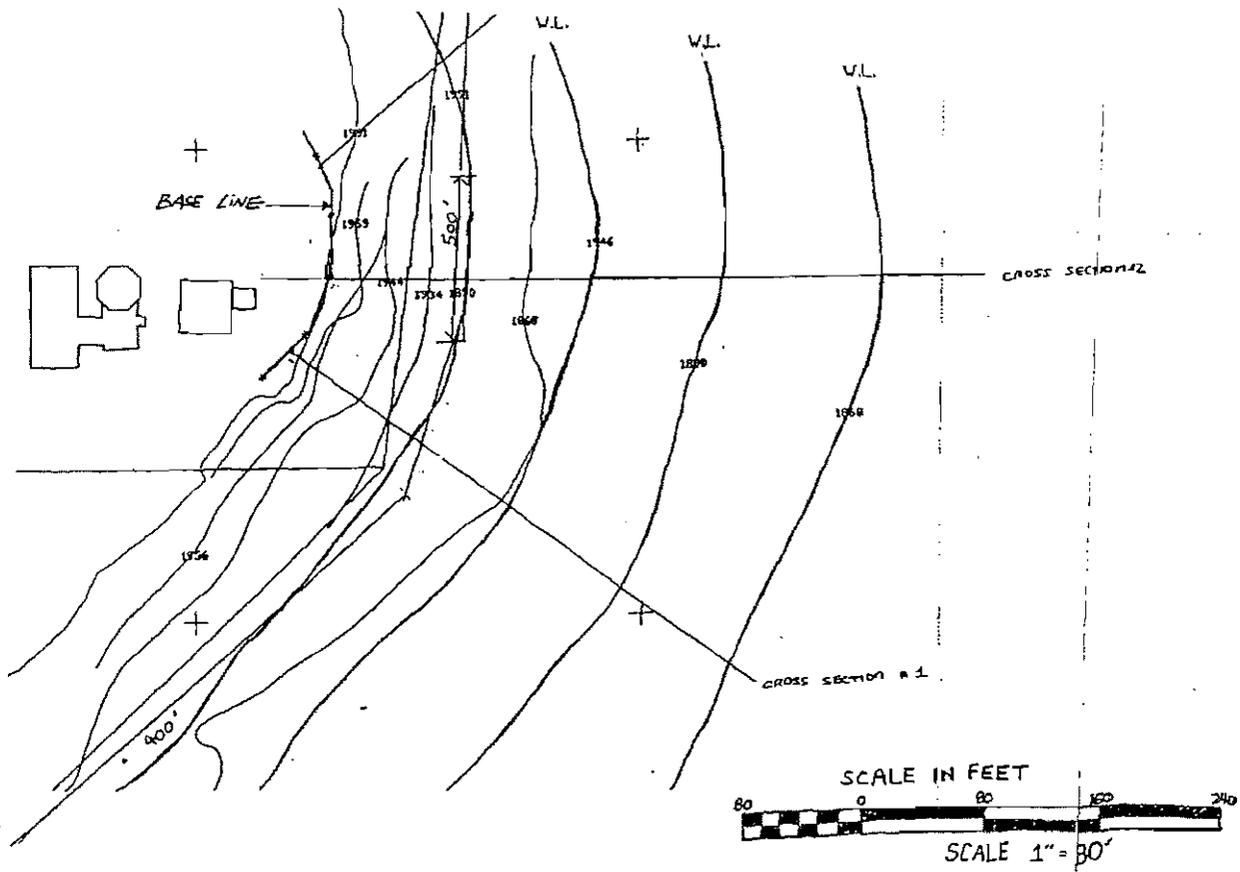
Figure A-4. Shoreline Changes 1865-1992 (New York District, 1993).

A-40 Long term erosion rates along two cross sections using reported historic shorelines and aerial photography were analyzed (Figure A-4). The data was plotted in cross-section view (Figure A-5) and averaged as shown in Figure A-6. The historical long-term shoreline recession rate was found to be 2.2 feet per year for the beach and bluff toe and 1.2 foot per year for the top of the bluff (New York District, 1993). In the past 125 years of record, the bluff has receded 150 feet and beach has receded about 330 feet. Erosion rates since 1993 in critical areas of erosion are not pertinent due to the construction of a successfully performing revetment at this region which is curtailing shoreline retreat. It has been estimated that the average annual erosion rate for the bluff and beach is 6 cubic yards per foot per year, resulting in a total of 5,000 cubic yards of erosion per year in the critical erosion area. The historic data shows that the beach recession rate adjacent to the revetment has been reduced by about 50% since the construction of coastal structures, whereas the bluff recession has stabilized at about 25% of the pre-1945 revetment recession rate due to the terracing construction above the revetment.

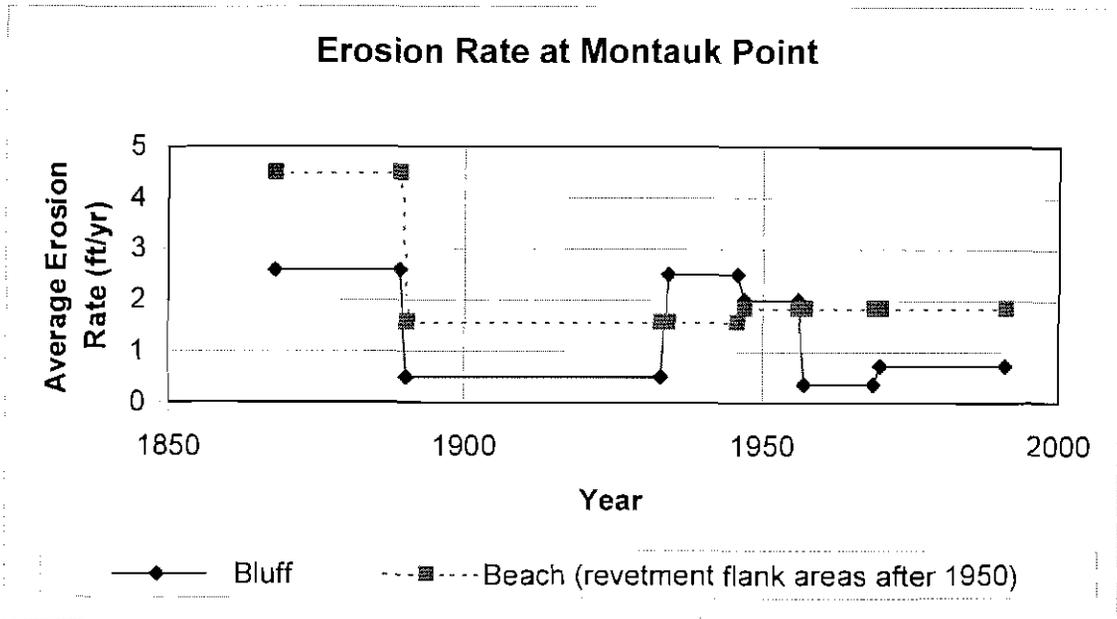
Figure A-6. Average Erosion Rates Since 1868 at Montauk Point (New York District, 1993)

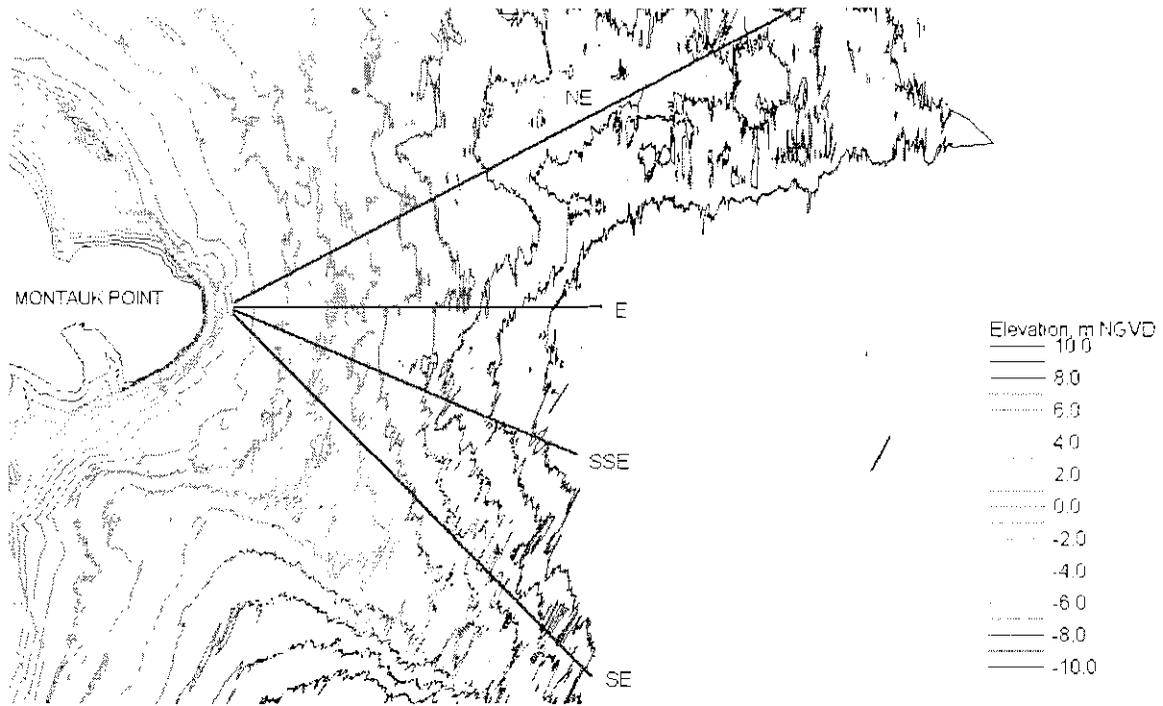
**Figure A-7. Location of Beach Profile Lines Considered for SBEACH Wave Transformation Analysis**

A-48 Table A-3 presents the results of the calculations for significant wave heights at the toe of the present structure based on the two numerical models employed. The differences in results at the structure toe are due to slightly different representations of the bottom profile and the wave breaking processes.

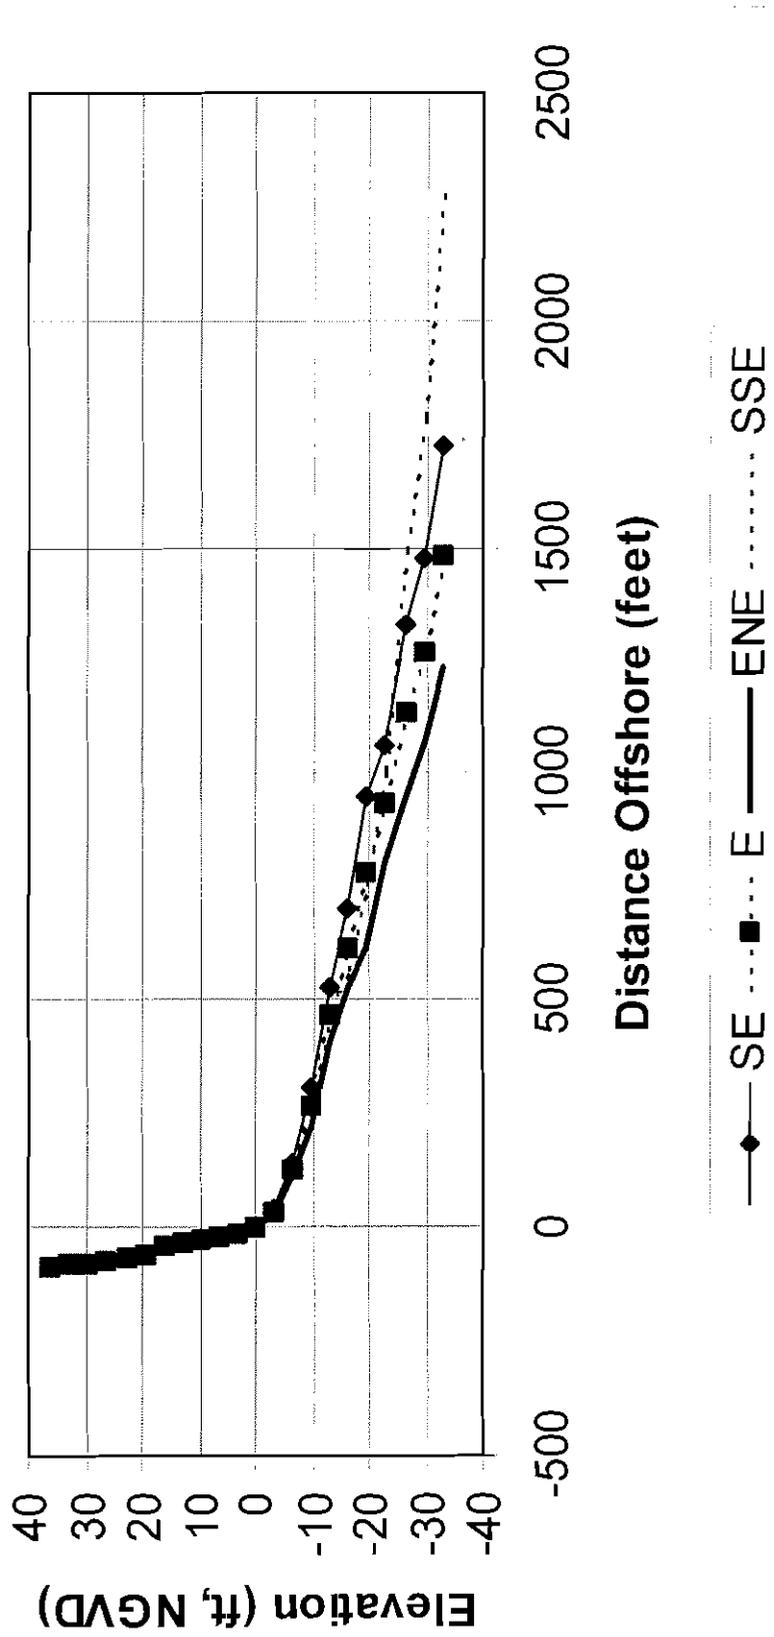
Figure A-8. Beach Profiles Considered for Wave Transformation Analysis

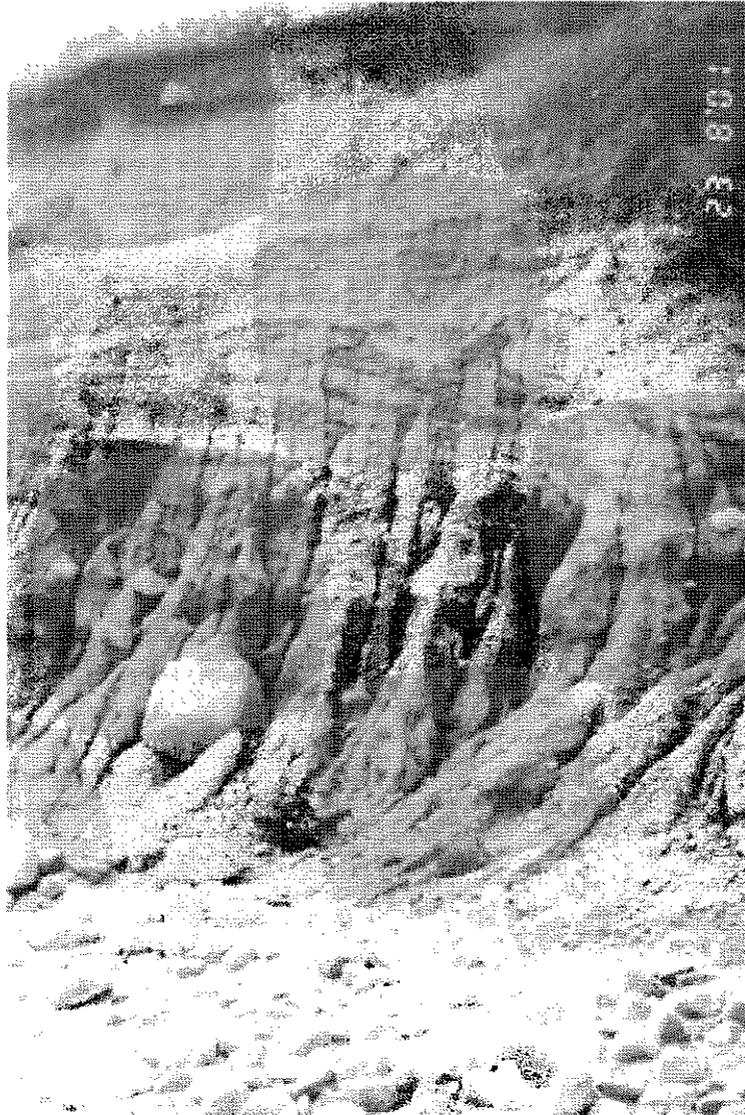
**Figure A-9. Typical bluff cross-section with glacial till at Montauk Point.**

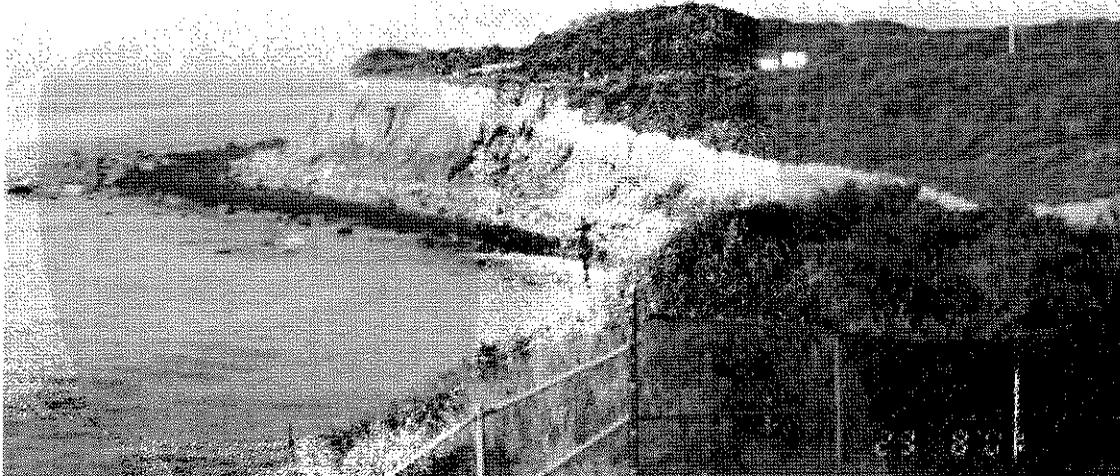
**Figure A-10. Eroded bluff south of Turtle Cove with wave-eroded toe and consequent bluff failure.**

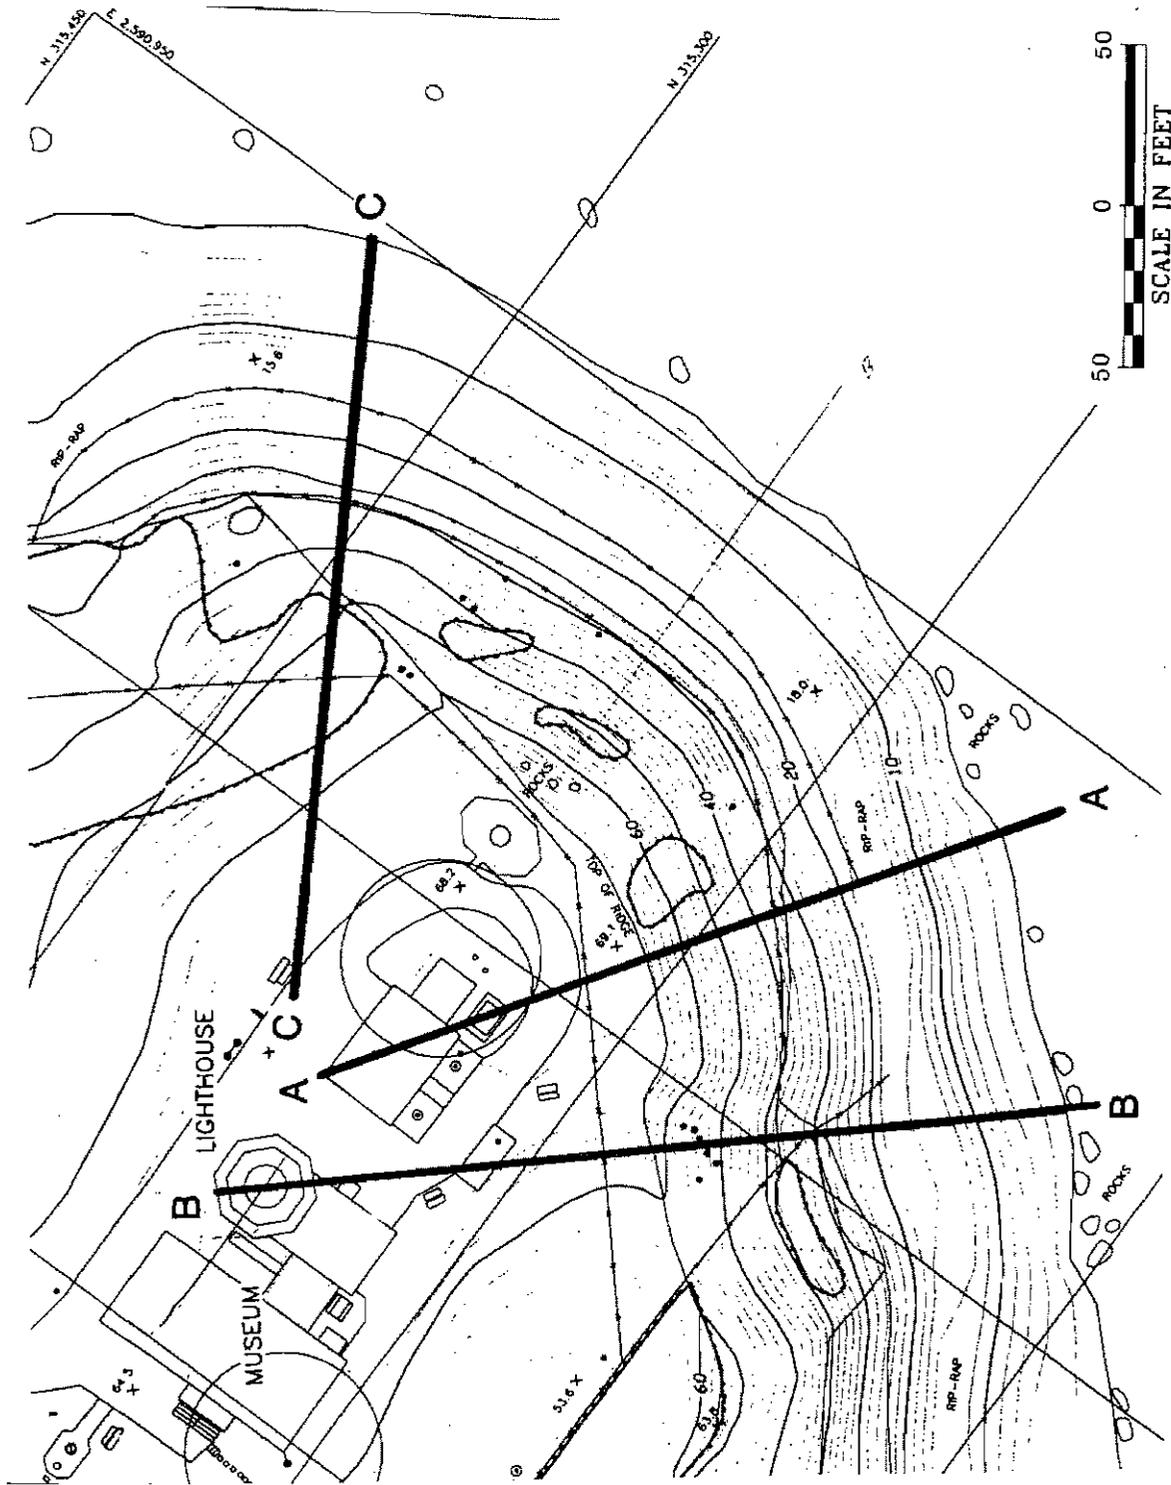
Figure A-11. Locations of cross-sections for slope stability modeling.

A-61 However, a much larger failure surface and volume of material starting at the shoreline also has a low FS (1.094) in section A-A and can fail with external disturbance, however is unlikely to occur due to the very dense nature of the soils near the toe of the bluff below el. +15 ft. NGVD +/-.

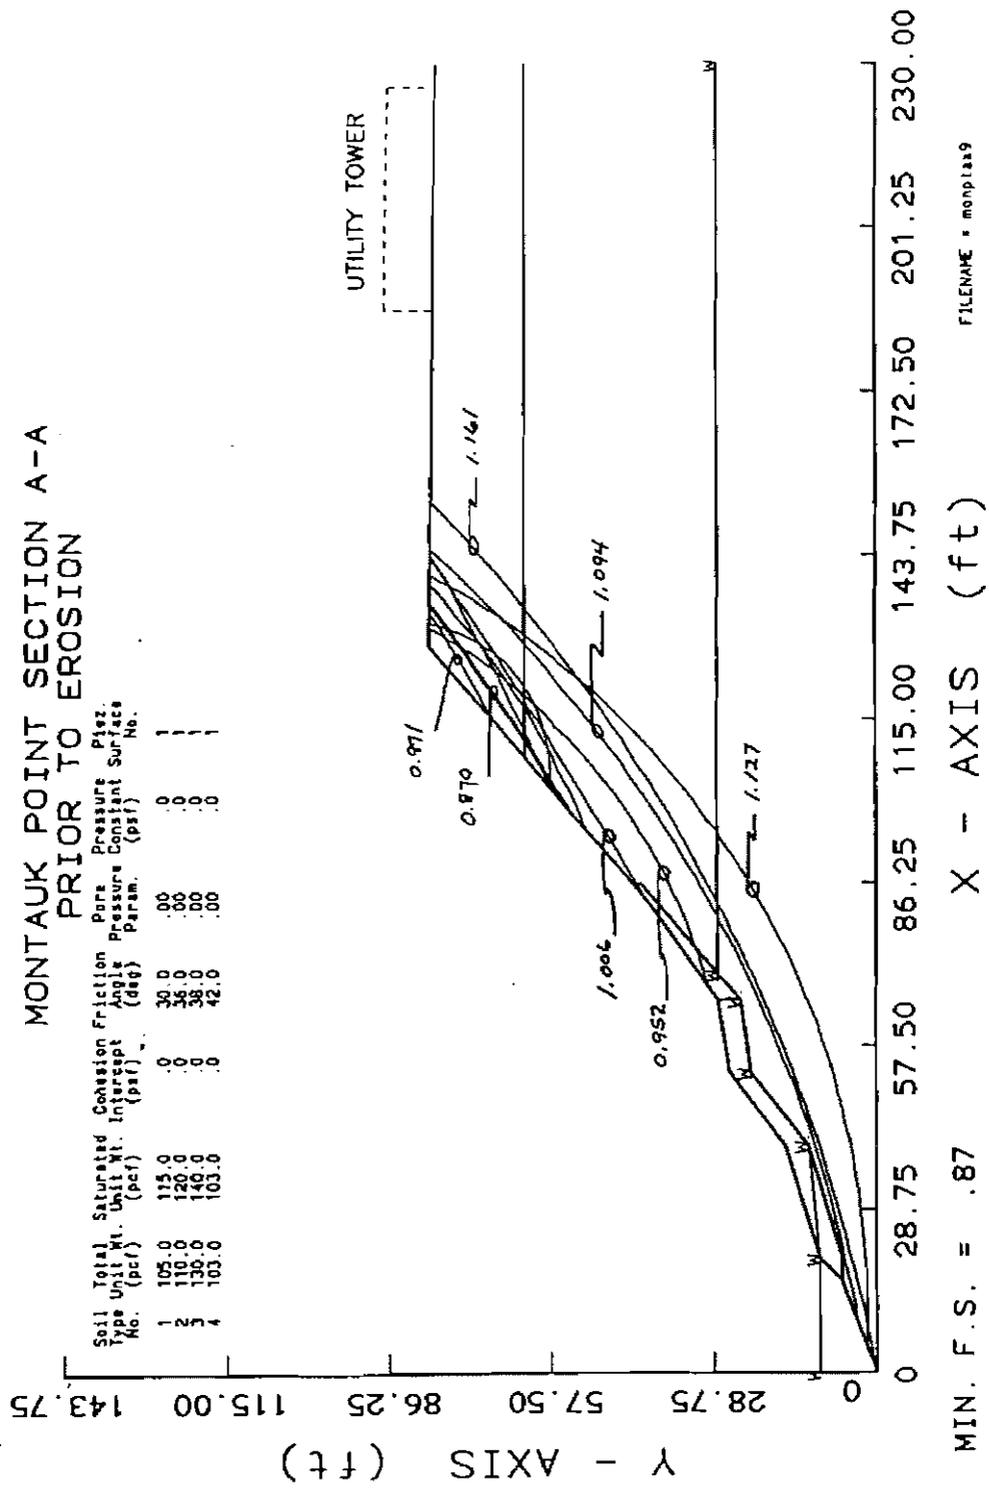
MONTAUK POINT SECTION A-A  
PRIOR TO EROSION

Figure A-12. Slope stability model results for existing conditions, Section A-A.

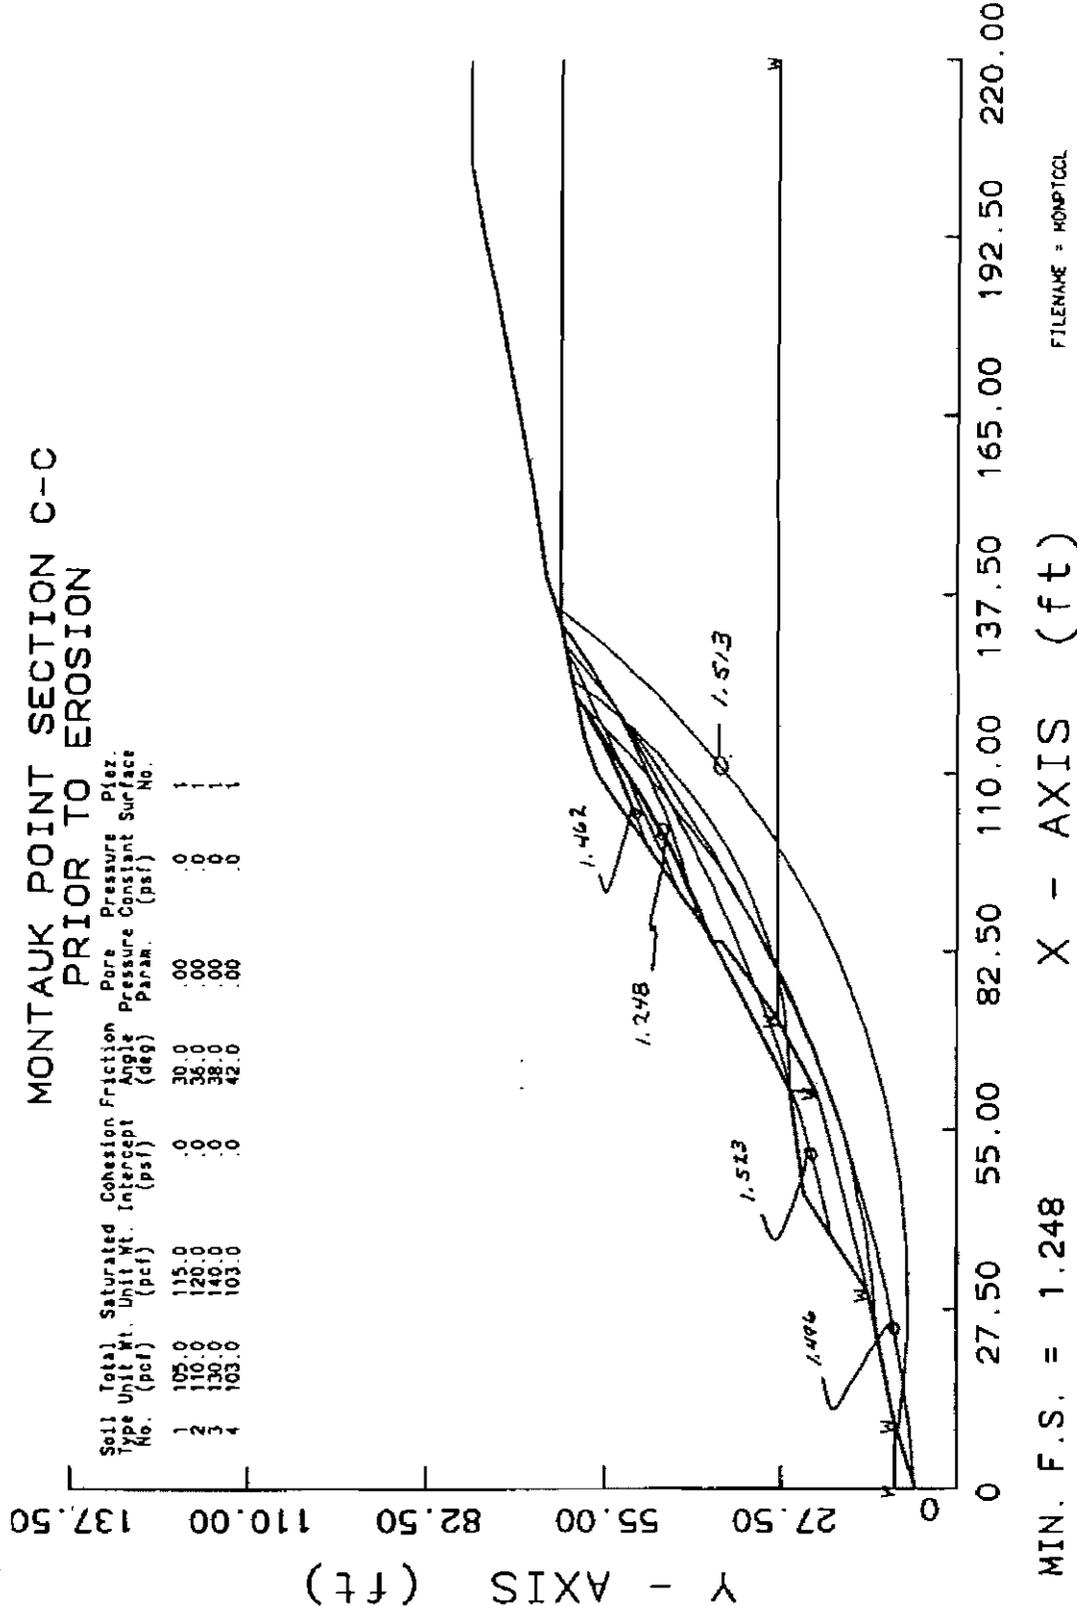
MONTAUK POINT SECTION C-C  
PRIOR TO EROSION

Figure A-14. Slope stability model results for existing conditions, Section C-C

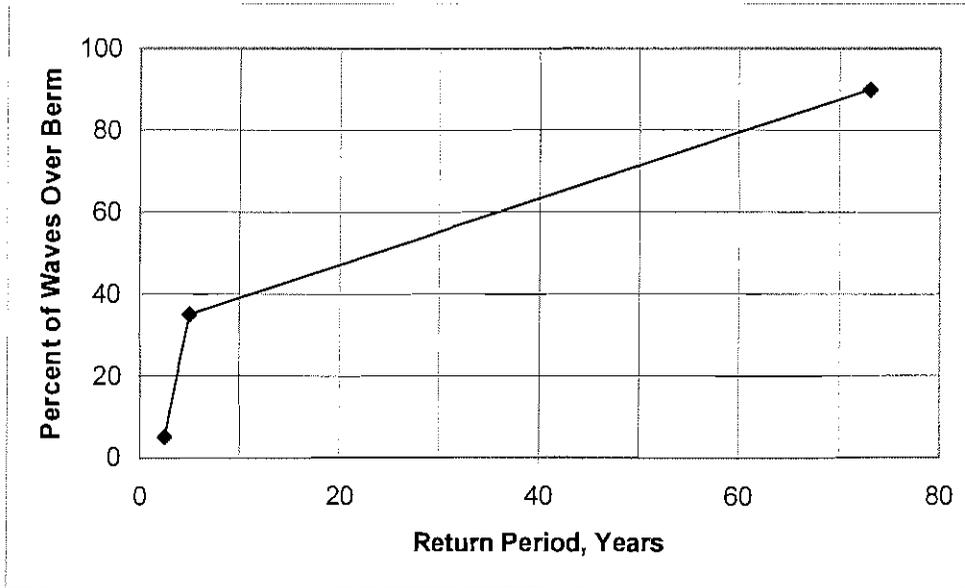
**Figure A-26. Percent of wave runup exceeding the existing berm elevation based upon physical model test studies performed for this feasibility study.**

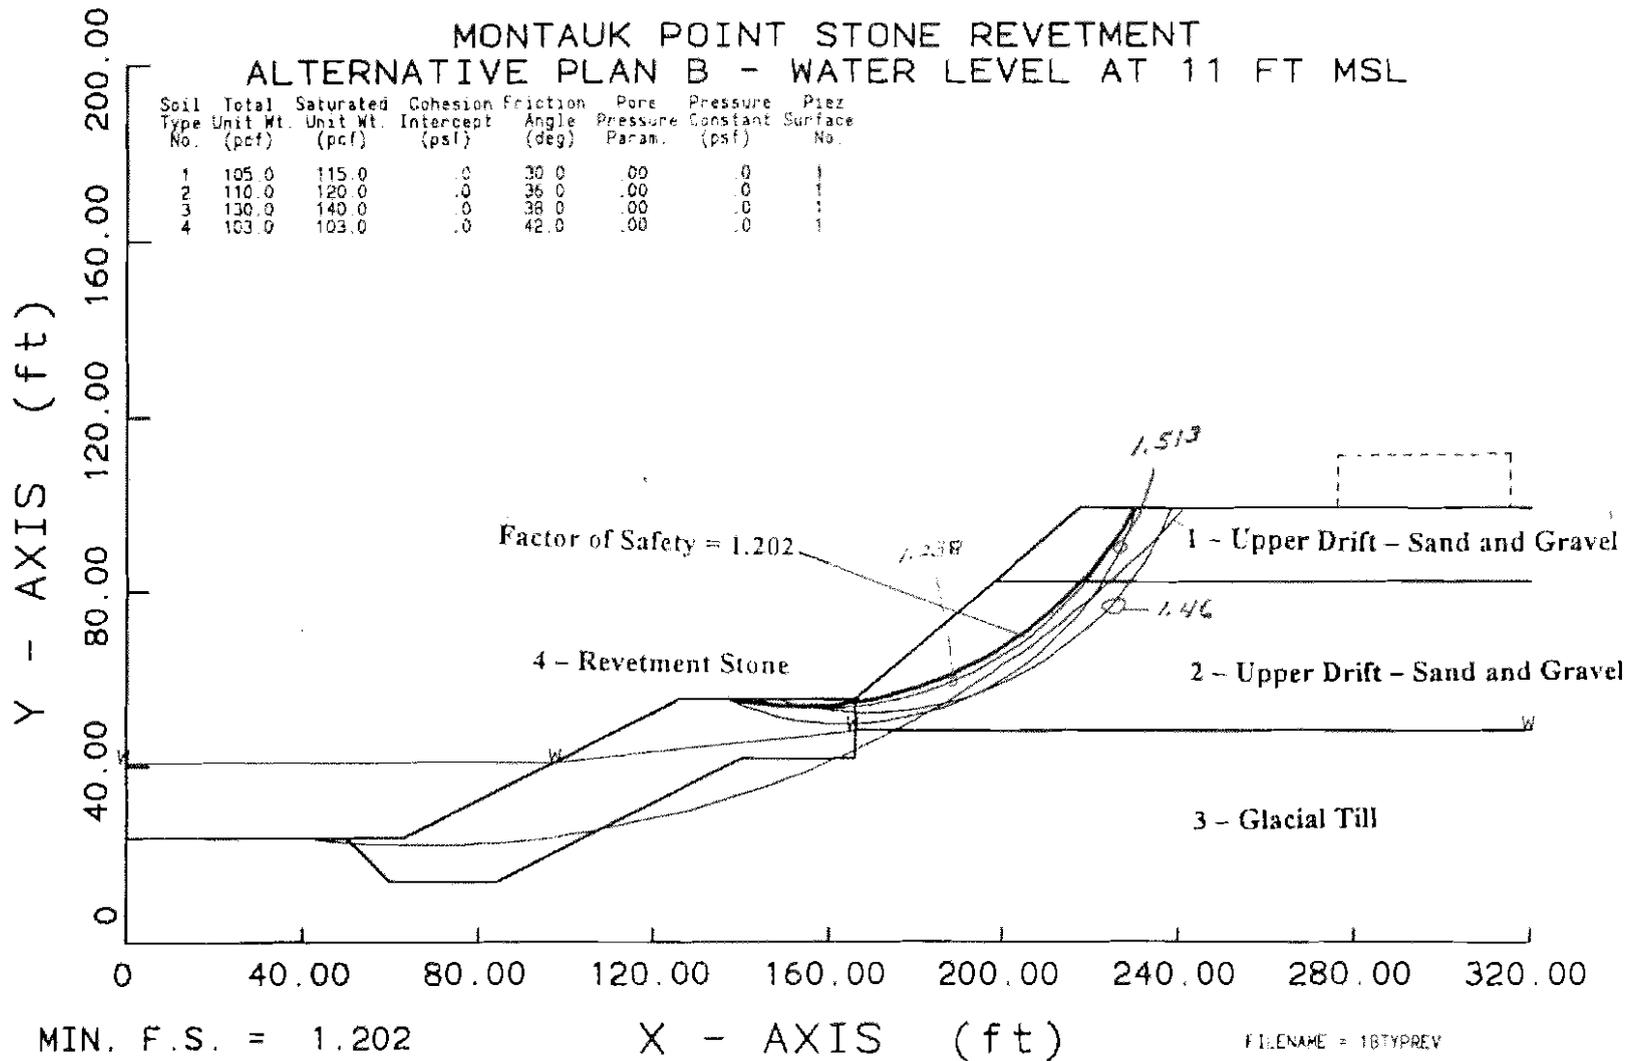
Figure A-27. Slope Stability Analysis for Stone Revetment Alternative "B"
