# Montauk Point, New York

## Hurricane & Storm Damage Reduction

### Final Feasibility Report & Environmental Impact Statement

**FINAL - October 2005**

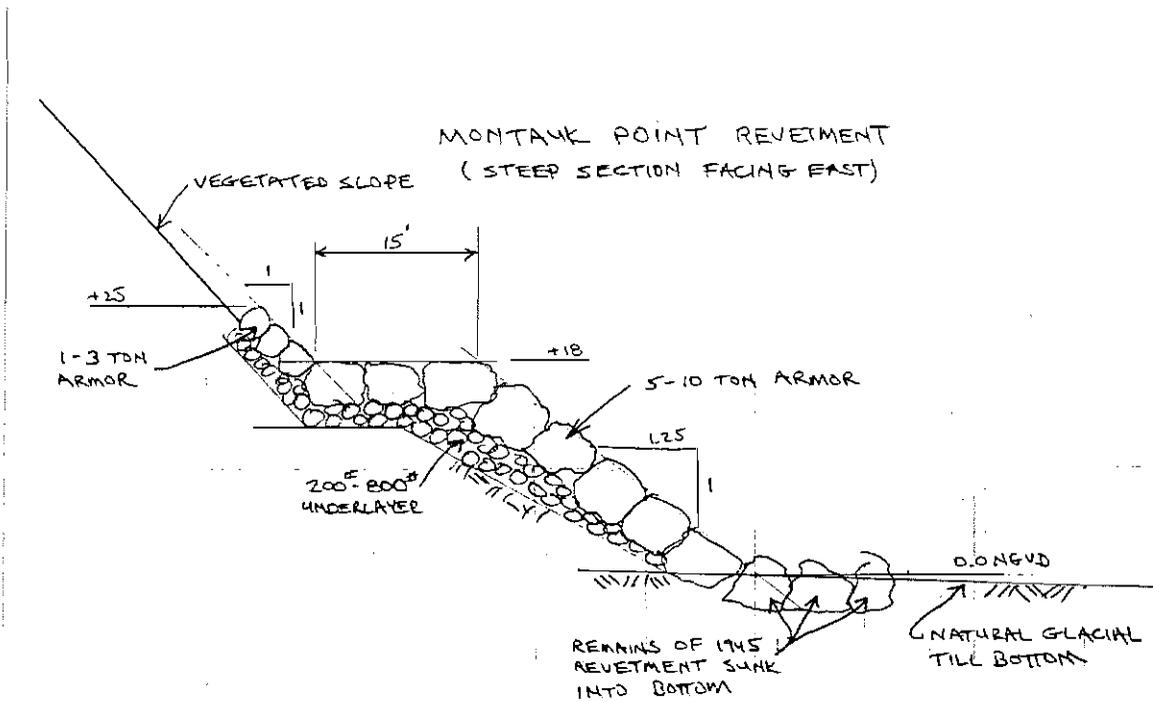
Figure A-5-1. Existing revetment cross-section used for physical modeling.

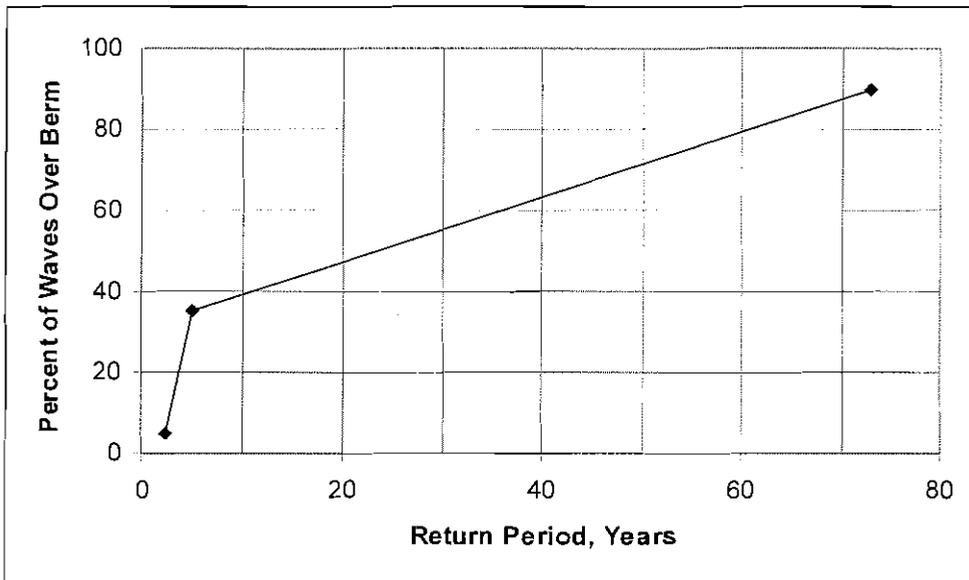
**Figure A-5-4. Runup on bluff versus storm return period**

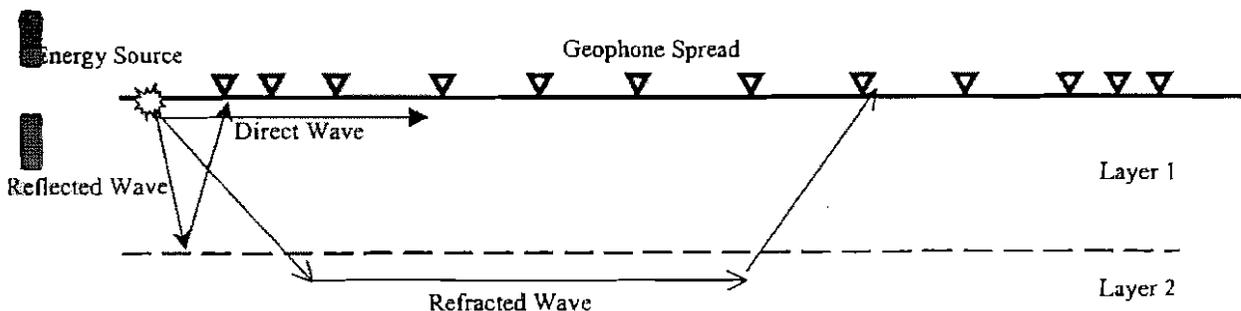
FIGURE A1:  
SEISMIC WAVE PATHS FOR DIRECT WAVE, REFLECTED WAVE AND REFRACTED WAVE ILLUSTRATING EFFECTS OF A BOUNDARY BETWEEN MATERIALS WITH DIFFERENT ELASTIC PROPERTIES

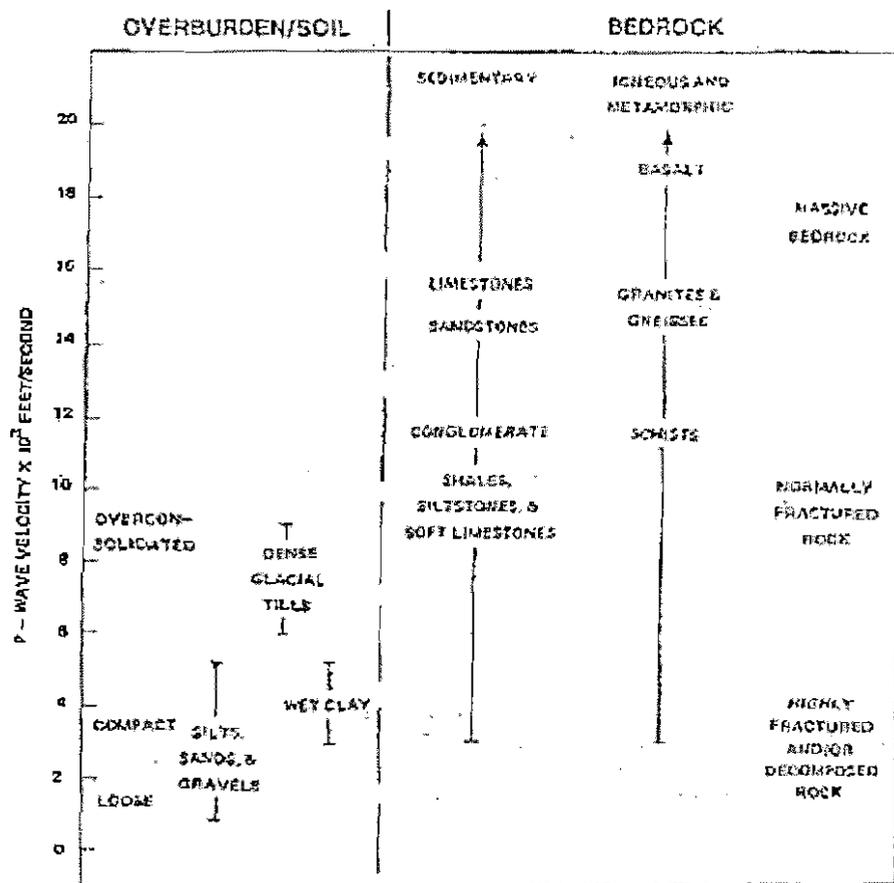
**FIGURE A2:**  
GUIDE TO MATERIAL IDENTIFICATION BY P-WAVE VELOCITY

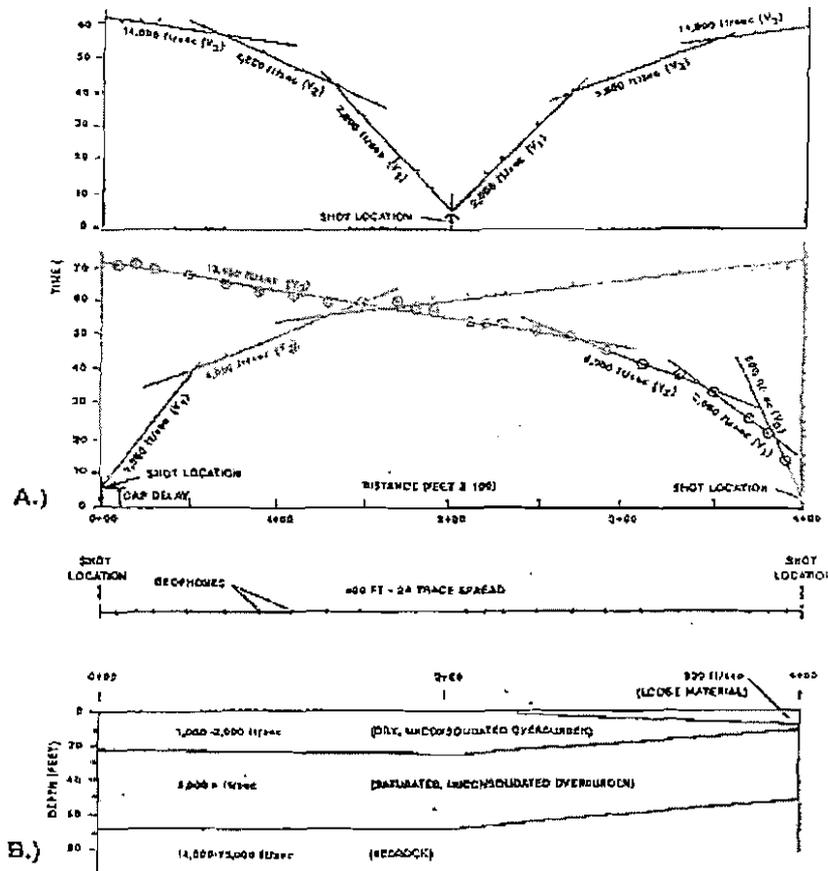
**FIGURE A4:**  
 A: TRAVEL-TIME PLOTS; UPPER PLOT IS A CENTER SHOT, LOWER PLOT IS TWO END SHOTS  
 B: RESULTING PROFILE OF SUBSURFACE MATERIALS SHOWING INTERFACE BETWEEN DIFFERENT SEISMIC VELOCITY LAYERS
