# **SCOPING DOCUMENT**

## **SAW MILL RIVER BASIN, NEW YORK ECOSYSTEM RESTORATION STUDY**

**October 2004**

**U.S. Army Corps of Engineers  
New York District (CENAN-PL-EA)  
26 Federal Plaza  
New York, New York 10278-0090**

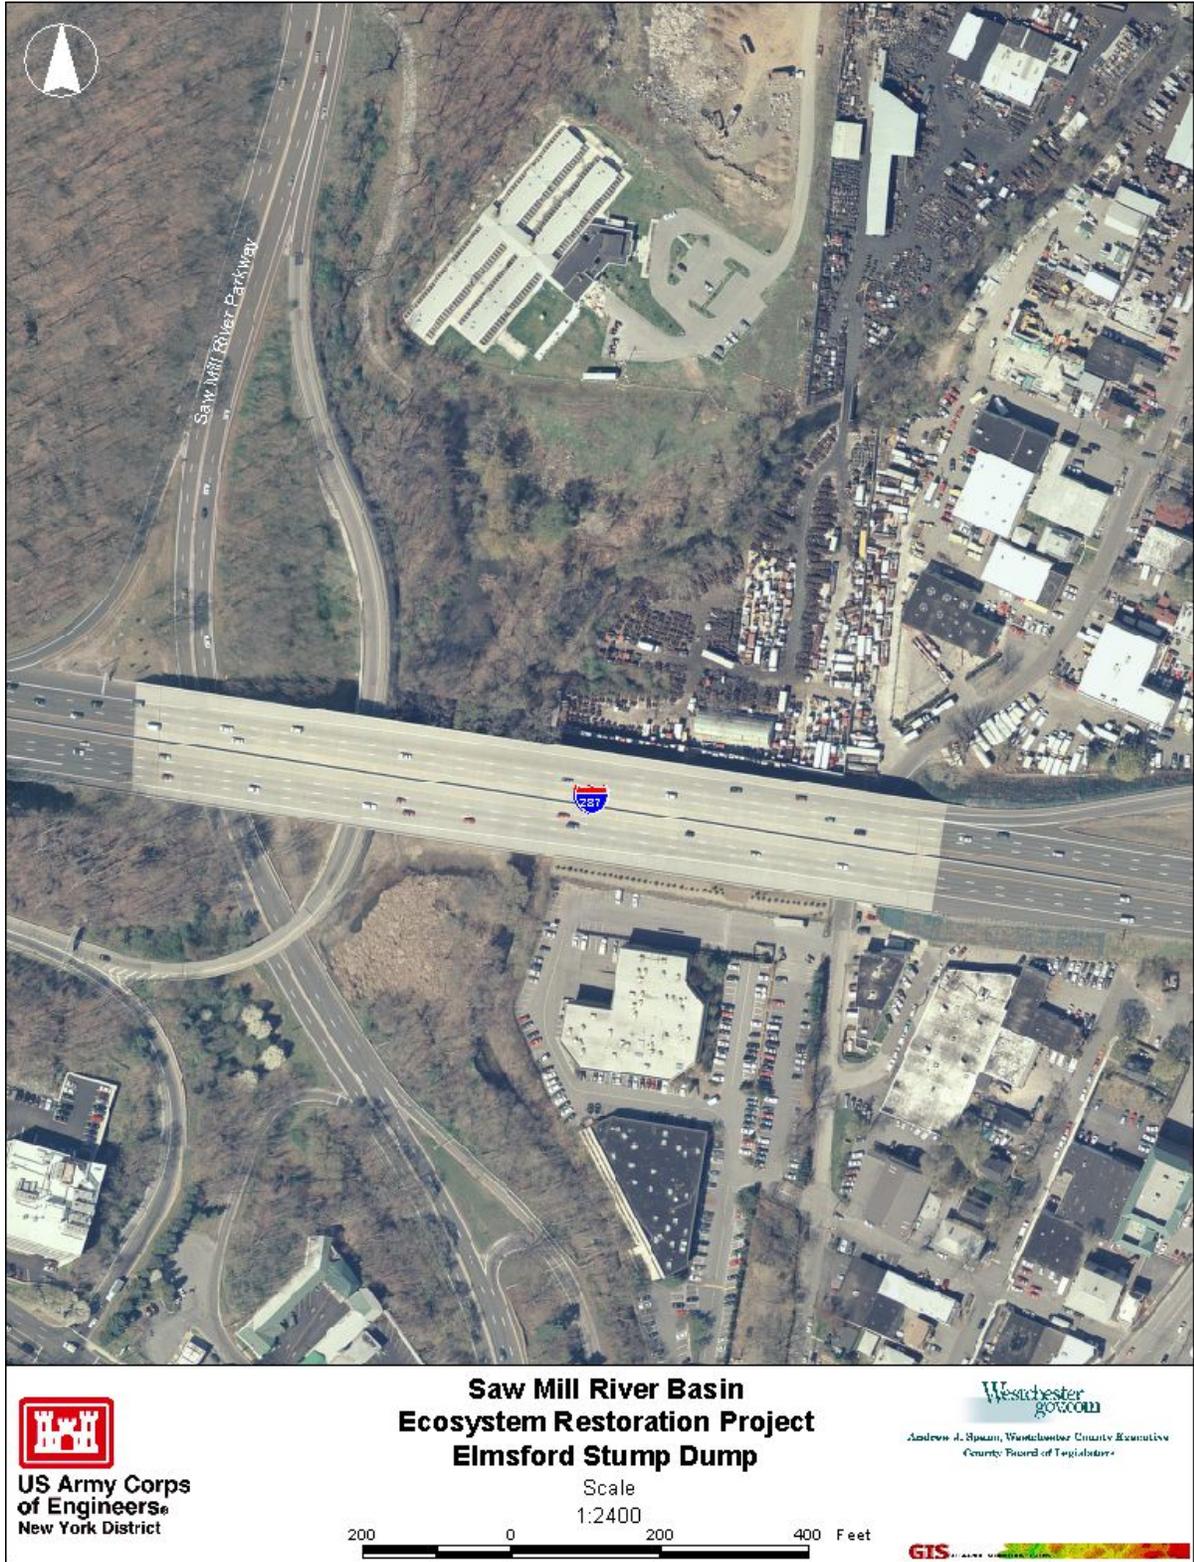
Figure 3 Ecosystem Restoration Site #1: Elmsford Stump Dump, Elmsford, New York

- Elmsford Stump Dump (Figure 3): The former stump dump is located in the Village of Elmsford across the river and upstream from the Vreeland Avenue industrial park, which contains multiple salvage yards. The 3.7 acre site, which includes a small pond, is situated on floodplain behind a forested riparian strip. Much of the site is overgrown with invasive Japanese Knotweed, an upland species. Approximately 600 ft downstream of the stump dump is a one-acre wetland overgrown with *Phragmites australis*.

Proposed restoration opportunities include reestablishing the floodplain by regrading and removing fill, and replacing invasive plant species with native vegetation. In addition, restoration of these sites presents a recreational opportunity by linking two disconnected portions of the South County Trail, a rails-to-trails bikeway that parallels the Saw Mill River for approximately six miles.

Temporary impacts will occur to the existing wetlands within the Elmsford and Woodlands Lake sites as a result of construction activities. However, implementation of the selected plans will have a long-term beneficial impact by improving wetland function in existing wetland areas and increasing the amount of overall wetland habitat. Prior to implementing the proposed Study, the USACE will conduct wetland surveys of the proposed restoration sites to accurately determine direct or indirect impacts project implementation will have on existing wetlands.

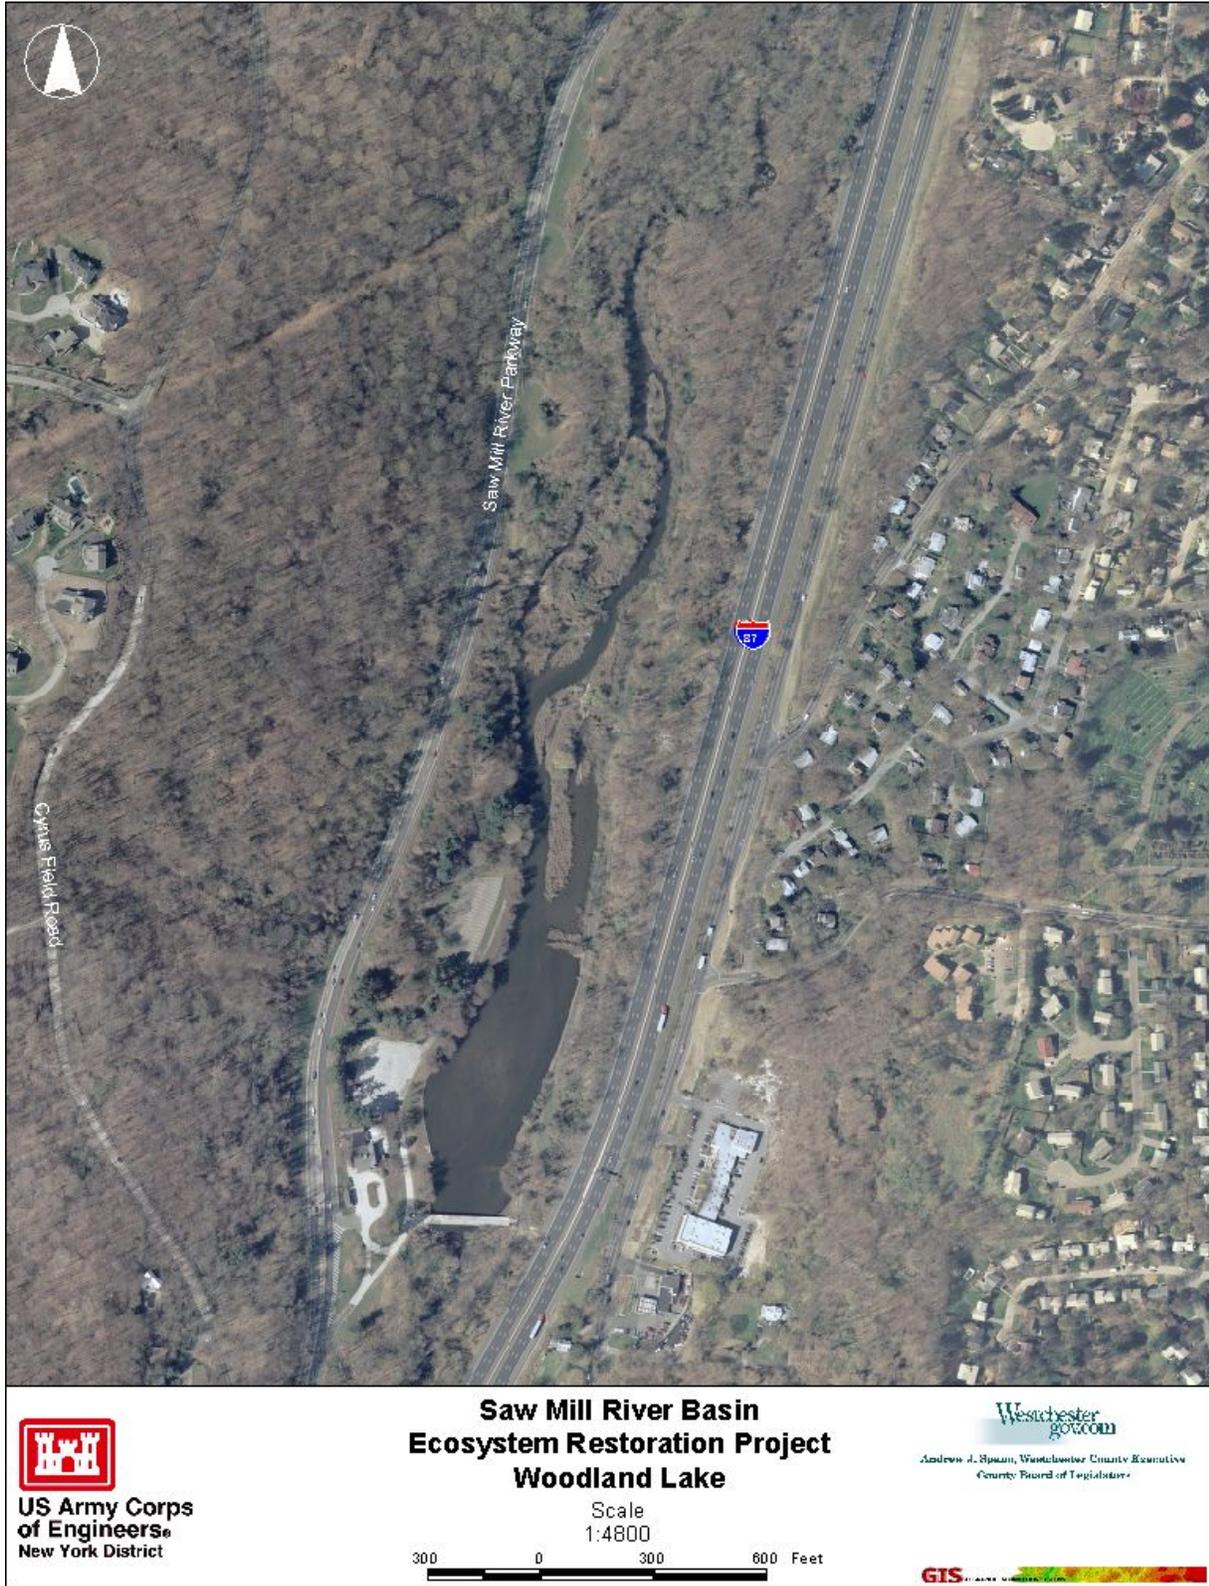
Figure 4 Ecosystem Restoration Site #2: Woodlands Lake, Village of Irvington, New York

- Woodlands Lake (Figure 4): Woodlands Lake is located within V. Everett Macy Park in the Village of Irvington. The lake, approximately one mile in length, is an in-line impoundment on the Saw Mill River formed by Macy dam. The primary factors contributing to the ecosystem degradation of the site are sediment accretion and purple loosestrife invading the wetlands in the upstream portion of the lake. Proposed restoration measures include wetland creation and restoration in conjunction with sediment control. Sediment control could be accomplished in the upstream end of the lake through construction of a forebay in combination with bank stabilization and wetlands restoration/creation. Dredging would be required to construct the forebay, which would include a baffle structure to induce sediment deposition and capture baseload transport. Access to the forebay would be a critical project feature to allow regular maintenance.

Westchester County recently completed dredging the lake as part of a long term restoration program that includes: (1) rehabilitating the dam, (2) reestablishing a café concession in the former restaurant onsite, (3) providing boat and bike rentals, (4) converting a large, lakeside parking lot into a picnic area, and (5) upgrading a modest trail system around the upstream end of the lake into an interpretive nature walk. The Federal restoration action will complement the county restoration effort, particularly in the upstream portion of the lake, by establishing a sediment management system, restoring substantial quantities of degraded wetlands, and stabilizing the lake/river shore.
