HISTORICAL AND ARCHAEOLOGICAL INVESTIGATIONS
DUNHAM'S MILL SITE
WOODBIDGE TOWNSHIP
MIDDLESEX COUNTY, NEW JERSEY

WOODBIDGE CREEK MITIGATION SITE
NEW YORK AND NEW JERSEY HARBOR
NAVIGATION PROJECT

CONTRACT NO. DACW51-01-D-0015

Prepared by:
Hunter Research, Inc.

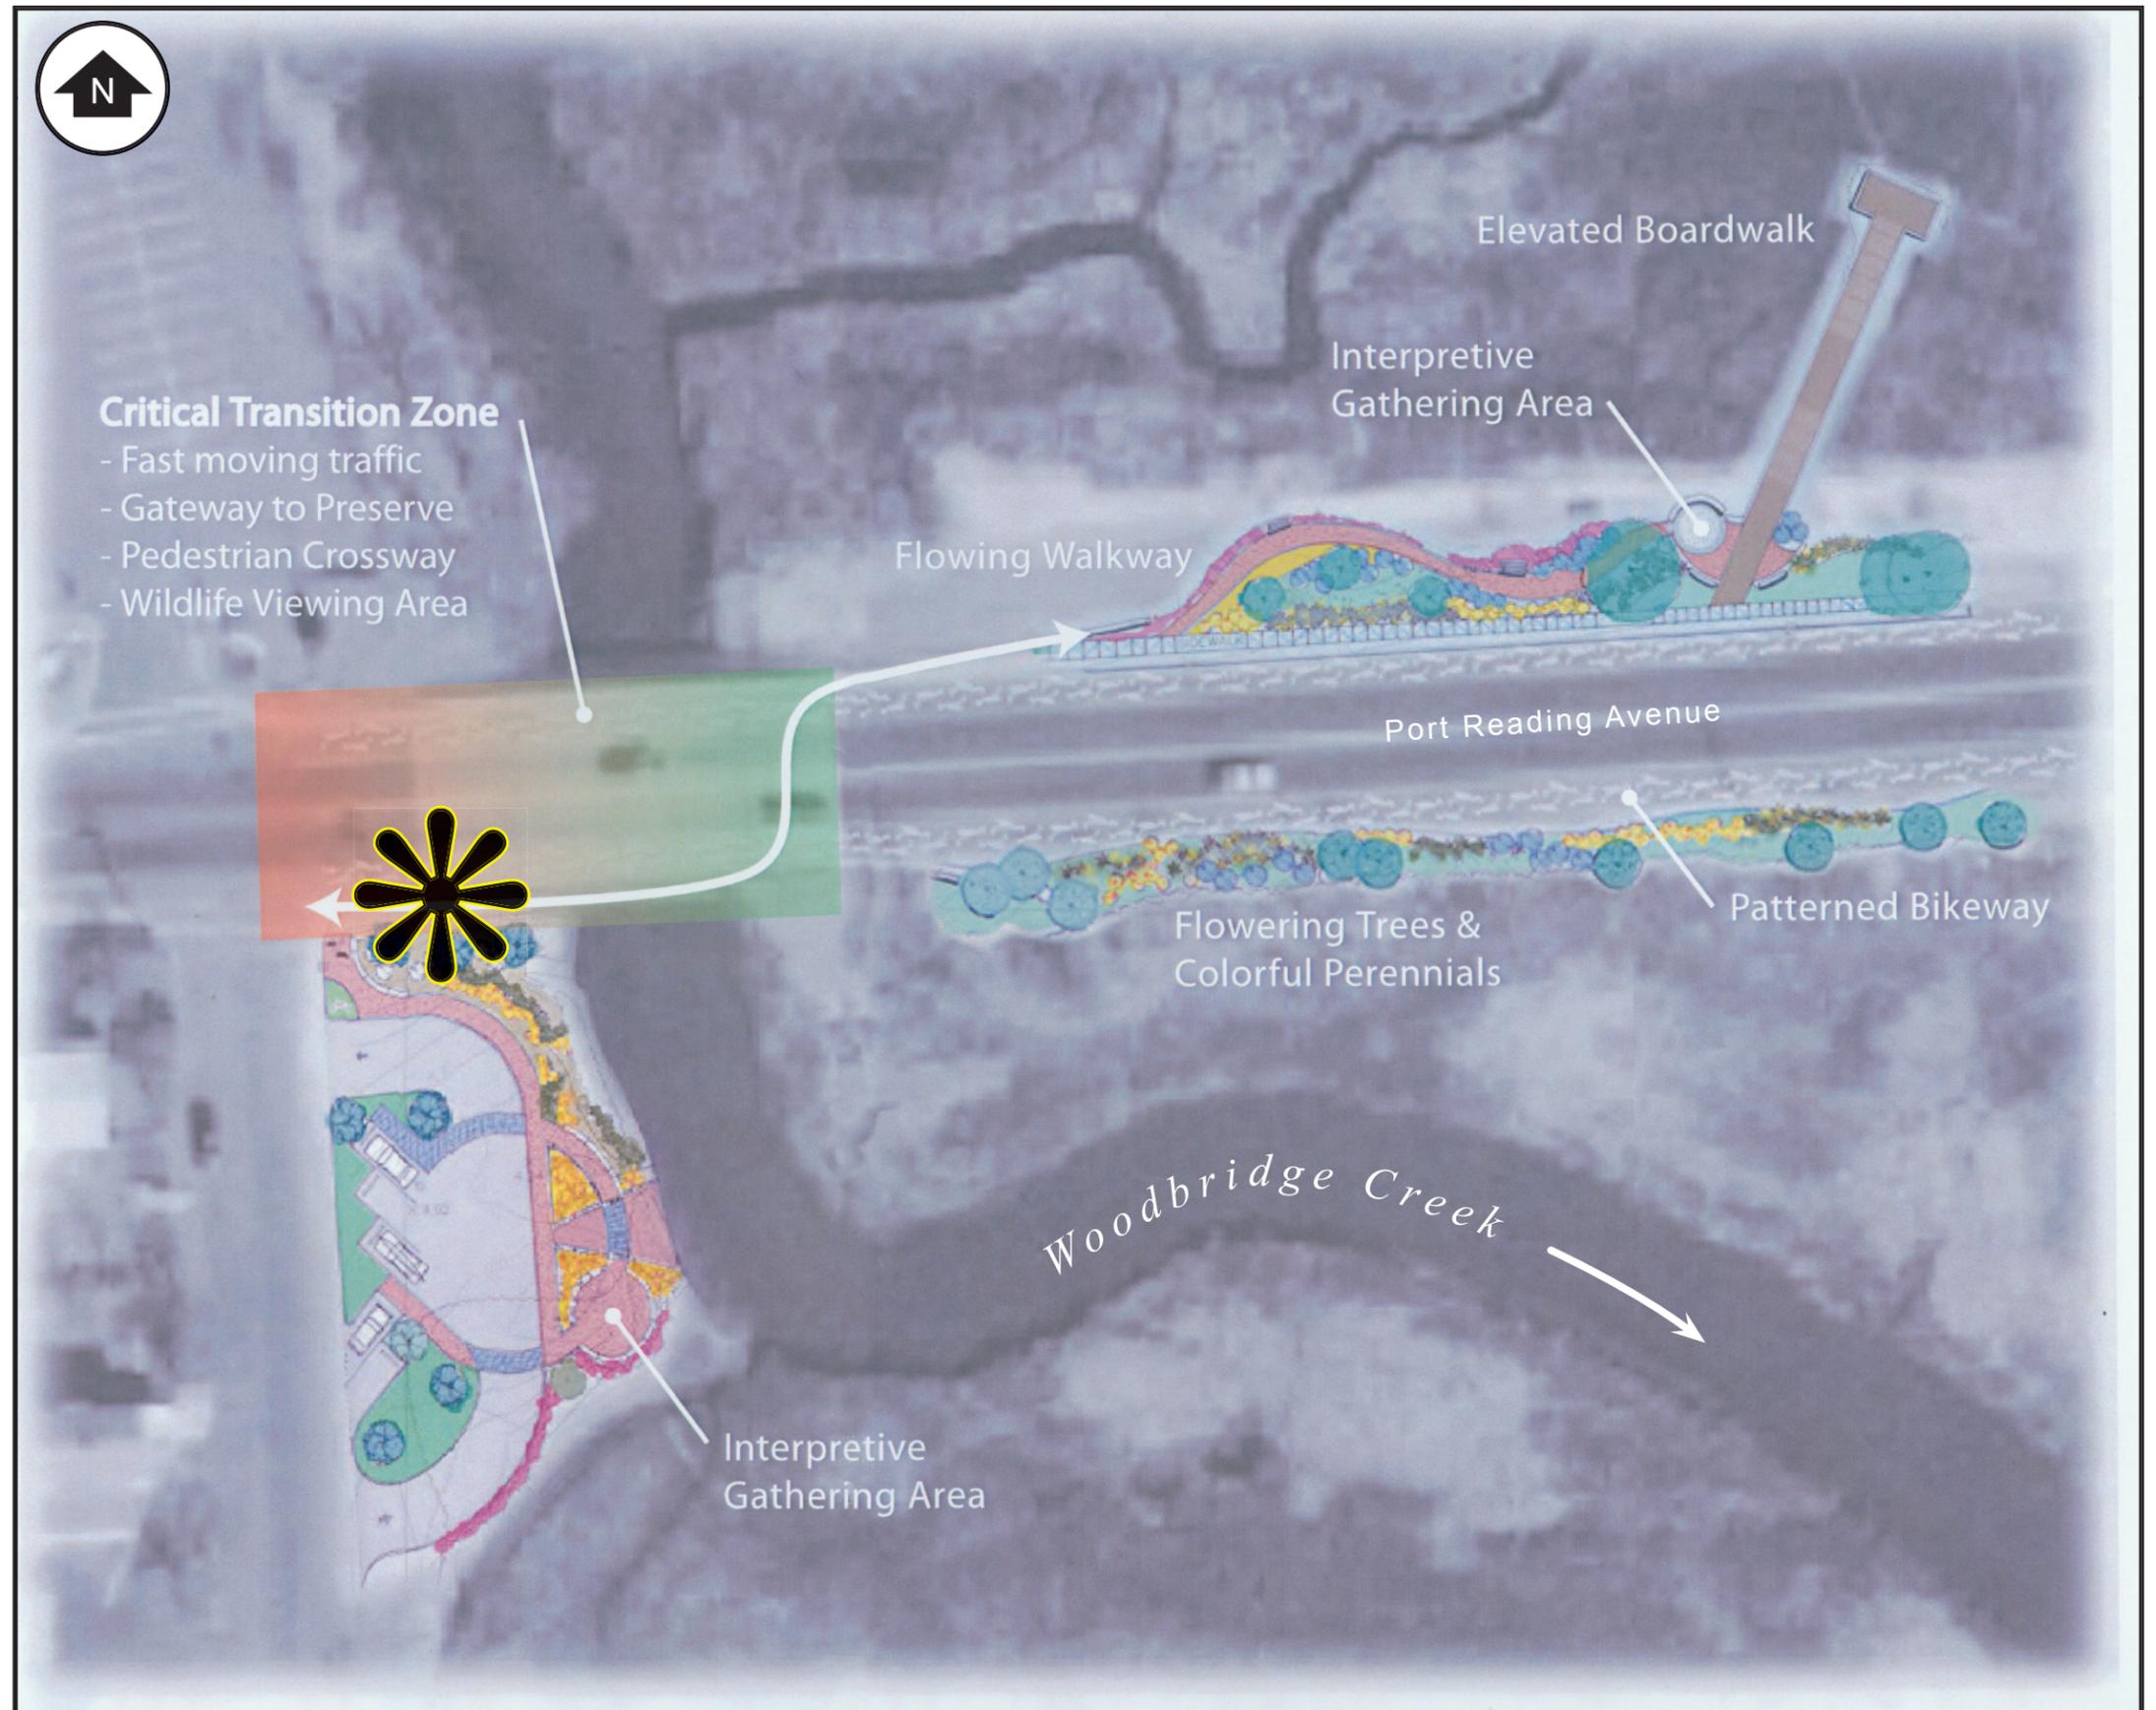
Figure 1.4. Public Access and Port Reading Avenue - Conceptual Design. Approximate Location of Dunham's Mill Site Indicated by Asterisk. Scale: 1 inch= 35 feet (approximately). (Source: Louis Berger and Associates, Inc. 2005).

The initial stage of work concluded that the site of Dunham's Mill likely stood within the bounds of the Woodbridge River Mitigation Site on the right bank of Woodbridge Creek either beneath or just downstream of the Port Reading Avenue crossing. Timber remains observed in the bed of the creek just upstream of the Port Reading Avenue crossing were considered to mill-related remains, possibly dating from the colonial period. The mill site, although still imprecisely located and poorly understood at this point, was preliminarily judged to be at risk of being affected by ground disturbance from the proposed public access improvements (Figure 1.4).

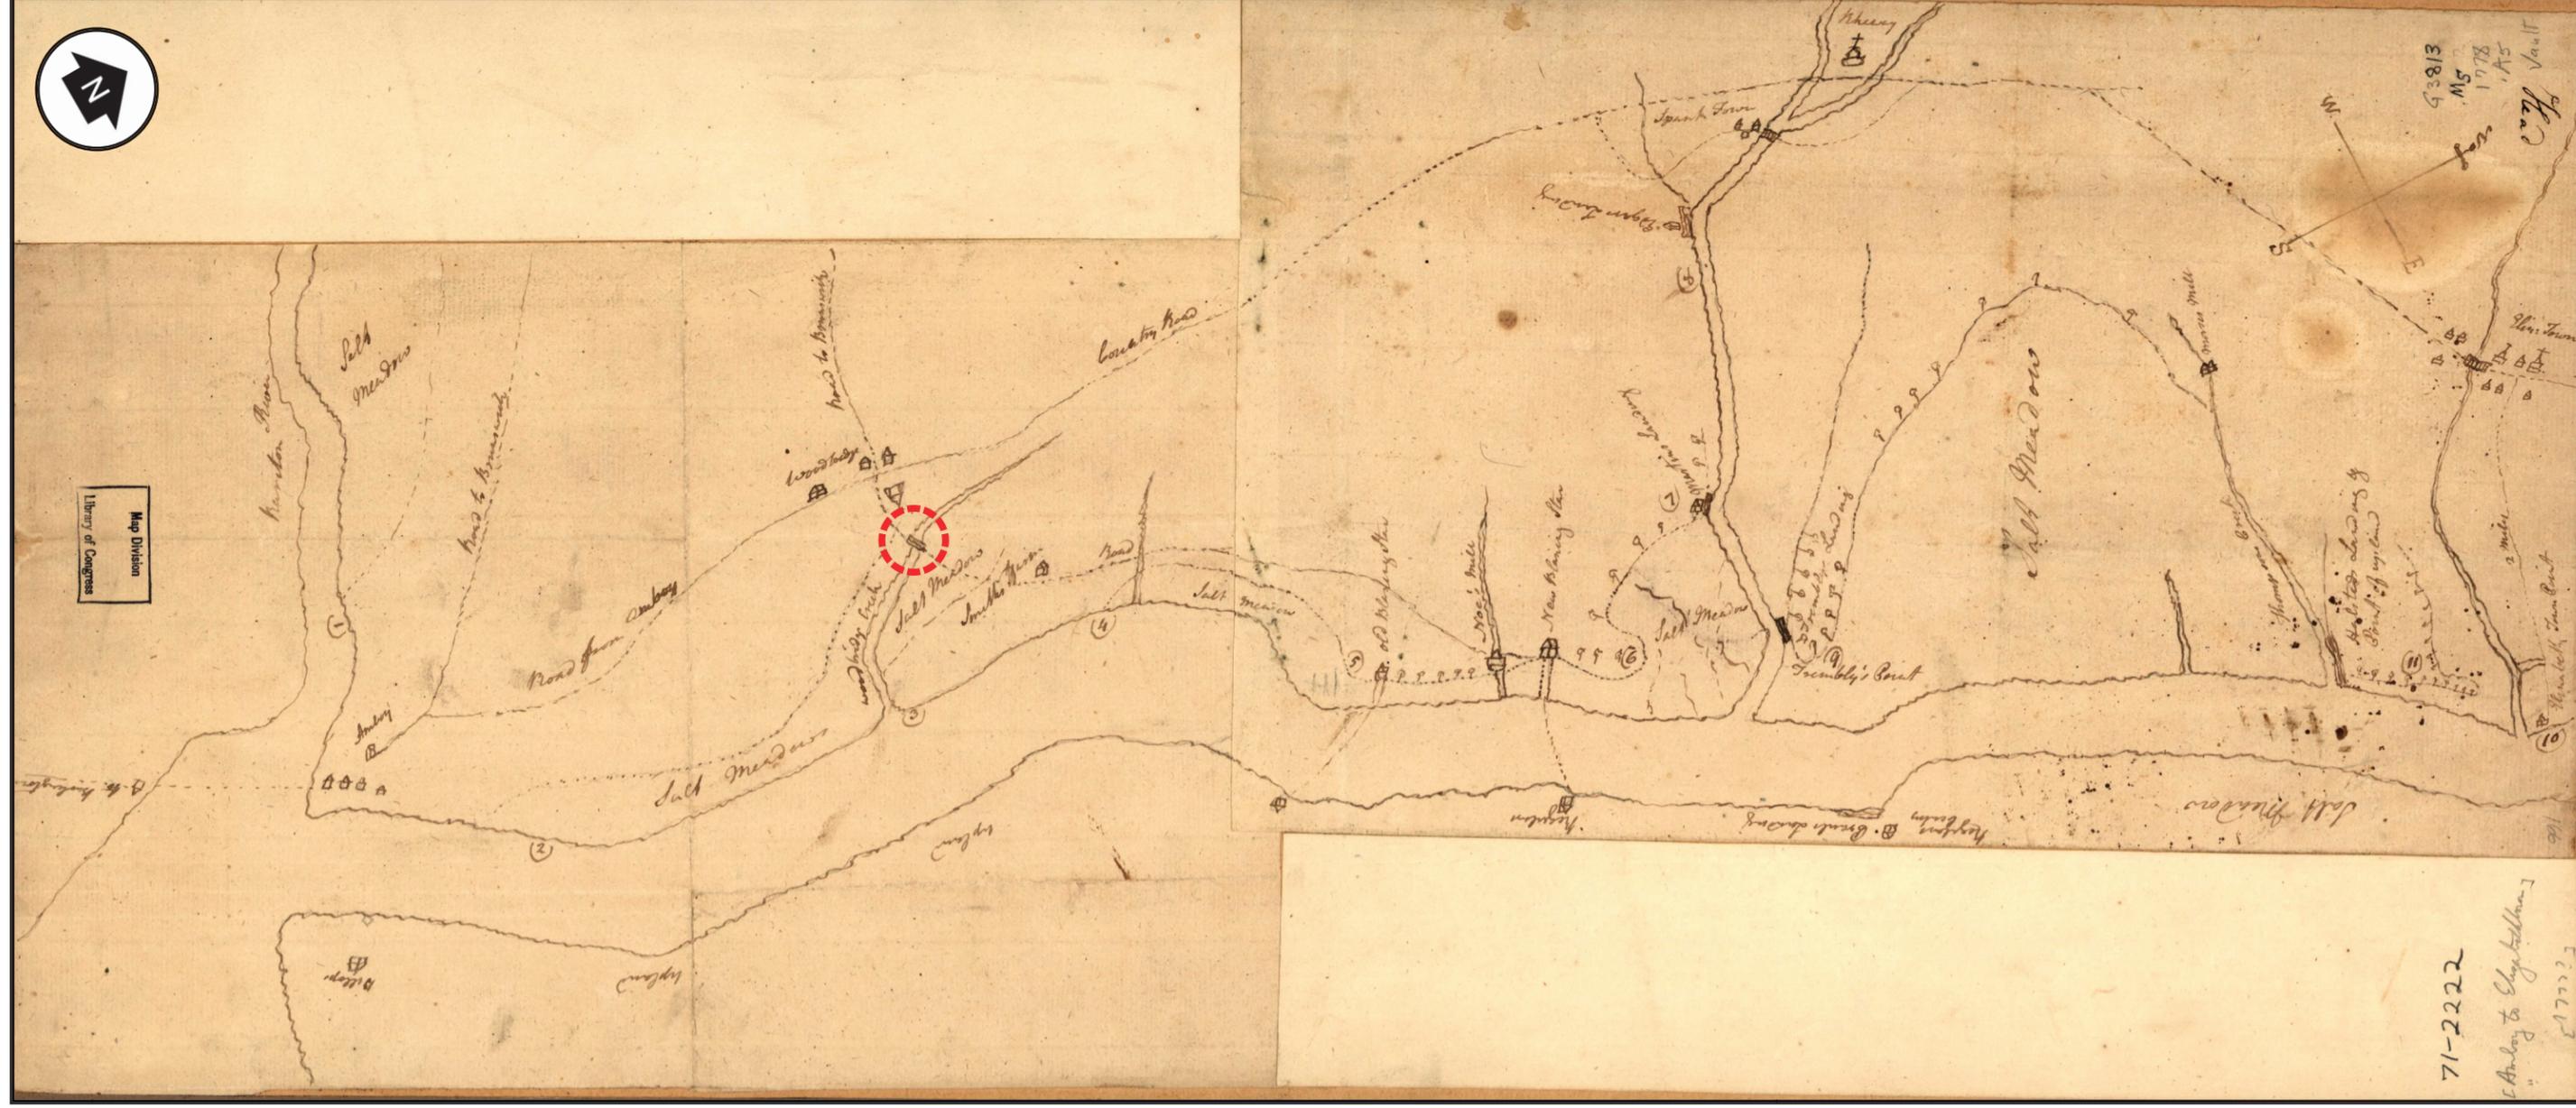
Figure 3.1. Amboy to Elizabethtown. Circa 1778. Scale 1 inch=2000 feet (approximately). Location of project site circled.

A map showing the route from Amboy to Elizabethtown, sketched *circa* 1778 (Figure 3.1), indicates that by the Revolutionary War era Papiack Creek was being referred to as Woodbridge Creek. Unfortunately, this map does not depict Stone’s Mill, although it does show the course of the road from Woodbridge

to “Old Blazing Star” and the location of the bridge over the creek. To the east of the creek the map identifies “Smith’s Farm.” Another Revolutionary War period map, rendered by John Andre *circa* 1778 and held in the Sir Henry Clinton Collection at the William L. Clements Library (Figure 3.2), echoes the Dunham map, identifying “Stones Mill” on Woodbridge Creek south and downstream of the causeway and bridge. This map also shows William Stone’s property extending north of the road and east of Woodbridge Creek.

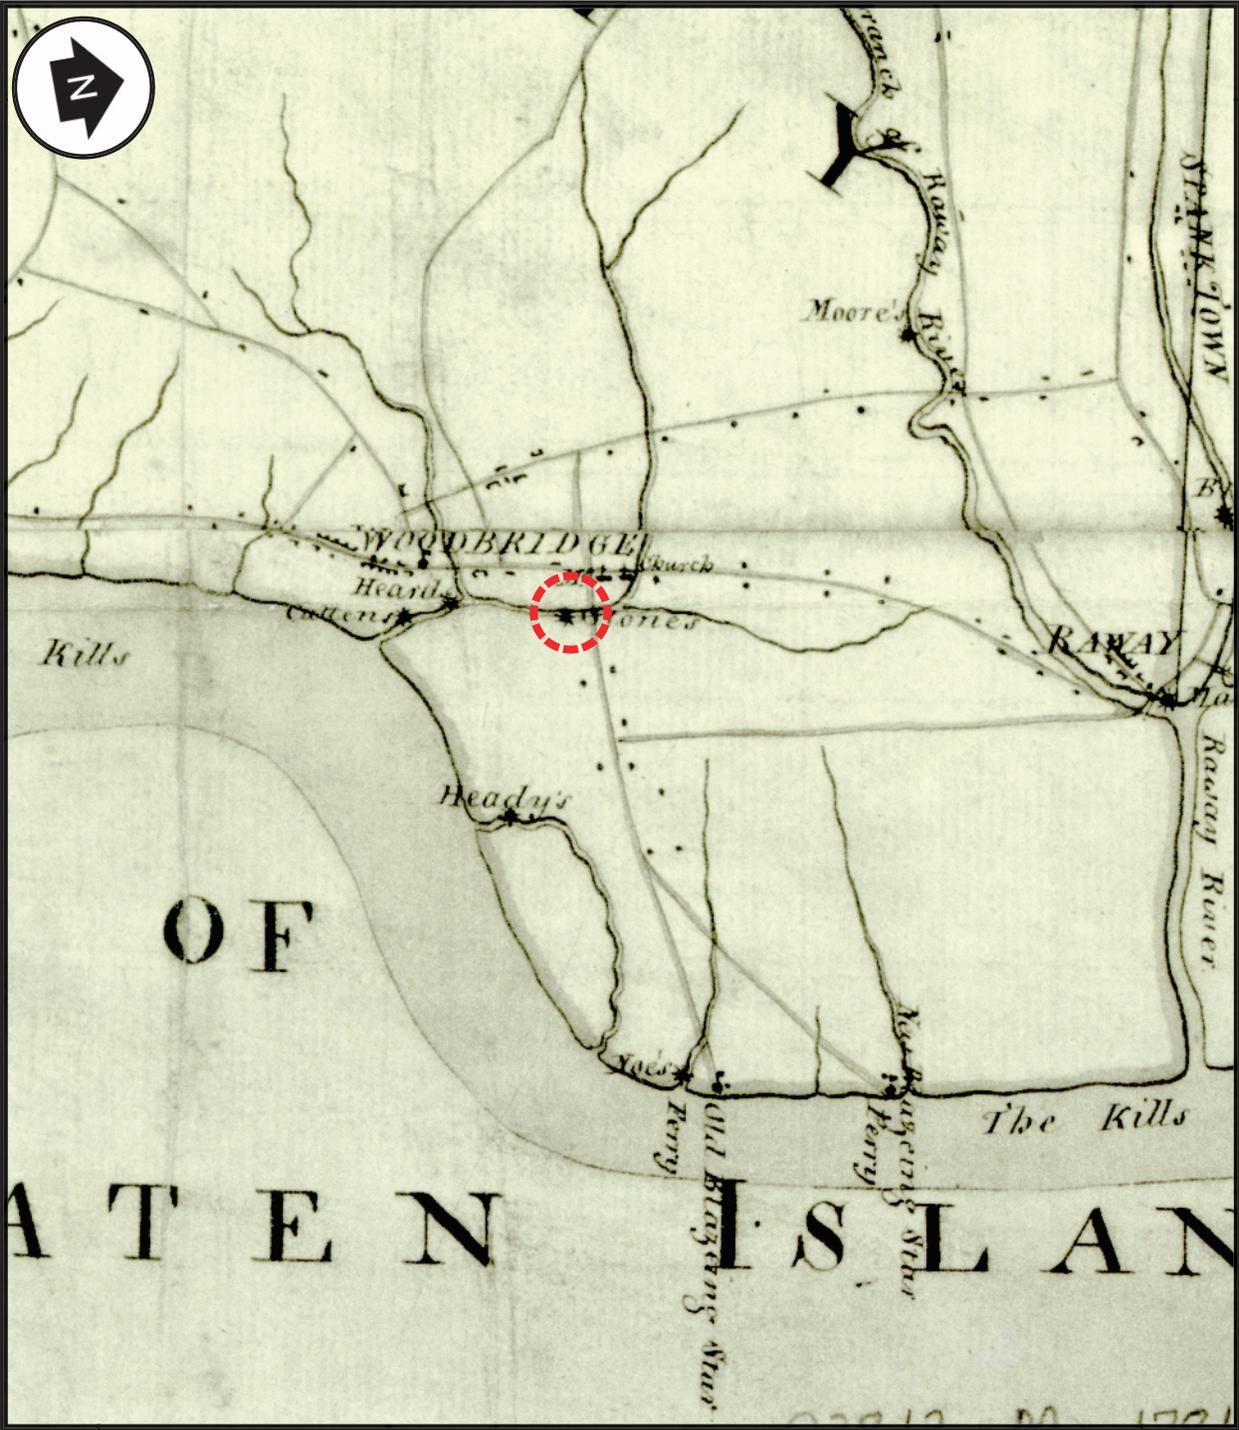
Figure 3.3. Hills, J. *A Map Middlesex County Reduced from the Original Survey.* 1781. Scale 1 inch= 1.1 miles (approximately). Location of project site circled.

Two Hills maps, both drawn in 1781, are reproduced here. *A Map Middlesex County Reduced from the Original Survey* (Figure 3.3) shows an asterisk (the symbol used to indicate a mill site) downstream from the point where the road from Woodbridge to the ferries at “Old Blazing Star” and “New Blazing Star” crosses Woodbridge Creek. The annotation “Stone’s” accompanies the asterisk. *A Map of Part of the Province of Jersey Compiled from the Original Surveys* (Figure 3.4) gives much the same information, although it is notable that the asterisk marking the mill site is shown on the left (or east) bank of the creek. All other cartographic and documentary evidence suggests that the mill was on the right bank, on the

On the *Plan of Middlesex County in the Province of East Jersey*, prepared by Azariah Dunham in 1766 and later copied by John Hills in 1781 (see below, Figures 3.3 and 3.4), a mill is shown at the point where the road from Woodbridge to the Blazing Star ferry (the predecessor to Port Reading Avenue) crosses the stream today known as Woodbridge Creek. This map identifies “Stone’s” mill just south and downstream of the crossing. If the current interpretation of primary archival materials and suggestions by secondary sources regarding the location of Jonathan Dunham’s gristmill are accurate, Stone’s Mill stood in approximately the same location as the mill previously operated by Jonathan Dunham. It may have been the same building erected by Dunham in 1670-71 or a new edifice erected in approximately the same spot.

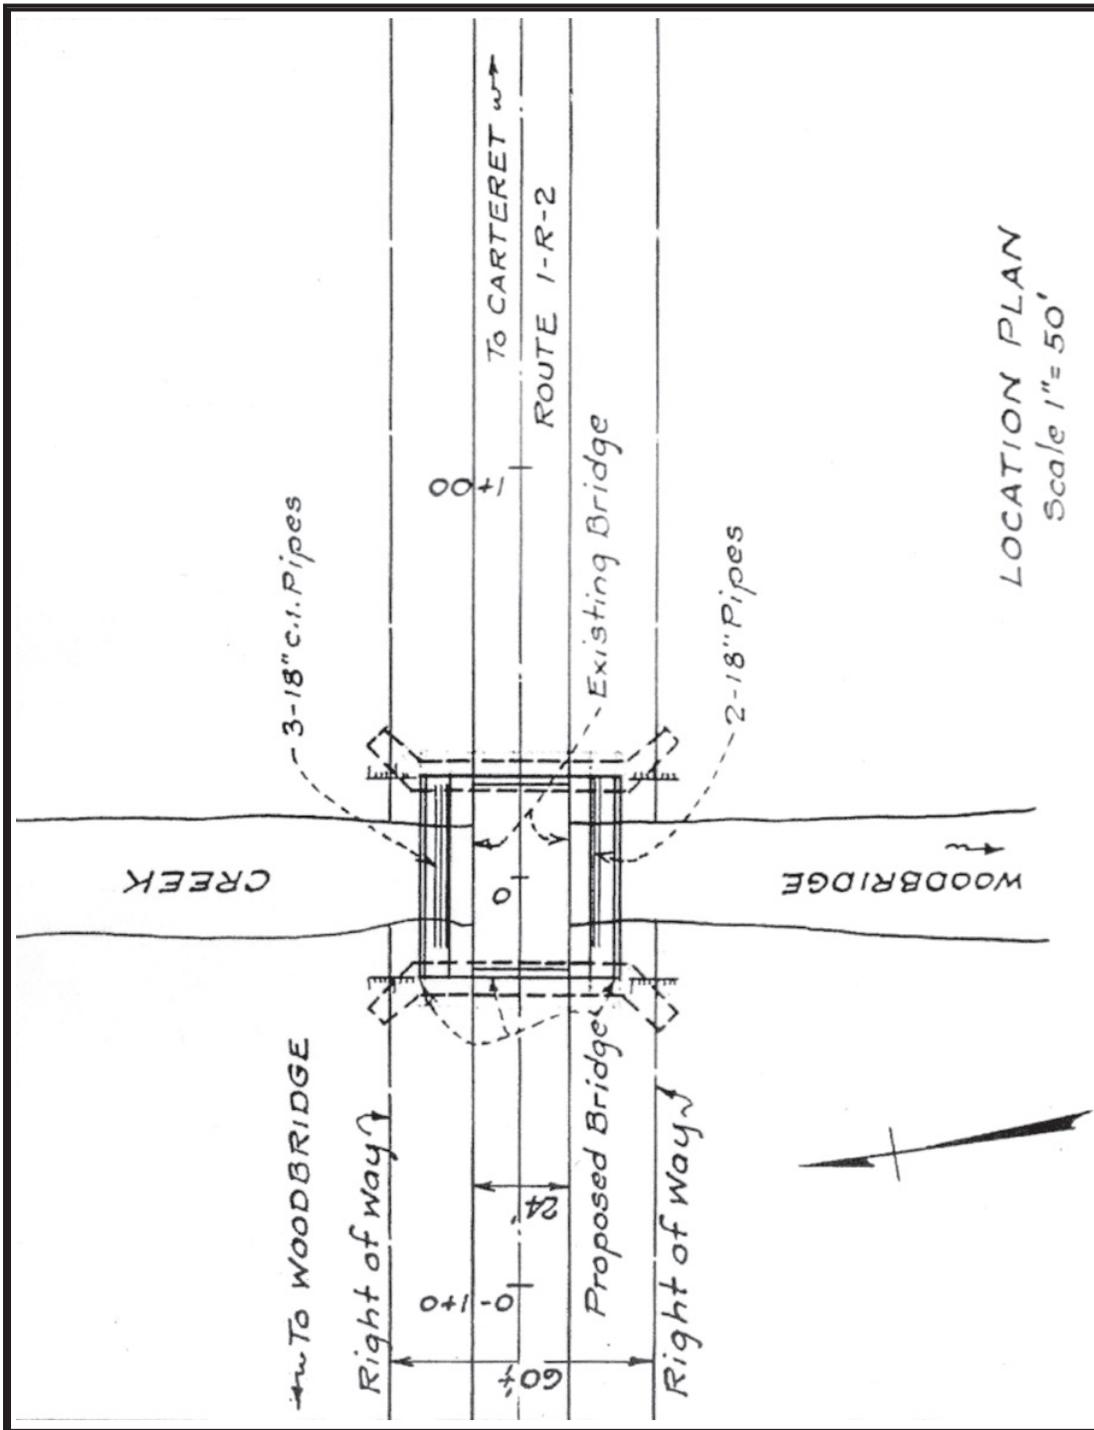
Figure 3.11. Plan of Proposed Concrete Bridge 1-B-17 and Predecessor Bridge in 1938. (Source: Middlesex County Engineer Department).

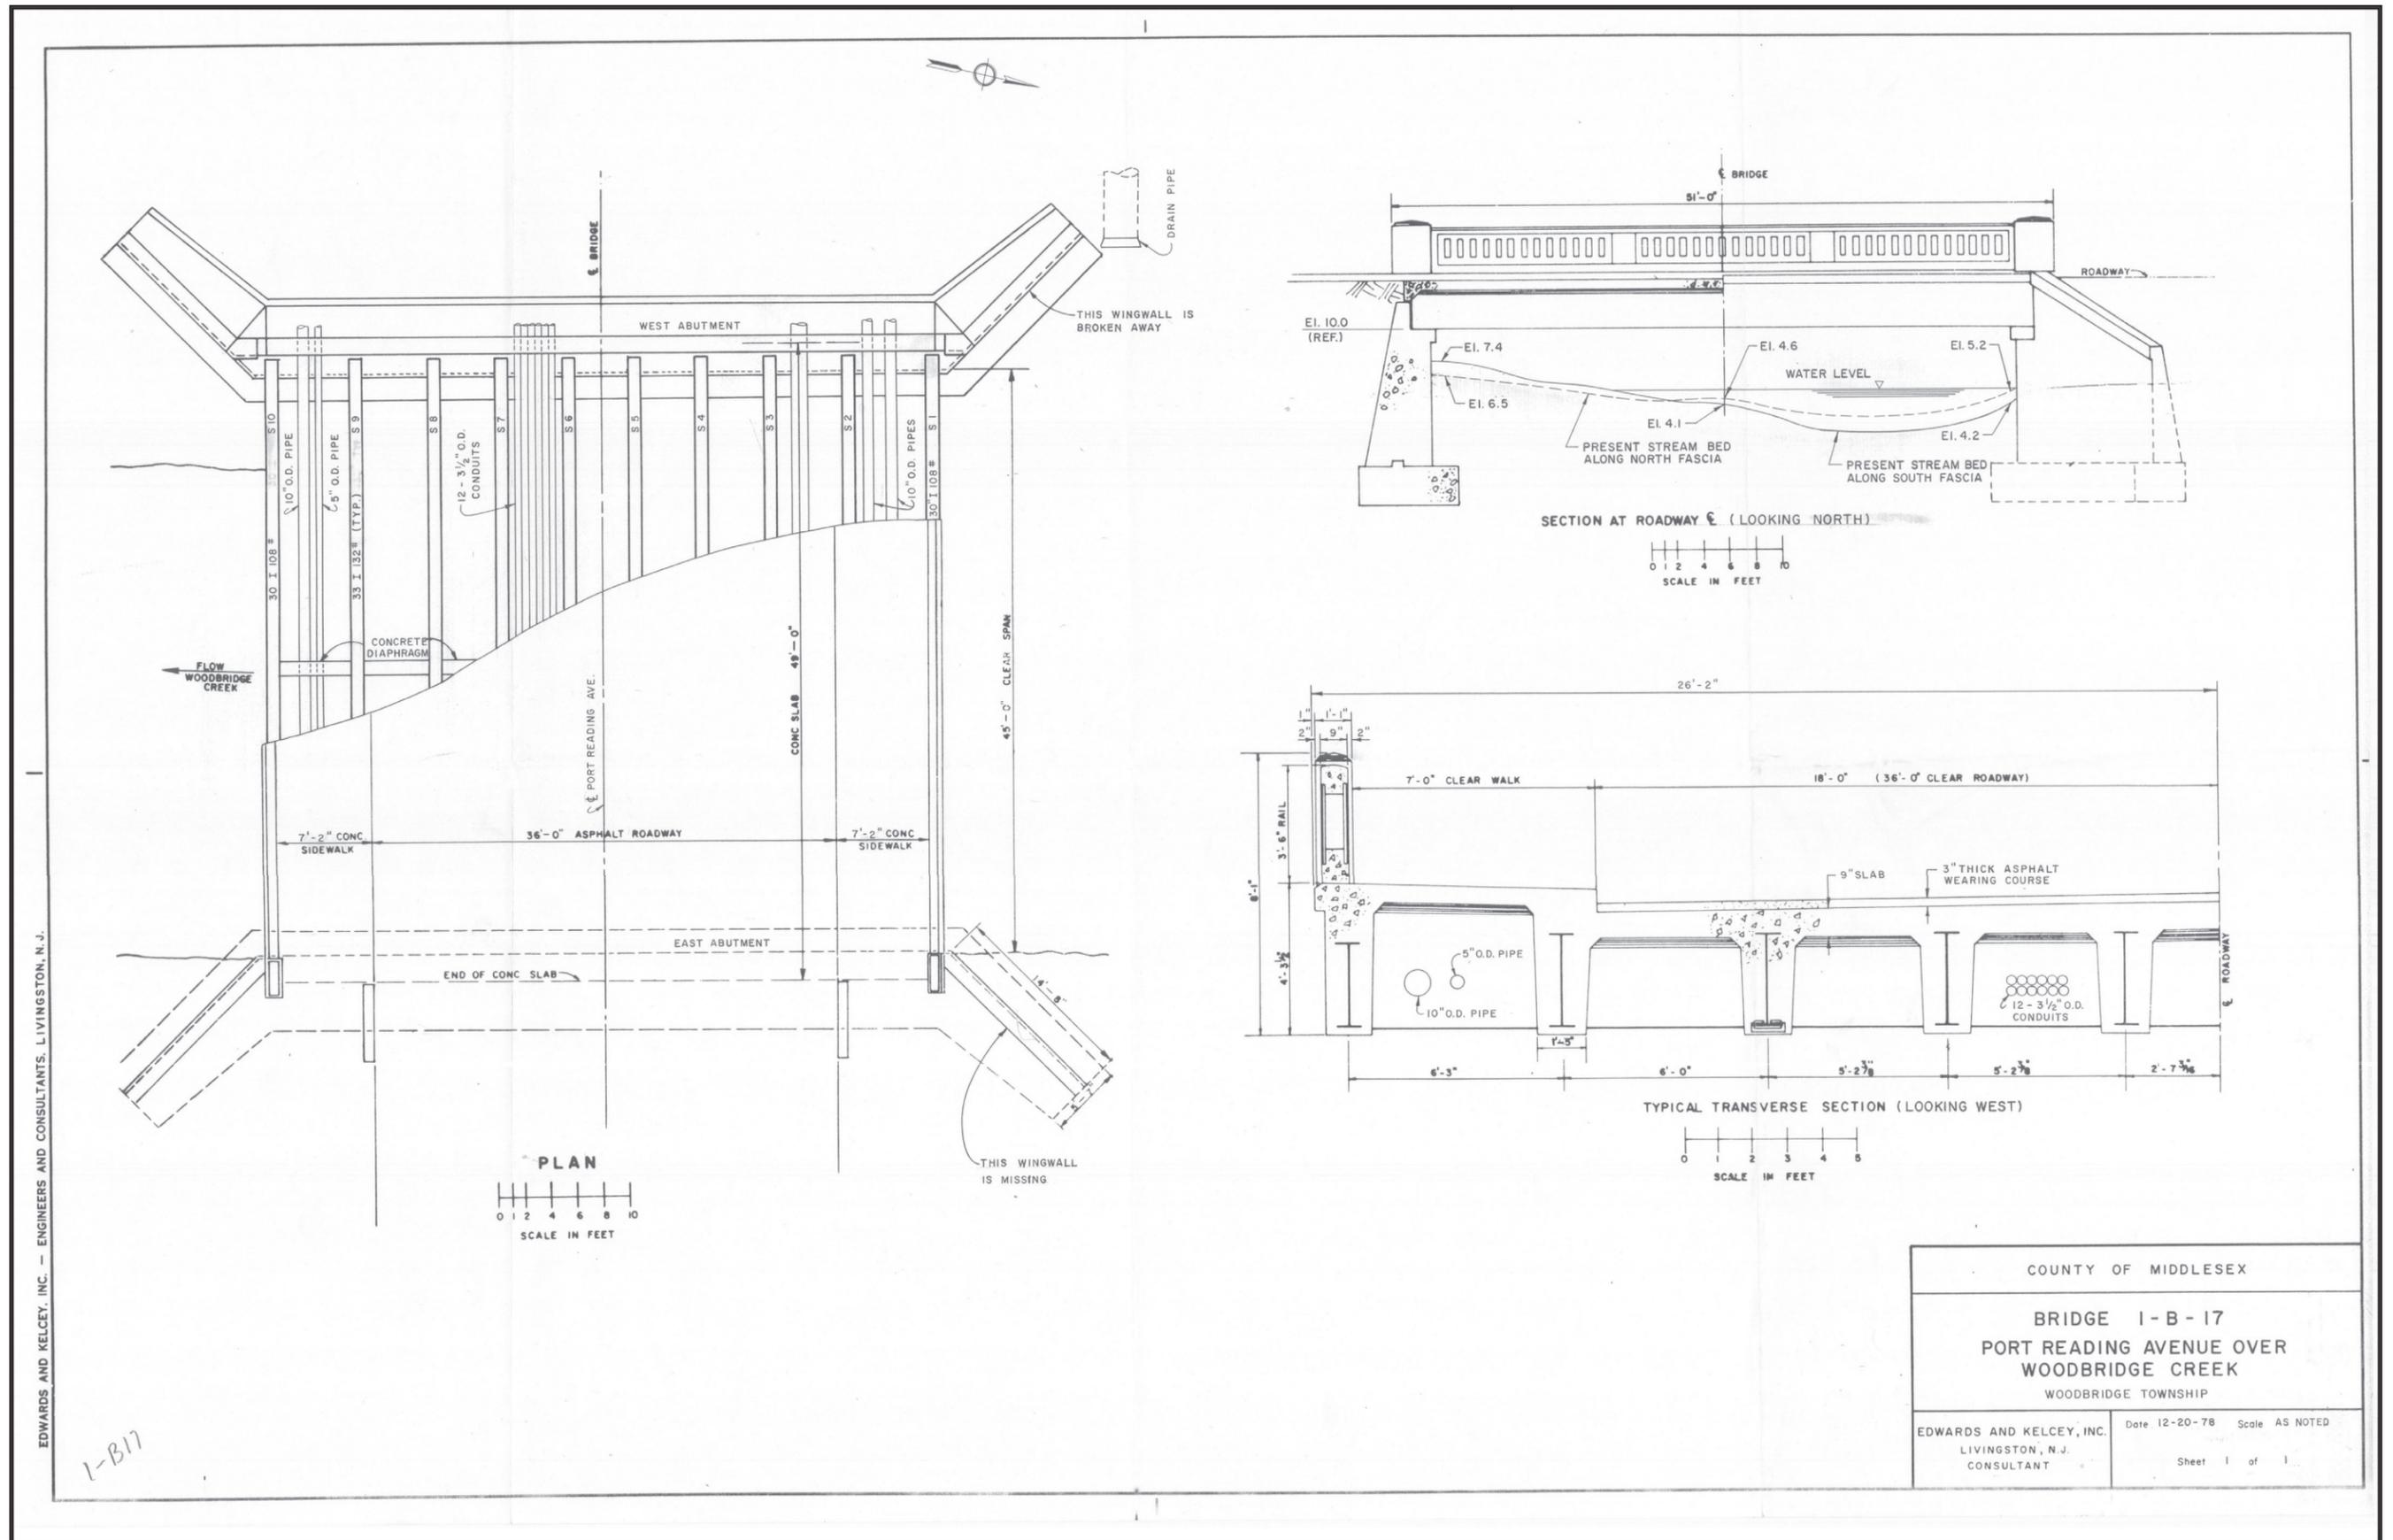
Figure 3.12. Plan and Sections of Bridge 1-B-17 (Port Reading Avenue over Woodbridge Creek), Woodbridge Township. (Source: Edwards and Kelcey, Inc. 1978).

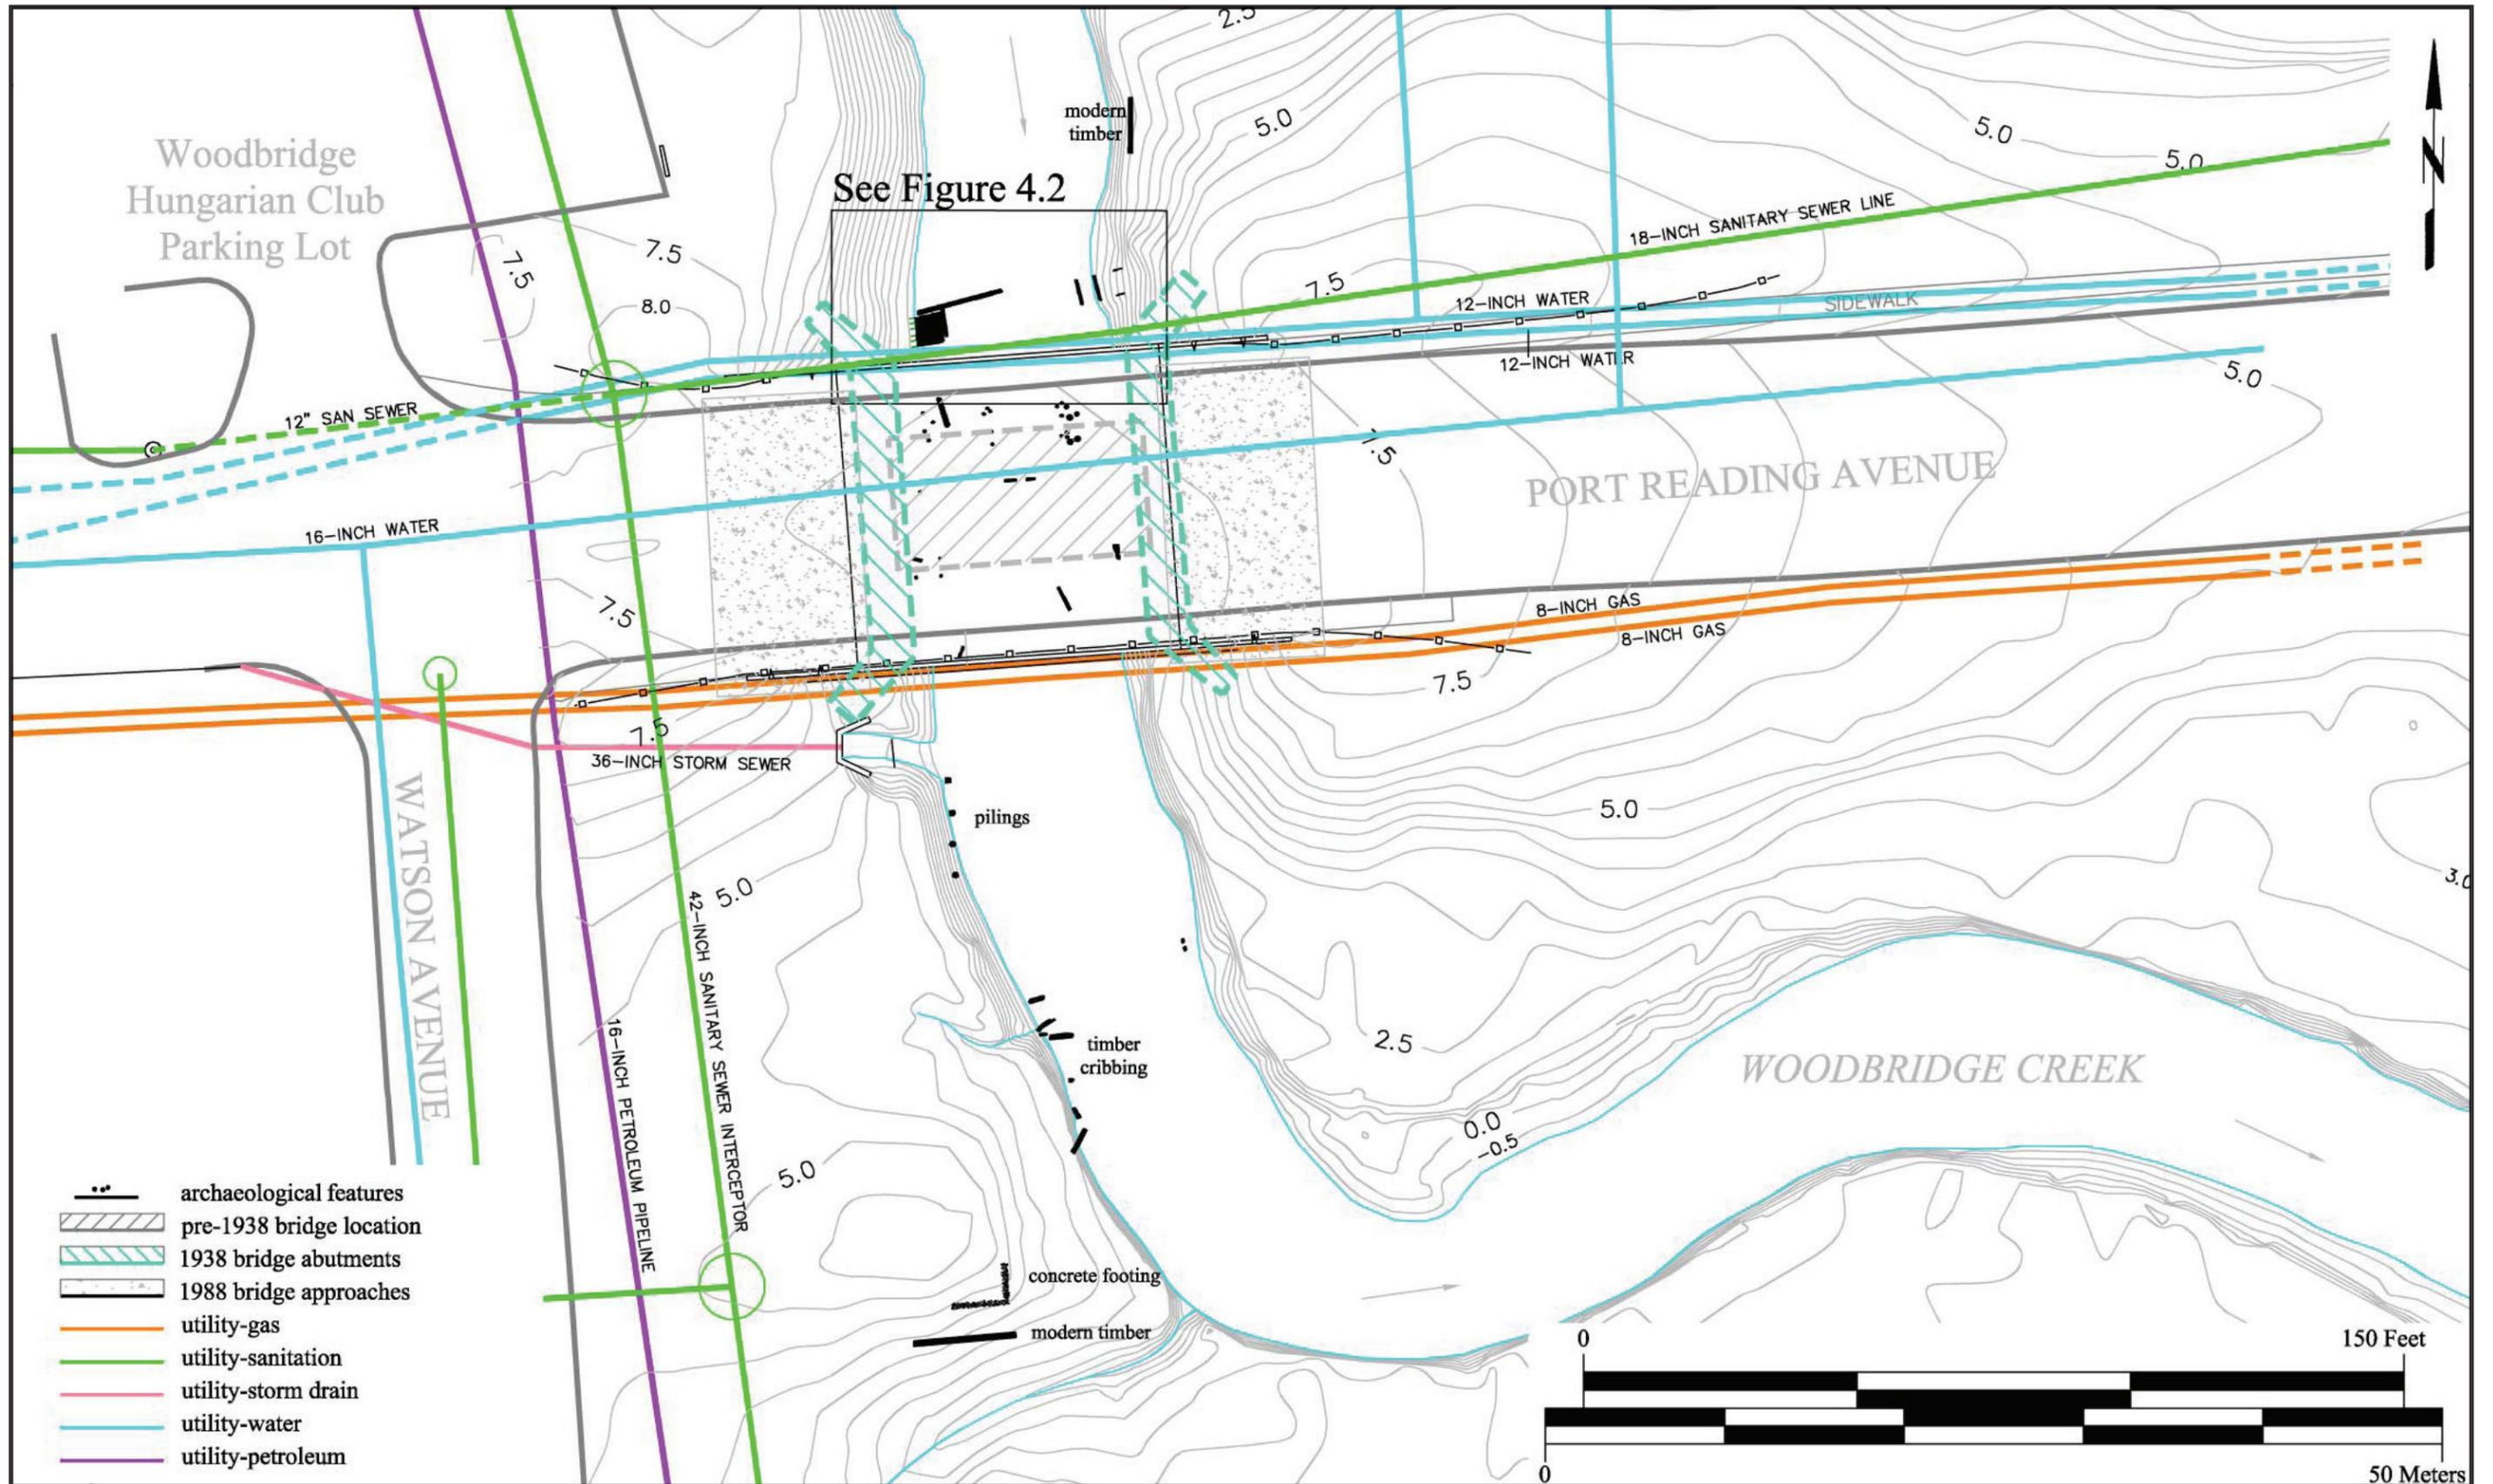
Figure 4.1. Overall Site Plan Showing Archaeological Features, Recent Bridges and Utility Lines.

Surficial inspection of the more elevated areas bordering either side of Woodbridge Creek, upstream and downstream of the Port Reading Avenue crossing indicated that fill has been placed atop much of the property immediately adjoining the roadway. On the east side of the creek, the fill quickly gives way to tidal wetland vegetation as one moves 30 feet or so away from the top of the causeway. On the west side of the creek, thicker fill deposits, perhaps up to five feet in places, extend for at least 100 to 150 feet north and south of the Port Reading Avenue roadway. The area between Watson Avenue and the creek to the south of the road, and the ground underlying the Woodbridge Hungarian Club parking lot, are both predominantly fill (Figure 4.1).

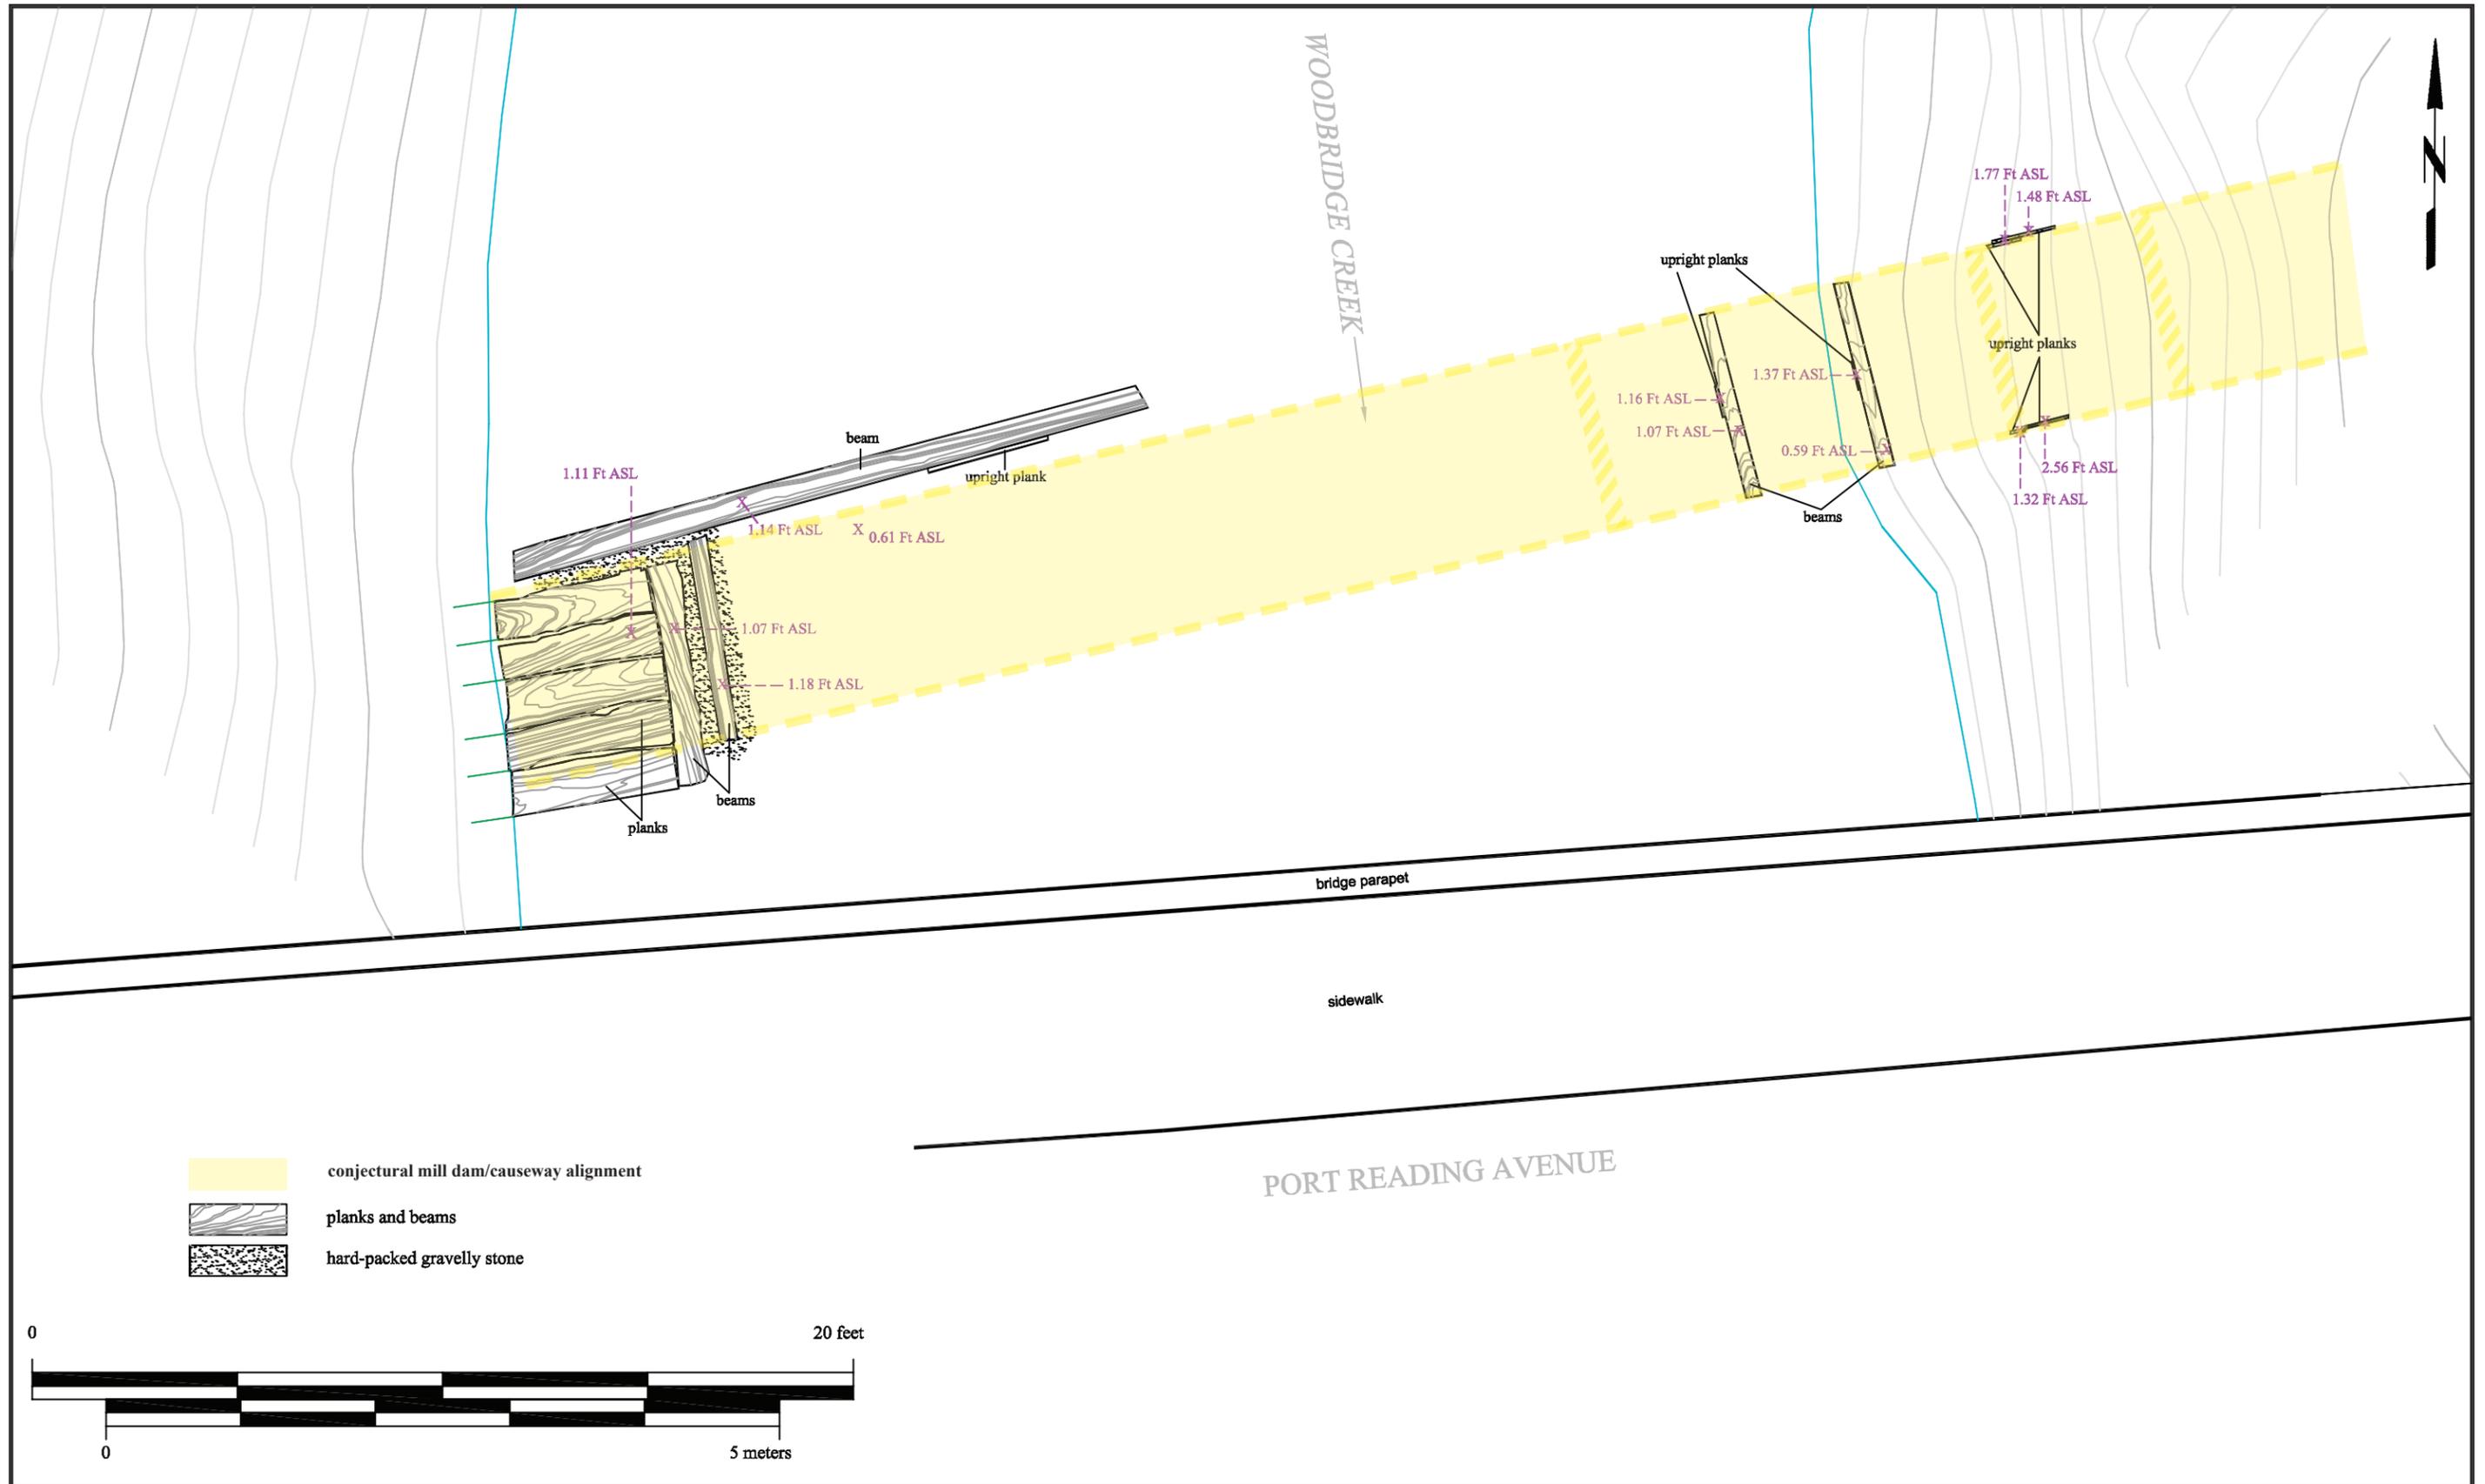
Figure 4.2. Detailed Plan View of Timber Remains.
