HISTORICAL AND ARCHAEOLOGICAL INVESTIGATIONS
DUNHAM'S MILL SITE
WOODBIDGE TOWNSHIP
MIDDLESEX COUNTY, NEW JERSEY

WOODBIDGE CREEK MITIGATION SITE
NEW YORK AND NEW JERSEY HARBOR
NAVIGATION PROJECT

CONTRACT NO. DACW51-01-D-0015

Prepared by:
Hunter Research, Inc.

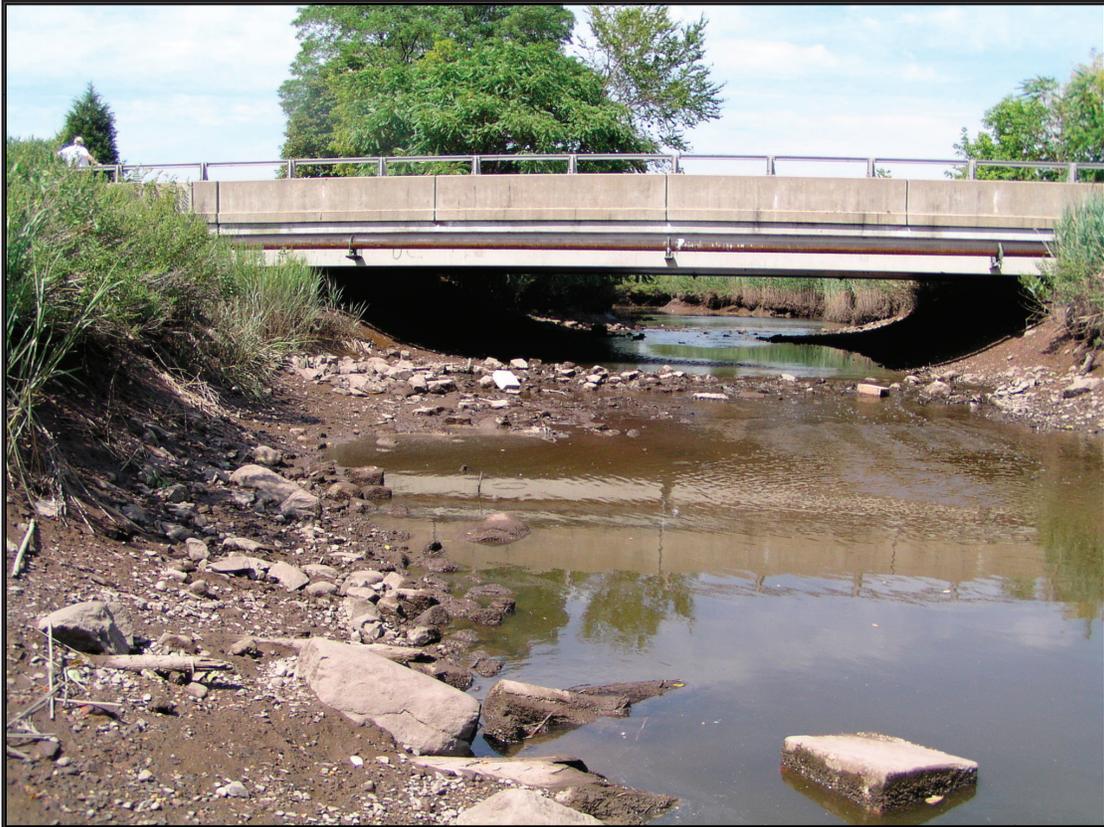
Plate 4.2. View looking north up Woodbridge Creek at the Port Reading Avenue Bridge (Photographer: Damon Tvaryanas, August 2005) (HRI Neg.#05048/D2:37).

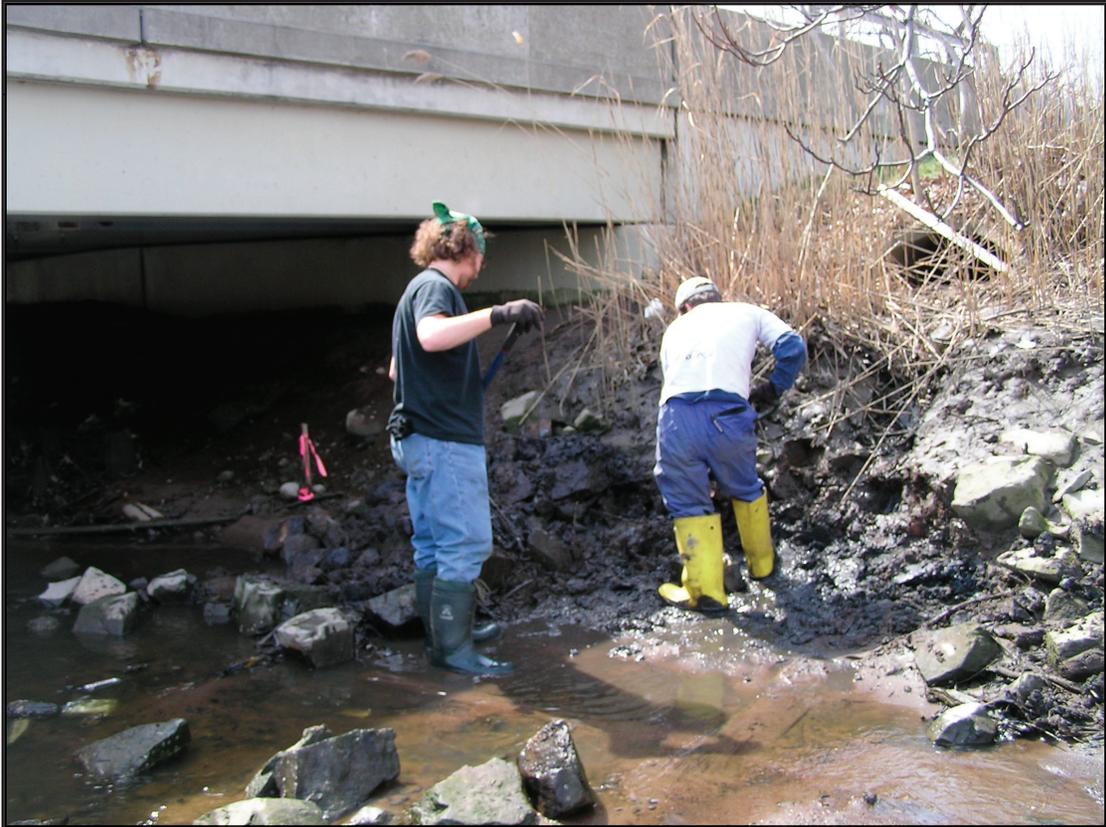
Plate 4.7. View looking southwest showing the right bank of Woodbridge Creek immediately upstream from the Port Reading Avenue bridge; archaeological fieldworkers are removing rubble and mud to expose timber remains (Photographer: George Cress, March 2006) (HRI Neg.#05091/D1:06).

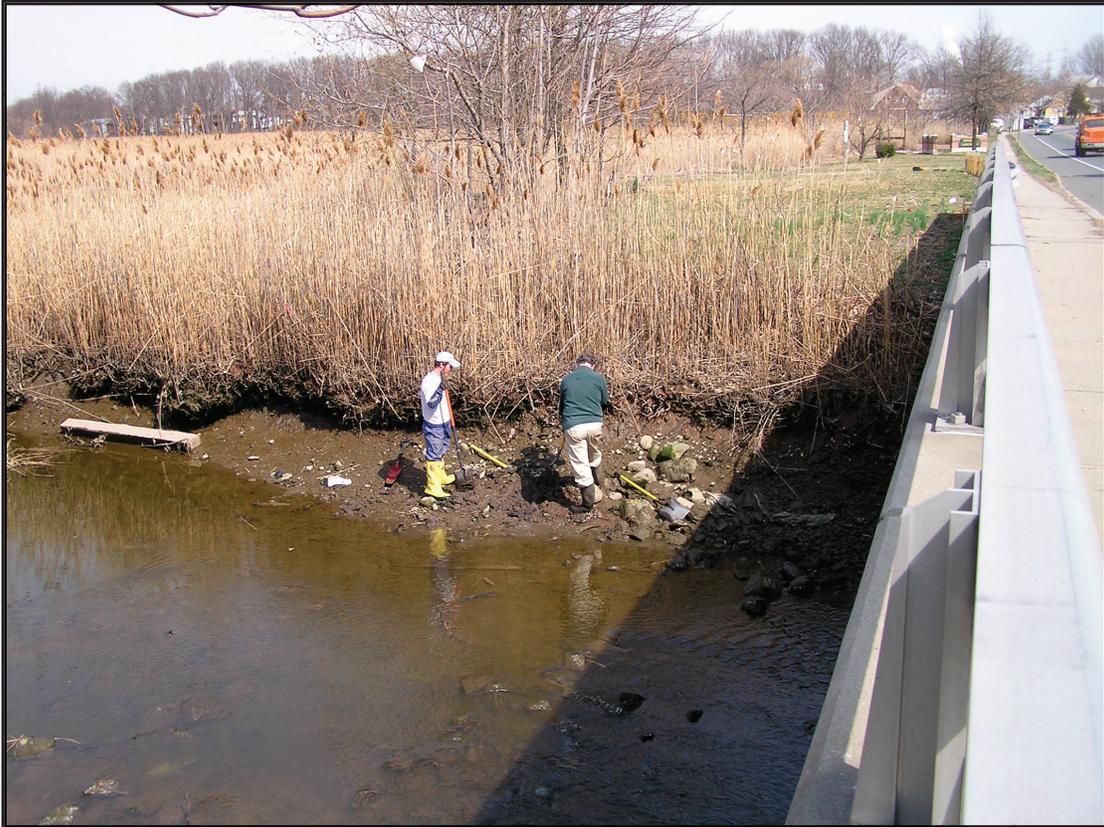
Plate 4.8. View looking east showing the left bank of Woodbridge Creek immediately upstream from the Port Reading Avenue bridge; Port Reading Avenue at right; archaeological fieldworkers are removing rubble and mud to expose timber remains (Photographer: George Cress, March 2006) (HRI Neg.#05091/D1:12).

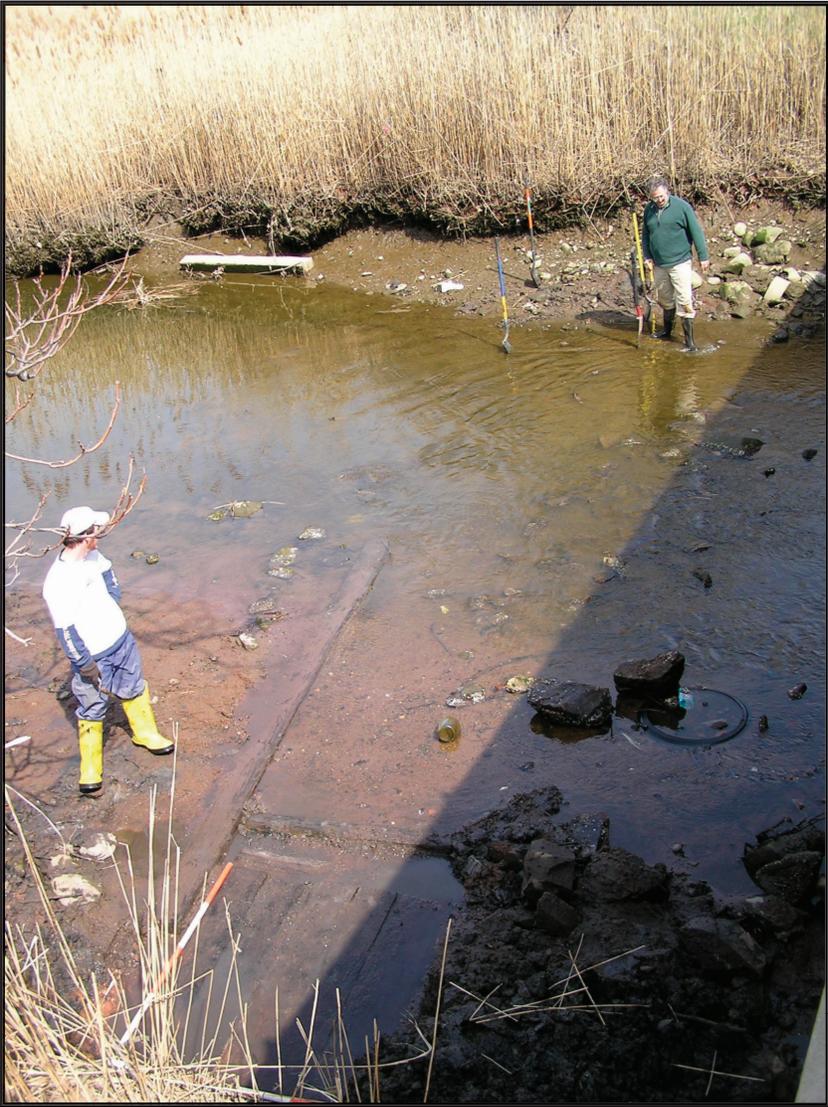
Initially, on the west side of the creek, one very long timber beam was found set into the creek bed in a matrix of hard-packed gravelly stone and clay (Plates 4.9 and 4.10). This beam, eight by nine inches in cross section and at least 16 feet long (its western extent was not established), projected out from the base of the bank and ran west-east to roughly the mid-point of the creek. On its downstream side it was abutted by at least one piece of horizontal planking, which appeared to have been set into the creek bed and was

presumably designed to hold the beam in place. While this beam may have been dislodged slightly (based on its relationship to other nearby timber components), it is essentially *in situ* and resisted all efforts to pry it loose by hand.

Plate 4.9. General view looking northeast showing showing timber remains in the bed of Woodbridge Creek immediately upstream from the Port Reading Avenue bridge; in left foreground are wood beams and planking; at top right, shovels indicate continuation of alignment of timber remains on the left bank (Photographer: George Cress, March 2006) (HRI Neg.#05091/D1:28).

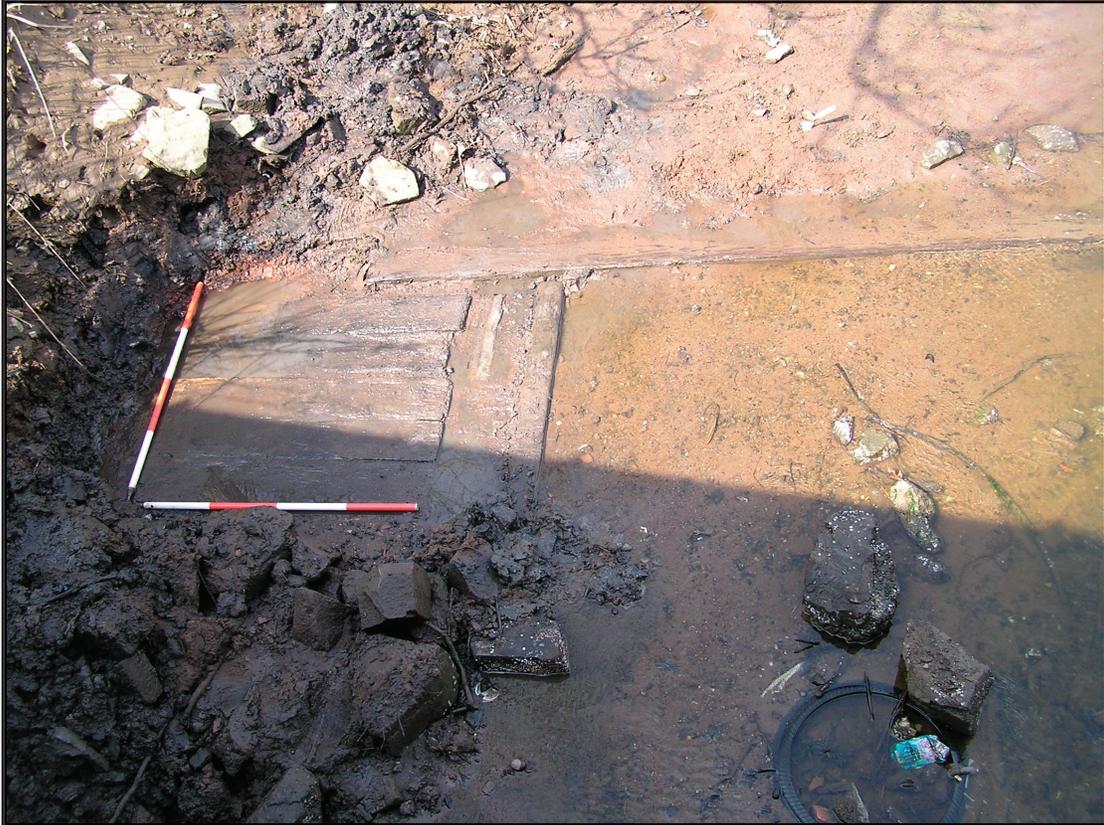
Plate 4.10. View looking north showing wood beams and planking on the right bank of Woodbridge Creek immediately upstream of the Port Reading Avenue bridge; scales in feet (Photographer: George Cress, March 2006) (HRI Neg.#05091/D1:13).

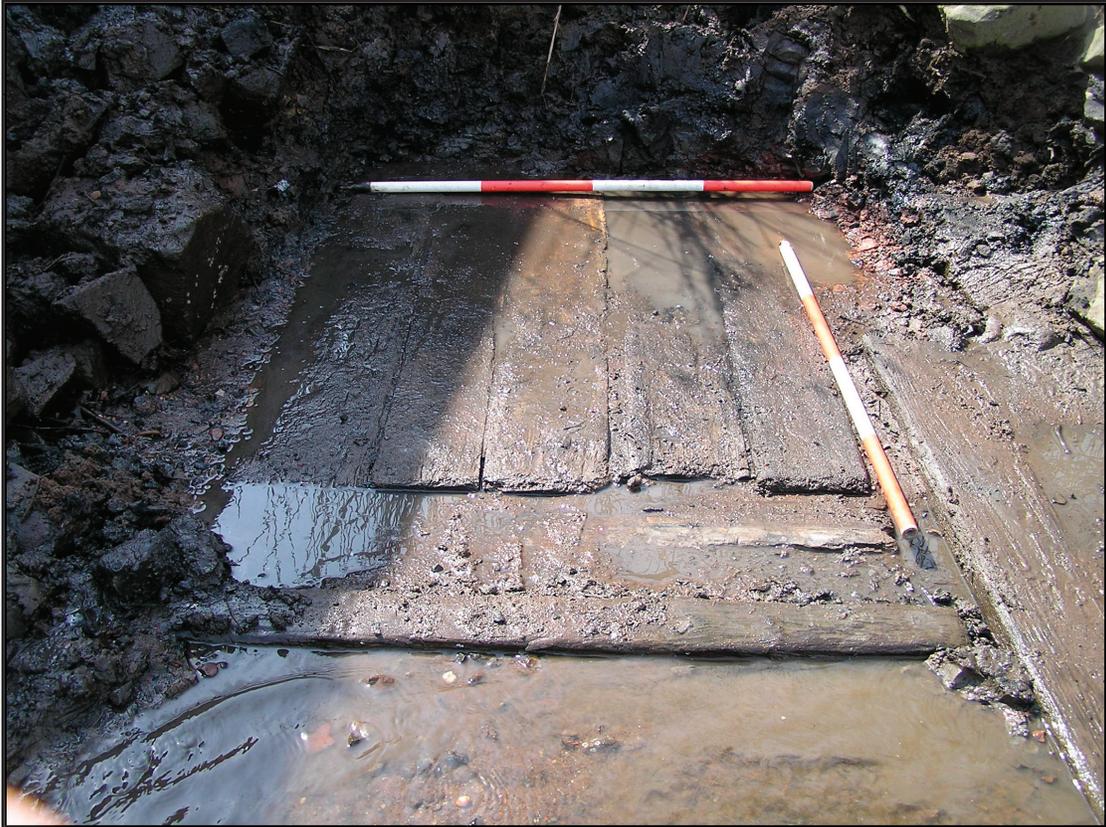
Plate 4.11. View looking west showing wood beams and planking on the right bank of Woodbridge Creek immediately upstream of the Port Reading Avenue bridge; scales in feet (Photographer: George Cress, March 2006) (HRI Neg.#05091/D1:08).

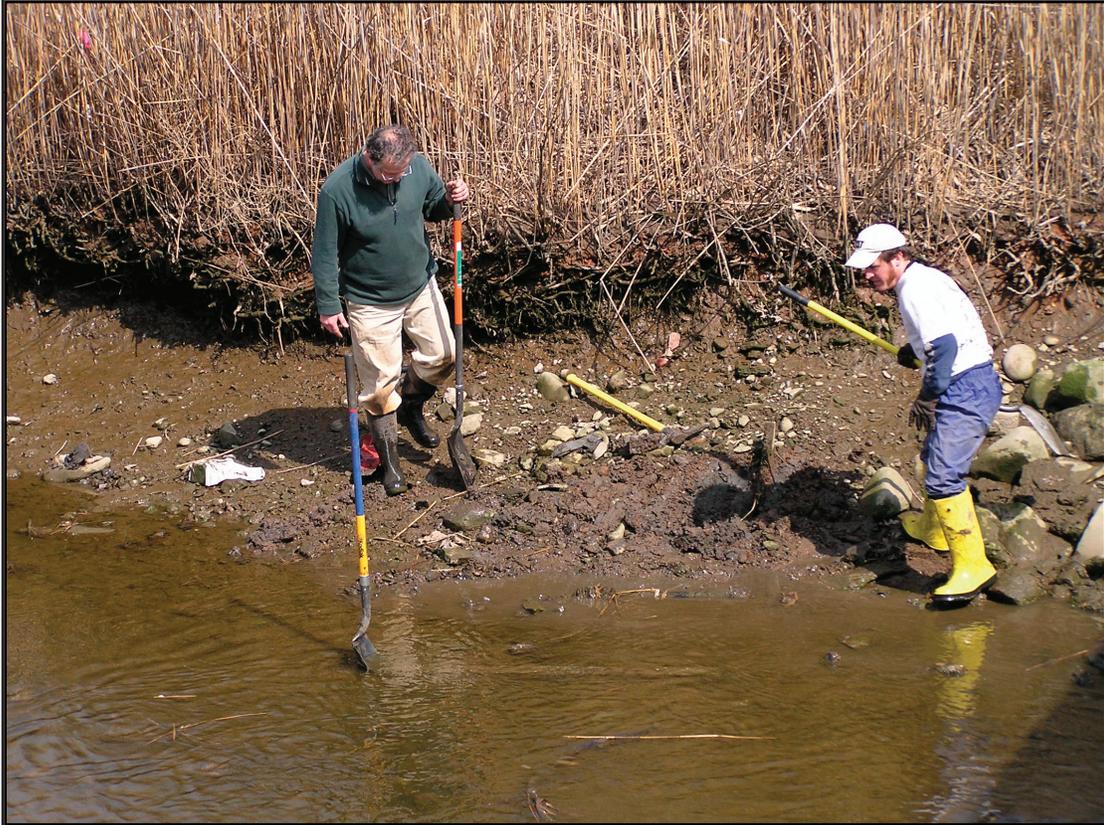
Plate 4.12. View looking east showing timbers being exposed on the left bank of Woodbridge Creek immediately upstream of the Port Reading Avenue bridge; shovel in foreground marks the upstream end of a horizontal wood beam that continues the alignment of the remains found on the right bank of the creek; this beam was removed for dendrochronological analysis (Photographer: George Cress, March 2006) (HRI Neg.#05091/D1:20).

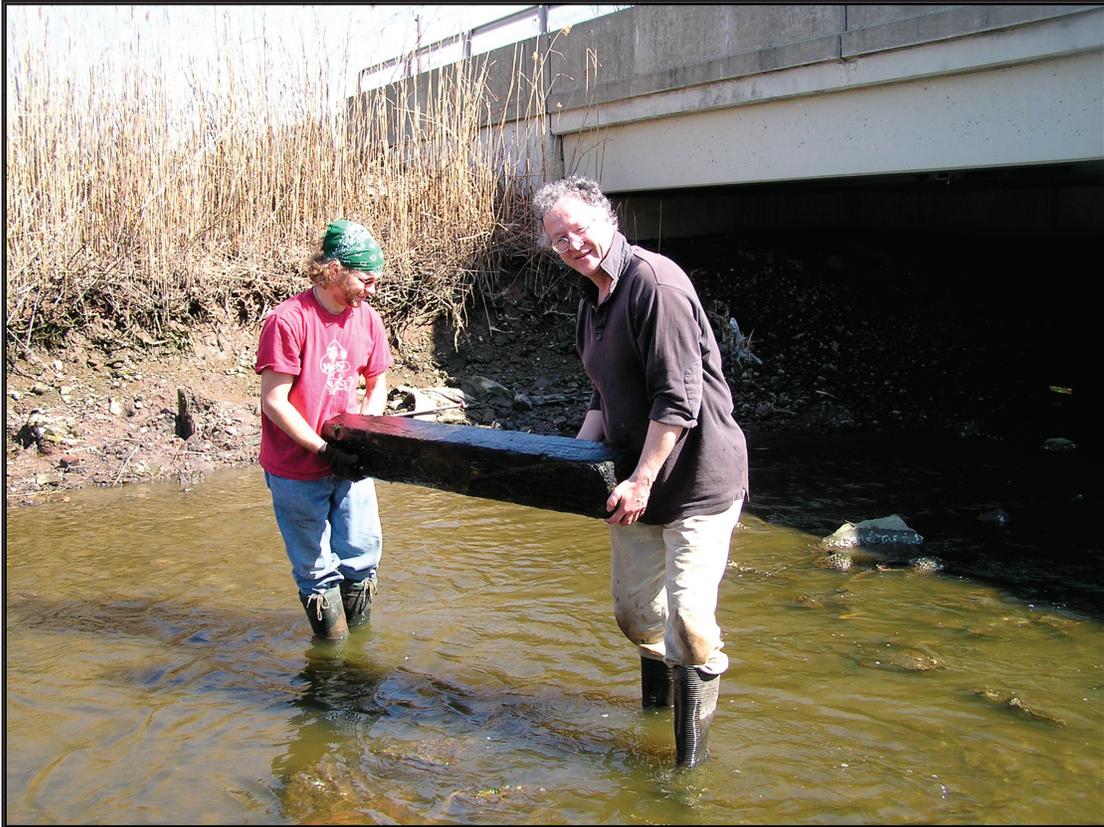
Plate 4.13. View looking southeast showing wood beam being removed from the left bank of the creek for dendrochronological analysis (Photographer: George Cress, March 2006) (HRI Neg.#05091/D1:45).

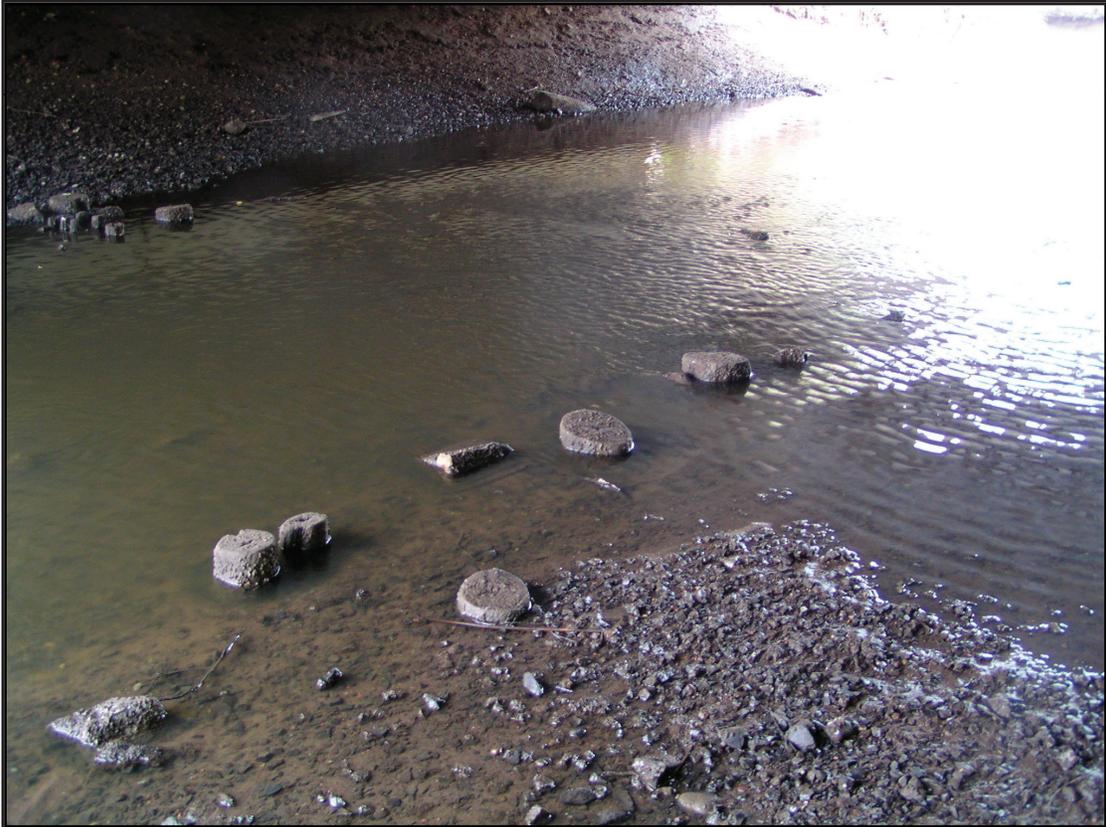
Plate 4.14. View looking northwest showing pilings under the Port Reading Avenue bridge over Woodbridge Creek; these timbers are probably part of the superstructure which supported the bridge that was replaced in 1938-39 (Photographer: Damon Tvaryanas, August 2005) (HRI Neg.#05048/D2:10).

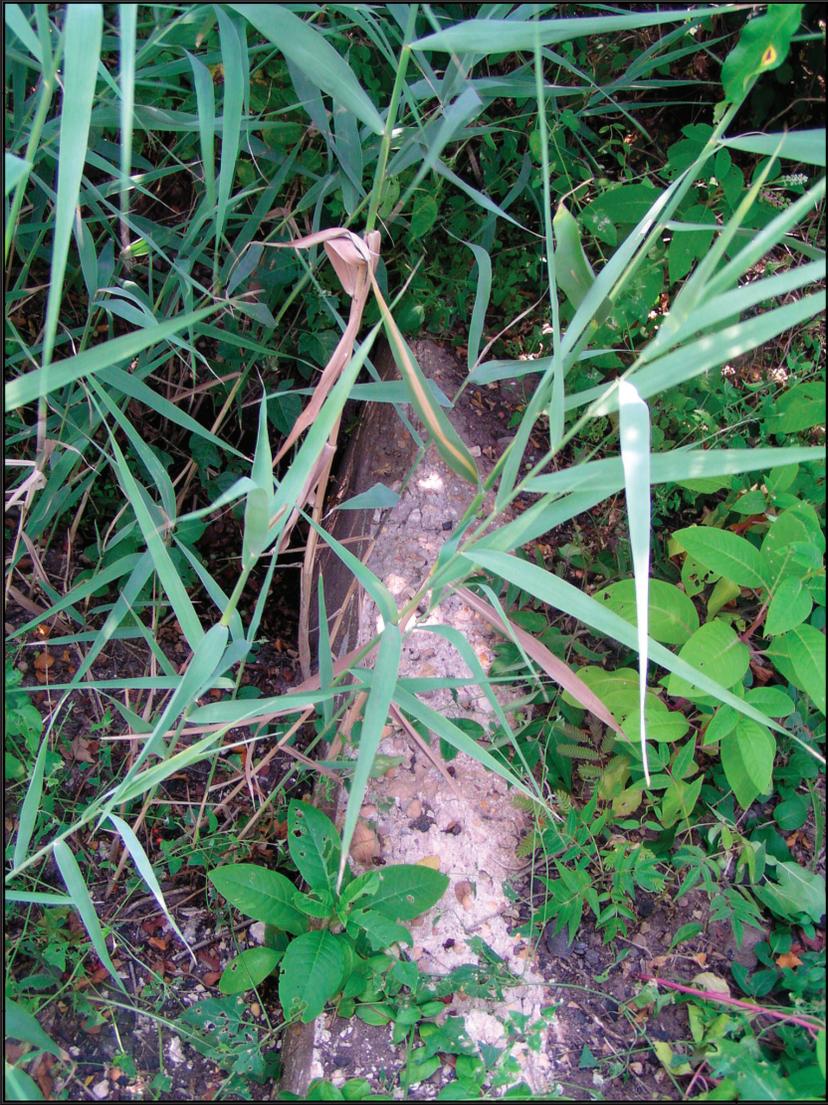
Plate 4.15. View of concrete foundation on the right bank of Woodbridge Creek downstream of the Port Reading Avenue bridge (Photographer: Damon Tvaryanas, August 2005) (HRI Neg.#05048/D2:41).

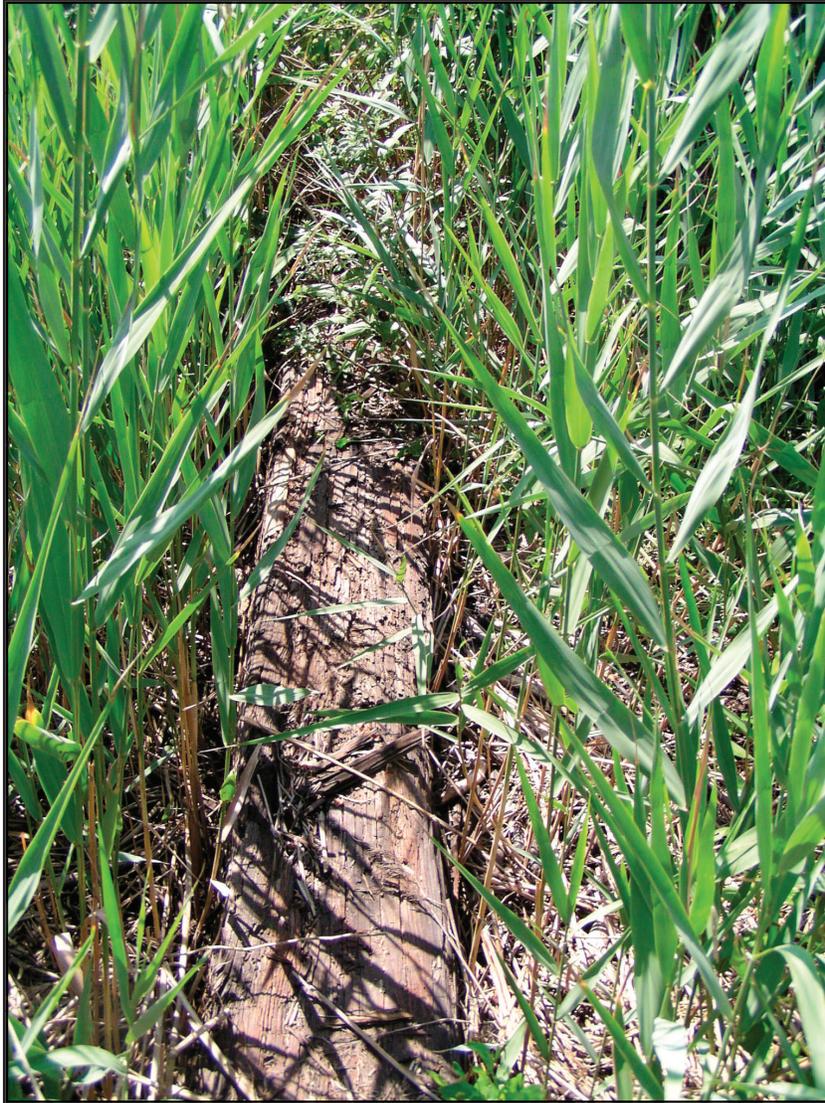
Plate 4.16. View of large timber on the right bank of Woodbridge Creek downstream of the Port Reading Avenue bridge (Photographer: Damon Tvaryanas, August 2005) (HRI Neg.#05048/D2:40).

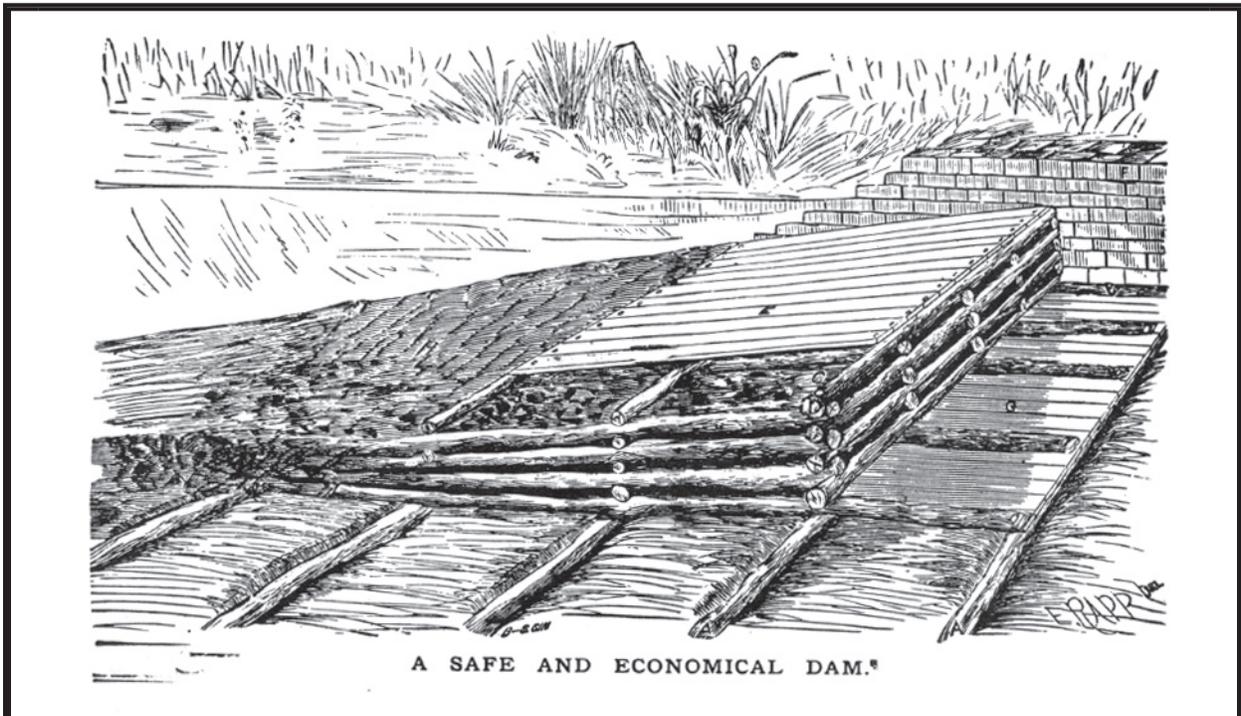
Figure 4.3. "A Safe and Economical Dam." (Source: James Leffel & Co. 1881:12 [reprinted 1972]).

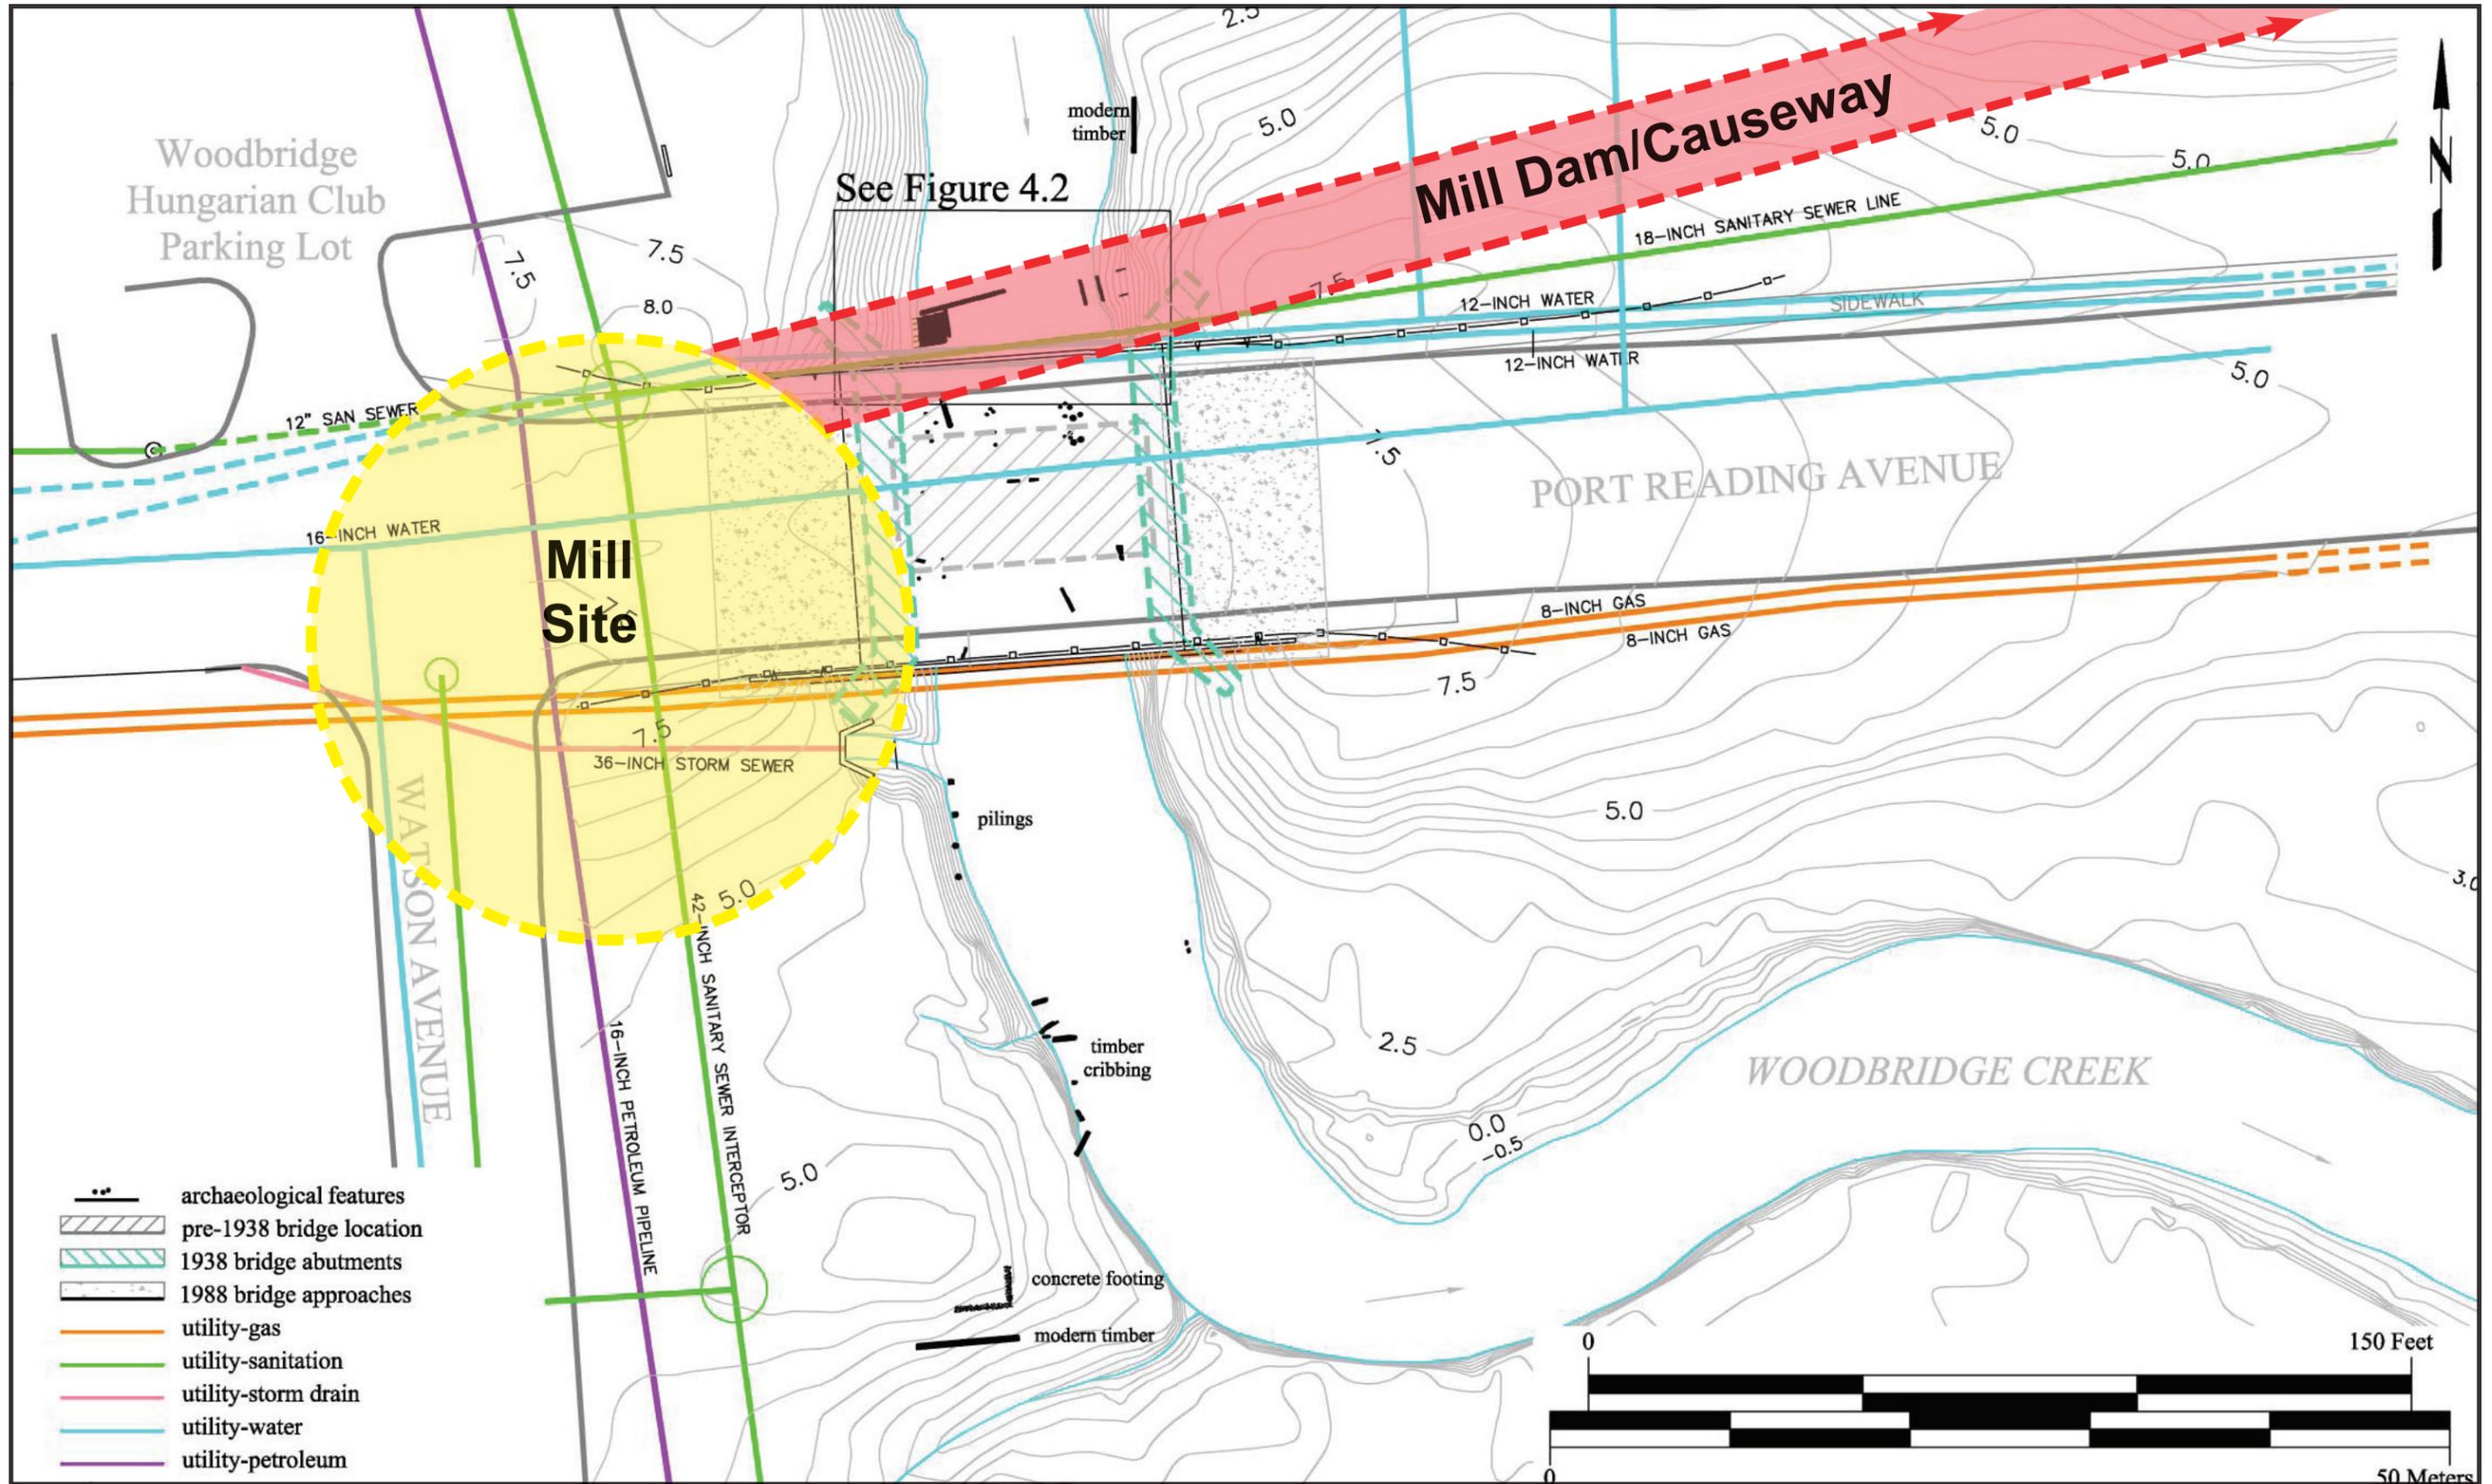
Figure 4.4. Overall Site Plan with Conjectured Location of Mill Site and Dam.

If one accepts that these dam remains can be linked to the mill and hydropower configuration shown in the Prall division map of 1790, this would place the site of the actual Prall mill to the west of the creek, probably beneath or immediately to the south of the western approaches to the Port Reading Avenue bridge, and beneath or just east of Watson Avenue (Figure 4.4). This may also be the approximate location of the predecessor mills of William Stone and Jonathan Dunham/Singletary. This area has been disturbed in part by successive bridge replacement projects and is crisscrossed by several utilities, the installation of some of which has entailed the open-cut excavation of trenches in excess of ten feet in depth. Archaeological

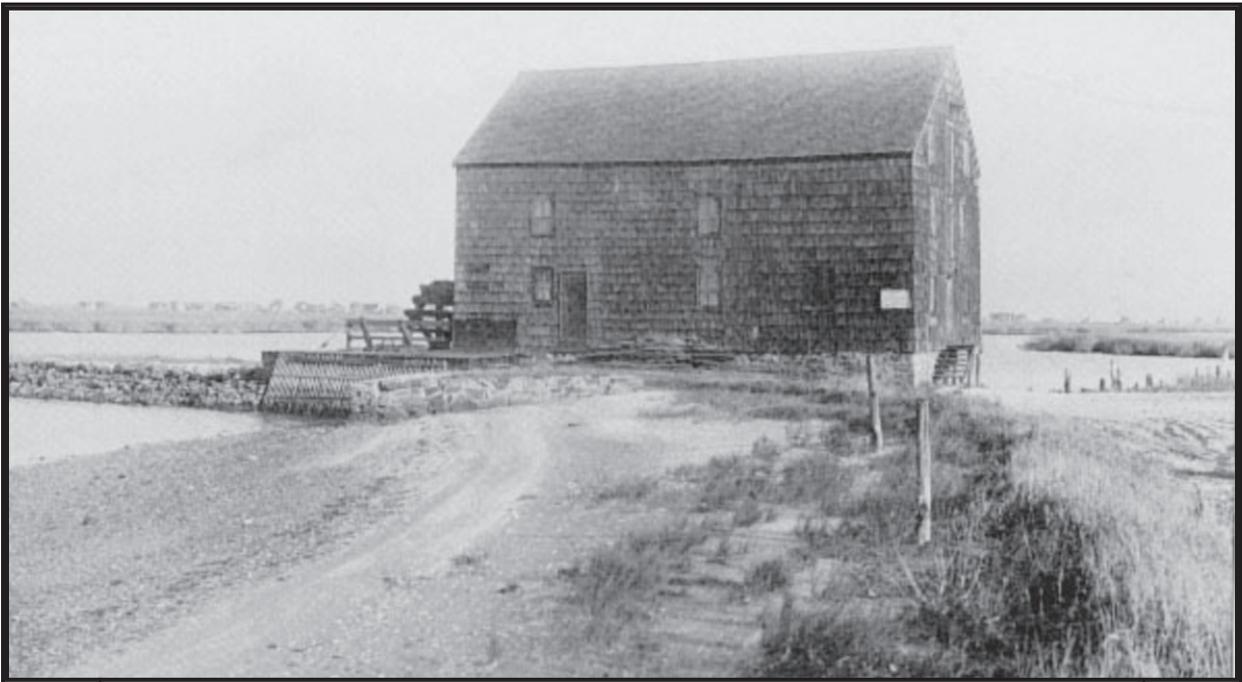
Plate 4.17. Early 20th-century view of the Gerritsen Tide Mill, looking east; milldam at left (Source: Ricciardi 2002).

To gain a better sense of how the Dunham/Stone/Prall tidal gristmill might have looked in the landscape, one may look to well documented examples of very similar structures in nearby Long Island. One such mill, the Gerritsen Tide Mill on Gerritsen's Creek in Brooklyn, serves as a particularly good comparison (Plates 4.17 and 4.18). From the mid-18th century up until destruction by fire in 1936, this mill was similarly positioned at the western end of a causeway in tidal wetland with one sluice gate close to the mill and a second one further east along the causeway (Hunter Research, Inc. 2002).

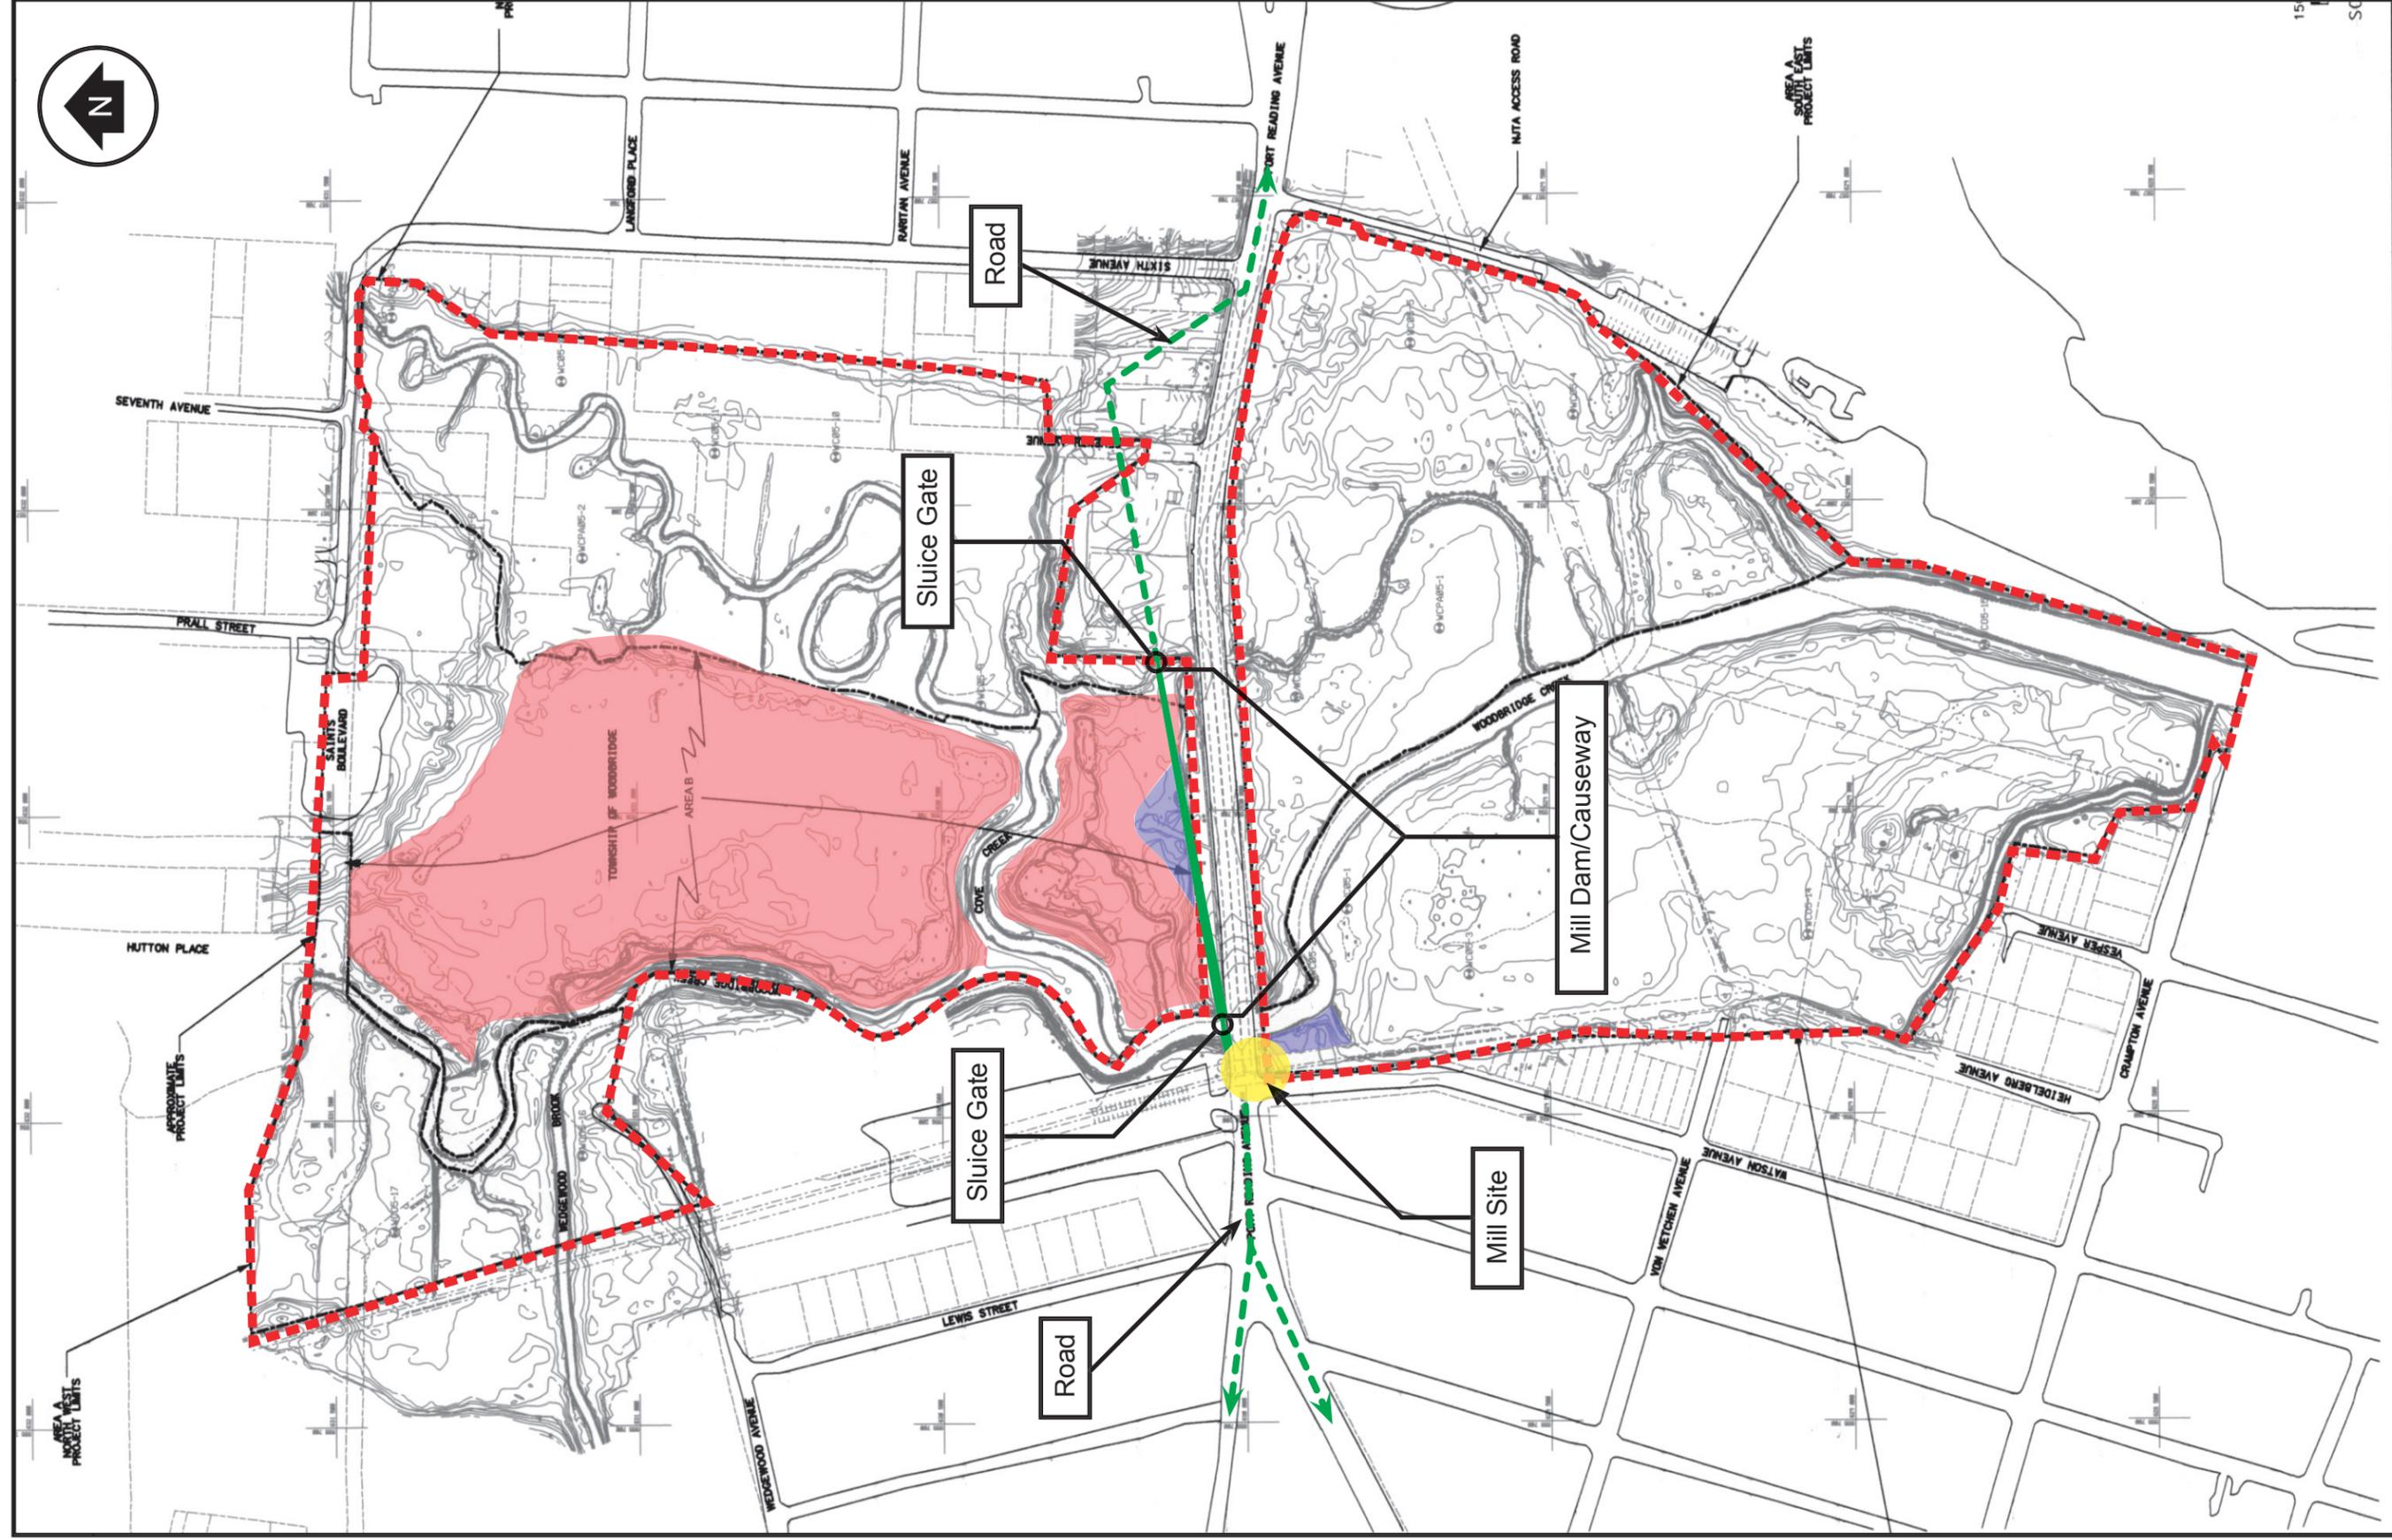
Figure 5.1. Detailed Location of Project Site Showing Probable Site of Dunham's Mill and Mill Dam/Causeway. Overall U.S. Army Corps of Engineers Wetland Restoration Area Limits Outlined in Red; National Oceanic & Atmospheric Administration/New Jersey Department of Environmental Protection Wetland Restoration Site Shaded in Red; Proposed Public Access Areas Shaded in Purple. Scale: 1 inch = 270 feet (approximately).

All archaeological monitoring should be carried out by a qualified historical or industrial archaeologist with experience of water-powered industrial sites in accordance with the guidelines and standards of the New Jersey Historic Preservation Office. Particular attention should be given to the coordination of archaeological monitoring with low tide conditions. Monitoring work may offer an opportunity for retrieval of wood samples suitable for dendrochronological analysis and wood species identification. Reasonable efforts should be made to retrieve such samples in the field, since this technique may provide the best means of accurately dating the timber remains found at this site.
