HISTORICAL AND ARCHAEOLOGICAL INVESTIGATIONS
DUNHAM'S MILL SITE
WOODBIDGE TOWNSHIP
MIDDLESEX COUNTY, NEW JERSEY

WOODBIDGE CREEK MITIGATION SITE
NEW YORK AND NEW JERSEY HARBOR
NAVIGATION PROJECT

CONTRACT NO. DACW51-01-D-0015

Prepared by:
Hunter Research, Inc.

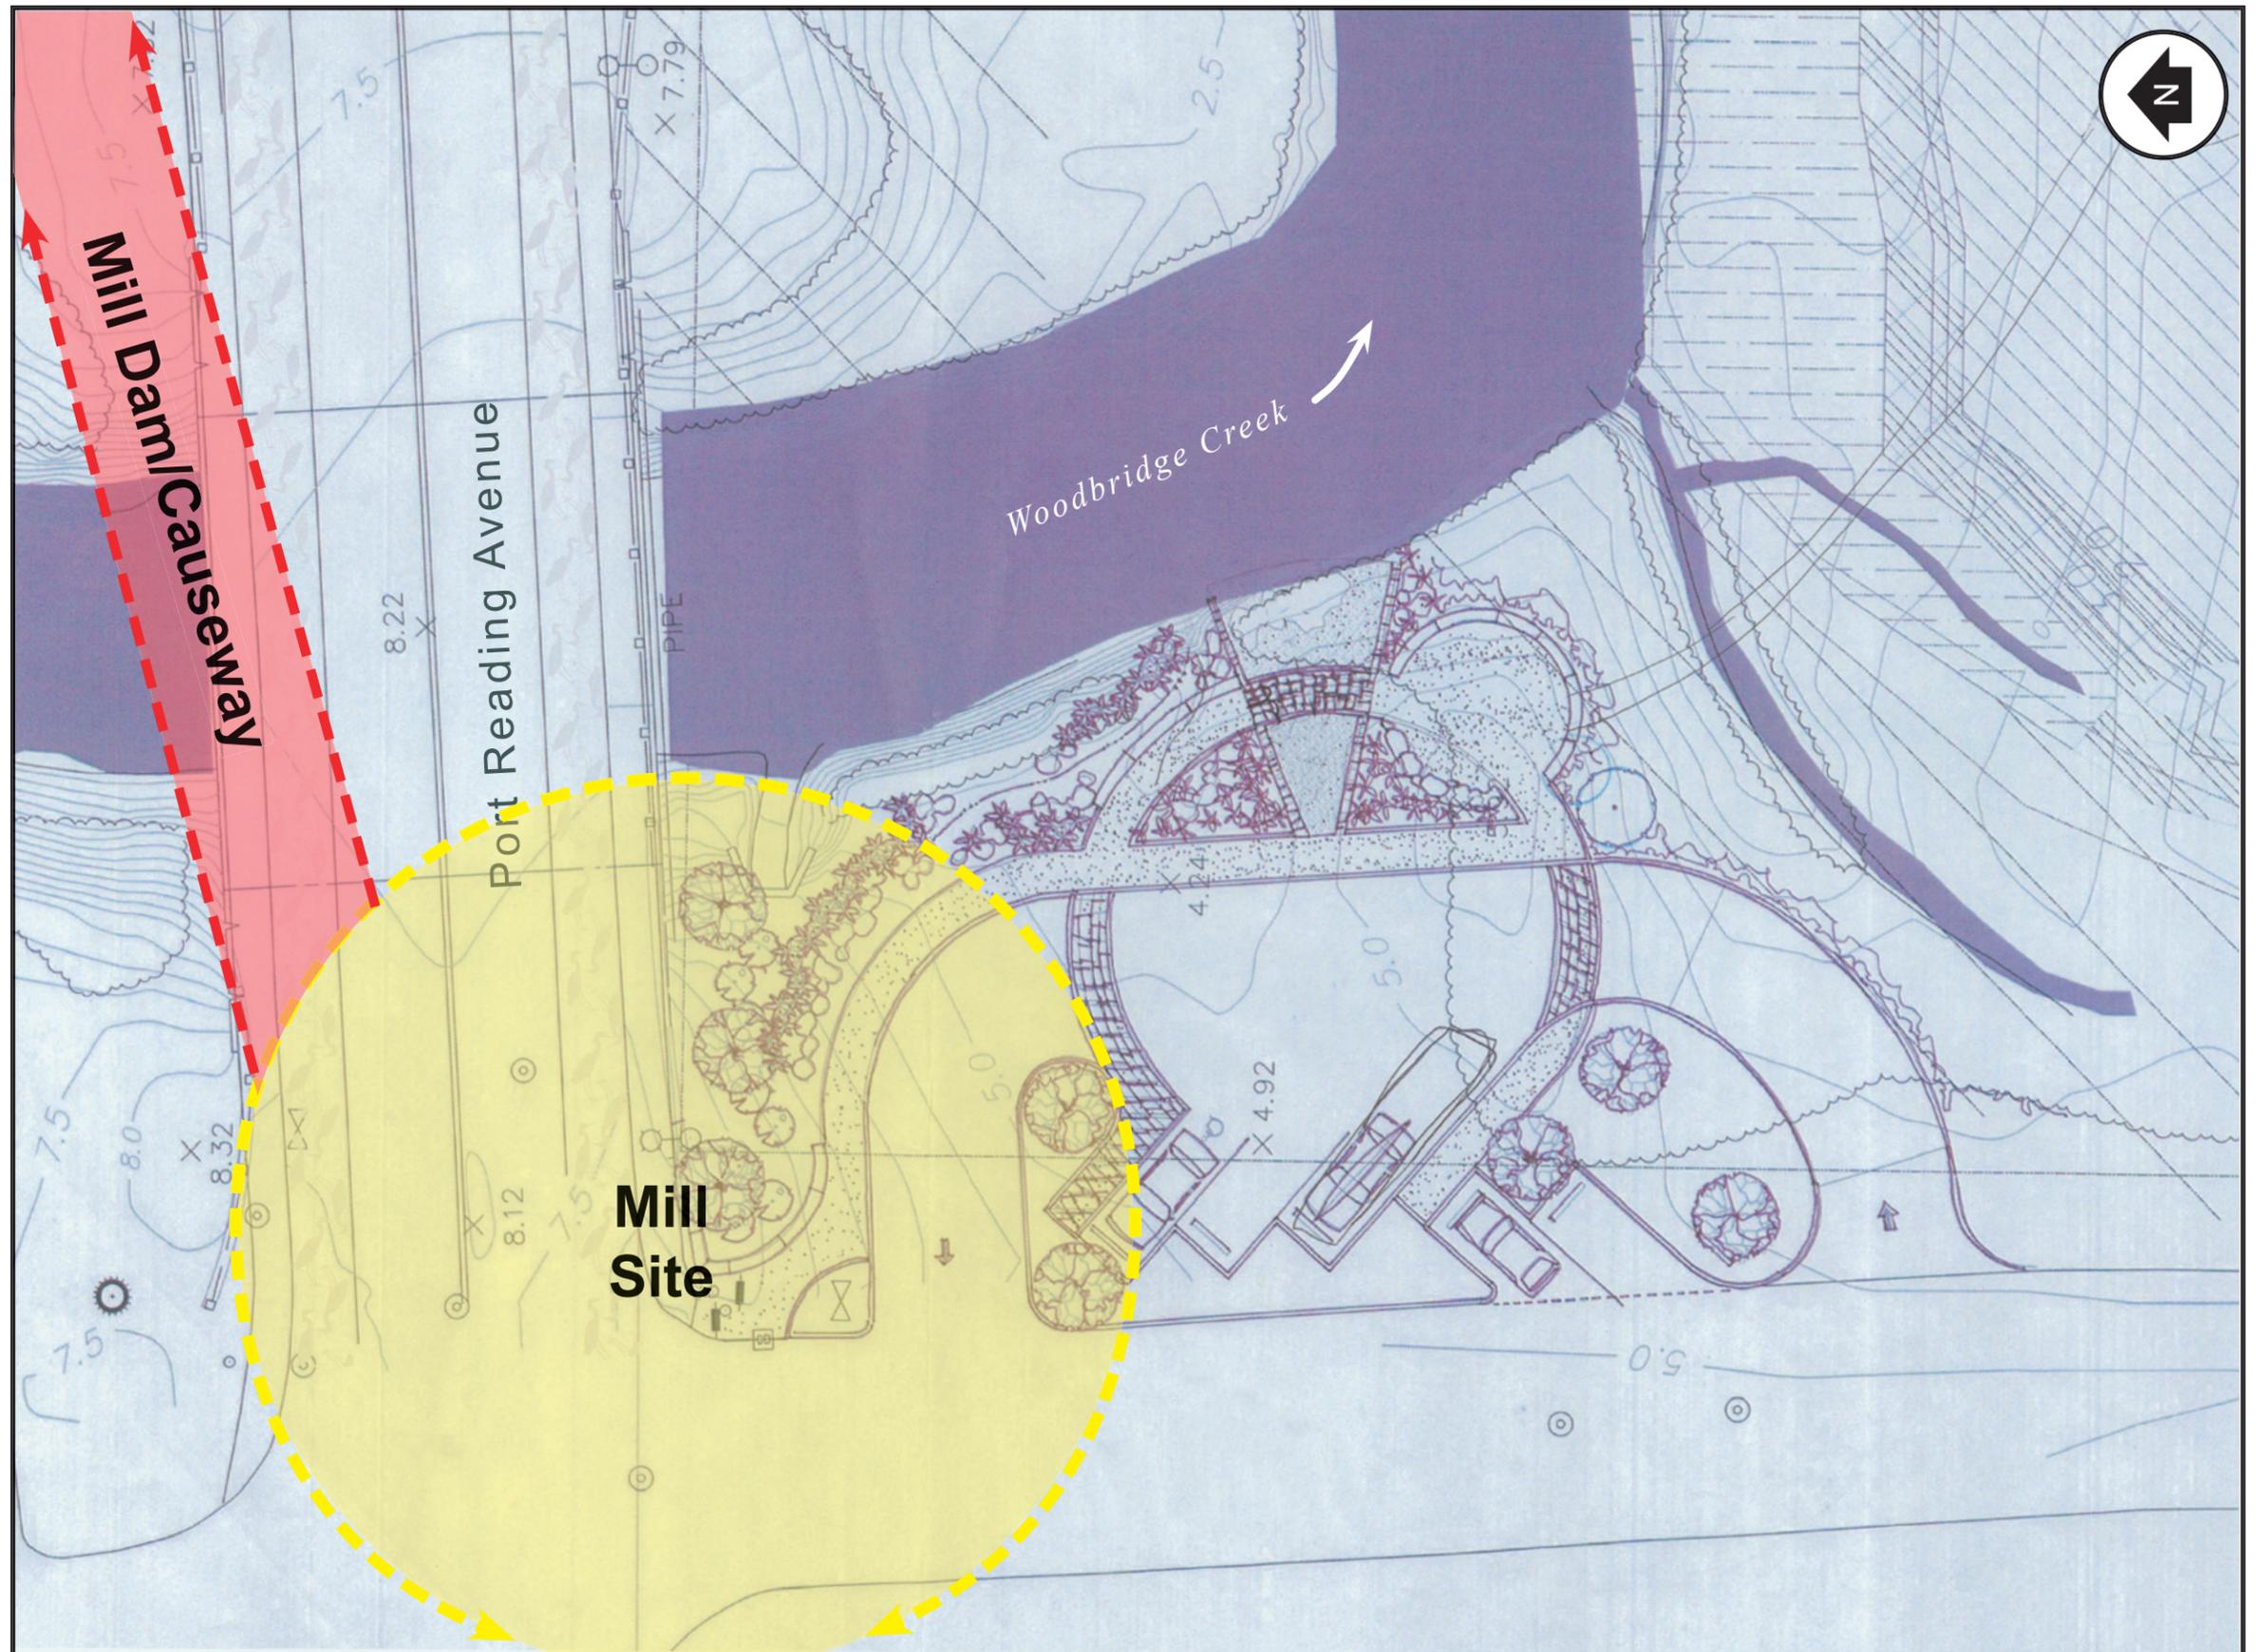
Figure 5.2. Conceptual Design of Proposed Public Access Area South of Port Reading Avenue and West of Woodbridge Creek in Relation to Probable Site of Dunham's Mill and Mill Dam/Causeway. Scale: 1 inch= 18 feet (approximately). (Source: Louis Berger and Associates, Inc. 2005).
