FINAL MMRP REMEDIAL INVESTIGATION REPORT

**Remedial Investigation/Feasibility Study
Fort Hancock Formerly Used Defense Site
Monmouth County, New Jersey**

**U.S. Army Corps of Engineers
Baltimore District**

ERT, Inc.

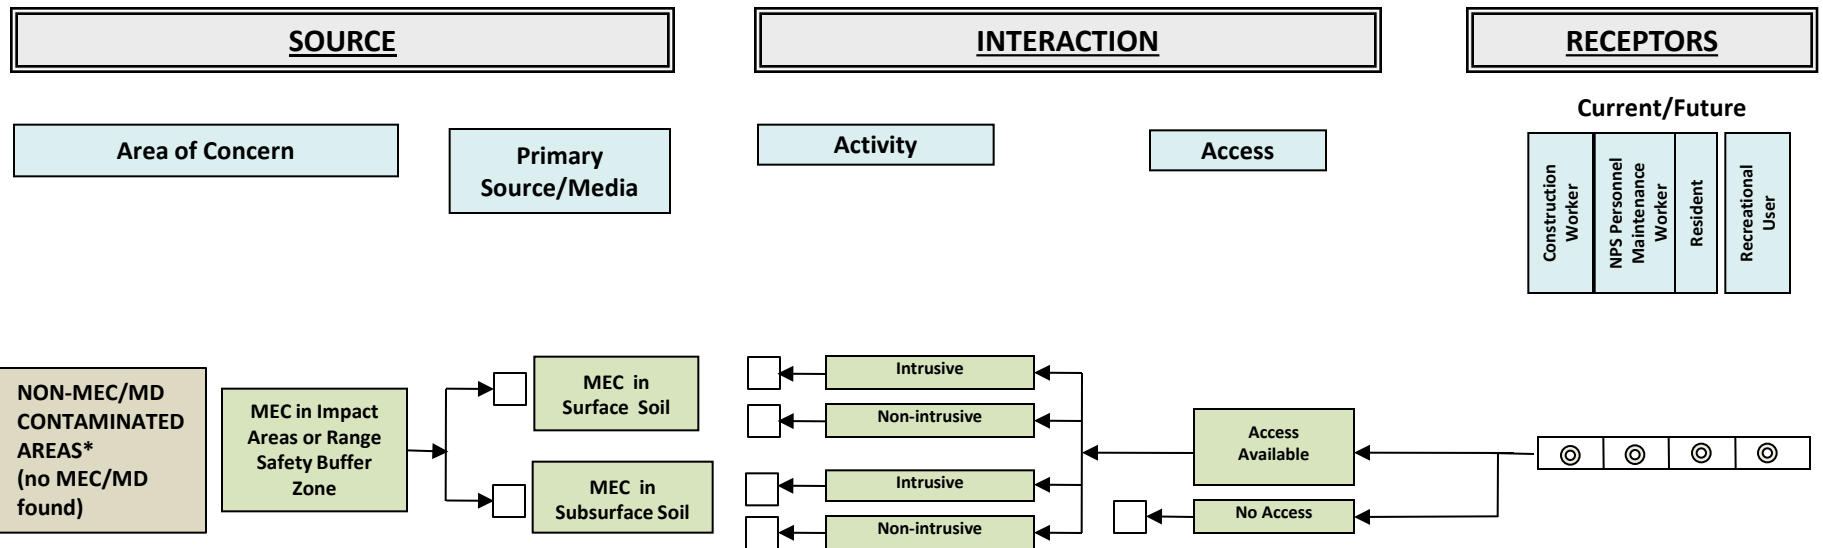
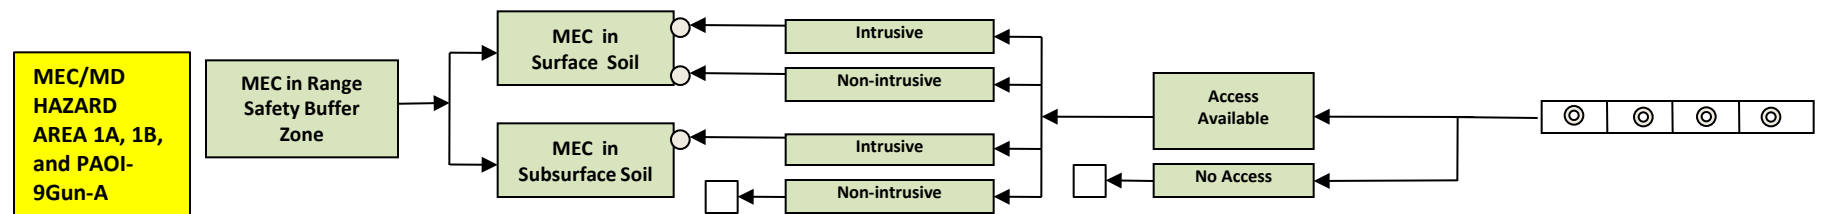
Figure A-5-12. Revised CSM for MRS-1 (MEC/MD)

* All areas of MRS-1 other than MEC/MD Hazard Area shown below

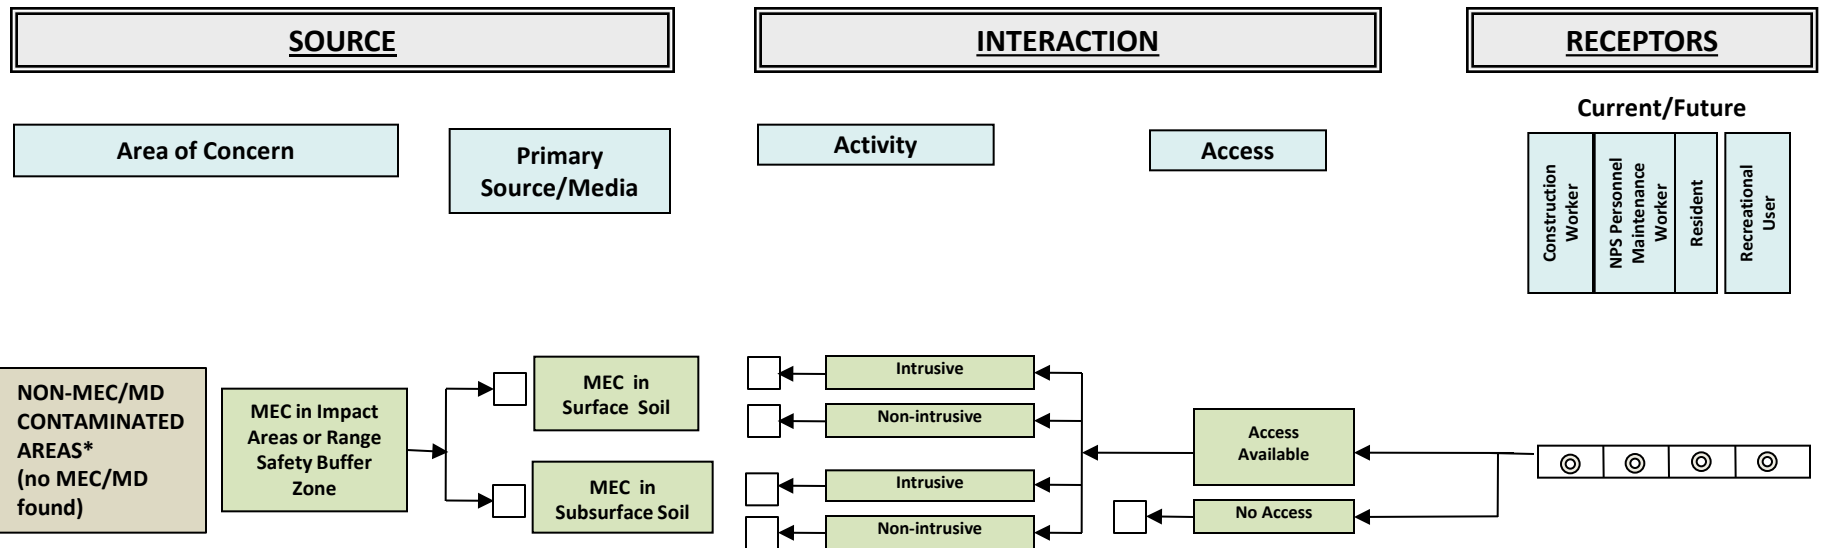
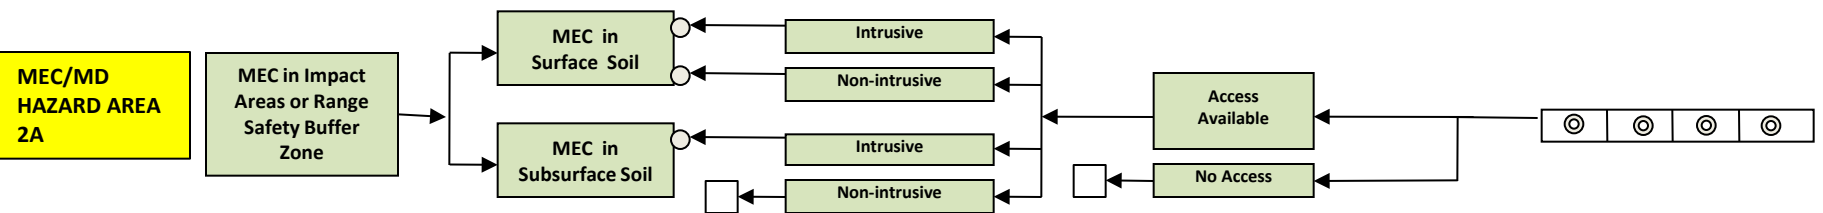
Figure A-5-13. Revised CSM for MRS-2 (MEC/MD)

* All areas of MRS-2 other than MEC/MD Hazard Areas shown below

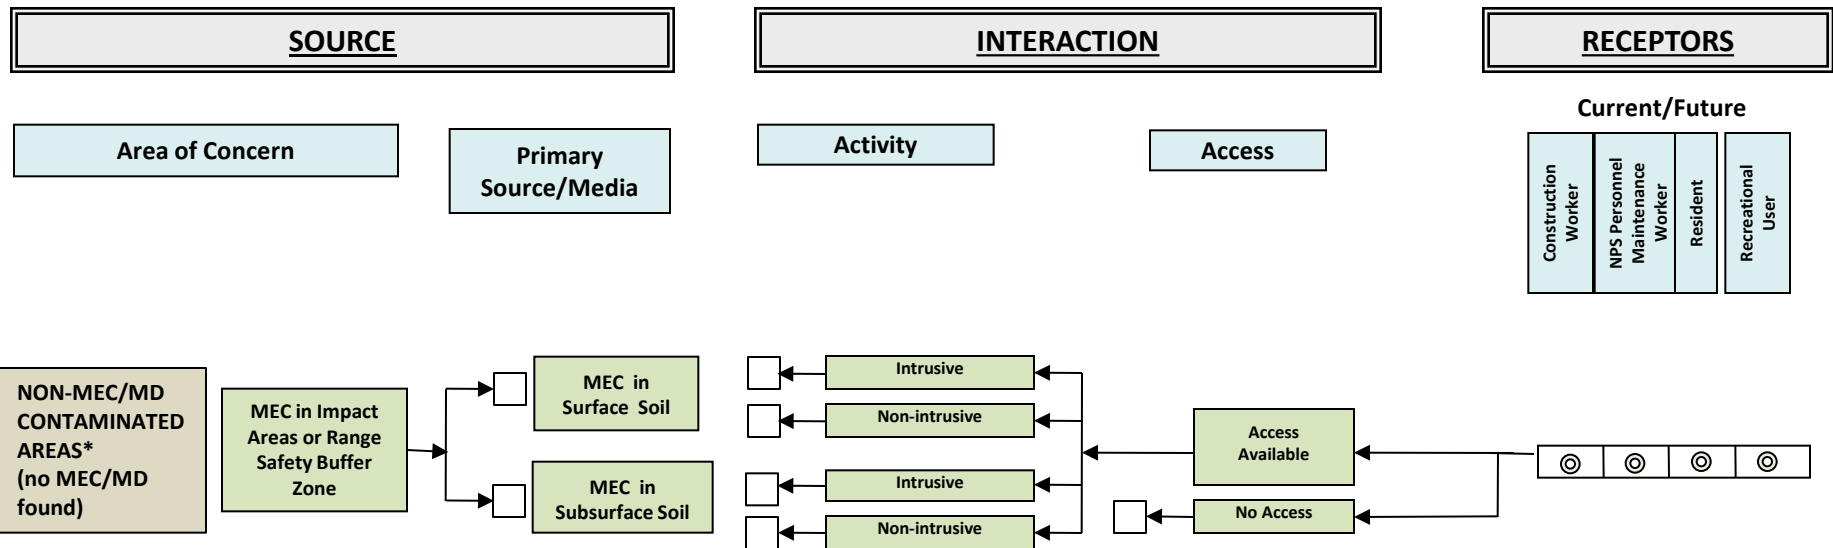
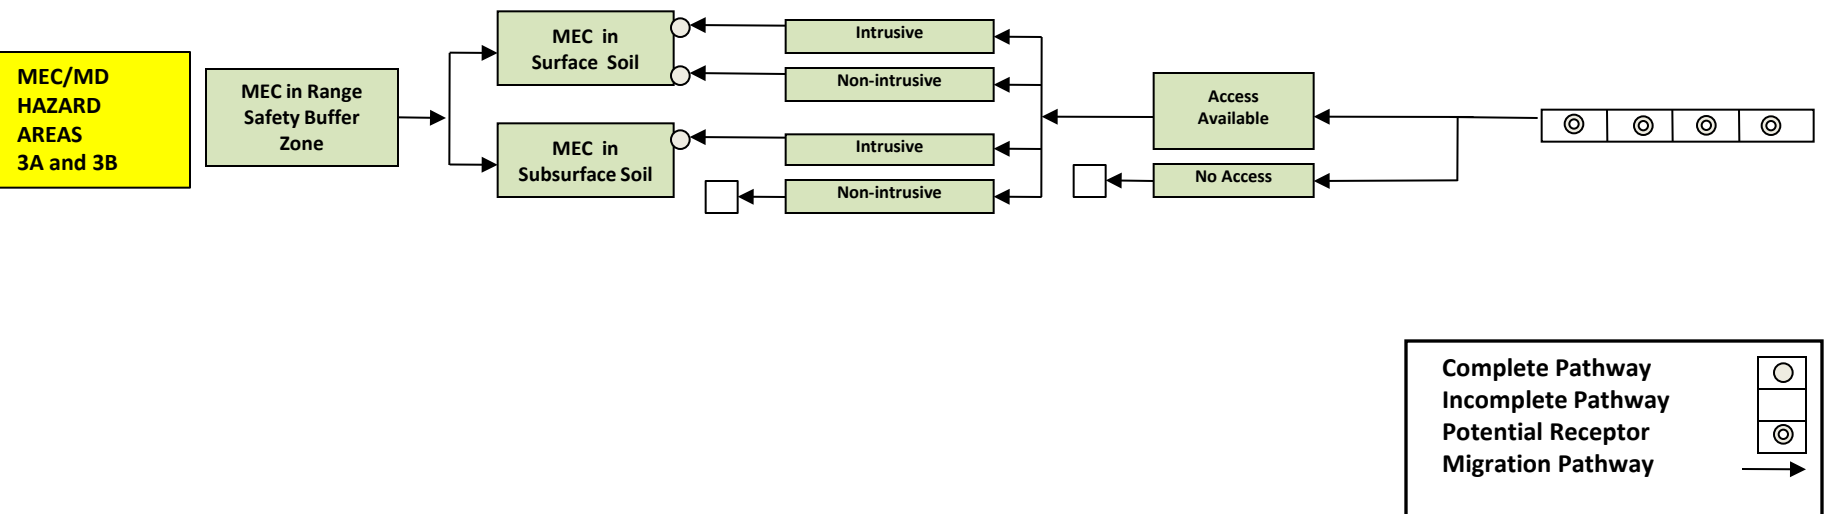
Figure A-5-14. Revised CSM for MRS-3 (MEC/MD)

* All areas of MRS-3 other than MEC/MD Hazard Areas shown below

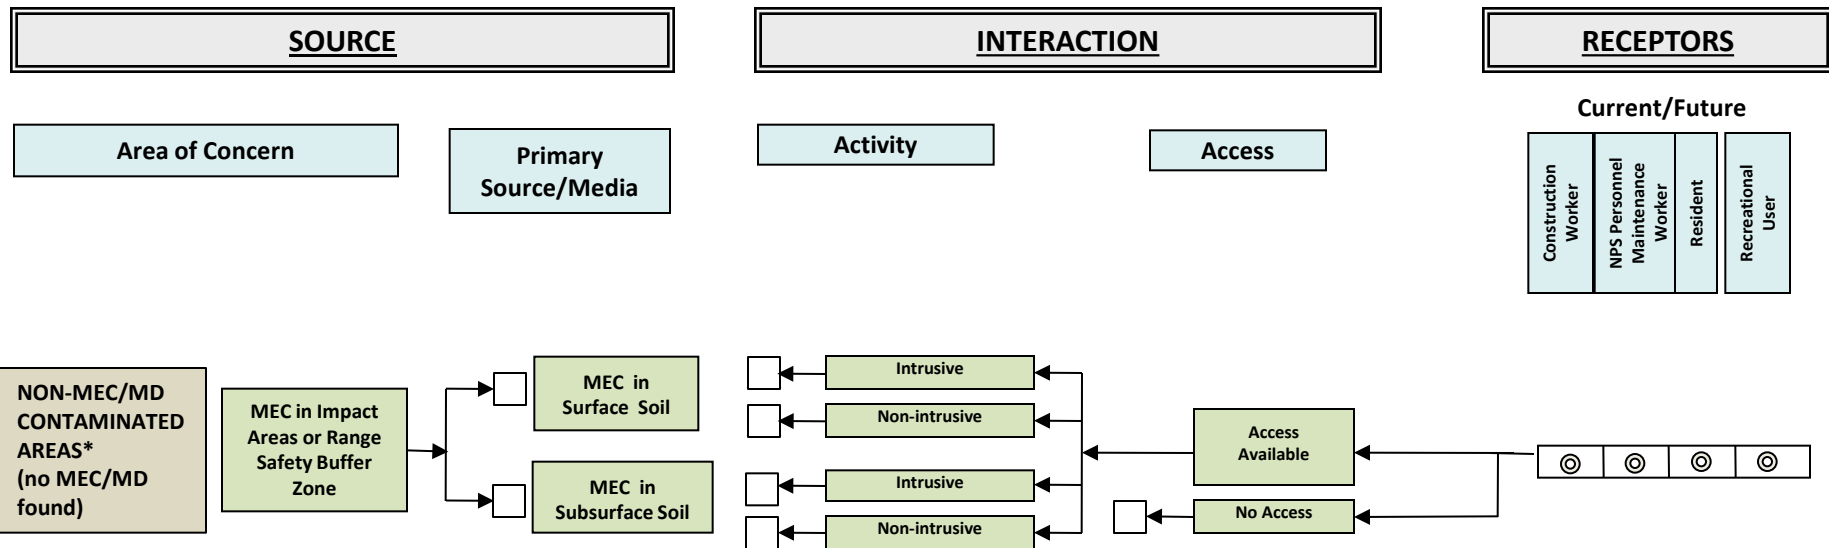
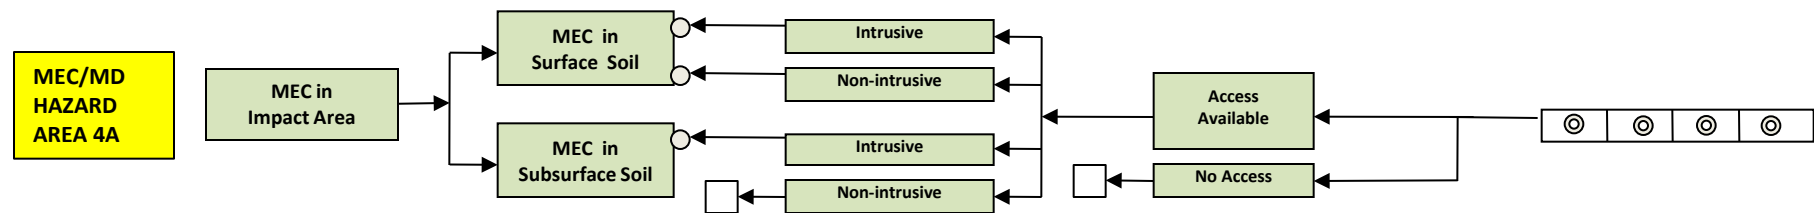
Figure A-5-15. Revised CSM for MRS-4 (MEC/MD)

* All areas of MRS-4 other than MEC/MD Hazard Area shown below

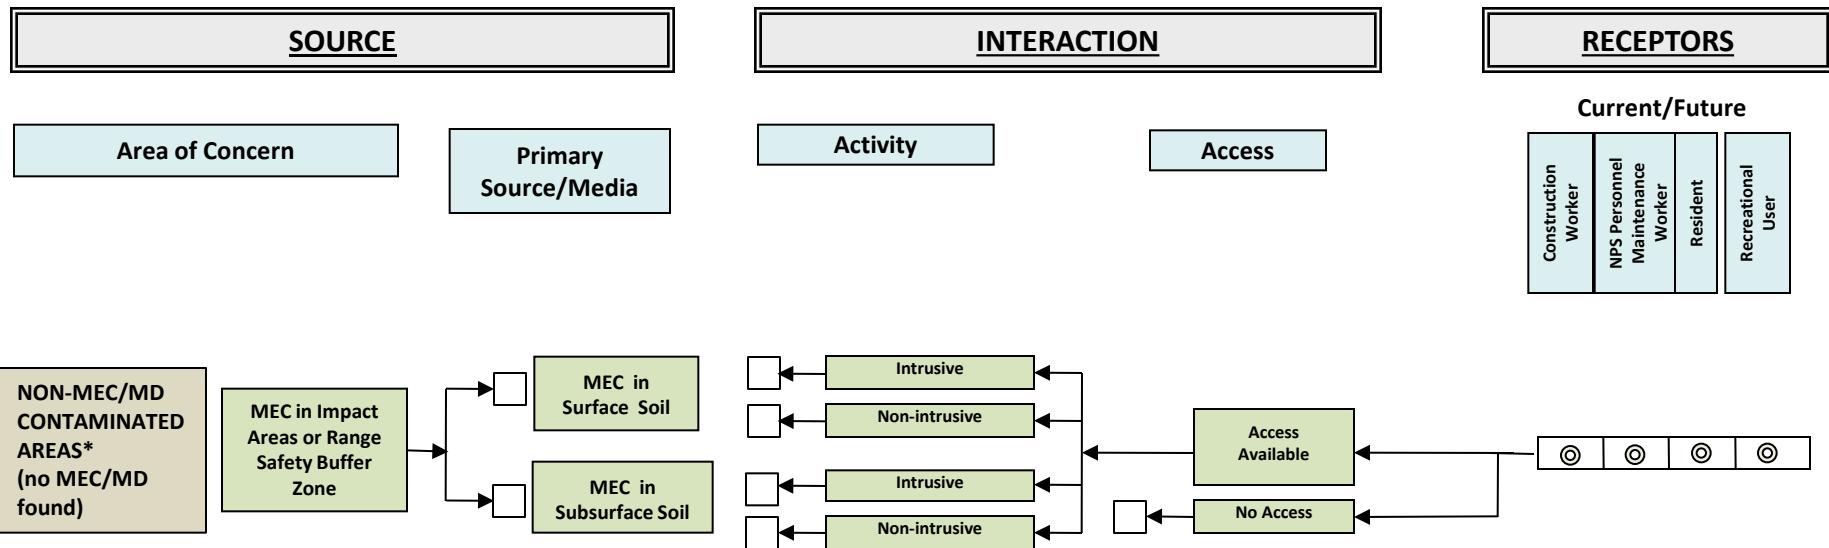
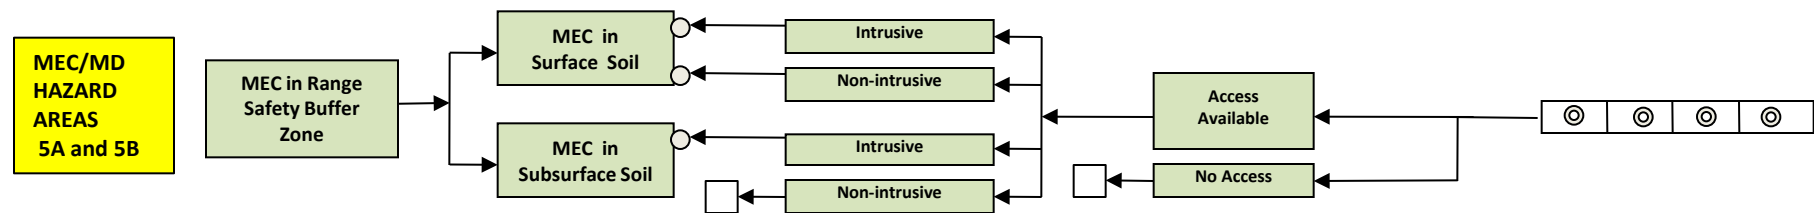
Figure A-5-16. Revised CSM for MRS-5 (MEC/MD)

* All areas of MRS-5 other than MEC/MD Hazard Areas shown below

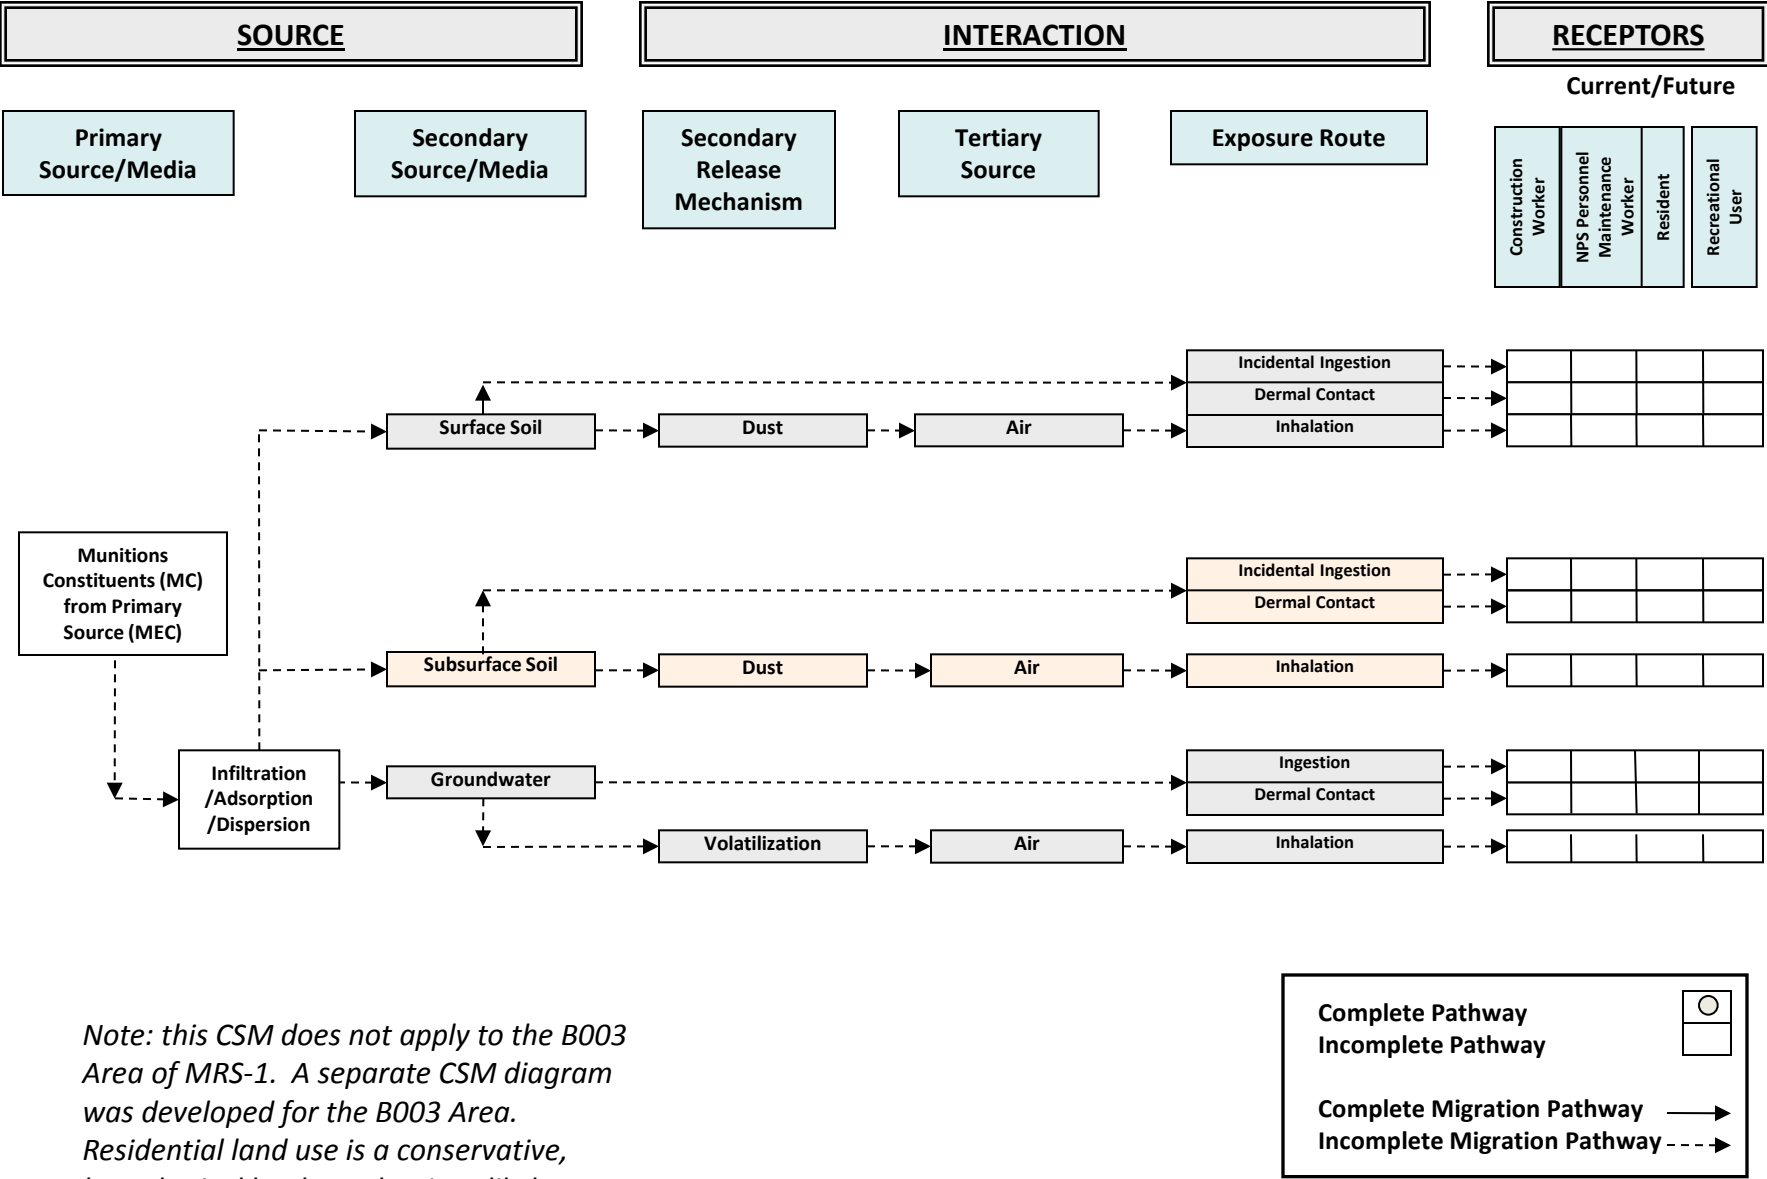
Figure A-5-18. Revised CSM for MRS-1, MRS-2, MRS-3, MRS-4, MRS-6, and MRS-7 (MC - Human Health)

Note: this CSM does not apply to the B003 Area of MRS-1. A separate CSM diagram was developed for the B003 Area. Residential land use is a conservative, hypothetical land use that is unlikely to occur.

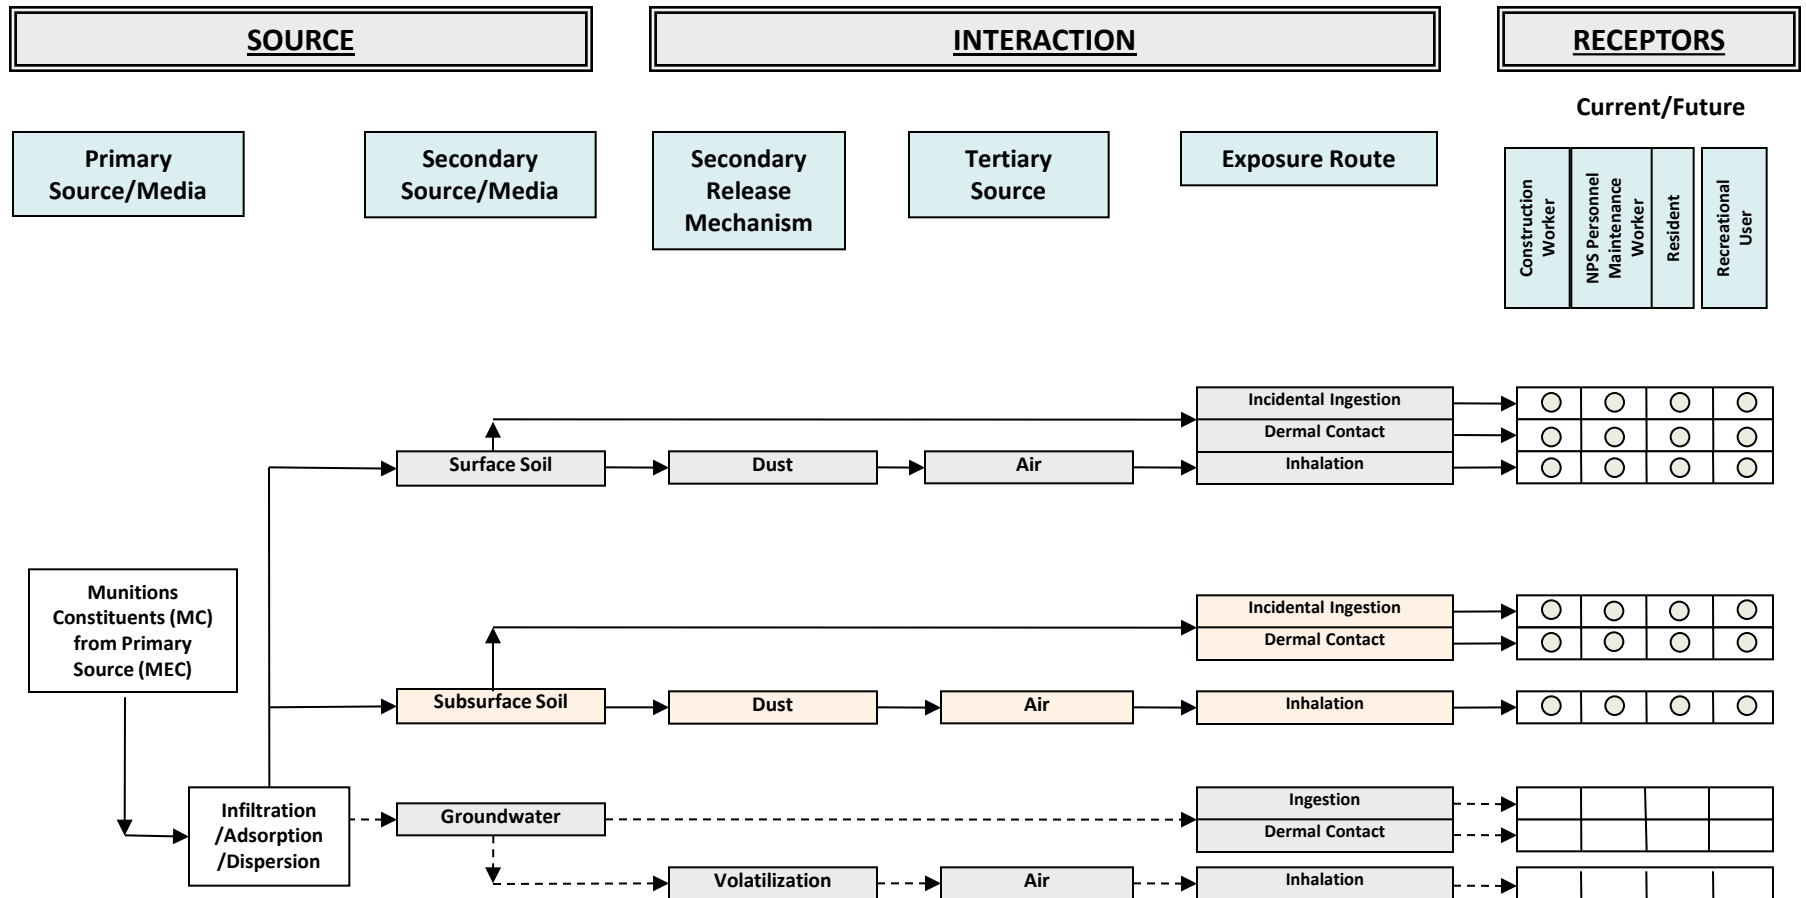
Figure A-5-19. Revised CSM for the Grid B003 Area (MC - Human Health)

Note: residential land use is a conservative, hypothetical land use that is unlikely to occur.

In addition, the potential human health and ecological risks posed by MC found in the B003 Area soil may warrant additional investigation. It is recommended that additional soil sampling be conducted to determine the extent and source of metals contamination in this area.

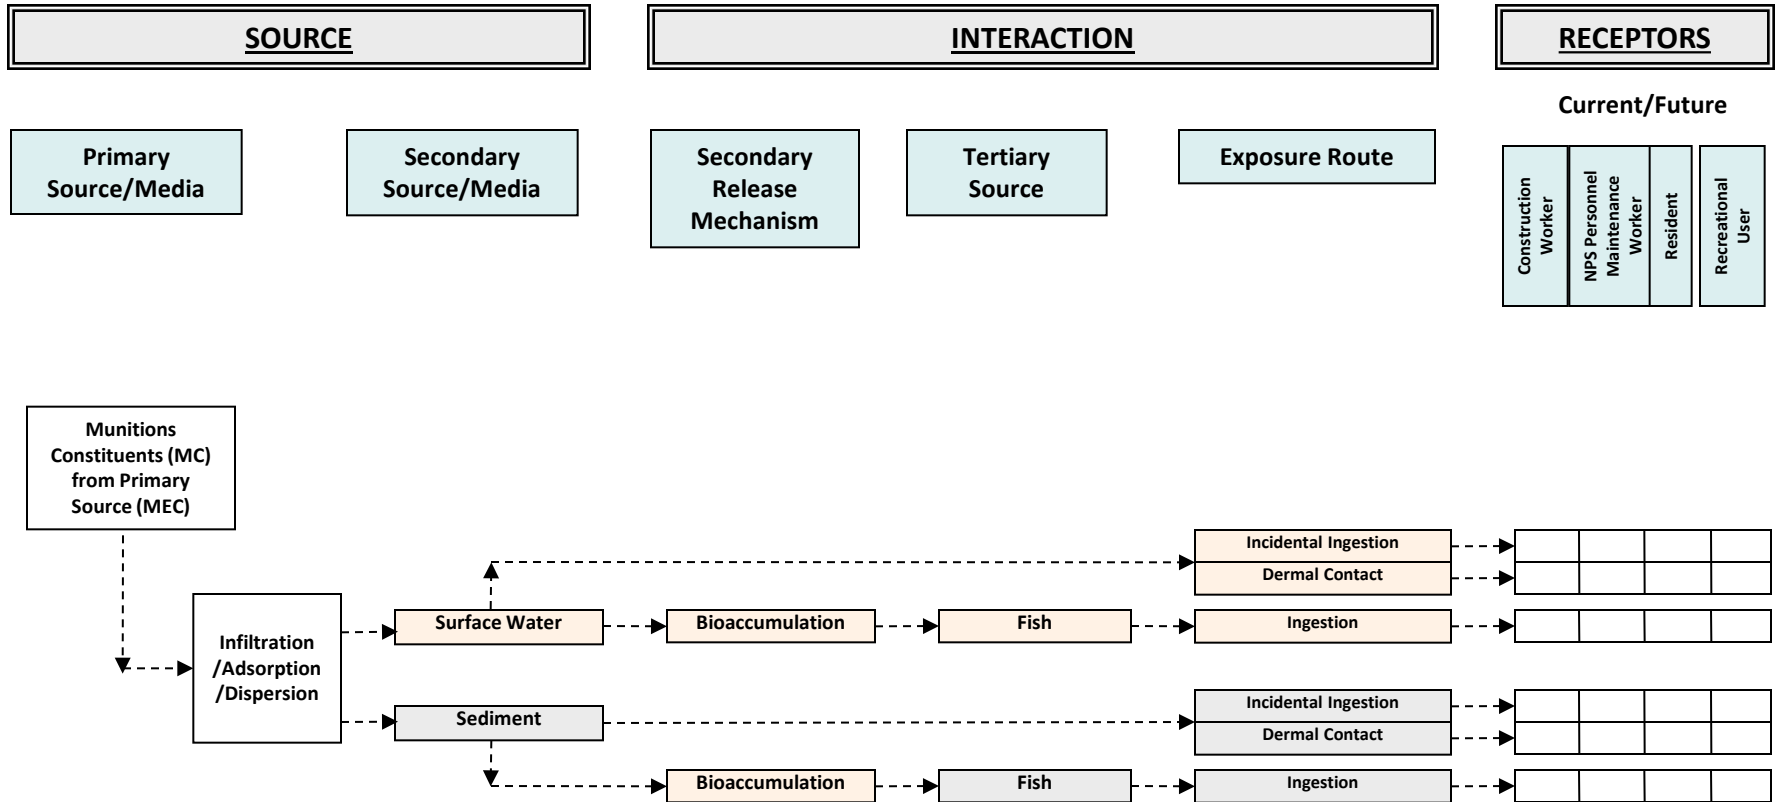
Figure A-5-21. Revised CSM for MRS-8 (MC - Human Health)

Note: residential land use is a conservative, hypothetical land use that is unlikely to occur.
