Hudson Raritan Estuary Ecosystem Restoration Feasibility Study
Appendix K
Restoration Site One-Pagers

HRE- Jamaica Bay- Fresh Creek

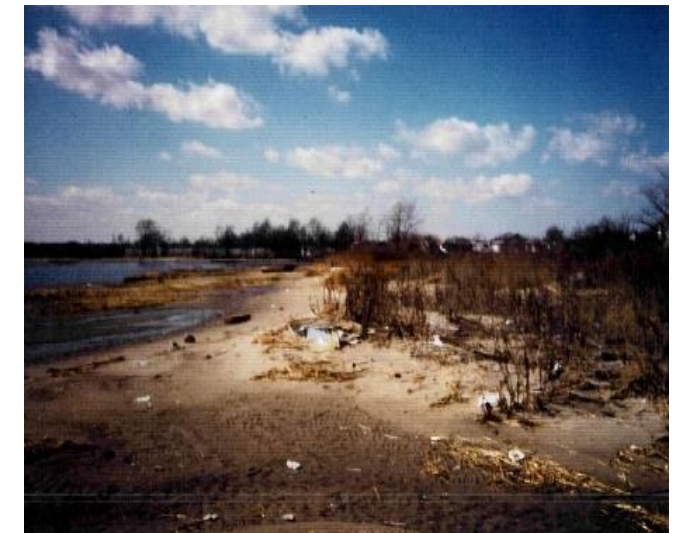
Tentatively Selected Plan Design

Alternative	1
Description	<p>Recommended at AFB 2010 and Approved:</p> <ul style="list-style-type: none"> ✓ Within the limited confines of Hawtree Point, one solution was developed. ✓ Alternative 1 recovers 1.7 acres of coastal scrub shrub and grassland habitat from the existing invasive dominated areas. Some regrading and grubbing would remove the invasive species and native grasses and shrubs will be planted at the site. ✓ This alternative also includes the creation of a natural barrier to motorized vehicles. By placing boulders along the boundary of the restoration area, the newly created habitats as well as the preserved existing marshes will be protected. ✓ Through implementation of this project, an existing patch of salt marsh hay (0.07 acres) will be excavated and replaced. ✓ This area is currently being invaded by the surrounding invasives. Salt marsh hay will be planted in the location after the excavation and regrading of the surrounding land. The net amount of wetland habitat will be the same before and after project implementation.

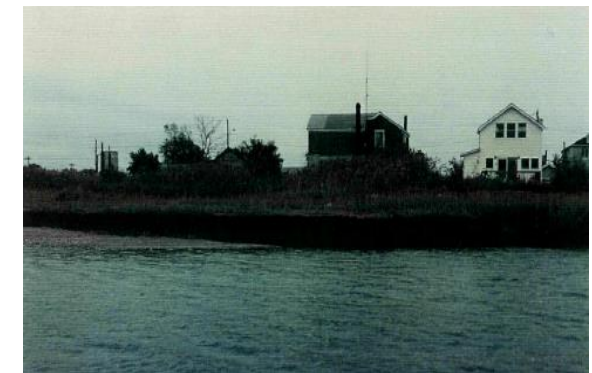
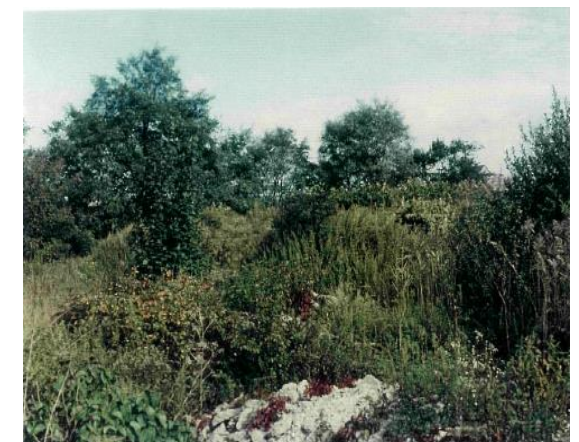
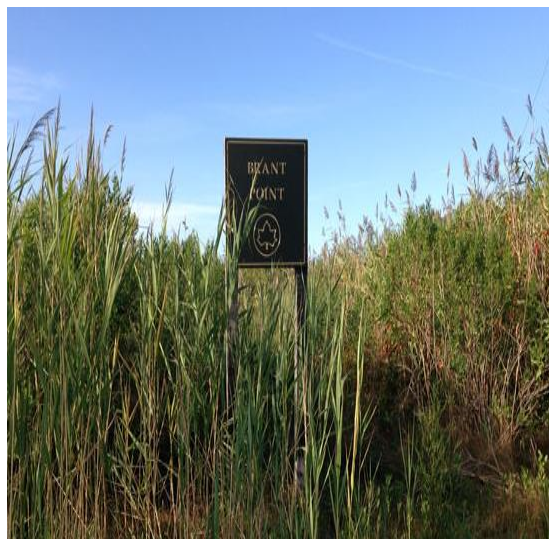
Alternative	1	2
Description	<ul style="list-style-type: none"> ✓ Protection of existing 1.2 acres of marsh and restores an additional 1.9 acres of low marsh, 0.7 acres of high marsh, 2.5 acres of meadow, and 2.4 acres of maritime forest to prevent the spread of invasive species into the aquatic habitat. ✓ Soil excavated to regrade for the marsh creation will be used for onsite landscaping. 	<p>Recommended at AFB 2010 and Approved:</p> <ul style="list-style-type: none"> ✓ In addition to the tidal fringe marsh of Alternative 1, Alt. 2 maximizes marsh habitat protection and creates macroinvertebrate habitat by creating offshore rubble mounds. ✓ The grounded barge at this site shows that offshore structures are capable of protecting the marshes and creating beneficial habitat for macroinvertebrates. Three rock mounds are needed to protect the point from the ongoing erosion. The rocks will be placed randomly within a trapezoidal shape to create interstitial spaces of various sizes that can be used as refugia by various species.

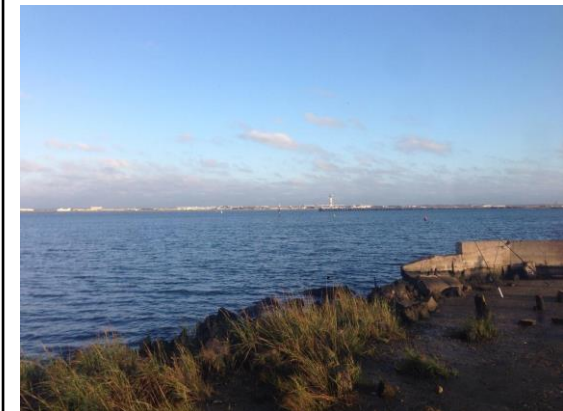
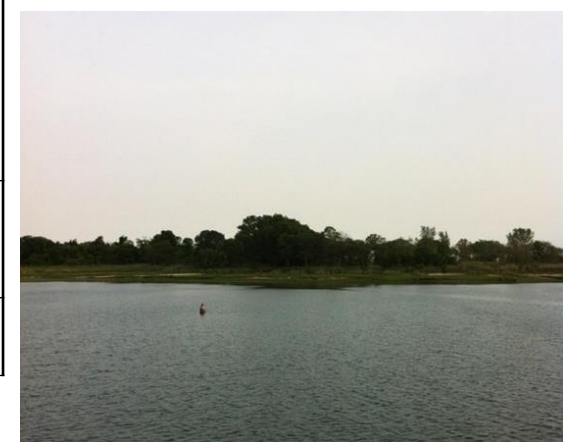
Alternative	1	2	3
Description	<ul style="list-style-type: none"> ✓ Removal of invasive dominated areas by regrading and creating a tidal channel of approximately 0.21 acres and associated salt marsh of 2.0 acres low marsh and 0.4 acres high marsh. All existing areas of marsh or native species will be preserved to the extent possible. ✓ Creation of ~ 0.7 acres of beach/dune ✓ Through selective removal of invasive/non-native vegetation, the mature woodland stands will be restored and replanted with native vegetation to prevent the spread of invasive species into the aquatic habitat and to provide a protective buffer for the marsh system. ✓ Training structures will be created on the banks at the mouth of the creek to stabilize the tidal creek and protect the existing beach and salt marsh habitat. 	<p>Recommended at AFB 2010 and Approved:</p> <ul style="list-style-type: none"> ✓ Similar to Alt. 1, but with the addition of creating a tidal pool to the west of the creek/marsh complex. The tidal pool will cover approximately 0.6 acres to allow the creation of an additional 0.5 acres of low marsh. ✓ This area currently includes small patches of salt marsh and switchgrass, as well as some mowed areas that are mugwort-dominated. ✓ Hard structures will cover approximately 0.6 acres including armoring of the point and training structures at the mouth of the channel to protect the area from erosion. 	<ul style="list-style-type: none"> ✓ Integrates the tidal creek and marsh system of Alt. 1, but adds in the creation of a T-groin system and coastal dune restoration. ✓ The tidal creek area of restoration is exactly the same as in Alt. 1 and 2. The T-groin system would allow further inundation of tides creating 0.4 acres of shallow water and creating 0.5 acres of low marsh. ✓ Approximately 1.0 acre of dunes/ beach would also be constructed behind the groins. Low/high marsh will be planted in between rocks where tidal inundation and wave climate permit habitat survival.

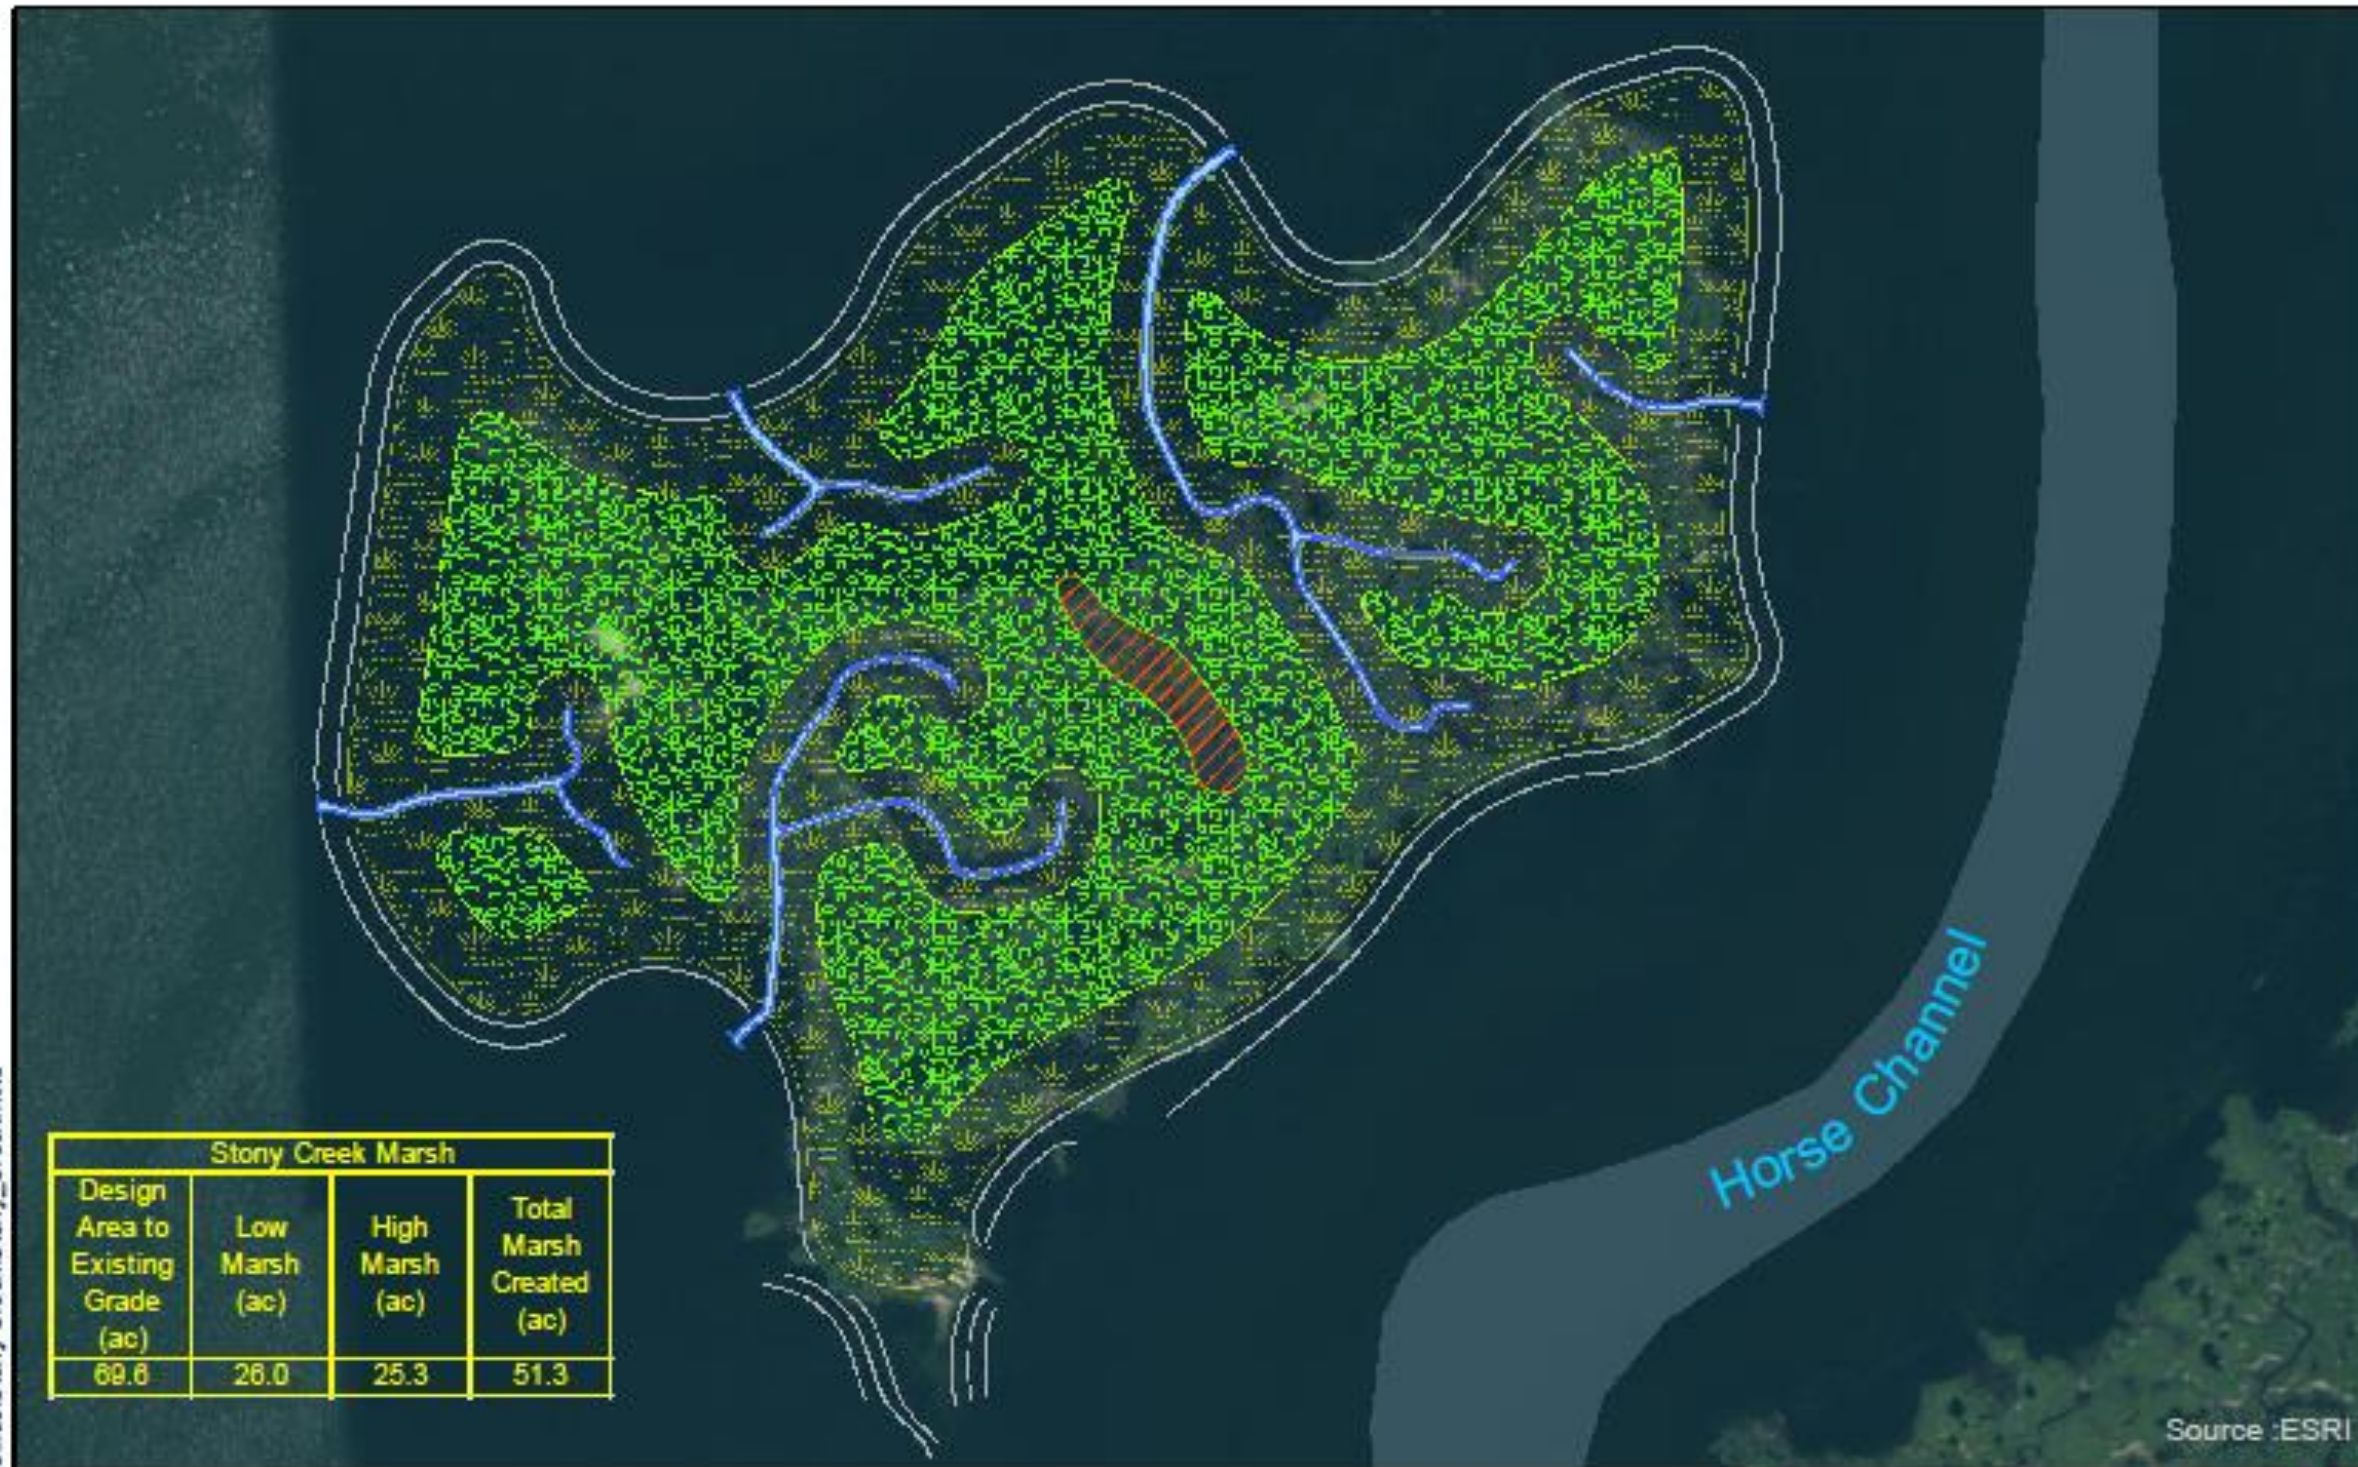
Tentatively Selected Plan Design

Stony Creek Marsh			
Design Area to Existing Grade (ac)	Low Marsh (ac)	High Marsh (ac)	Total Marsh Created (ac)
69.6	28.0	25.3	51.3

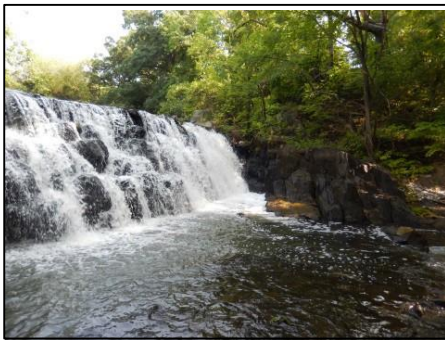
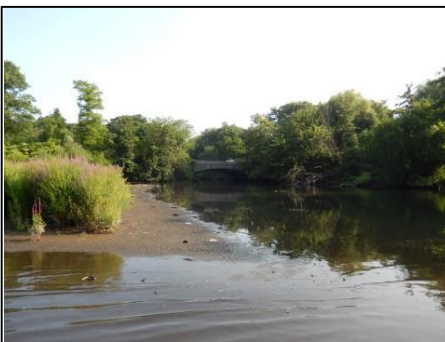
Alternative	A	B	C
Description	<ul style="list-style-type: none"> ✓ Removal of invasive vegetation and native planting (0.27 ac) along both banks, on the upland island upstream of the dams, and additional location downstream of the dams. ✓ Channel modification (~0.35 ac): river bottom excavation and bed material replacement between the island and the west bank . ✓ Bank softening of the west side (415 lf) by select removal of the existing armor and native planting. ✓ Installation of a fish ladder (0.04 ac) to link the excavated channel area upstream of the dams to the river channel below the dams . ✓ Creation of emergent wetlands (0.99 ac) along both banks upstream of the dams, and along the west bank downstream of the dams. ✓ Creation of forested wetlands (0.29 ac) in two locations upstream of the dams, along the east bank and on the island . ✓ Debris removal between the dams (0.09 ac). ✓ Installation of a sediment trap to reduce sediment loads reaching the river. ✓ Improved public access. 	<ul style="list-style-type: none"> ✓ Removal of invasive vegetation and native planting (0.56 ac) along both banks, on the upland island upstream of the dams, and additional location downstream of the dams. ✓ Channel modification (~0.35 ac): river bottom excavation and bed material replacement between the island and the west bank . ✓ Bank softening of the west side (415 lf) by select removal of the existing armor and native planting. ✓ Installation of a fish ladder (0.04 ac) to link the excavated channel area upstream of the dams to the river channel below the dams . ✓ Creation of emergent wetlands (0.70 ac) along both banks upstream of the dams, and along the west bank downstream of the dams. ✓ Debris removal between the dams (0.09 ac). ✓ Installation of a sediment trap to reduce sediment loads reaching the river. ✓ Improved public access. 	<ul style="list-style-type: none"> ✓ Removal of invasive vegetation and native planting (0.56 ac) along both banks, on the upland island upstream of the dams, and additional location downstream of the dams. ✓ Installation of a fish ladder (0.04 ac) to link the excavated channel area upstream of the dams to the river channel below the dams . ✓ Creation of emergent wetlands (0.54 ac) along both banks upstream of the dams, and along the west bank downstream of the dams. ✓ Debris removal between the dams (0.09 ac). ✓ Installation of a sediment trap to reduce sediment loads reaching the river. ✓ Improved public access.

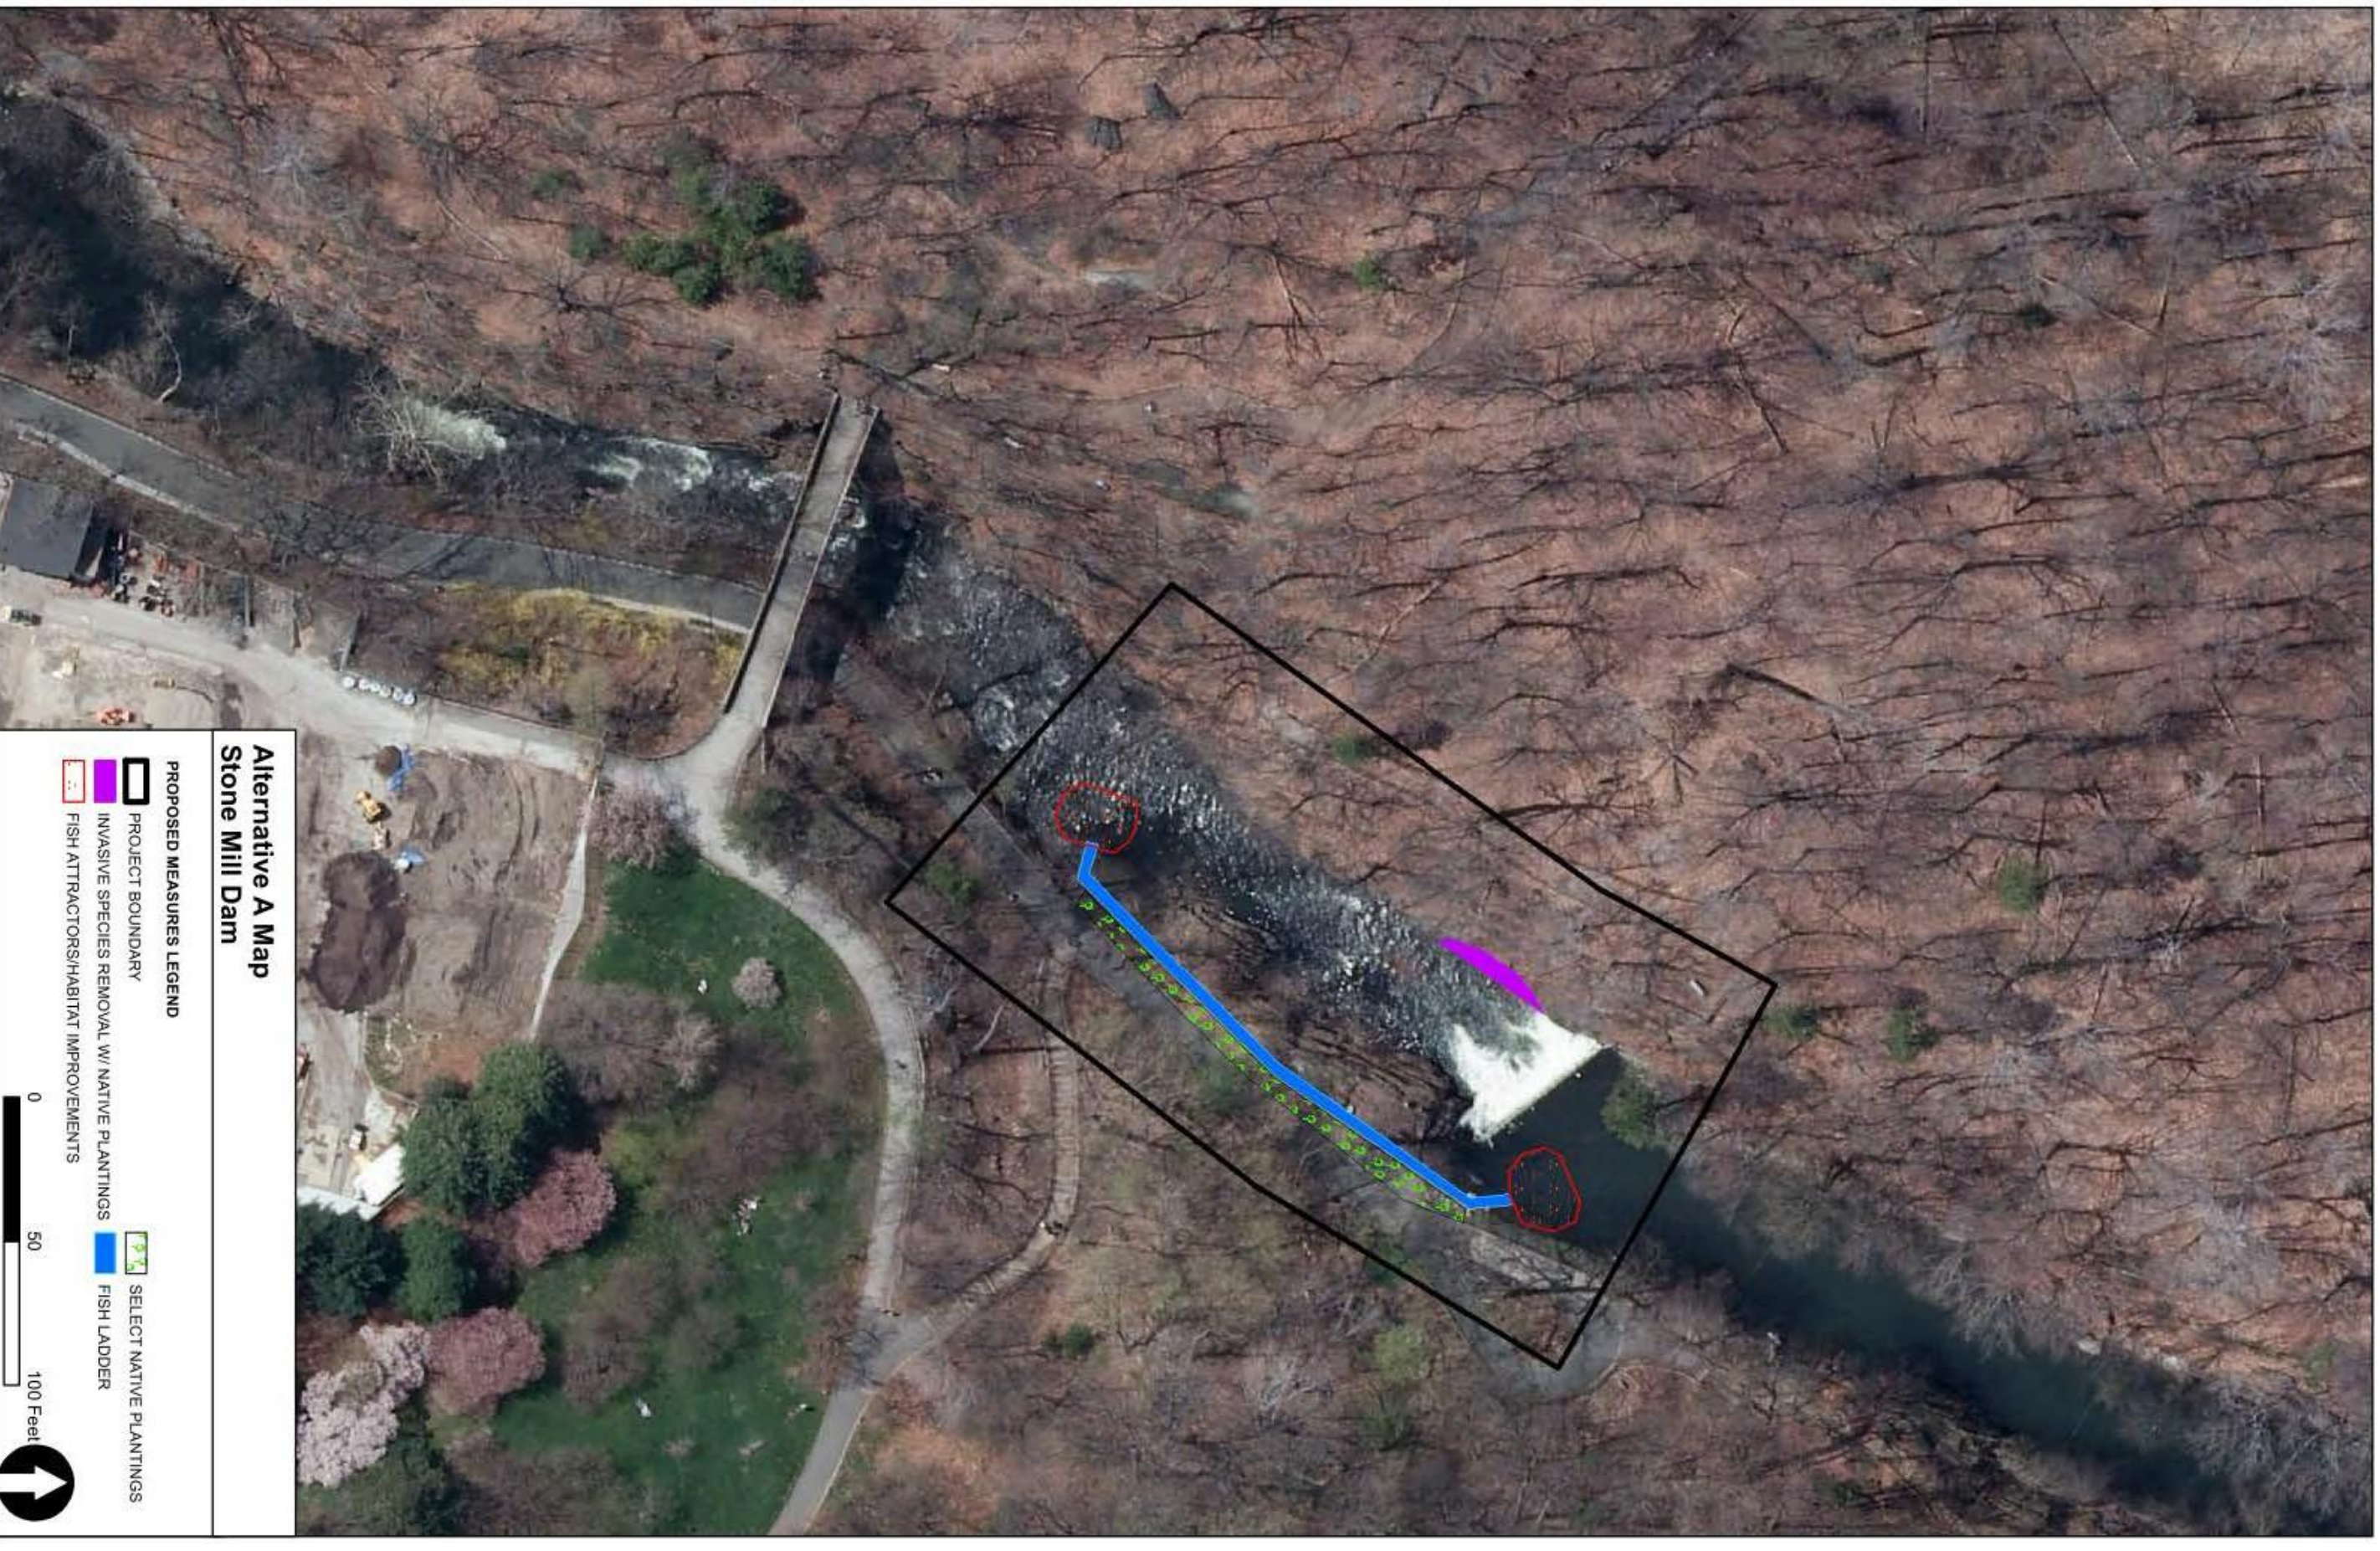
Tentatively Selected Plan Design

Alternative	A	B	C
Description	<ul style="list-style-type: none"> ✓ Installation of a fish ladder to link the slow-flowing pool upstream of the dam and the faster-flowing channel downstream of the dam. ✓ Placement of clay-pipe fish attractors at both the upstream and downstream ends of the fish ladder to function as refuge habitats for fish. ✓ Planting of native vegetation along the east bank of the river, abutting the fish ladder (0.03 ac). ✓ Removal of invasive vegetation from a small area along the west bank, immediately downstream of the dam, and replacement with native vegetation. 	<ul style="list-style-type: none"> ✓ Installation of a fish ladder to link the slow-flowing pool upstream of the dam and the faster-flowing channel downstream of the dam. ✓ Planting of native vegetation along the east bank of the river, abutting the fish ladder (0.03 ac). 	<ul style="list-style-type: none"> ✓ River bed excavation and material replacement upstream of the dam (0.09 ac).

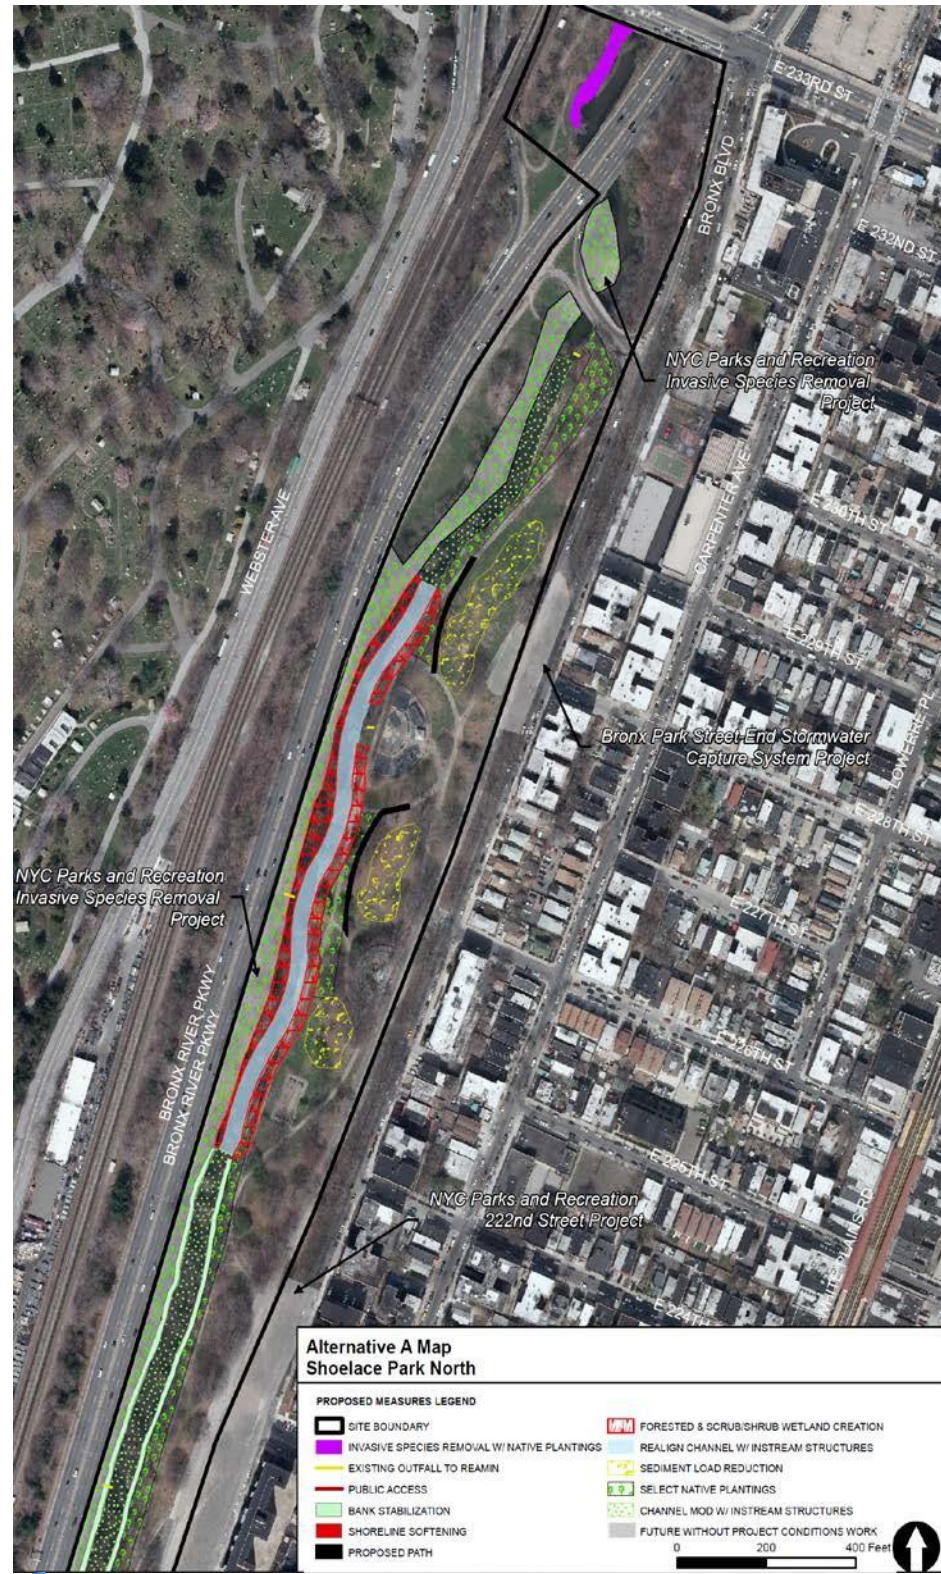
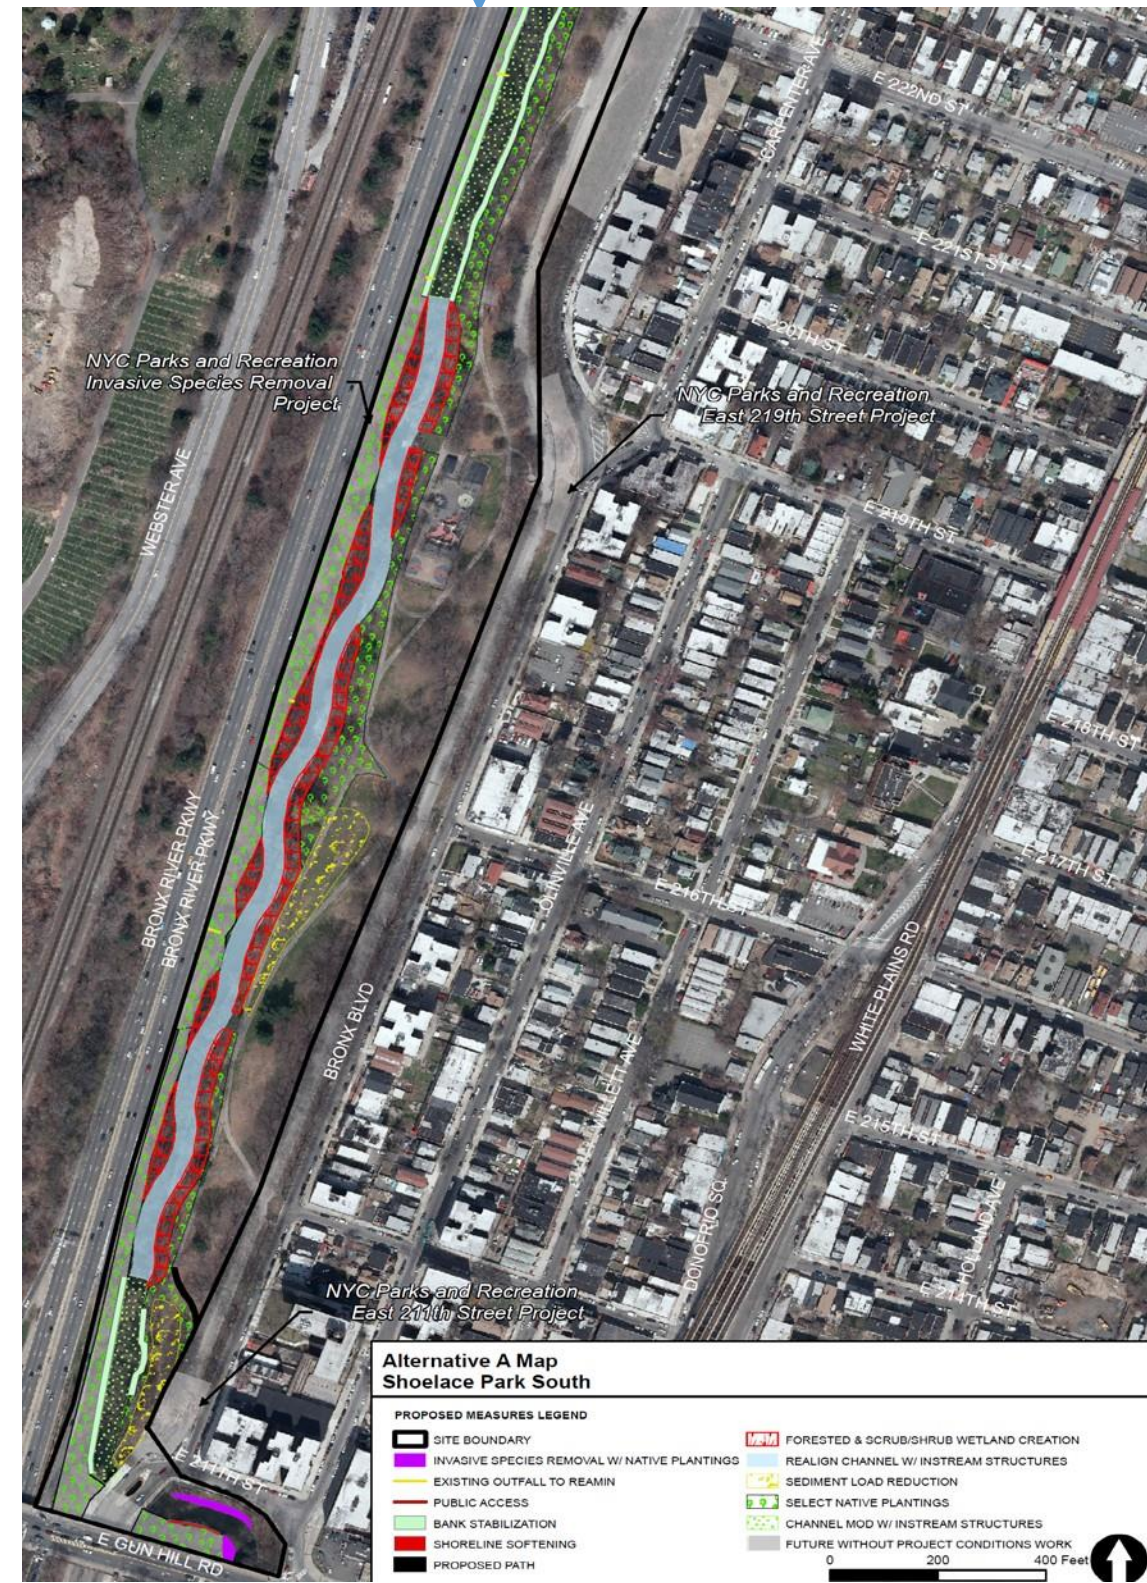
Tentatively Selected Plan Design

Alternative	A	B	C
Description	<ul style="list-style-type: none"> ✓ Restoration of Bronx River reach to pre-industrialization conditions: realigns channel with natural meanders and restores large tracts of forested wetlands along the banks. ✓ Entire channel modification with instream structures (6,680 Lft mi): restoration of natural pools, thalweg, riffle complexes, etc. - resulting in a substantial increase of aquatic habitat value. ✓ Bank stabilization with environmental engineering techniques that provide vegetation coverage along the banks (11,620 Lft, on both sides). ✓ Select native plantings (6.5 ac) would provide a wooded riparian corridor along the banks of the entire reach. The riparian woodlands and restored forested wetlands would provide habitat resources that are currently very limited in the Bronx urban environment and reduce nutrient inputs to the water. ✓ Sediment load reduction with bank stabilization and installation of rain gardens, bioretention basins, etc. ✓ Invasive removal and select native plantings. ✓ Public access to the river would be maintained. 	<ul style="list-style-type: none"> ✓ Entire channel modified with instream structures (1.3 mi): restoration of natural pools, thalweg, riffle complexes, etc. - resulting in a substantial increase of aquatic habitat value. ✓ Bank stabilization with environmental engineering techniques that provide vegetation coverage along the banks (>1 mi on both sides). ✓ Select native plantings would provide a wooded riparian corridor along the banks of the entire reach. ✓ Sediment load reduction with bank stabilization and installation of rain gardens, bioretention basins, etc. ✓ Invasive removal and select native plantings (~3.5 ac). ✓ Public access to the river would be maintained. 	<ul style="list-style-type: none"> ✓ Entire channel modified with instream structures (~1.2 mi): restoration of natural pools, thalweg, riffle complexes, etc. - resulting in a substantial increase of aquatic habitat value. ✓ Bank stabilization with environmental engineering techniques that provide vegetation coverage along the banks (>1.1 mi). ✓ Sediment load reduction with bank stabilization and installation of rain gardens, bioretention basins, etc. ✓ Invasive removal and select native plantings (3.5 ac). ✓ Public access to the river would be maintained.

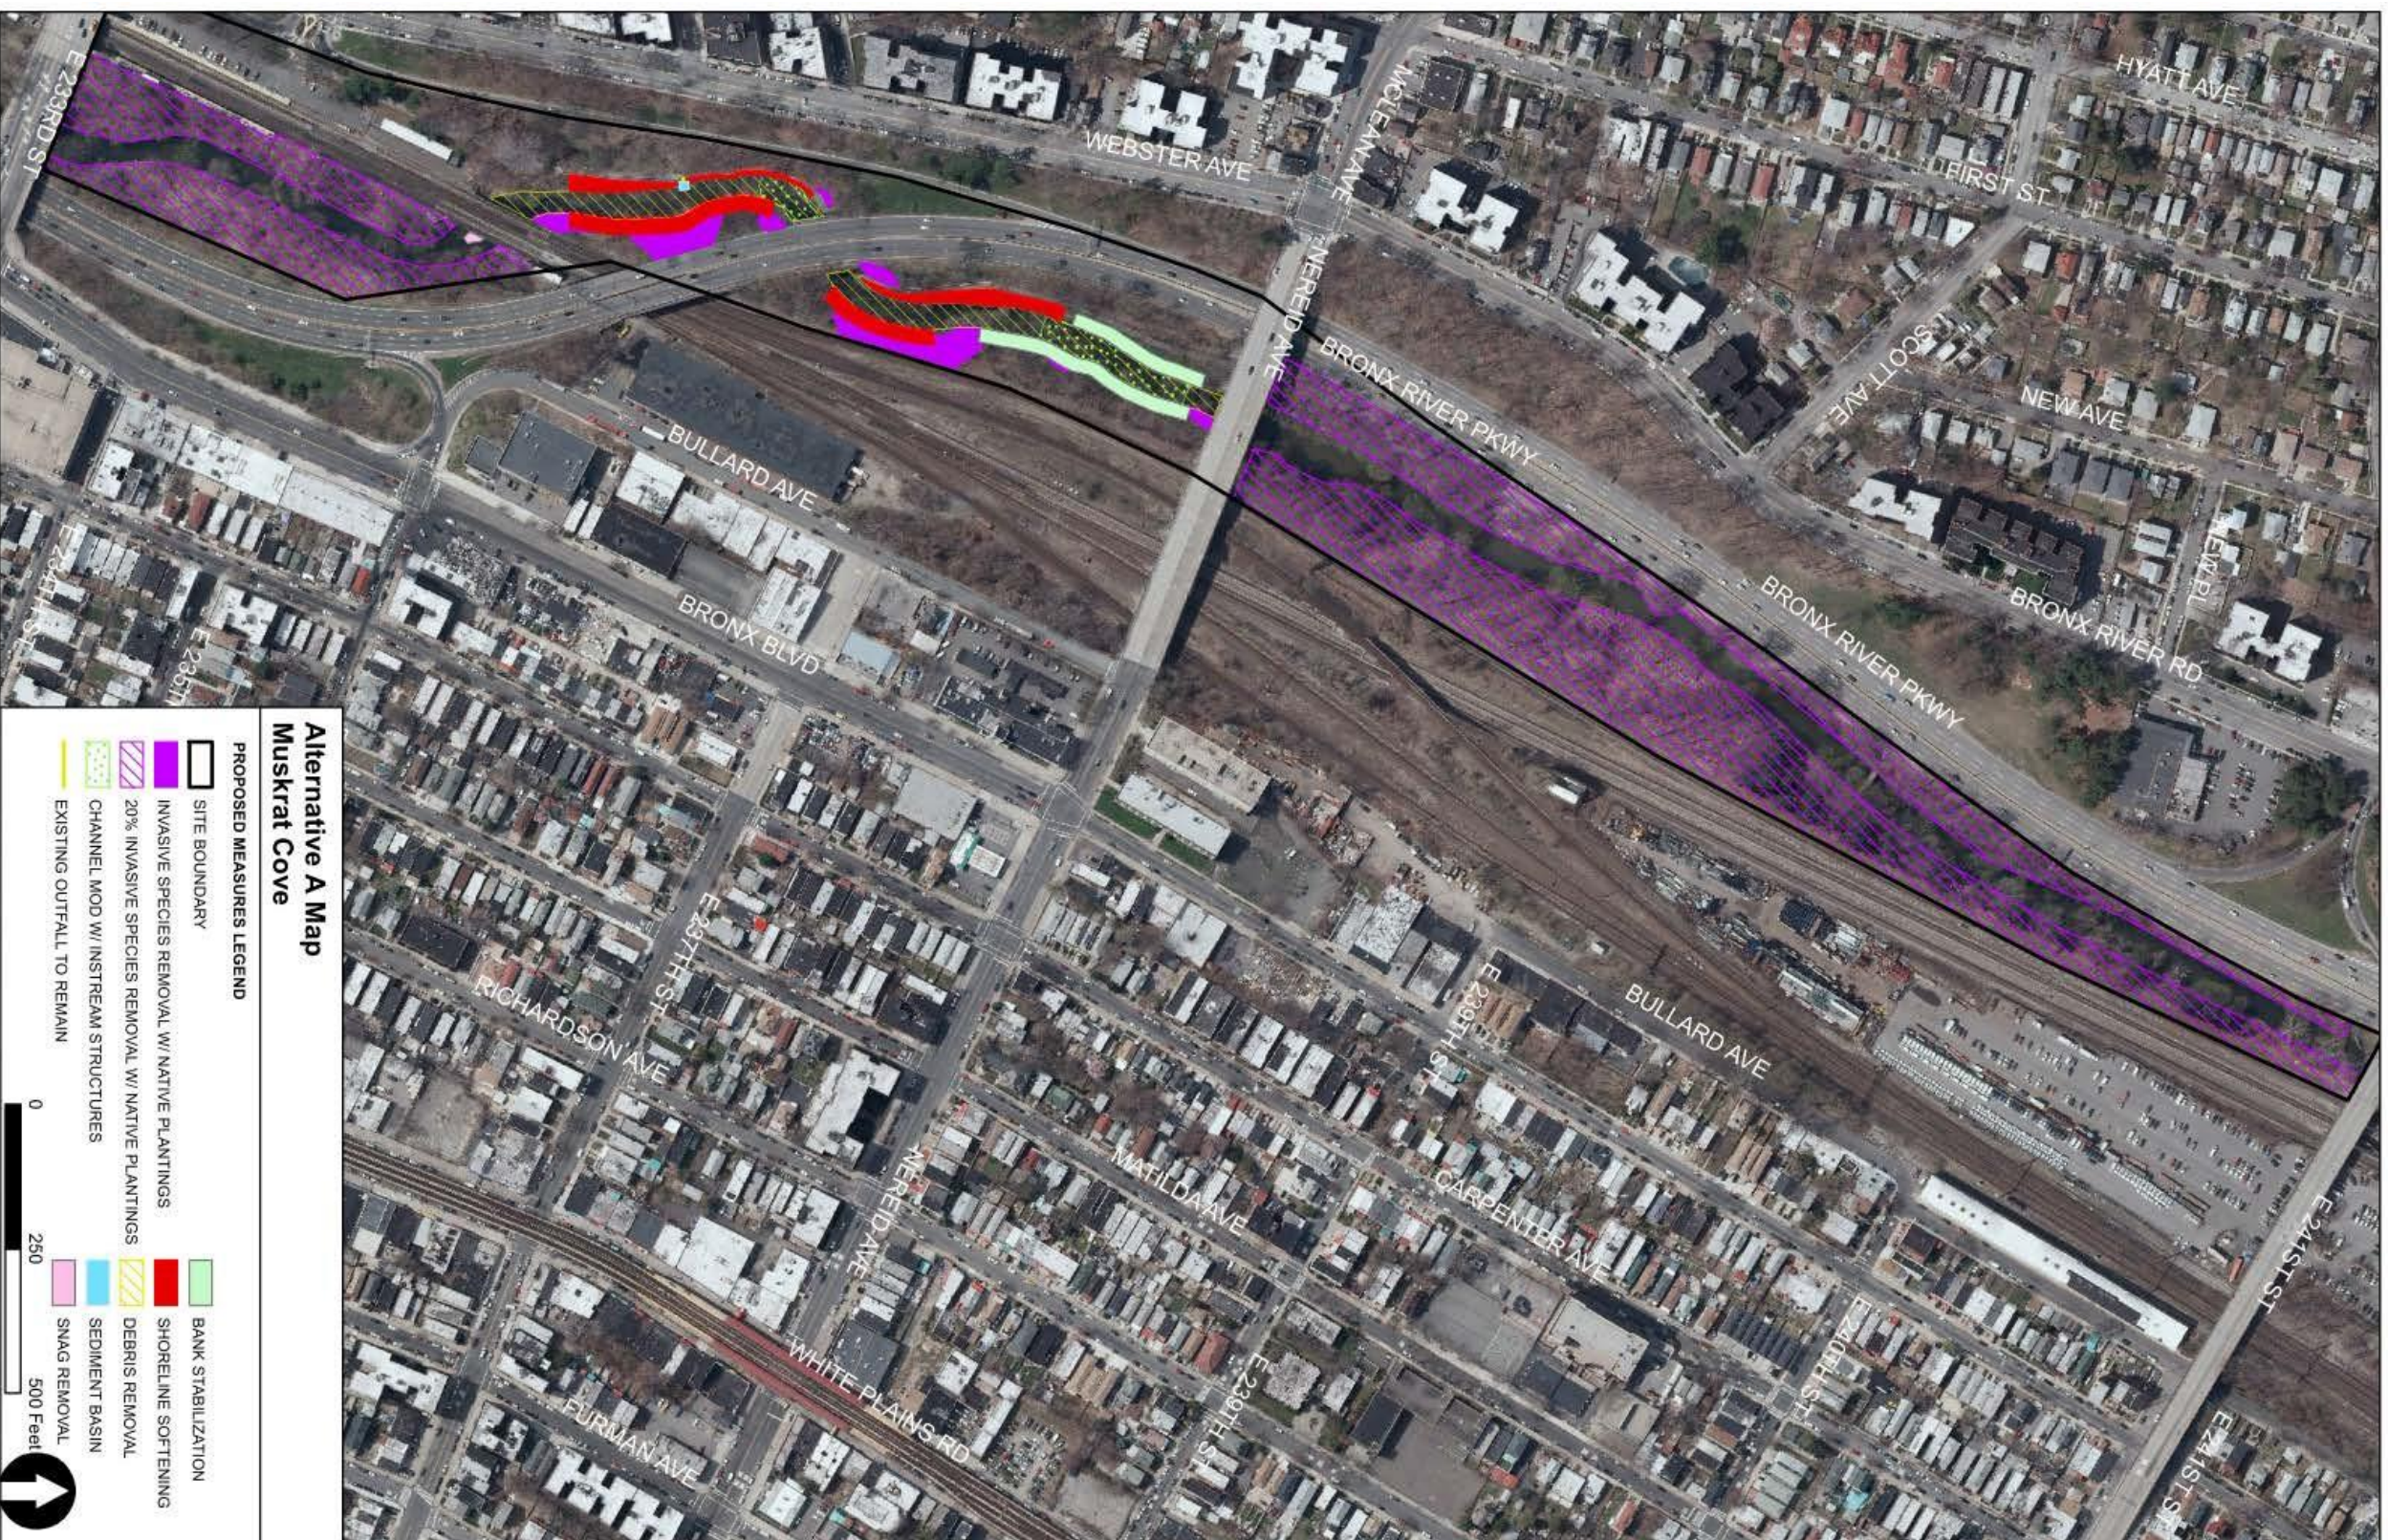
Tentatively Selected Plan Design

Alternative	A	B	C
Description	<ul style="list-style-type: none"> ✓ Invasive species removal with native plantings on the upland slopes and along both banks throughout the length of the site (~0.49 ac). ✓ River bank stabilization between Nereid Avenue and the rail line bridge over the river, construction of vegetated cribwalls, softening using drilling with native plant materials (1,350 lf). ✓ Removal of debris and log jams from the river (1.24 ac). ✓ Channel modification along two segments (1.24 ac), excavation and replacement of bed material, and construction of instream cross vanes and J-hooks. ✓ Installation of a sediment basin at an existing outfall to reduce sediment loads reaching the river. 	<ul style="list-style-type: none"> ✓ Invasive species removal with native plantings on the upland slopes and along both banks throughout the length of the site (~0.49 ac). ✓ River bank stabilization between Nereid Avenue and the rail line bridge over the river, construction of vegetated cribwalls, softening using drilling with native plant materials (1,350 lf). ✓ Removal of debris and log jams from the river (1.24 ac). ✓ Channel modification along one segment, excavation and replacement of bed material, and instream structures (0.11 ac). ✓ Bed restoration along another segment (0.26 ac) with creation of a riffle-pool complex. Excavation and replacement of bed material (0.10 ac), and placement of cut and round boulders. ✓ Installation of a sediment basin at an existing outfall to reduce sediment loads reaching the river. 	<ul style="list-style-type: none"> ✓ Invasive species removal with native plantings on the upland slopes and along both banks throughout the length of the site (~0.49 ac). ✓ River bank stabilization between Nereid Avenue and the rail line bridge over the river (640 lf). ✓ Removal of debris and log jams from the river (1.24 ac). ✓ Bed restoration along another segment (0.26 ac) with creation of a riffle-pool complex. Excavation and replacement of bed material (0.10 ac), and placement of cut and round boulders. ✓ Installation of a sediment basin at an existing outfall to reduce sediment loads reaching the river.

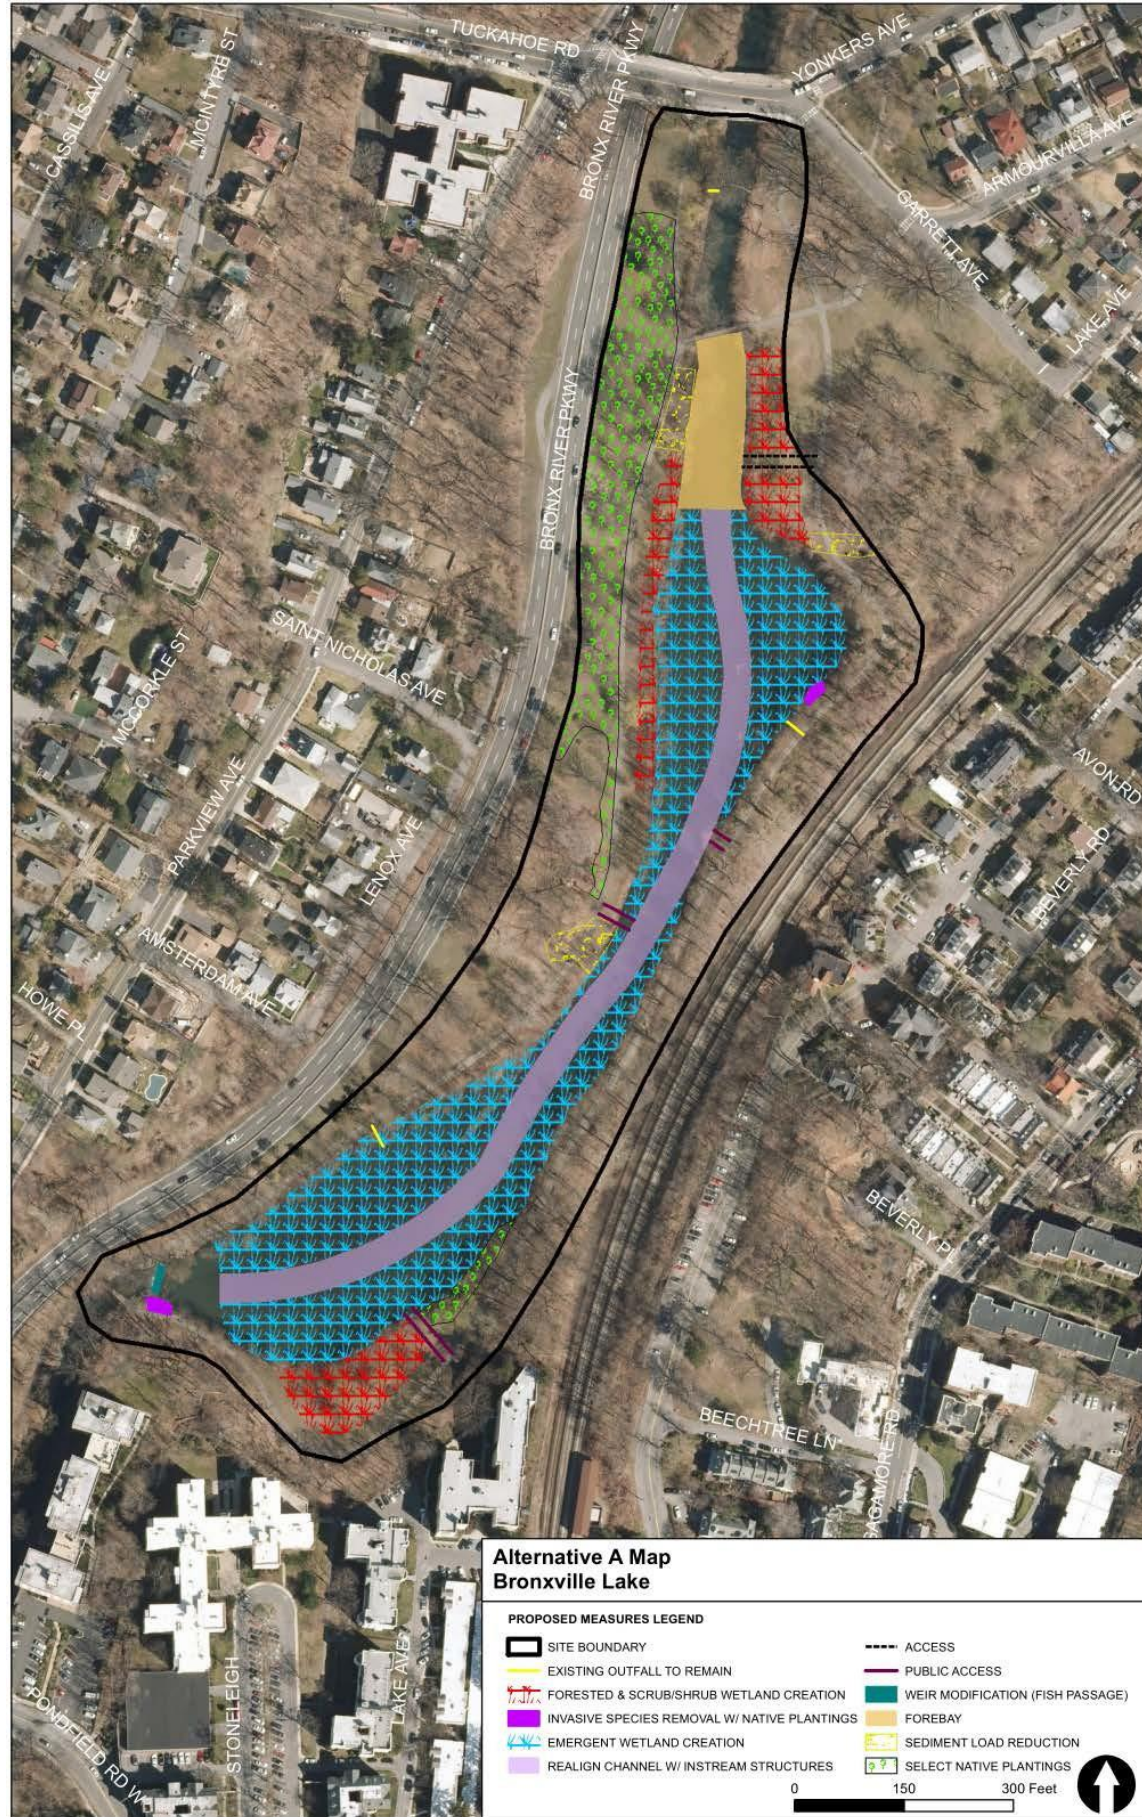
Tentatively Selected Plan Design

Alternative	A	B	C
Description	<ul style="list-style-type: none"> Native planting: upland trees and shrubs in the northwest portion of the site along the Bronx River Parkway (~1.3 ac) and along the southeast portion of the lake (~0.09 ac). Construction of a rip rap forebay upstream of the lake (0.43 ac). Channel realignment (1.28 ac) with replacement of bed material and construction of 11 instream cross vanes. Creation of emergent wetlands between the channel and the lake banks (3.67 ac) and forested and scrub/shrub wetlands around the lake perimeter (1.02 ac). Modification of the existing rock weir at the southern end of the lake to facilitate fish passage. Removal invasive vegetation (0.03 ac) and replacement/addition of native species (1.40 ac). Sediment load reduction with installation of vegetated swales, bioretention basins, and rain gardens at three locations (0.24 ac). Improved public access to the river. 	<ul style="list-style-type: none"> Channel bed restoration with excavation and bedding stone installation (~1.28 ac). Creation of emergent wetlands in narrow strips along the banks of the lake (0.59 ac) Creation of forested and scrub/shrub wetlands around sections of lake perimeter and in filled areas (2.90 ac). Modification of the existing rock weir at the southern end of the lake to facilitate fish passage. Removal invasive vegetation and replacement/addition of native species (1.40 ac). Sediment dredging in two small sections of the channel. Sediment load reduction with installation of vegetated swales, bioretention basins, and rain gardens at three locations (0.24 ac). 	<ul style="list-style-type: none"> Native planting: upland trees and shrubs in the northwest portion of the site along the Bronx River Parkway (~1.3 ac) , and along the southeast portion of the lake (~0.09 ac). Construction of a rip rap forebay upstream of the lake (0.43 ac). Channel bed restoration along the intervening river channel (0.37 ac). Creation of emergent wetlands in smaller and narrower strips along the lake shore (~0.2 ac) Creation of forested and scrub/shrub wetlands east bank of the river, upstream of the lake (0.57 ac). Installation of fish passage to link the lake and the river downstream of the existing weir. Removal invasive vegetation (0.03 ac) and replacement/addition of native species (1.40 ac). Sediment dredging both broad, shallow lobes of lake. Sediment load reduction with installation of vegetated swales, bioretention basins, and rain gardens at three locations (0.24 ac). Improved public access to the river.
