Hudson Raritan Estuary Ecosystem Restoration Feasibility Study
Appendix K
Restoration Site One-Pagers

HRE- Jamaica Bay- Fresh Creek

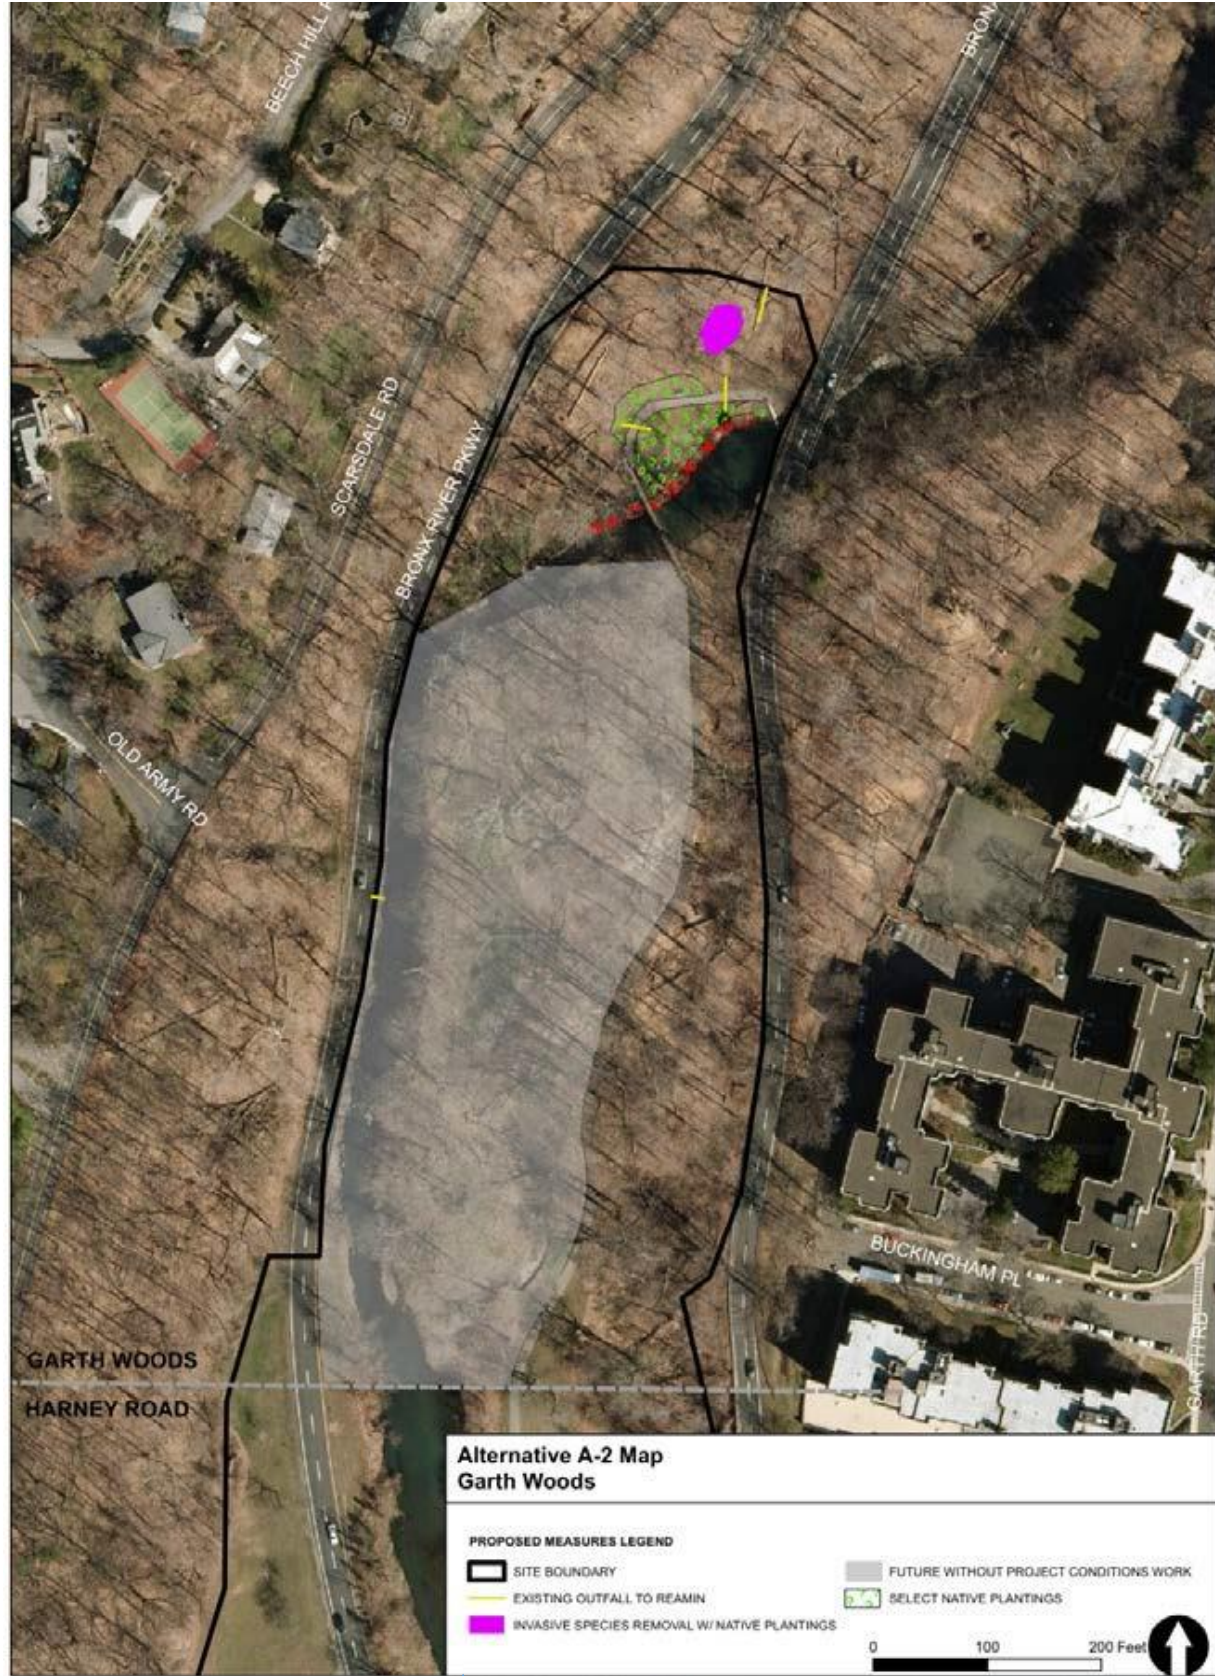
Tentatively Selected Plan Design

Note: For each alternative, the same actions are proposed for the Garth Woods site. The actions are the following: <ul style="list-style-type: none"> Creation of forested and scrub/shrub wetlands along the west bank of the river at the upstream end of the site (0.03 ac). Select native plantings in the adjacent lawn, on both sides of the paved path (0.14 ac). Removal of invasive species near the northern border of the site and replacement with native upland or wetland shrubs and herbaceous vegetation (0.02 ac). 		
AAFUs	3.23	2.44	2.26
Project Cost	\$7,200,000	\$6,490,000	\$3,750,000
Annual Cost	\$275,830	\$248,630	\$143,490
Average Cost/AAFCU	\$85,470	\$101,810	\$63,410

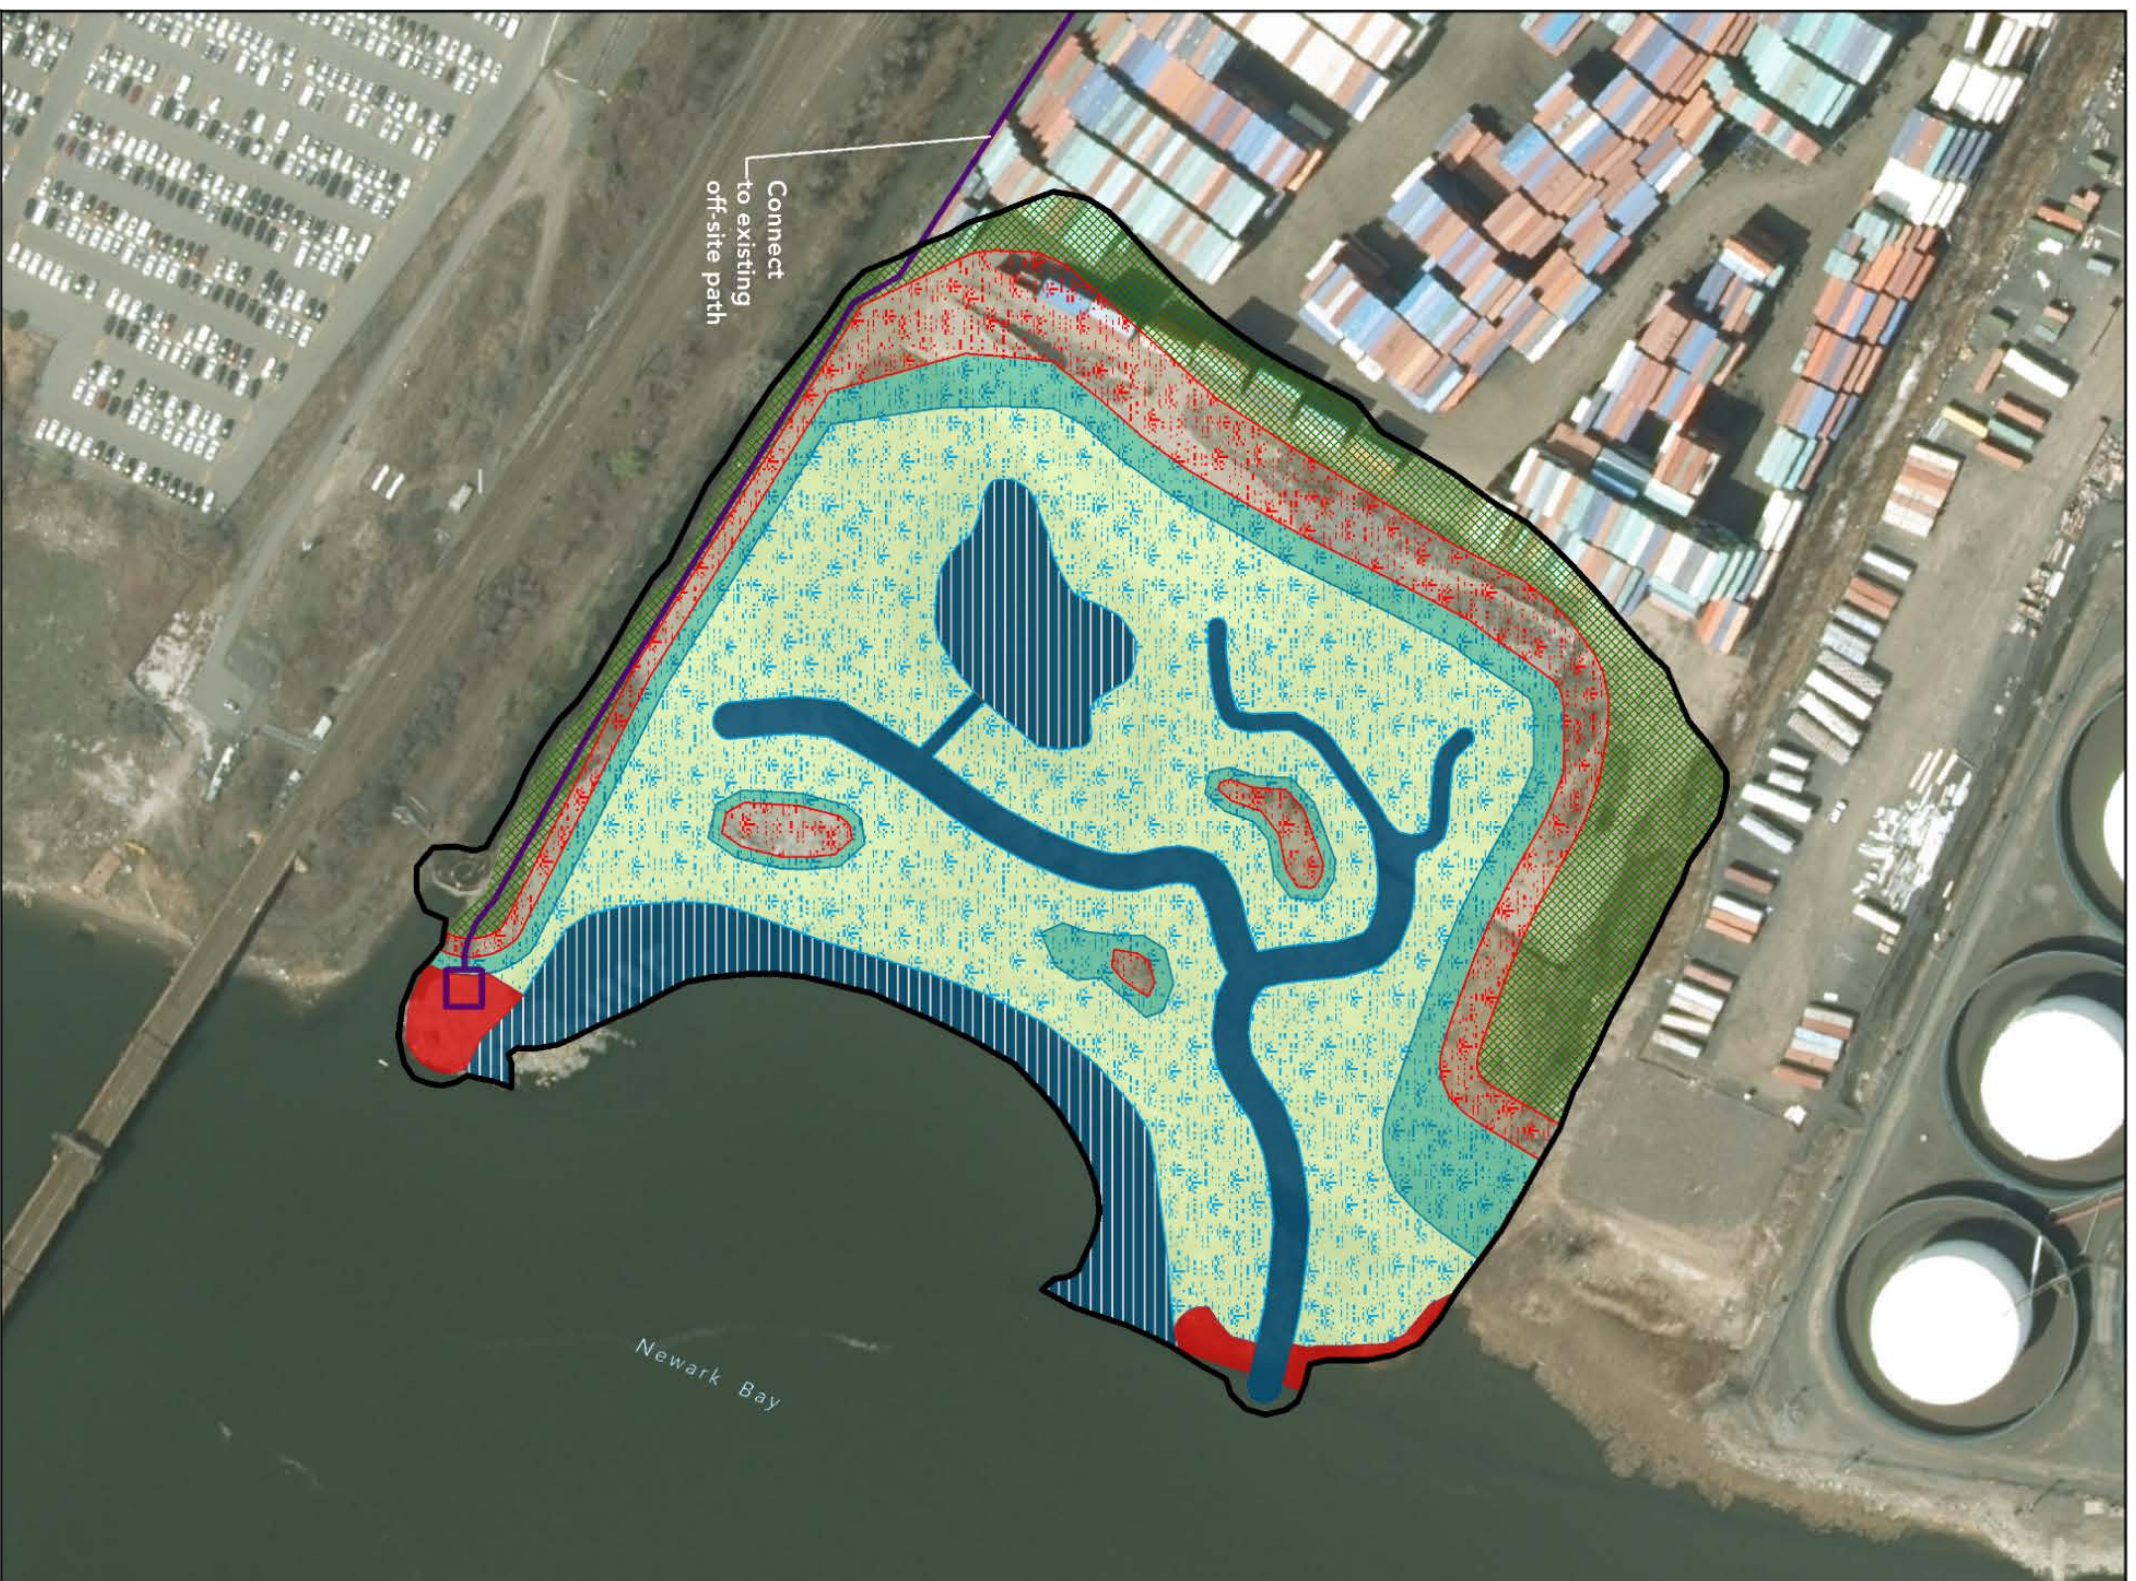
Alternative A Map
Oak Island Yards, Newark, New Jersey (Deferred Site)

Tentatively Selected Plan Design

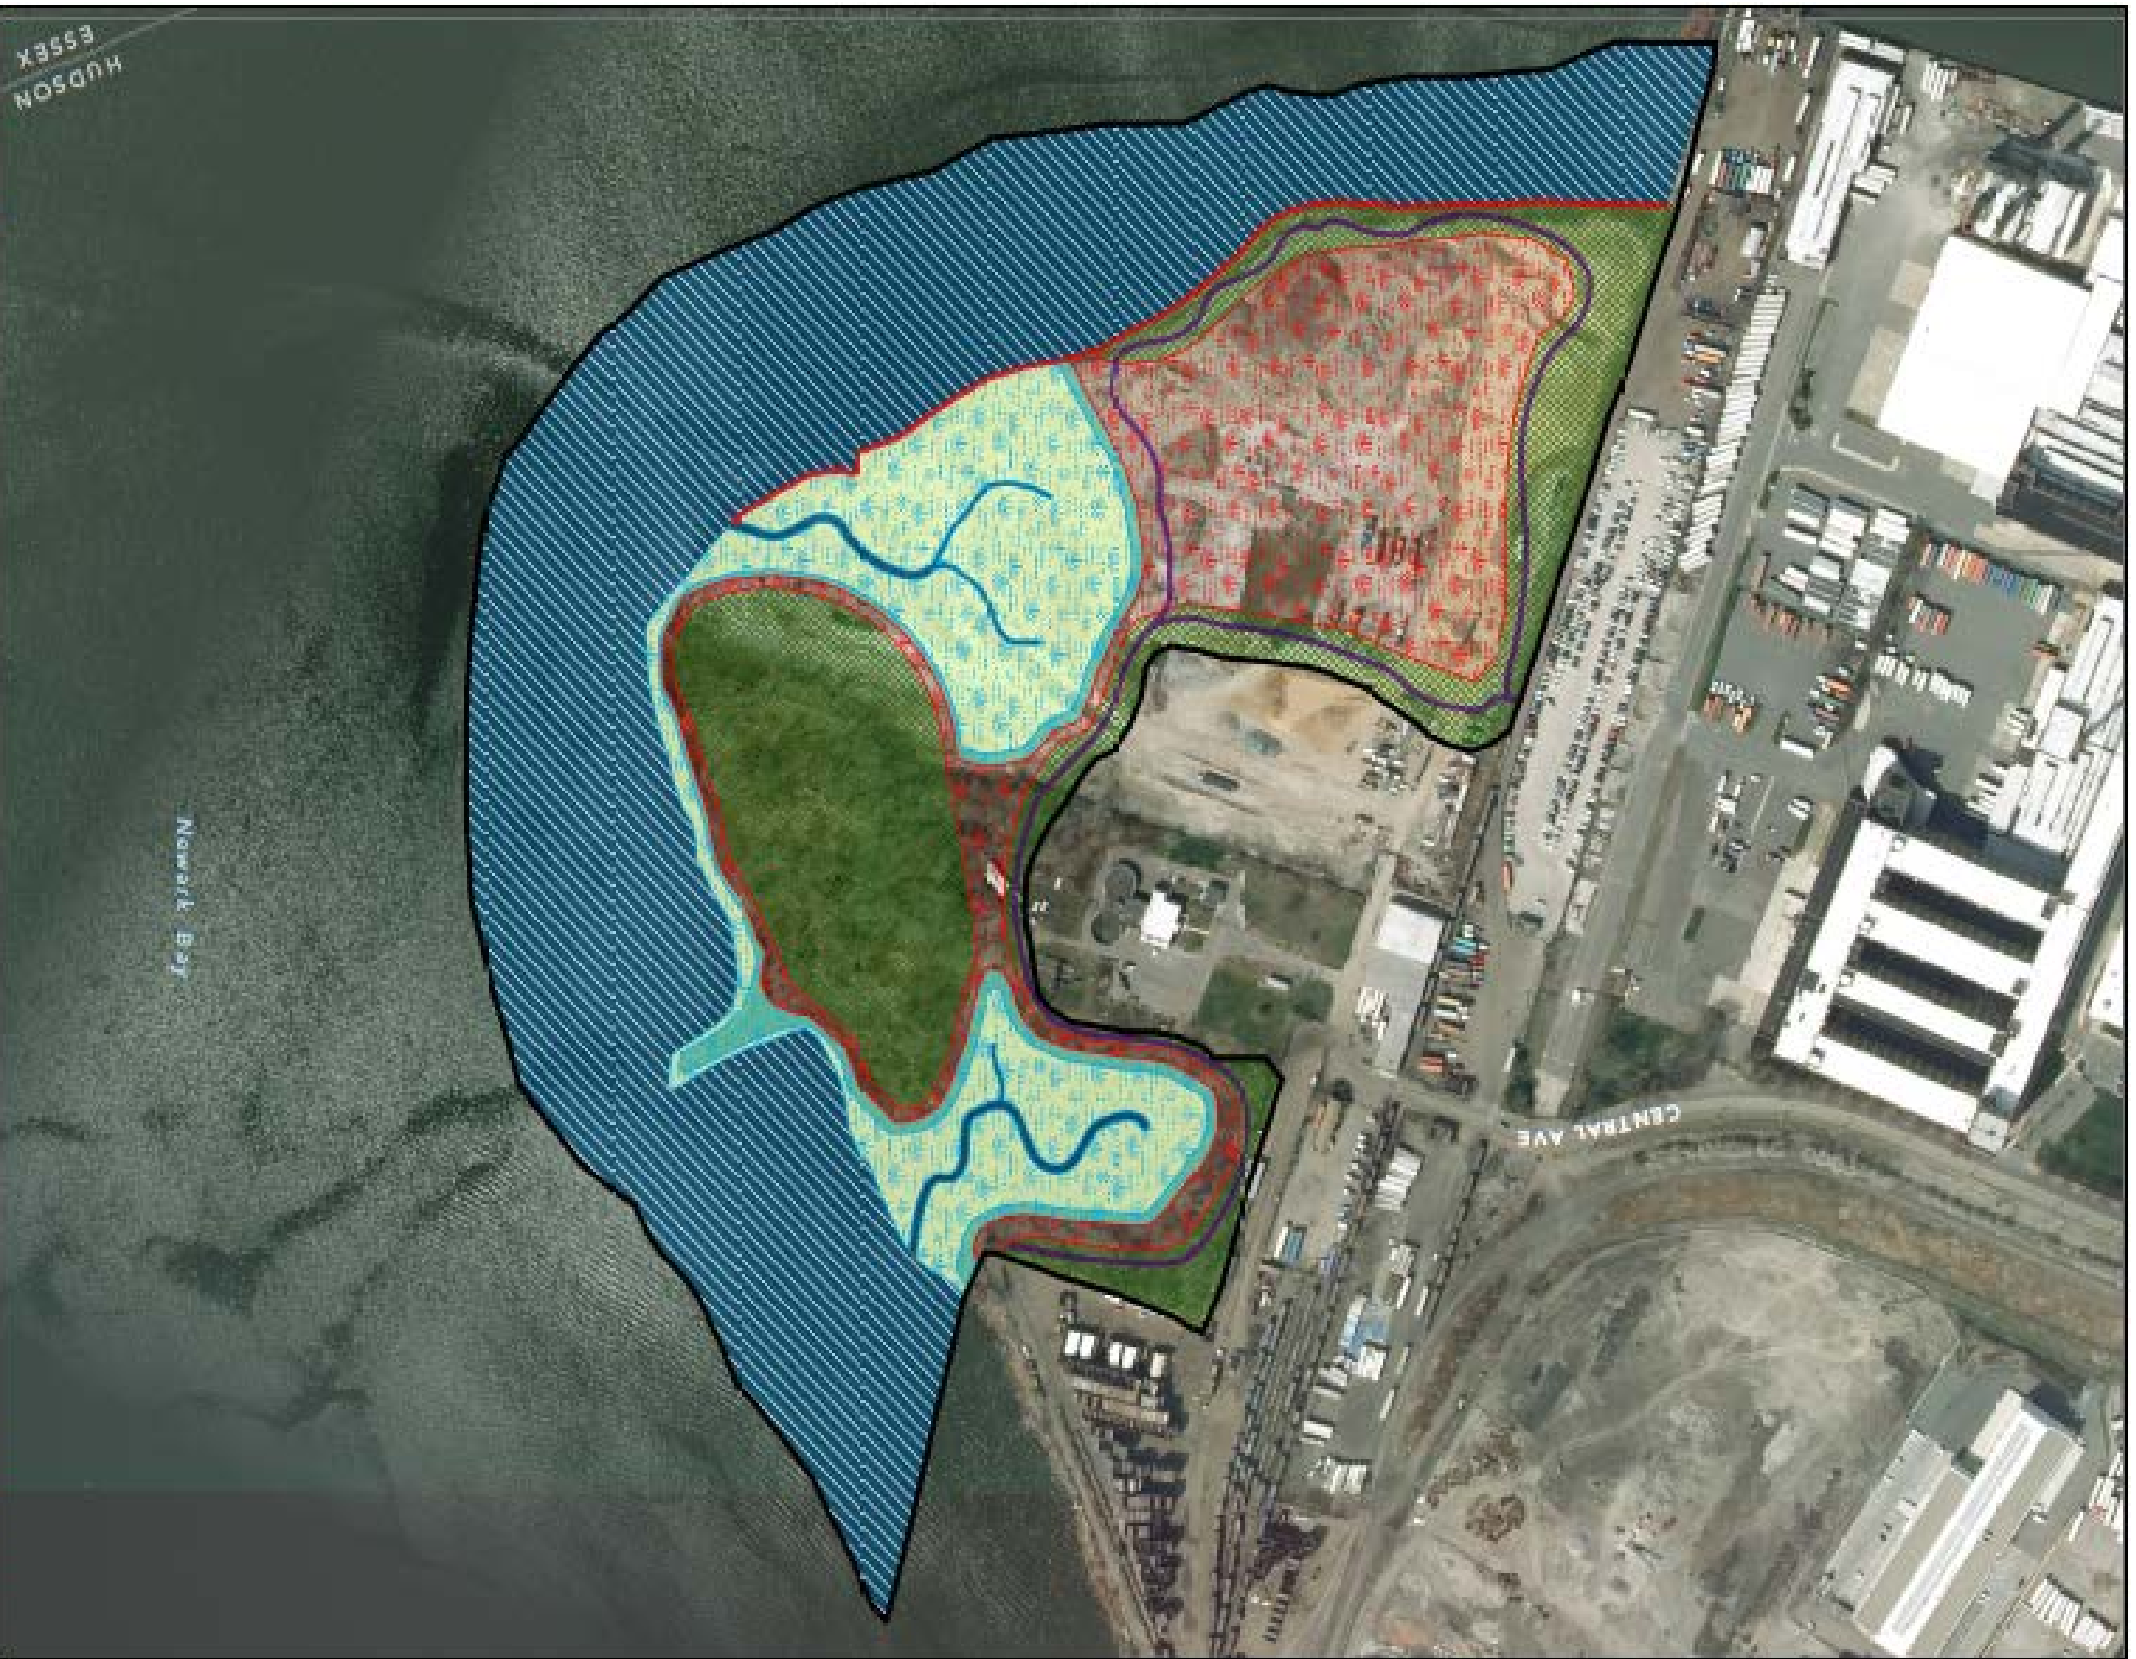
Alternative C Map
Keamy Point, Keamy, New Jersey (Deferred Site)

Tentatively Selected Plan Design

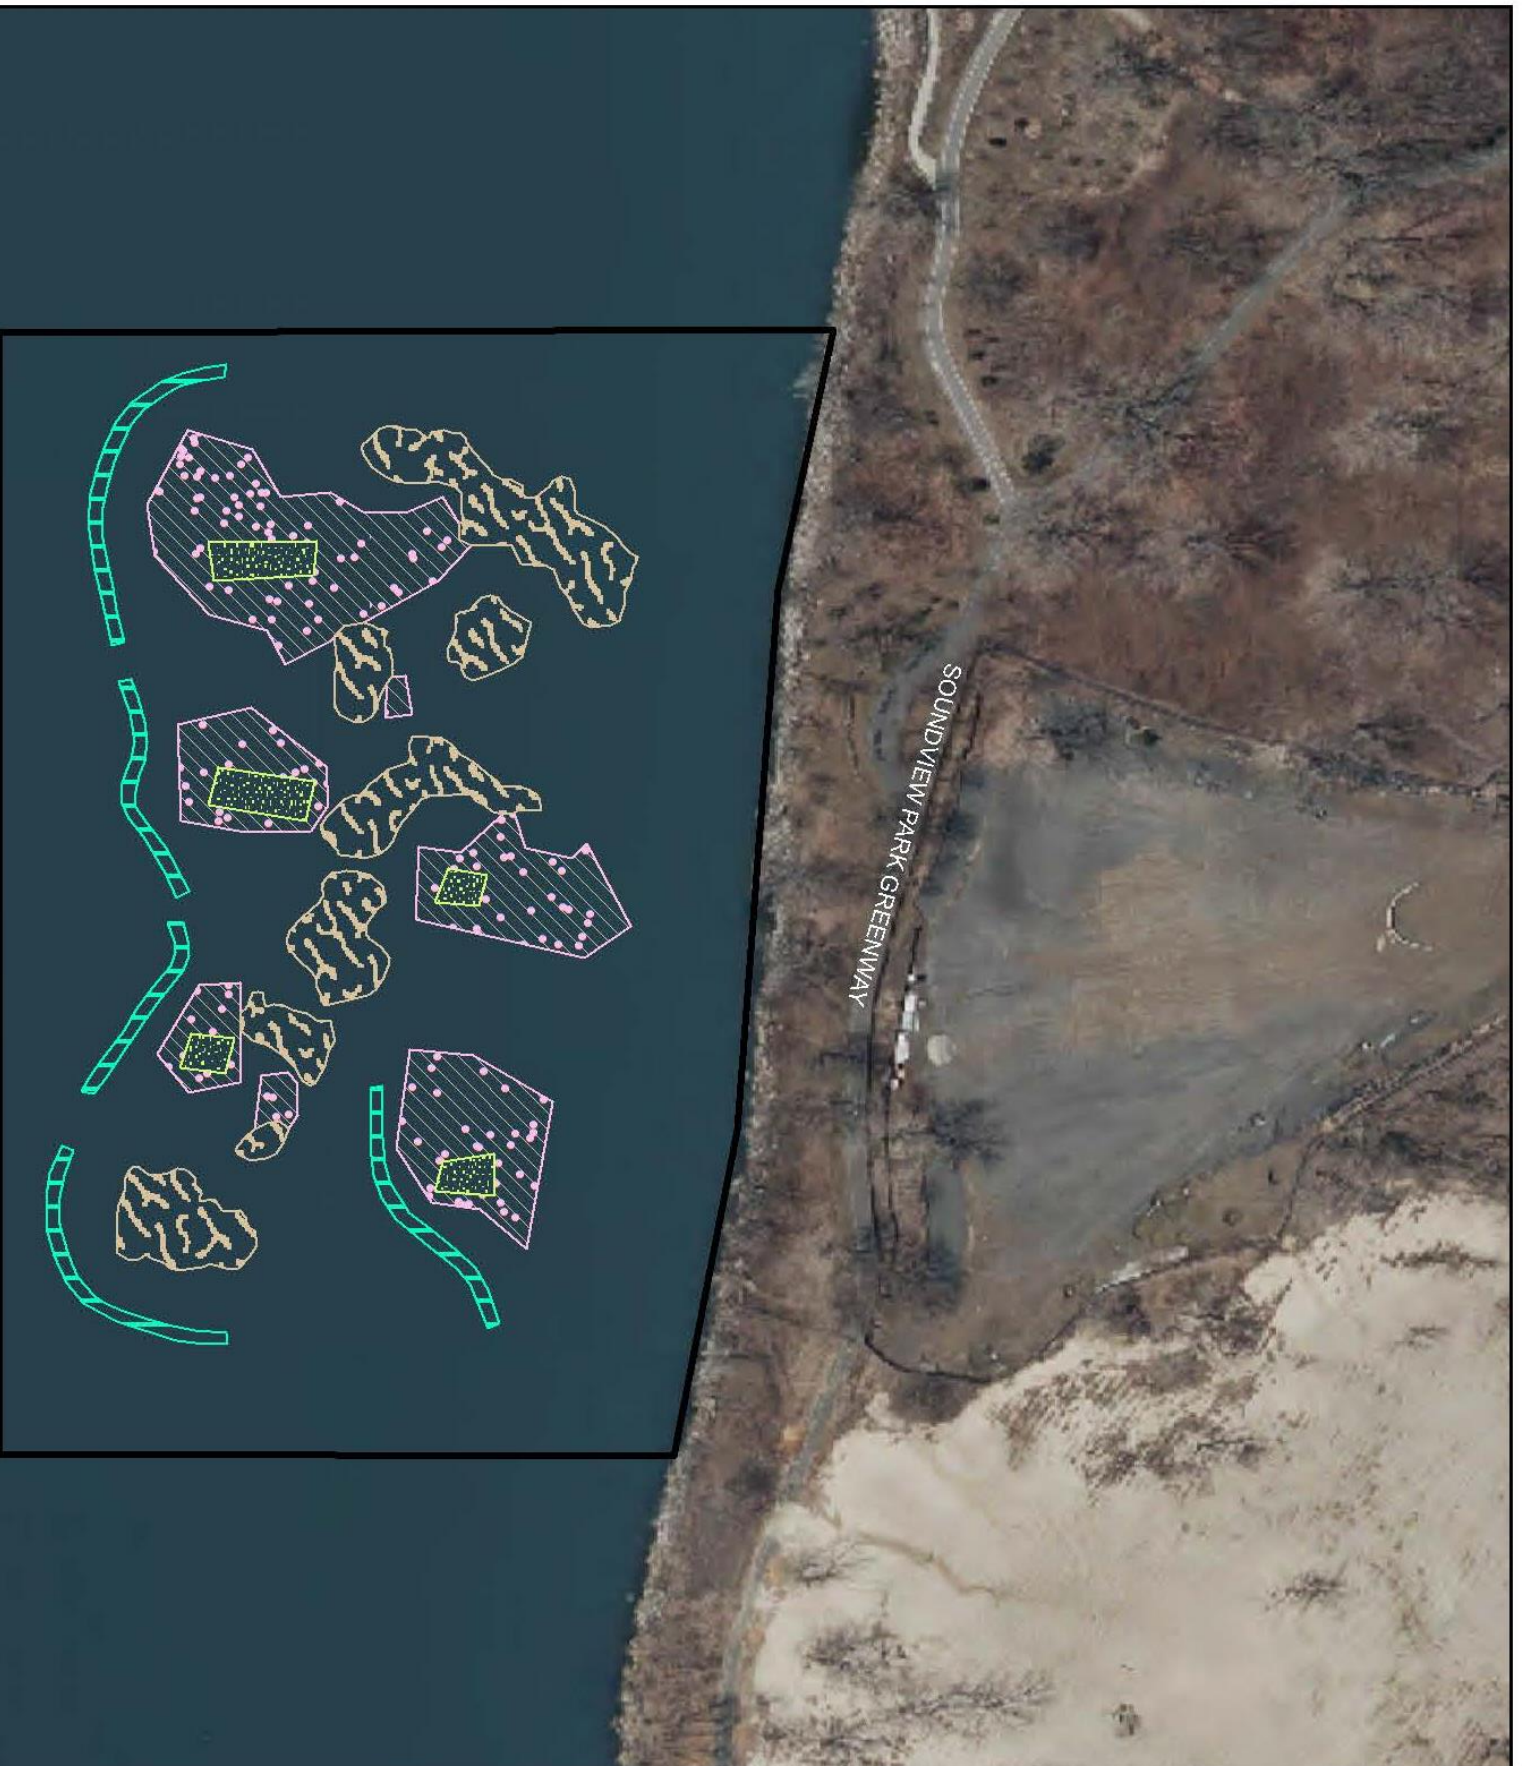
-   SITE BOUNDARY
-   OYSTER BEDS (SHELLS, GRAVEL AND/OR PORCELAIN)
-   OYSTER STRUCTURES (HANGING SUPER TRAYS AND CABLE)

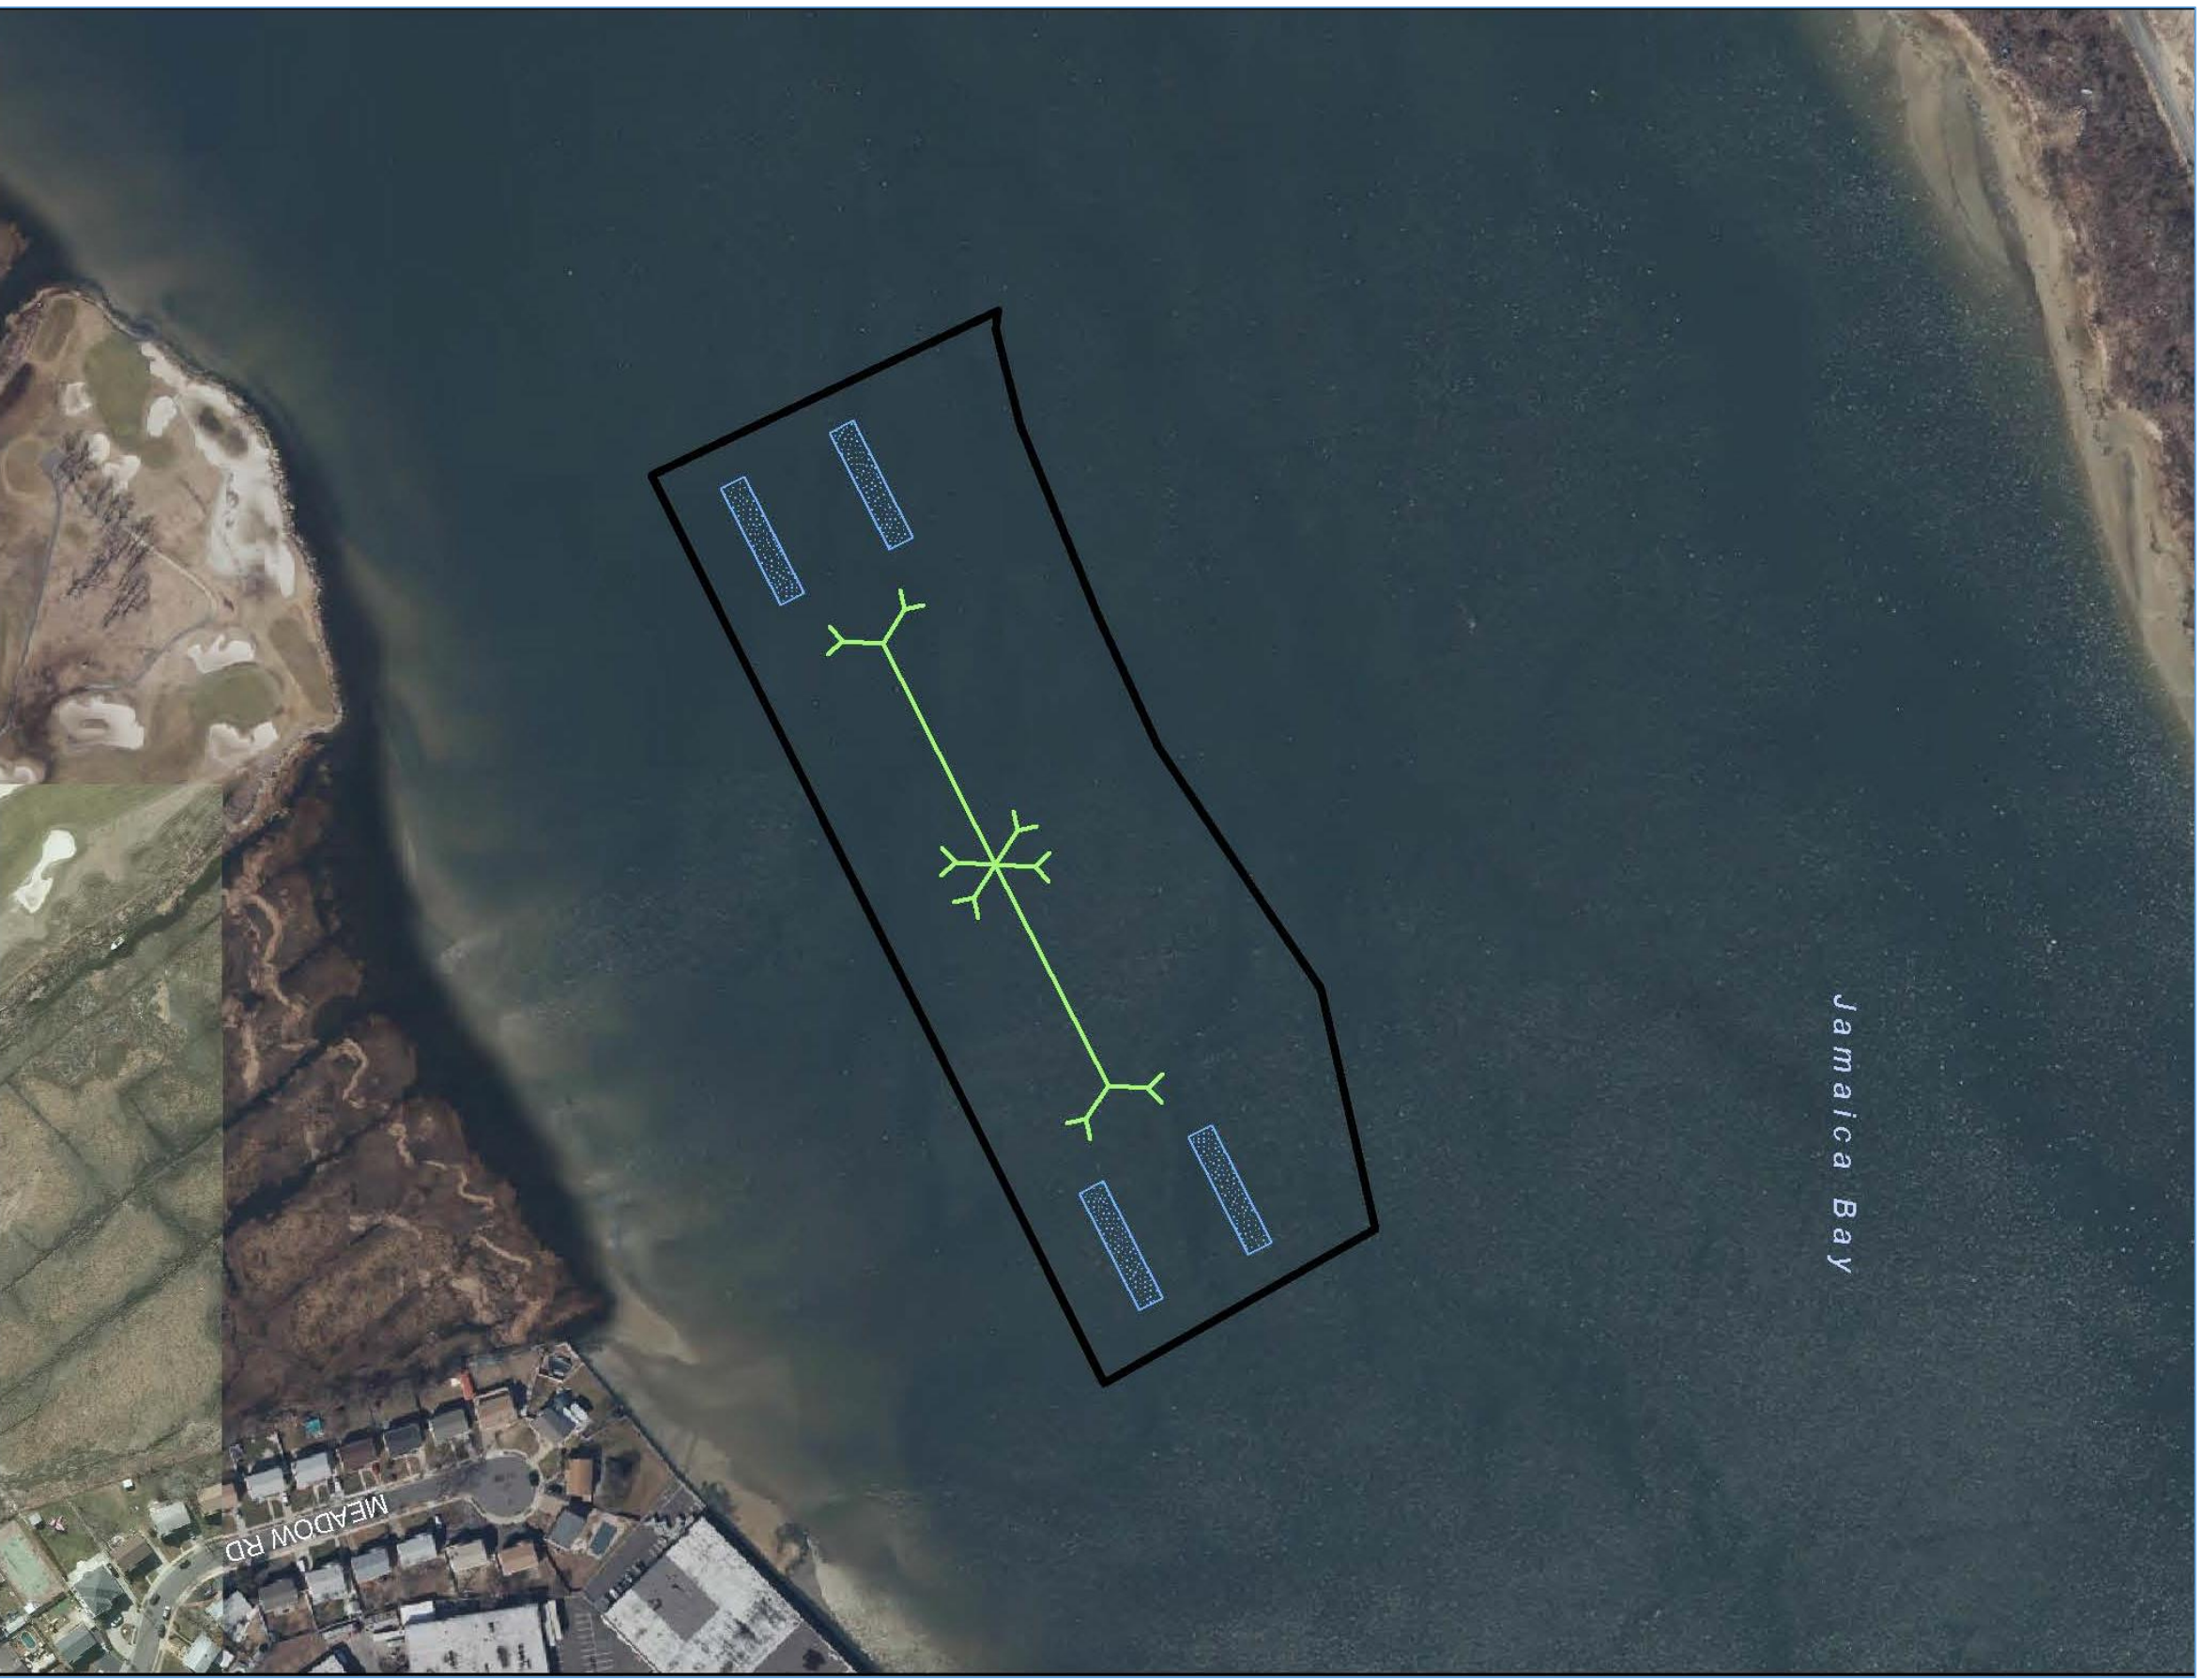
Tentatively Selected Plan Design

Hudson-Raritan Estuary (HRE) Feasibility Study
Jamaica Bay, Queens, New York

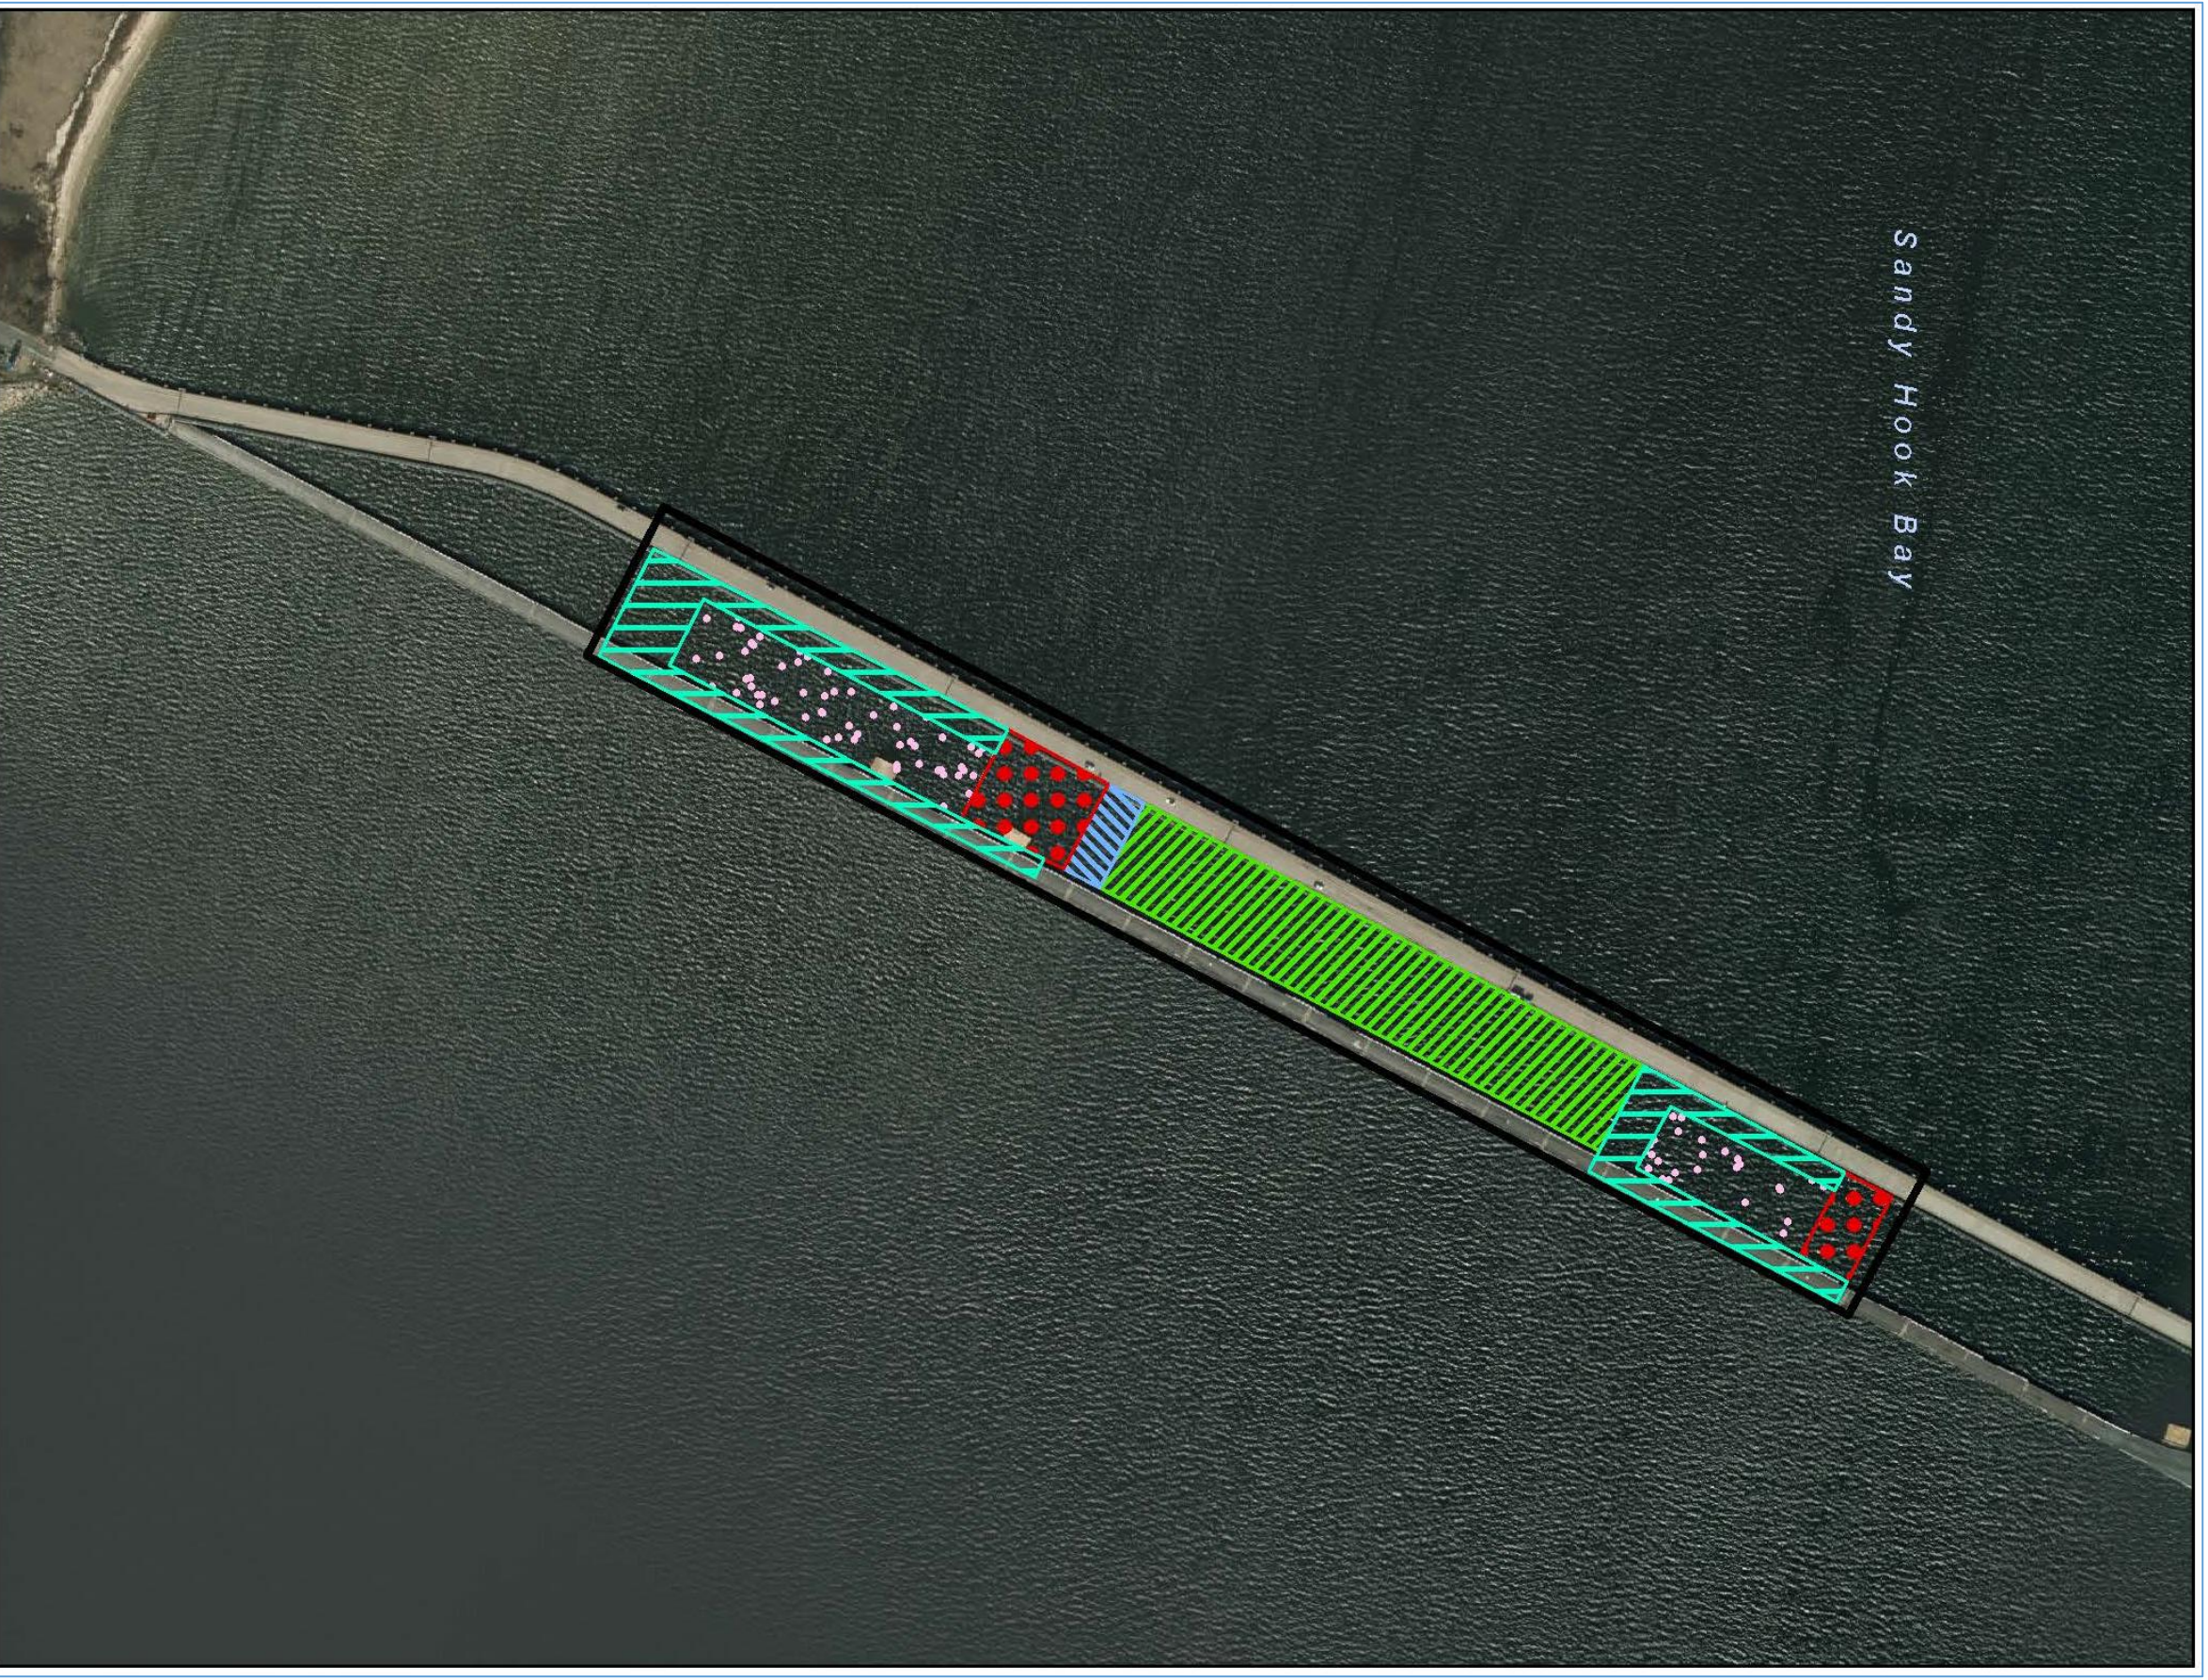
Tentatively Selected Plan Design

Hudson-Raritan Estuary (HRE) Feasibility Study
 Navy Earle Pier, Middletown, New Jersey
