Hudson-Raritan Estuary Ecosystem Restoration Feasibility Study

Appendix D
Plan Formulation Appendix
Foreword & Chapter 1: Introduction

Final Integrated Feasibility Report
& Environmental Assessment

Prepared by the New York District
U.S. Army Corps of Engineers

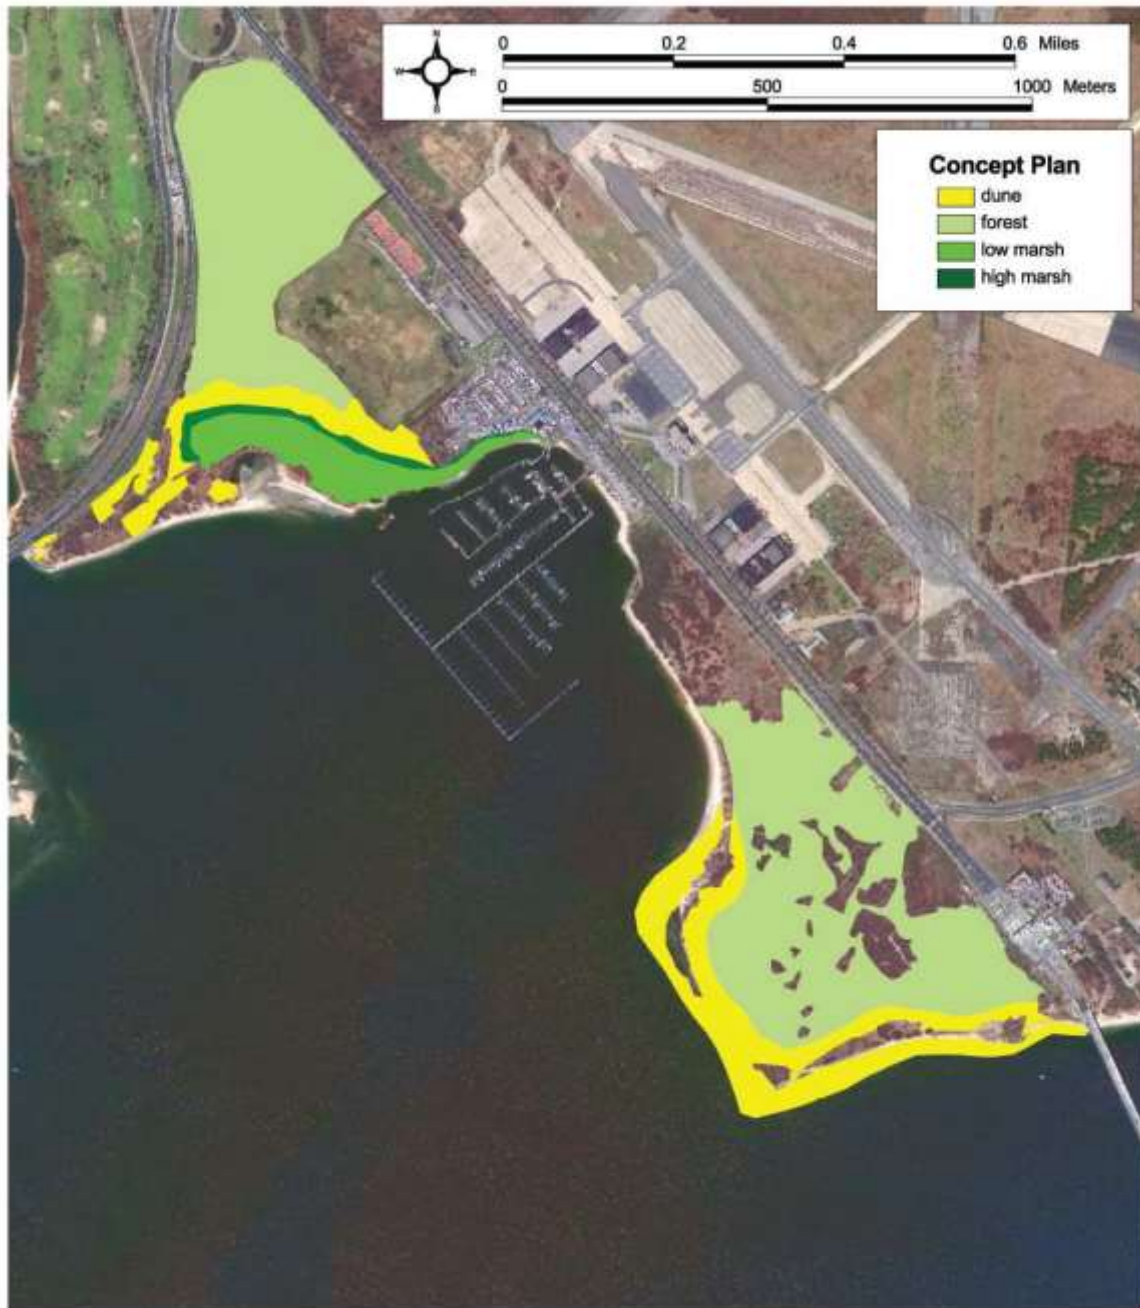
Figure D2-13. Dead Horse Bay – Alternative 1. In Alternative 2, some dunes would instead be emergent wetlands.

To stabilize the tidal creek and protect the existing beach habitat, training structures will be created on the banks at the mouth of the creek. The structure is estimated to extend 150 to 200 feet in length, out to a depth of six (6) to eight (8) feet, from both banks of the tidal creek. The training structure will be four (4) feet wide at the top and 25 feet wide at the base, extending to just over MHW. The other hard points are situated mostly on existing beach and upland areas, but will also raise above MHW to protect during storm surges. The structure will be made of rock with an overall trapezoidal shape. The rocks will be placed randomly within the shape to create various size interstitial spaces that can be used as refuges by various species.

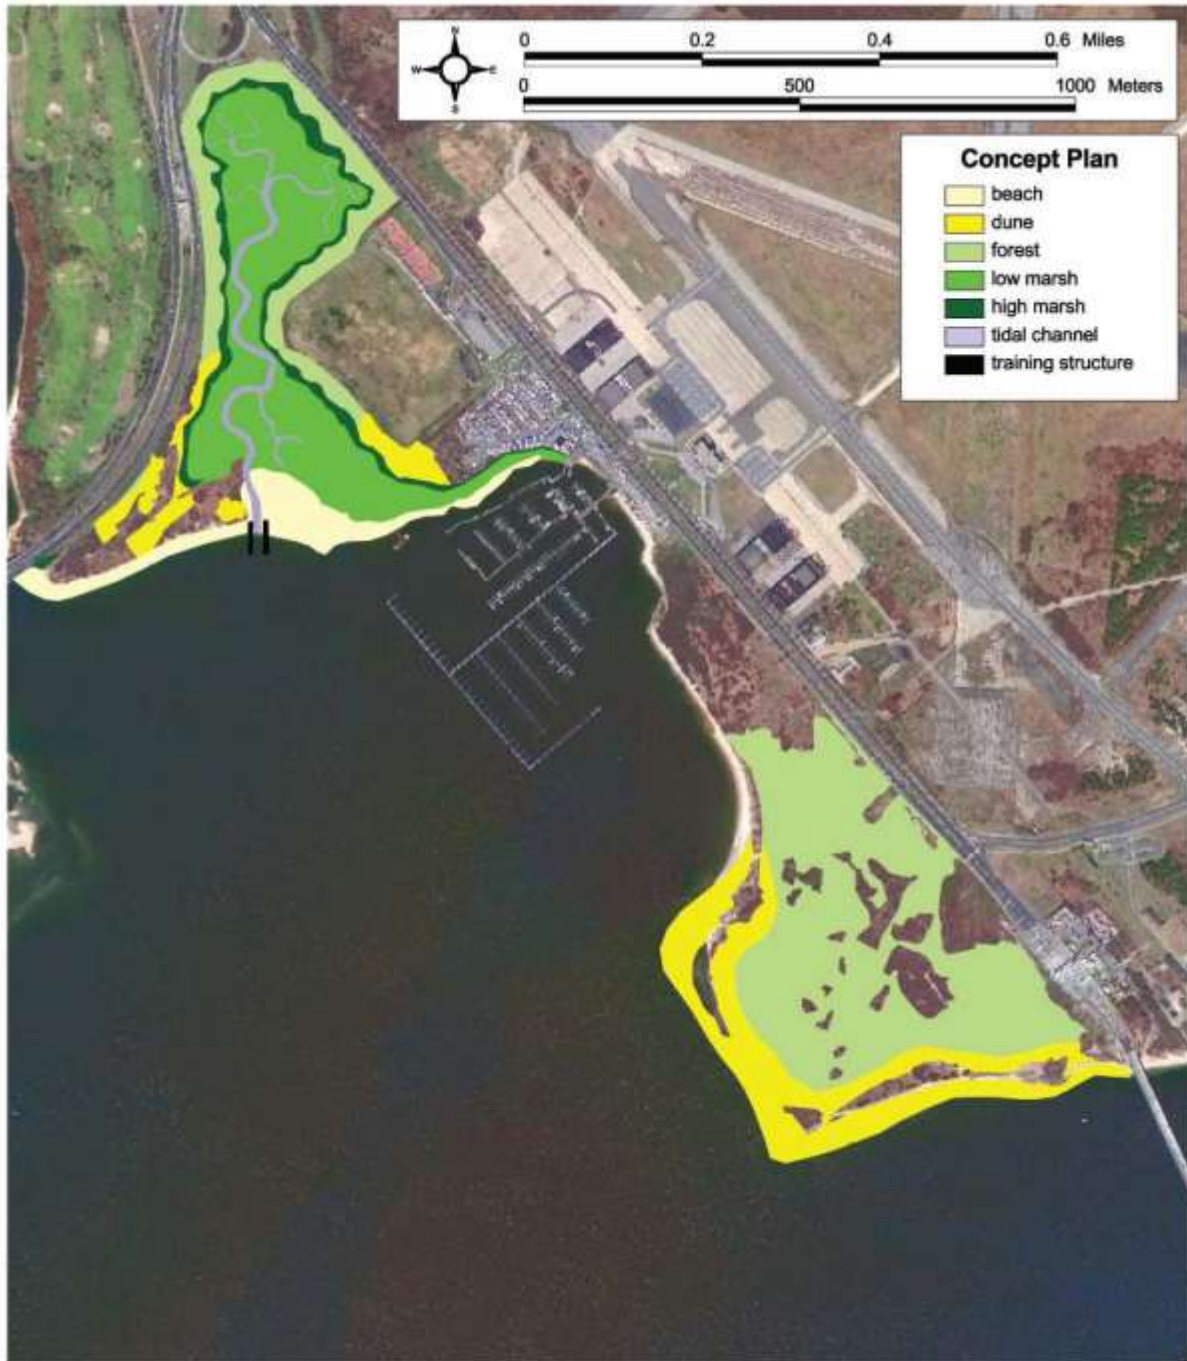
Figure D2-14. Dead Horse Bay – Alternative 3. In Alternative 4, some of the dunes in Dead Horse Bay South would be replaced with marsh.

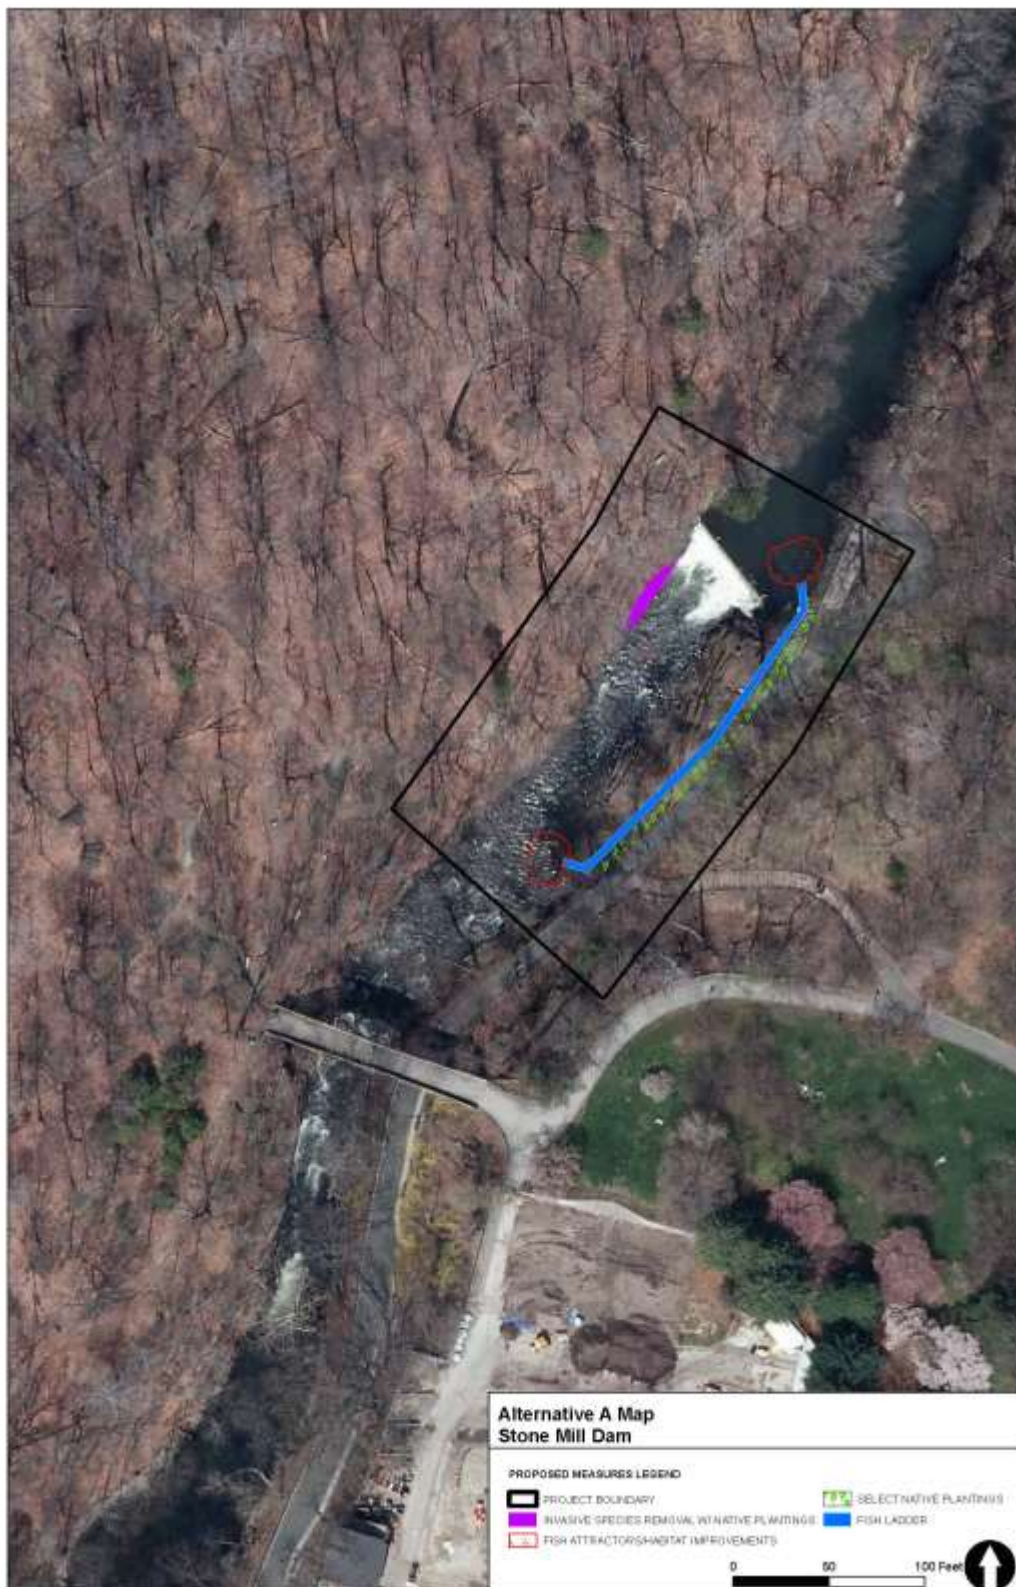
Figure D5- 16. Stone Mill Dam – Alternative A

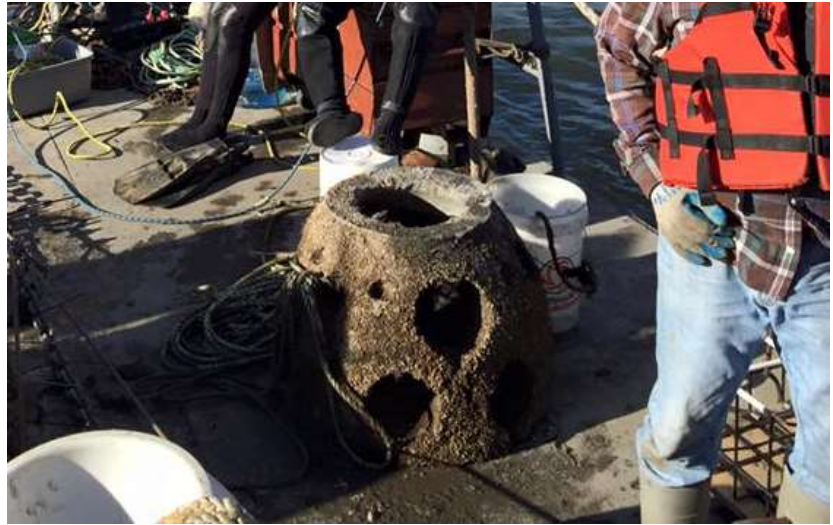
Figure D8- 5. Reef Ball

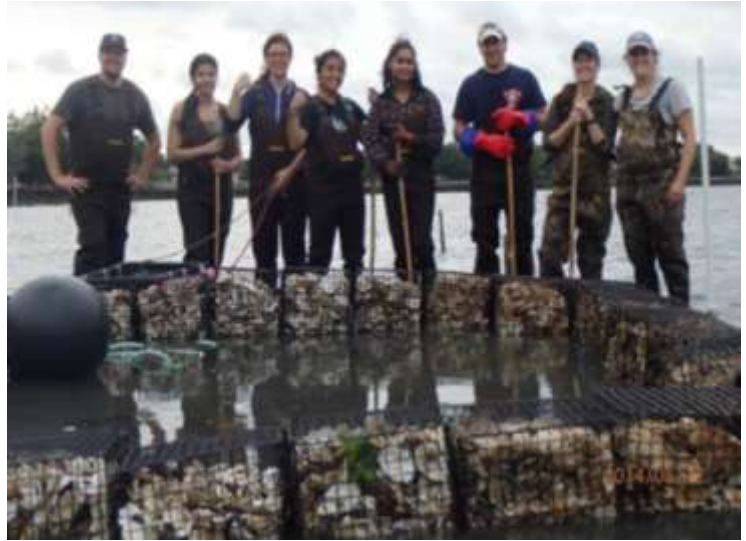
Figure D8- 8. Wire Cages/Gabions

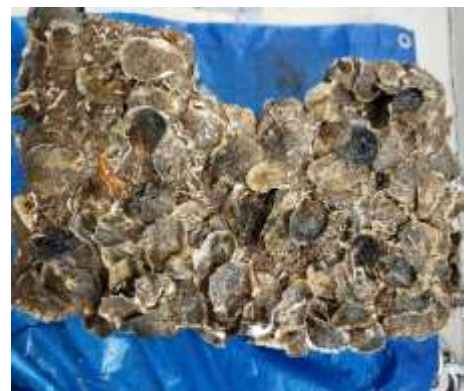
Figure D8- 16. Oyster growth and survivorship on 9/12/19. Photo courtesy of NY/NJ Baykeeper.

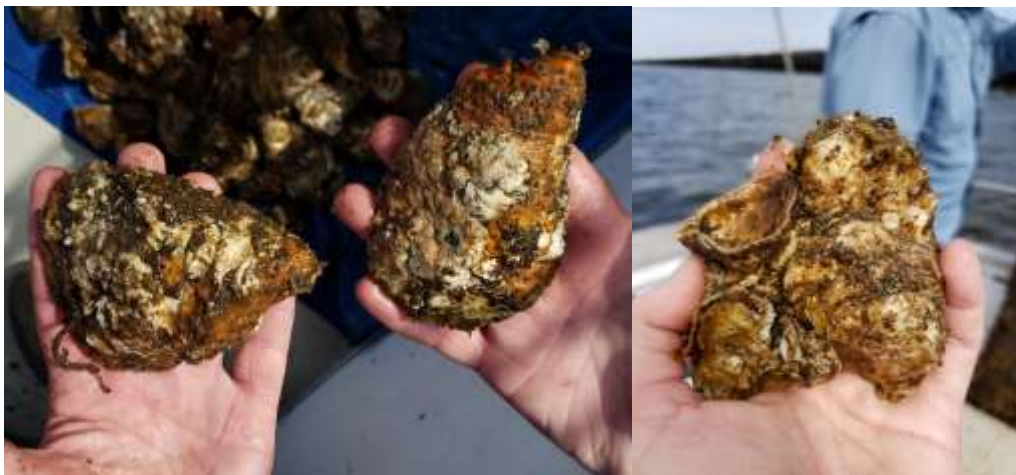
**Figure D8- 17. Oysters from 2015 and natural recruitment.
Photo courtesy of NY/NJ Baykeeper.**

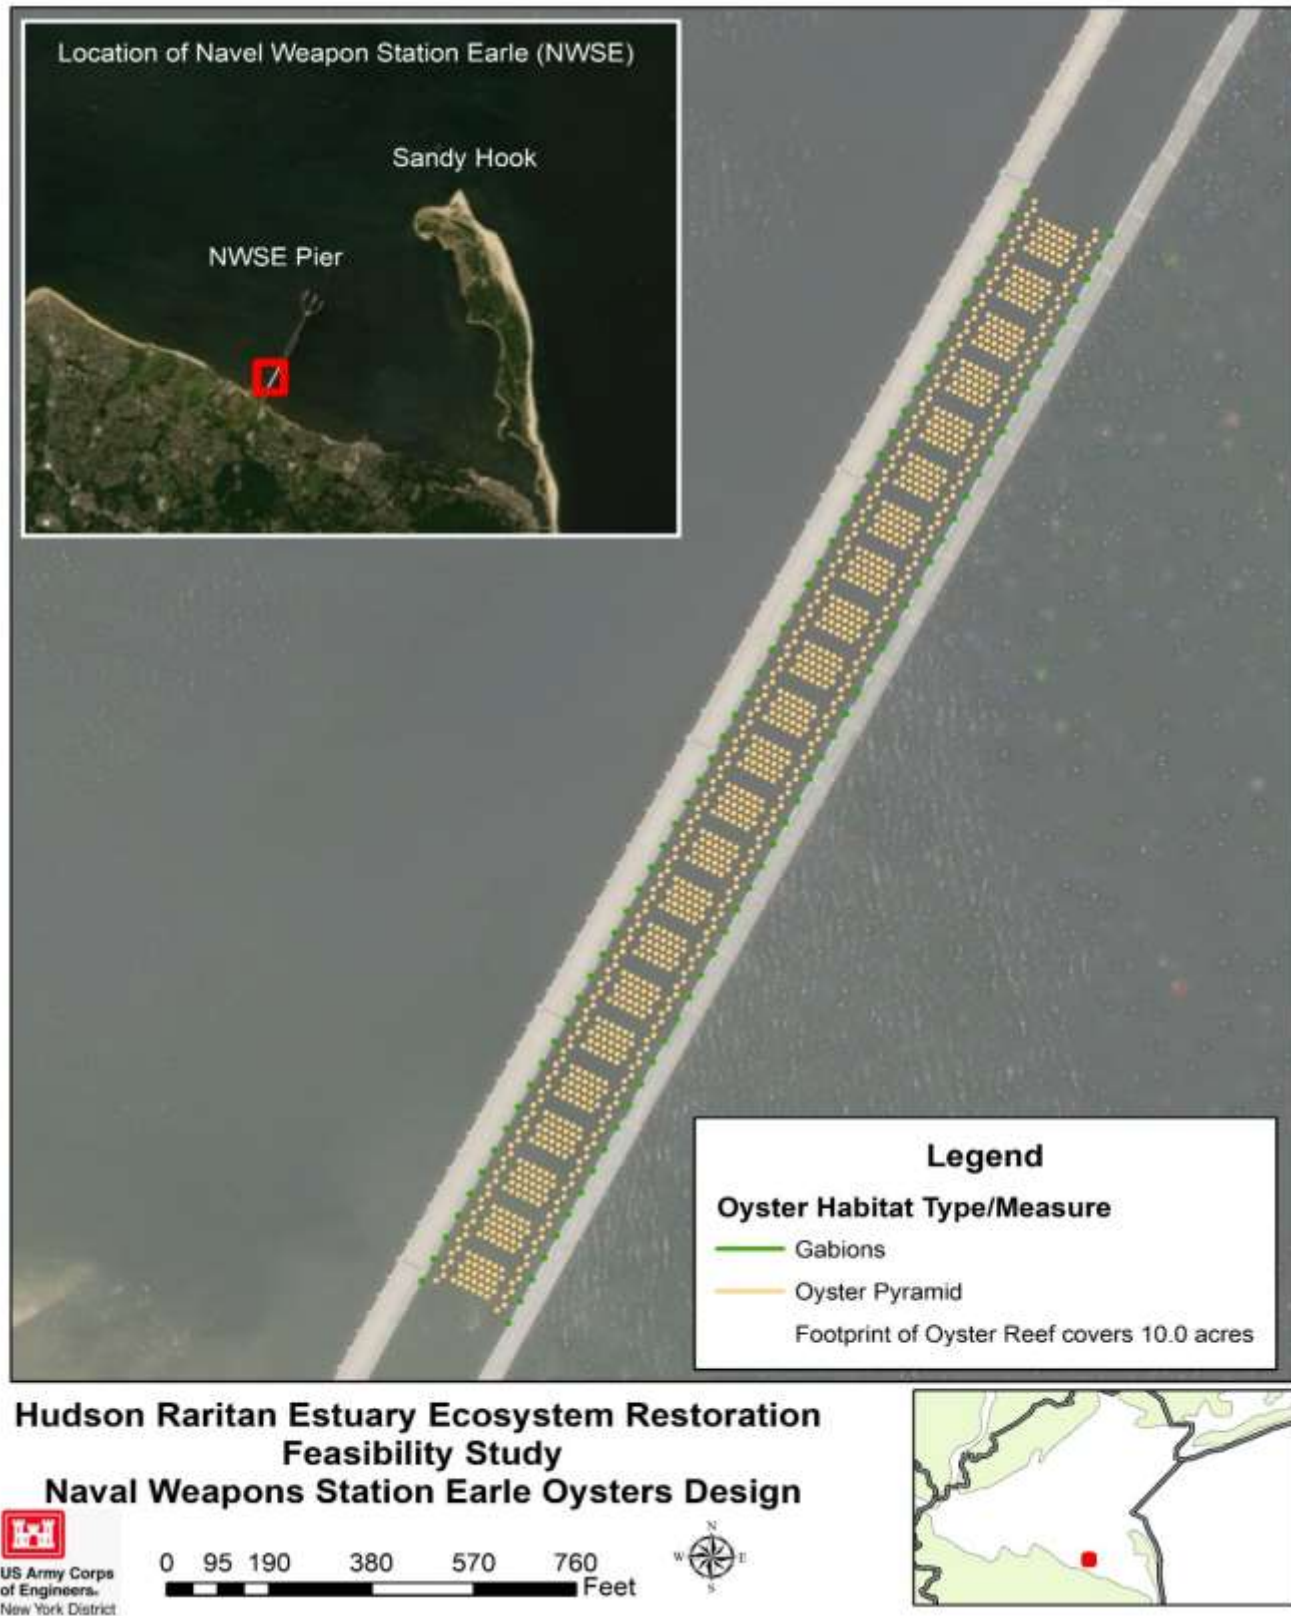
Figure D8- 18. Naval Weapons Station Earle – Recommended Plan

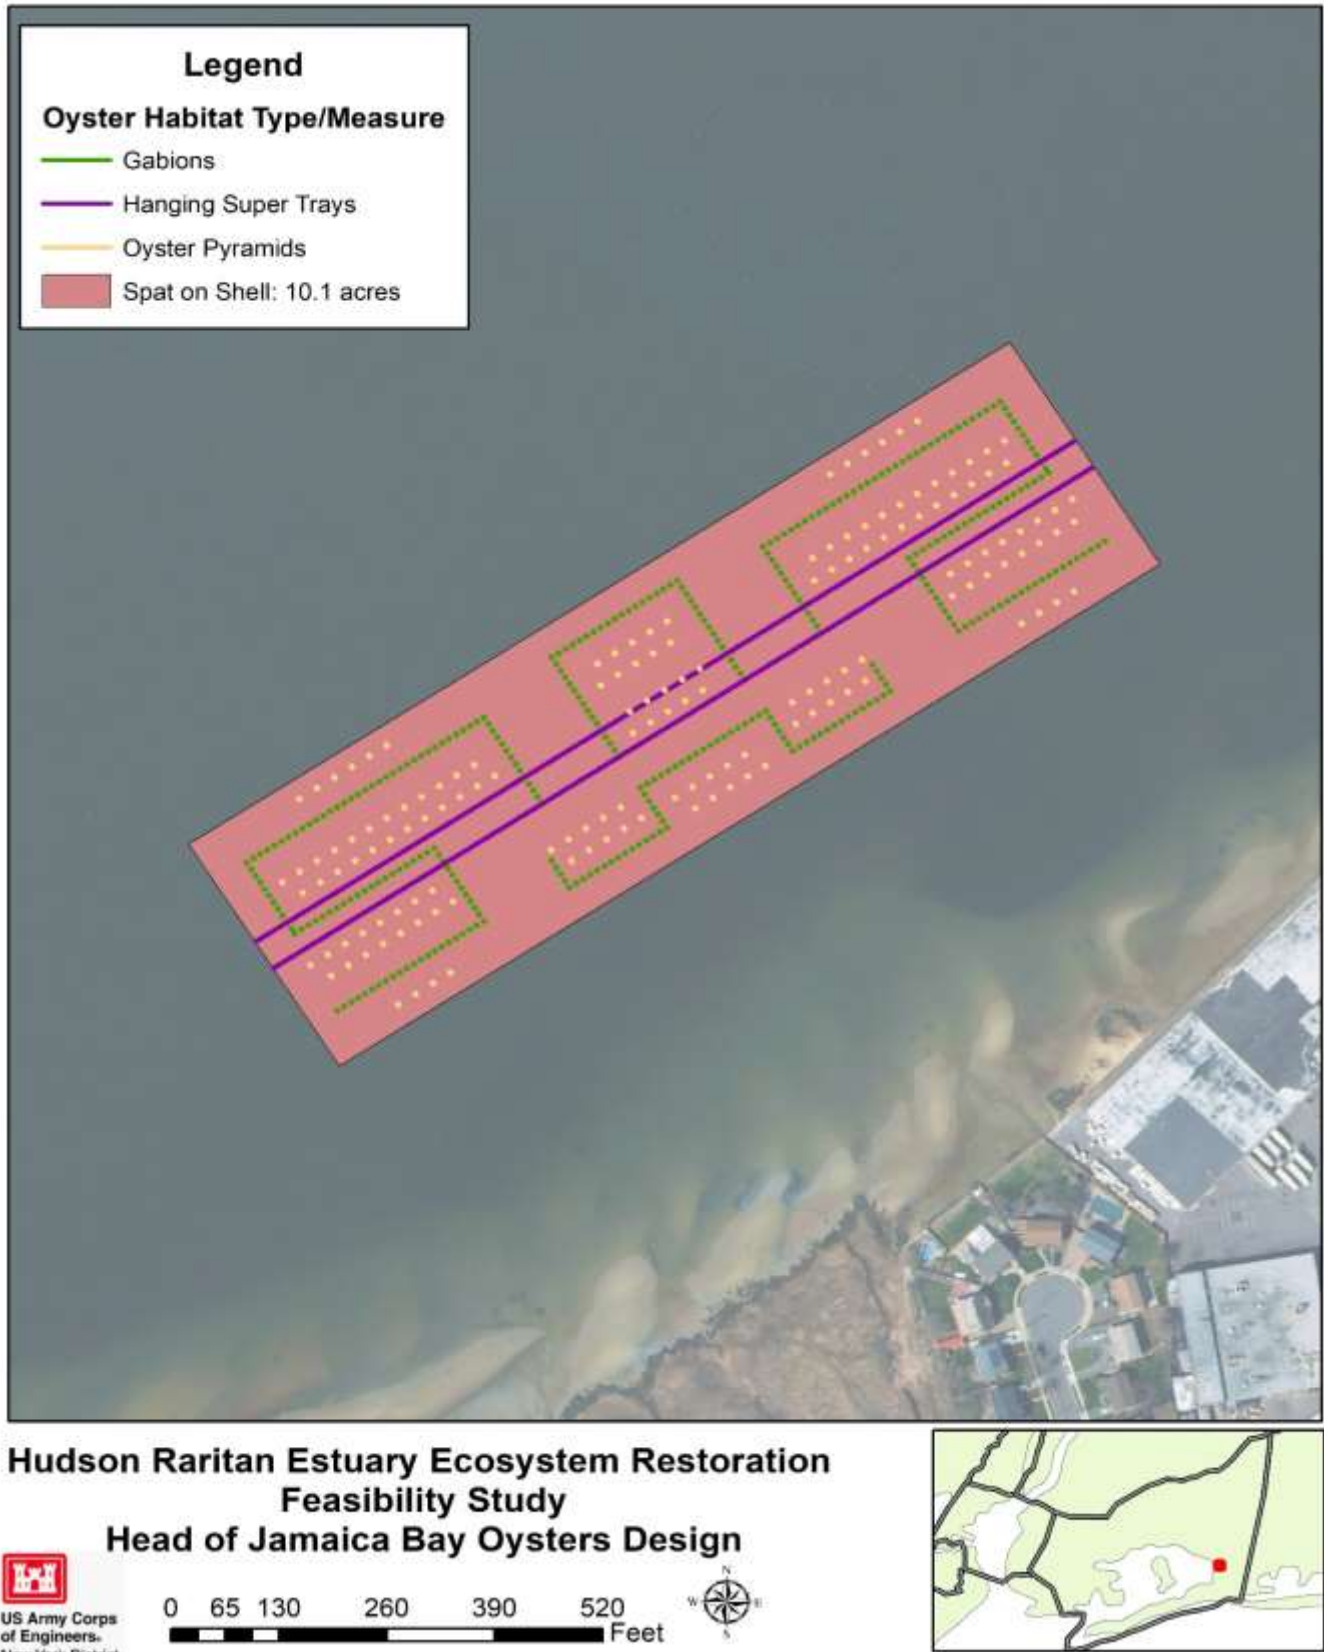
Figure D8- 26. Head of Jamaica Bay – Recommended Plan
