Hudson-Raritan Estuary Ecosystem Restoration Feasibility Study

**Appendix D
Plan Formulation Appendix
Foreword & Chapter 1: Introduction**

**Final Integrated Feasibility Report
& Environmental Assessment**

**Prepared by the New York District
U.S. Army Corps of Engineers**

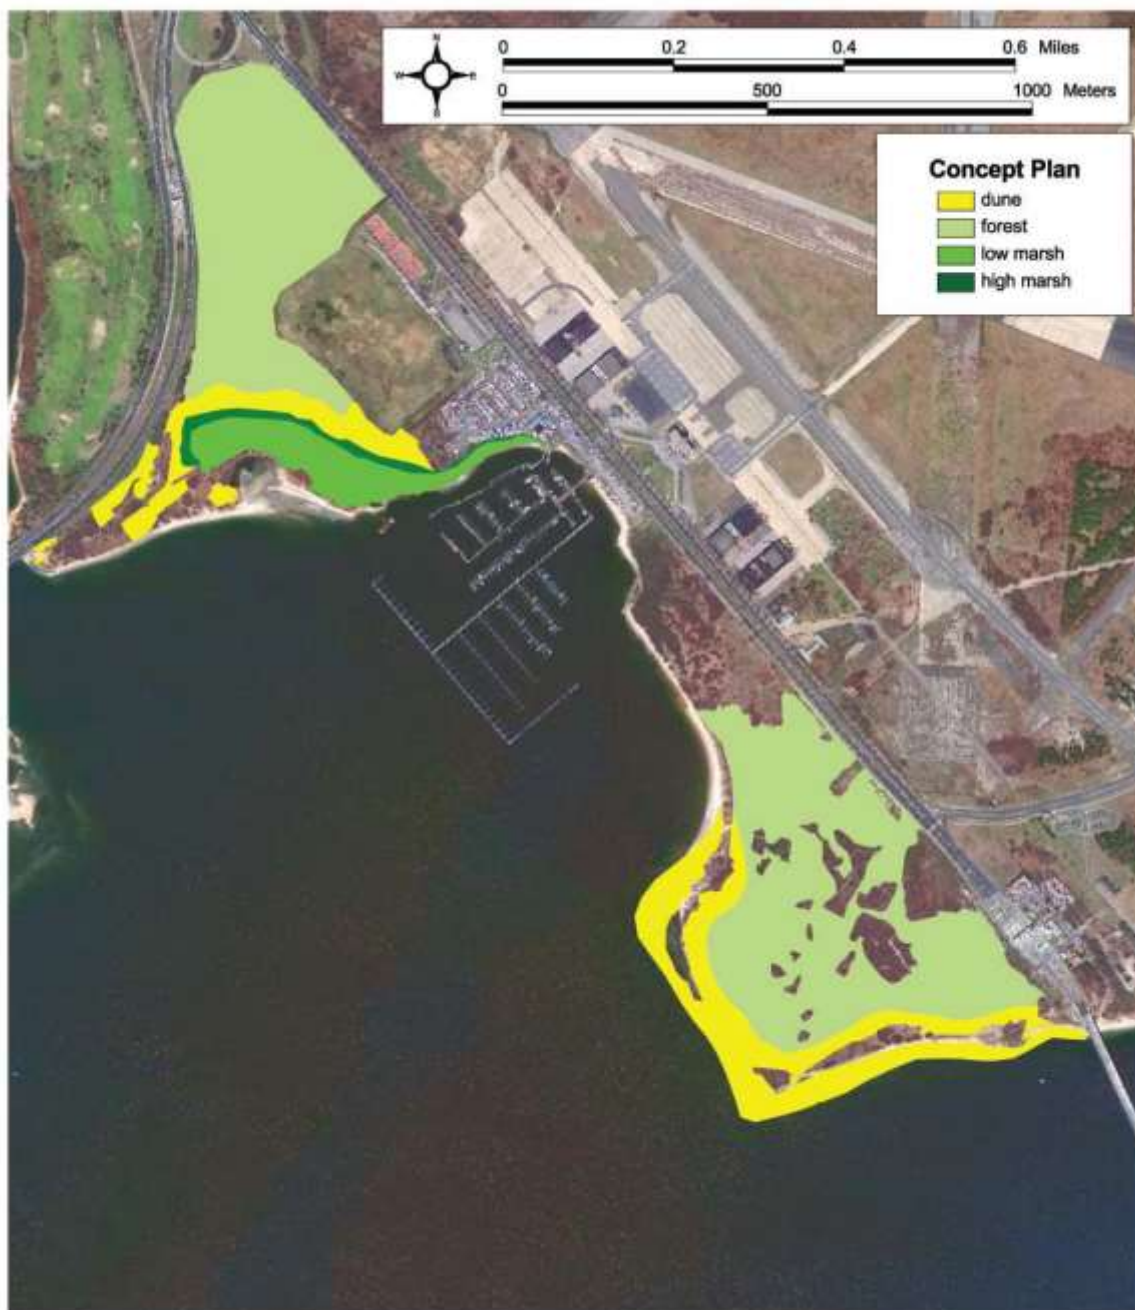
Figure D2-13. Dead Horse Bay – Alternative 1. In Alternative 2, some dunes would instead be emergent wetlands.

To stabilize the tidal creek and protect the existing beach habitat, training structures will be created on the banks at the mouth of the creek. The structure is estimated to extend 150 to 200 feet in length, out to a depth of six (6) to eight (8) feet, from both banks of the tidal creek. The training structure will be four (4) feet wide at the top and 25 feet wide at the base, extending to just over MHW. The other hard points are situated mostly on existing beach and upland areas, but will also raise above MHW to protect during storm surges. The structure will be made of rock with an overall trapezoidal shape. The rocks will be placed randomly within the shape to create various size interstitial spaces that can be used as refuges by various species.

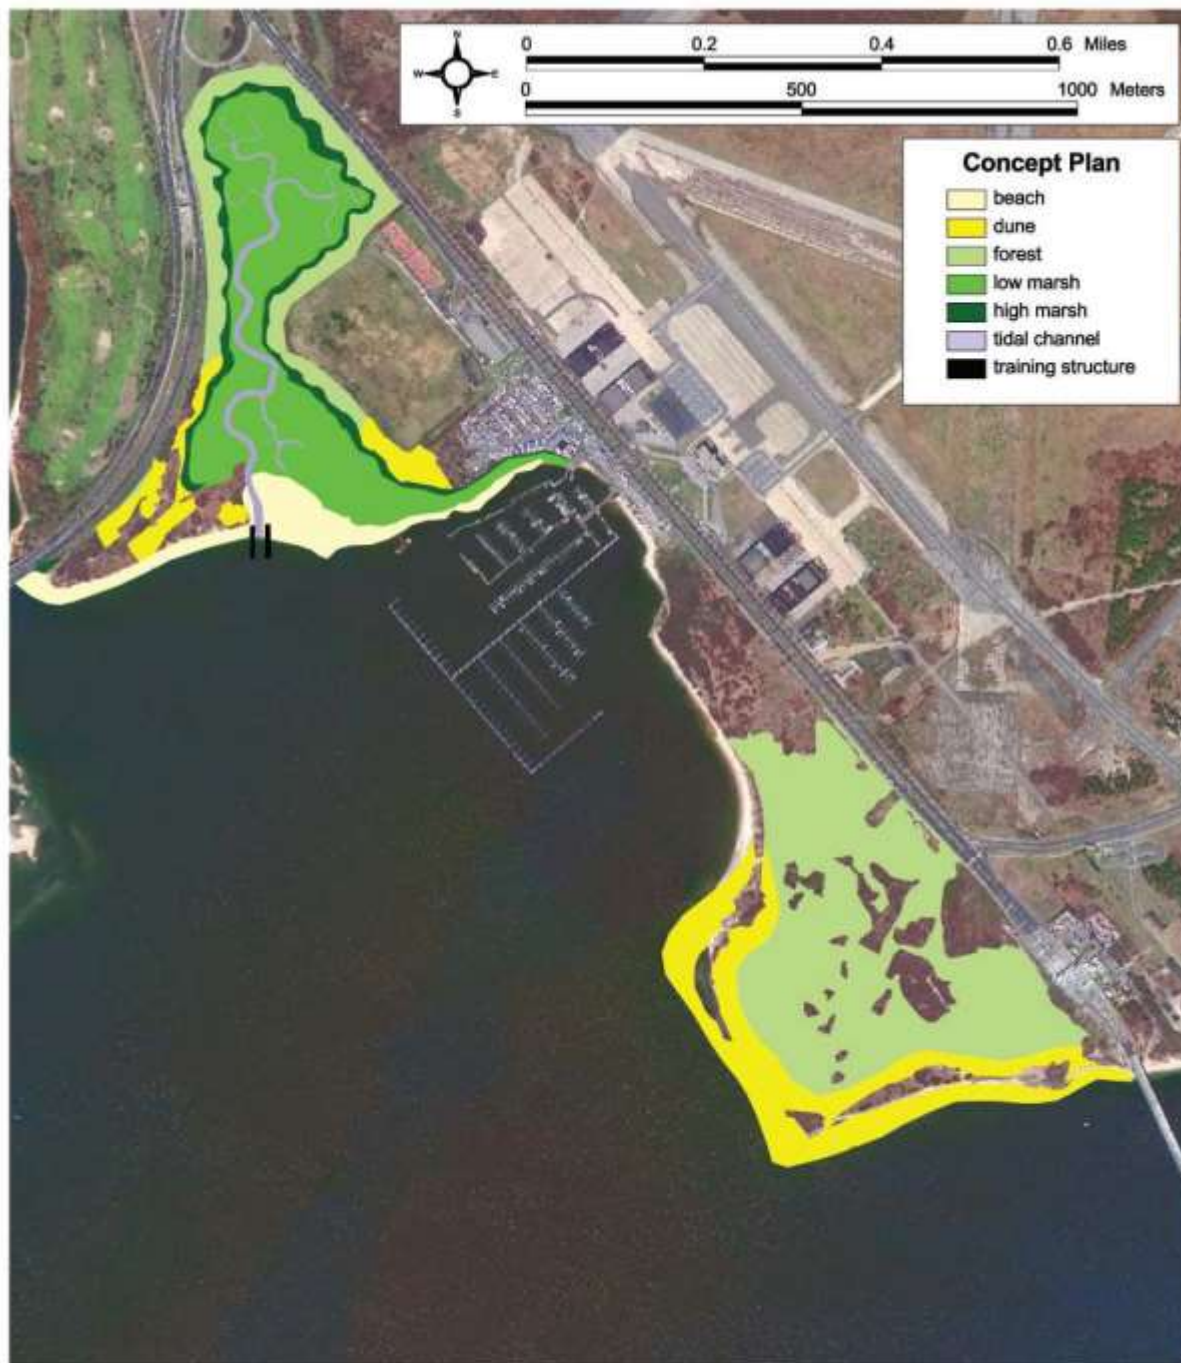
Figure D2-14. Dead Horse Bay – Alternative 3. In Alternative 4, some of the dunes in Dead Horse Bay South would be replaced with marsh.

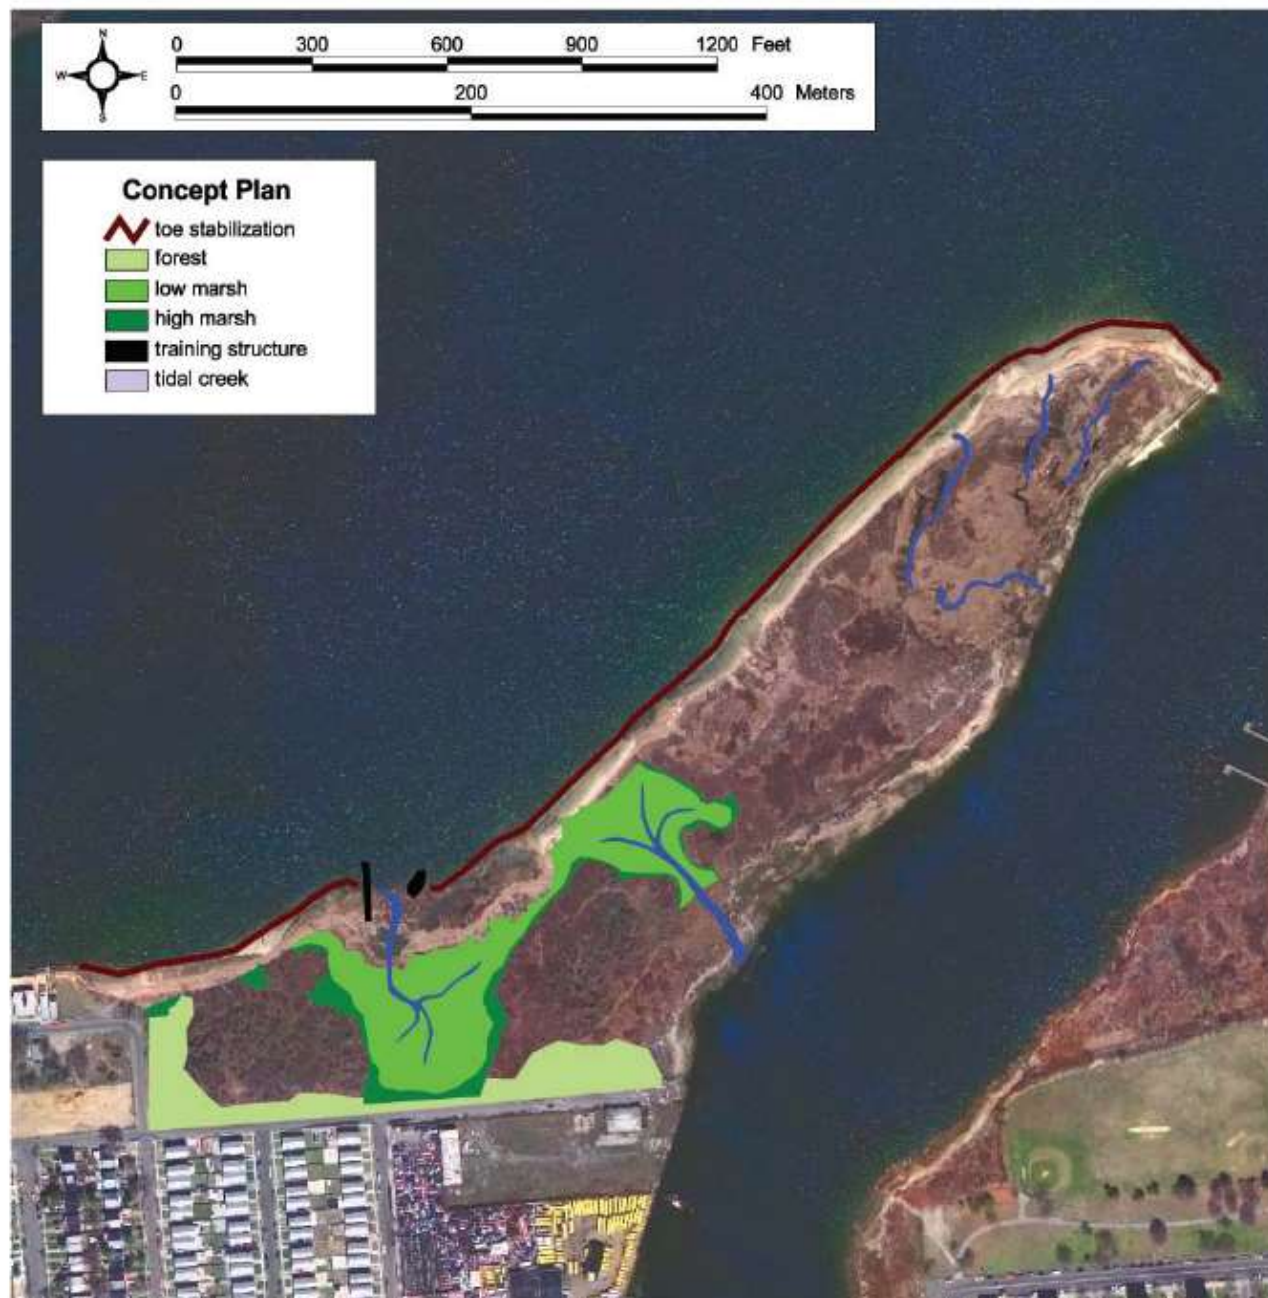
Figure D2-26. Dubos Point Alternatives 1, 2 and 3 (Difference is in the amount of toe stabilization under consideration)

Alternative 3 includes all the elements of Alternative 1 and maximizes marsh habitat protection by implementing toe protection surrounding the entire western and northern shore (Figure D2-26). The north and west shorelines are exposed to high wave velocities from Jamaica Bay. Soldier piles were installed in the past, and still exist on the site but are beginning to fail. In the areas of failure, the erosion is quite obvious. Toe protection in this alternative includes the use of soldier piles or its equivalent, placed to the level of MLW, along the entire shoreline replacing all of the existing piles.

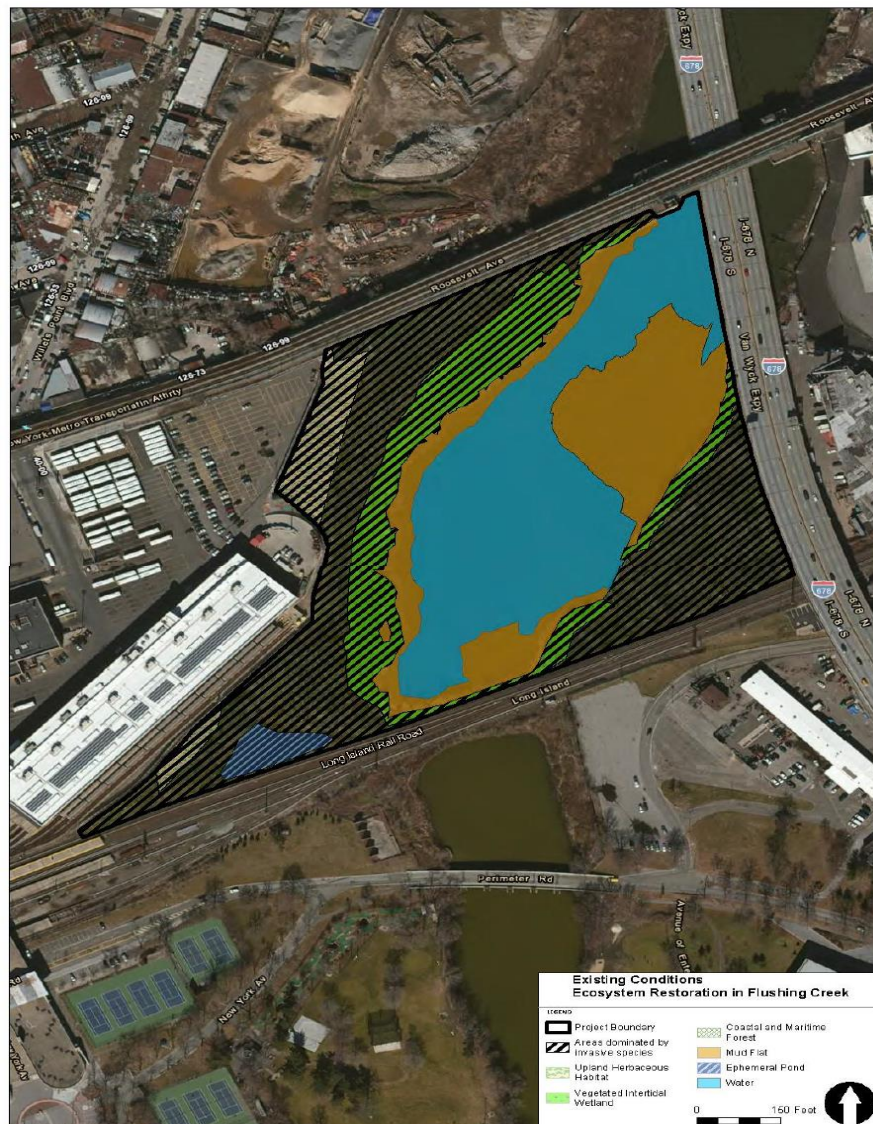
Figure D4- 8. Flushing Creek – Existing Conditions

The future without-project condition was determined by projecting conditions in the study area over a 50-year period of analysis. In the absence of federal action, it is anticipated that the degraded condition of the study area ecosystem will continue into the future. Non-federal improvements include water quality improvements associated with the operation of the CS4 retention facility and the New York City waterfront zoning laws that cover 36 acres of Flushing Creek waterfront. The zoning change requires waterfront access and waterfront viewing corridors. These planned improvements, including those in the Brownfield Opportunity Area, may have an effect on ecosystem restoration resulting in improved water quality and revitalization of the area. NYCDEP also planned (2013-2018) to conduct environmental dredging as part of their Long Term Control Plan improving the bathymetry, hydrology and sediment quality of the creek adjacent the site. Without restoration within this area, invasive species, degraded habitat and poor benthic and wildlife habitat would persist.

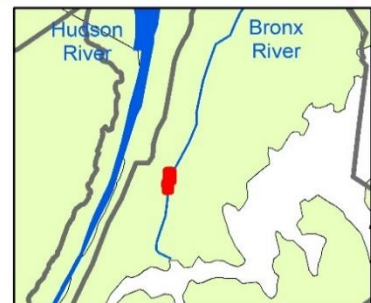
Figure D5- 26. Shoelace Park North and South – Recommended Plan

Additional restoration measures at Shoelace Park include installation of 2.07 acres of v emergent wetlands/bio-retention basins along the east bank to reduce sediment loads reaching the river. This plan will improve aquatic habitat and provide secondary water quality benefits by modifying the channel with in-stream structures, restoration of natural pools, thalweg and riffle complexes. Invasive species located on site will be reduced and select native plantings will provide wooded riparian corridor along the backs of the entire reach. The riparian woodlands and restored forested wetlands would provide habitat resources that are currently very limited in the Bronx urban environment and reduce nutrient inputs to the water. See Engineering Appendix for the grading and planting plans for the site.

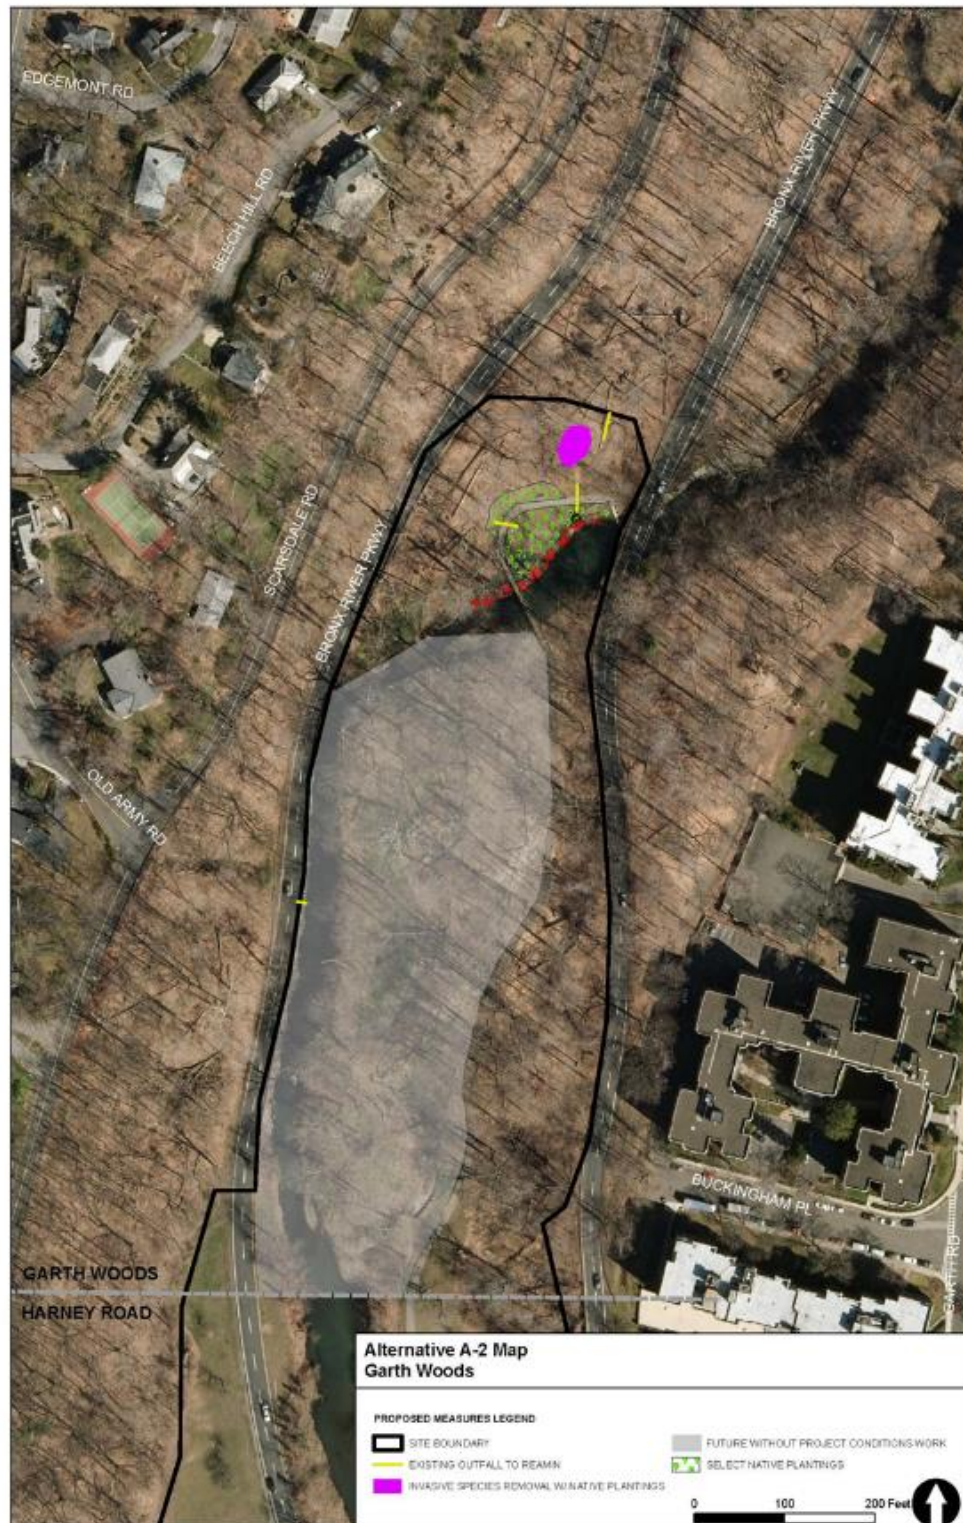
Figure D5- 31. Garth Woods – Alternative A-2

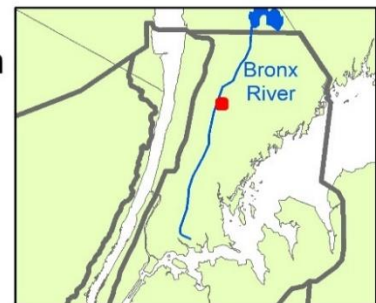
Figure D5- 35. Garth Woods and Harney Road – Recommended Plan

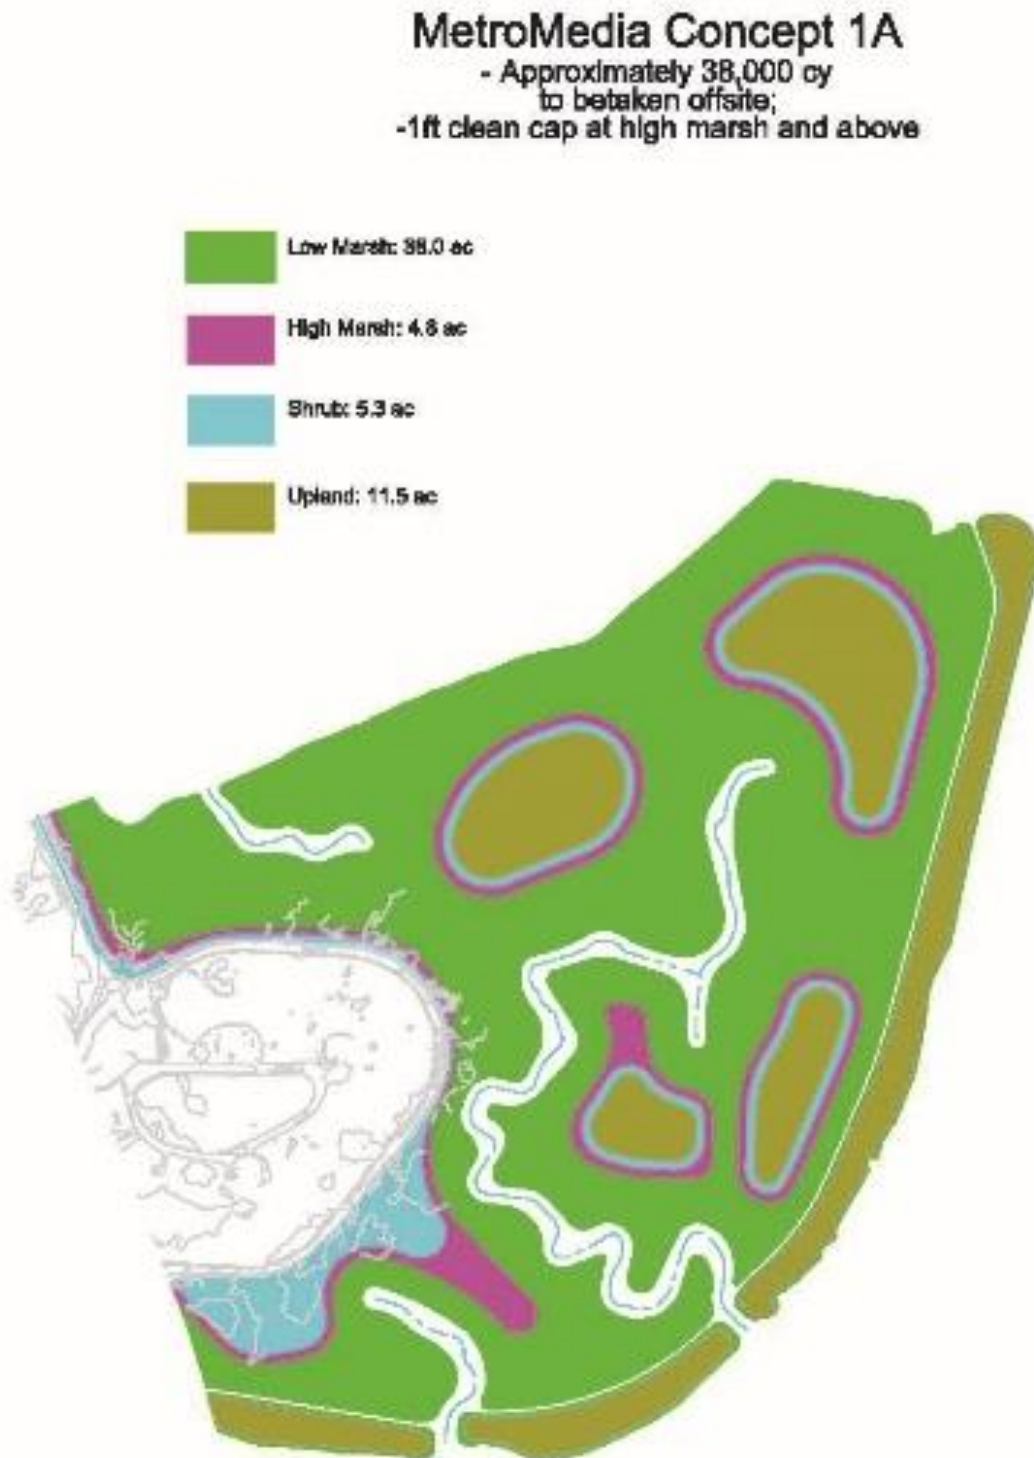
Figure D7- 3. Metromedia Tract – Alternative A

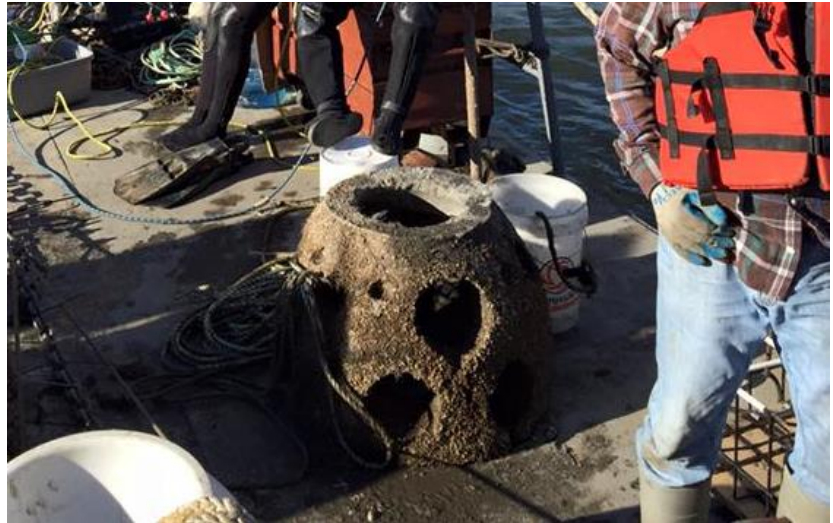
Figure D8- 5. Reef Ball

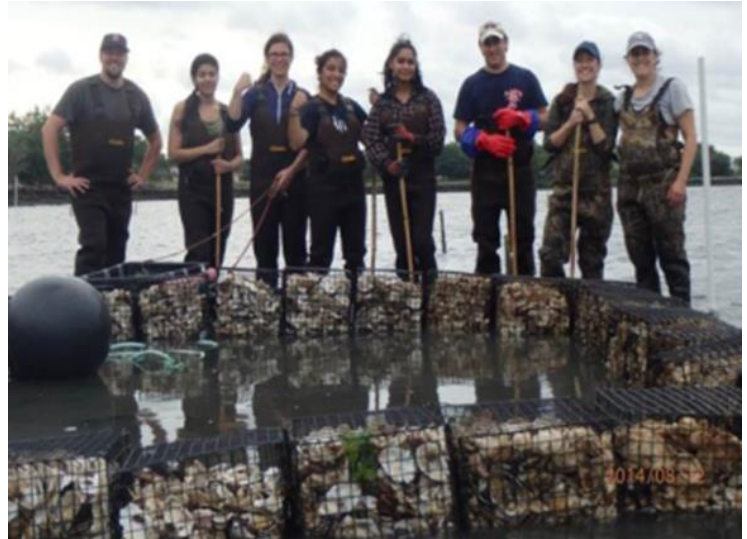
Figure D8- 8. Wire Cages/Gabions

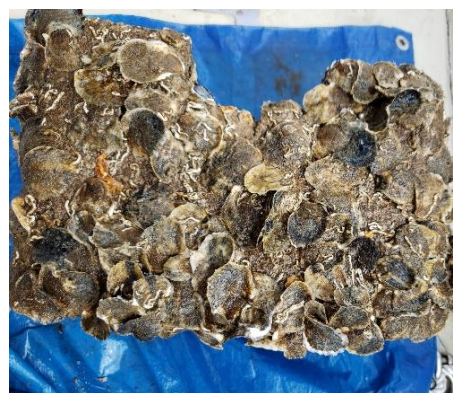
**Figure D8- 16. Oyster growth and survivorship on 9/12/19.
Photo courtesy of NY/NJ Baykeeper.**

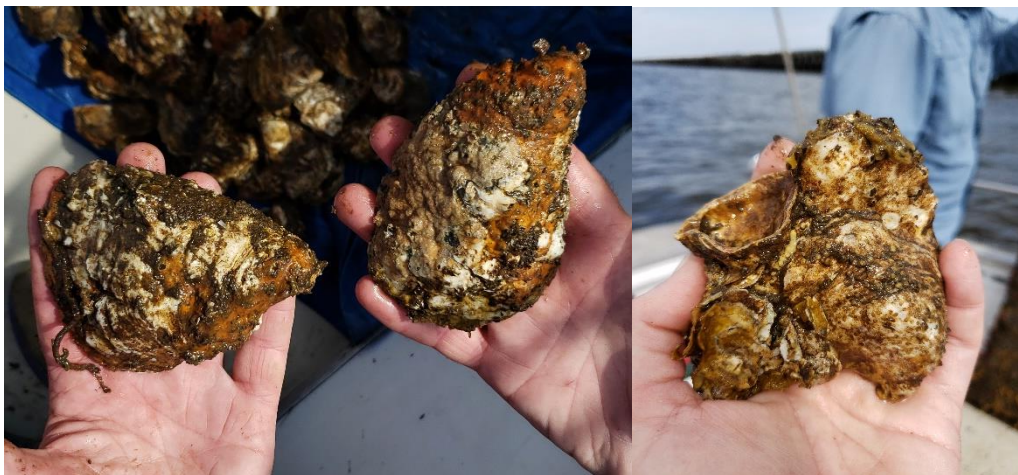
**Figure D8- 17. Oysters from 2015 and natural recruitment.
Photo courtesy of NY/NJ Baykeeper.**
