RESULTS OF THE SUMMER 2006 SEDIMENT-PROFILE IMAGING AND SUB-BOTTOM PROFILING SURVEY AT THE HISTORIC AREA REMEDIATION SITE

FINAL REPORT

December 2006

SAIC Report No. 715

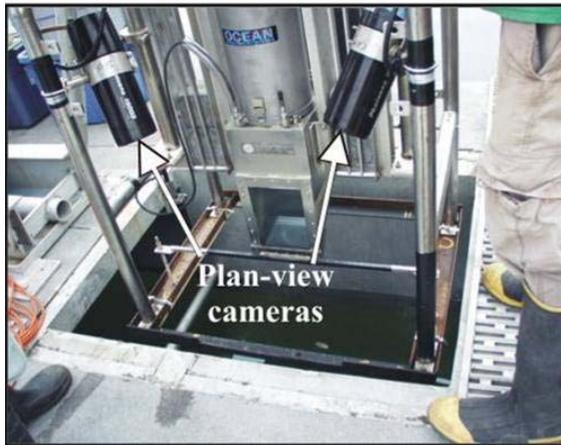
Figure 2.3-1. Schematic diagram of Benthos, Inc. Model 3731 REMOTS[®] (and Ocean Imaging Systems digital head) sediment-profile camera and sequence of operation on deployment. The image in the upper left shows the sediment-profile camera with plan-view camera attached.

The camera frame is lowered to the seafloor at a rate of approximately 1 m/sec (Figure 2.3-1). When the frame settles onto the seafloor, slack on the winch wire allows the prism to penetrate

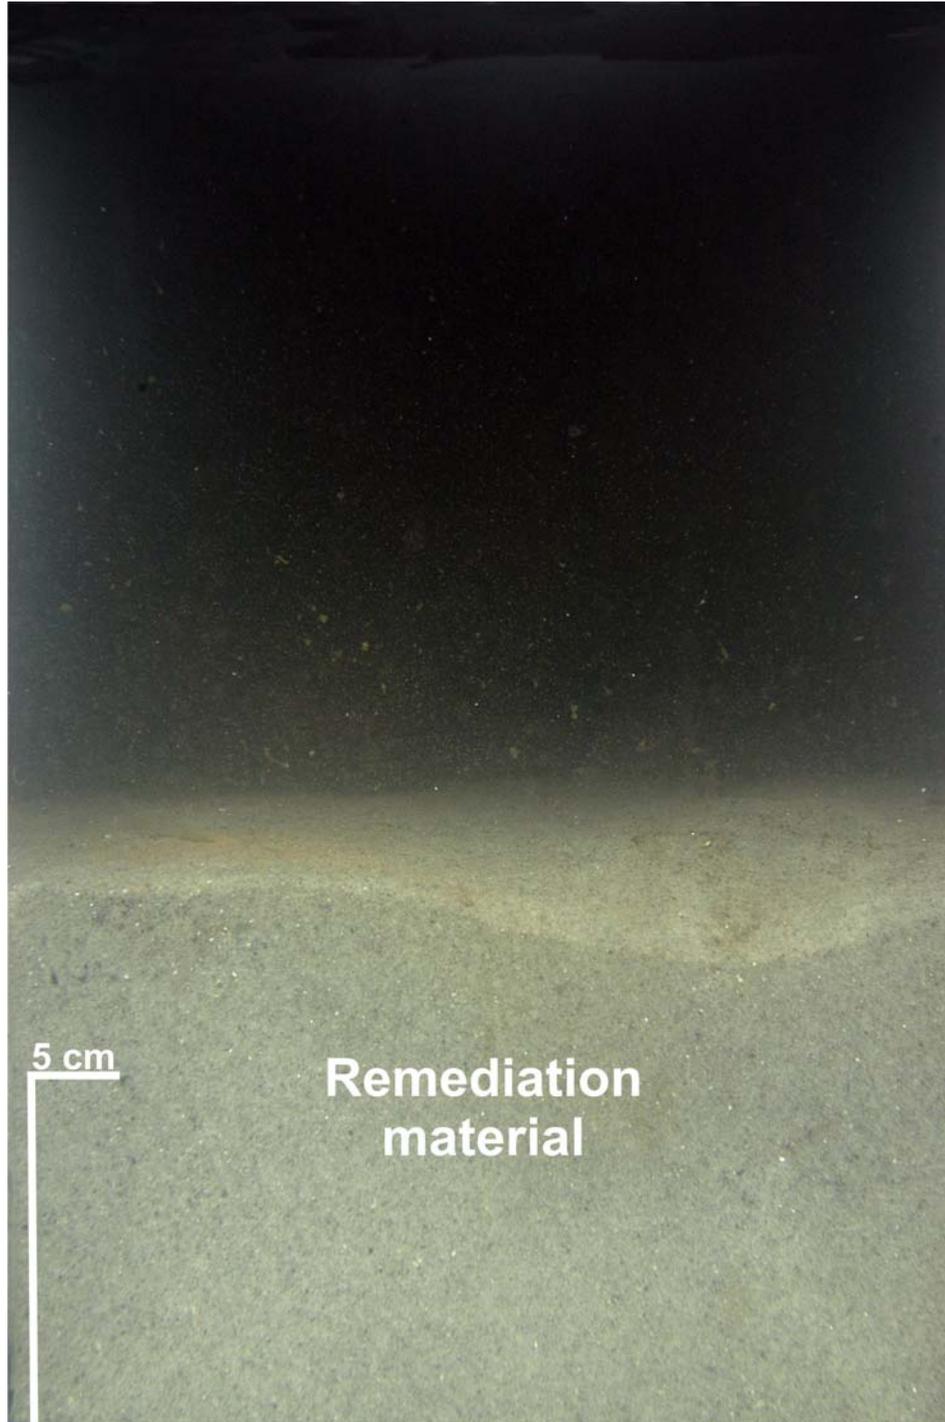
Figure 3.1-4. Sediment-profile image from Station 20028 illustrating remediation material consisting of clean, homogenous, fine sand from Ambrose Channel (grain size major mode of 3 to 2 phi)

At nine of the stations in PRAs 1 and 2, the observed remediation material consisted of clean, homogenous, light-colored fine sand that was dredged from Ambrose Channel as part of an ongoing Navigation Improvement Project (Figure 3.1-4). At Station K0800 in PRA 2, Station M1200 in PRA 3, Stations P2800 and P3200 in PRA 4, and Station A2 outside PRA 2, the remediation material consisted of soft red clay (Figures 3.1-2 and 3.1-5). At the majority of stations in PRAs 1 through 4, the remediation material consisted of “conventional” soft, organic-rich, muddy dredged material (Figures 3.1-2 and 3.1-6).

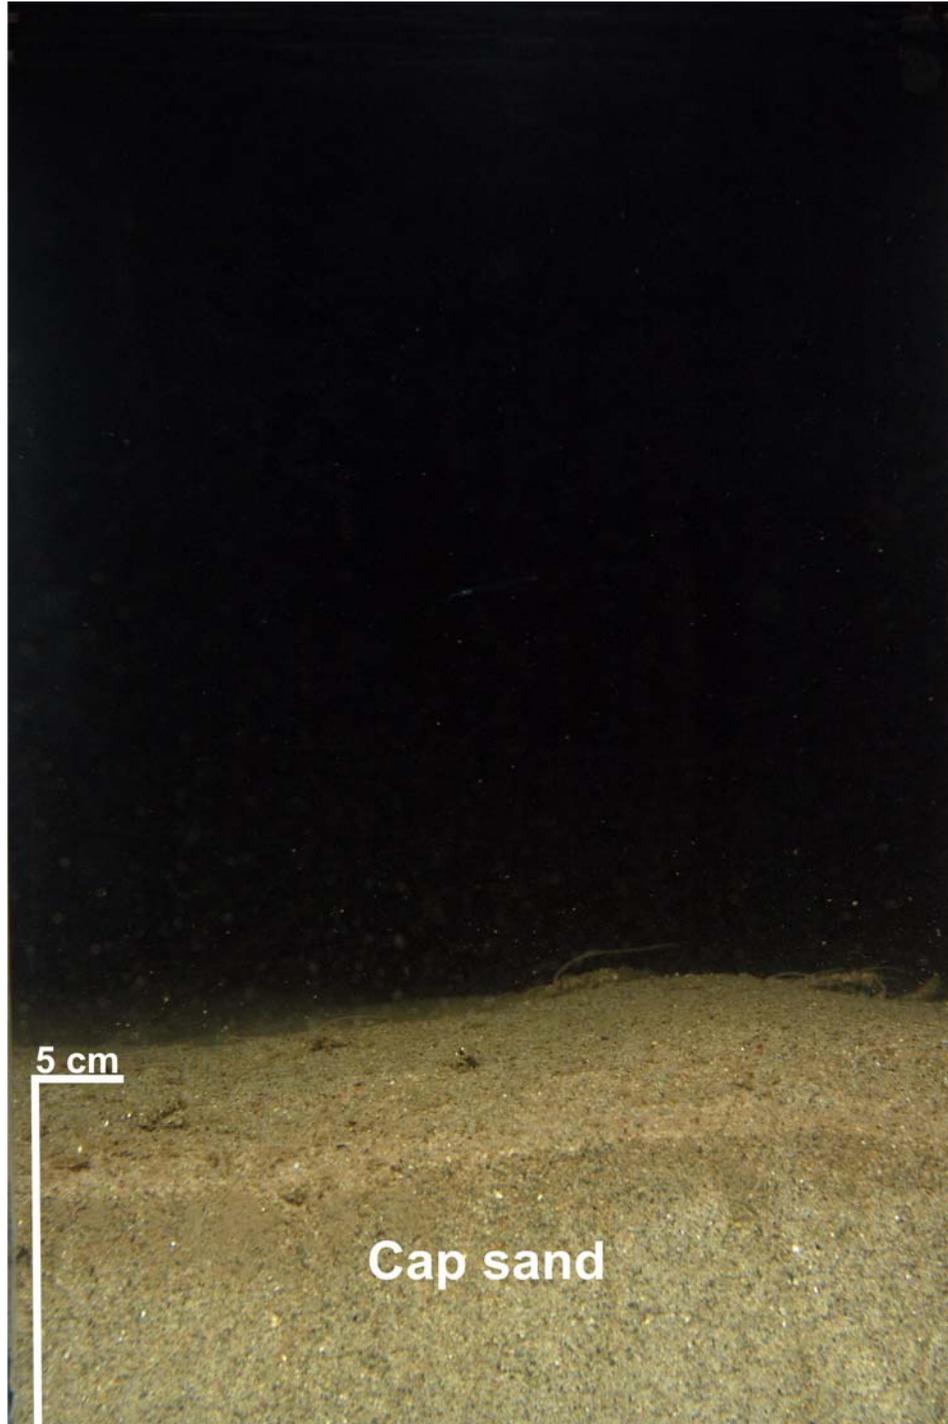
Figure 3.1-9. Sediment-profile image from Station 97004 showing capping material composed of fine sand from the 1993 Dioxin Capping Project

Outside of the active PRAs 1 through 4, the majority of stations exhibited fine-grained relic dredged material from past disposal activities in and around the former Mud Dump Site (Figures 3.1-1 and 3.1-7). At Station 4 in PRA 1 and at Stations A9 and 17 located in the northwest quadrant of the former Mud Dump Site, a distinct stratigraphy was observed consisting of a surface layer of ambient fine sand overlying black, muddy dredged material at depth (Figures 3.1-1 and 3.1-8). Finally, fine sand was observed at Stations 97004 and 97006; this sand represents capping sand used in the 1993 Dioxin Mound and 1997 Category II Capping Projects (Figures 3.1-1 and 3.1-9).
