HISTORIC AREA REMEDIATION SITE (HARS) HEMPSTEAD REEF FIRE ISLAND REEF

FALL 2011

United States Army Corps of Engineers
26 Federal Plaza
New York, New York 10278

Rogers Surveying, P.L.L.C.
1632 Richmond Terrace
Staten Island, New York 10310

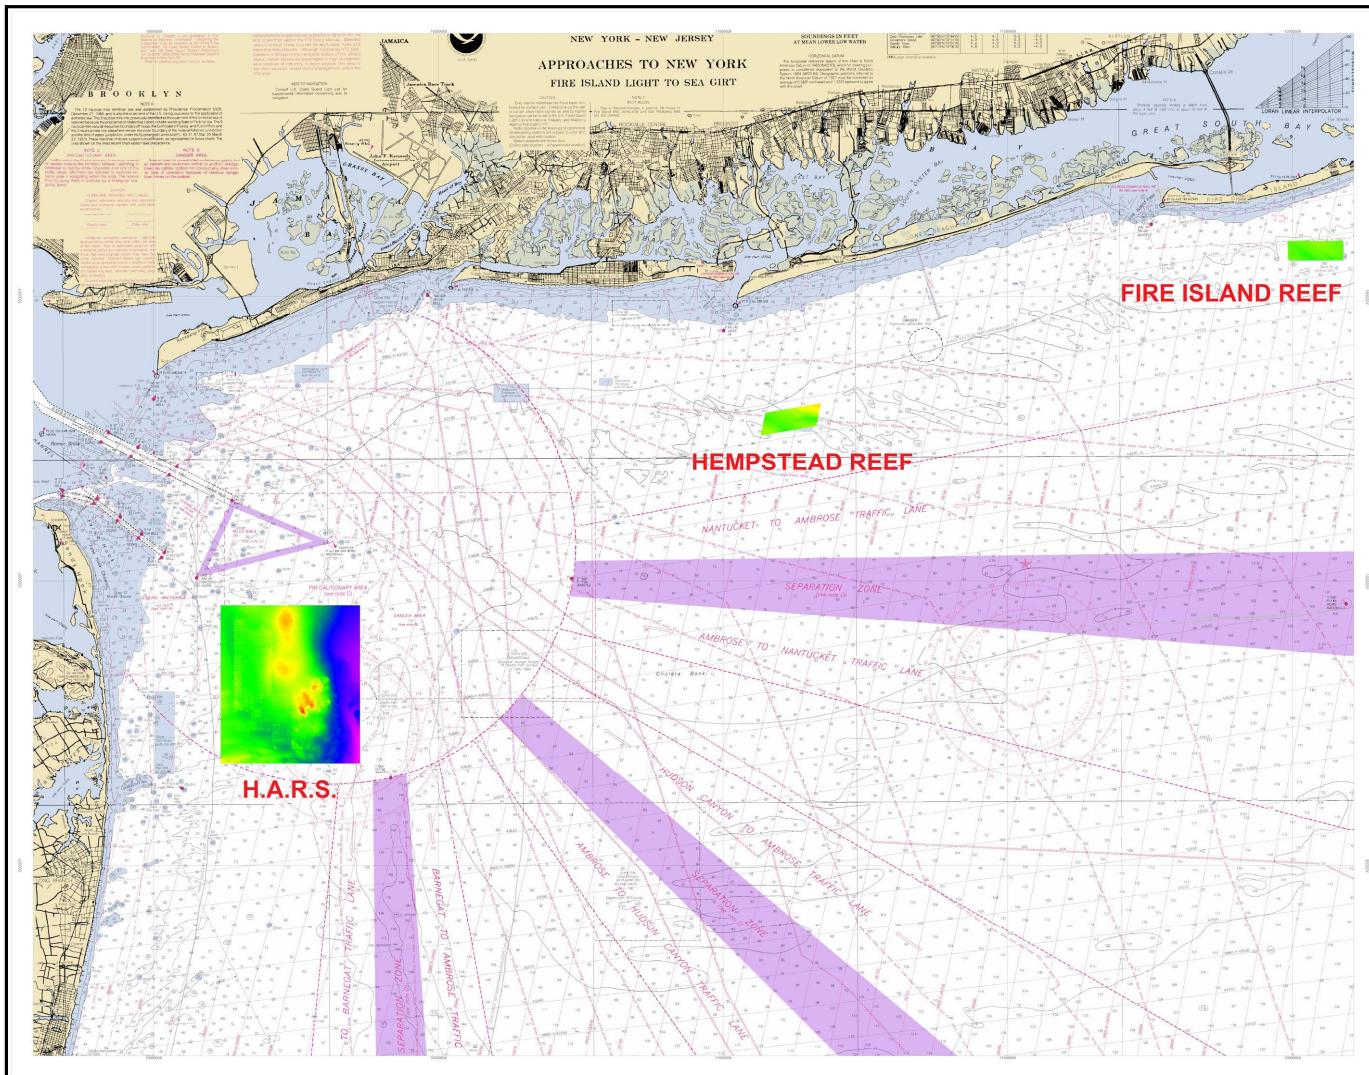
Figure 1.0-1
Task Order 004

As part of Rogers Surveying's Indefinite Delivery Contract with The United States Army Corps of Engineers. Rogers Surveying was tasked with surveying the HARS (Historic Area Remediation Site), Hempstead and Fire Island Reefs. The HARS, which was re-designated as a remediation site in September 1977 was formerly known as the Mud Dump Site (MDS), and was used for the deposit of sediments dredged from the New York / New Jersey Harbor Estuary. The remediation consists of placing a one-meter "cap" layer of uncontaminated dredged material on top of the existing surface sediments within the nine Priority Remediation Areas (PRA's) of the HARS. The Reefs at Hempstead, and Fire Island are planned for rock placement during 2011 and 2012. The surveys are to serve as a baseline surveys.

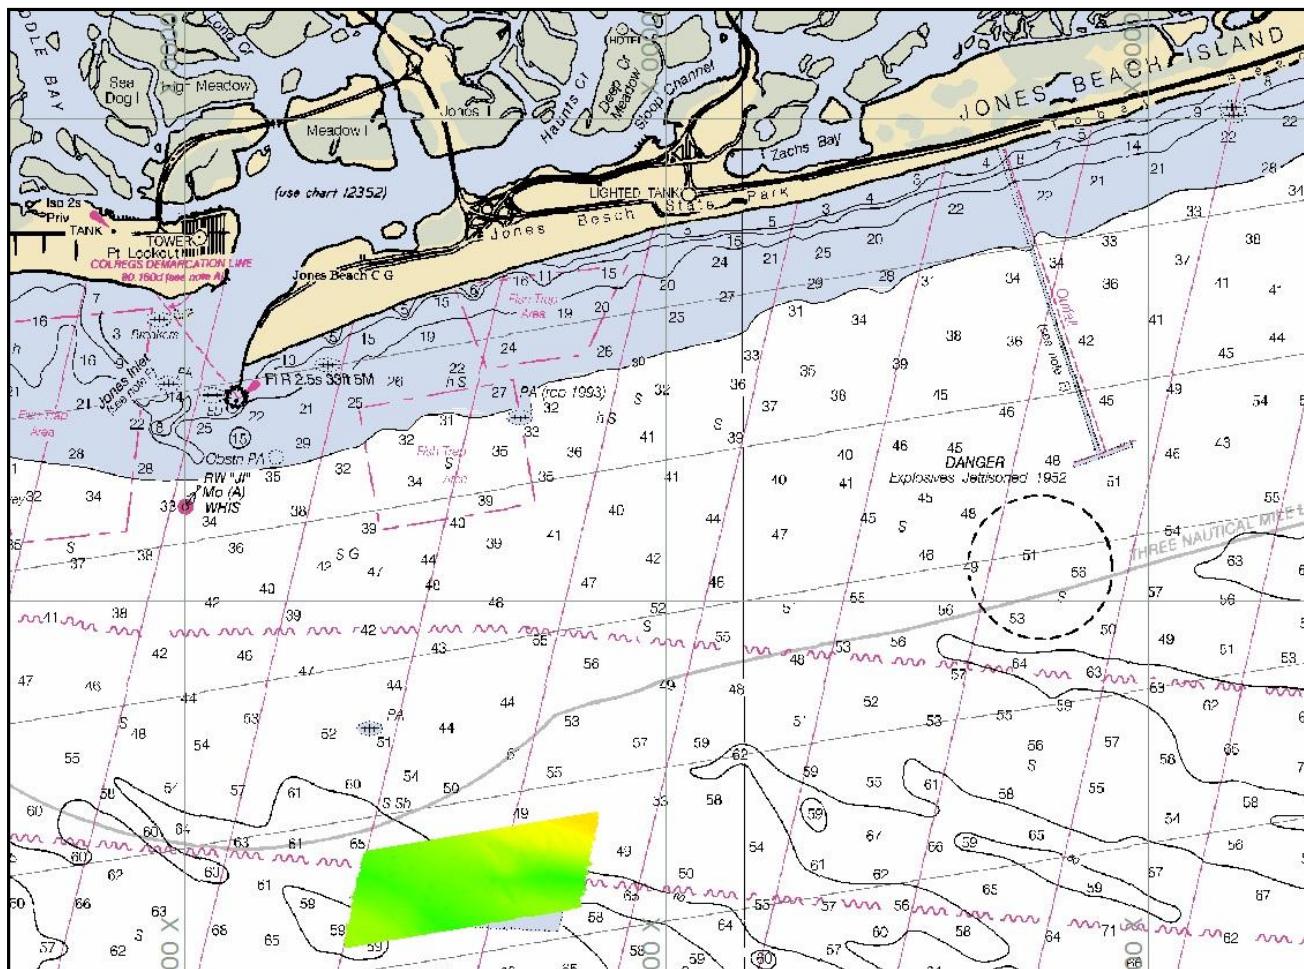
Figure 2.0-2
Hempstead Reef

Hempstead Reef - The primary objective of this task order is to obtain current high-accuracy multibeam bathymetry of the Reef site, the survey is to be used as a baseline survey. The site limits being bounded by North latitude of $40^{\circ} 31.5'$, a West longitude of $73^{\circ} 31.369999'$, North latitude of $40^{\circ} 31.25'$, a West longitude of $73^{\circ} 33.350001'$, North latitude of $40^{\circ} 31.92'$, a West longitude of $73^{\circ} 31.550001'$, North latitude of $40^{\circ} 30.67'$, a West longitude of $73^{\circ} 33.519999'$. The total survey coverage area being approximately 1.2 square miles. (Figure 2.0-2)

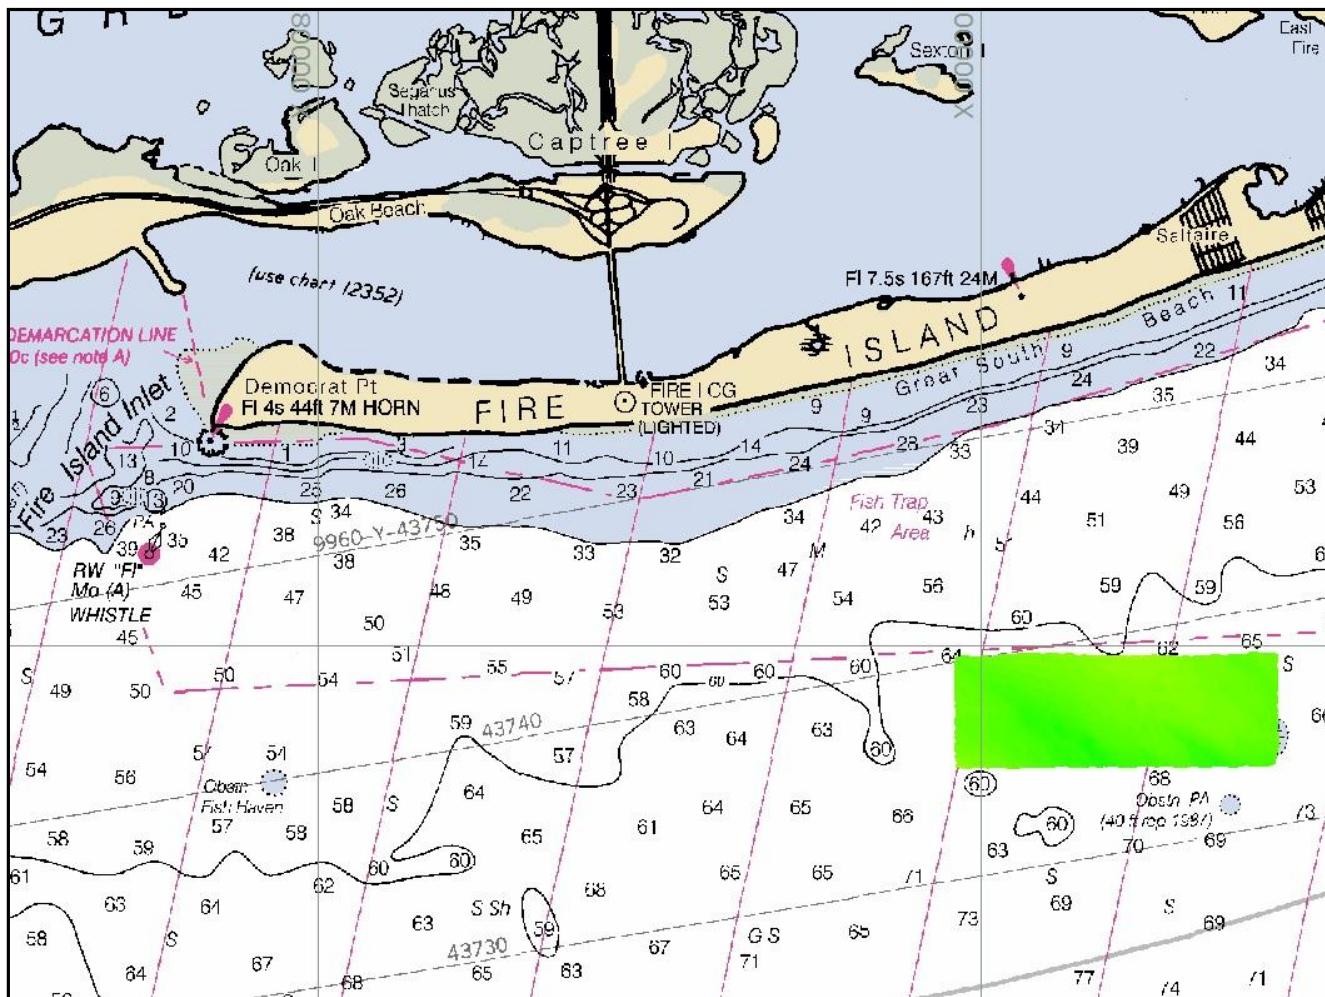
Figure 2.0-3
Fire Island Reef

Fire Island Reef - The primary objective of this task order is to obtain current high-accuracy multibeam bathymetry of the Reef site, the survey is to be used as a baseline survey. The site limits being bounded by North latitude of $40^{\circ} 36.1'$, a South latitude of $40^{\circ} 35.60'$ and East longitude of $73^{\circ} 11.500'$, a West longitude of $73^{\circ} 13.500'$. The total survey coverage area being approximately 1.2 square miles. (Figure 2.0-3).

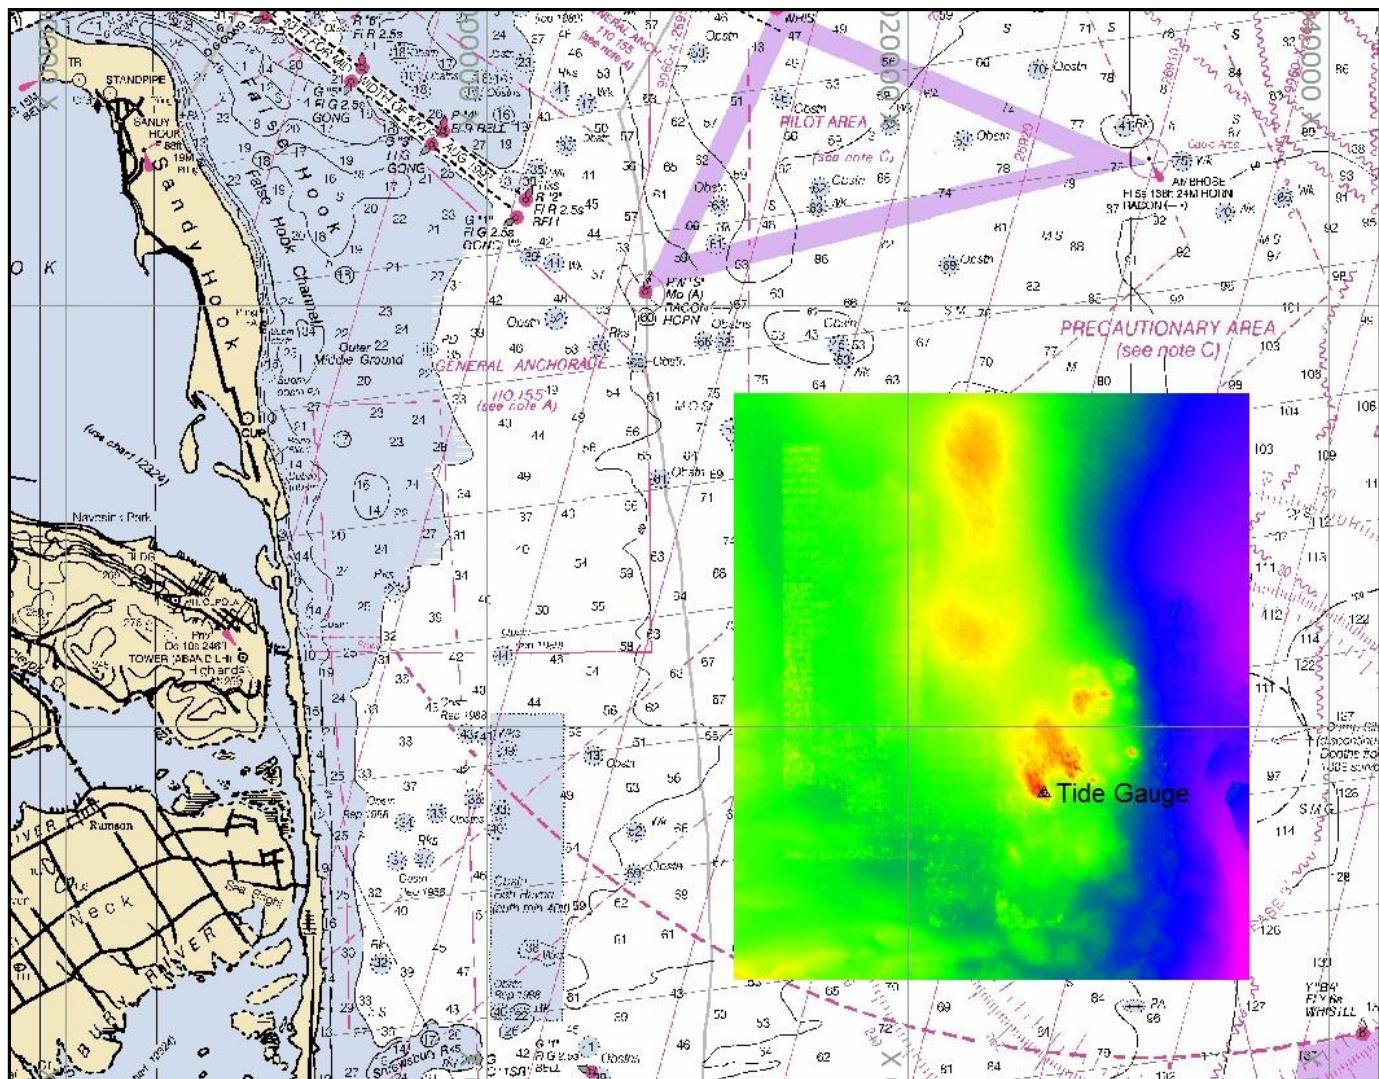
Figure 3.0-2
Final multibeam coverage of the HARS, with submersible Tide Gauge location.

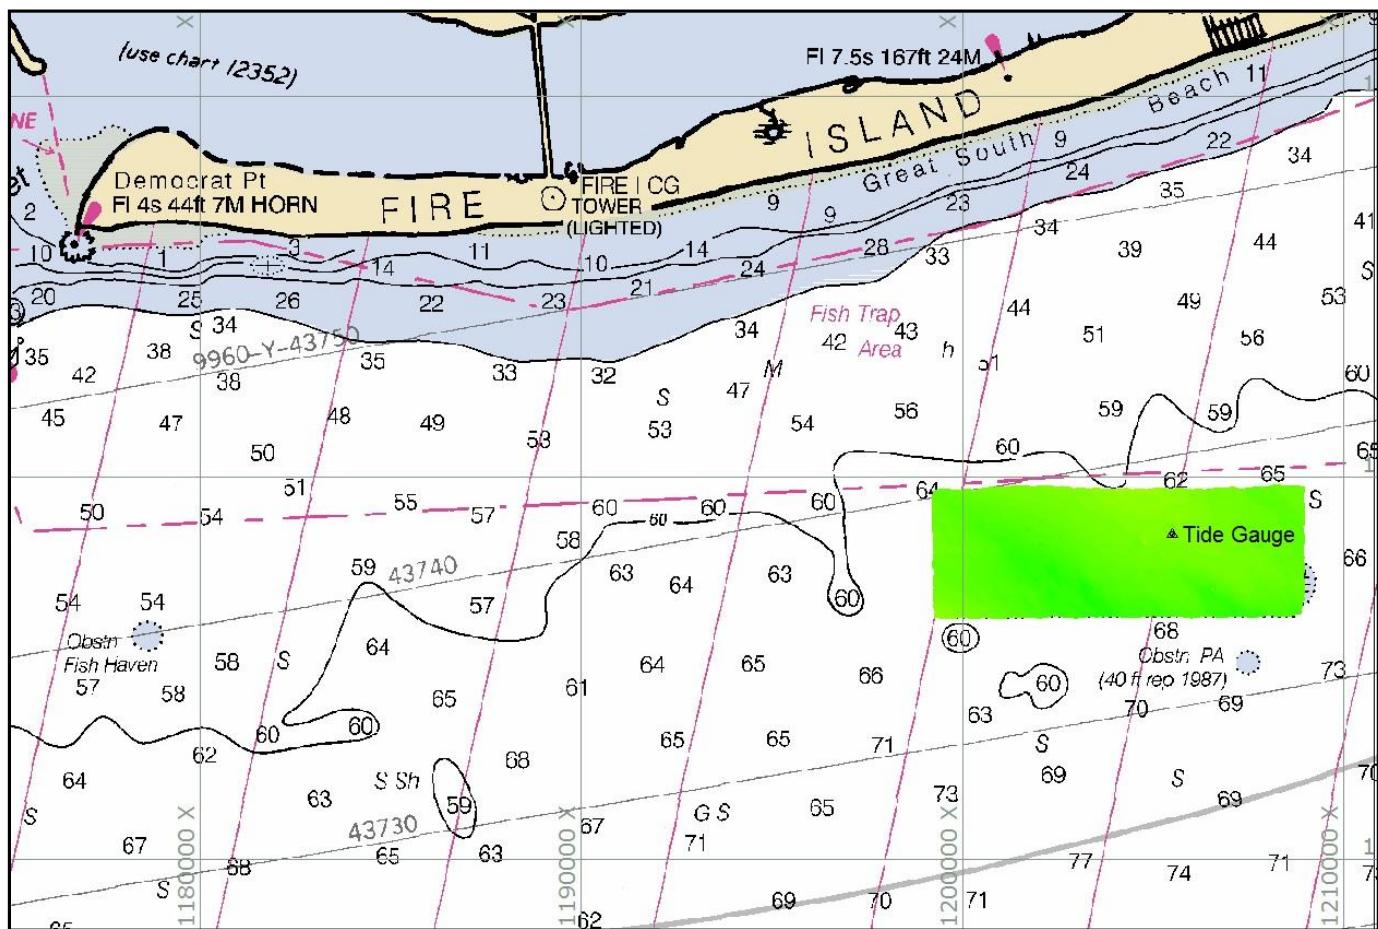
Figure 3.0-3

Final multibeam coverage of the Fire Island Reef, with submersible Tide Gauge location.

For the Fall 2011 bathymetry survey at Fire Island and Hempstead Reefs the *Valeport Mini* submersible tide gauge was replaced with the more robust *Valeport WLR*. The gauge was deployed prior to collection of multibeam data at the reefs. It was decided to begin with Fire Island Reef and then move on to Hempstead Reef. This gauge which measures pressure was located on the sea floor (see Figure 3.0-3), attached to an anchor with an additional attachment to an acoustic release buoy (see Figure 3.0-1). Real Time Kinematic GPS (RTK) option of the POS/MV on board the survey vessel was used to provide real time water level elevations. This system was referenced to NAVD88 during data collection. The Fire Island Reef survey area was within cellular coverage and RTK GPS was constant for the entire survey. Using RTK GPS the water level was measured at the seabed tidal sensor for a length of time while sea conditions were relatively calm. This calibration or water level was then used to derive a fixed offset from sensors water level to NAVD 88. NOAA’s *VDATUM* program was then used to determine mean low water (MLW) at the Fire Island Site, which was determined to be 2.23’ below 0’ NAVD88.

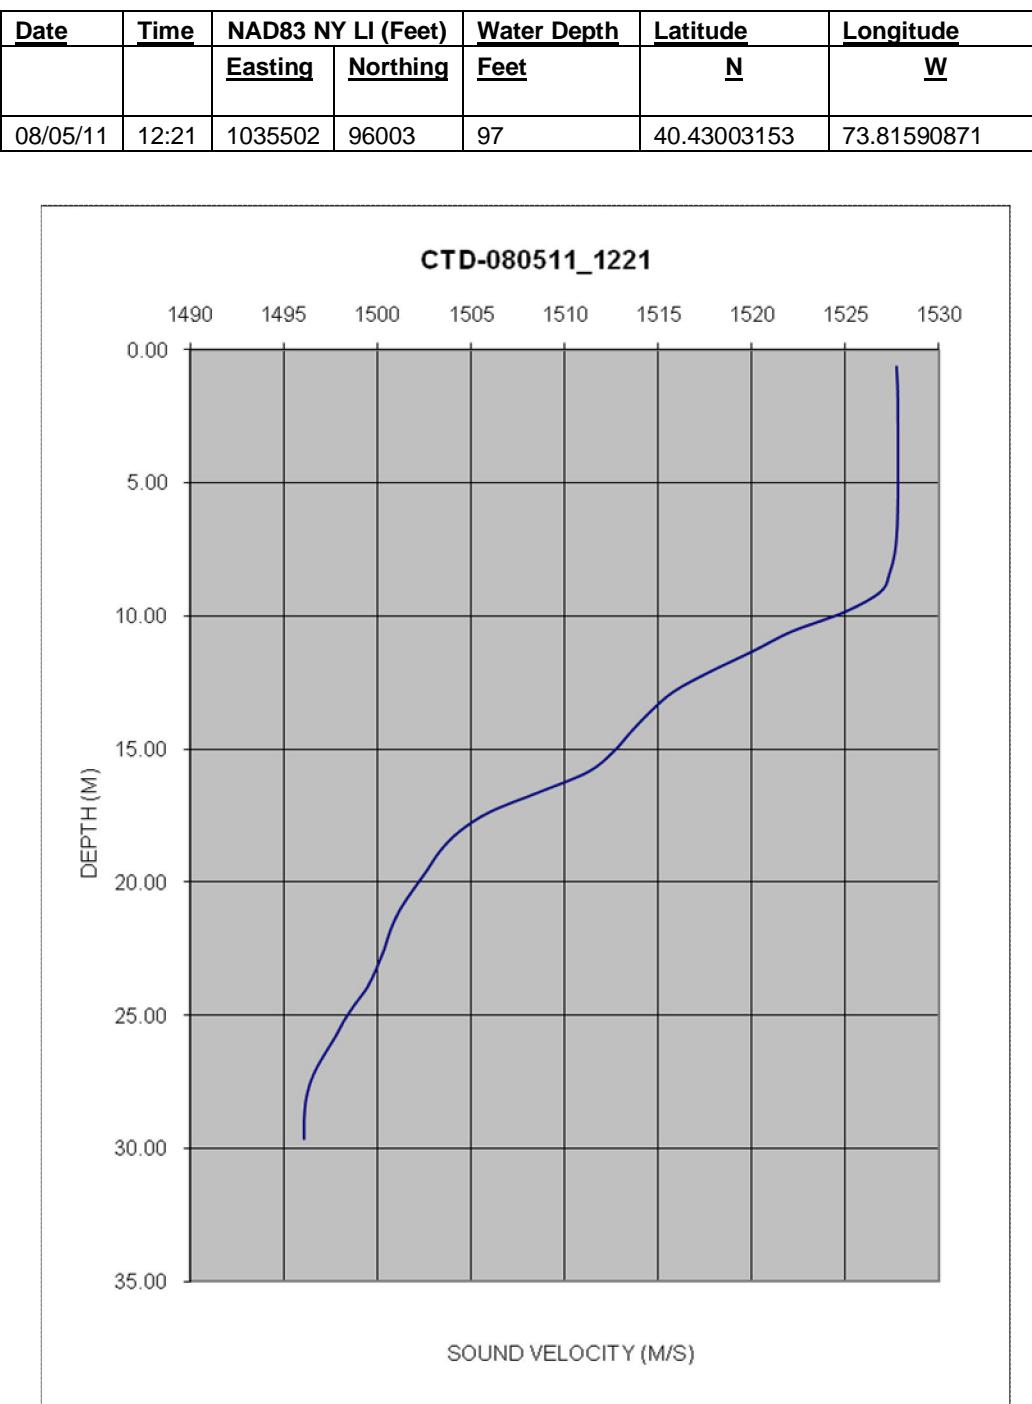
CTD PROFILE # 080511_1221

Sound velocity profiles were taken during the course of the survey using a SeaBird SBE 19plus Version 2 CTD. Casts were obtained before, during and after each survey period. During survey operations casts were taken not less than three hours apart and at opposite ends of the days survey area, to account for any spatial water column speed of sound changes. The SeaBird SBE 19plus was last calibrated by the manufacturer on 05/25/07 and is periodically checked against our Odom Digibar Pro velocity profiler. For HARS a total of 66 SVP casts were taken over the course of the multibeam survey (Table 3.2-0). Plots of all SVP casts are shown in Figures 3.2-1 to 3.2-65.

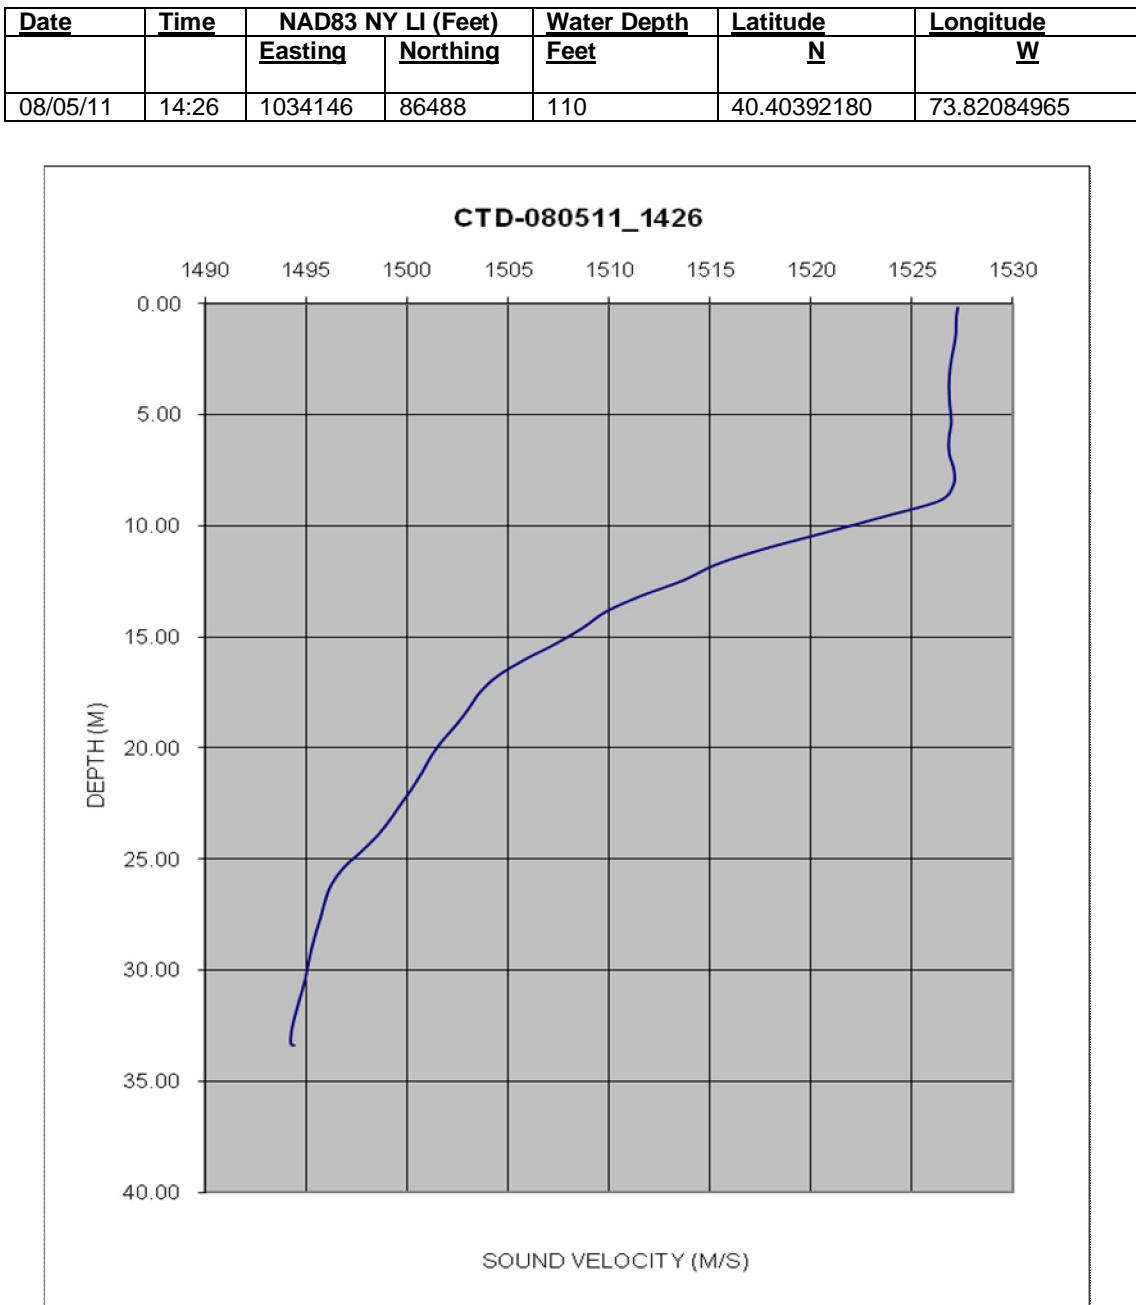
CTD PROFILE # 080511_1426

Figure 3.2-2
SVP 080511_1426 taken during the Fall 2011 multibeam survey at the HARS.

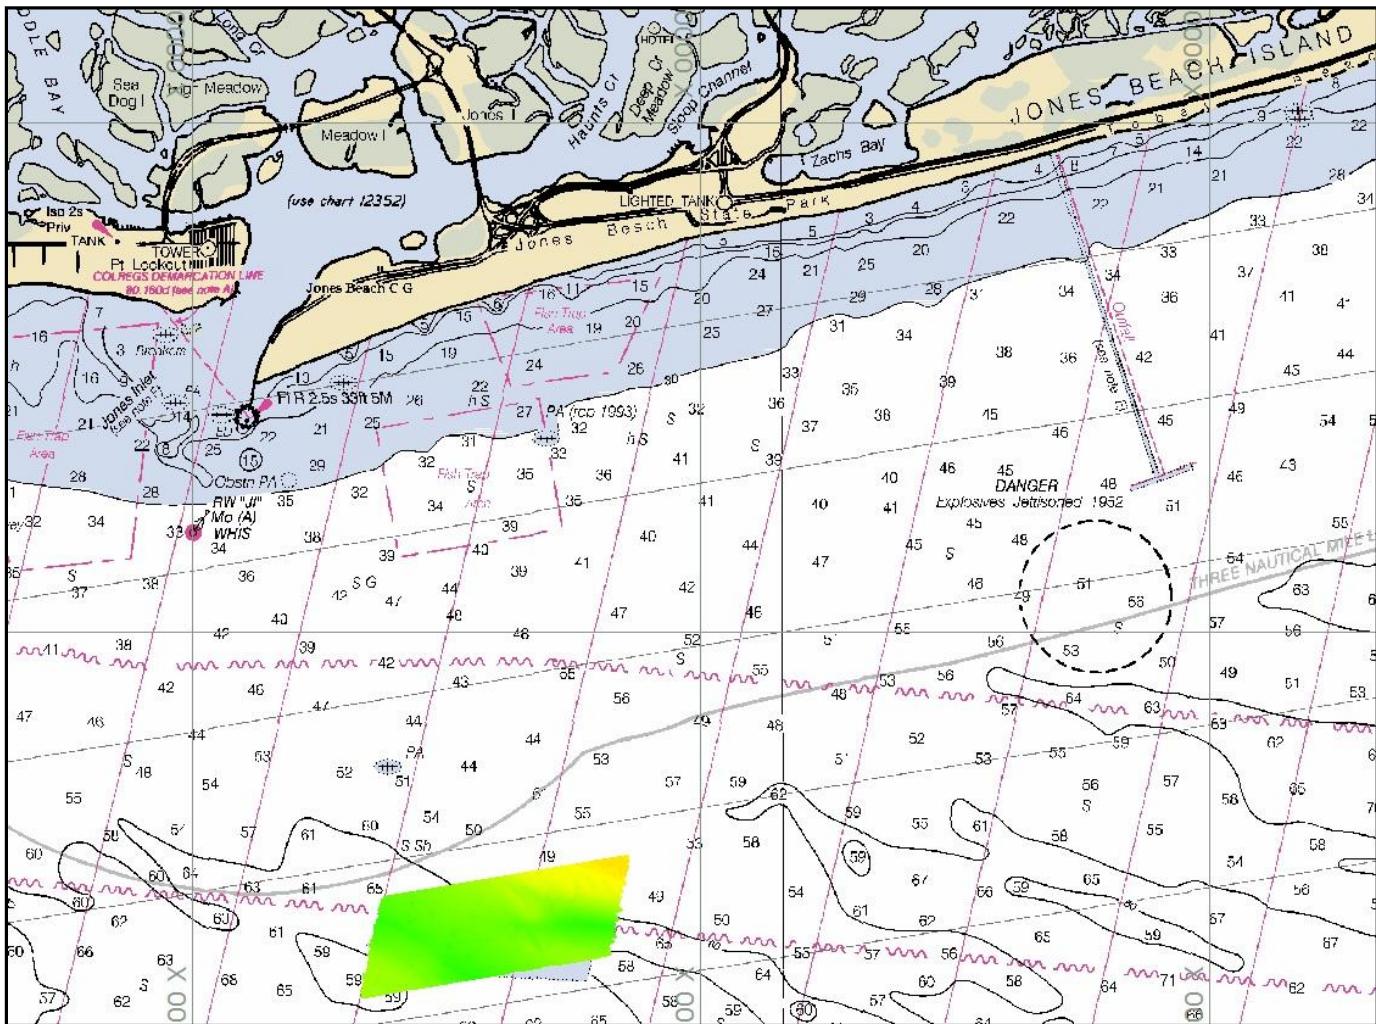
Figure 3.0-4
Final multibeam coverage of the Hempstead Reef.
