HISTORIC AREA REMEDIATION SITE (HARS)

SPRING 2012

Rogers Surveying, P.L.L.C.
1632 Richmond Terrace
Staten Island, New York 10310

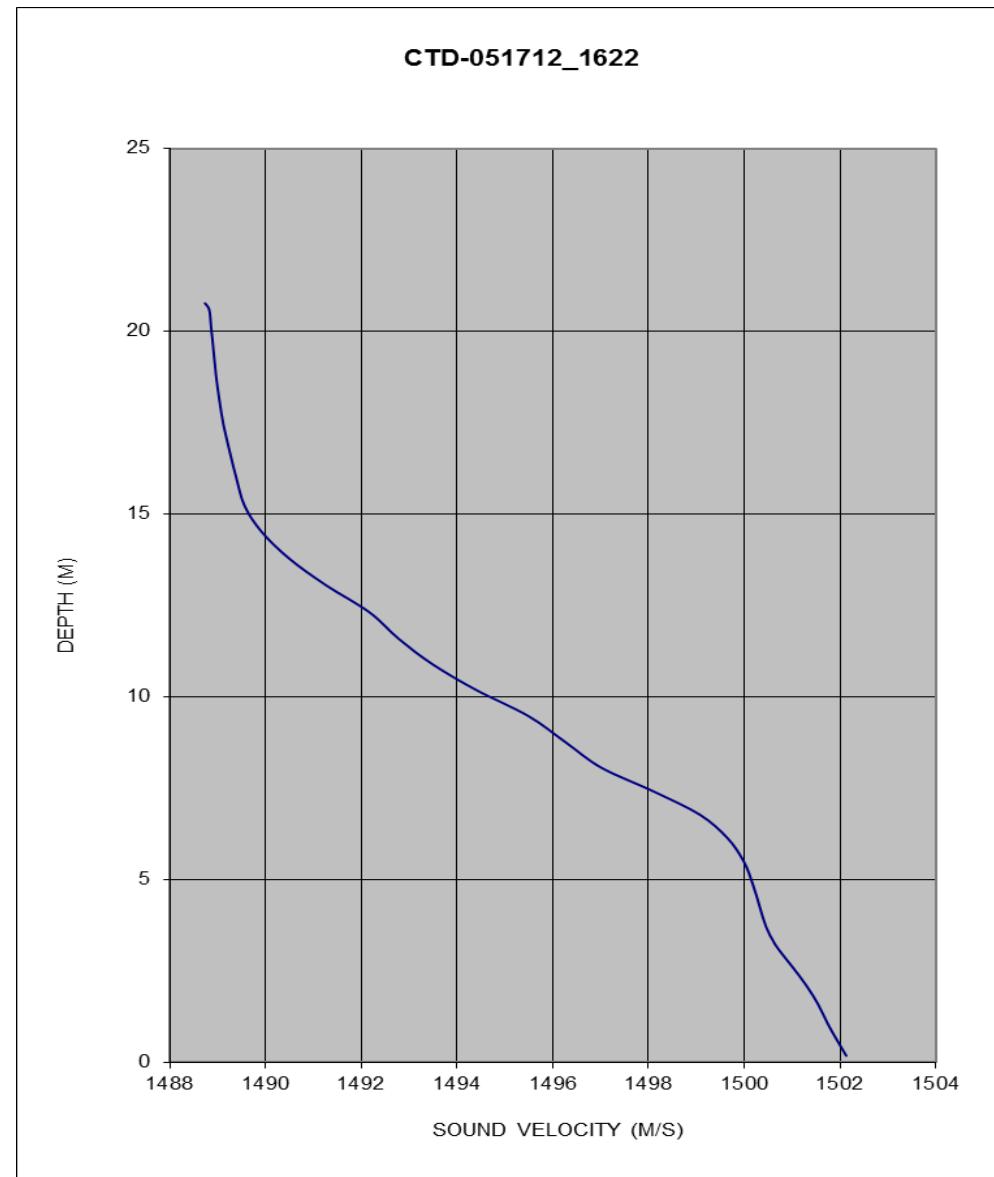
Figure 3.2-1
SVP 051712_1622 taken during the Spring 2012 multibeam survey at the HARS.

CTD PROFILE # 051712 1622

Sound velocity profiles were taken during the course of the survey using a SeaBird SBE 19plus Version 2 CTD. Casts were obtained before, during and after each survey period. During survey operations casts were taken not less than three hours apart and at opposite ends of the days survey area, to account for any spatial water column speed of sound changes. The SeaBird SBE 19plus was last calibrated by the manufacturer and is periodically checked against our Odom Digibar Pro velocity profiler. A total of 26 SVP casts were taken over the course of the multibeam survey (Table 3.2-0). Plots of all SVP casts are shown in Figures 3.2-1 to 3.2-65.

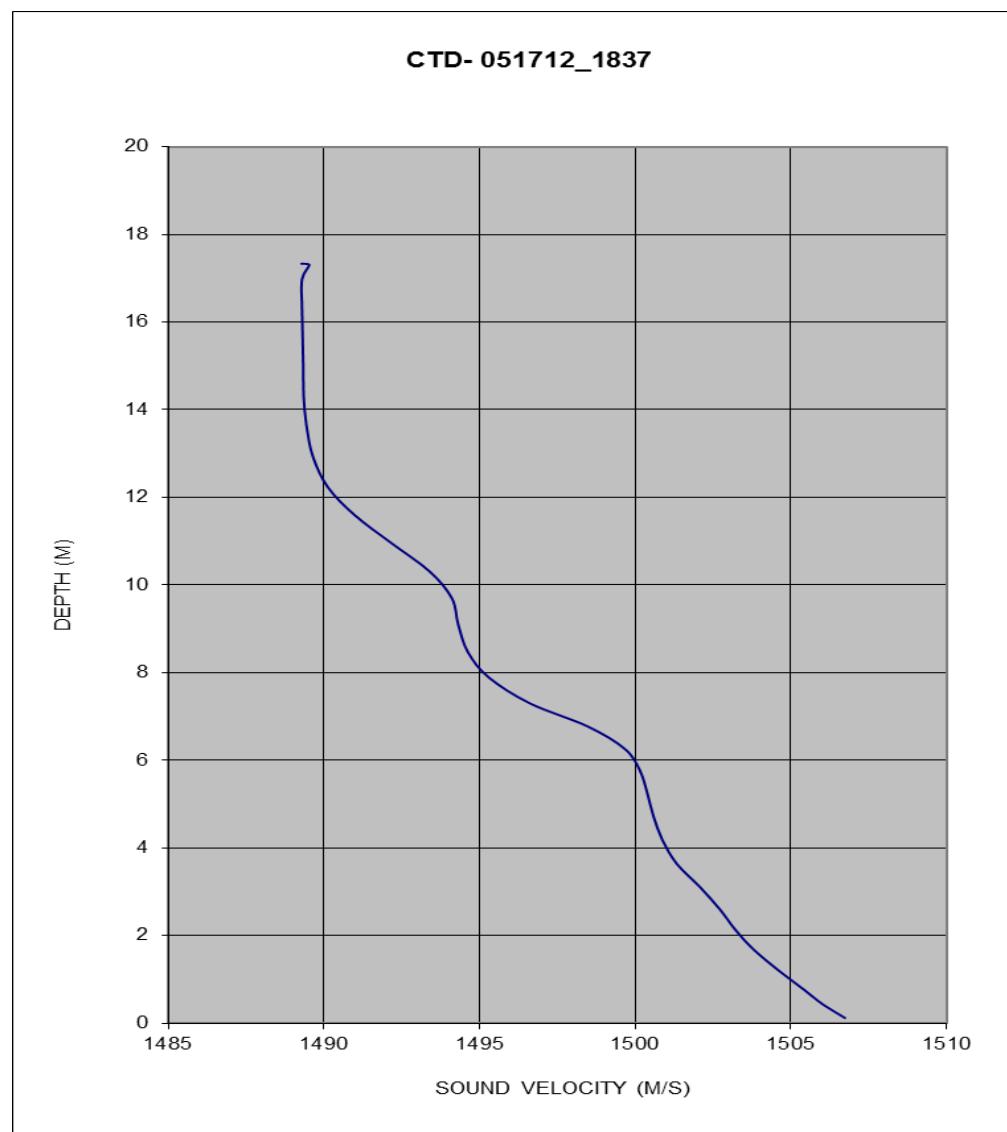
Figure 3.2-2
SVP 051712_1837 taken during the Spring 2012 multibeam survey at the HARS.

CTD PROFILE # 051712_1837

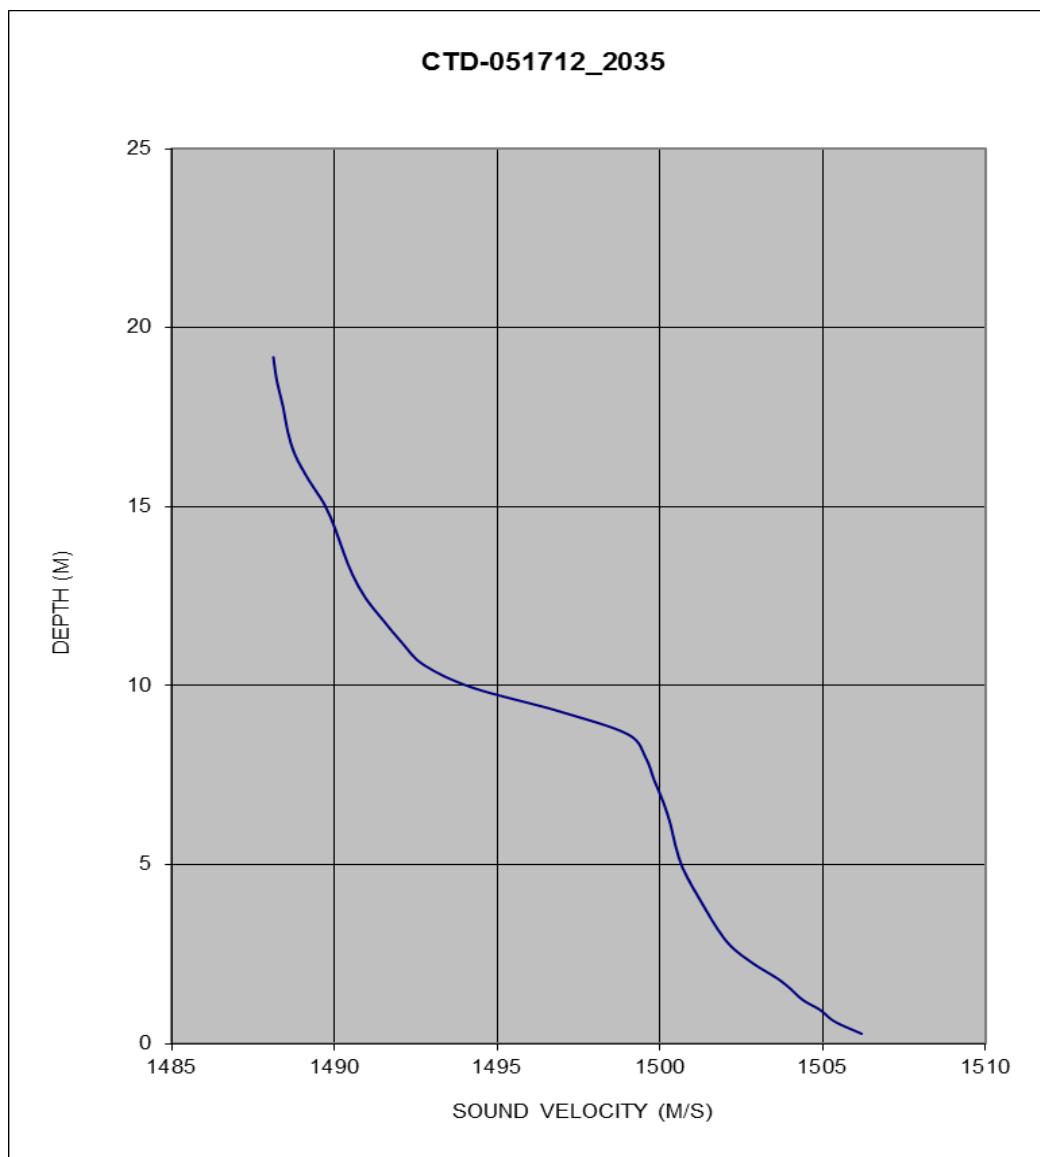
Figure 3.2-3
SVP 051712_2035 taken during the Spring 2012 multibeam survey at the HARS.

CTD PROFILE # 051712_2035

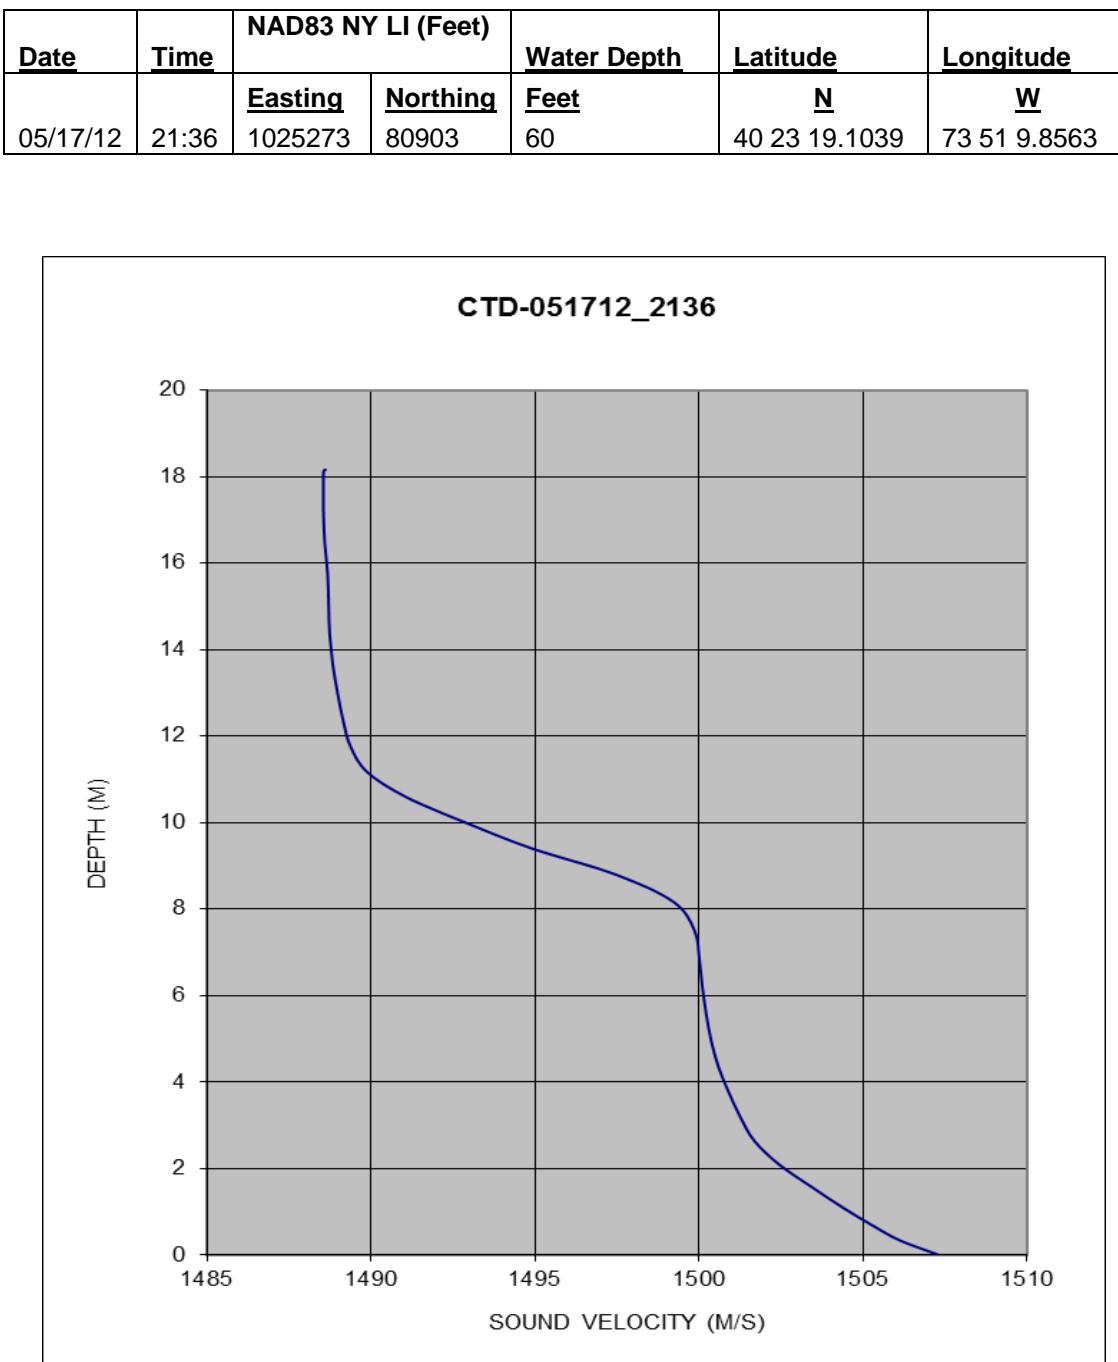
Figure 3.2-4
SVP 051712_2136 taken during the Spring 2012 multibeam survey at the HARS.

CTD PROFILE # 051712_2136

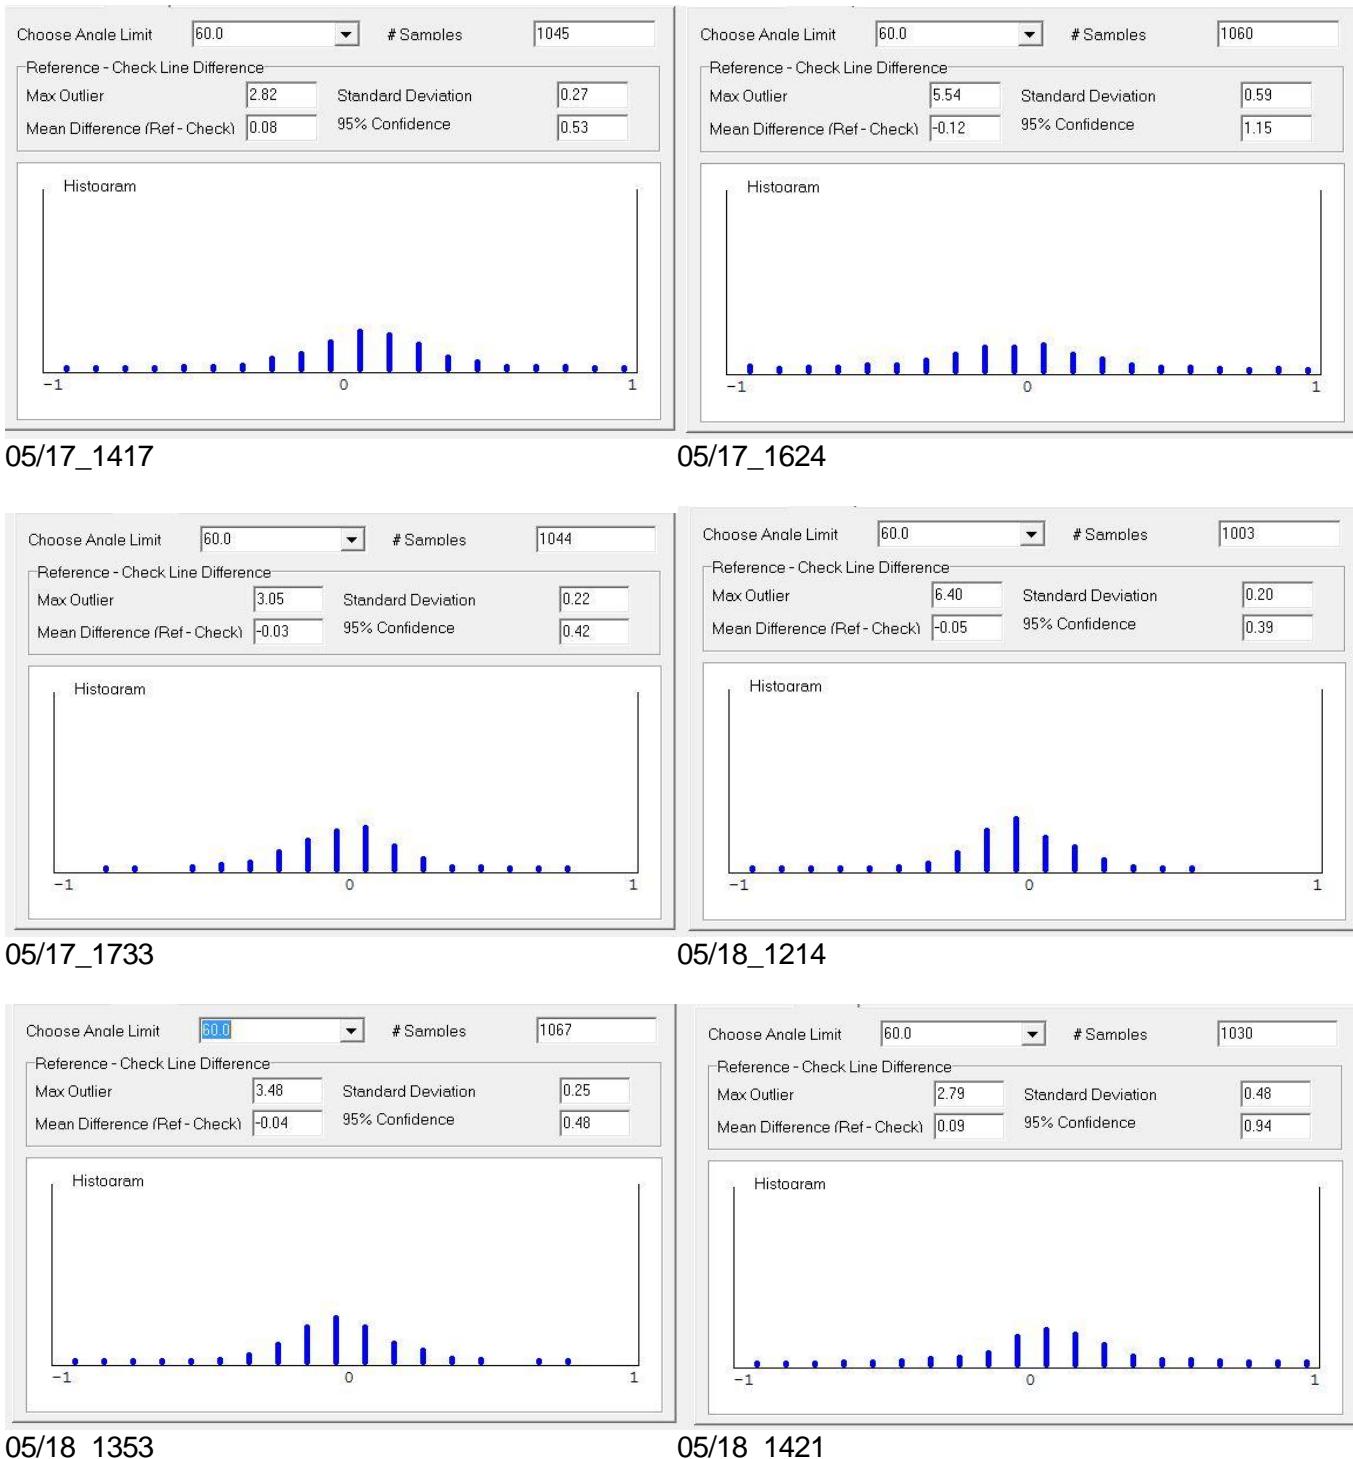
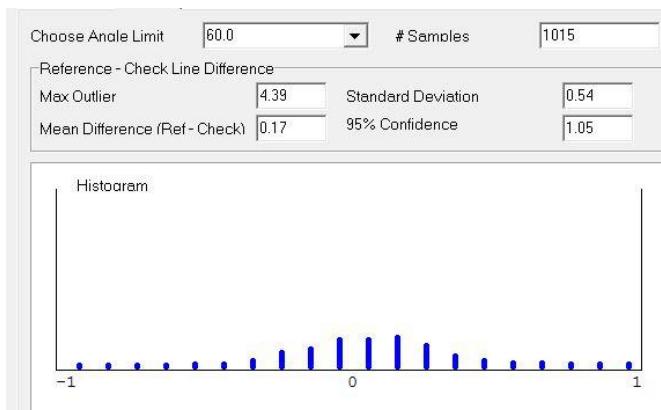
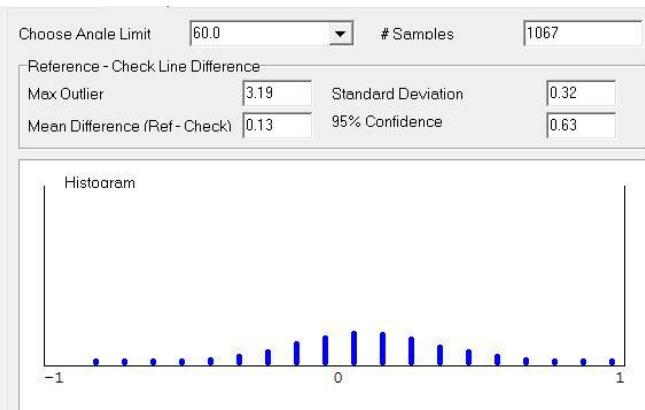
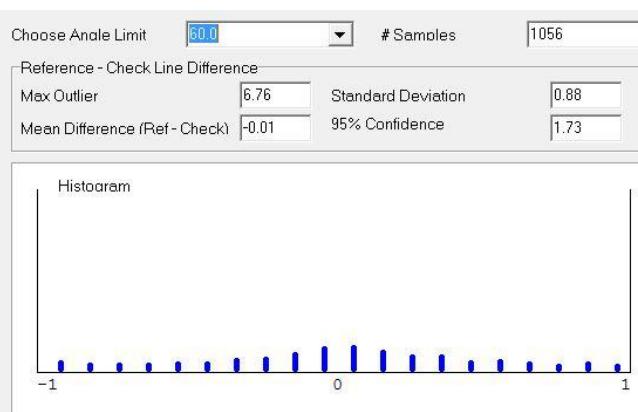
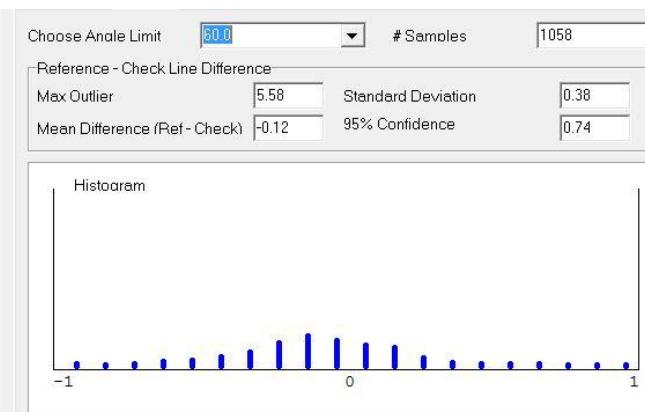
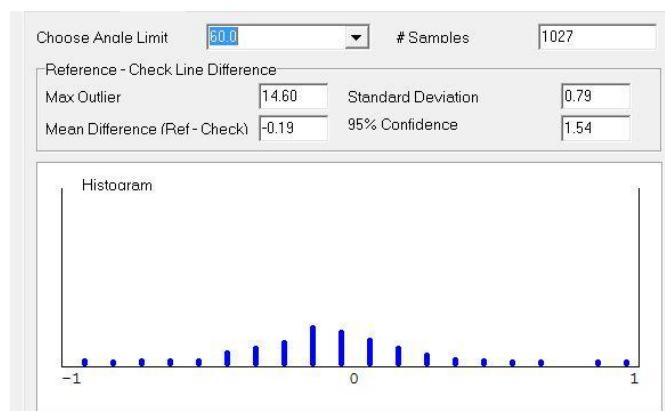
Figure 4.1-1

Plots of +/- 60 Deg. Beam Analysis Results for crossings 05/17 to 06/07 during HARS Spring 2012 survey.
