## 1.0 Introduction

As part of Rogers Surveying's Indefinite Delivery Contract with The United States Army Corps of Engineers. Rogers Surveying was tasked with surveying the HARS (Historic Area Remediation Site). The HARS, which was re-designated as a remediation site in September 1977 was formerly known as the Mud Dump Site (MDS), and was used for the deposit of sediments dredged from the New York / New Jersey Harbor Estuary. The remediation consists of placing a one-meter "cap" layer of uncontaminated dredged material on top of the existing surface sediments within the nine Priority Remediation Areas (PRA's) of the HARS.

The primary objective of this task order is to obtain current high-accuracy multibeam bathymetry of the site, to be used in the monitoring and planning of dredge placement. The site limits being bounded by North latitude of 40° 25.757, a South latitude of 40° 21.189' and East longitude of 73° 48.798, a West longitude of 73° 54.075'. The total survey coverage area being approximately 24.6 square miles. (Figure 2.0-1). Rogers Surveying was given a scope of work and proceeded to perform survey operations on 9/16/09 (Table 2.0-1).

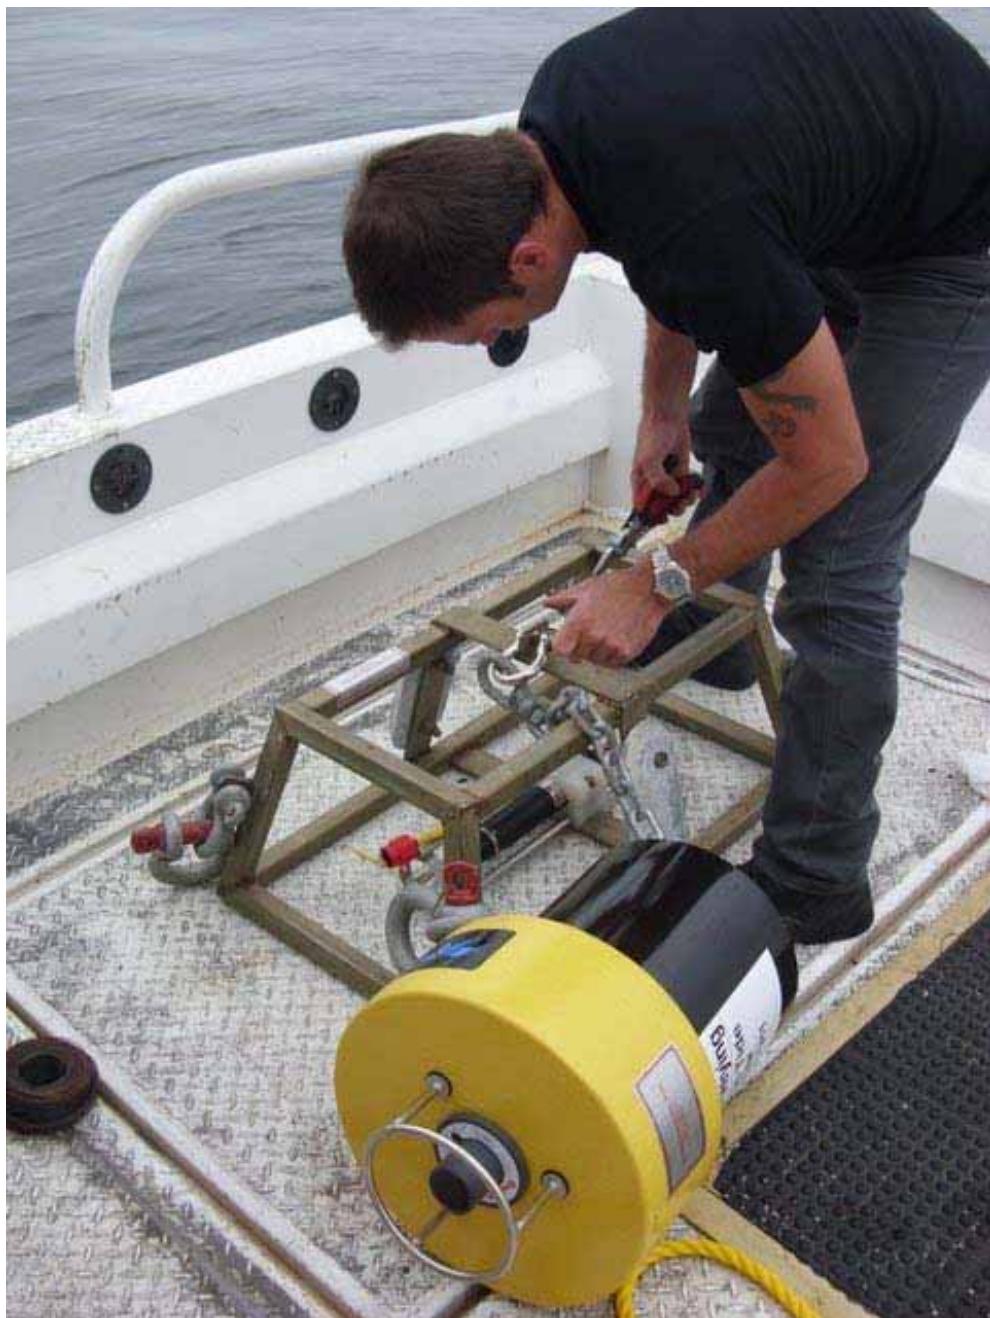
**Figure 3.0-1**  
Attaching Acoustic Release Buoy to Submersible Tide Gauge

A seabed mounted water pressure gauge was installed at latitude N 40 °22' 38.9677" and longitude W 73° 50' 54.9287". It was anchored in approximately 40' of water (Figures 3.0-1 and 3.0-2). An acoustic release system was incorporated for retrieval of the tide gauge. The gauge was preset to record data for 60 seconds every 5 minutes. The Real Time Kinematic GPS, which augmented the POS/MV position also provided real time water levels. The RTK and VRS corrections were provided via a cellular Internet GPS Network operated by Keystone Precision of PA.

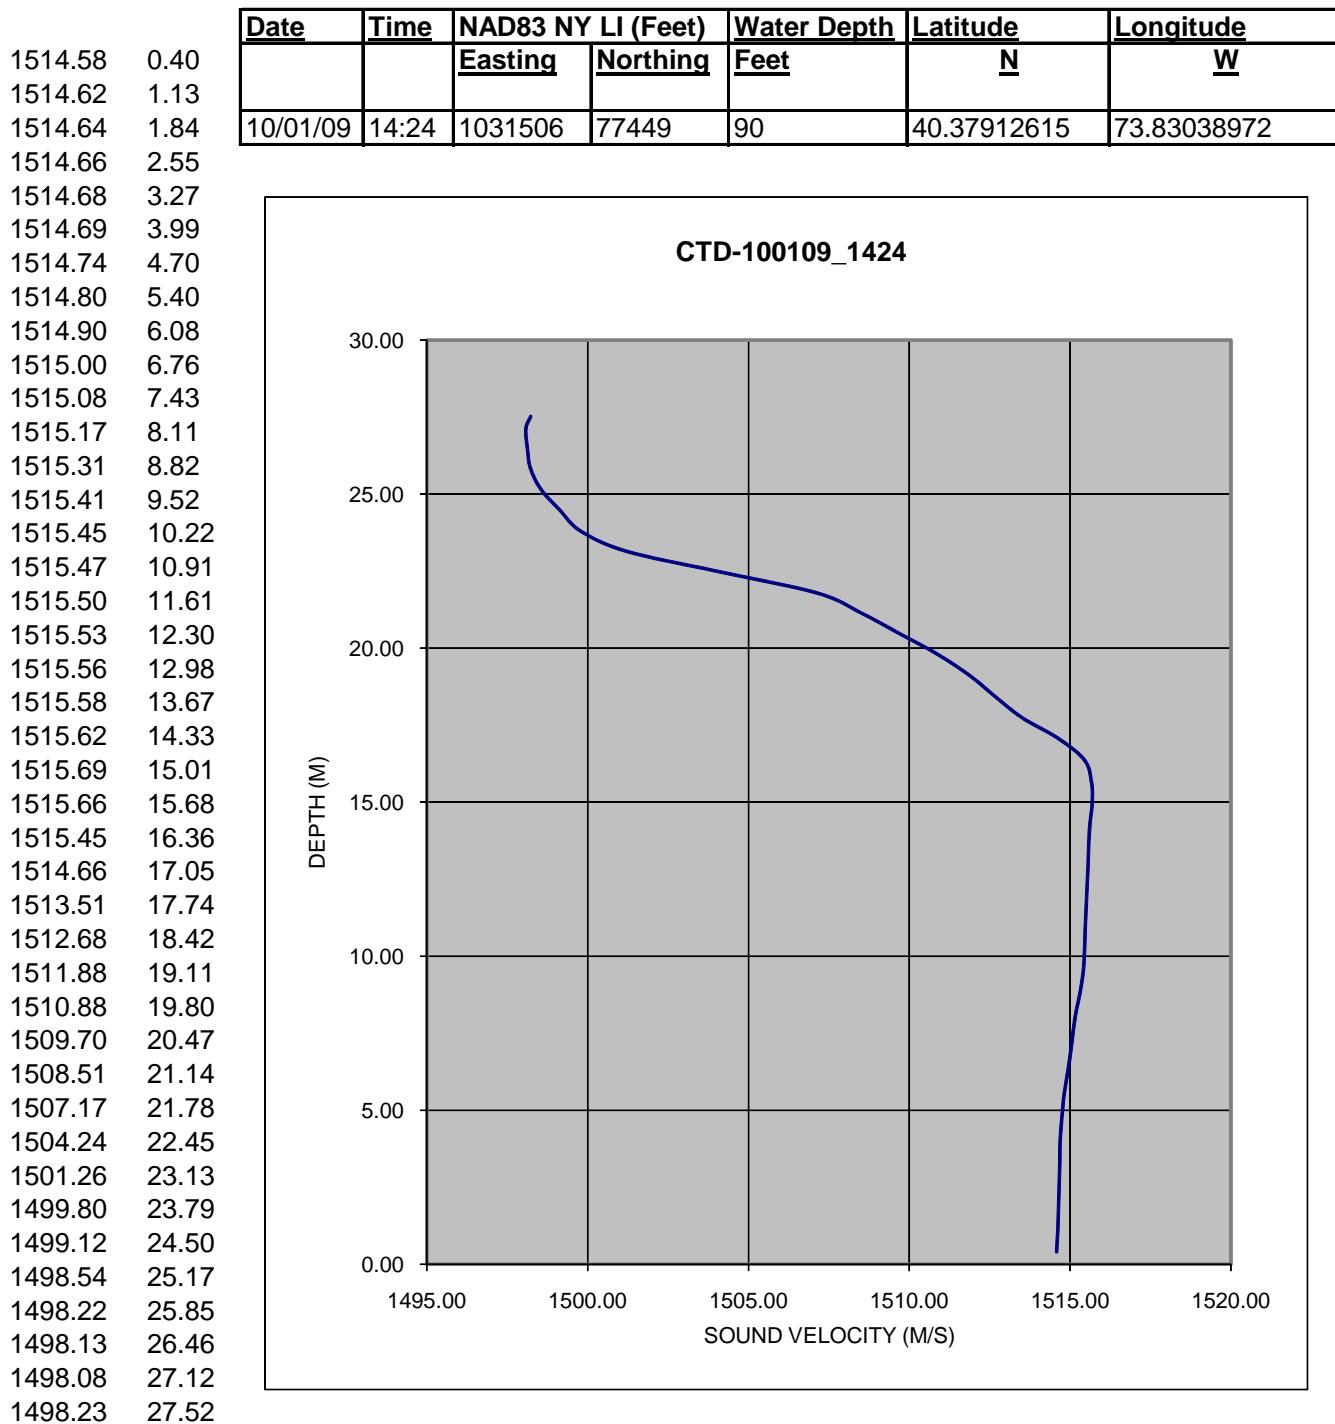
**CTD PROFILE # 100109 1424**

**Figure 3.2-14**  
**SVP 10/01/09\_1424 taken during the Fall 2009 multibeam survey at the HARS**

Sound velocity profiles were taken during the course of the survey using a SeaBird SBE 19plus Version 2 CTD. Casts were obtained before, during and after each survey period. During survey operations casts were taken not less than three hours apart and at opposite ends of the days survey area, to account for any spatial water column speed of sound changes. The SeaBird SBE 19plus was last calibrated by the manufacturer on 05/25/07 and is periodically checked against our Odom Digibar Pro velocity profiler. A total of 66 SVP casts were taken over the course of the multibeam survey (Table 3.2-0). Plots of all SVP casts are shown in Figures 3.2-1 to 3.2-65.
