# **Hurricane Sandy Coastal Projects Performance Evaluation Study Disaster Relief Appropriations Act, 2013**

**US Army Corps  
of Engineers®**

**November 6, 2013**

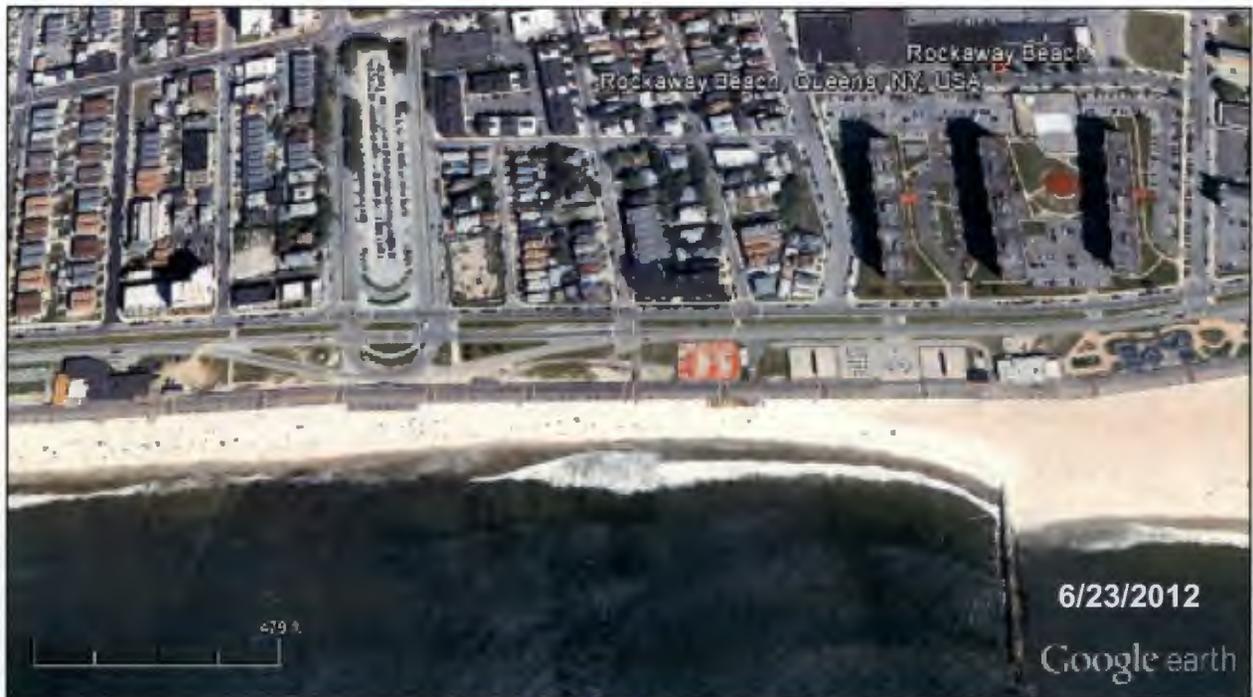
**Figure 14: Rockaway before Hurricane Sandy**

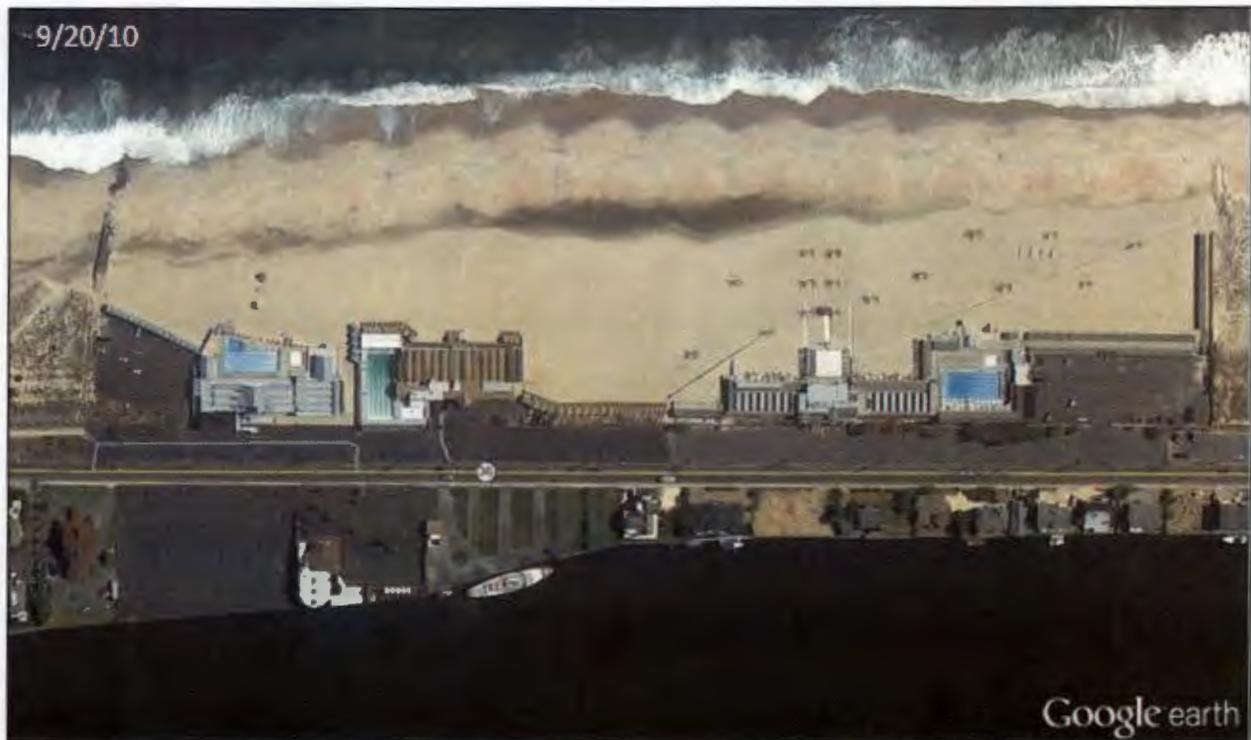
Figure 18: Pre-storm beach condition at Sea Bright (area w/o seawall)

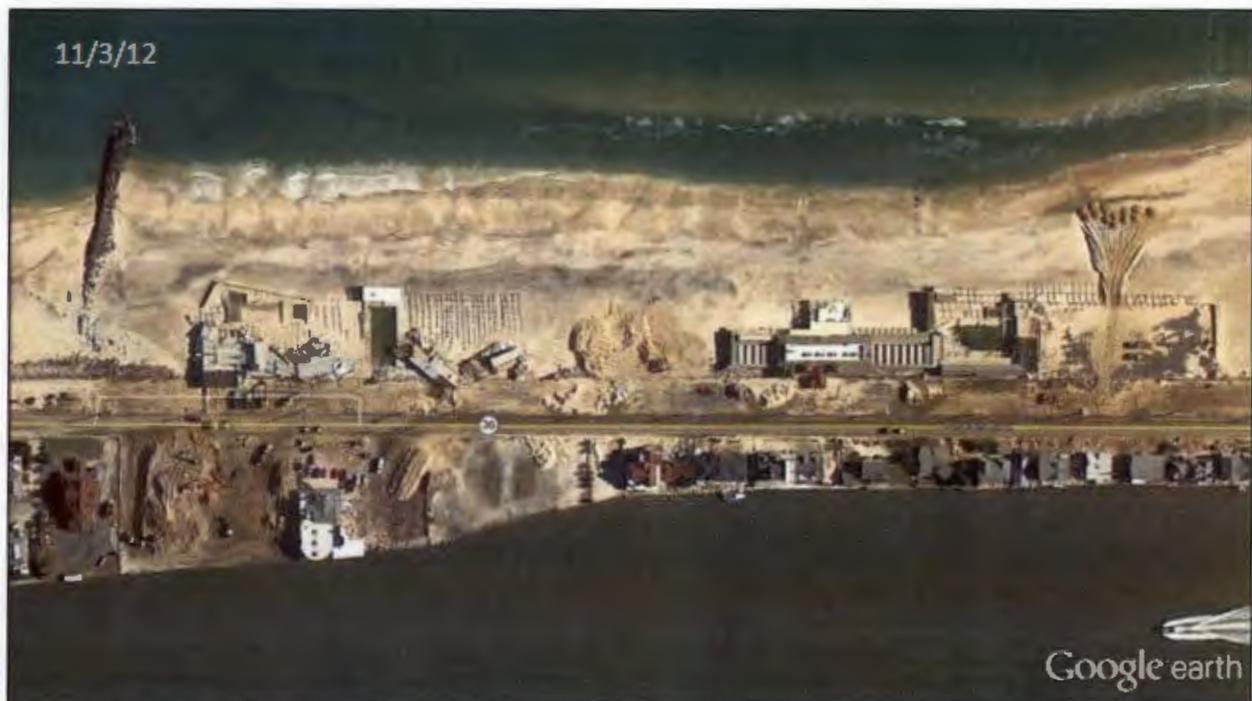
Figure 19: Post-storm beach condition at Sea Bright (area w/o seawall)

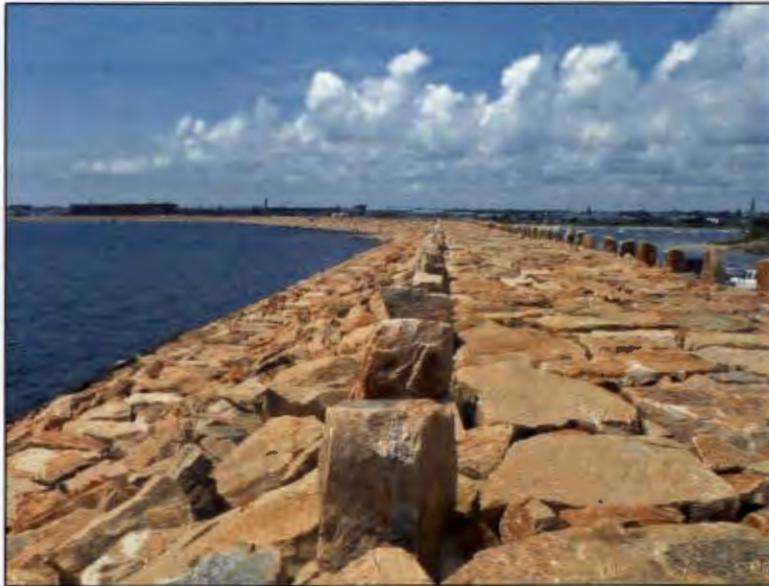
Earth structure along sea or river in order to protect low lands from flooding by high water (see for an example see Figure D-2); dikes along rivers are sometimes called LEVEES. Sometimes written as DYKE.

**Figure D-2: Dike constructed as part of the New Bedford Hurricane Barrier, MA**

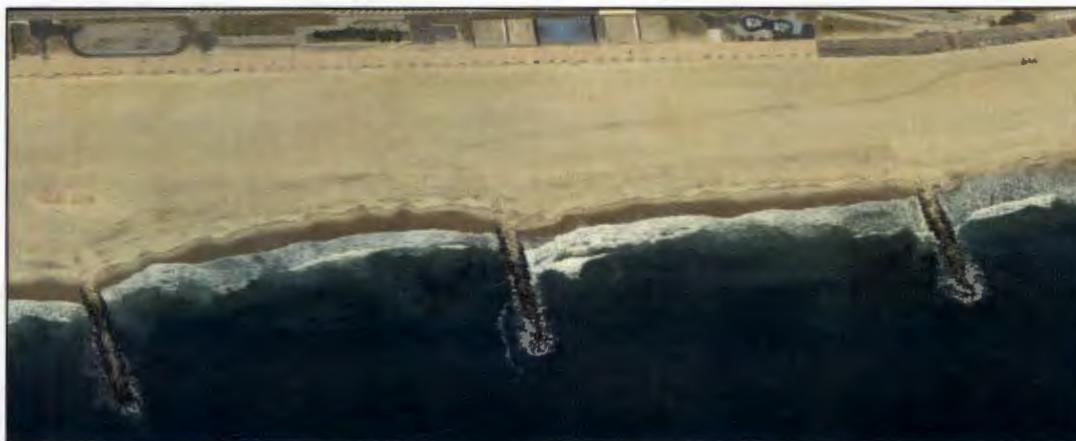
Narrow, roughly shore-normal structure built to reduce longshore currents, and/or to trap and retain littoral material. Most groins are of timber or rock and extend from a SEAWALL, or the backshore, well onto the foreshore and rarely even further offshore (See Figure D-3 for an example).

**Figure D-3: Groins at Rockaway Beach, New York**

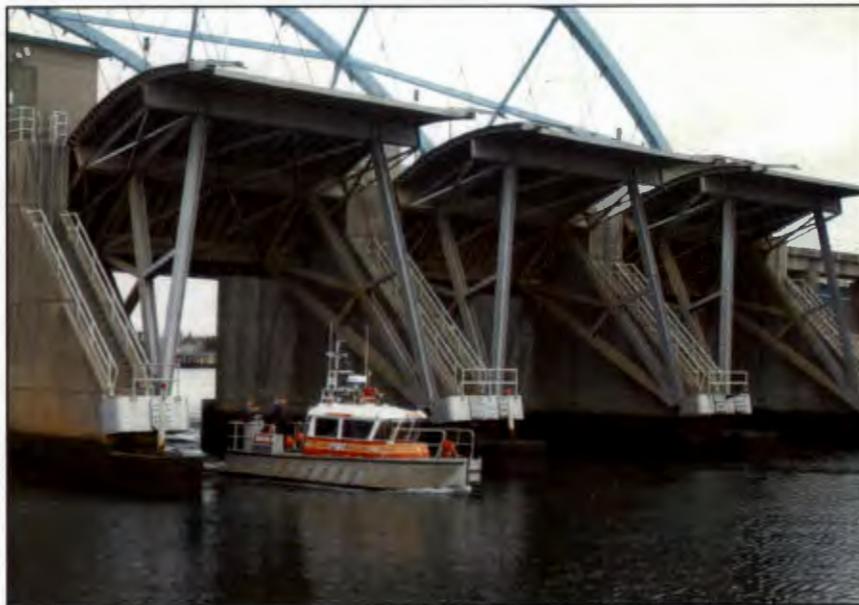
**Figure D-5: Navigation Gates at the Fox Point Hurricane Barrier, Providence, RI**

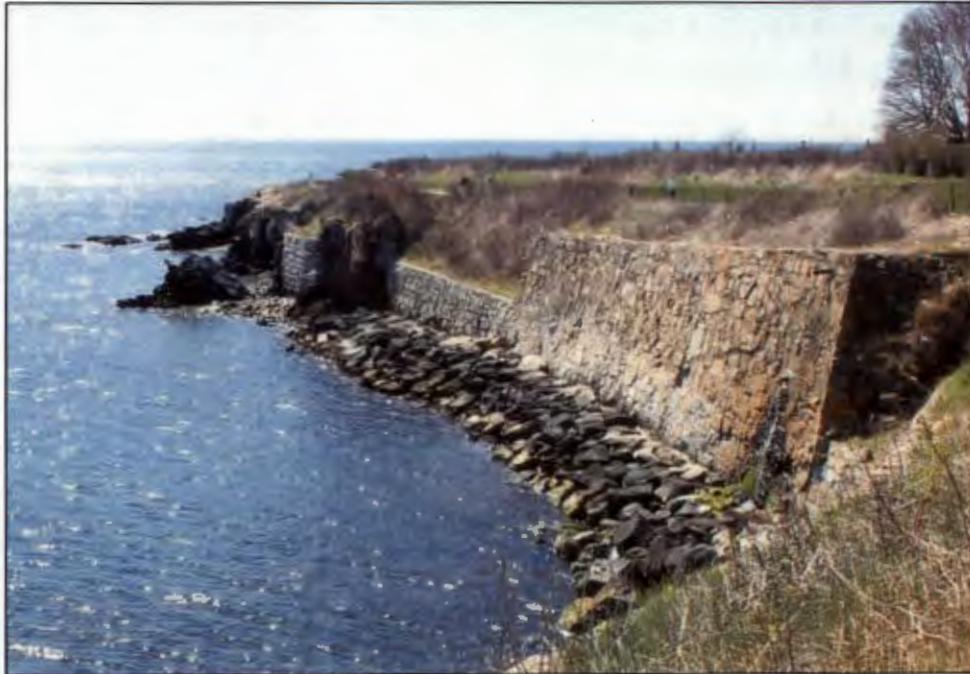
A structure designed and constructed to resist the lateral pressure of soil when there is a desired change in ground elevation that exceeds the angle of repose of the soil (see Figure D-7).

**Figure D-7: Rock Revetment and retaining wall at Cliff Walk, Newport, RI**

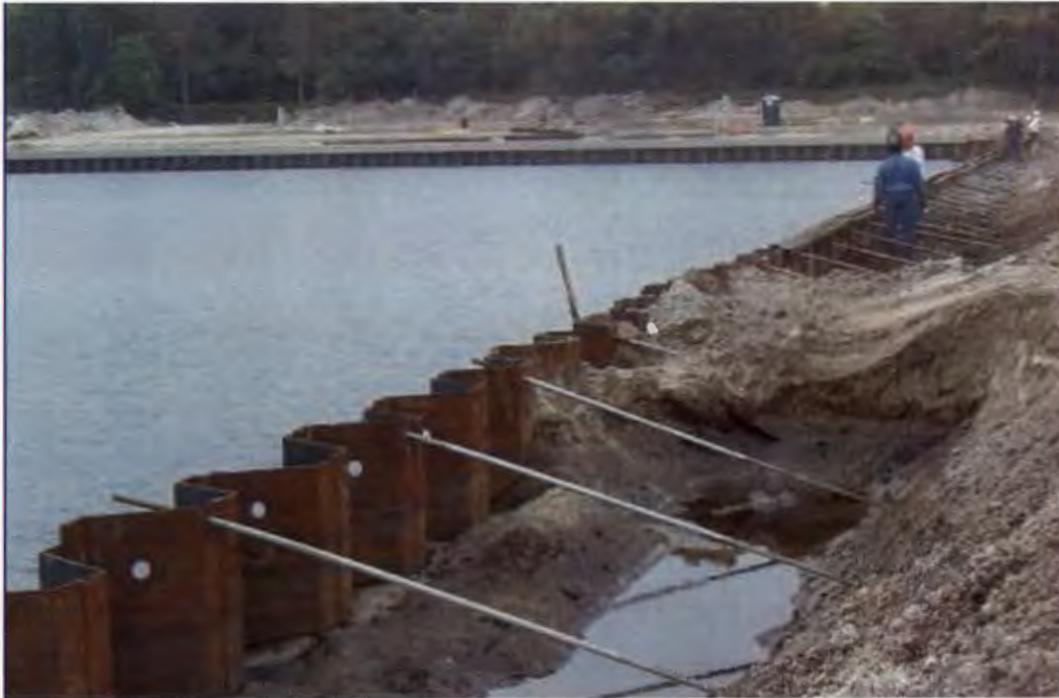
One of a group of piles made of timber, steel, or prestressed concrete set close together to resist lateral pressure, as from earth or water (see Figure D-8.)

**Figure D-8: Sheet Pile Bulkhead under Construction**

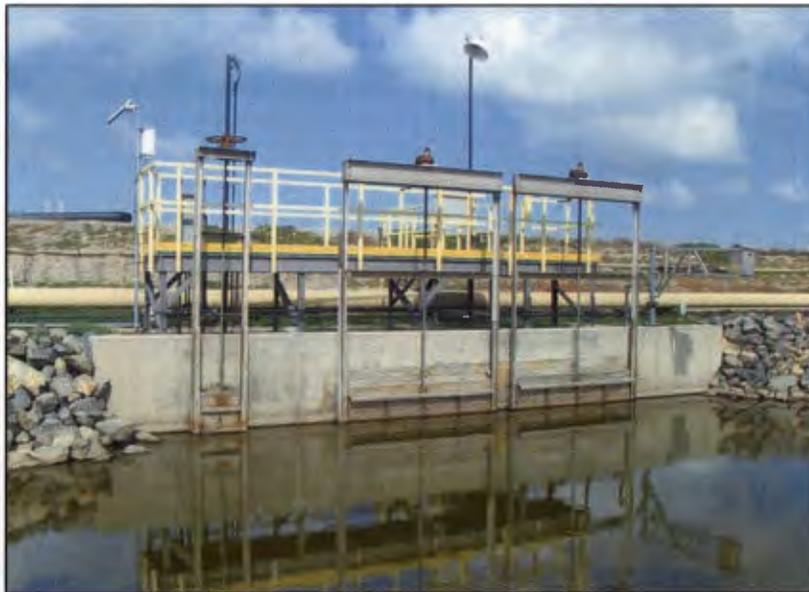
An opening through which water may flow freely when the tide moves in one direction, but which closes automatically and prevents the water from flowing in the other direction (see Figure D-10 for an example.)

**Figure D-10: Tide Gate at the Bolsa Chica Wetlands Restoration Project, CA**
