# Site Inspection Report

Middlesex Municipal Landfill  
Formerly Utilized Sites Remedial Action Program  
Middlesex Borough, New Jersey

**September 2011**

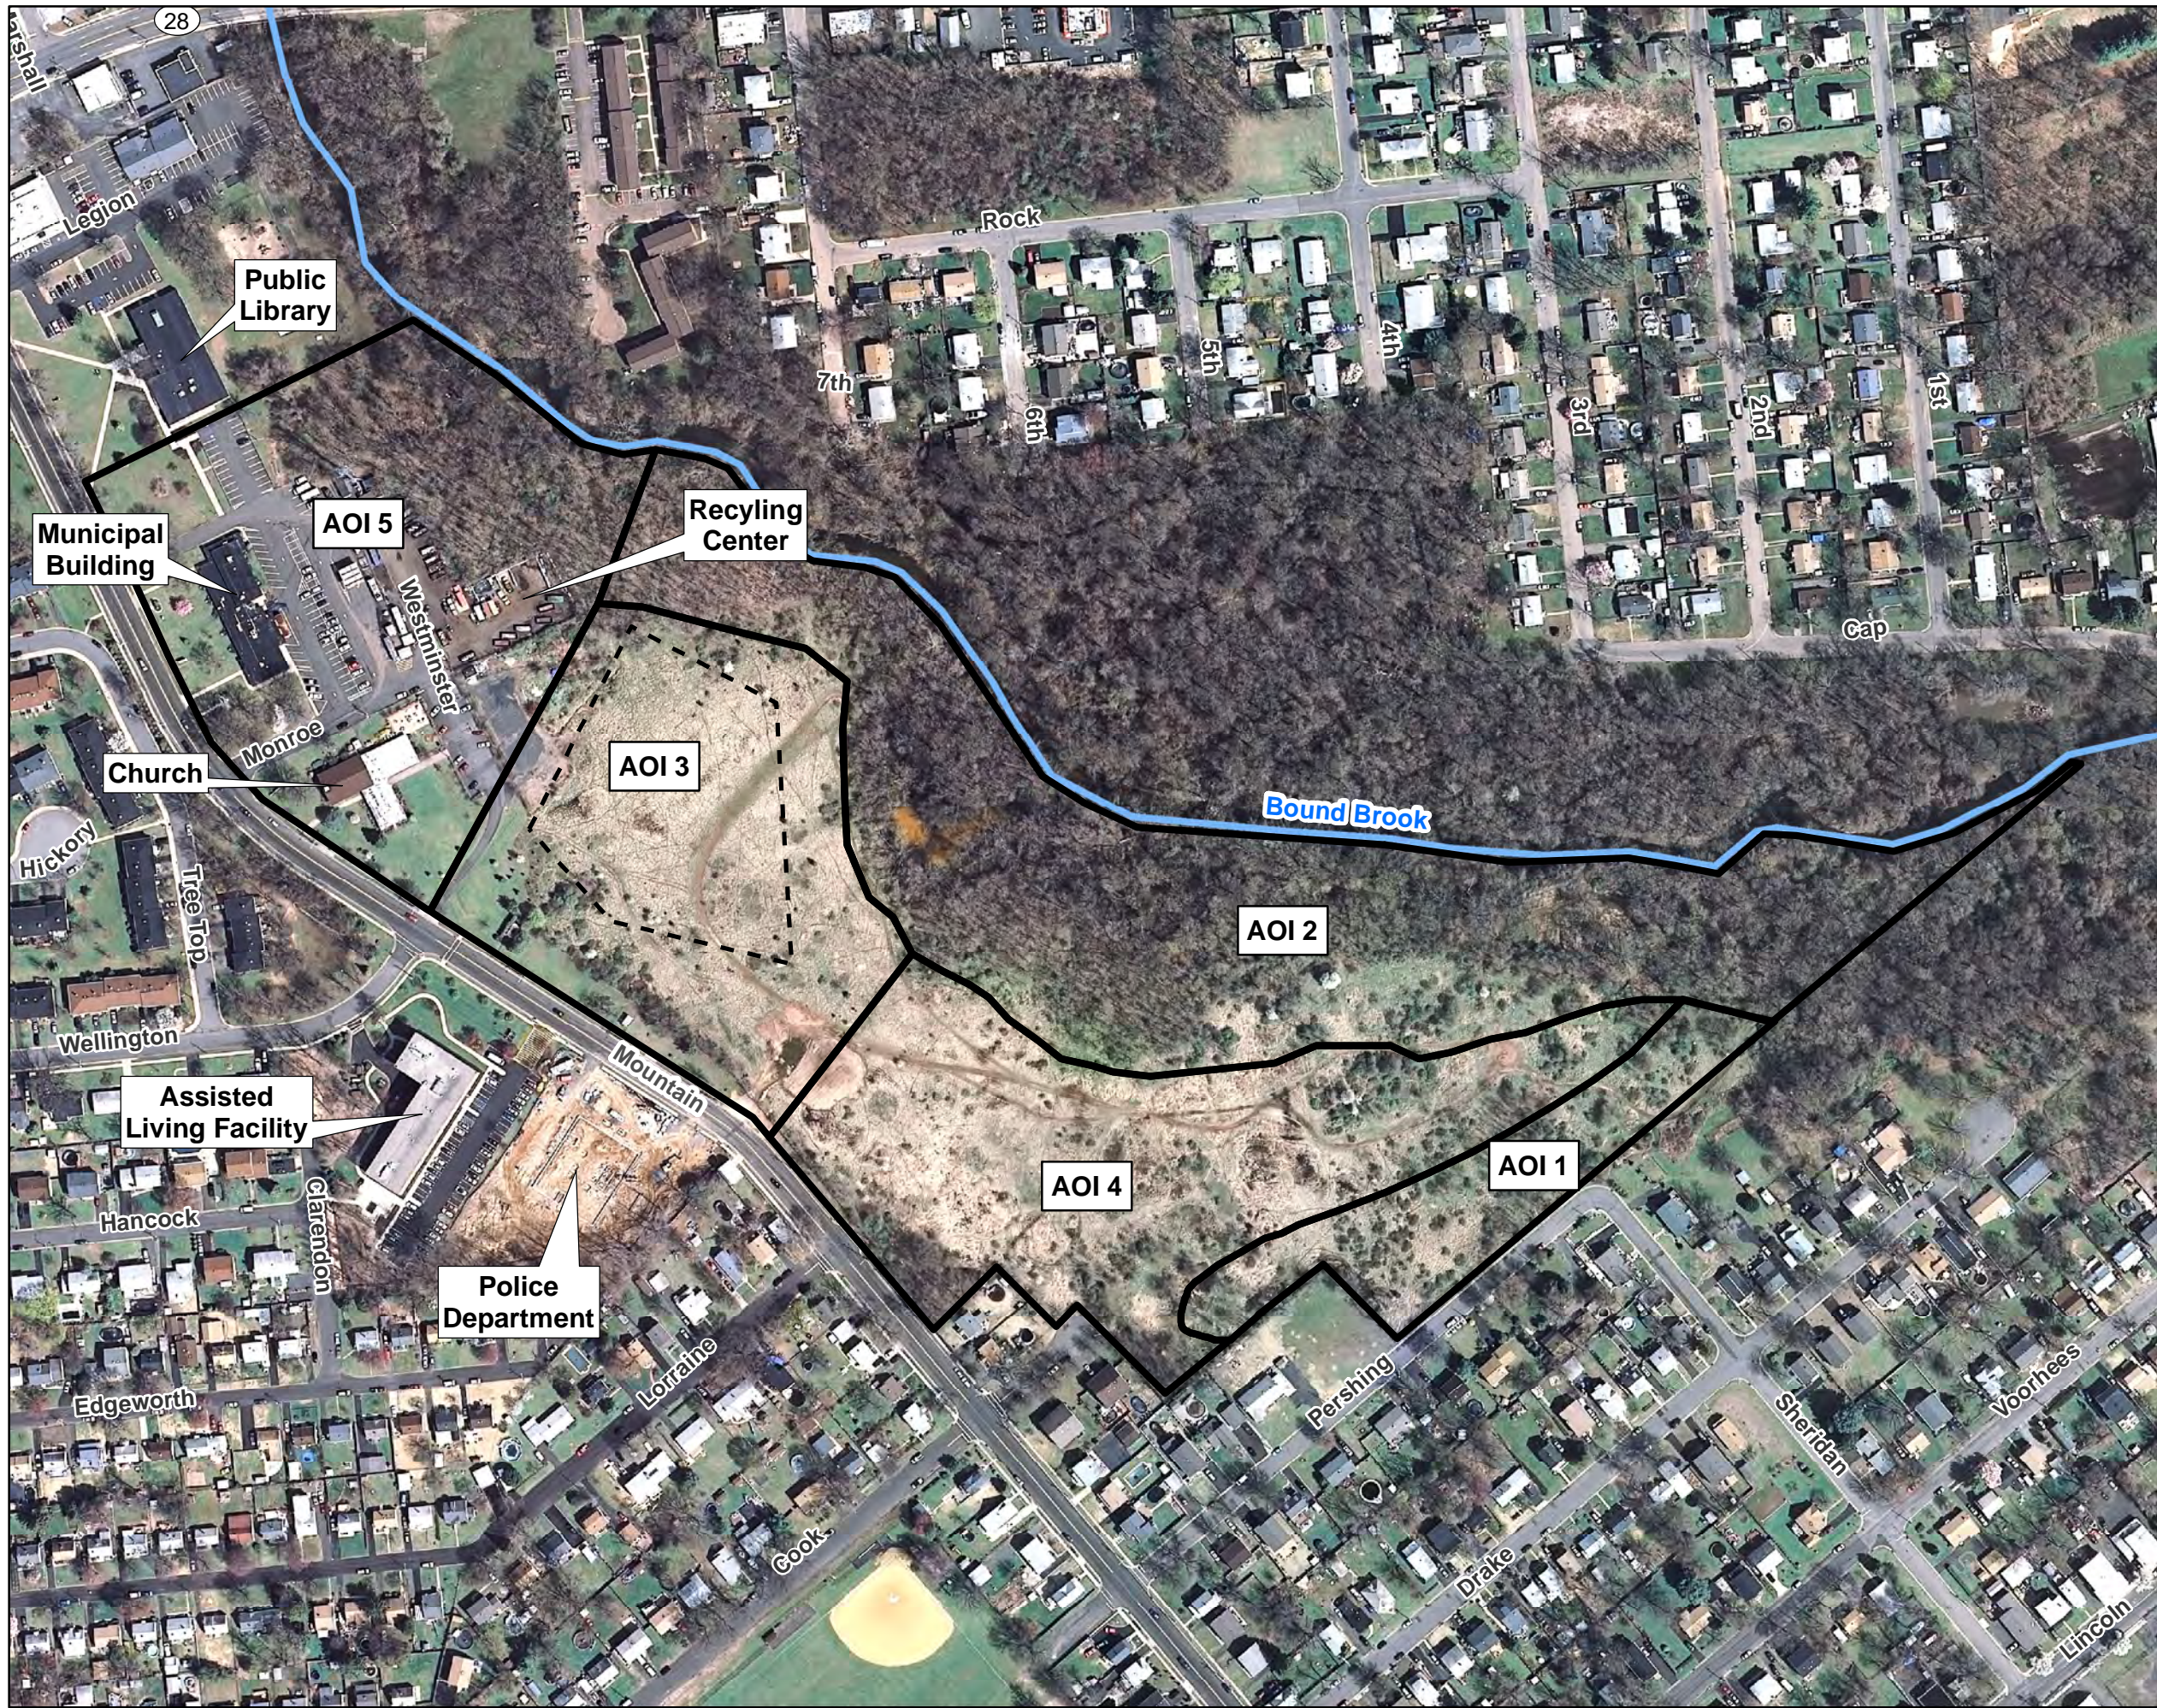
-   Areas of Interest
-   DOE Excavation  
1984 - 1986
-   Site Boundary

Aerial Source: USGS, Spring 2007  
Data Collected Dec. 2009 - Jan. 2010

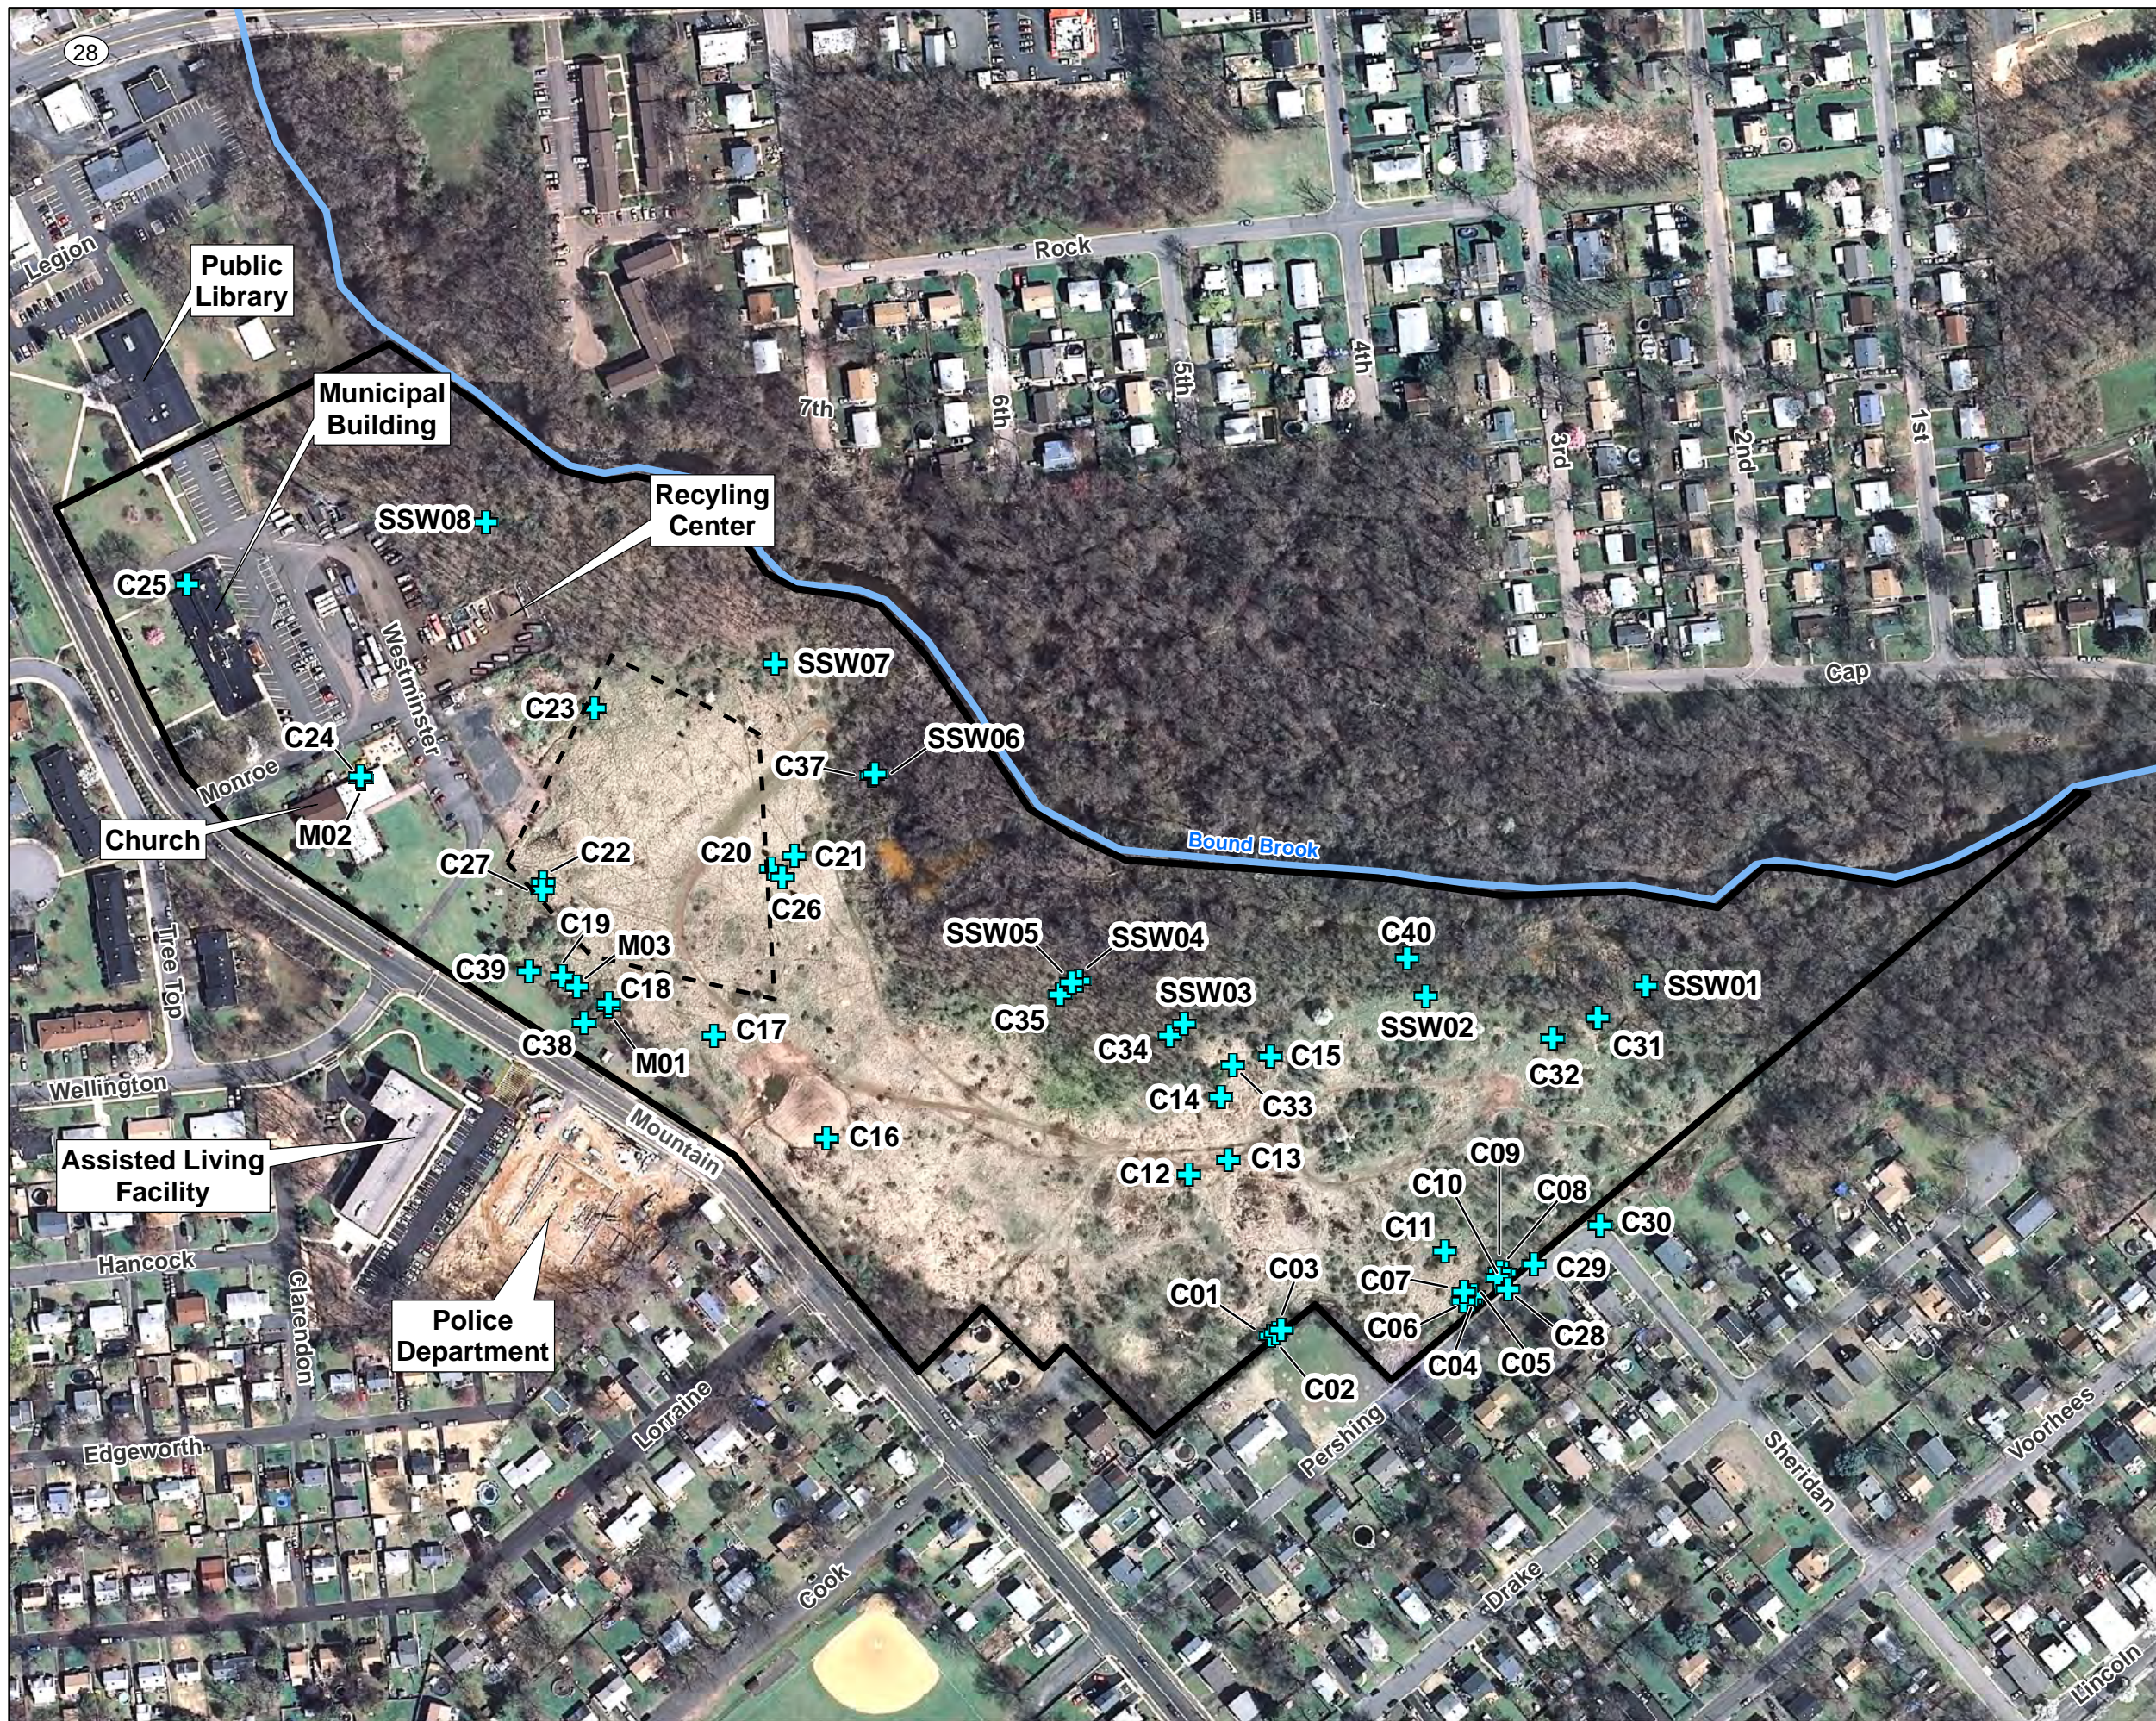
9/10	CABRERA Project No. 08-3800.08	FIGURE 5-6
	Cabrera Services 1106 N. Charles St Suite 300 Baltimore, MD 21201	U.S. Army Corps of Engineers

- Surface Soil Sample Locations
- DOE Excavation 1984 - 1986
- Site Boundary

ID Definitions  
C - Sample Location based on CLASS  
SSW - Surface Soil Woods  
M - Sample Location based on Walk Over Survey

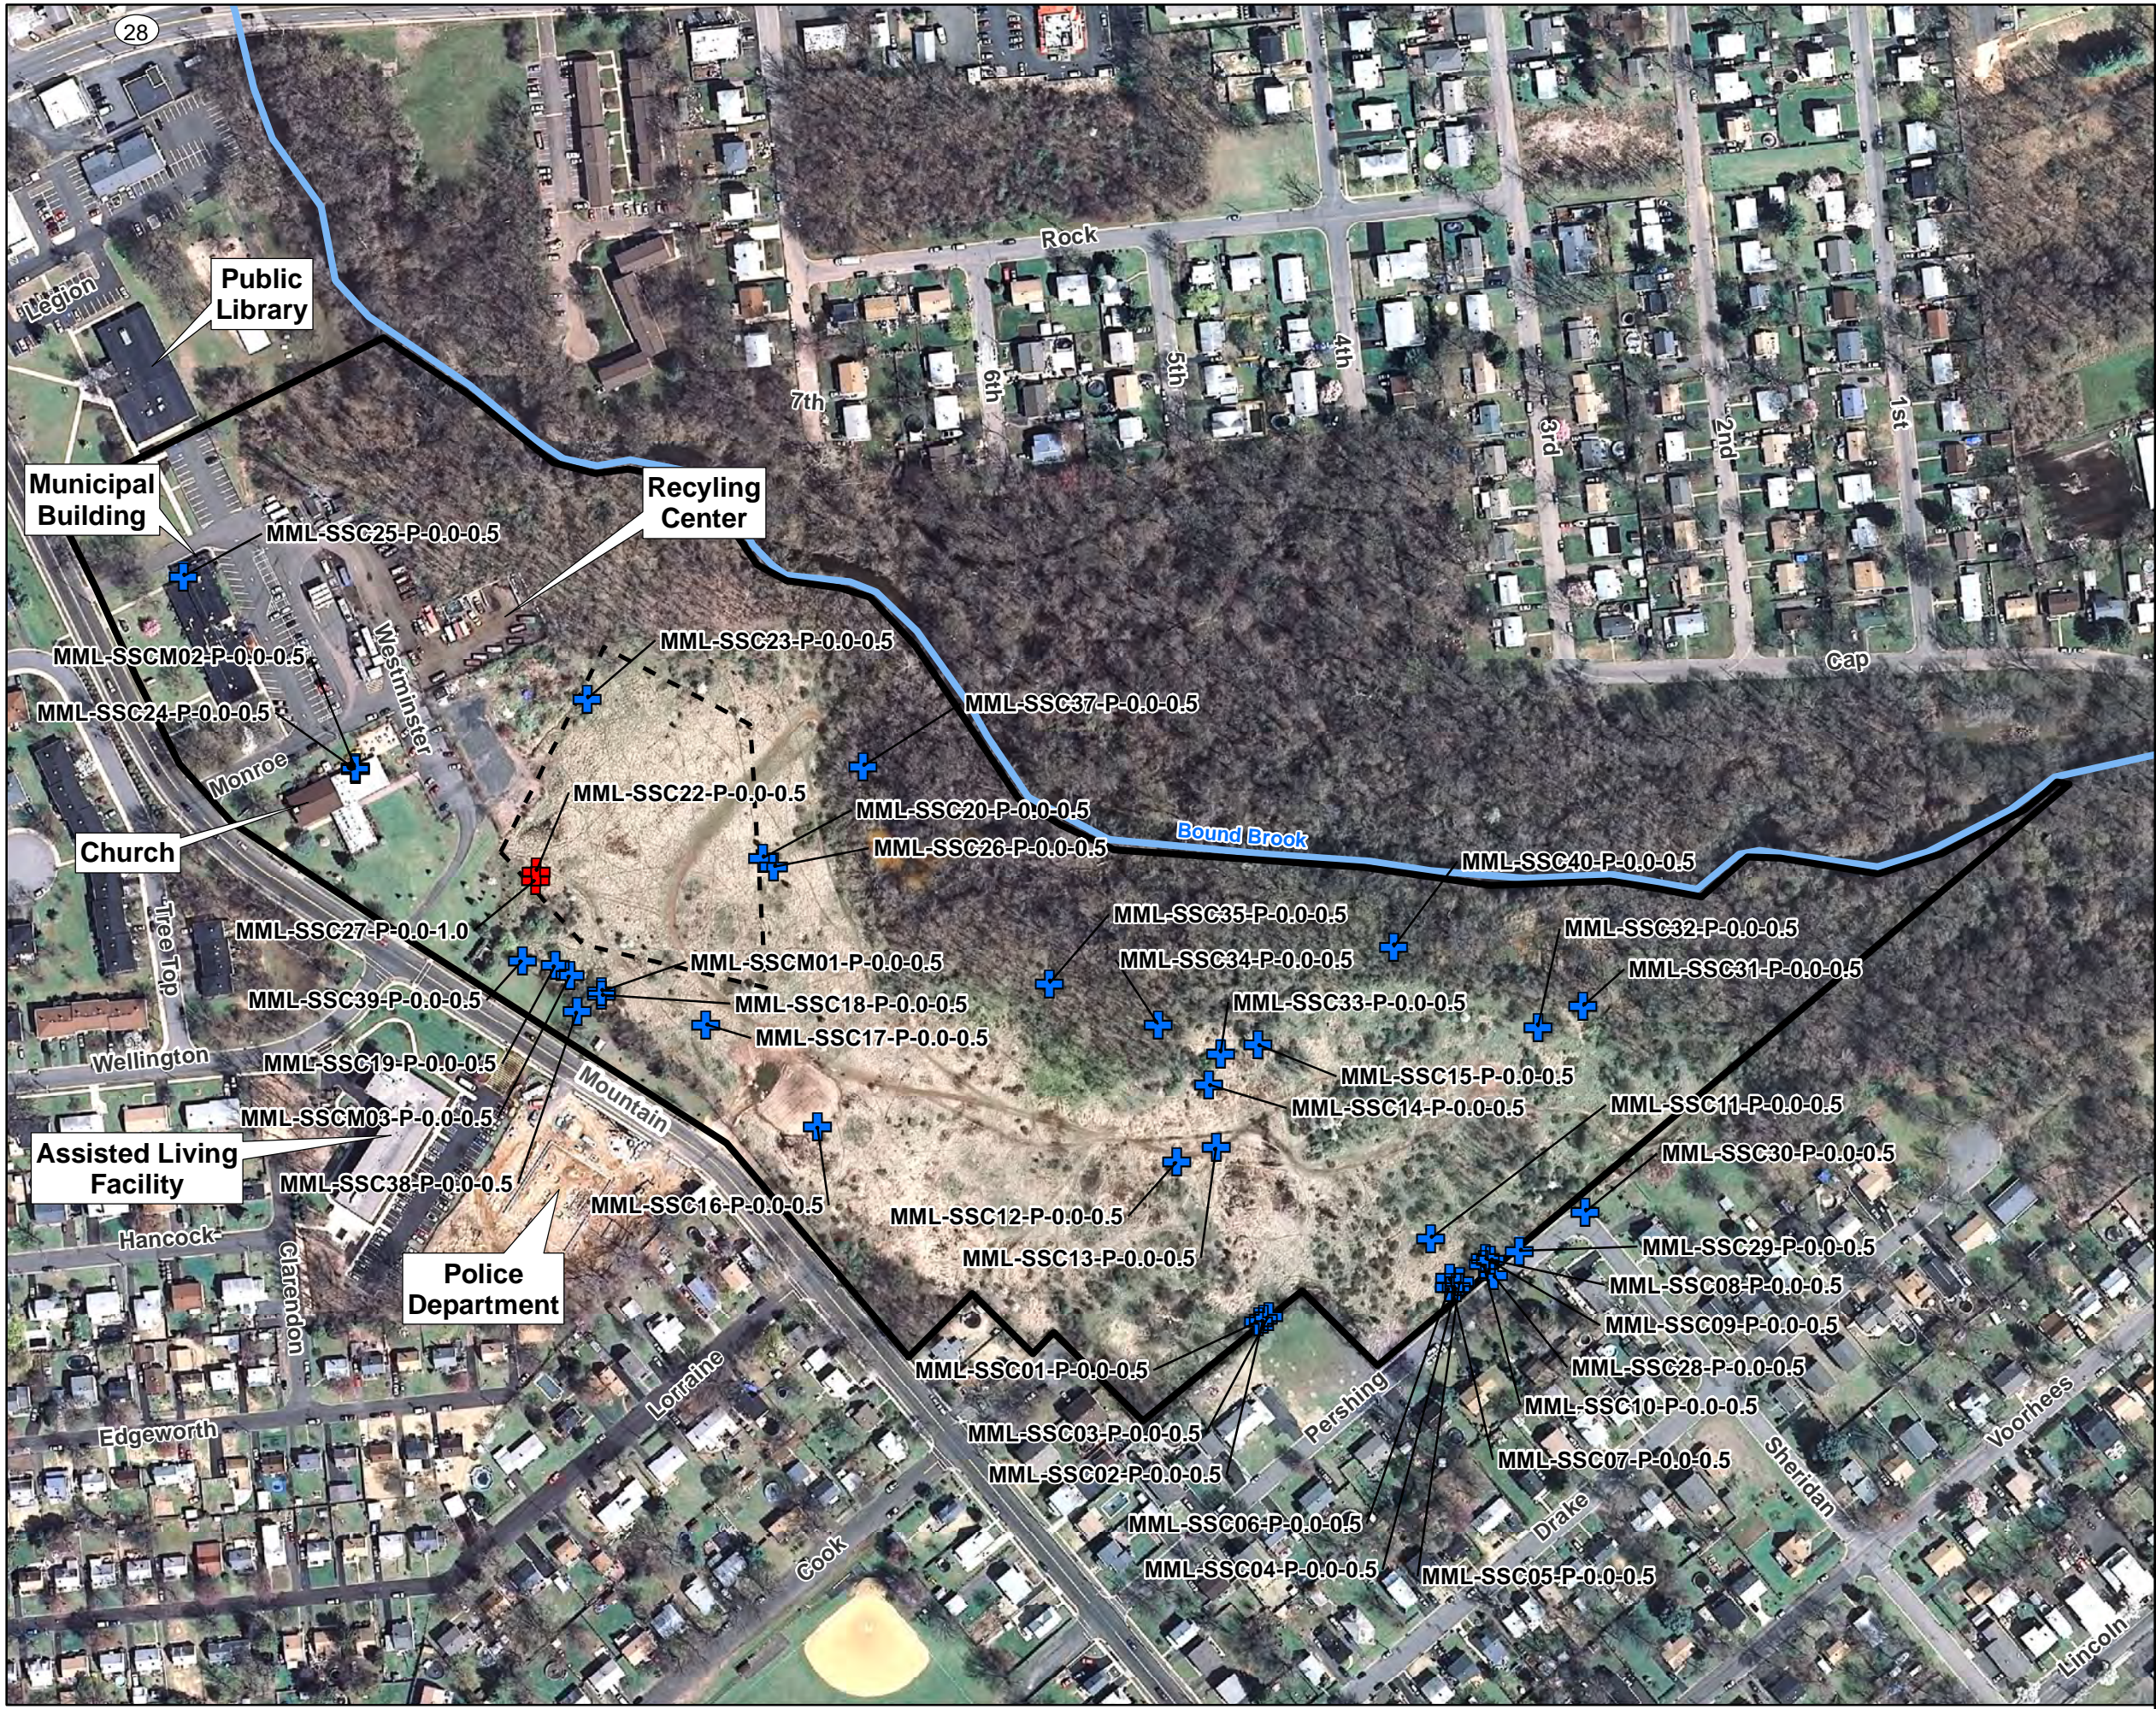
**Surface Soil Samples  
Thorium Results**

- + < 2.18
- + 2.19 - 9.00

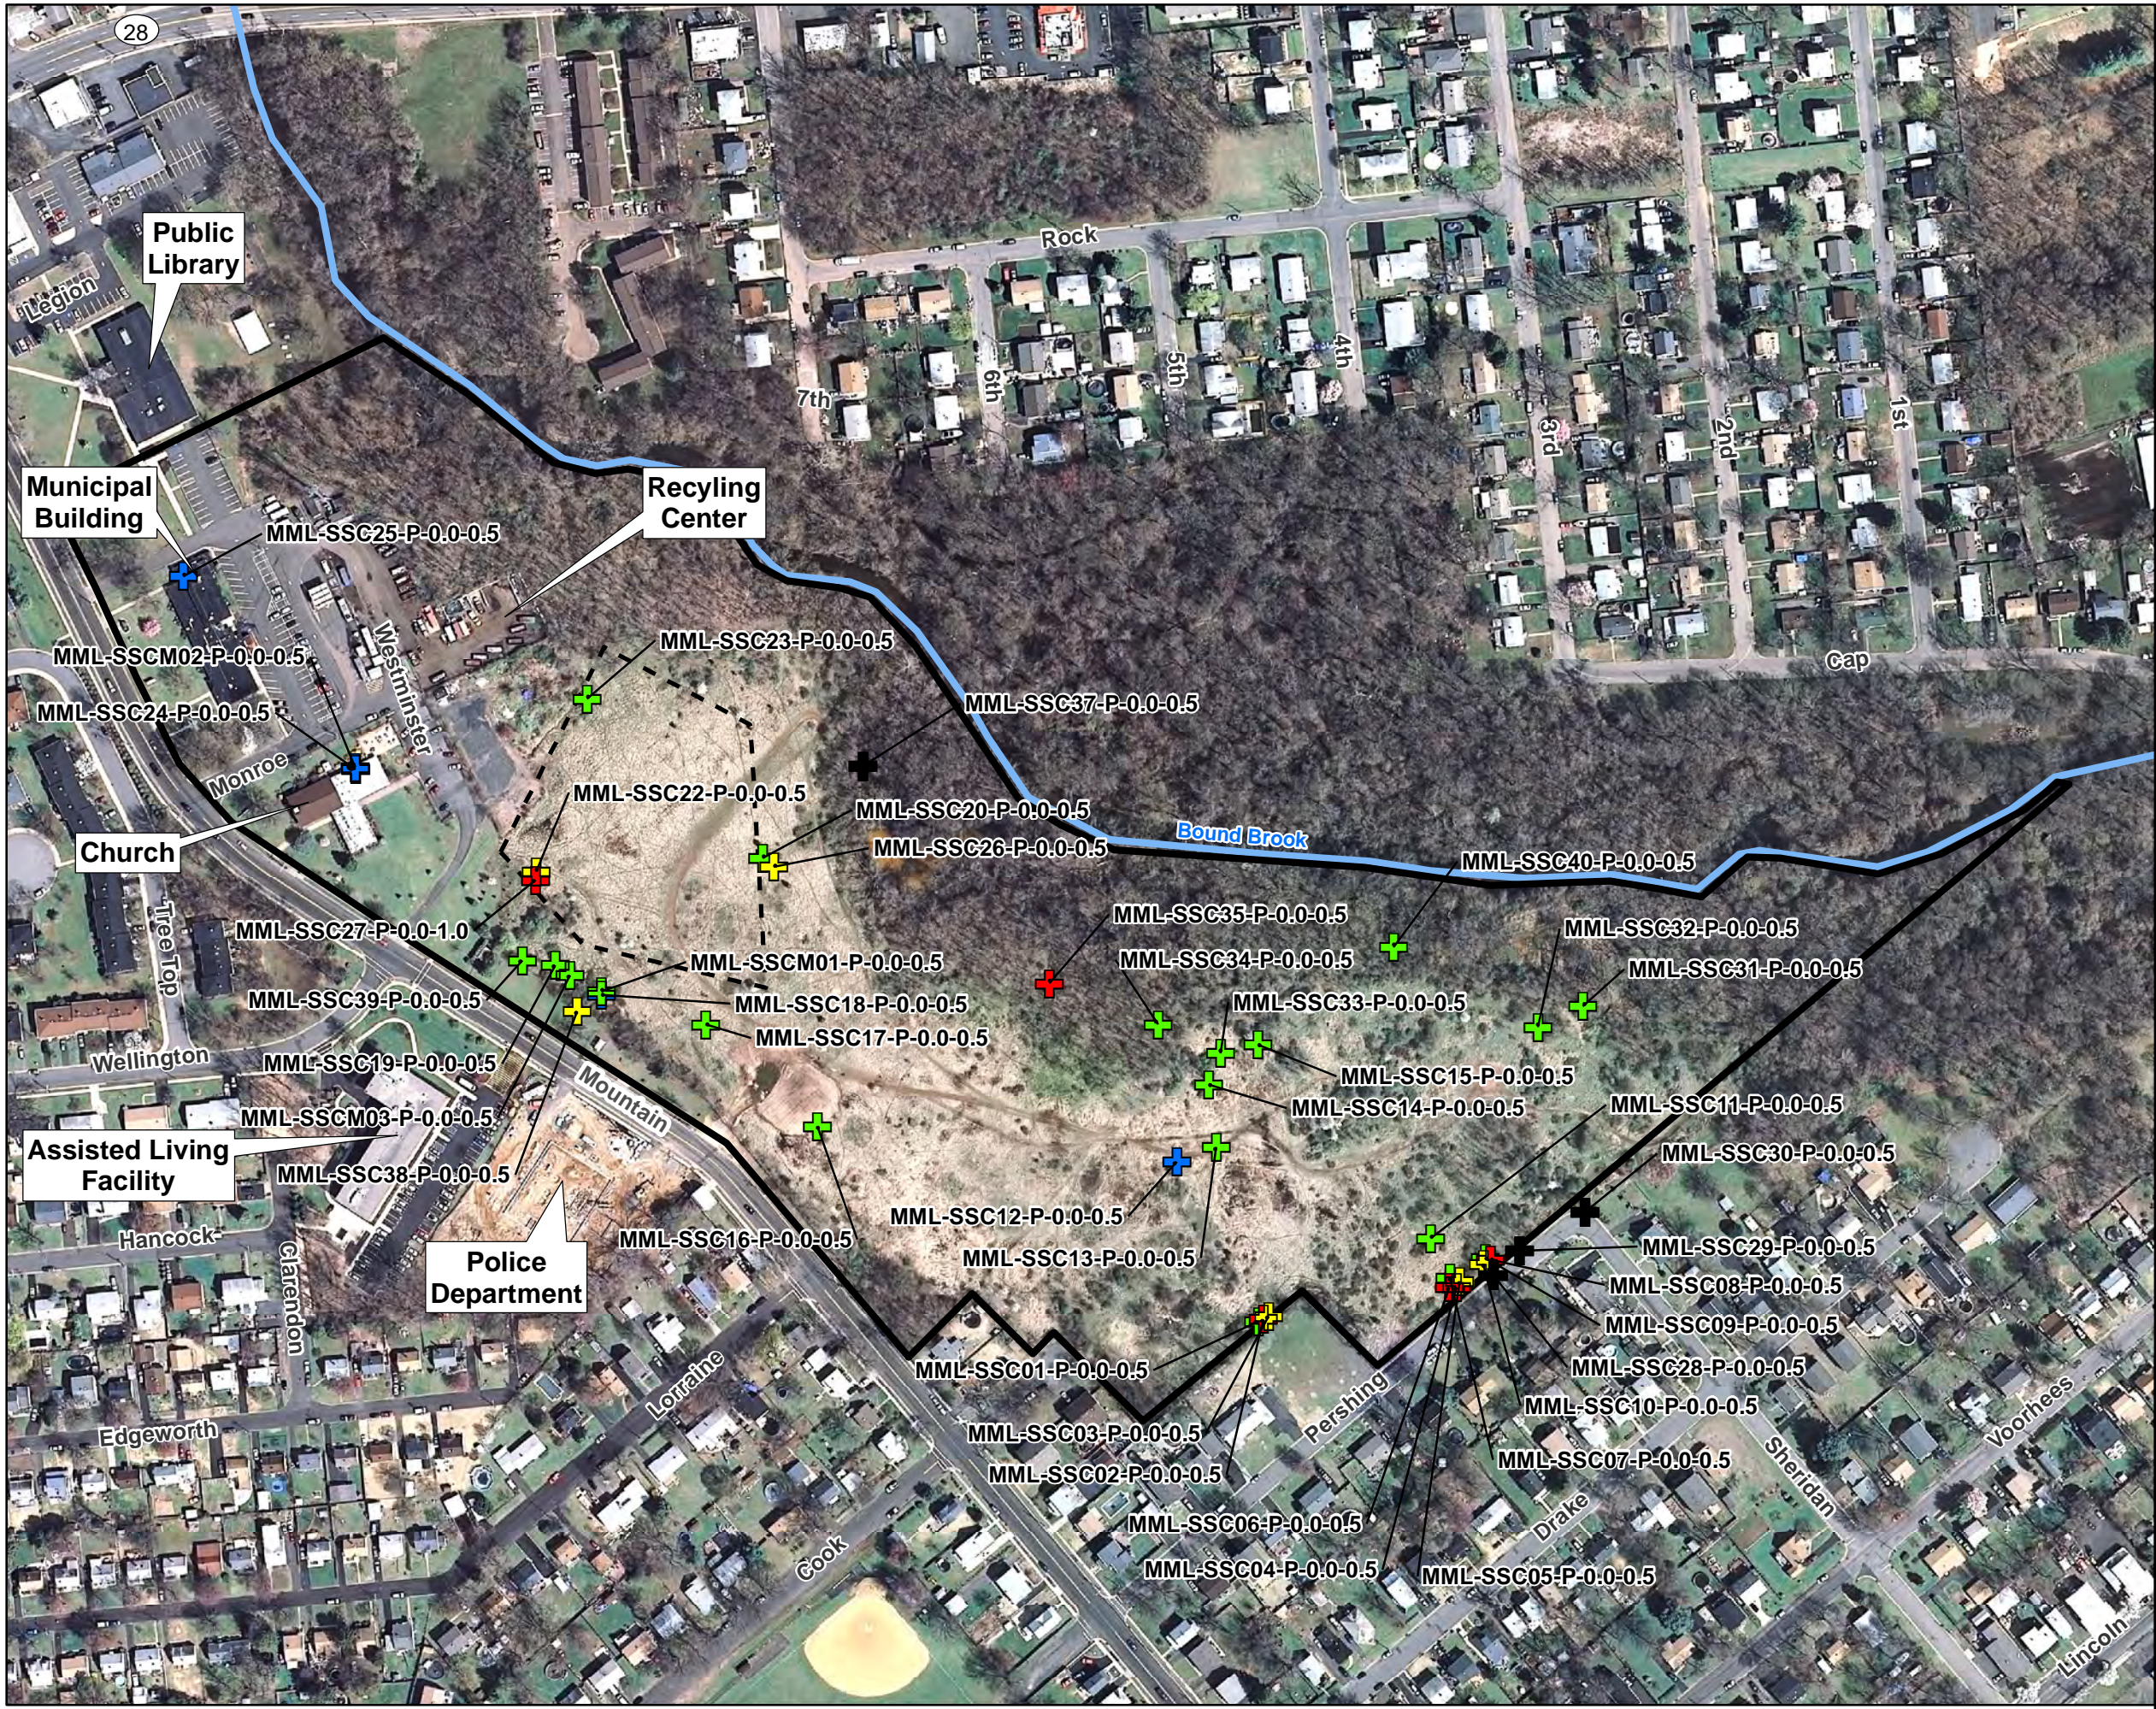
Surface Soil Samples  
Radium Results

- + < 1.46
- + 1.47 - 5.99
- + 6.00 - 15.99
- + 16.00 - 50.99
- + 51.00 - 79.60

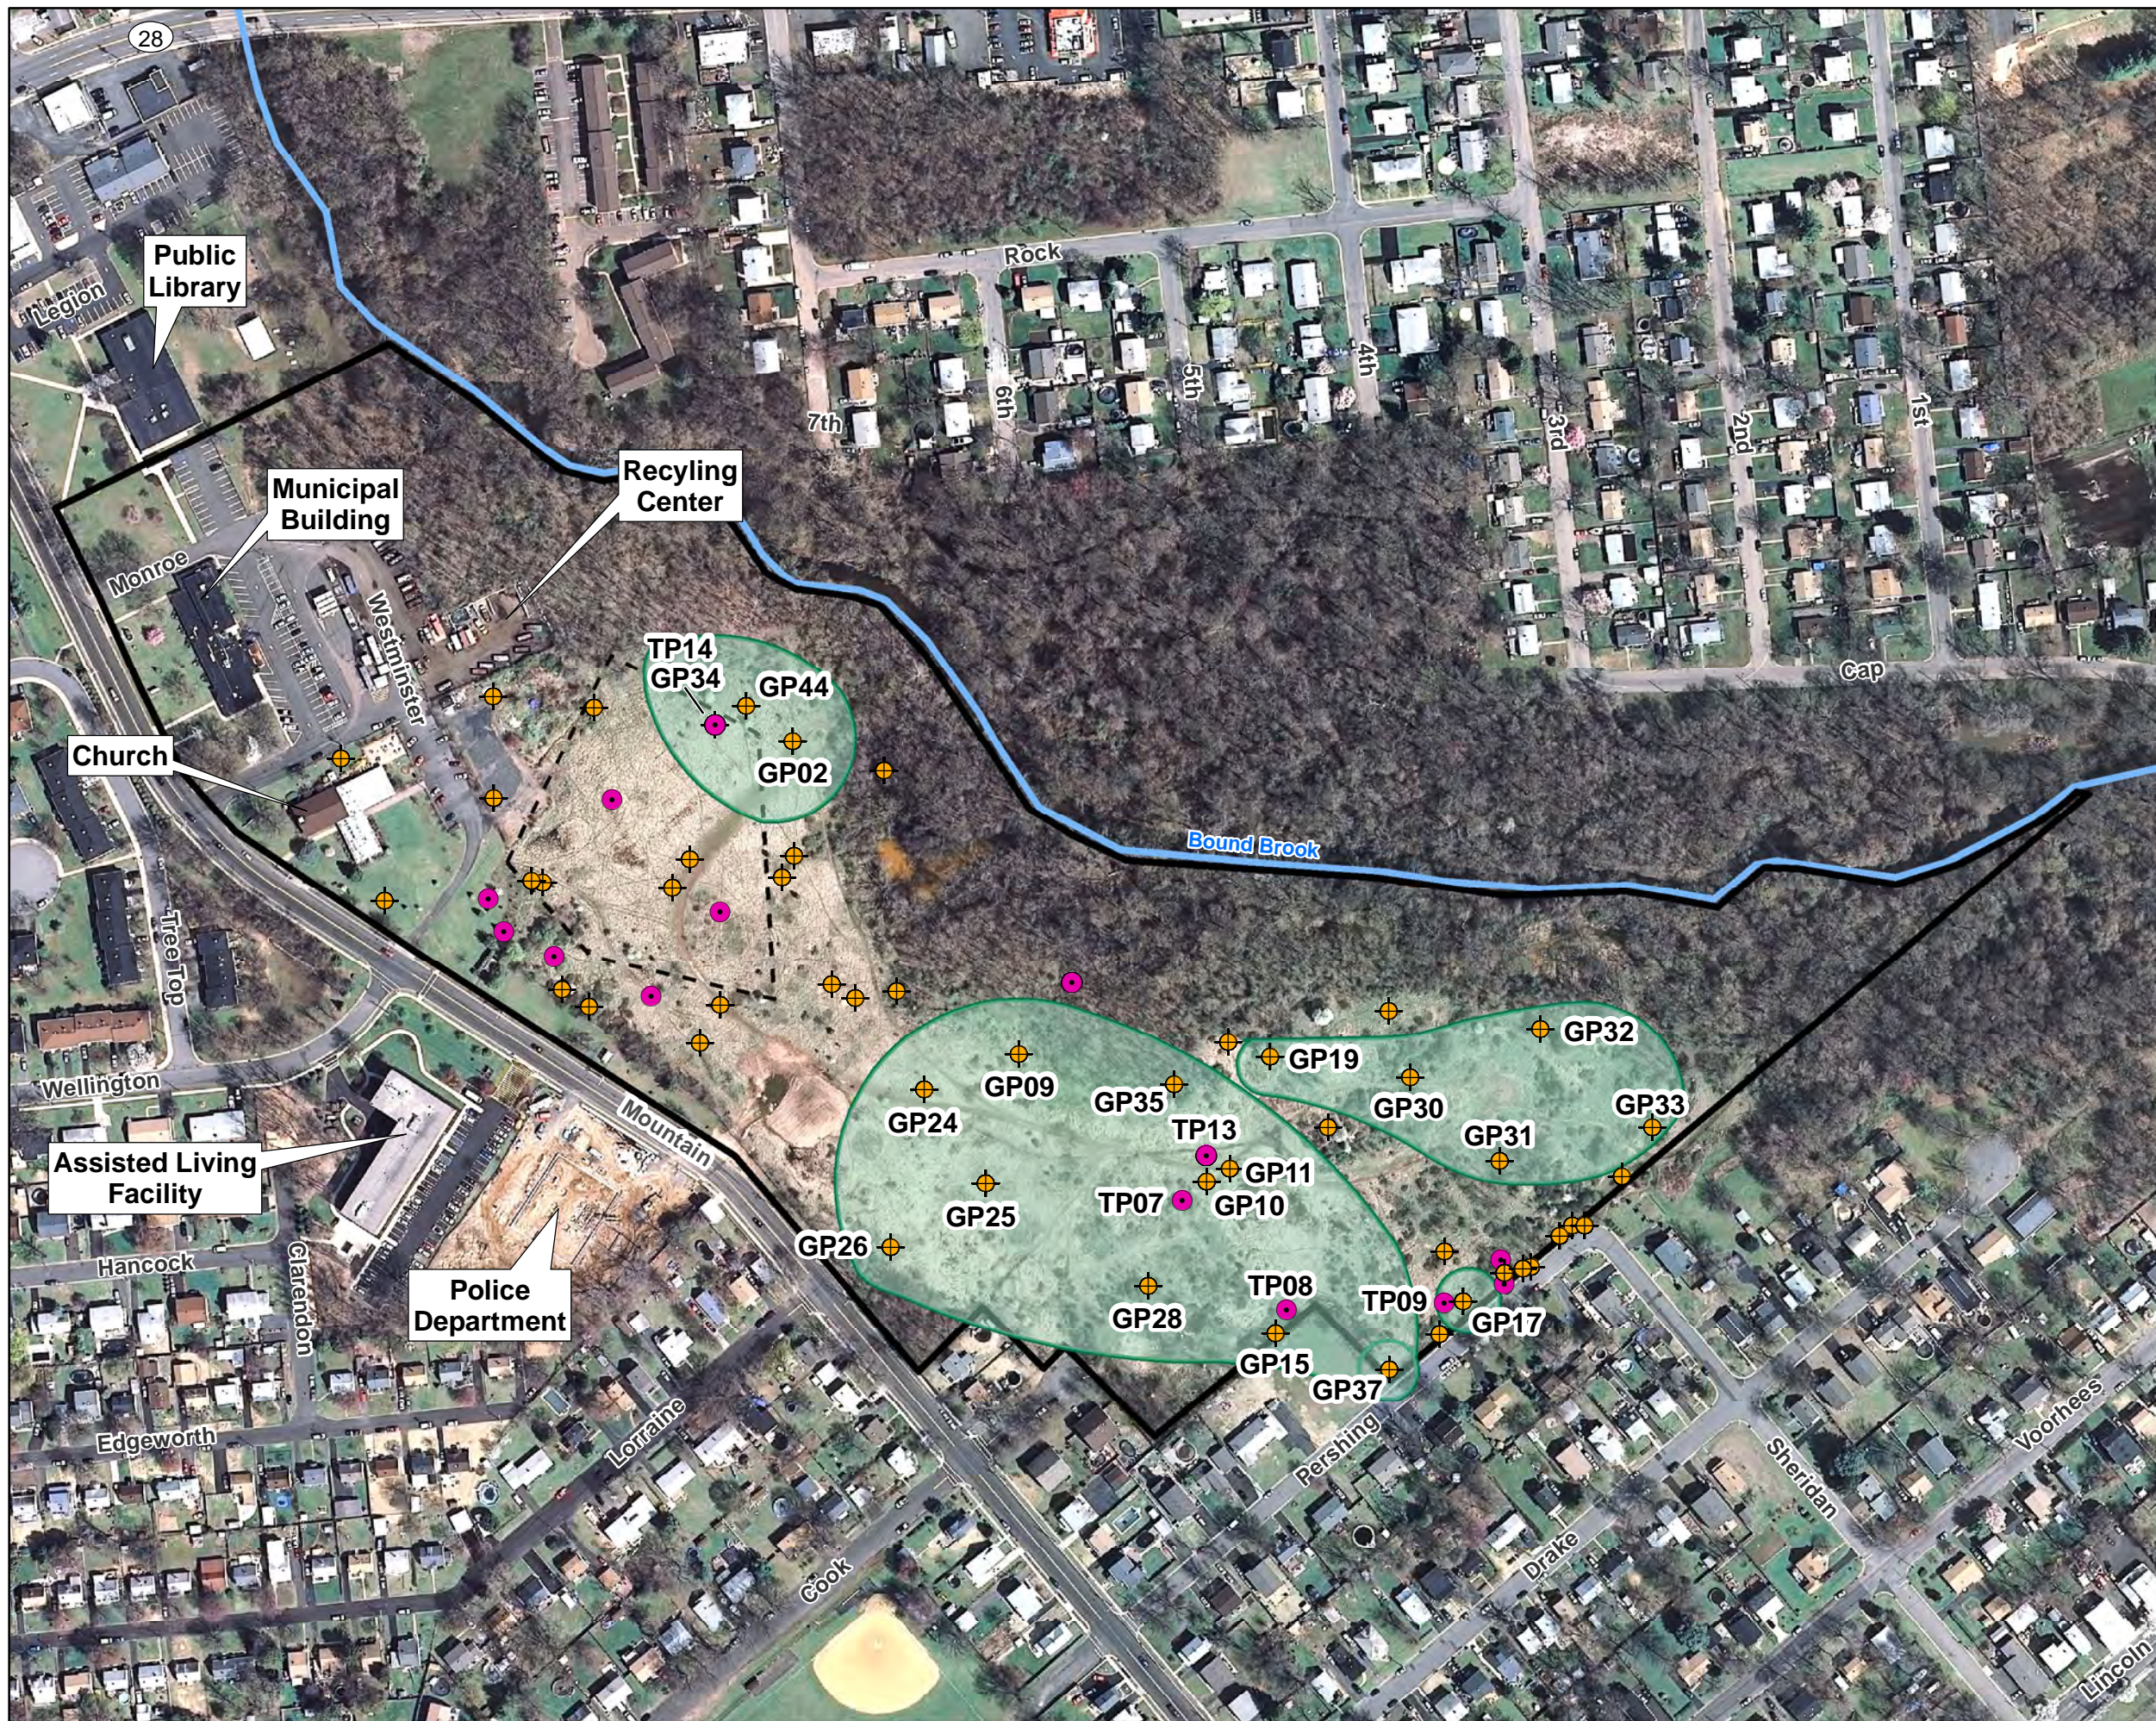
9/10	CABRERA Project No. 08-3800.08	FIGURE 5-13
------	-----------------------------------	-------------

- Geoprobe Sample Locations
- Test Pit Sample Locations
- Area of Elevated Methane Gas
- DOE Excavation 1984 - 1986
- Site Boundary

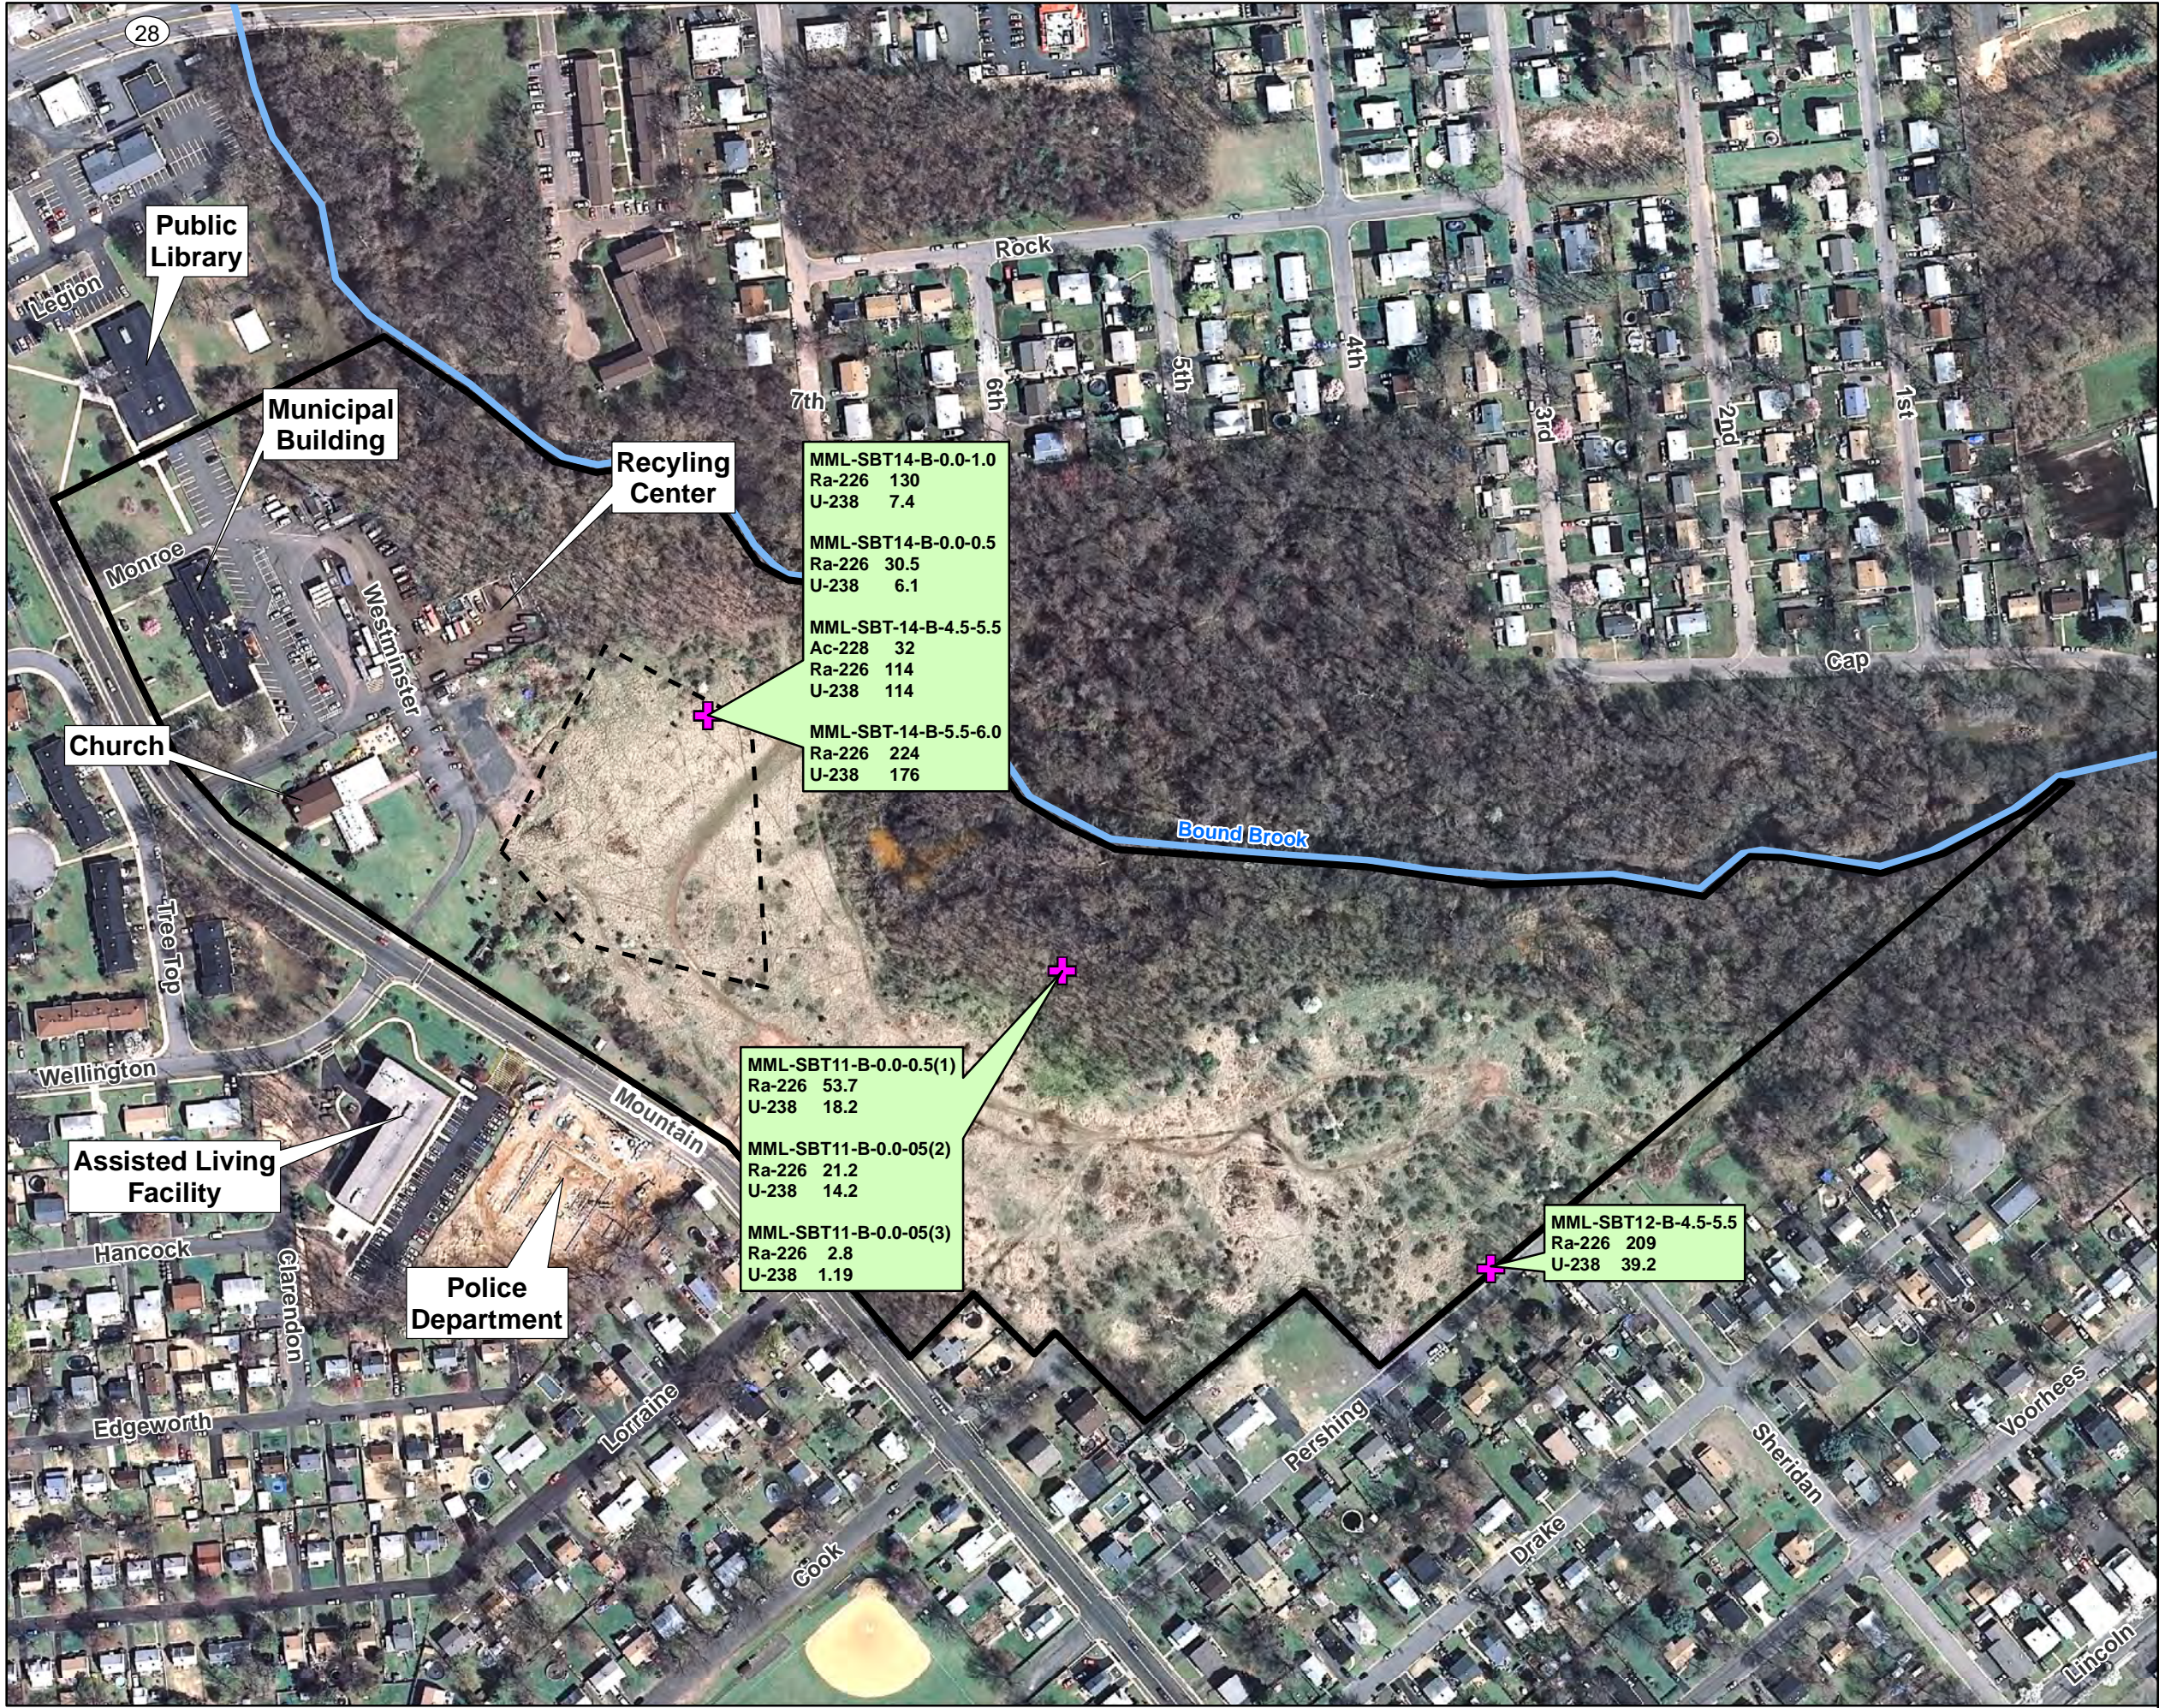
9/10	CABRERA Project No. 08-3800.08	FIGURE 5-14
	Cabrera Services 1106 N. Charles St Suite 300 Baltimore, MD 21201	U.S. Army Corps of Engineers

- Test Pit Sample Locations
- DOE Excavation 1984 - 1986
- Site Boundary

All Results in pCi/g - picoCuries per gram  
Ac-228 is assumed to equal Th-232
