# Site Inspection Report

Middlesex Municipal Landfill  
Formerly Utilized Sites Remedial Action Program  
Middlesex Borough, New Jersey

**September 2011**

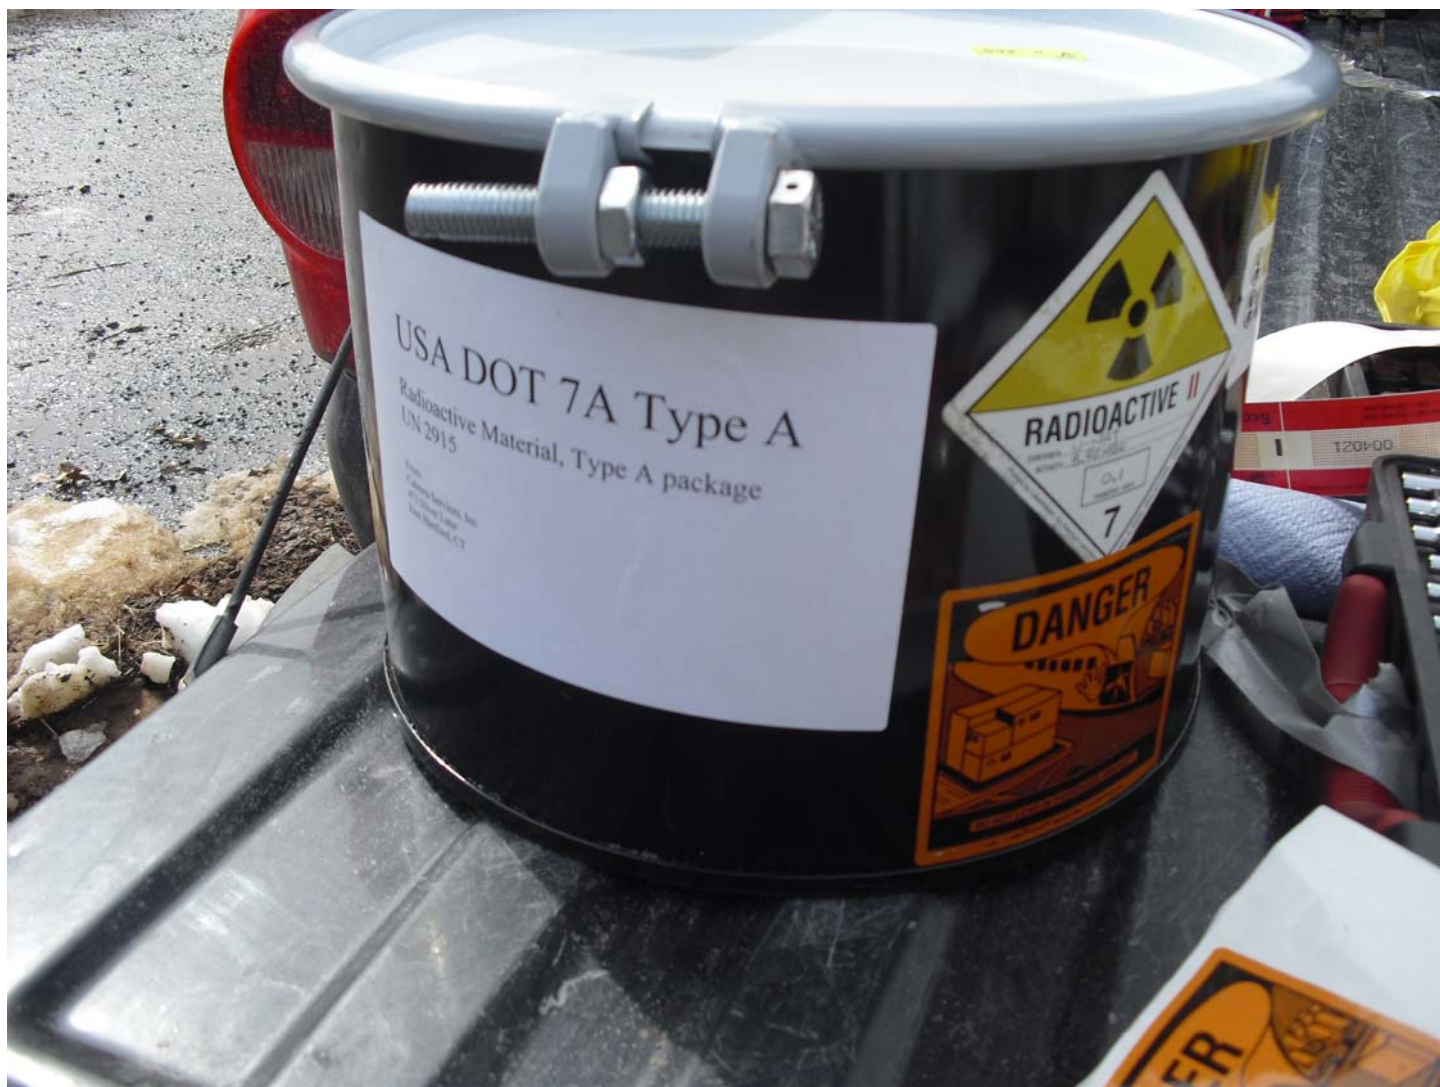
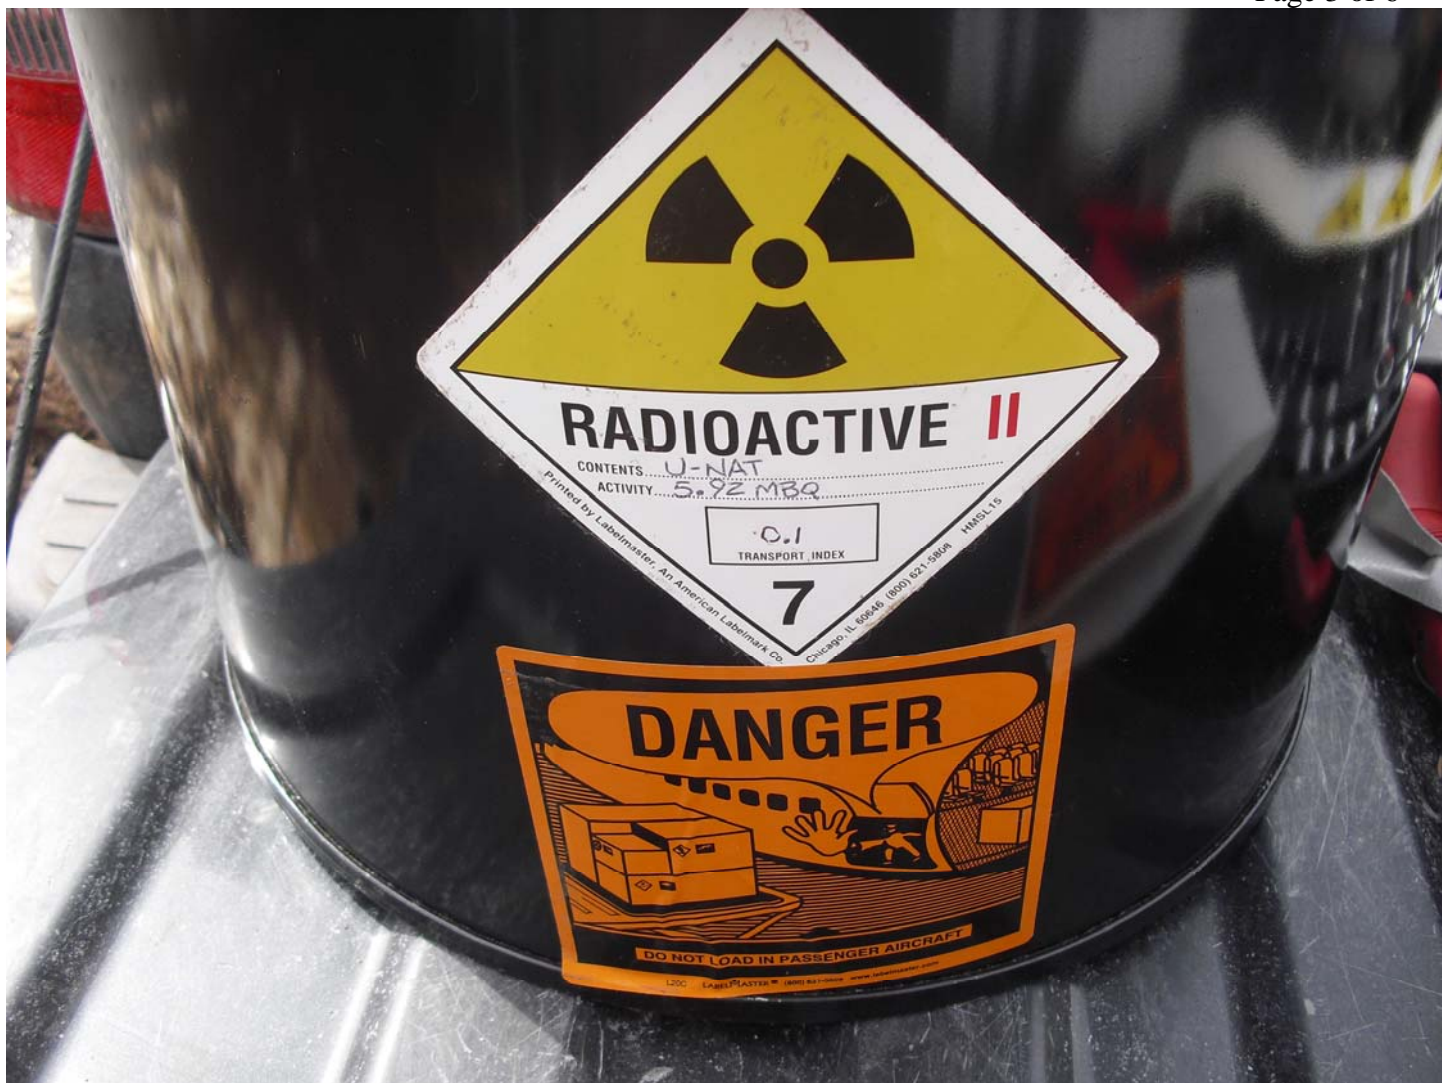
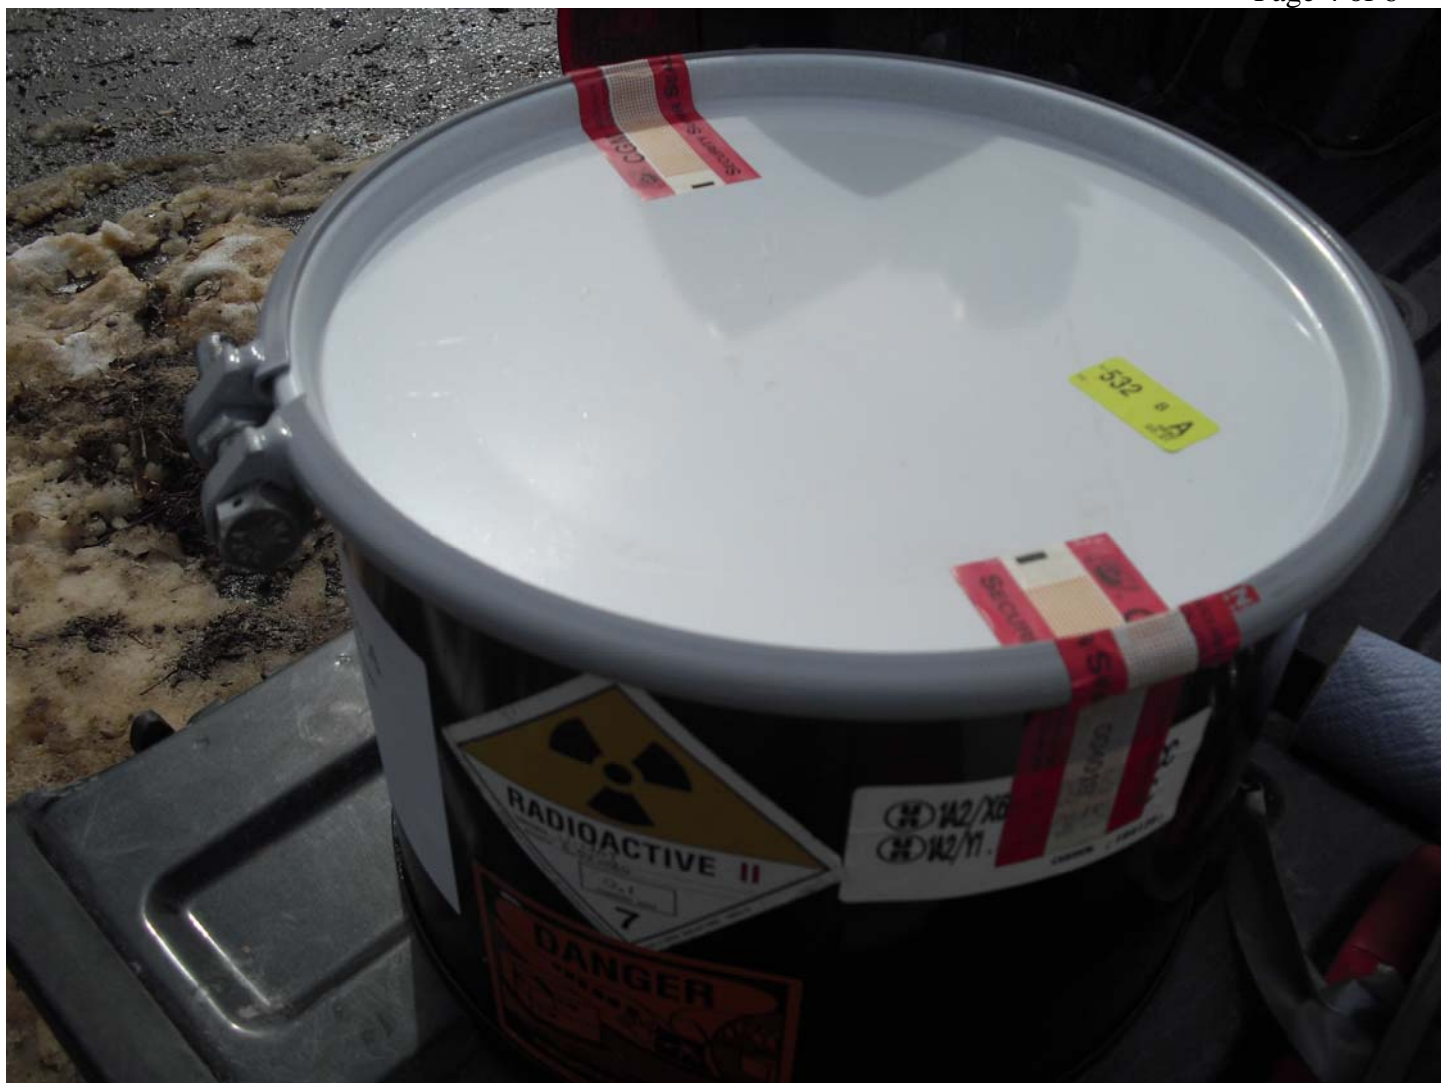
<b>Quality Control Activities:</b>	Instrumentation daily QC, field inspection to insure that procedures were being followed. Reviewed CoCs prior to shipping soil samples.		
<b>Health And Safety Levels And Activities:</b>	Carefully packaged hot rocks (up to 8mr/hr contact) in to 7A Type A container (see pictures).		
<b>Problems Encountered/ Corrective Action Taken:</b>	Several discussions took place between the Cabrera FSM, ALS (lab) Project Manager and the Cabrera Corporate RSO regarding shipment of hot rocks to the lab for analysis. Initially the lab indicated that they would accept the shipment then the laboratory RSO voiced concerns that the dose rate on the samples exceeded the upper range to their dose rate meter's capability. The lab requested the field team "break" the large rock into smaller pieces which could potentially spread contamination and was not a desirable option. The Cabrera FSM proposed to send one of our field instruments to the lab prior to shipping the higher activity samples and the lab agreed. Dave Hays was informed of the conditions and progress.
