**US Army Corps
of Engineers®**
New York District

**Integrated Hurricane Sandy
General Reevaluation Report
and
Environmental Impact Statement**

**East Rockaway Inlet to
Rockaway Inlet and Jamaica Bay**

Appendix A1
Shorefront Engineering and Design Appendix

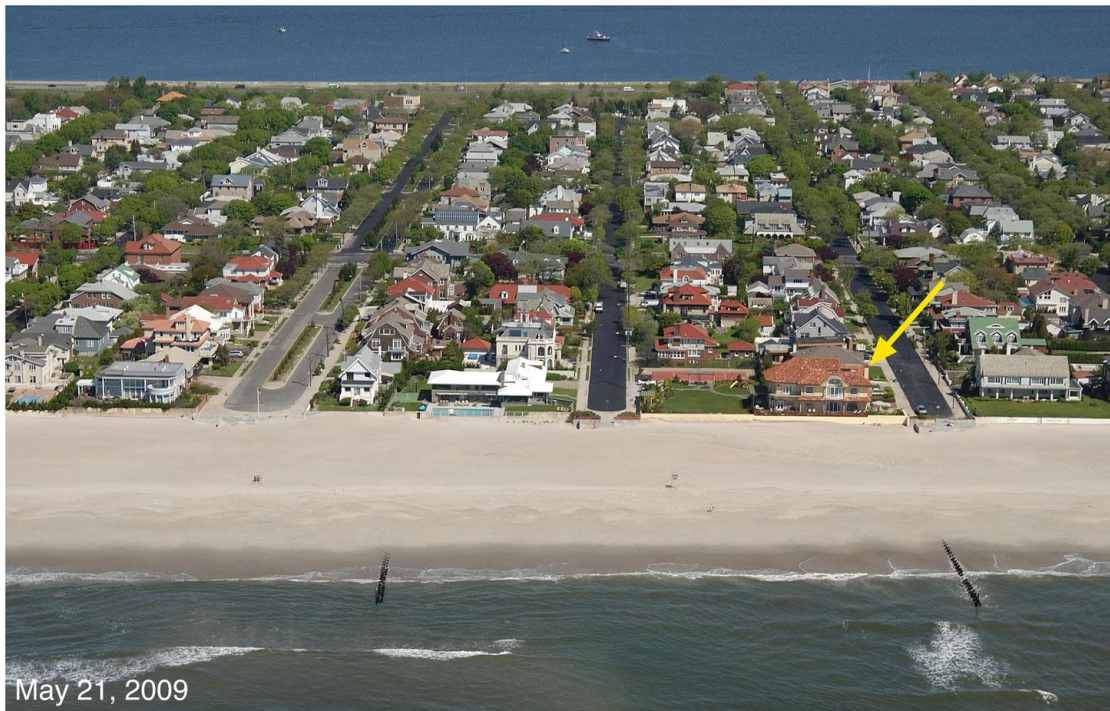
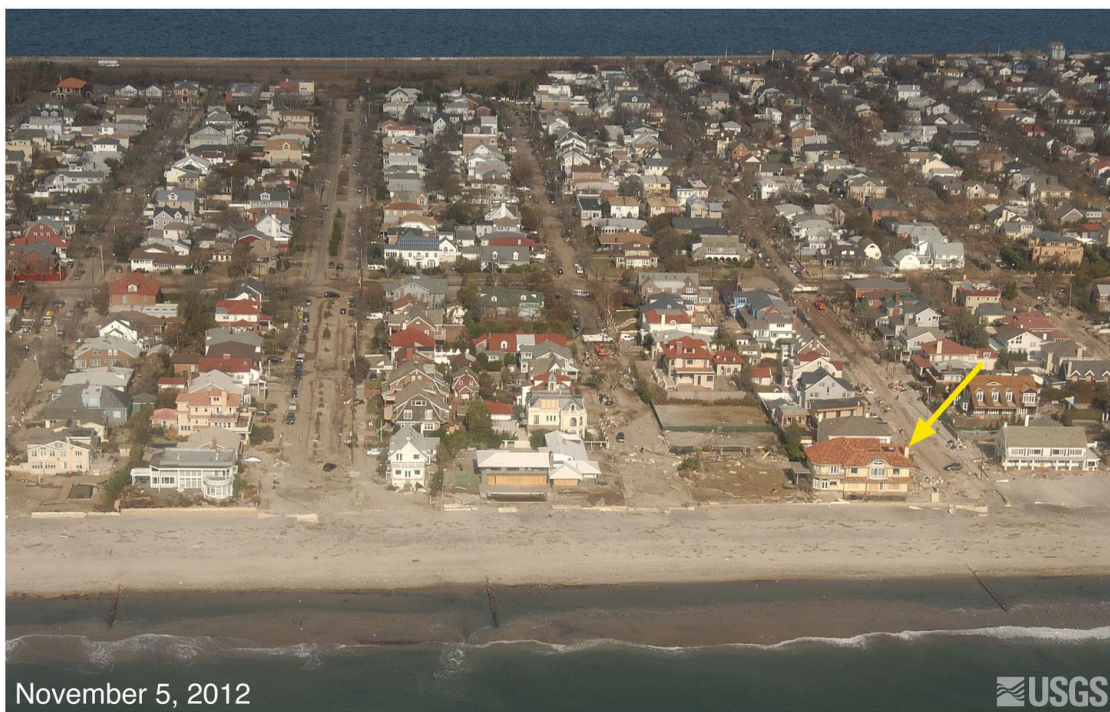
Figure 2-2: Pre- and Post-Storm Photo Comparison at Rockaway Beach

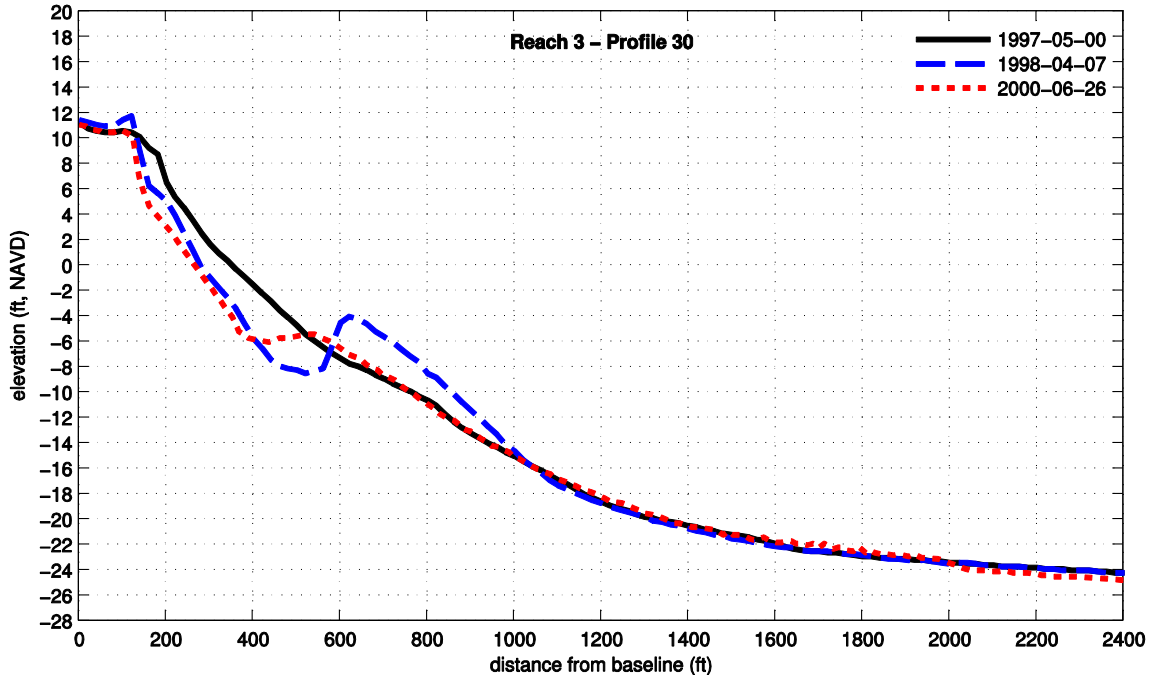
Figure 3-4: ACNYMP Data at Profile 30

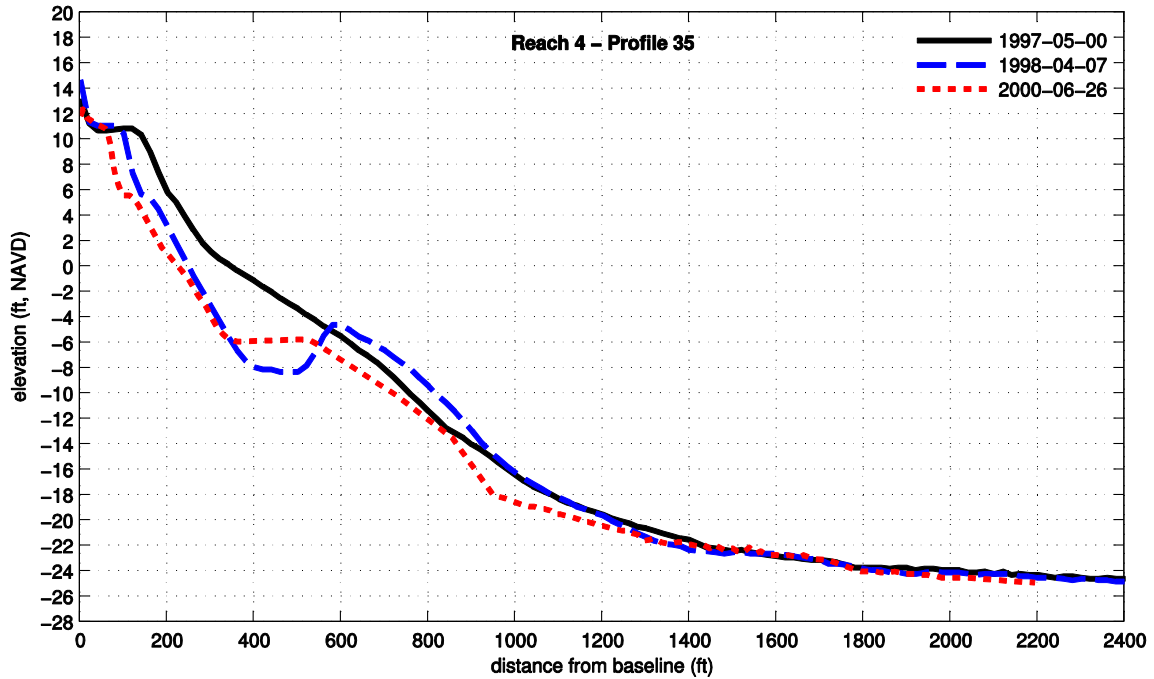
Figure 3-5: ACNYMP Data at Profile 35

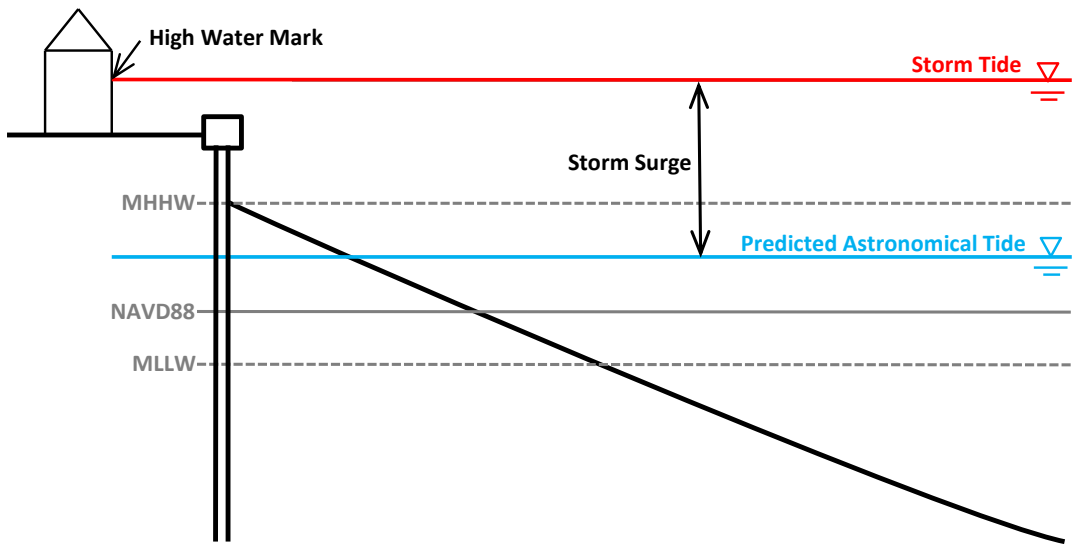
(a) Shoreline Exposed to Storm Tide and Waves

(b) Shoreline Exposed to Storm Tide (no waves)

Figure 4-1: Components of Water Surface Elevation

Storm tide is the total observed water level during a storm due to the combination of storm surge and astronomical tide. Storm surge is defined as a rise above normal water level on the open coast due to the action of wind stress on the water surface and the decrease in atmospheric pressure during major storms. Water levels rise at the shoreline when the motion of wind driven waters is arrested by the coastal landmass. Two types of storms, as mentioned in section 2.1) are of primary significance along in the Project Area: (1) tropical storms which typically impact occur from July to October, and (2) extratropical storms which are primarily winter storms occurring from October to March. These extratropical storms are often referred to as "nor'easters" due to the predominate direction from which the winds originate. Figure 4-1 shows the different contributions to the water

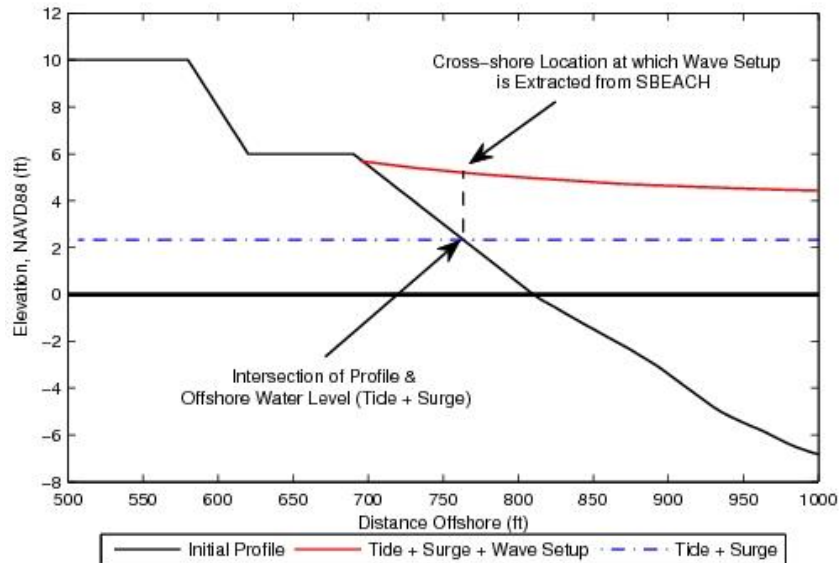
Figure 4-3: Cross-shore Location at which Wave Setup is extracted from SBEACH

In this study the wave setup value near the shoreline was extracted from the SBEACH model simulations. Figure 4-3 shows the cross-shore location at which the wave setup is extracted from SBEACH. The wave setup extracted from the cross-shore location of the intersection of the offshore water elevation and initial profile. This location varies with the offshore boundary conditions to SBEACH; however, this location is generally near the instantaneous shoreline. This is the same location that was used to determine the nearshore wave setup for FIMP (Gravens et al, 1999).

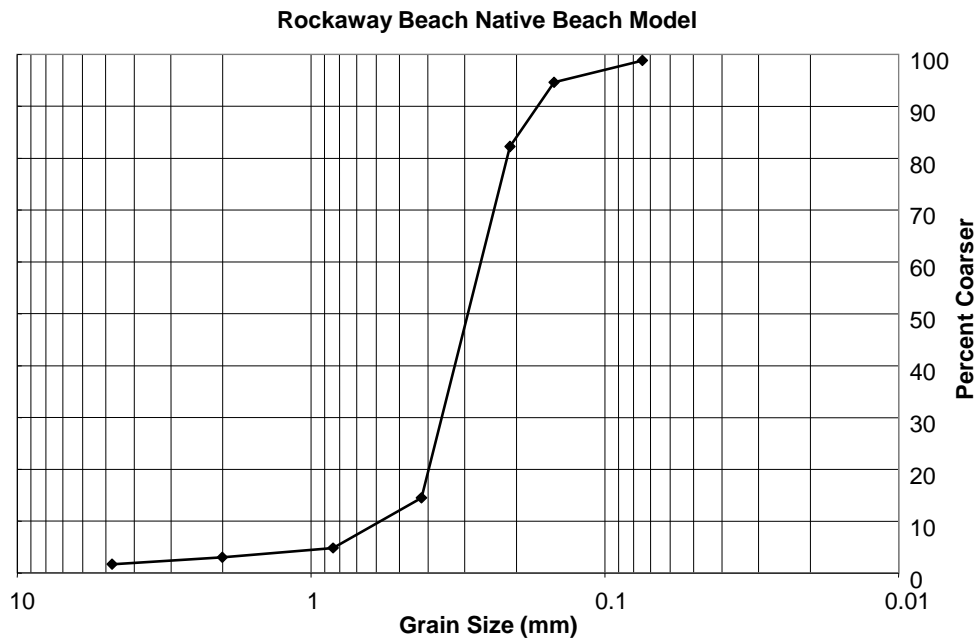
Figure 5-2: Native Beach Model

Mean (ϕ)	1.79
Mean (mm)	0.29
Standard Deviation (ϕ)	0.52

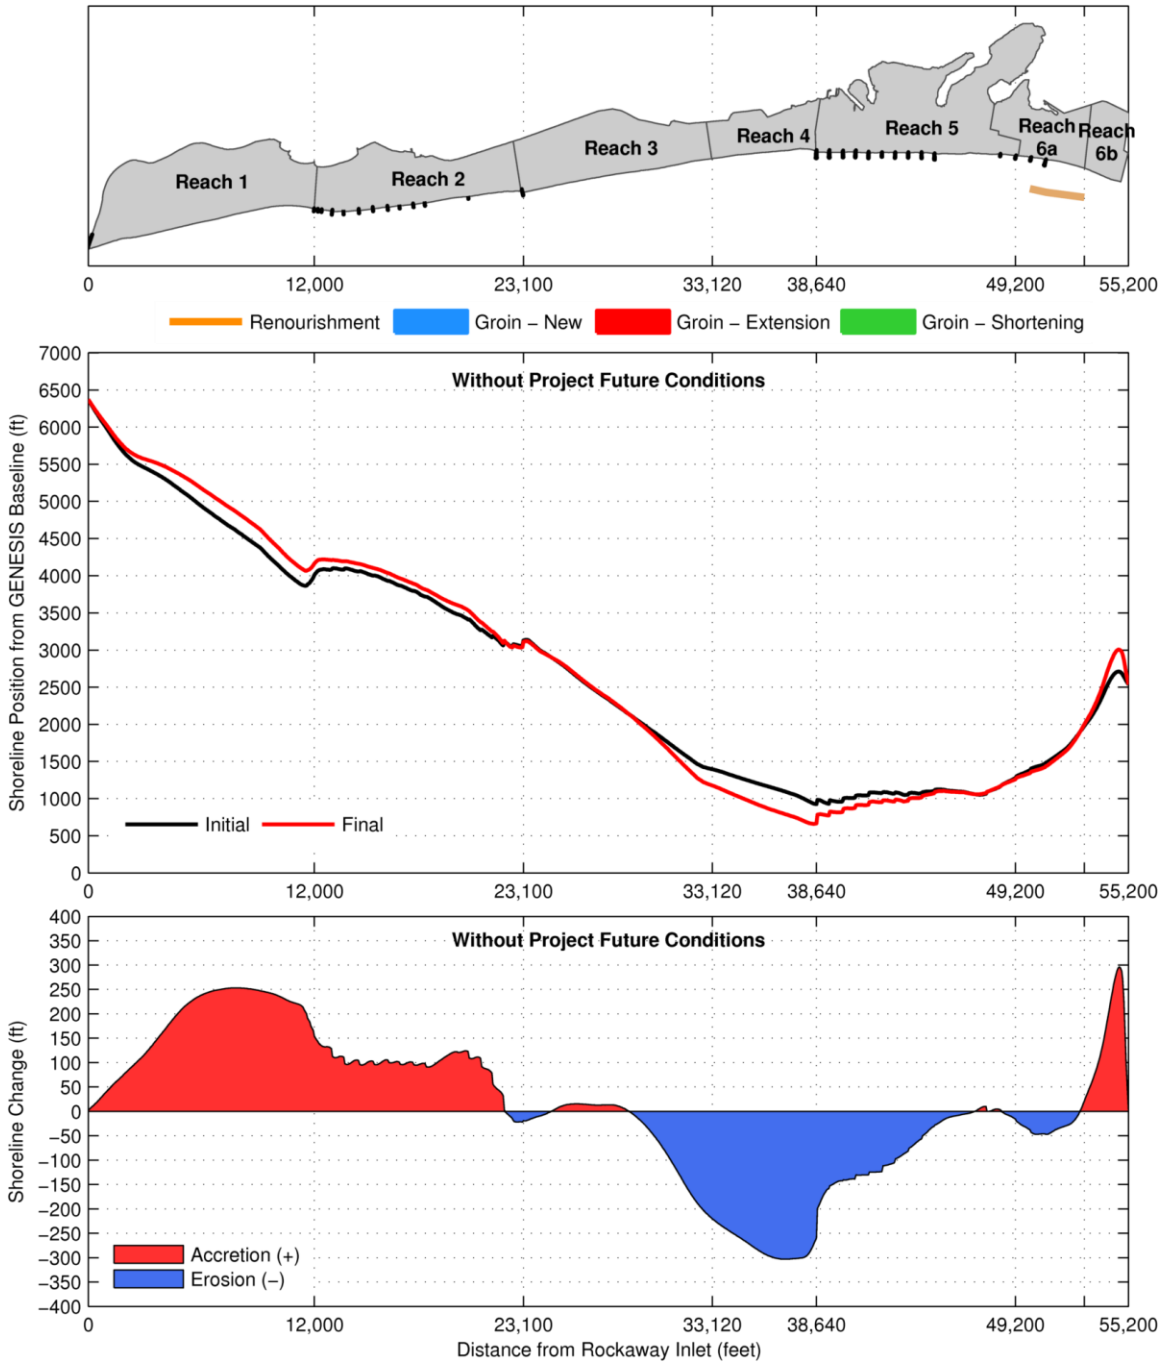
Figure 6-4: WOPFC Shoreline Changes

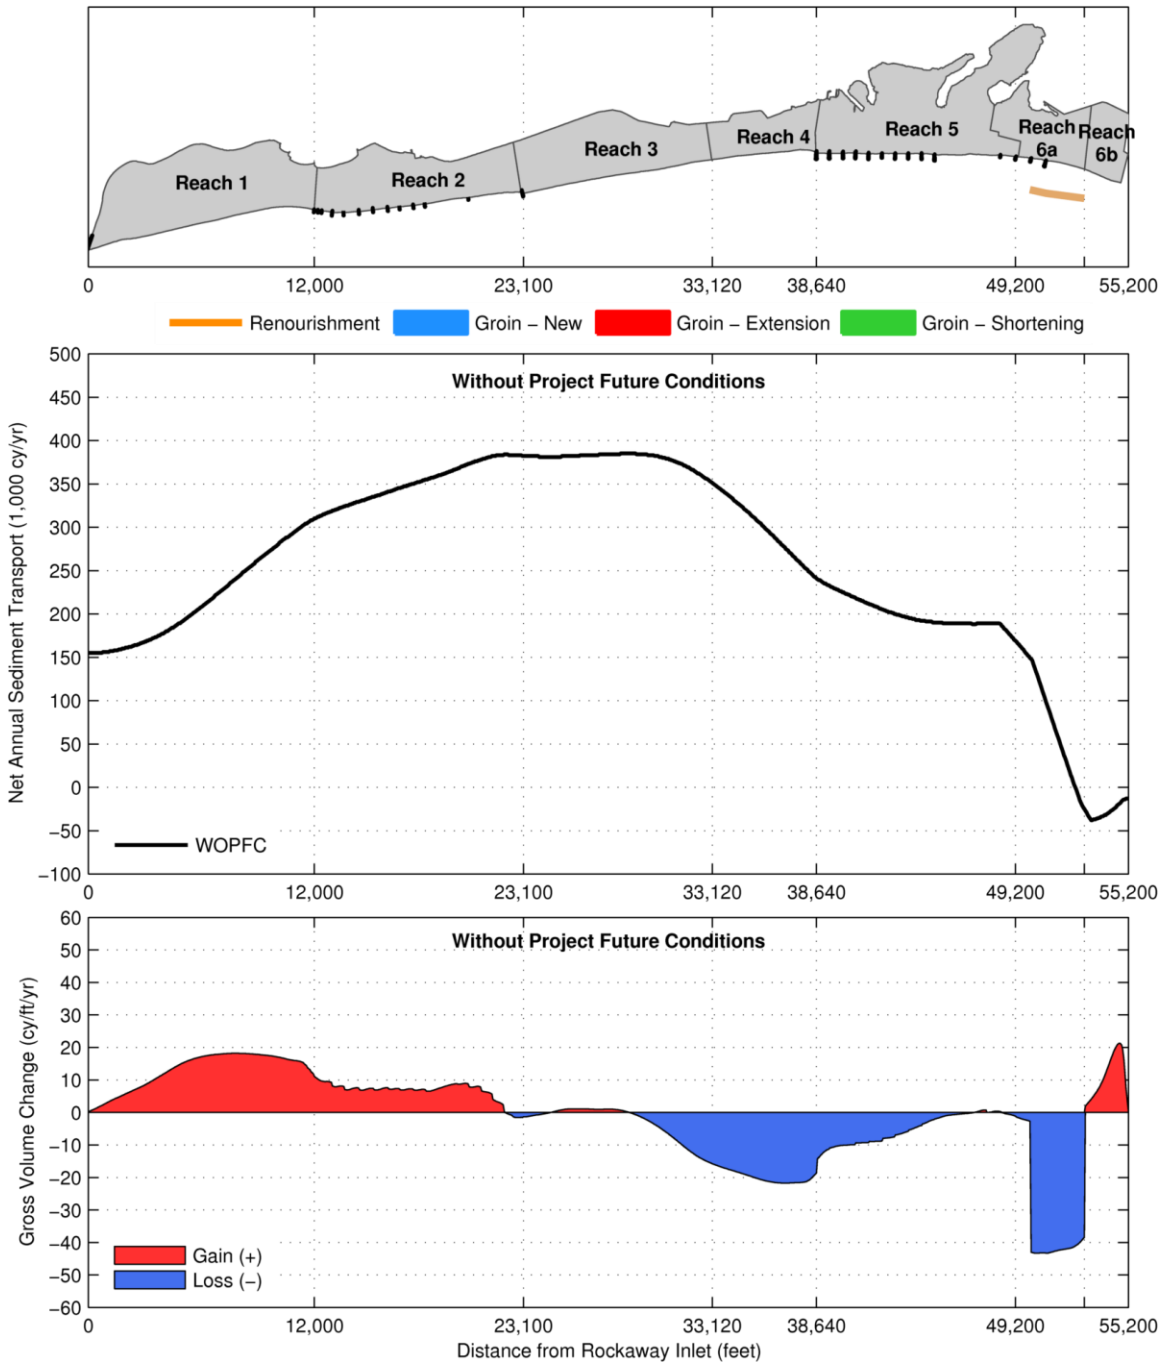
Figure 6-5: WOPFC Sediment Transport & Gross Volume Changes.

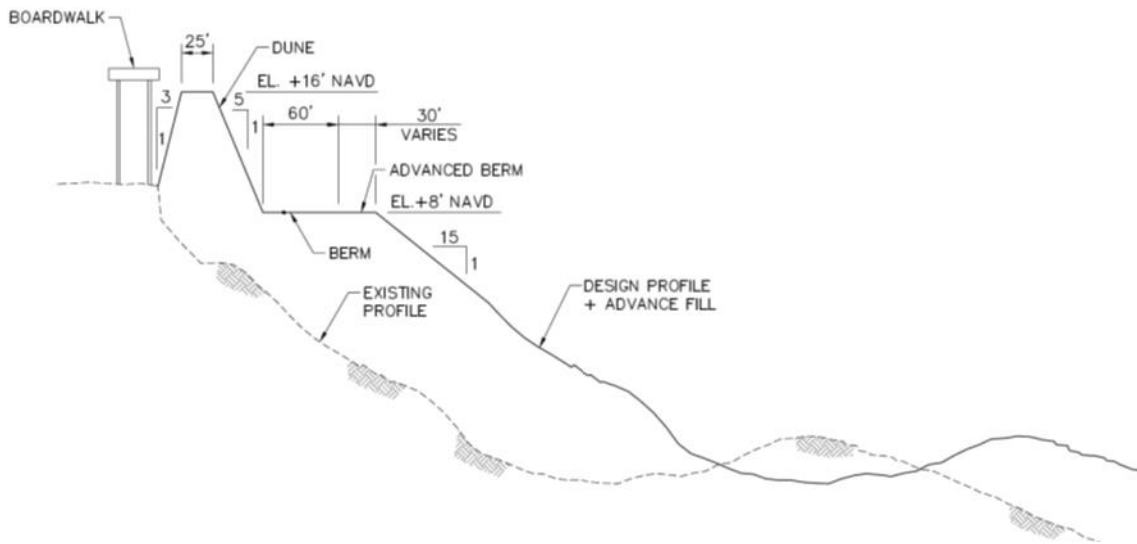
Figure 8-4: Design Beach Profile (note: Baseline location varies)

also tapers from an elevation of +18 ft NAVD88 at 19th Street down to approximately +12 ft NAVD88 at Beach 9th Street which will be tied into the existing grade. The west beachfill taper is approximately 5,000 ft in shorefront length from Beach 149th Street west to Beach 169th street fronting Riis Park. The beachfill taper will be beach fill only with a berm width tapered from the design width at 149th Street to the existing width and height at 169th Street.
