**US Army Corps  
of Engineers®**  
New York District

**Integrated Hurricane Sandy  
General Reevaluation Report  
and  
Environmental Impact Statement**

**East Rockaway Inlet to  
Rockaway Inlet and Jamaica Bay**

**Appendix A1**  
**Shorefront Engineering and Design Appendix**

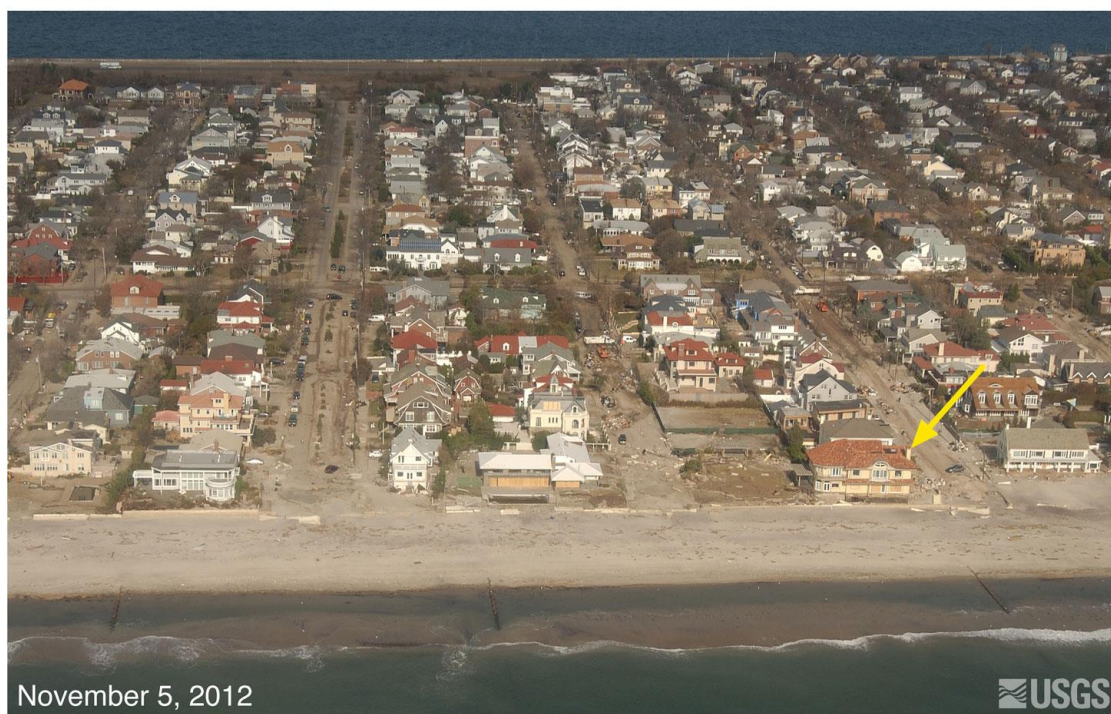
**Figure 2-2: Pre- and Post-Storm Photo Comparison at Rockaway Beach**

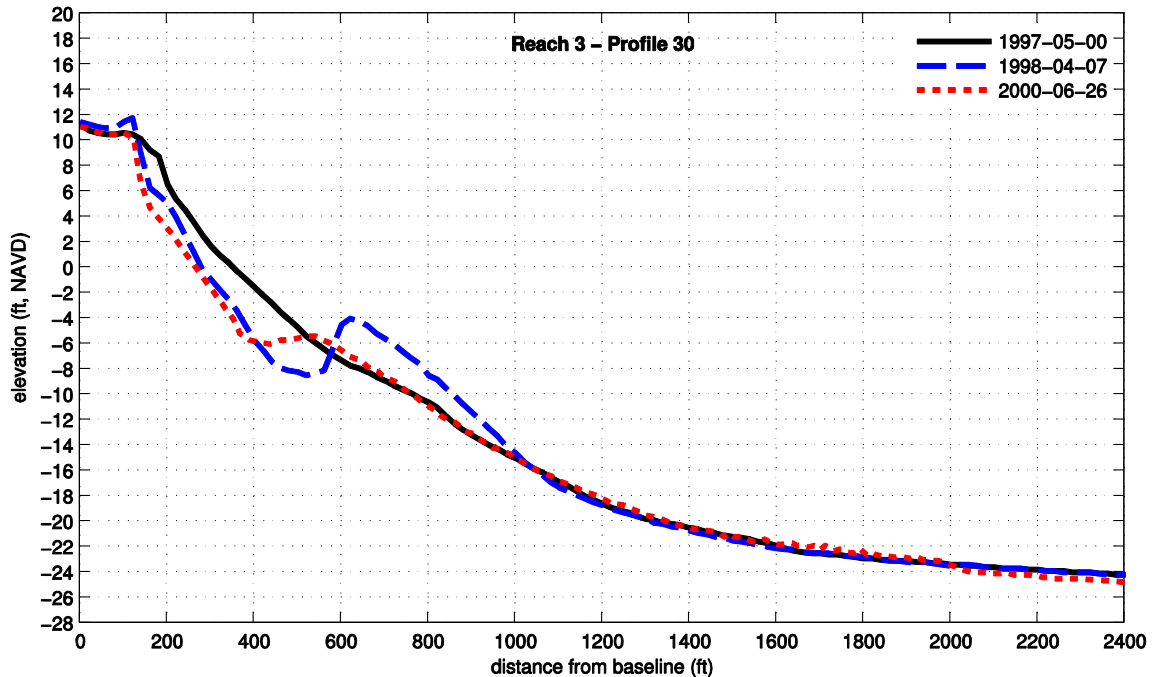
**Figure 3-4: ACNYMP Data at Profile 30**

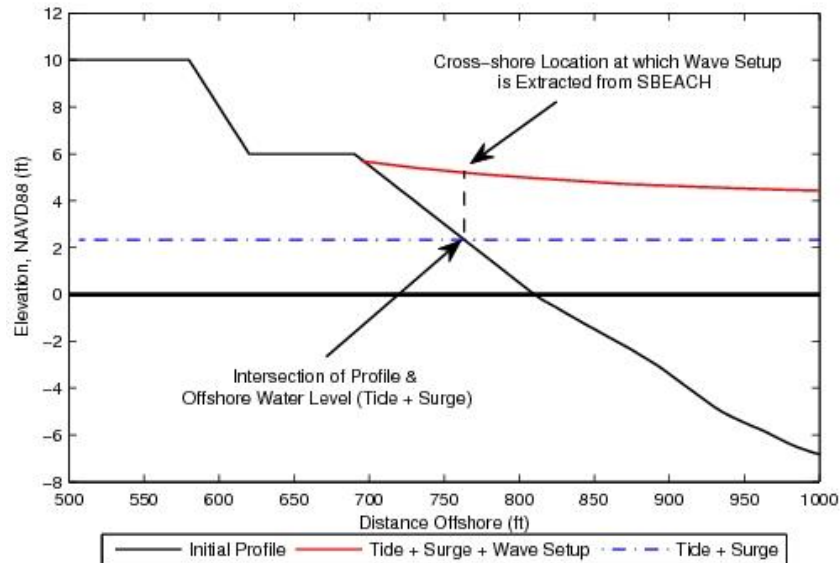
In this study the wave setup value near the shoreline was extracted from the SBEACH model simulations. Figure 4-3 shows the cross-shore location at which the wave setup is extracted from SBEACH. The wave setup extracted from the cross-shore location of the intersection of the offshore water elevation and initial profile. This location varies with the offshore boundary conditions to SBEACH; however, this location is generally near the instantaneous shoreline. This is the same location that was used to determine the nearshore wave setup for FIMP (Gravens et al, 1999).

**Figure 4-3: Cross-shore Location at which Wave Setup is extracted from SBEACH**

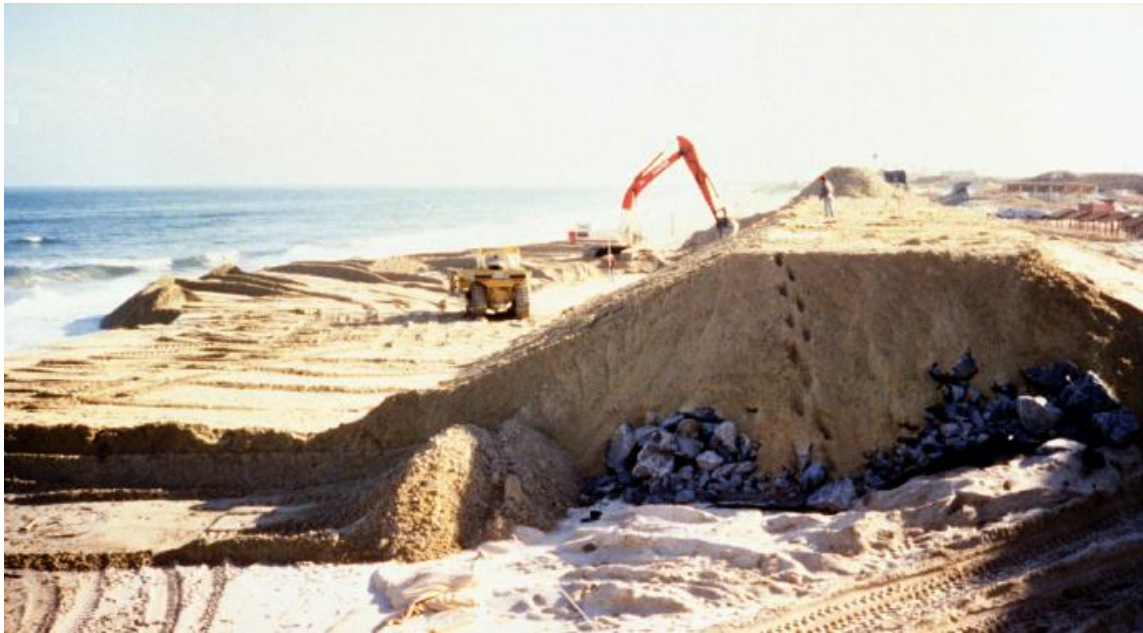
The proposed buried seawall for the Atlantic Ocean Shorefront is very similar to the examples in Bay Head, NJ and Dam Neck, VA. Since the purpose of the structure is wave protection, it may be constructed intermittently along the shoreline in the most vulnerable areas.

**Figure 7-12: Buried Seawall Example at Dam Neck, Virginia (USACE, 1999)**
