# **North Shore of Long Island, Asharoken, Suffolk County, New York**

## **Coastal Storm Risk Management Feasibility Study**

### **Feasibility Report**

November 2015

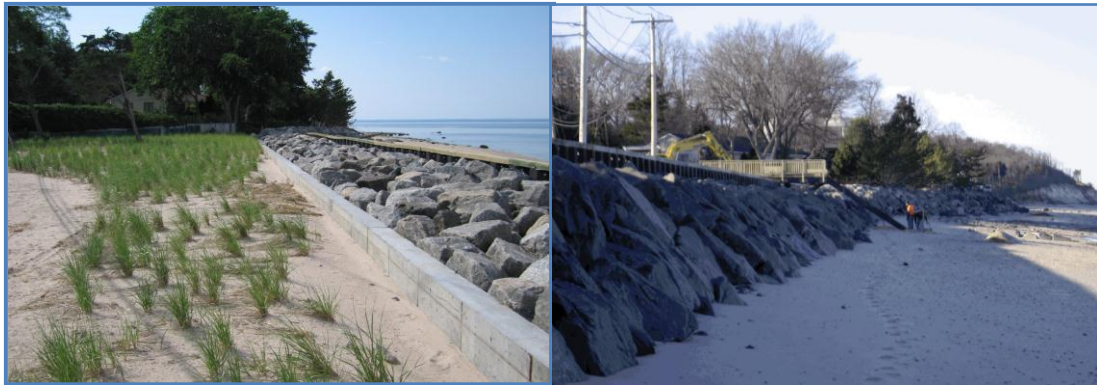
**Figure 4:** USACE Section 103 project repaired after a storm (Picture taken June 2011). Timber caps were replaced with bent steel caps after Hurricane Sandy (2012).

The project has generally performed as expected, and reduced damages to Asharoken Avenue. The performance of the project has been affected by changed conditions since initial construction, including the erosion of the beach in front of the project. The project was also designed with a relatively low-level of design, since it was intended as a stop-gap measure until a larger project could be constructed. The low-level of design, and the erosion in front of the project have resulted in storms that damaged the structure which required repairs. Tropical Depression Ernesto in September 2006 damaged the Section 103 project, and emergency repairs were made in two phases in 2007; the Norlida coastal storm in November 2009 and a nor'easter in March 2010 again damaged the project and a short length of the roadbed of Asharoken Avenue, and emergency repairs were again made; and, finally, the

project was again damaged during Hurricane Irene in August 2011 and Hurricane Sandy in October 2012, and the project was yet again repaired.

With these repairs, the project continues to provide a low level of risk reduction (approximately a 10% annual chance of exceedance). It is expected that the project will be maintained in the future, but that the project will continue to be damaged by storm events and require repairs in the future. The effectiveness of the project will also continue to diminish in the future with continued long-term erosion in front of the project.

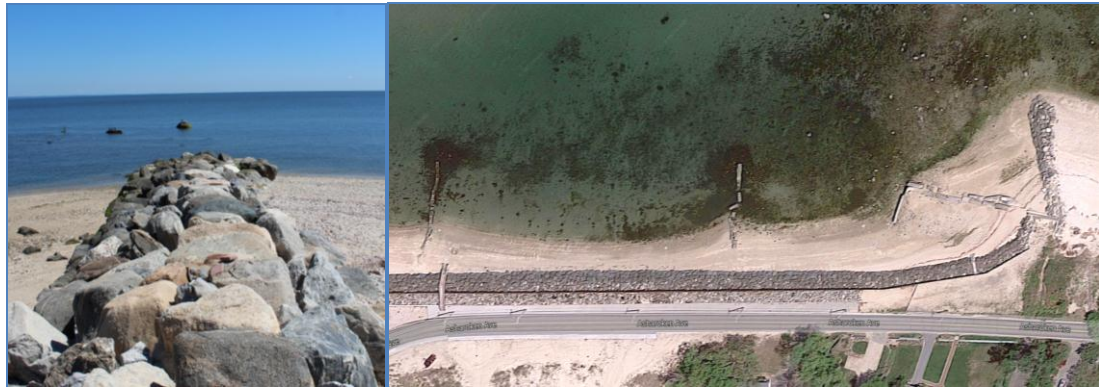
**Figure 5:** Stone groin and non-engineered minor groins at eastern extent of project area.

- ii. A stone groin was constructed at the northwest portion of the shoreline in 1952, in the vicinity of where Asharoken Ave. & Bevin Rd. interact. This existing stone groin is located at the southeast end of the existing Section 103 Project and is acting as a terminal structure, trapping a significant quantity of longshore material and essentially holding the beach to the southeast in place in its current configuration. The exact condition and level of protection of the structure is undetermined.

- iii. Three non-engineered groins constructed to the northwest (downdrift) of the stone groin were identified in front of the Section 103 seawall. Details of the three groins design, material, date of construction are unknown, however, they are likely composed of concrete cube armor blocks during the same time period with the stone groin. Although partially damaged, the three groins appeared to maintain a basic downdrift shoreline with dune and beach until damaged by the 1996 northeaster and several storms that followed.

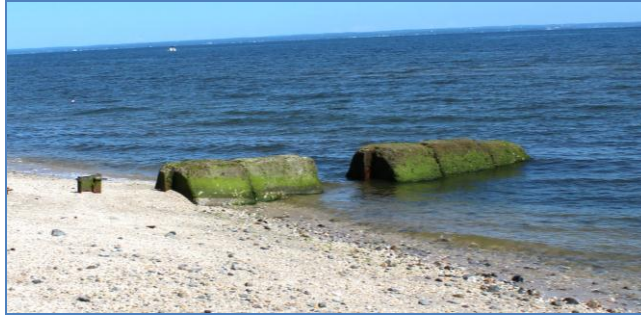
**Figure 6:** Exposed minor interlocking groin

Additional groins are evident along Asharoken beach. The groins are visible along the shoreline in front of the residential bulkheads on the southeastern portion of the project area. These interlocking groins appear to have been constructed along the eroding stretch of shoreline by New York State Department of Public Works in 1956 with the intention of stabilizing the critical erosion shoreline. Several of these groins are exposed just above the MLW line.

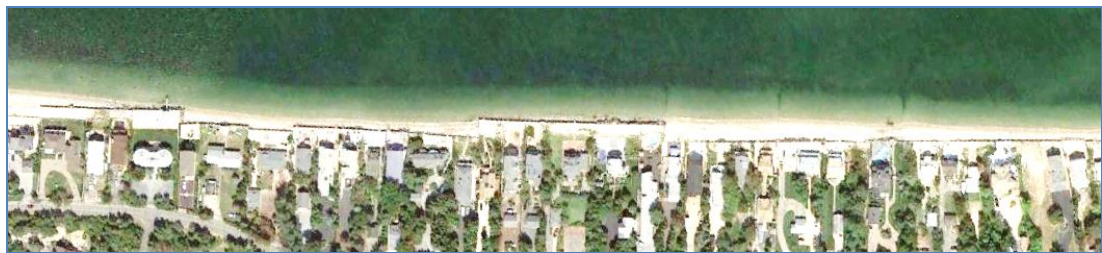
**Figure 7:** Residential Bulkheads fronting eroded shoreline and submerged minor groins.

- iv. The southwestern portion of the project shoreline is populated with residential development with year-round houses built to the edge of water. Typical beach profiles in this study reach include residential properties extending landward from privately built bulkheads. These mixed timber, concrete and sheetwall bulkheads along the eroding stretch were constructed and are maintained by the property owners themselves. The average height of the bulkheads and ground elevation behind the bulkheads is approximately +13 ft NGVD.

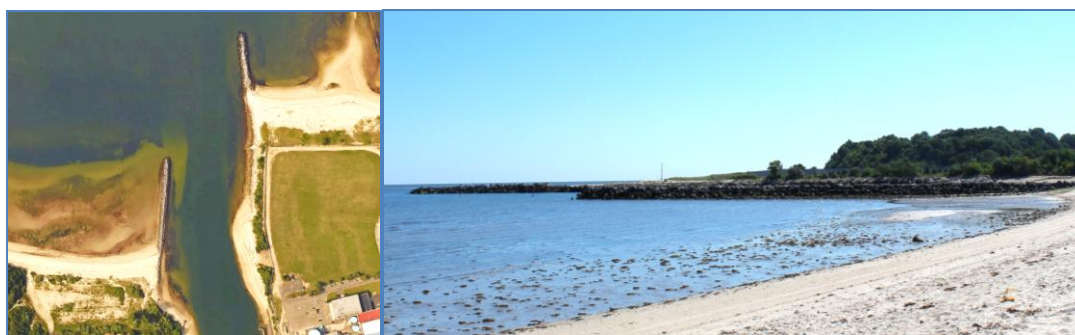
**Figure 8:** LIPA power plant jetties at western extent of project area.

The jetties now protect the inlet to the cooling water intake lagoon just west of the power plant. Tugs and other vessels use the basin and the channel between the jetties to service a fuel platform located two miles offshore where 50,000 Displaced Weight Tons (DWT) tankers dock to unload oil for the power plant. Recreational boaters and some commercial fisherman also use the Basin to launch their vessels. Since its construction, the power plant has bypassed material dredged from the channel serving the cooling water intake lagoon and deposited the material on the beach west of the jetties. The power plant's permit requires bypassing of sand equivalent to the amount that is captured in the littoral system. The powerplant has recently been bypassing sand on a 3 year cycle with the placement of 15,000 CY of sand per year, consisting of 10,000 CY of sand from Northport Basin, and 5,000 CY of sand that is trucked in. It is expected that the without-project future bypassing by the power plant would be 15,000cy/yr.

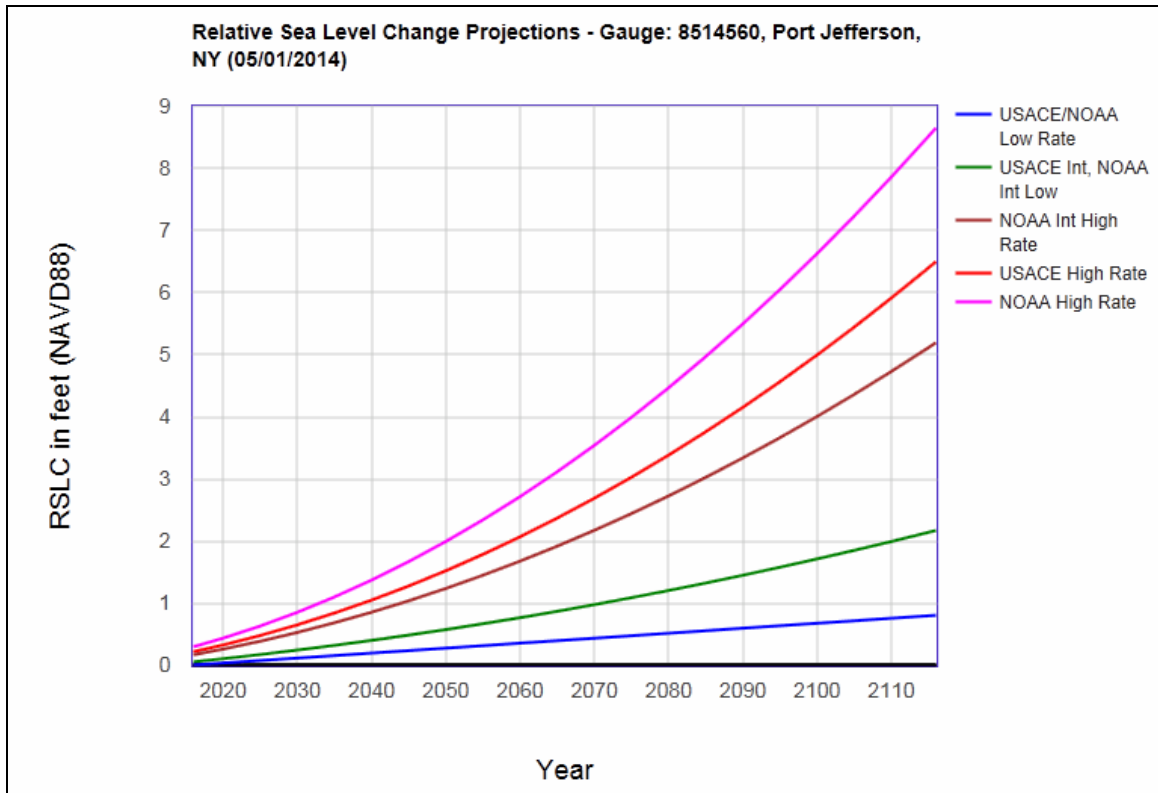
**Figure 11:** Relative Sea Level Change Projections – Port Jefferson, NY

For project development purposes, the historic rate of RSLC equal to +0.4 ft over 50 years is used for project planning, design, and analysis. Sensitivity, Risk and Uncertainty analyses will be conducted on the selected plan to determine how sensitive the recommended design is to the various rates of SLC, how RSLC affects calculated risk, and what design or operations and maintenance measures can be implemented to minimize adverse consequences of accelerated RSLC. Both the USACE intermediate and high rates in future 50 and 100 years will be used for sensitivity, risk & uncertainty analysis.

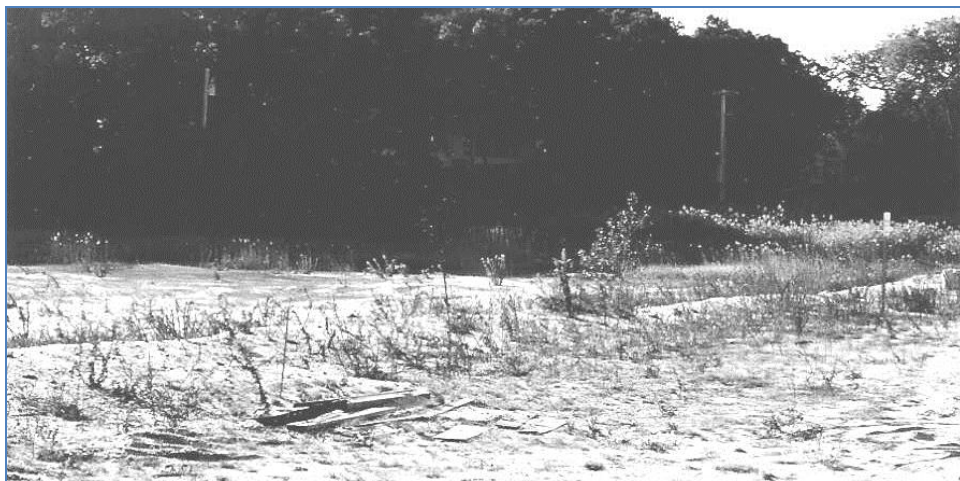
**Figure 14:** Sand-dune habitat on bayside of Asharoken Avenue at Duck Island Harbor

As has been discussed, overwash of sand material over Asharoken Avenue has occurred in the past and is expected, with medium to high probability, to continue to take place. It has been observed that sand has been transported across Asharoken Avenue near Bevin Road and deposited on the bayside in Duck Island Harbor. Figure 14, shows this transitional area.

A sand-dune plant community already exists on the bayside of Asharoken Avenue at Bevin Road and across from the Corps Section 103 Emergency Erosion Control project. Margiotta observed a sandy incline vegetated with plants such as beach grass
