# DEPARTMENT OF THE ARMY NEW YORK DISTRICT, CORPS OF ENGINEERS JACOB K. JAVITS FEDERAL BUILDING

Yonkers Avenue, Continuing Authorities Program, Section 14 Emergency Streambank

Stabilization Project

Tuckahoe, Westchester County, New York

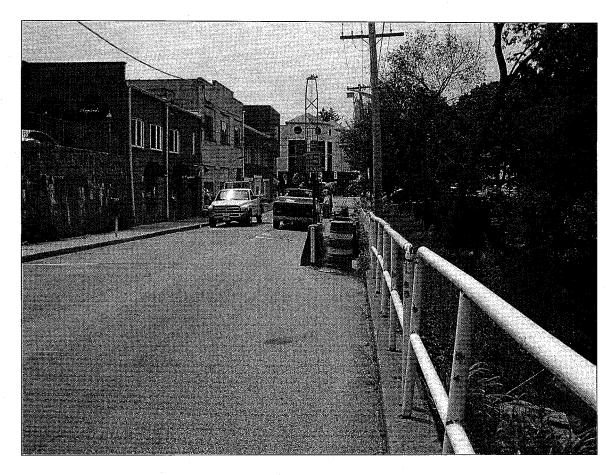
Figure A1: View southwest of the project area along Yonkers Avenue.

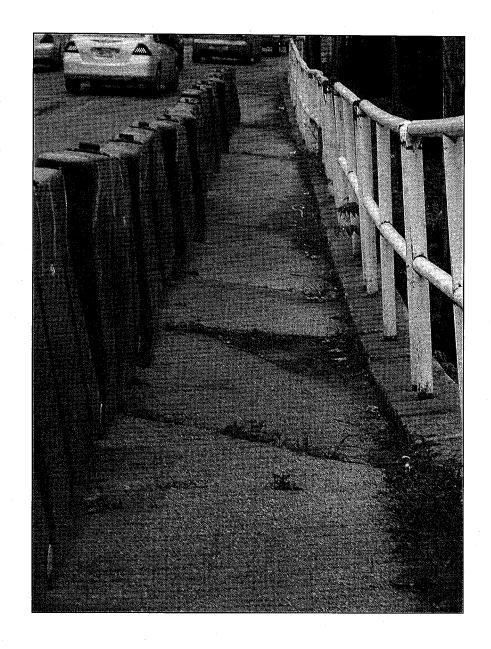
Figure A2: View southwest of cracks visible in the road surface along the project site on Yonkers Avenue.

Based on the preliminary survey, the project area is not likely to contain significant cultural resources. The stone wall that supports the road and utilities is in disrepair and what remains of it at the downstream end of the project area is being degraded by the scouring action of the river. It has likely been repaired and replaced periodically with the repair of the road. The impact of the proposed installation of sheet piling or a concrete wall is expected to be limited to the river bank and the retaining wall. Archaeological investigations within the project area would be extremely difficult and potentially dangerous and are not likely to yield useful data. Therefore, it is recommended that no further cultural resources activities be undertaken for this project. If the project plans change to extend beyond the current boundaries and additional work is proposed, additional cultural resources may be required to include consultation with the NYSOPRHP.

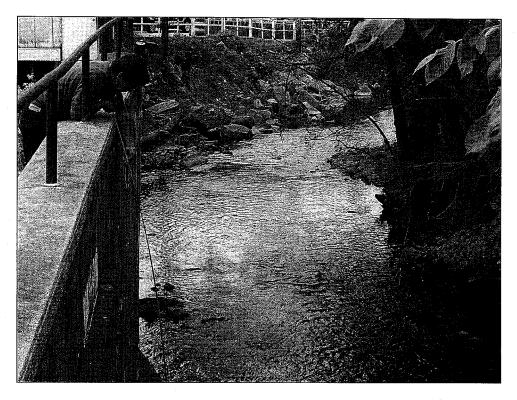
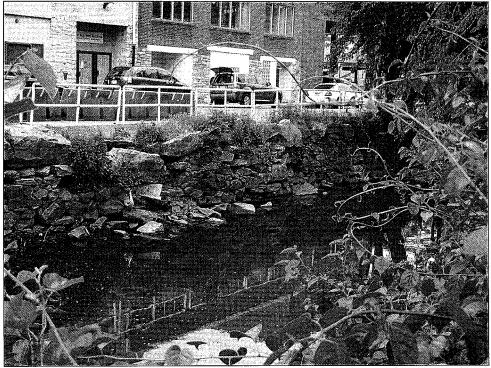
The study area is located on the eastern bank of the Bronx River along Yonkers Avenue between Main and Elm Streets in the Village of Tuckahoe (Appendix A). Yonkers Avenue is an active street in the center of the Village. The Bronx River flows up against a 20 foot tall stone retaining wall at this location and bank erosion along approximately 400 feet of the River is undermining the wall and Yonkers Avenue. The road surface is now showing signs of cracking, settlement, and sinking along the failed stretch (See Appendix A2). Yonkers Avenue contains vital infrastructure in the form of sewer lines, stormwater piping, and utility poles, and serves as the only emergency route between Tuckahoe and Yonkers. In the absence of action, this major road will be undermined by the Bronx River. The proposed plan is to protect the east bank by replacing the existing degraded stone retaining wall with either a reach approximately 170 feet long of concrete retaining wall or steel sheet piling along Yonkers Avenue (See Appendix A6-A10). The sheet piling wall is proposed to reach approximately 30 feet in height with 10 feet of

Figures A6 and A7: Views of the retaining wall within the project area.

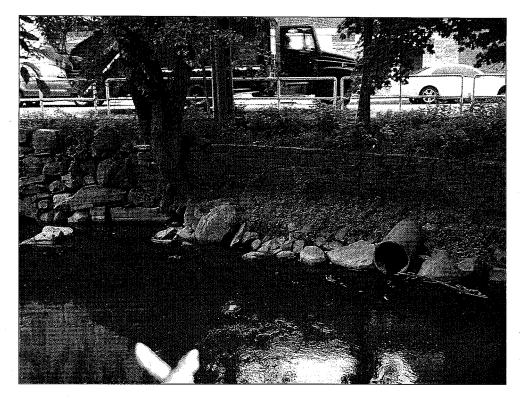
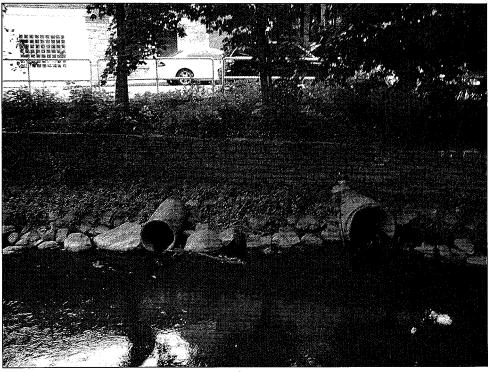
Figures A8 and A9: Views of the retaining wall at the downstream end of the project area where new riprap is proposed.

steel sheet piling exposed and about 20 feet embedded, assuming that rock is deep enough to make such an installation possible. A concrete wall to the same height is proposed if the bedrock will not support the sheet piling. Placement of a rip-rap apron at the ninety degree bend in the River is proposed to protect the toe of the wall against river scour. A conceptual design for the project illustrates the nature of these planned improvements (Appendix B).

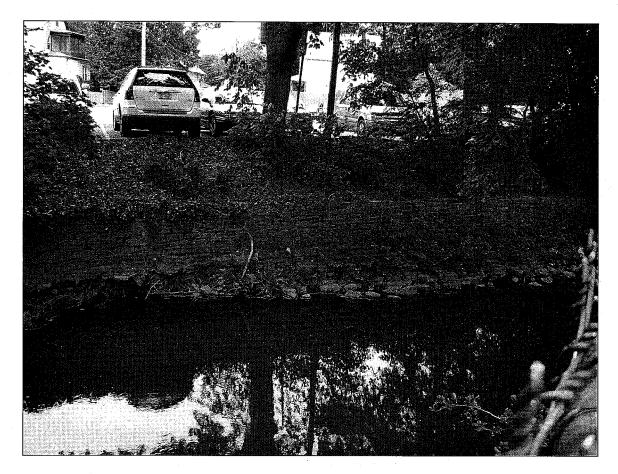
Figure A10: View of the retaining wall at the downstream end of the project area.

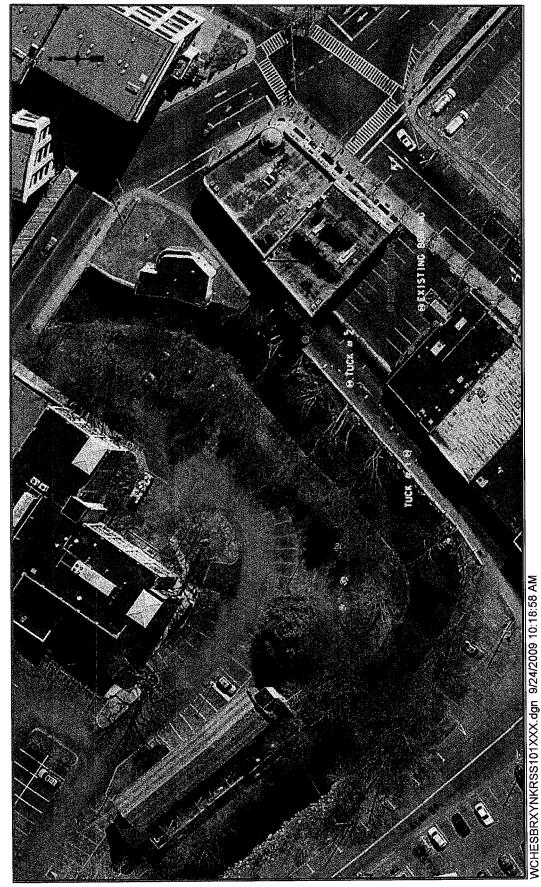
# Appendix C – Soil Profiles

A geotechnical survey was conducted by the Corps in 2009 to investigate the subsurface conditions along the river bank (Appendix C). Two borings were excavated in the center of Yonkers Avenue. The first, Tuck #1, was taken toward the downstream end of the study area and it contained fifteen feet of silty sand with gravel and wood inclusions which was interpreted as fill material overlying twenty feet of silty sand with traces of gravel. Bedrock was reached there at approximately 40 feet. The second boring, Tuck #2, contained the same fill material as that found in Tuck #1 but instead of extending downward the strata stopped at six feet over bedrock. An outcrop of bedrock is visible along the riverbank at the upstream end of the study area so it appears that the bedrock, which is shallow at the upstream end of the project area, extends downward into a flood plain toward the downstream end. No obvious cultural layers were encountered during the survey. The use of the project area as a major thoroughfare containing utility lines supports the conclusion that the first fifteen feet would likely be fill material from the many years of repair and regrading of the street. Much of the bank is also likely to be disturbed from the associated construction and repair of the retaining wall along the street.

EVATION	DEPTH  1 2 3 4 5 6 7 6 7 8 9	6- S1 44 S2 44 S2 44 S2 47 S2 47 S2	LEGEND	Tuckahoe, NY  classification of materials  Brown SAND, some Silt, trace Gravel. (pieces of wood)	REMARKS 5 AUGUST 2009
	2 3 4 5 6 7 8	5 S1 4 2 2 3 S2 3 S3 6 S3		Brown SAND, some Silt, trace Gravel. (pieces of wood)	5 AUGUST 2009
	2 3 4 5 6 7 8	4 2 3 5 2 3 5 5 5 7		Brown SAND, some Silt, trace Gravel, (pieces of wood)

- 6 - 7 - 8 - 9				
-	- 10	10	·		•
-	11 12 13 14	\$ S5.		15′-0"	
-	15 16 17 18	3 4 2 57		Brown fine to medium SAND. little Gravel.trace Silt	
	20 21 22 23 24 25 26	3 3 3 4 3 5 3 5 5 9		Dark Brown SAND, little fine Gravel, trace Silt	
	28 29 30 31 32 33	4 4 4 3	·	Dark Brown SAND, little fine Gravel, trace Silt	
	· 34 · 35 · 36 · 37	13 18 18	÷	Light Brown SAND, little Gravel, trace Silt 37'-0"	
	38 39		·	WEATHERED BEDROCK  TOP of CORING 40'-0"	
ŀ	41			BEDROCK	DRILL: 40' to 45' RUN: 5'-0" RECOVERY: 5'-0"
		32 33 34 35 36 37 38 39 40 41	32 3 33 3 34 35 13 3 36 18 37 35 38 39 40 40 41 42 42 43	32 3 33 3 34 35 13 1 36 18 3 37 15 38 39 40 40 41 42 42 43	- 32

TU	JCk	(#	<u> </u>	2		
						onkers Avenue, Tuckahoe, NY	
	ELEVATION	DEPTH	BLOWS 6"	SAMPLE	LEGEND	CLASSIFICATION OF MATERIALS	remarks 6 AUGUST 2009
8.0		1 2 3 4 5 6 7 8 9 10 11 12 13 14 15 16 17 18 19 20 21 22 23 24 25 26 27 28 29 30 31 32 33 34 35 36 37 38 39 40		\$1 \$2 \$3		PAVEMENT  Brown SAND, little to some Silt, little Gravel  (FILL)  5'-6"  WEATHERED BEDROCK  Top of Coring 6'-7"  BEDROCK  Bottom of Hole 18'-0"	RUN 1 : 8 to 13  RECOVERY: 4'-10"  RUN: 5'-0"  RUN 2 : 13 to 18  RUN: 5'-0"  RECOVERY: 4'-10"
