DEFENSE ENVIRONMENTAL RESTORATION PROGRAM
FORT TOTTEN, QUEENS, NEW YORK
PROJECT NO. C02NY005700

APPENDIX B - Site Report

APPENDIX C - Photographs

DEFENSE ENVIRONMENTAL RESTORATION PROGRAM
FINDINGS OF FACT AND DETERMINATION OF
DEPARTMENT OF DEFENSE RESPONSIBILITY
FORT TOTTEN, WILLETS POINT, NEW YORK
PROJECT NO. C02NY005700

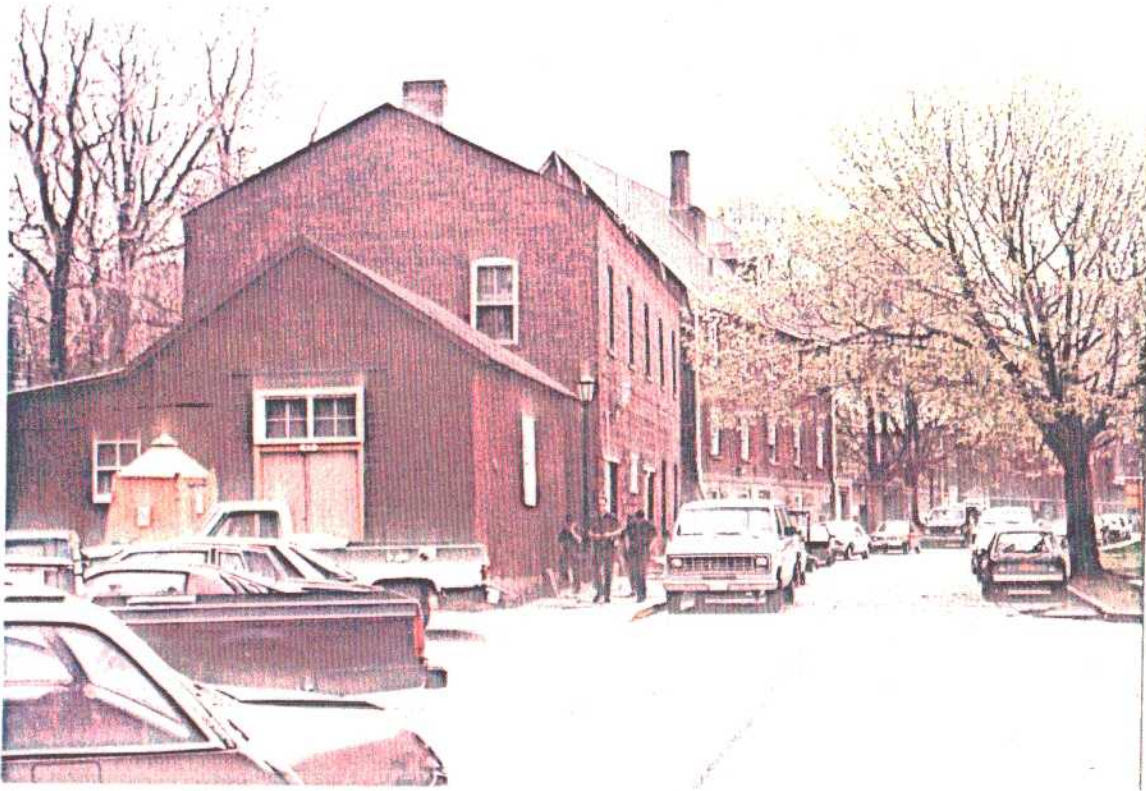
Left to right: Building #612 (Boatswain shop and storage), Building #611 (Galley, mess and engineering shop), Building #610 (Station building) and Building #609 (Electrical sub-station); all buildings are utilized.

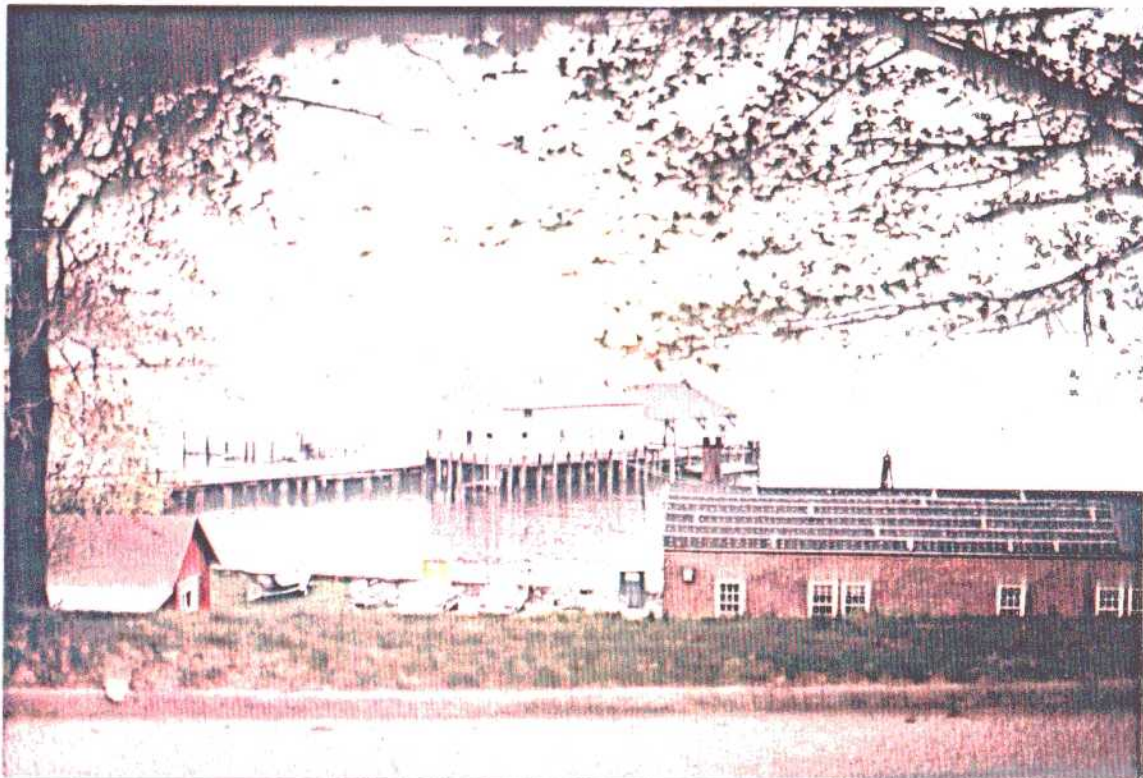
Left to right: Building #612 (Boatswain shop and storage), Buildings #606 and #607 on pier, and Building #614 (Warehouse). All buildings utilized except #606 and #607.

B. MARINE BUILDING DEMOLITION - Completely demolish and remove Marine Buildings #606 and #607 (3,610 square feet total). Also remove pile foundation, independent of pier, under Building #606.

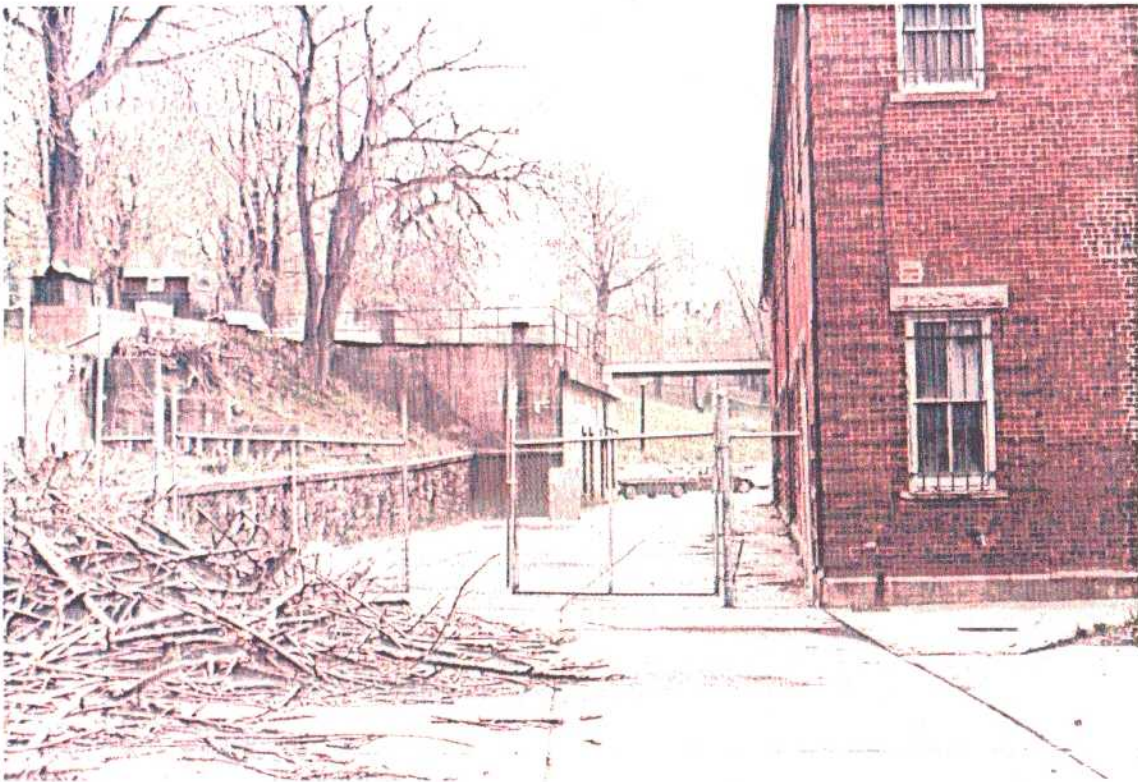
Left to right: Building #619 (Storage Bunker-not utilized) and Building #615 (Coast Guard Reserve unit and warehouse -utilized); fence marks boundary of U.S. Coast Guard property and U.S. Army property.

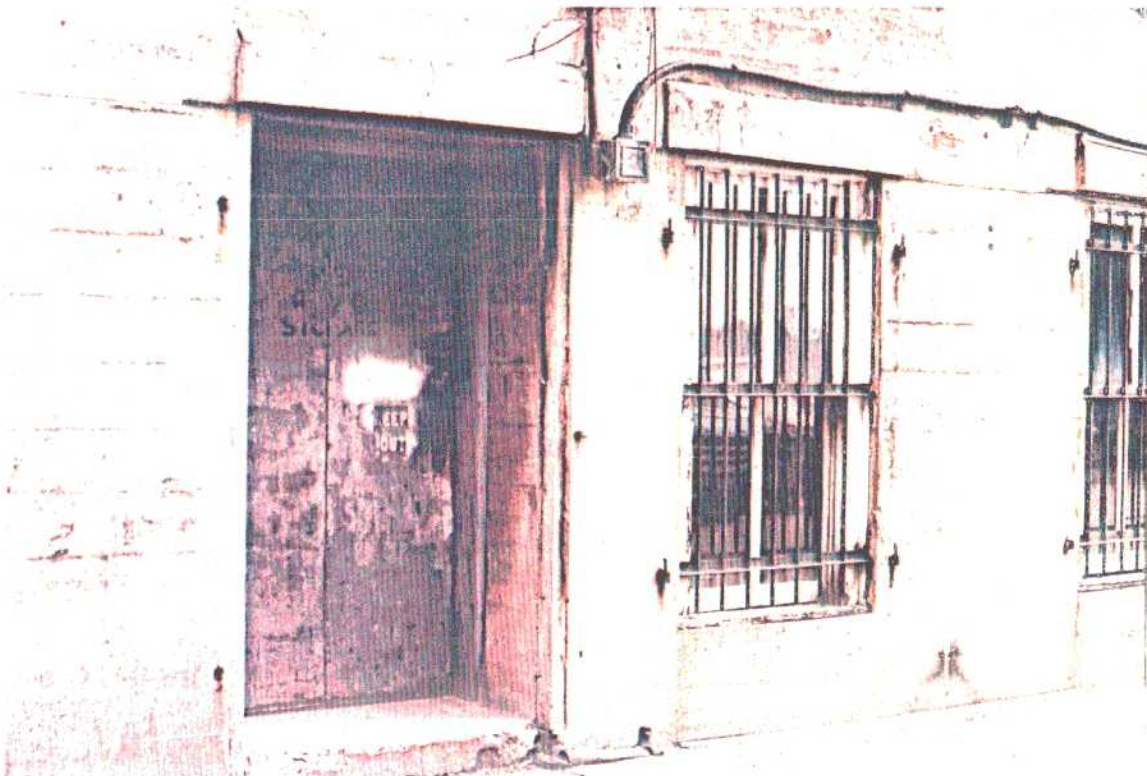
Building #619-inaccessible storage bunker contaminated with DDT; not utilized.

B.L.D.G. 6.19. FLOOR SURFACE CONTAMINATED WITH LEAKAGE FROM PREVIOUSLY STORED PESTICIDES, INCLUDING DDT.

C. BUNKER DEMOLITION - Completely demolish and remove one Bunker, #619 (2,100 square feet total). Back and side walls will remain intact in order that they can continue to function as retaining walls. The foundation will also remain intact. Prior to demolition and selection of disposal method, sampling of leakage remaining from previously stored insecticides is necessary to determine the presence of DDT.

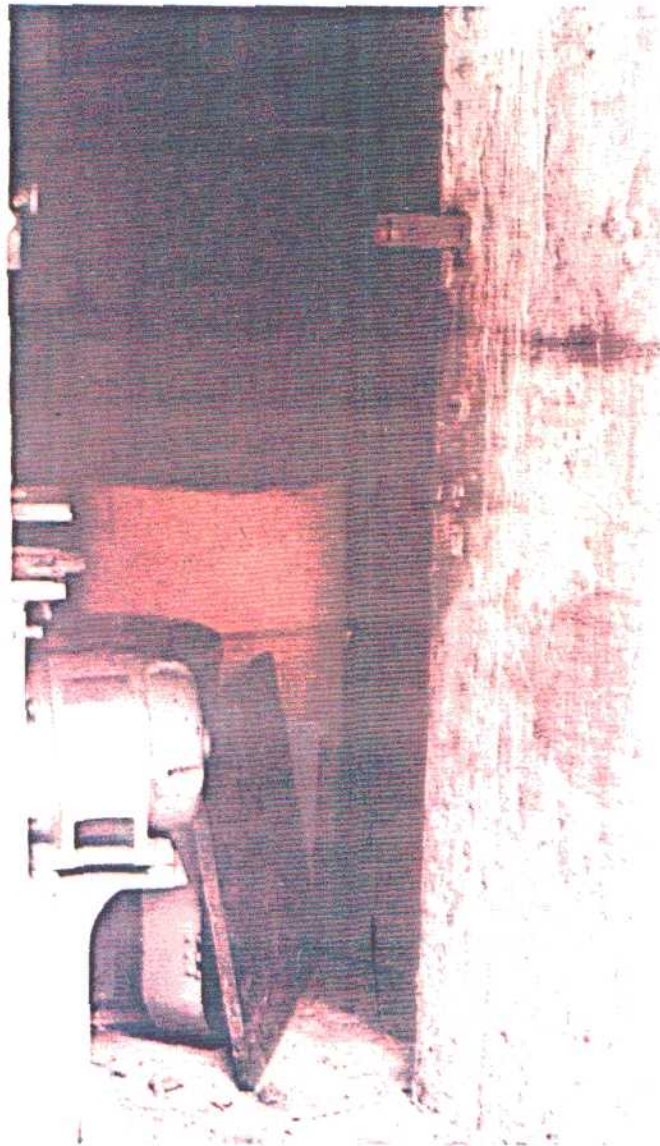
Interior view of Building #619-contaminated storage bunker.

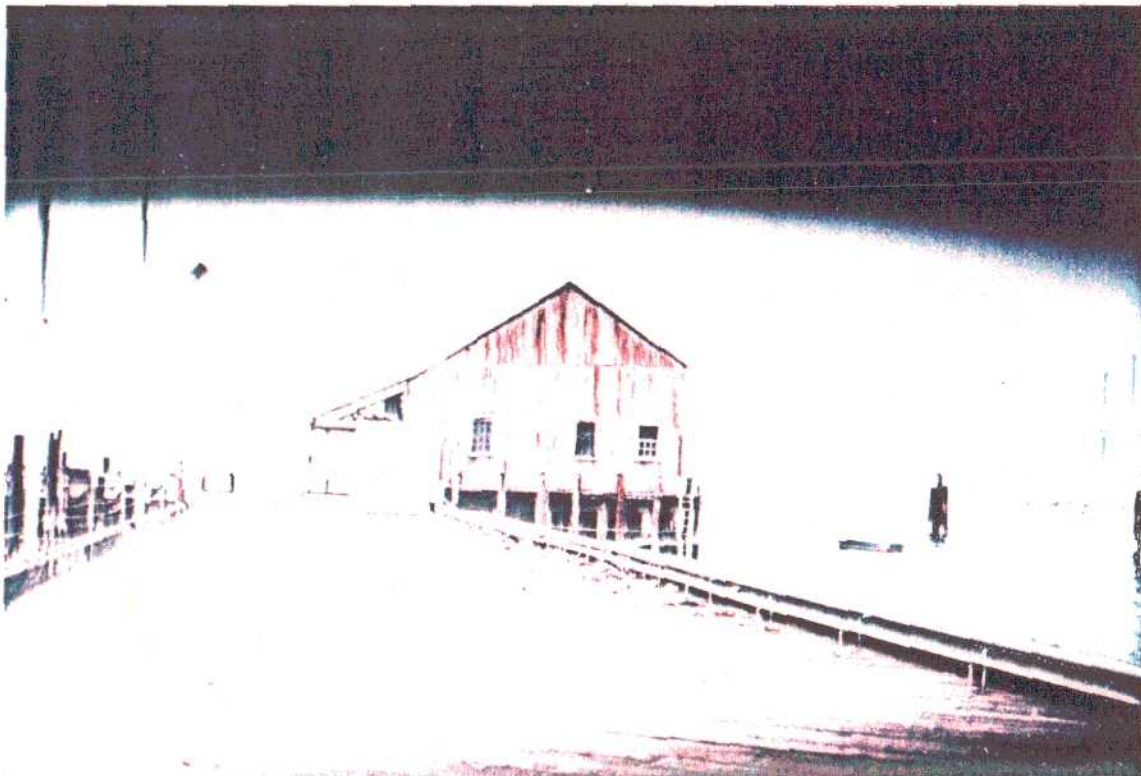
Building #606 in foreground (to be demolished including pile foundation) and portion of Building #607 in background (to be demolished); small white structure is an oily Water Separator Building.

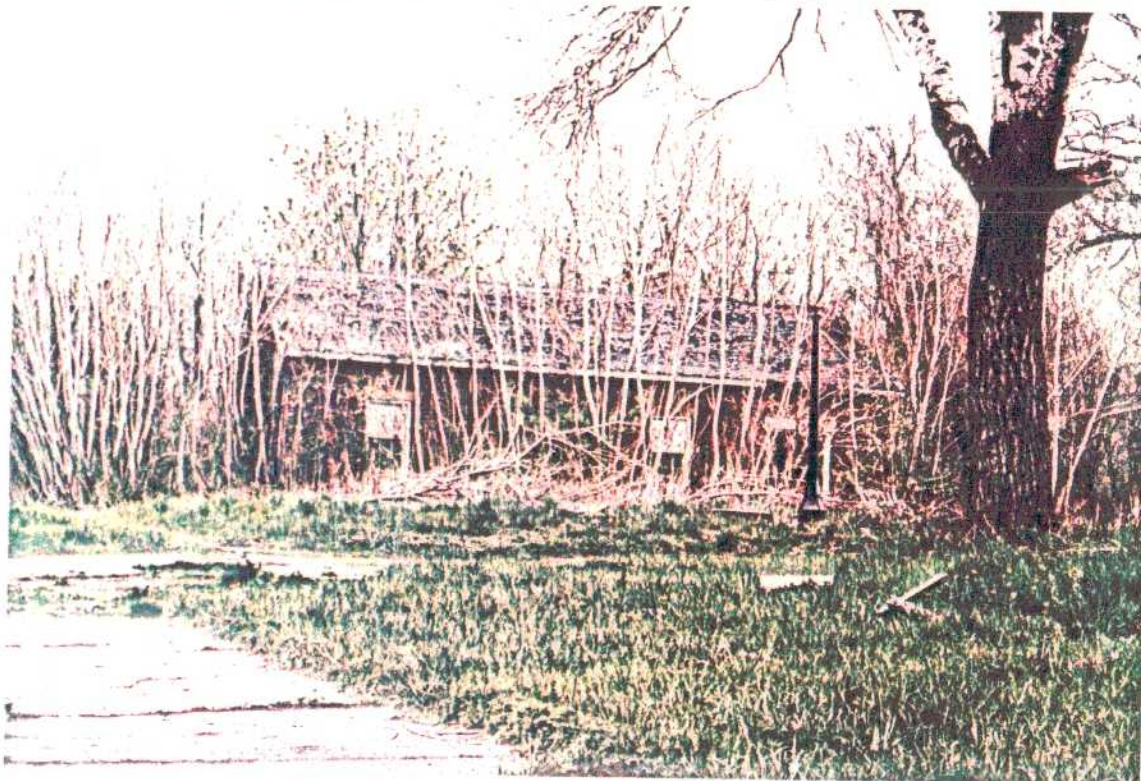
Side view of Building #624

A. BUILDING DEMOLITION - Completely demolish and remove three buildings (#623, #624, and #625) and foundations (3,490 square feet total). Also, remove one boiler and asbestos insulation located in Building #625. Include capping of utilities, backfill and compaction. Prior to demolition and selection of disposal method, sampling of insulation used in Building #625 is necessary to determine the presence of asbestos.

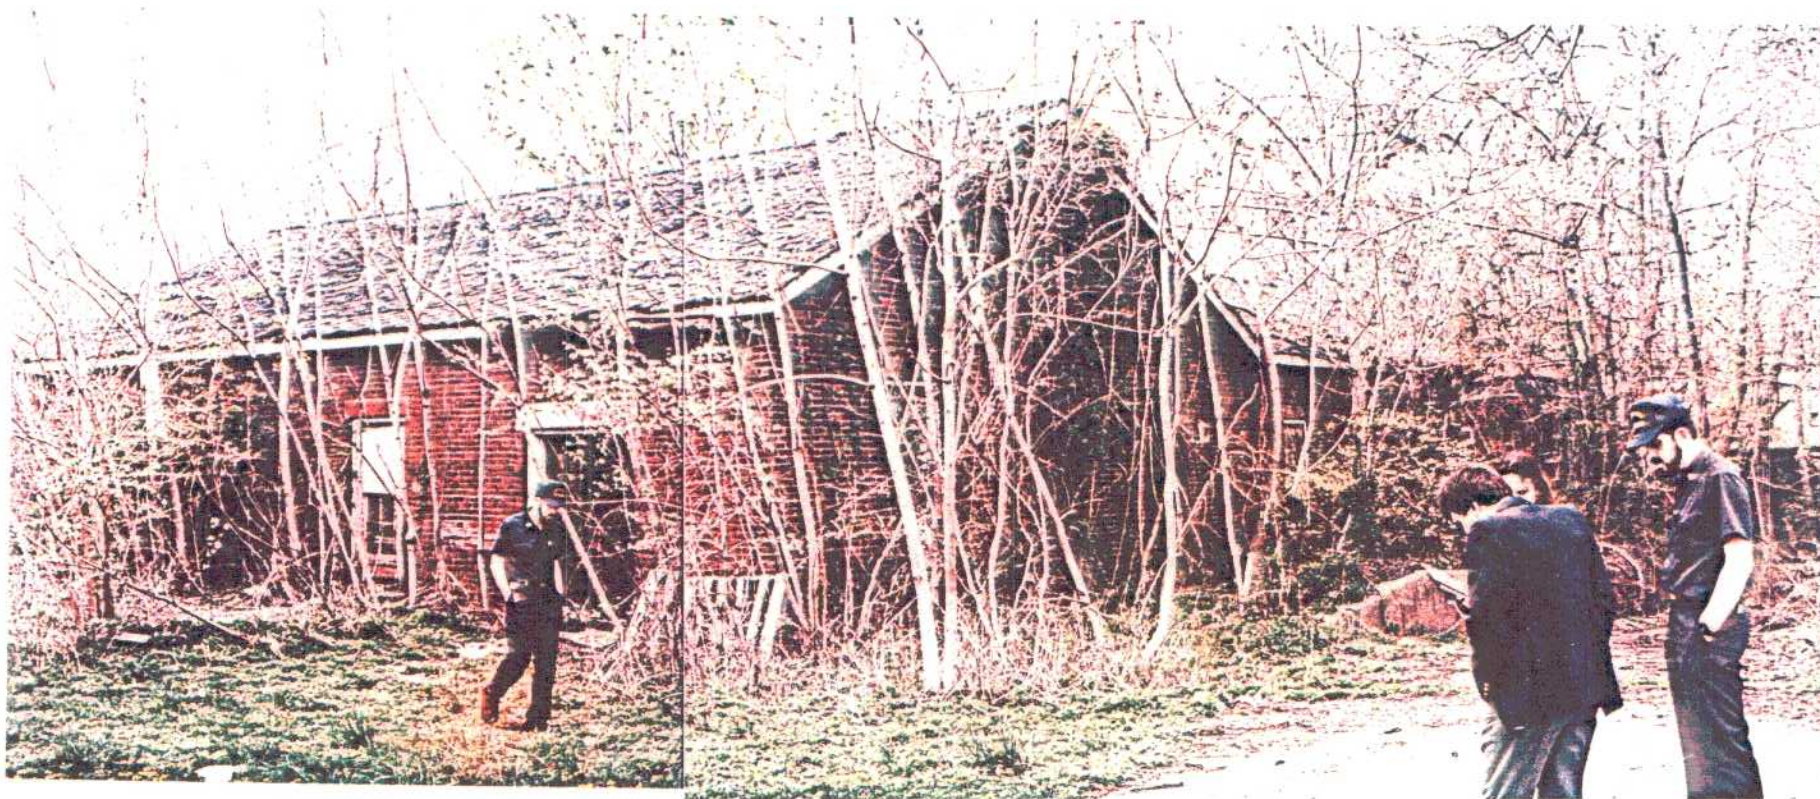
Front and side view of Building #624 formerly used as an ordnance repair shop; not utilized.

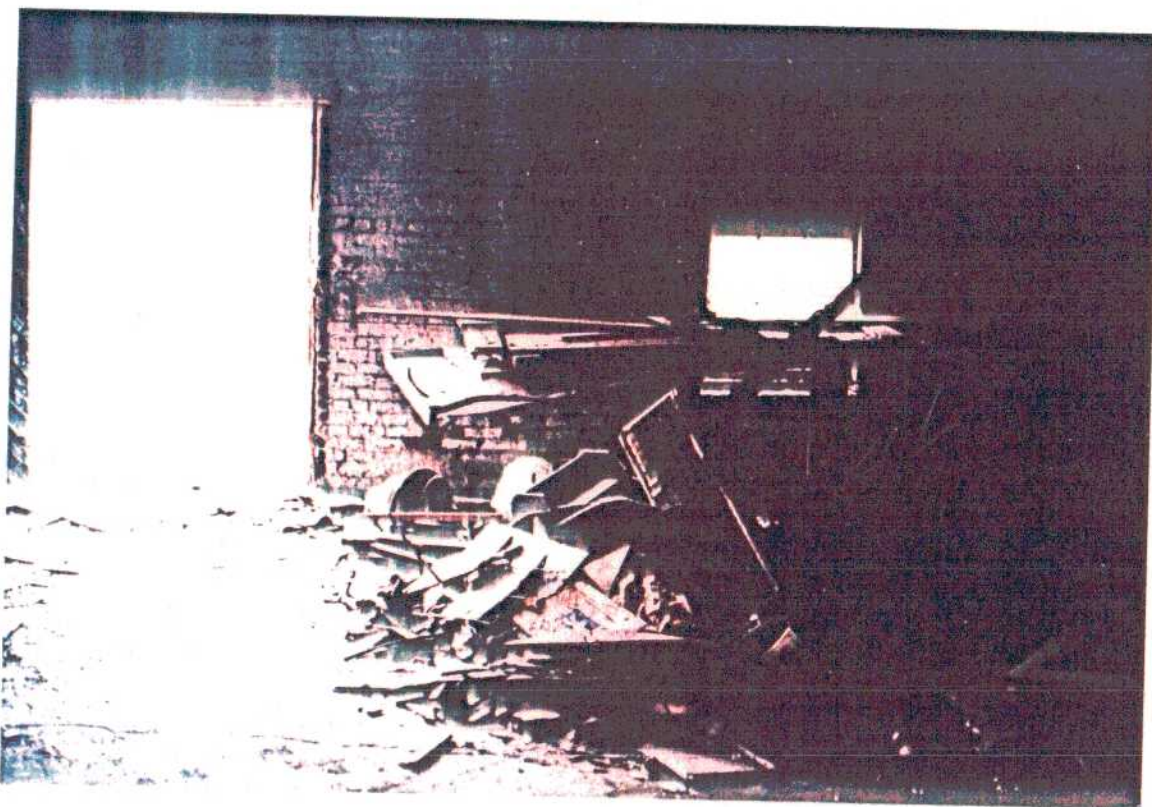
Interior of Building #624.

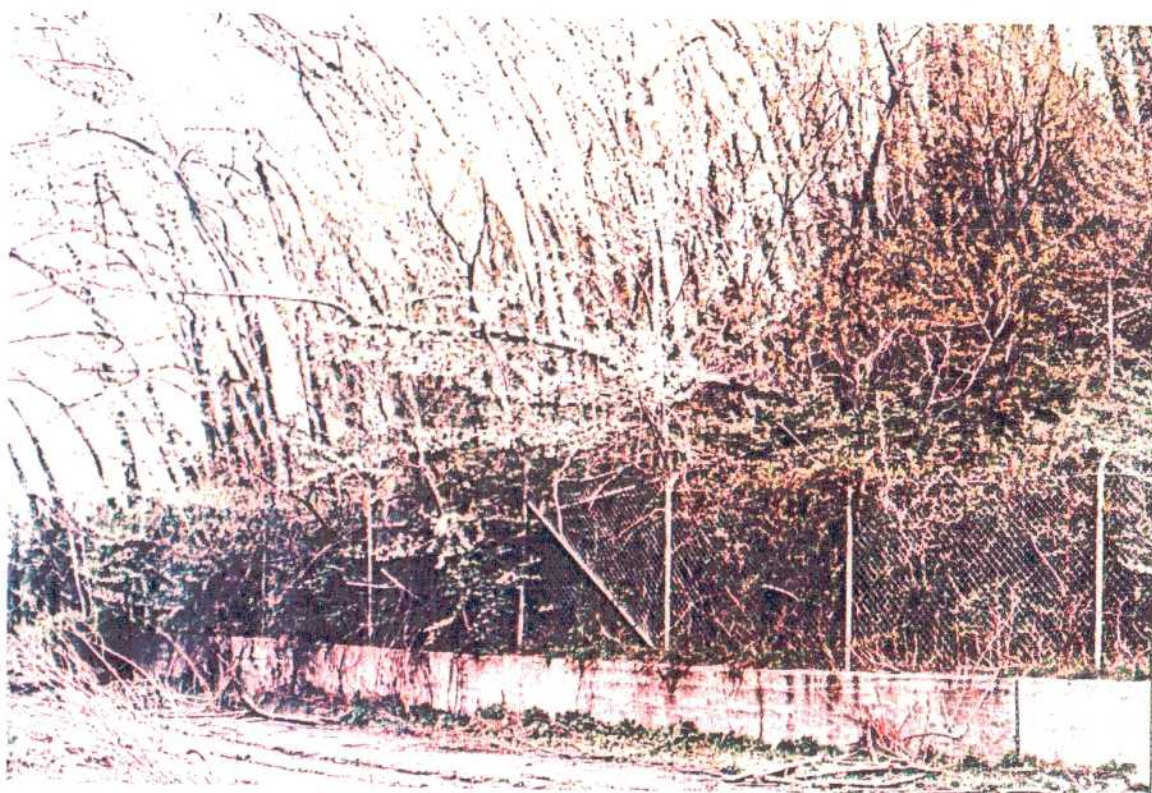
Army property on which live ordnance was found, adjacent to Coast Guard property.
